Figure 6 – Photos exhibiting typical conditions along recently constructed hiking trail: 6.1) Trail Through Mature Forest, 6.2) Side-hill Trail Construction, 6.3) Treadway Stabilized by Mosses and Outsloping, and 6.4) Recently Constructed Trail Segment Stabilized by Vegetation.

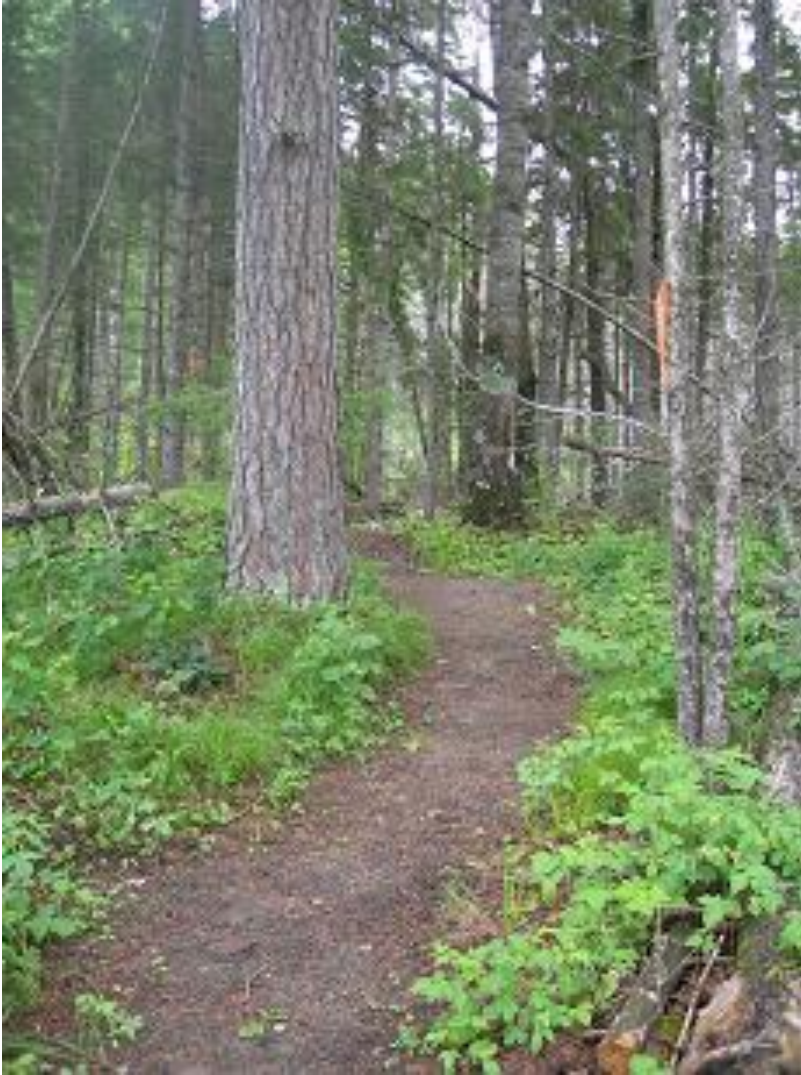
Figure 6.1 -- Trail Through Mature Forest.

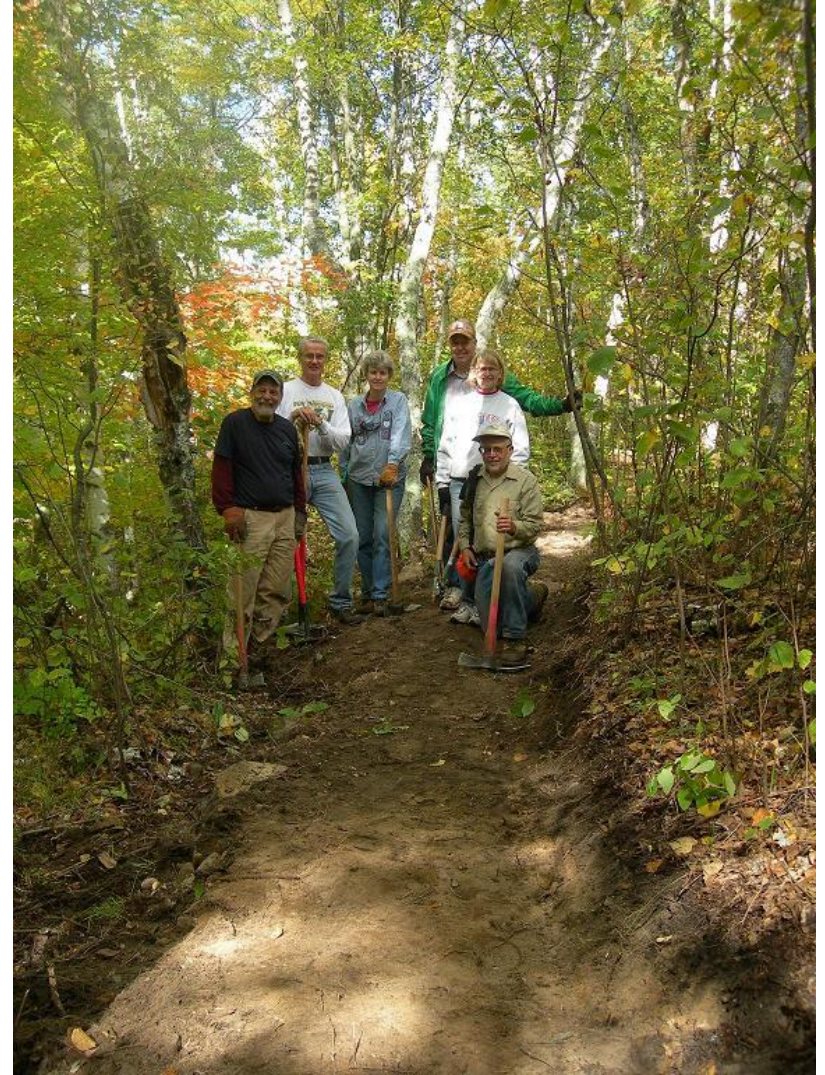
Figure 6.2 -- Side-hill Trail Construction.

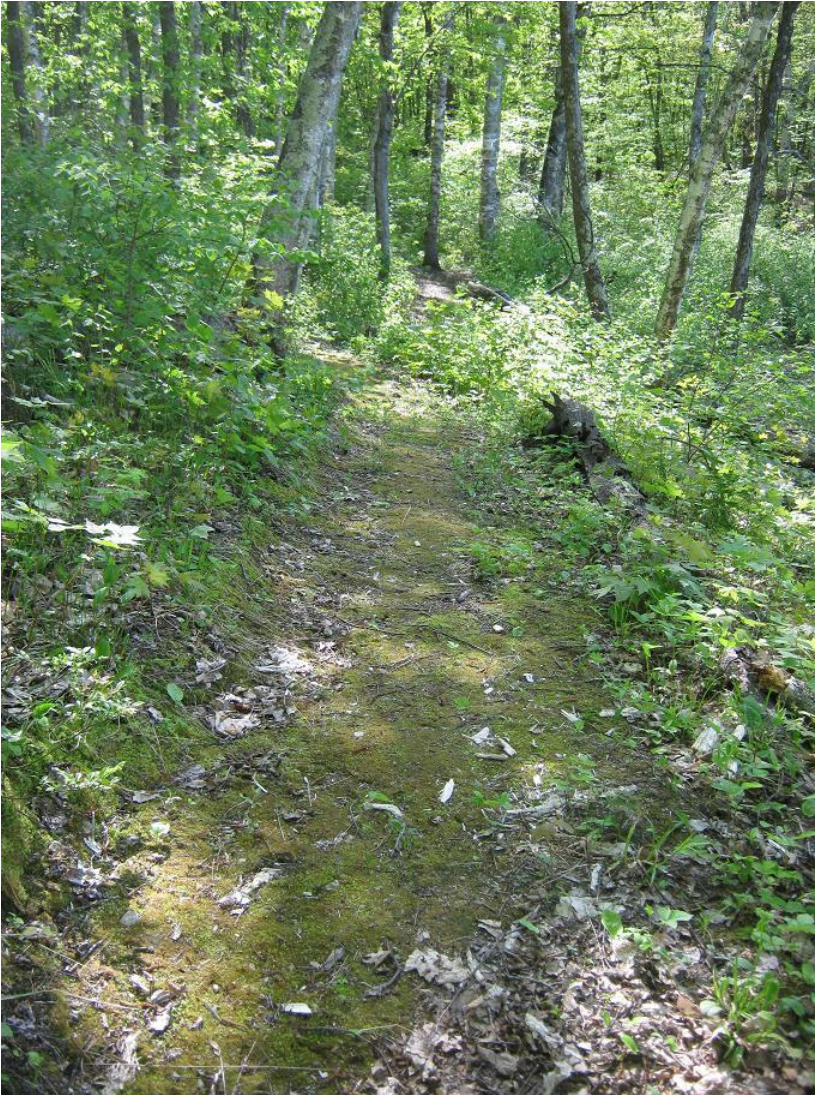
Figure 6.3 -- Treadway Stabilized by Mosses and Outsloping.

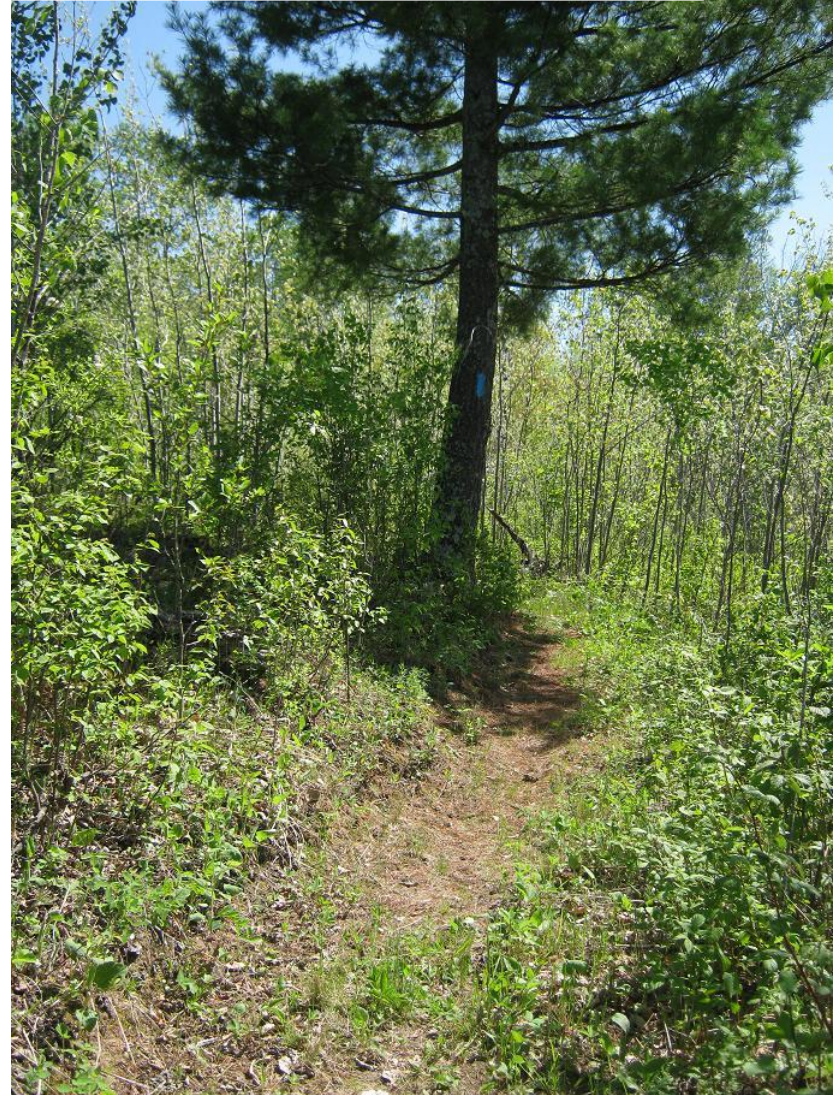
Figure 6.4 -- Recently Constructed Trail Segment Stabilized by Vegetation.
