Minnesota Department of Natural Resources
Minnesota Board of Water and Soil Resources

Appendix B: 2020 Legacy Fund Restoration Evaluation

Report March 2020

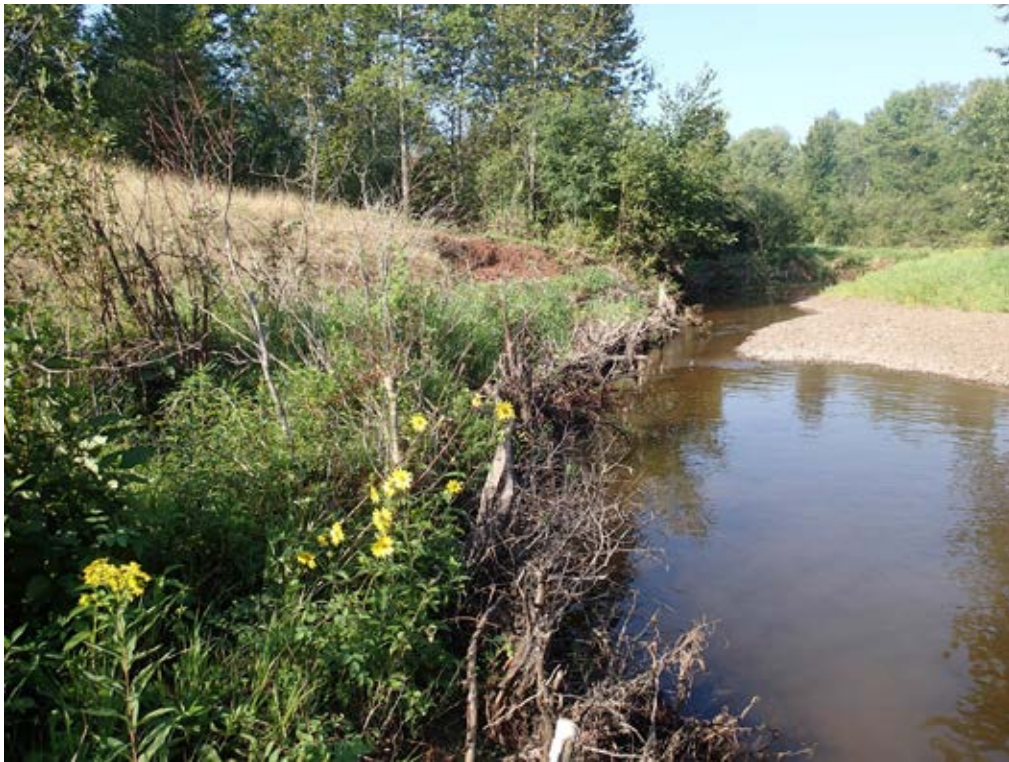
Photo 4-7 Toewood rootwads and vegetation growth, facing downstream during low water conditions. Site visit 08/24/2012.

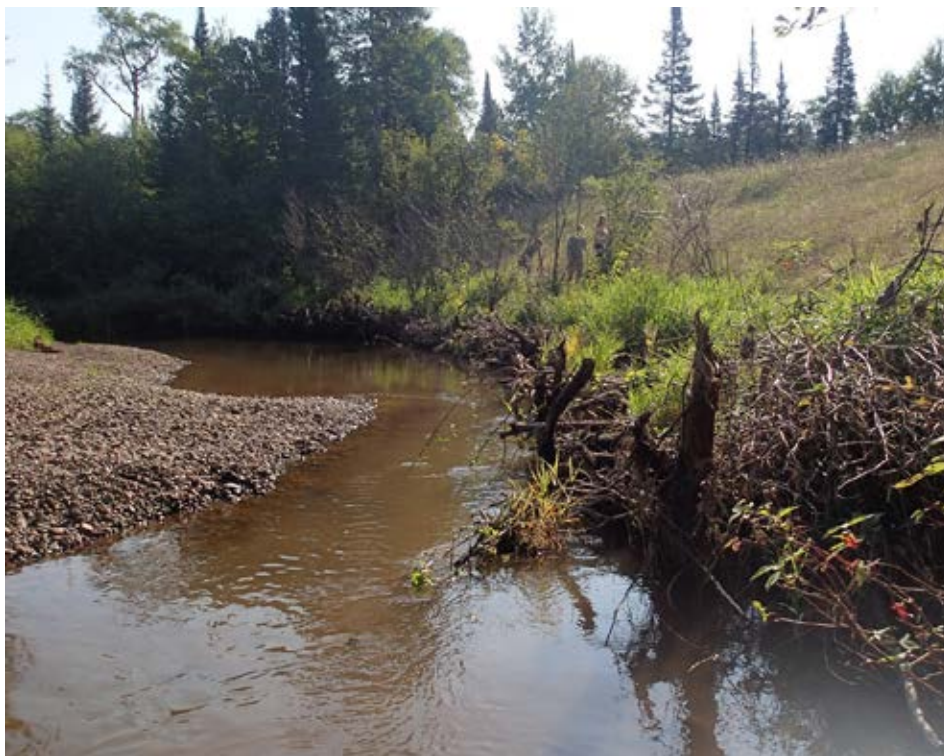
Photo 4-8 Toewood rootwads and first year's vegetation growth on slope. Facing upstream during low water conditions. Site visit 08/24/2012.

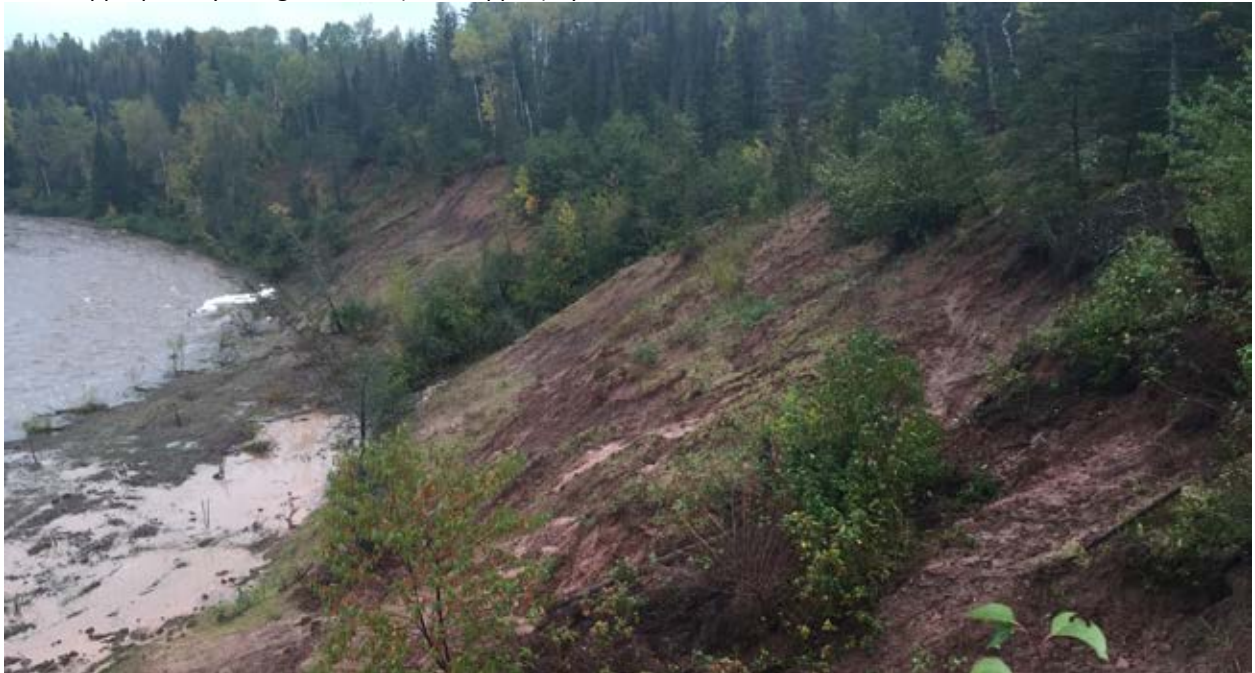
Figure 5-6 - Representative image of stabilization (bluff). As visible in photograph, the attempt to establish vegetated cover on the clay bluff in question (right side of image) via hydroseeding is showing early signs of failure. It is acknowledged though that the primary project means for reducing sediment from the bluff is the realignment of the stream away from the bluff and the creation of a stable bluff toe and associated bankfull bench. Date 09/24/2015.

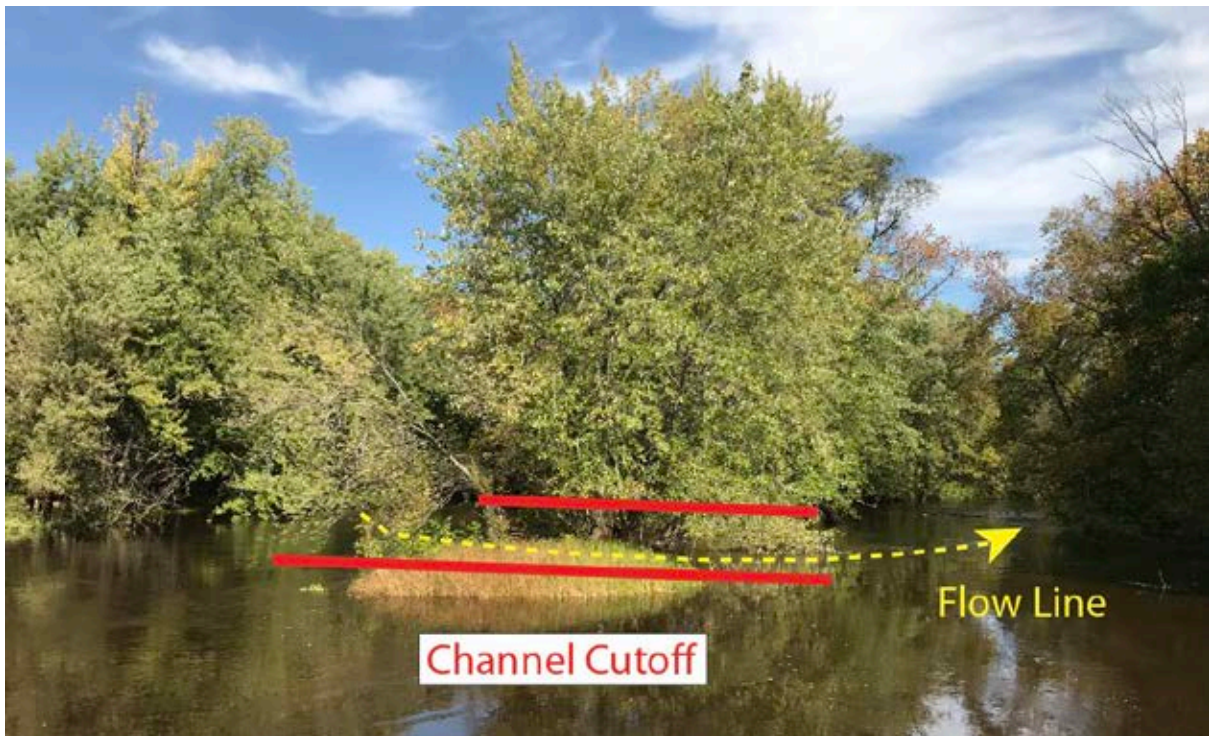
Photo 8-7 Point bar by-pass channel through the inside bend of the meandering channel to allow high flow to short-cut across the inside bend instead of the natural flow path through the outside bend, (Photo taken by Lucius Jonett during site visit 09/19/2019).

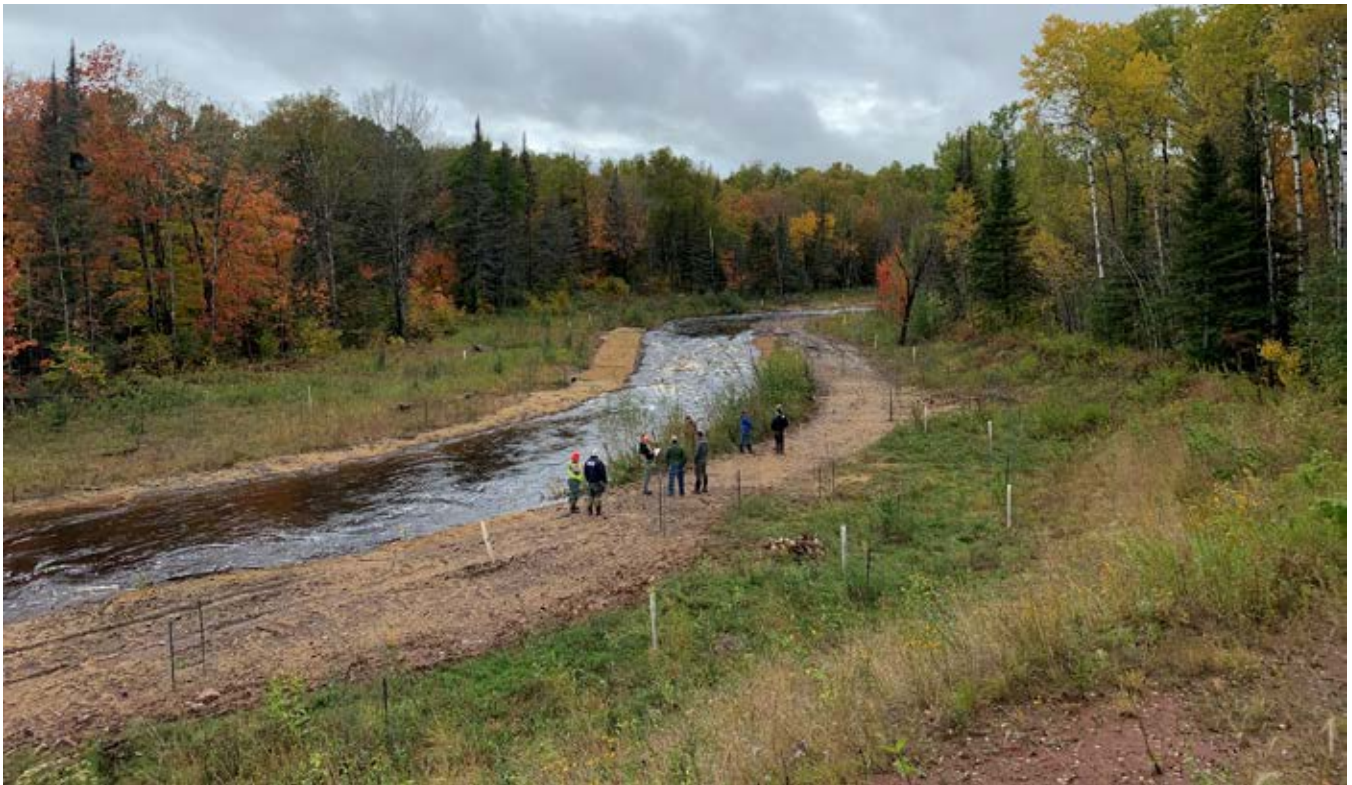
Photo 9-5 Disturbance and associated site restoration that parallels both side of the stream is a product of 2018-19 repairs and modifications. Photograph taken by Kevin Biehn during 10/1/2019 site visit.

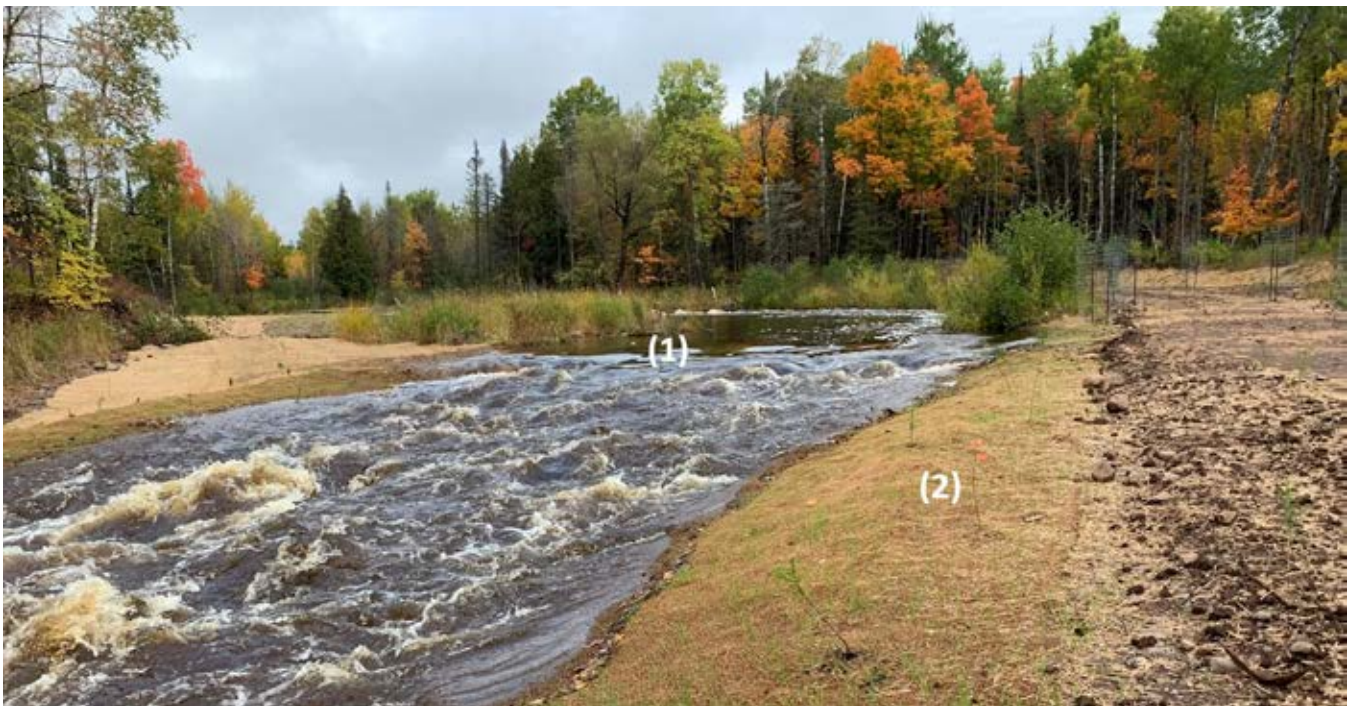
Photo 9-6 Representative image of high gradient segment of river and repaired grade control structure (1) looking upstream. Note saplings recently planted along stream edge (2). Photograph taken by Kevin Biehn during 10/1/2019 site visit.

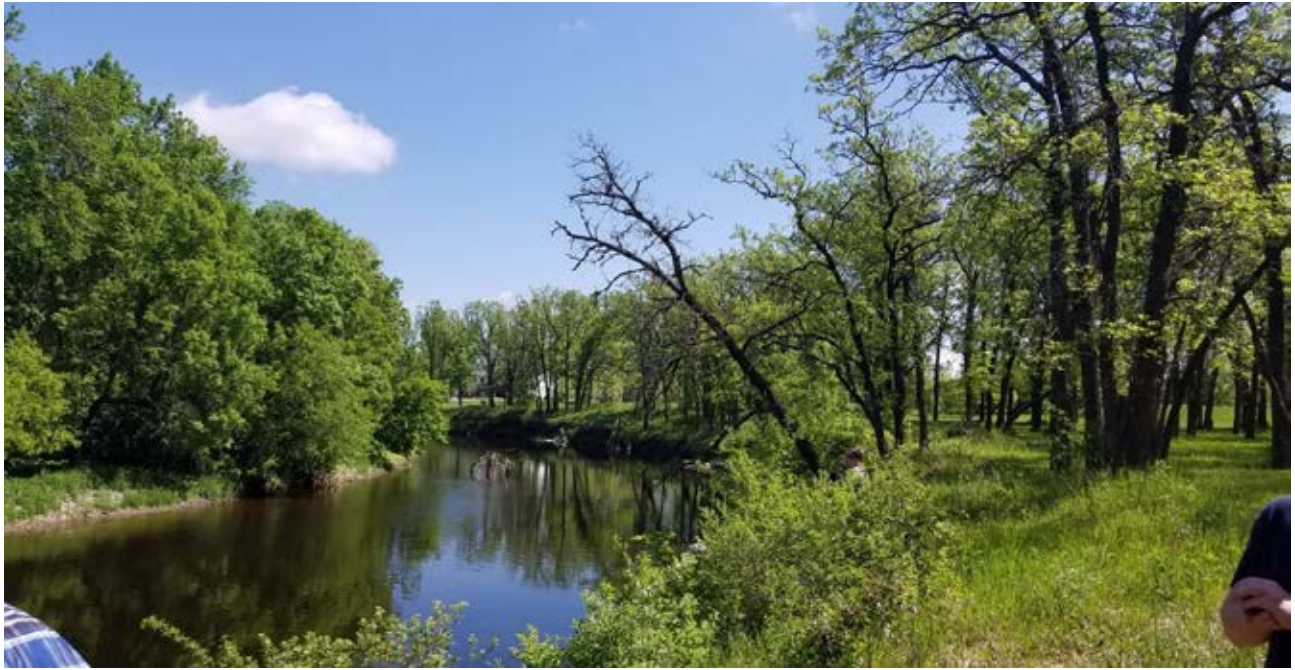
Photo 11-1 Upstream view of stream barbs 3 and 4 with some bare slopes downstream and trees leaning over the river. It is recommended to install live stakes on the bare slopes, provide a buffer to the top of the bank, and remove the leaning trees and limbs. Photo taken by Ed Matthiesen during site visit (6/5/2019).

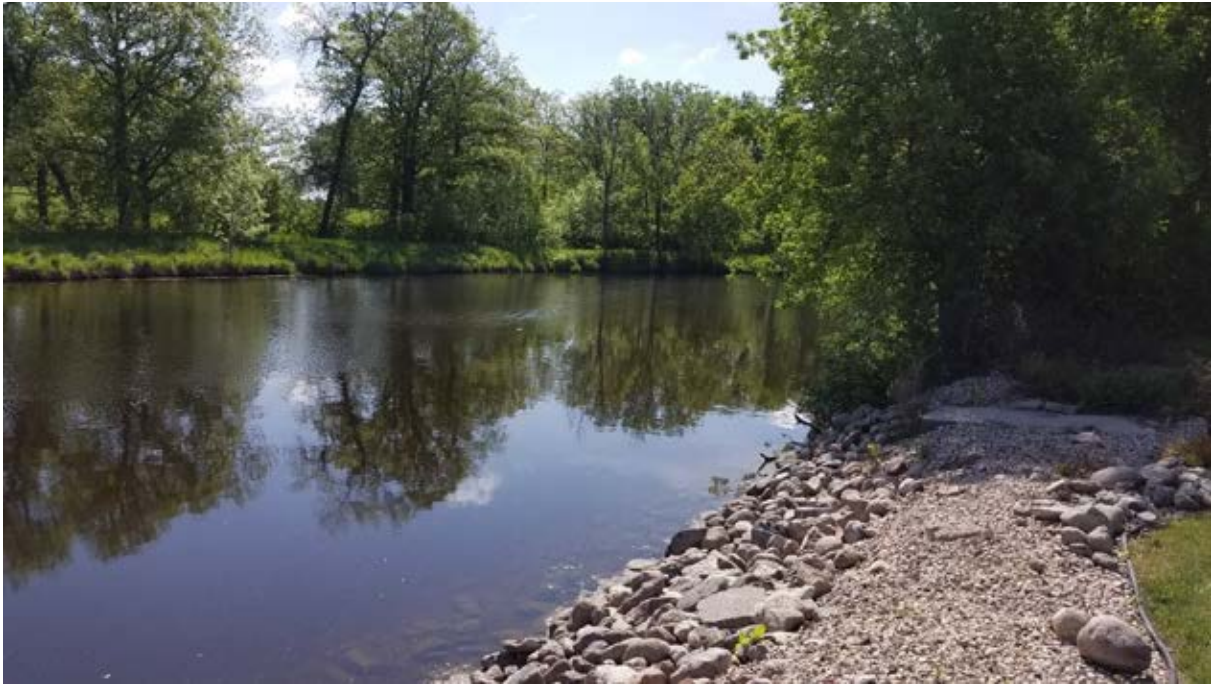
Photo 12-1 Upstream view of 0+25. It is recommended to consider vegetated riprap on slopes. Photo taken by Ed Matthiesen during site visit (6/5/2019).

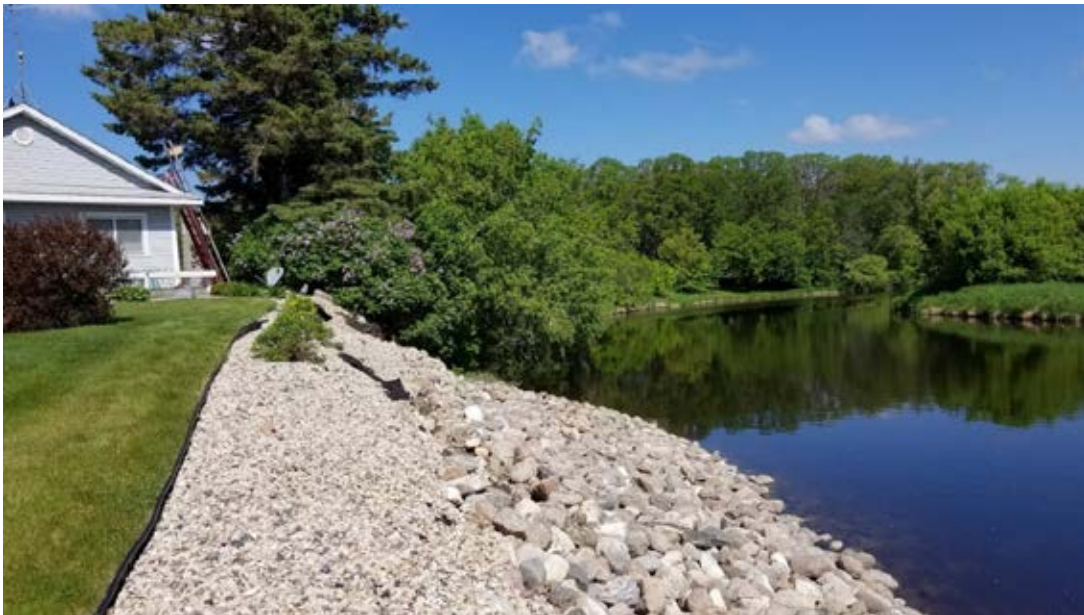
Photo 12-2 Downstream view from 0+50. There is a slope failure present on the upper slope resulting from a freeze-thaw or a quick drop in water level. It is recommended to add biological improvements. Photo taken during site visit 06/05/2019.

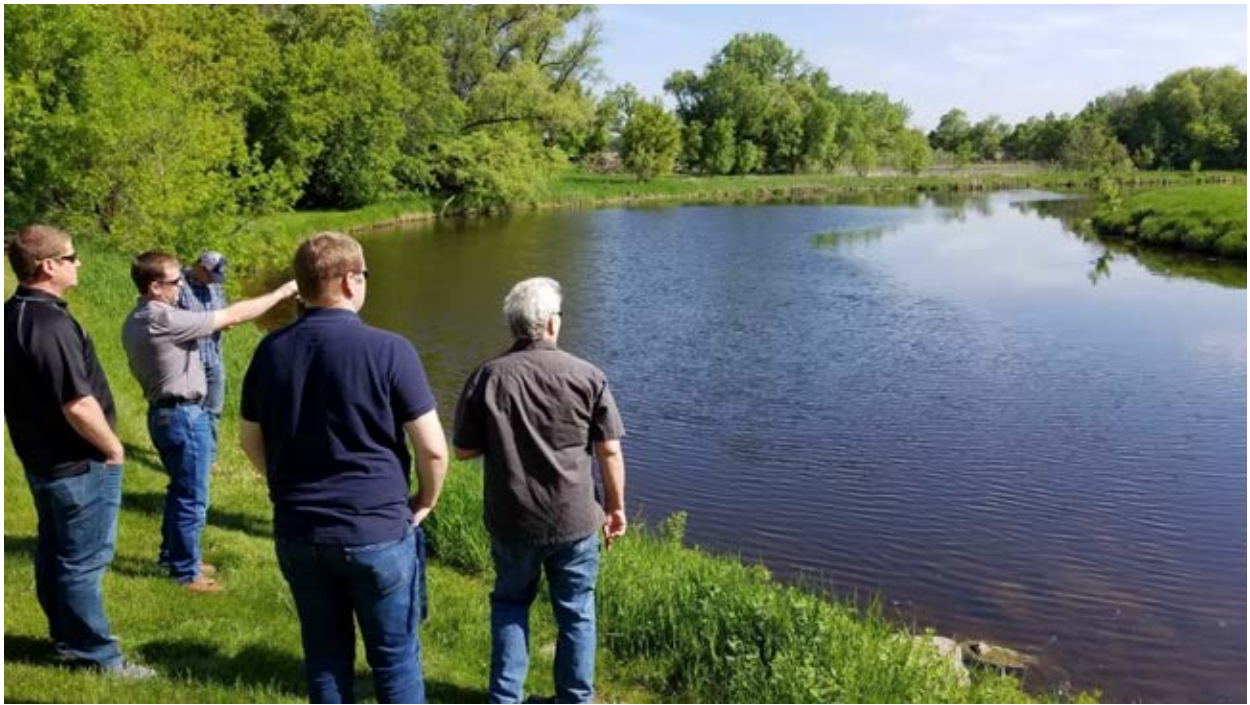
Photo 12-3 Downstream view of Stream Barb #1. Slopes of both banks are stable. There is an NRCS-type vane redirecting flow. Photo taken during site visit 06/05/2019.

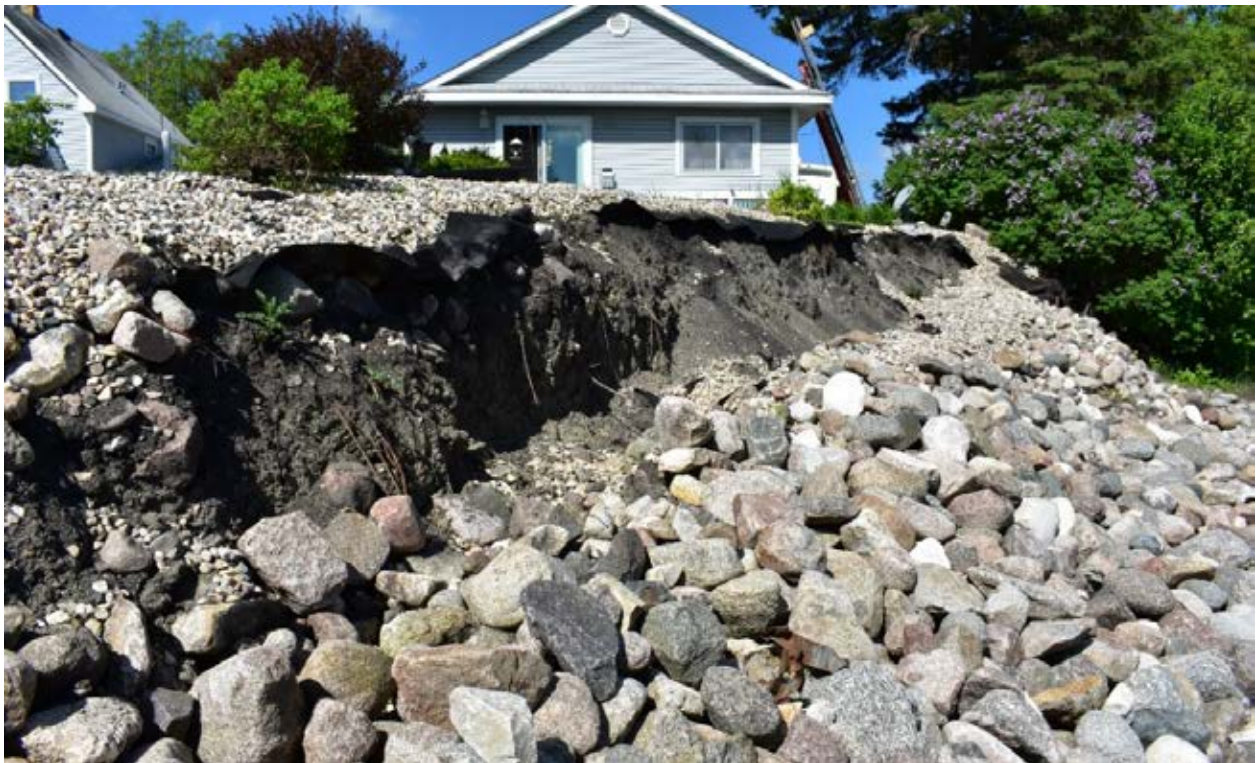
Photo 12-4 View of the disturbance at the top of the streambank which may be signs of a rotational failure or slump. Regrading of this ridge back toward the homes is recommended along with revegetation on the new slope. Photo taken during site visit 06/05/2019.

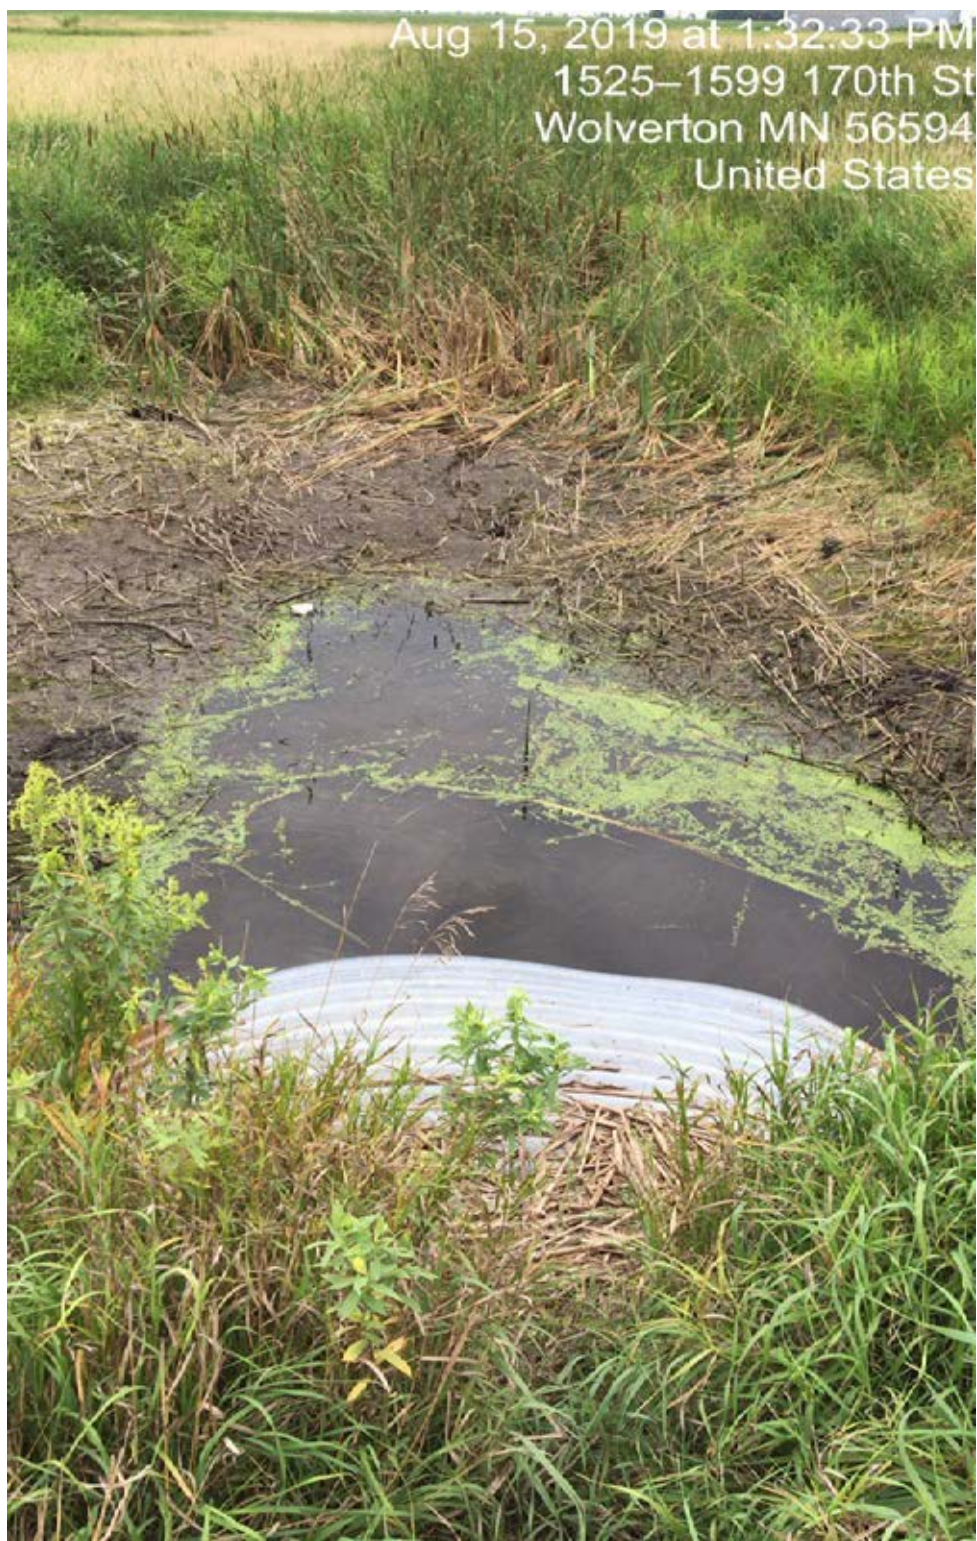
Photo 13-6. View of existing condition at a location just upstream from the Phase 1 construction. Water is stagnant and channel is choked with sediment and vegetation. Photo taken by Anna Varian during site visit (8/15/2019).

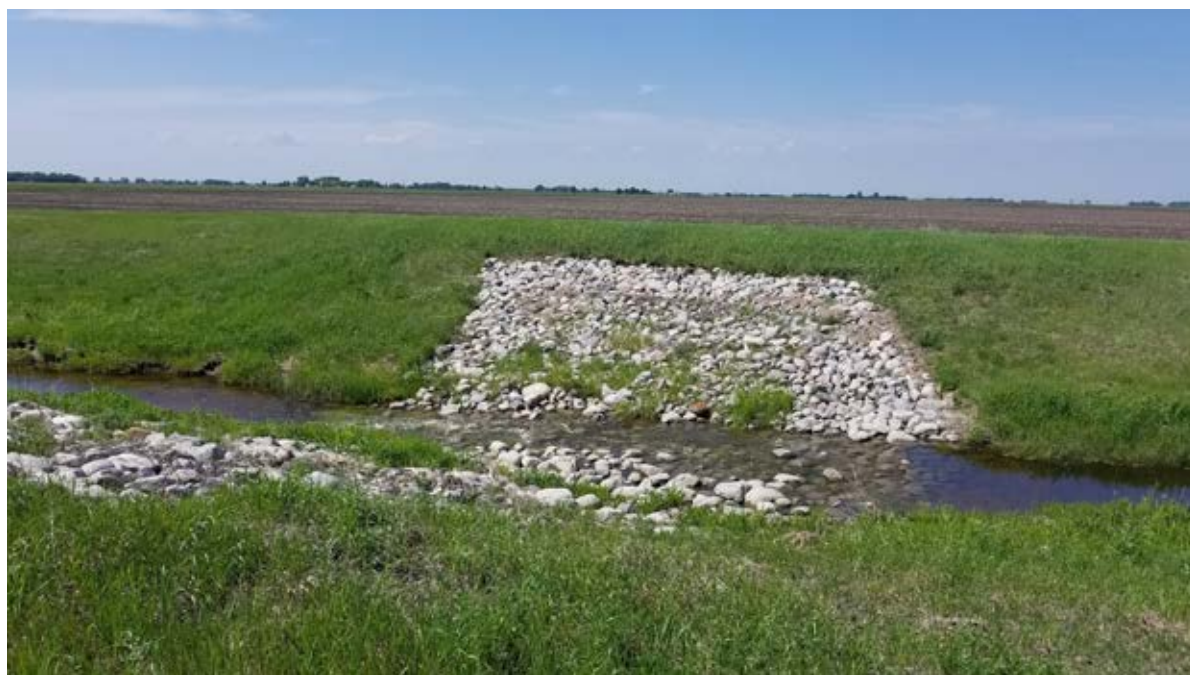
Photo 14-2 View of Burnham Creek riffle #3. Creek is 1-2 channel widths upstream (right) and 2-5 channel widths downstream (left). It is recommended to add live stakes. Photo taken by Ed Matthiesen during site visit (6/4/19).

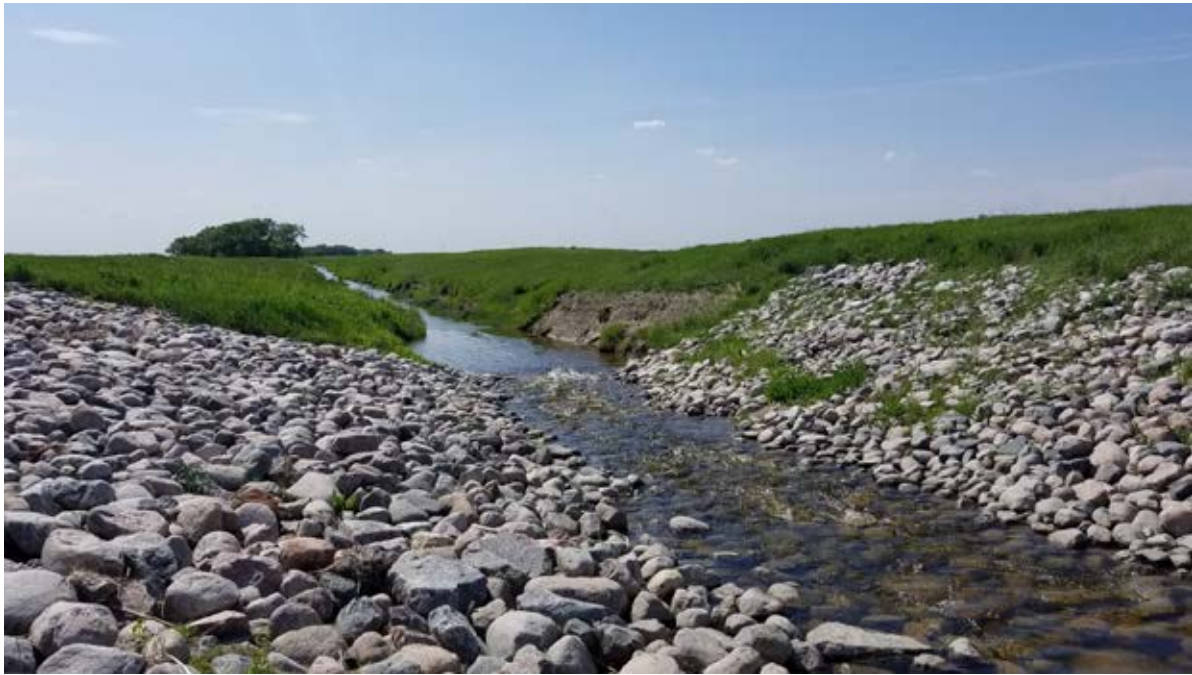
Photo 14-3 View of Burnham Creek riffle #4. Creek is 1-2 channel widths upstream (right) and 2-5 channel widths downstream (left). It is recommended to add live stakes to 2 channel widths downstream. Photo taken by Ed Matthiesen during site visit (6/4/19).

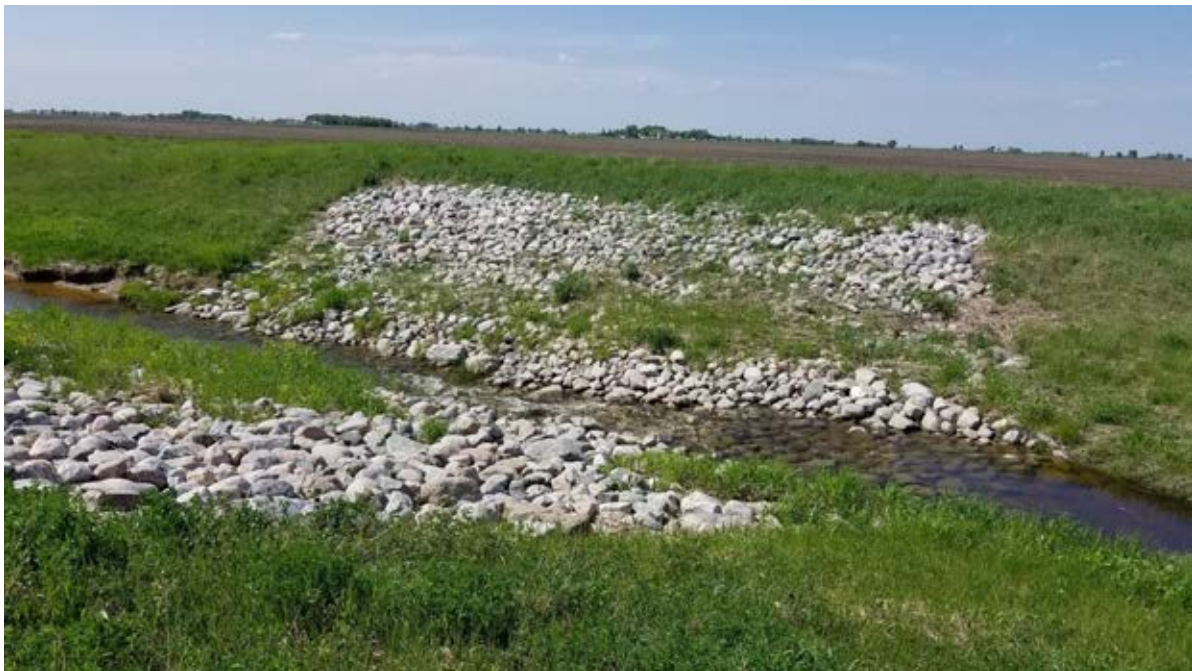
Photo 14-4 Upstream view of riffle #5. Creek is 1-2 channel widths upstream (right) and 2-5 channel widths downstream (left). It is recommended to add live stakes. Photo taken by Ed Matthiesen during site visit (6/4/19).

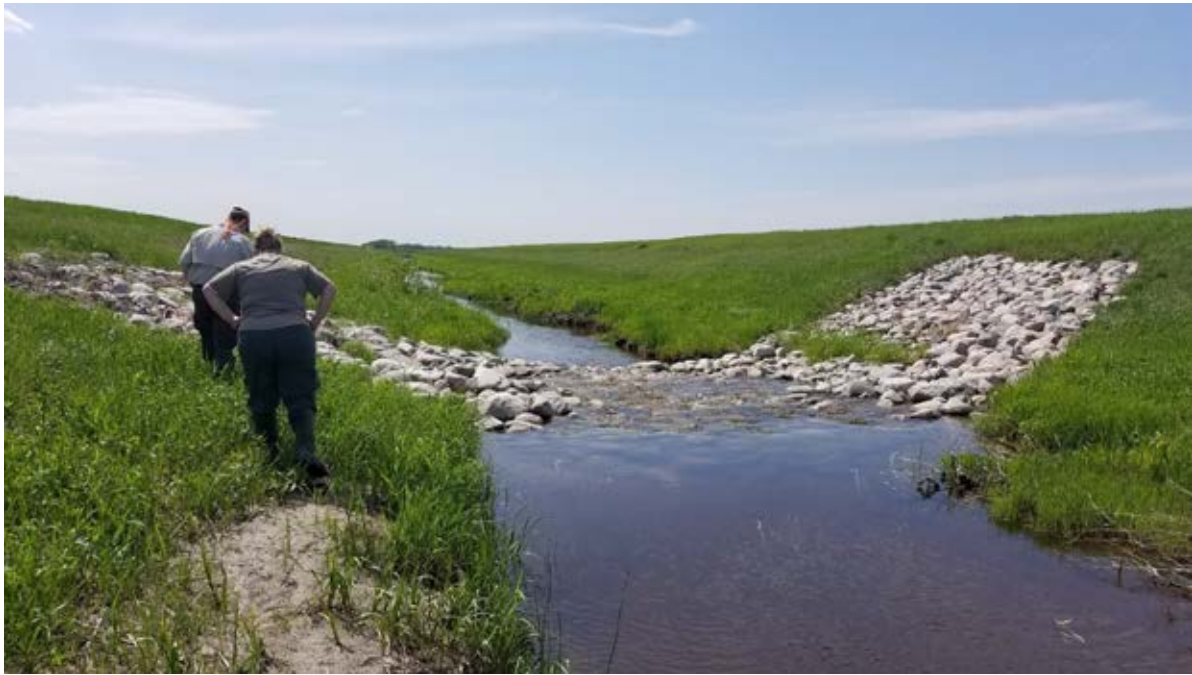
Photo 14-5 Upstream view of riffle #8. Creek is 1-2 channel widths upstream (front) and 2-5 channel widths downstream (back). This riffle is meeting project goals of reducing bank erosion. Photo taken by Ed Matthiesen during site visit (6/4/19).

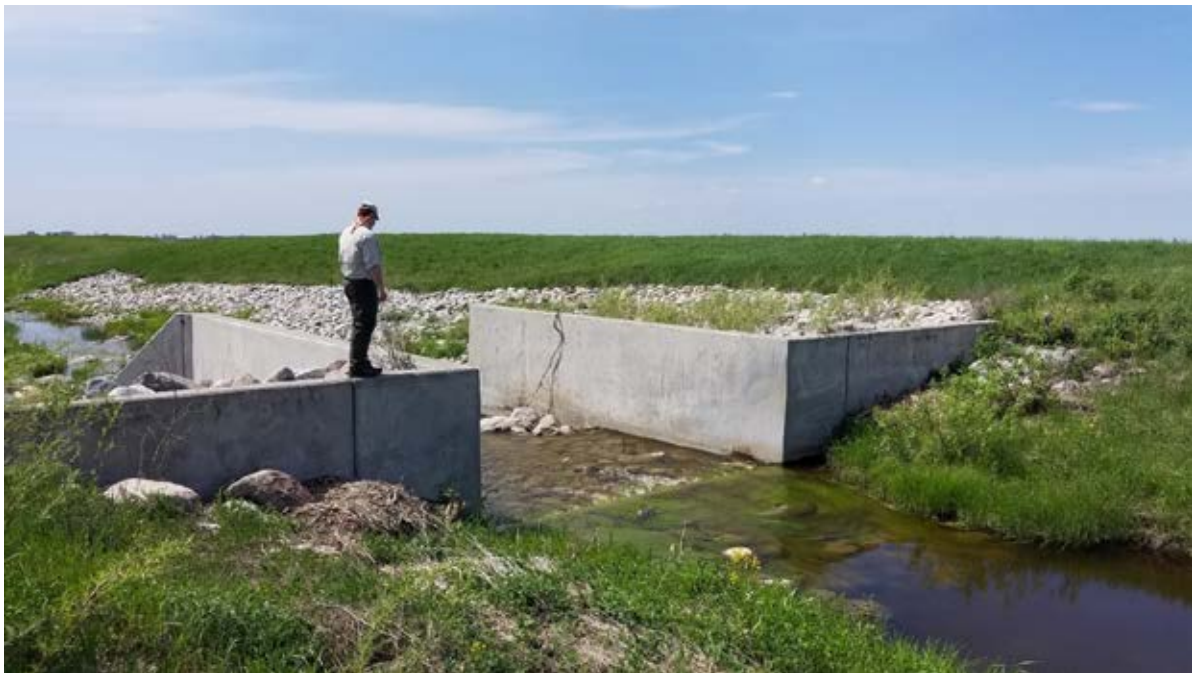
Photo 14-6 Upstream view of NRCS Rock Flume at project location 1502+00 on Burnham Creek. It is recommended to reduce the rise of the structure to less than 12 inches. Photo taken by Ed Matthiesen during site visit (6/4/19).

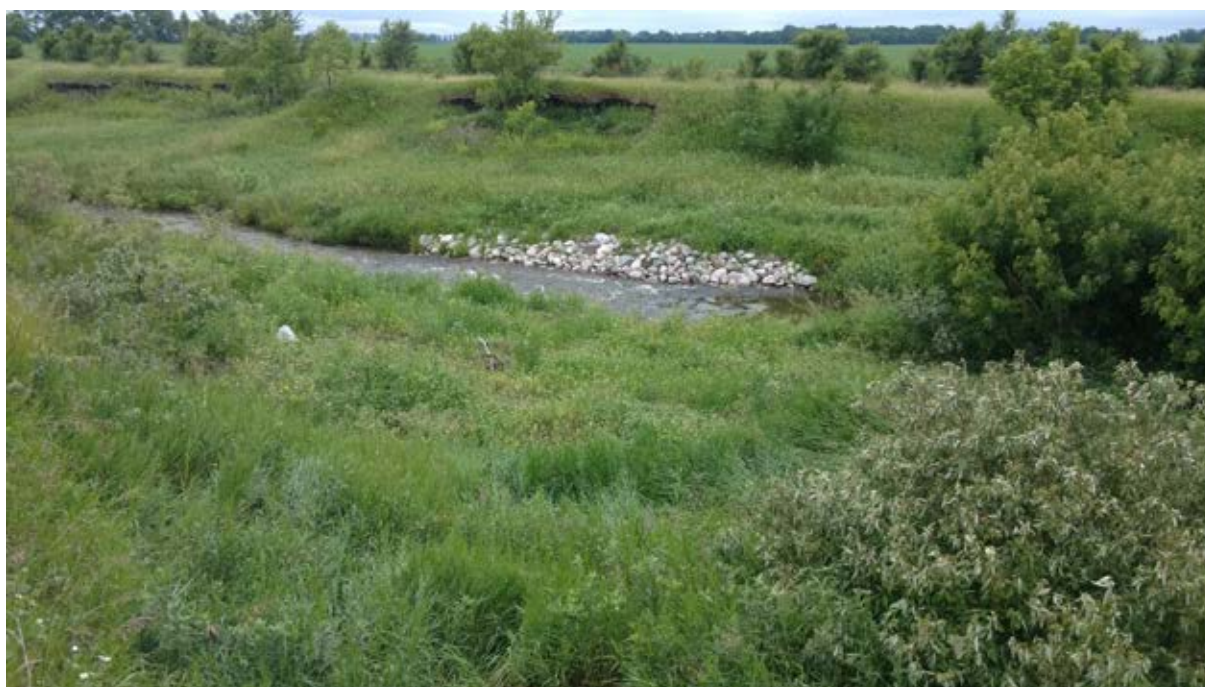
Photo 15-2 View of constructed riffle at project station 91+85. Pre-existing bank slump failures are still visible in the background. Photo taken by others during a post-construction, final inspection (6-29-2017).

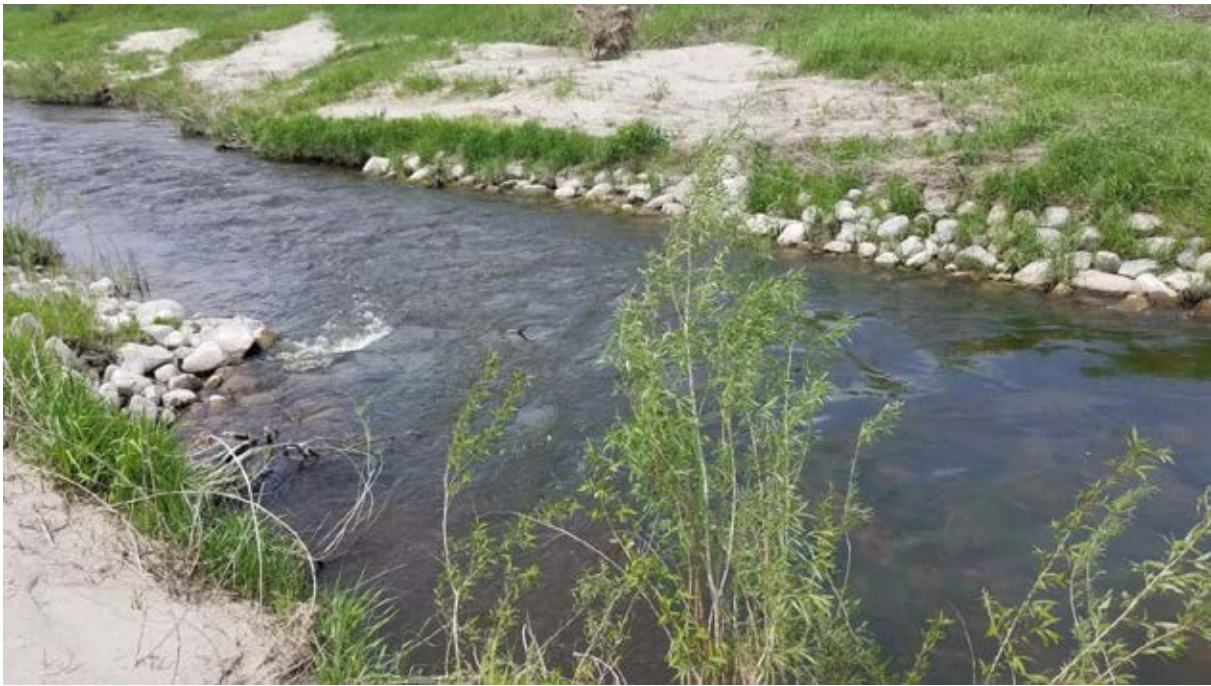
Photo 15-3 Upstream view of riffle #12. Note the sand accumulation. An observed opportunity for improvement is to add sandbar willow. Photo taken by Ed Matthiesen during site visit (6/4/2019).

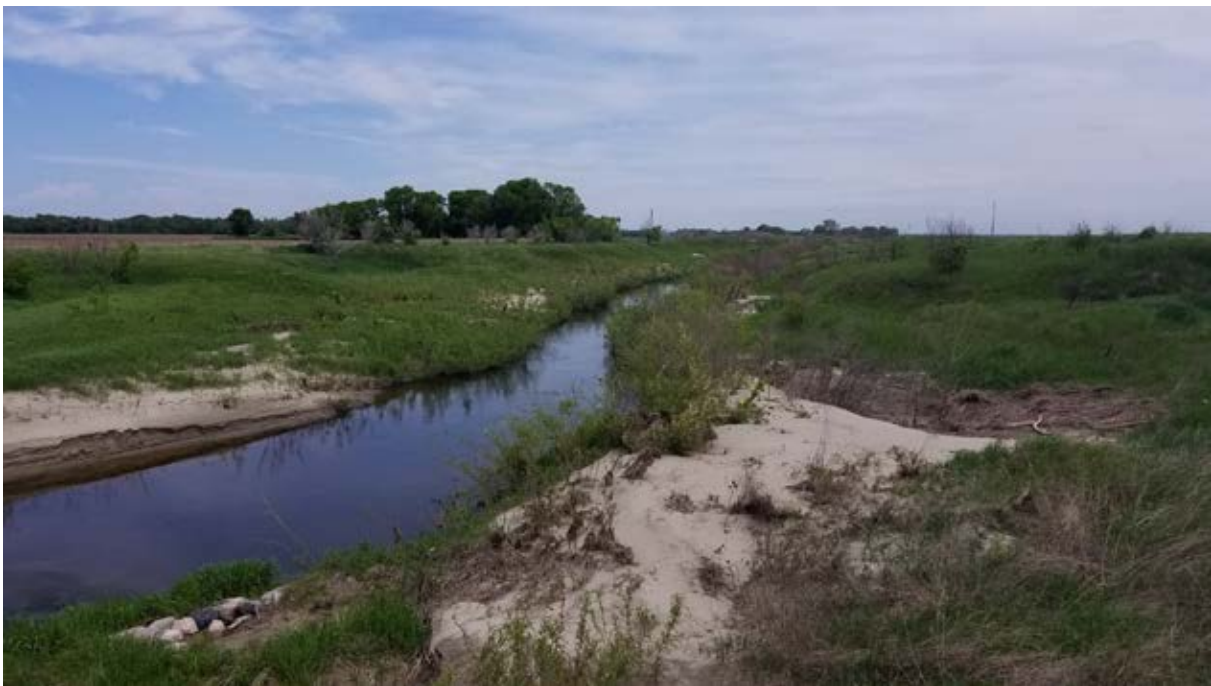
Photo 15-4 Upstream view of riffle #13. Note erosion on the bare bank (left). An observed opportunity for improvement is to add sandbar willow. Photo taken by Ed Matthiesen during site visit (6/4/2019).

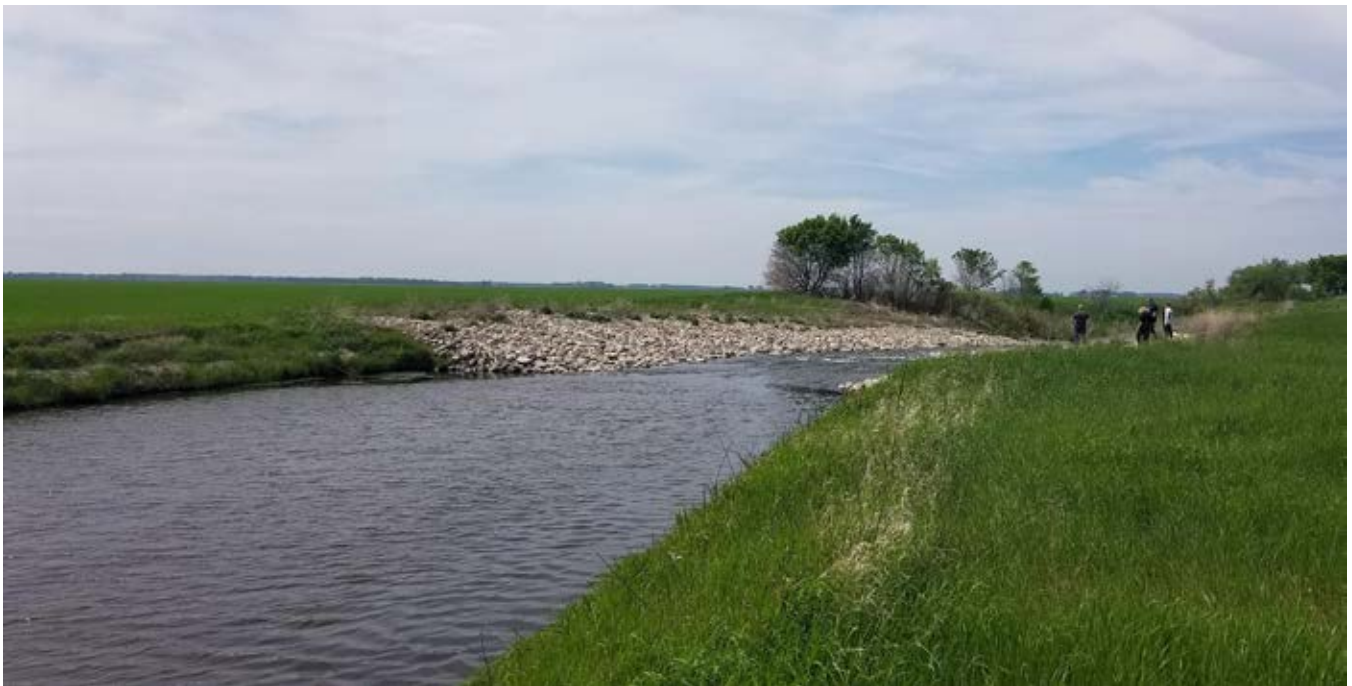
Photo 16-10 Upstream view of fishway ramp #3 with well-established vegetation and no noted erosion on the banks. Photo taken by Ed Matthiesen during site visit (6/4/2019).

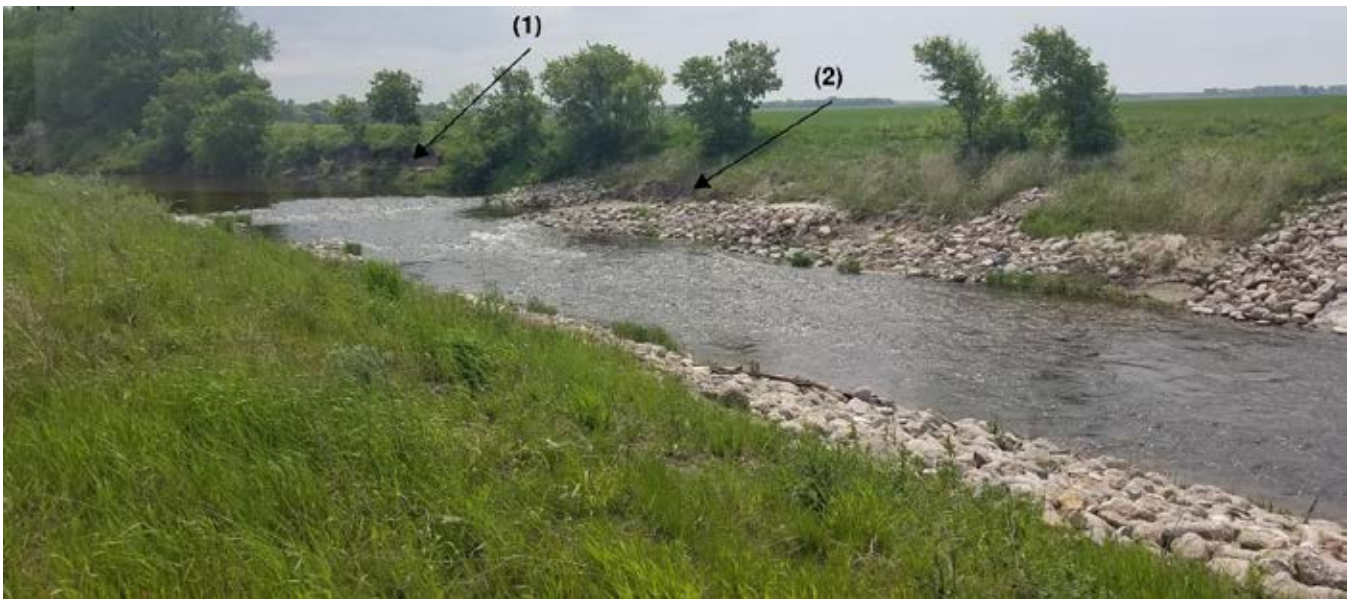
Photo 16-11 Sand Hill River fishway ramp #4 after the original drop structure was modified for fish passage. Upstream of the project area a washout is visible (1). Washout area will be repaired after the culvert connecting the reach to a side channel is addressed. There are also limited bare spots that could be reseeded in the project area (2). Photo taken by Ed Matthiesen during site visit (6/4/2019).

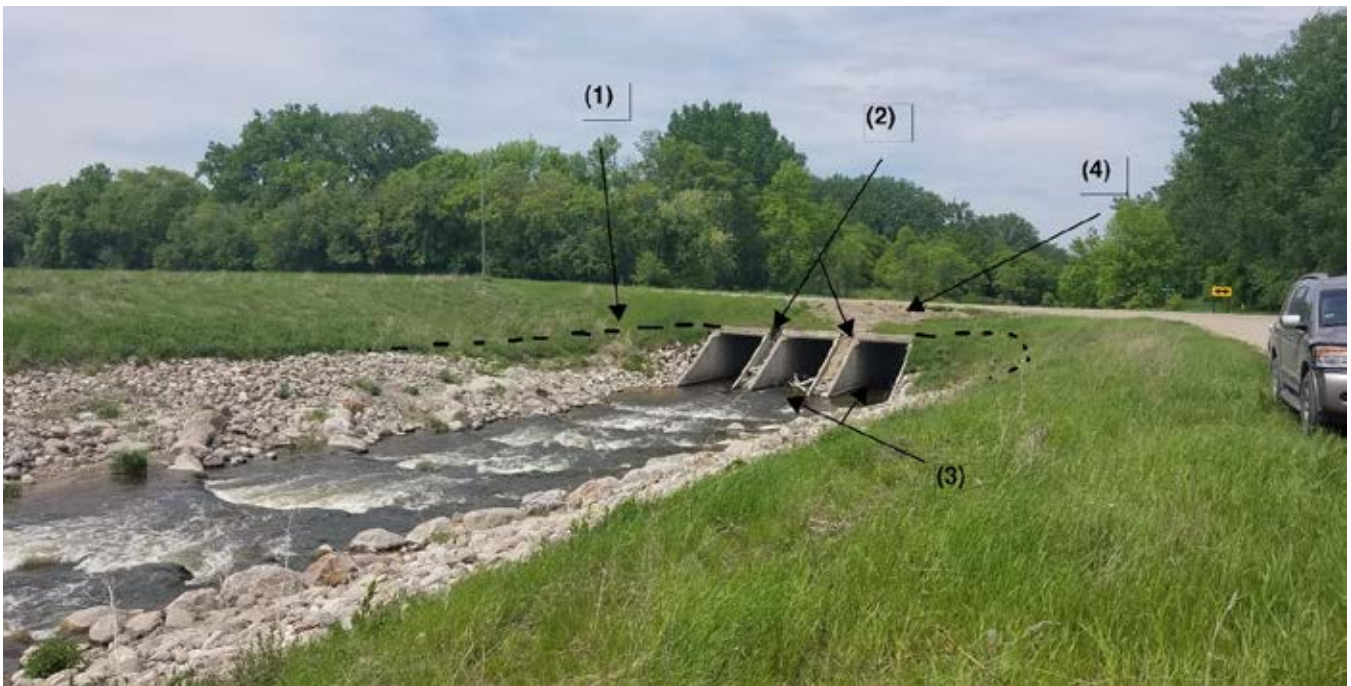
Photo 16-12 Sand Hill River fishway ramp #4. This area of the project has experienced some changes after high flows in spring 2019 came up over the road. Further damage could be mitigated by adding riprap of the same size to the top of the culvert on both sides (1) hand-placing riprap between culverts (2) and repairing the slop with topsoil/seed/25 blanket (4). Project partners also discussed considering rock or a barrier to force low flow into one box. Photo taken by Ed Matthiesen during site visit (6/4/2019).

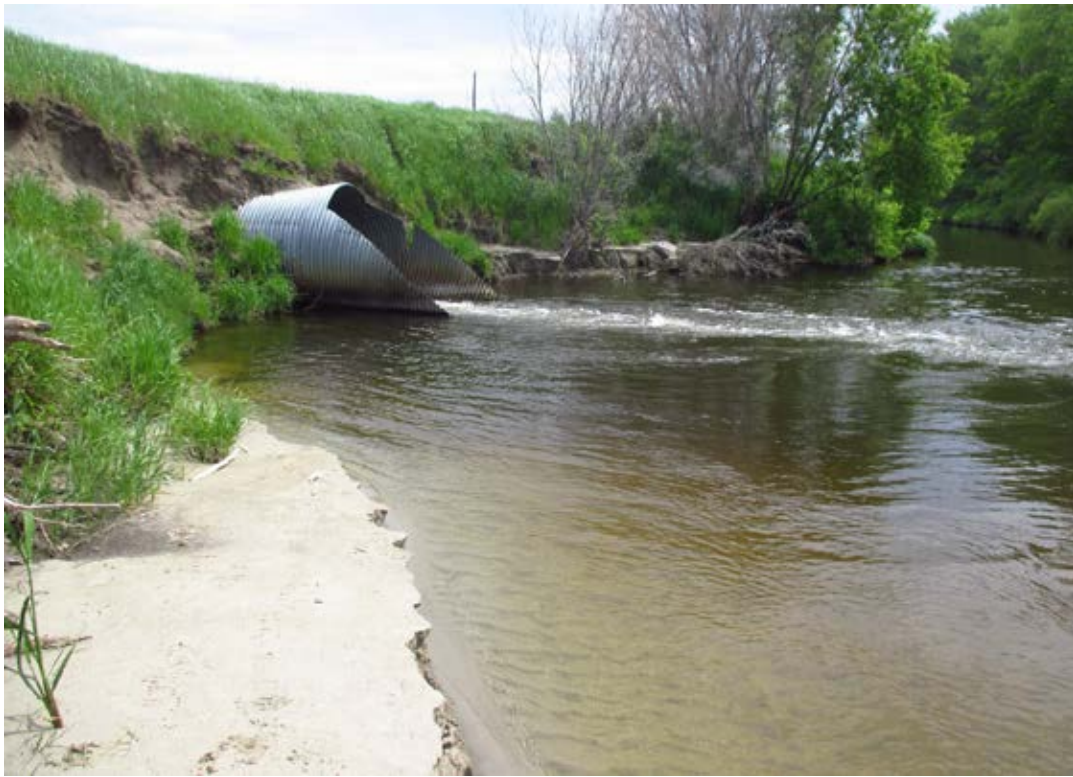
Photo 16-13 Perched culvert with erosion upstream of structure #4. Funds remaining because fishway work was completed under budget will be used to address fish passage and habitat work in this reach. Photo taken during site visit (6/4/2019).
