Minnesota Department of Natural Resources
Minnesota Board of Water and Soil Resources

Appendix B: 2020 Legacy Fund Restoration Evaluation

Report March 2020

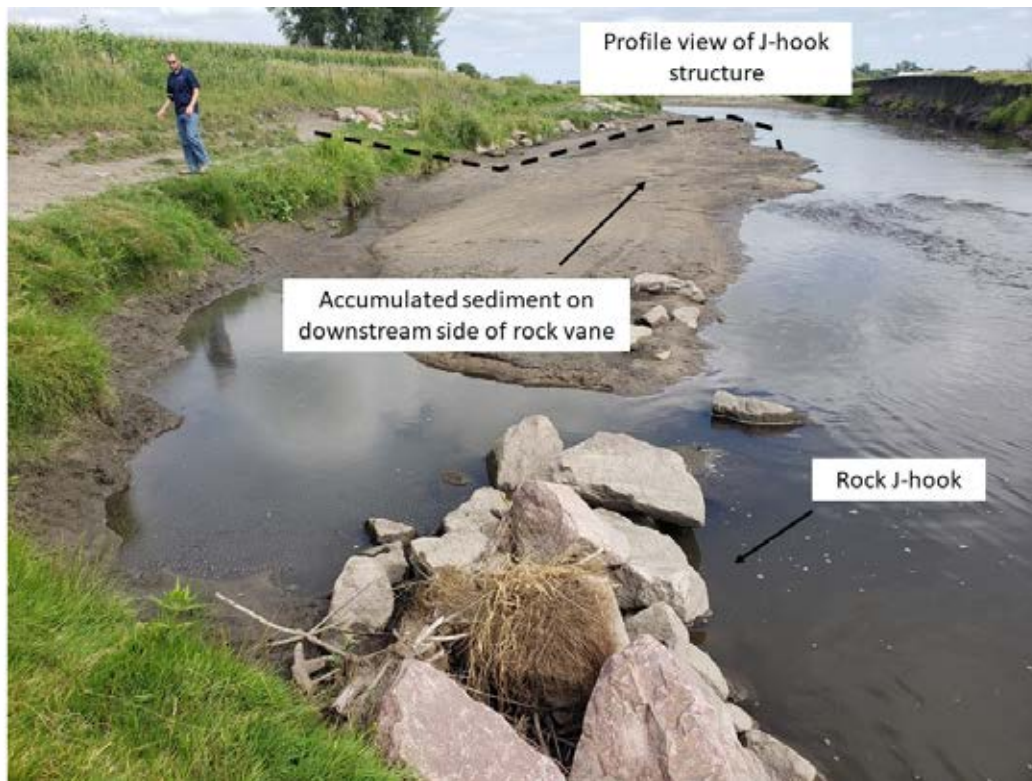
Photo 28-5. Looking upstream at the downstream project area. The two rock J-hook vanes installed in the project area can be seen. A large amount of sediment has accumulated between the structures, which helps to build the bank and protect against erosion. If the upstream vane angle was greater and extended into the channel more, the sediment in the hook of the vane would likely be scoured out, creating pool habitat. (Photo taken 8/22/19 by Mark Prankus, Cardno).

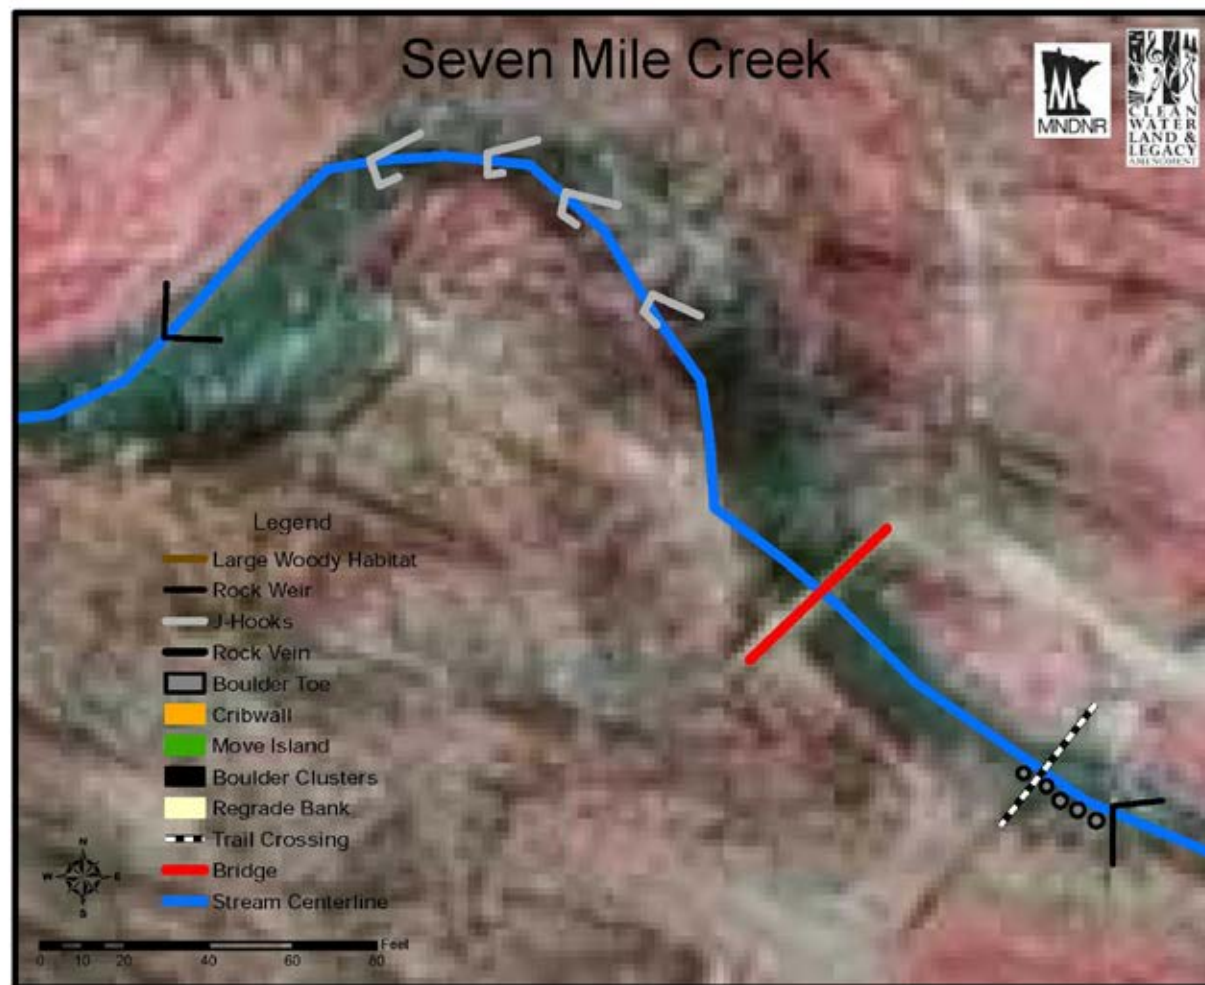
Figure 31-3 Seven Mile Creek project design plans sheet 2 of 5. Zoomed in plan sheet showing stream improvements and locations. Field observed changes from the plan include relocating the upstream cross vane to downstream of the J-hooks and using the downstream cross vane material to harden the existing riffle at the trail crossing instead of creating a new cross vane. It was noted that the J-hooks were actually single vanes previously constructed by the DNR in the early 2000's and material was used to strengthen those vanes in the single-vane configuration instead of converting them to J-hooks.

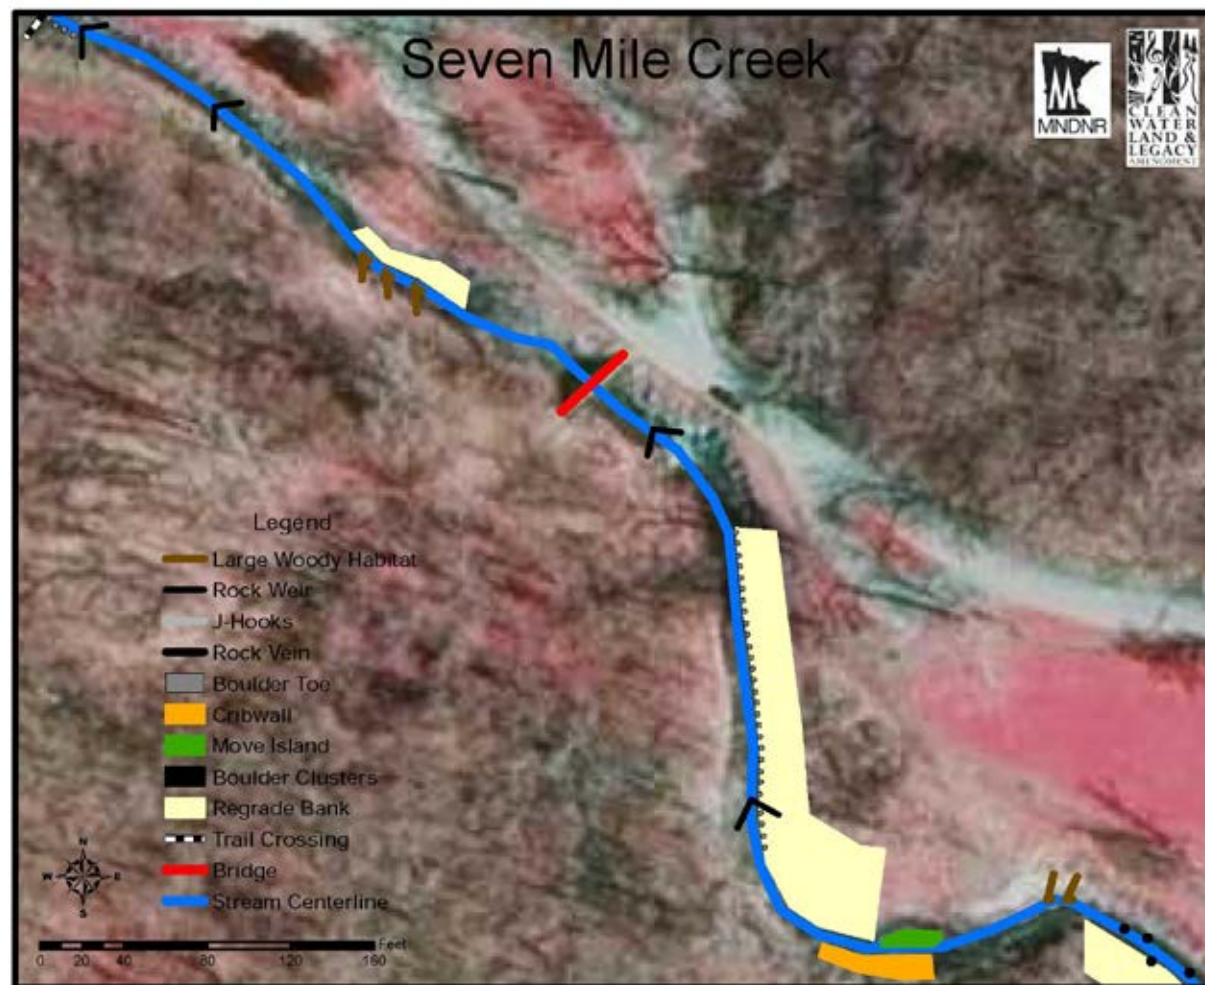
Figure 31-4 Seven Mile Creek project design plans sheet 3 of 5. Zoomed in plan sheet showing stream improvements and locations. Field observed changes from the plan include the large woody habitat upstream being removed. Three of them had been removed by unauthorized public members so that final rootwad was removed during final maintenance in August 2019.

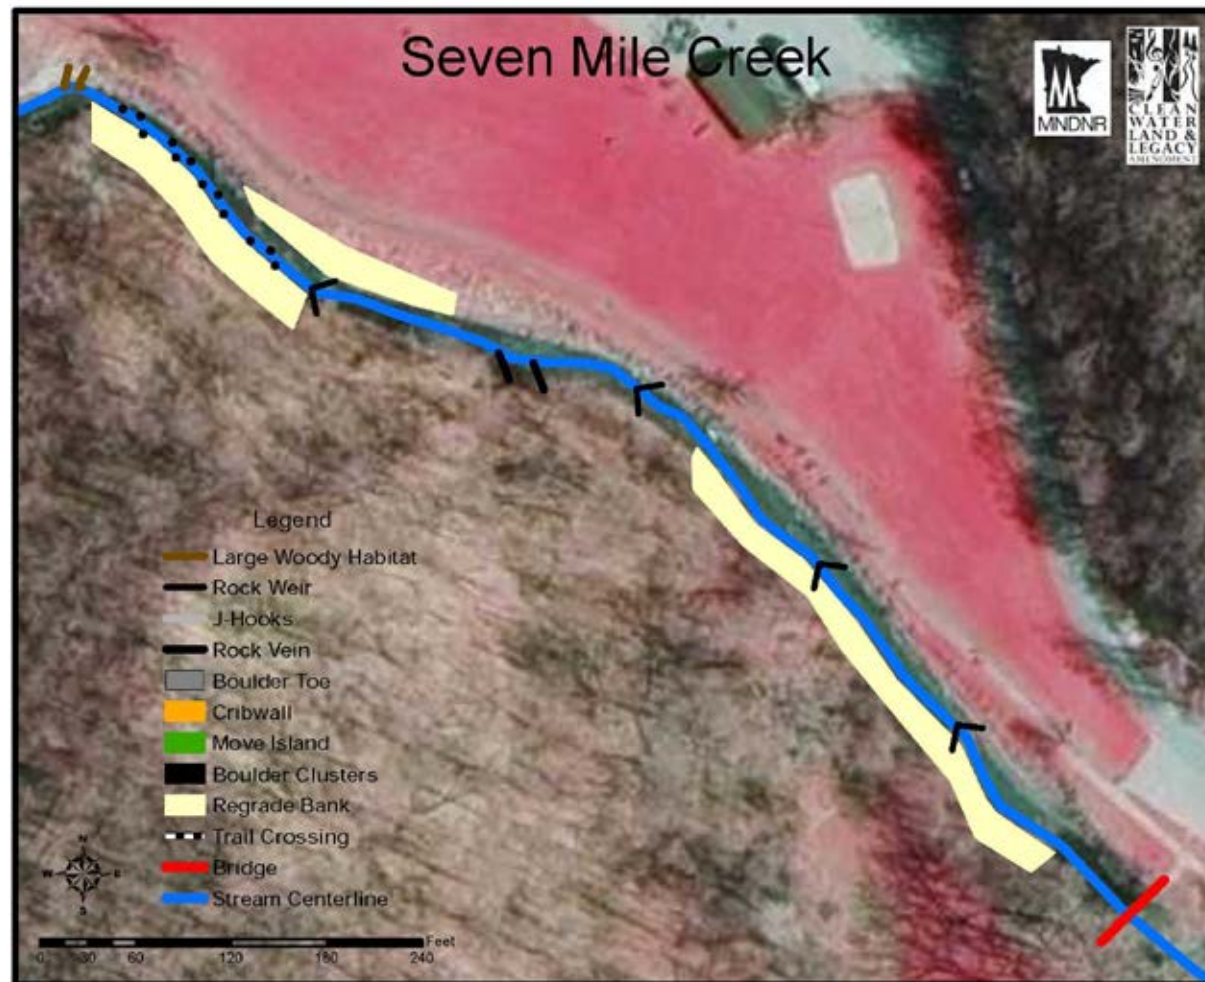
Figure 31-5 Seven Mile Creek project design plans sheet 4 of 5. Zoomed in plan sheet showing stream improvements and locations. Field observed changes from the plan include combining the two single vanes in the middle of the pictured reach into a single cross vane.

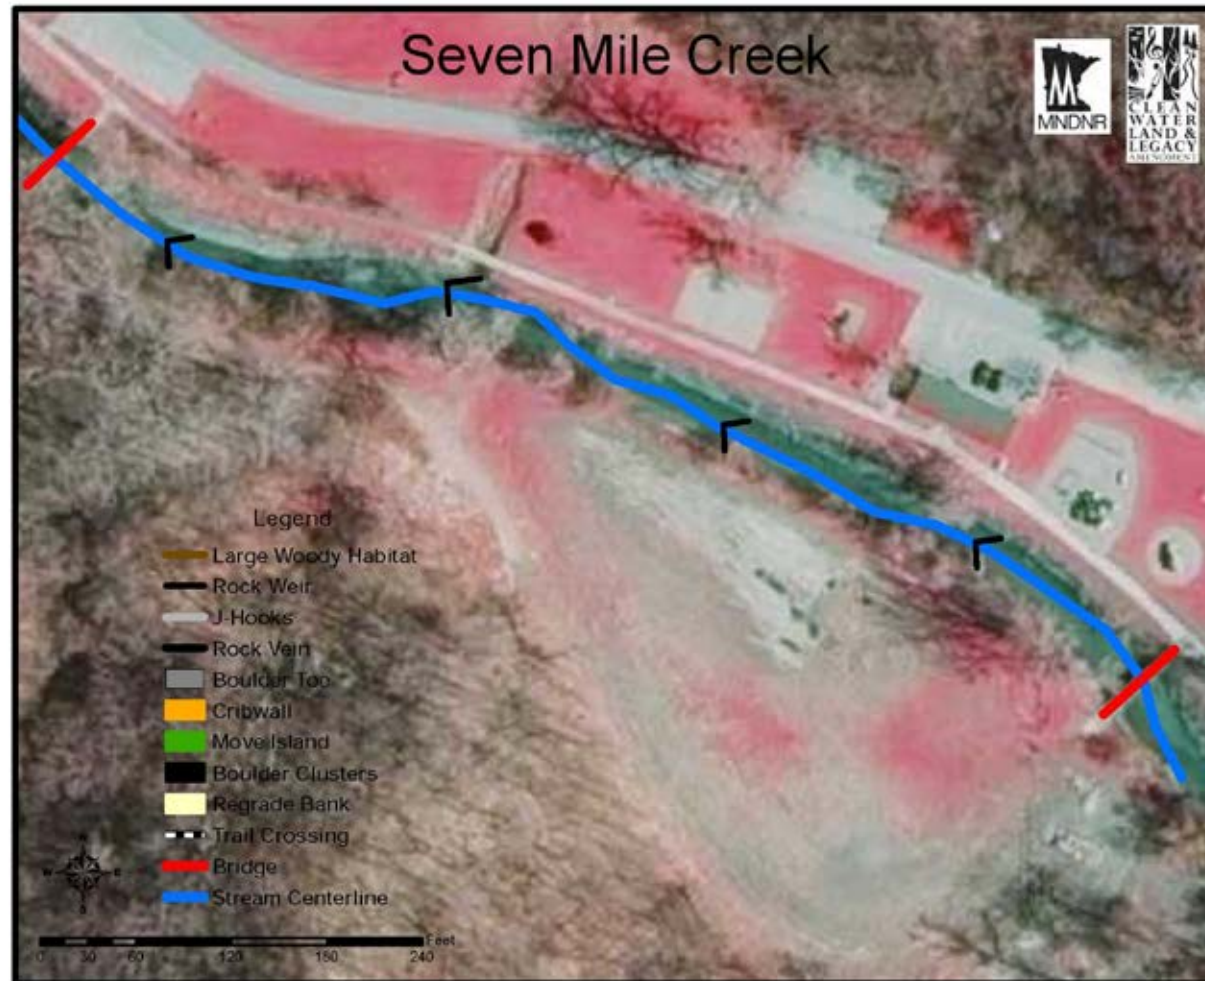
Figure 31-6 Seven Mile Creek project design plans sheet 5 of 5. Zoomed in plan sheet showing stream improvements and locations. Field observed changes from the plan include some of the proposed cross vanes being converted into single vanes and the remaining material used for bank protection.

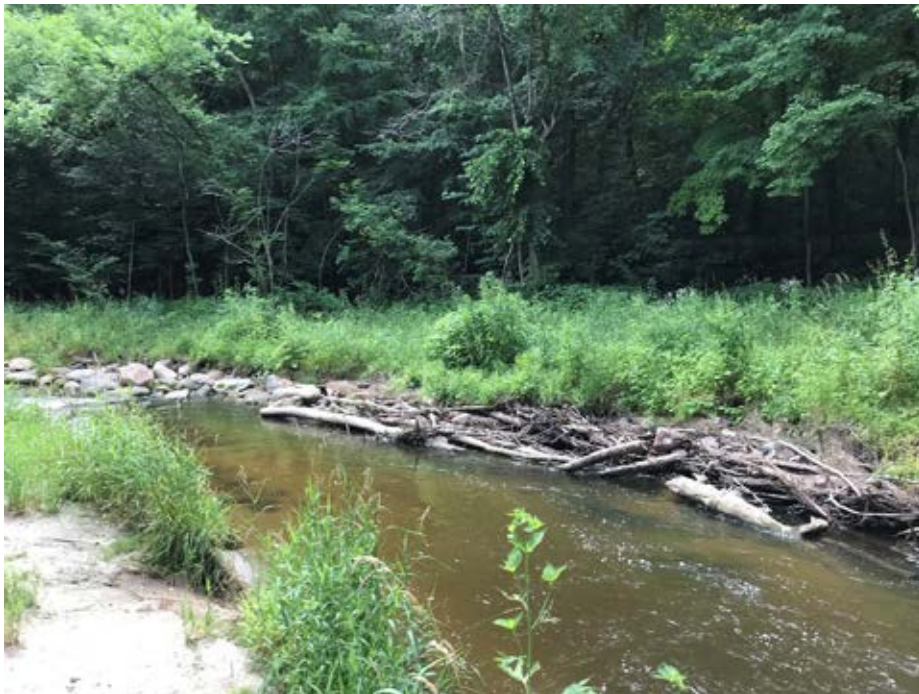
Photo 31-6 Cribwall after vegetation establishment and prior to reconfiguration repairs. (Seven Mile Creek County Park, photo taken by Mike Majeski at EOR, Inc. July 2019).

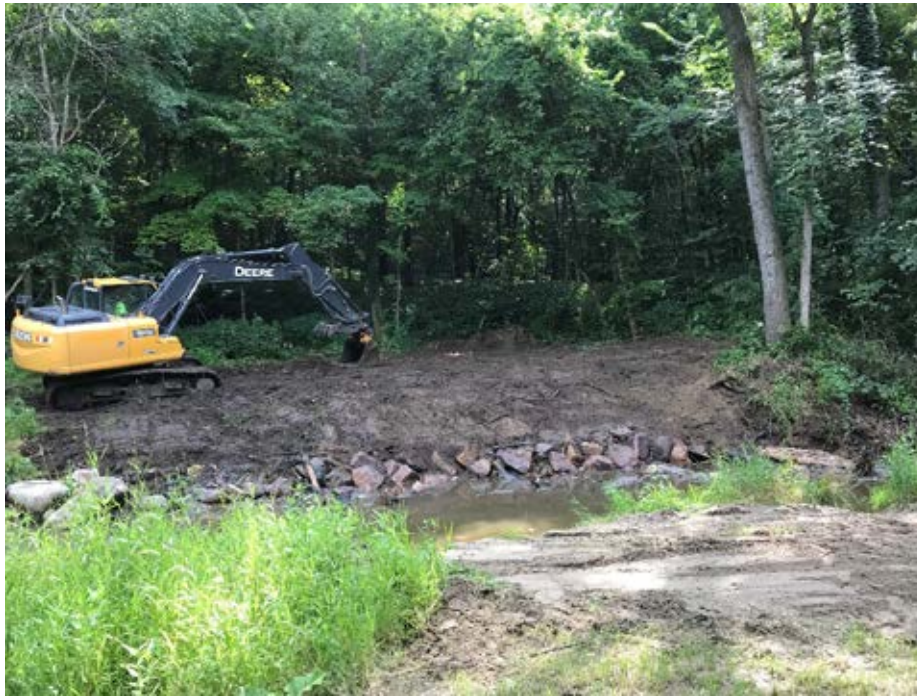
Photo 31-7 Cribwall during reconfiguration repairs. (Seven Mile Creek County Park, photo taken by Mike Majeski at EOR, Inc. August 2019).

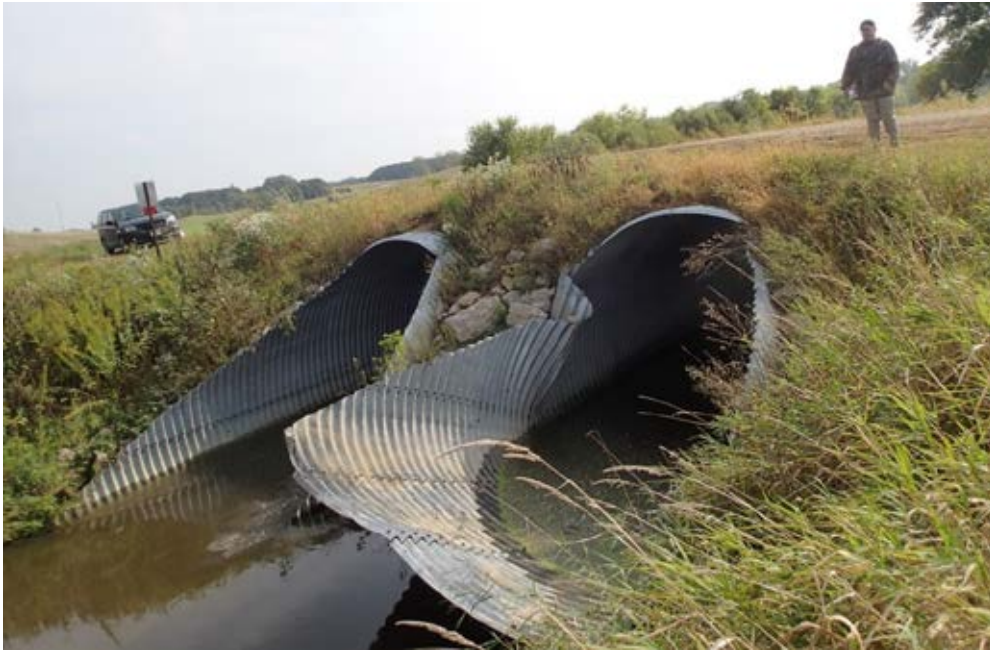
Photo 32-1 These two 12' culverts were installed on the upstream end of the project, on the upstream end of Reach 6, to replace an existing culvert that was undersized. Both culverts were incorrectly installed with an upstream invert 1.7' higher than specified. Spring runoff and ice flow in 2019 pushed up and bent the upstream end of one culvert making it non-functional. (Wedge Creek – Reach 6, photo taken by Lucius Jonett during site visit 09/20/2019).

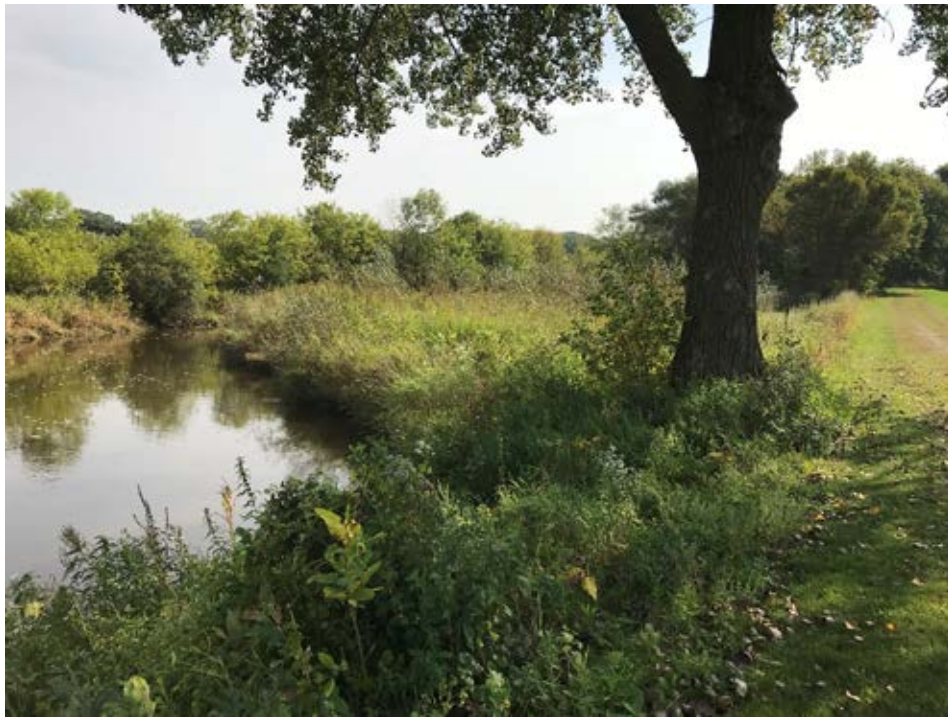
Photo 32-3 View of a lowered point bar to create a wetland terrace that is fully vegetated making it appear at almost the same elevation as the surrounding landscape. (Wedge Creek – Reach 6, photo taken by Lucius Jonett during site visit 09/20/2019).

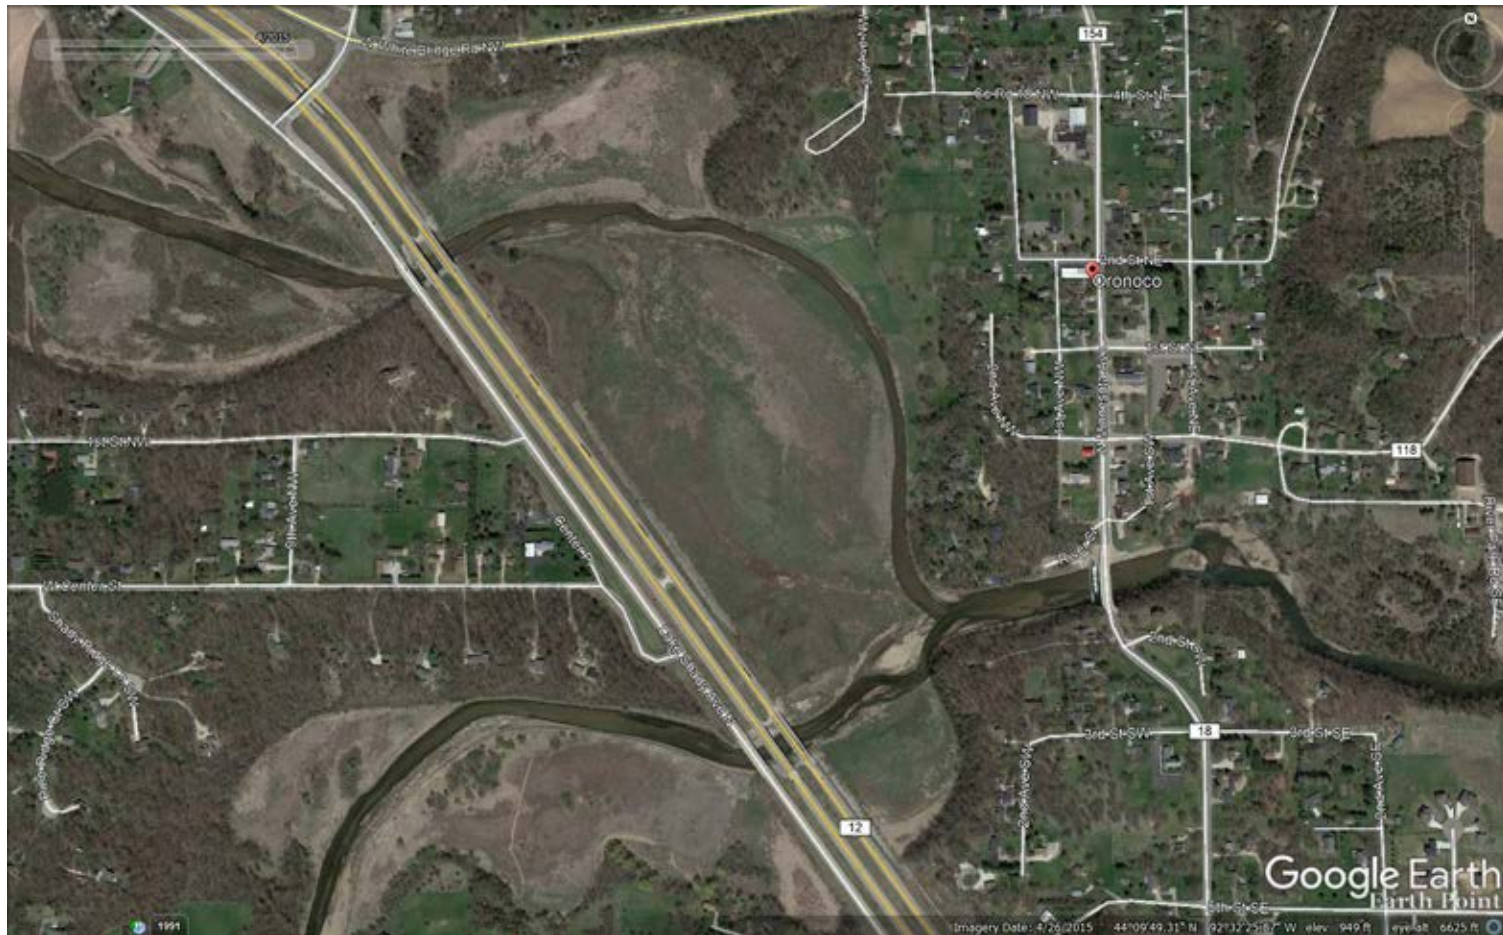
Figure 34-2 Aerial image of the former Lake Shady in 2015 prior to work. The channel through the former lake bed formed after the dam failed. Aerial photography is from April 2015 and provided by Google Earth.
