Subject: Revised Final Report Entitled "Assessment of Potential Corrosion Induced by Bromine Species Used for Mercury Reduction in a Taconite Facility"; Work Order Contract No. B24812; EERC Fund 14783

# **ASSESSMENT OF POTENTIAL CORROSION INDUCED BY BROMINE SPECIES USED FOR MERCURY REDUCTION IN A TACONITE FACILITY**

Final Report

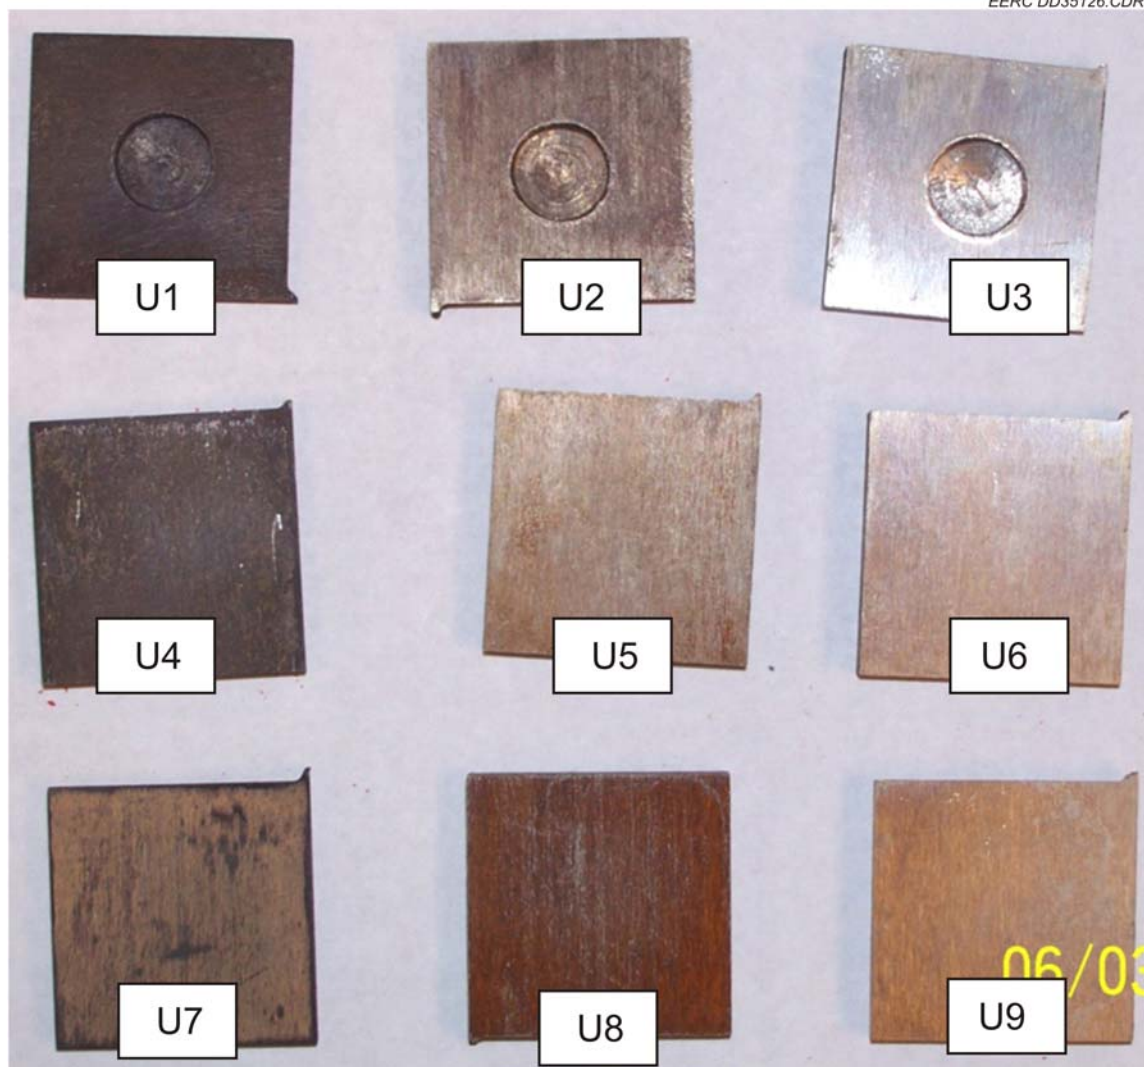
United Coupons U1–6 were exposed to flue gas containing HBr while coupons U7–9 were exposed to flue gas only. All of the coupons changed color although the flue gas containing HBr caused more surface discoloration than non-HBr-containing flue gas. Also, the coupons subjected to higher temperatures—U1, 4, and 7—show more surface oxidation than the lower-temperature coupons. The iron oxide/sodium sulfate deposit on U1–3 does not appear to have affected the surface coloration of the United coupons.

Figure 3. Surface of United coupons after testing.

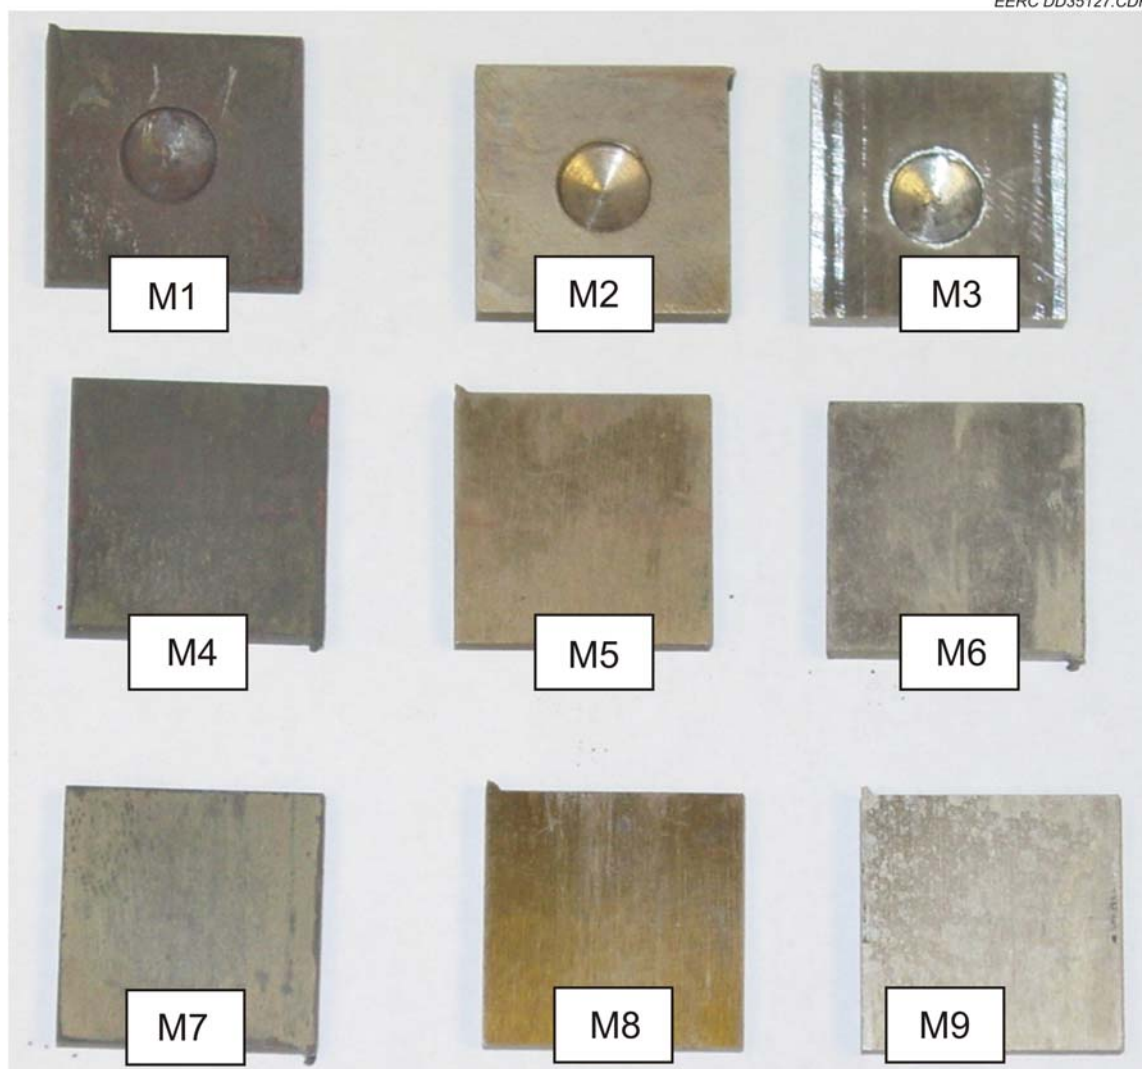
For the Minorca coupons, it appears that the exposure to HBr affected surface discoloration but not as greatly as what was seen in the United coupons. Unlike the United coupons, it does not appear that the temperature gradient caused greater surface discoloration across the set. The iron oxide/sodium sulfate deposits on M1–3 appear to have only caused significant surface discoloration on the M1 coupon, which was sitting in the 500°C chamber of the test apparatus.

Figure 4. Surface of Minorca coupons after testing.

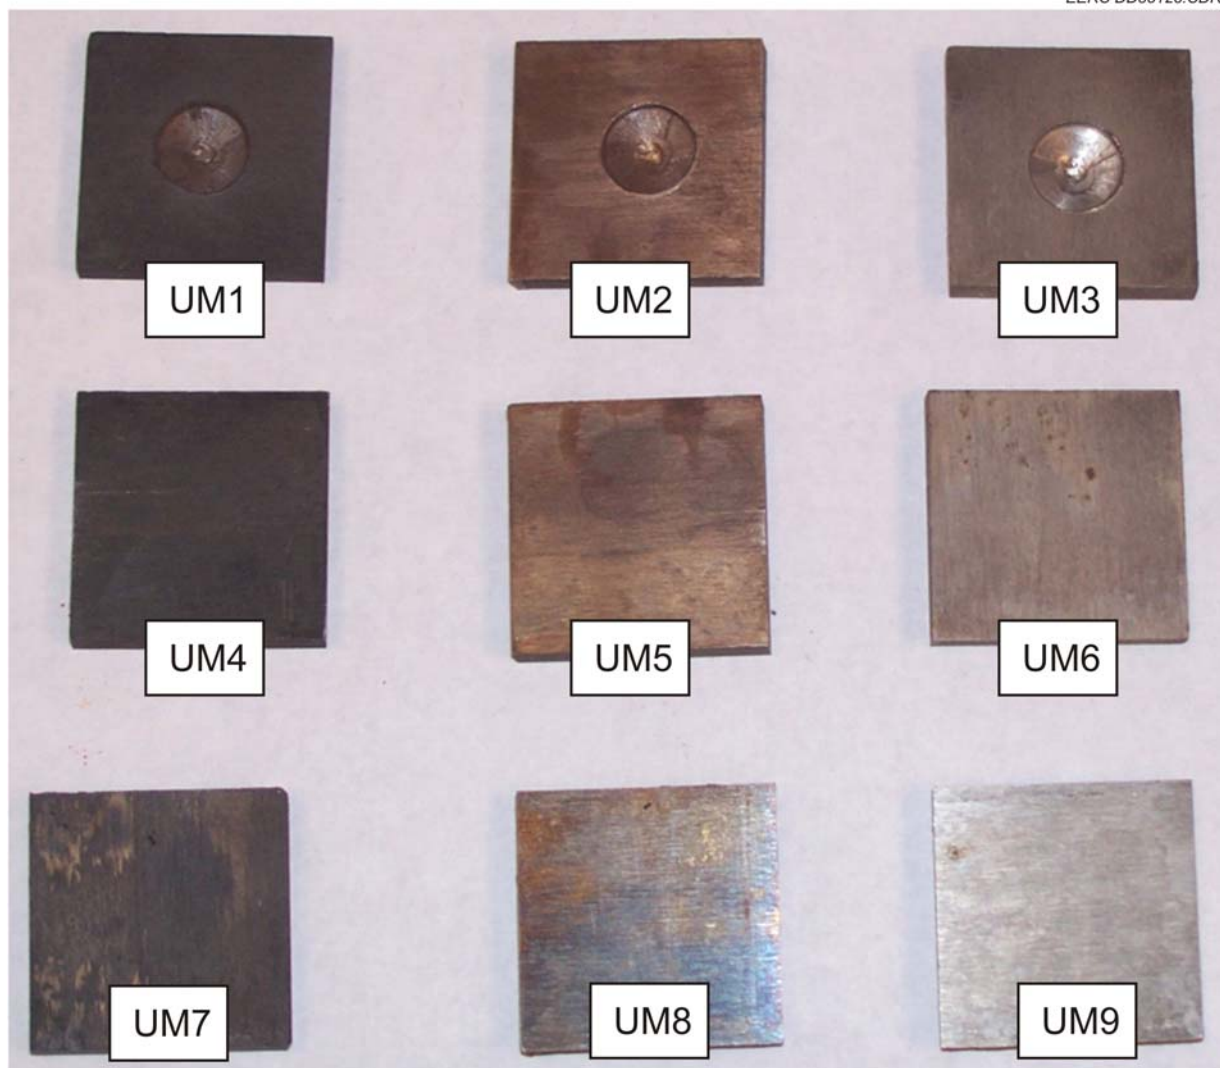
The surfaces of the USS Minntac coupons are shown in Figure 5. Exposure to higher temperatures caused more discoloration than lower temperatures. The effect of HBr exposure did not induce any additional surface oxidation compared to non-HBr-containing flue gas. A deposit of iron oxide/sodium sulfate on coupons UM1–3 did not cause any additional discoloration when compared to the other coupons.

Figure 5. Surface of USS Minntac coupons after testing.

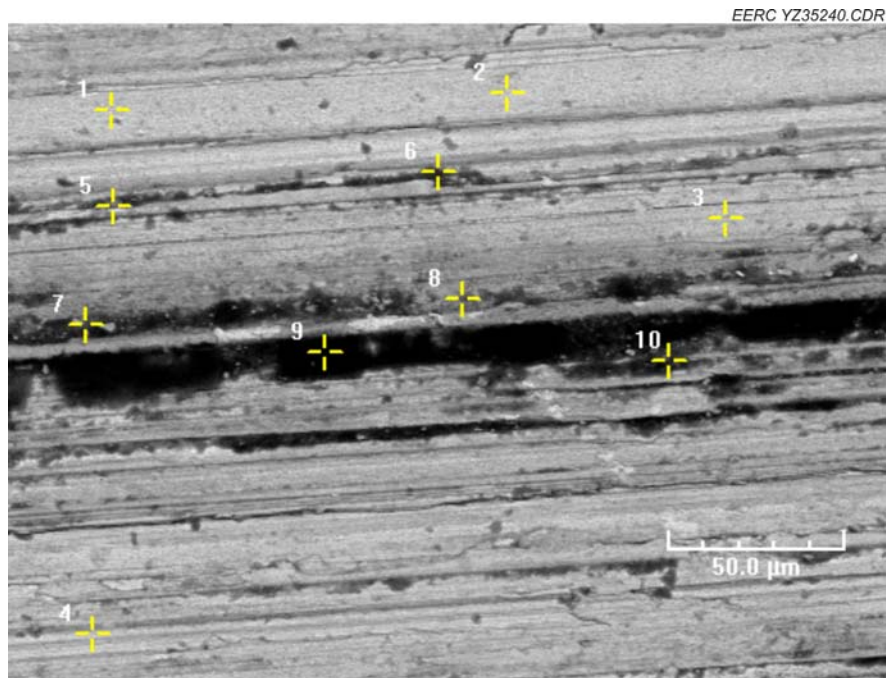
Figure 6. U7 surface SEM image.

Compared to the elemental pretest composition, all exposed United coupons experienced some surface corrosion. Coupons exposed to taconite flue gas only, U8 and 9, experienced very few elemental changes, while U7 indicated measurable loss of Ni. The Ni loss can be attributed to sulfur attack. Figures 6 and 7 show SEM images of the U7 surface and cross section, respectively. Table 6 lists measured elemental concentrations along the U7 cross section. The U7 surface appears to have slight surface striations. Although the U7 surface suffered Ni loss, there is no further corrosion penetration.

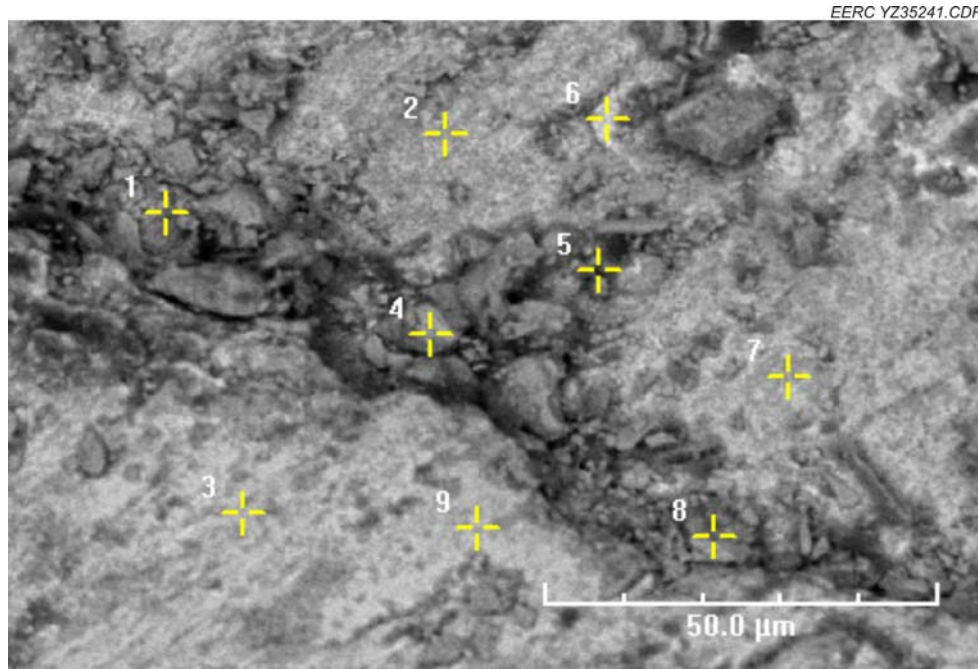
Figure 8. U1 surface SEM image.

Coupons that have been exposed to bromine and taconite flue gas, U1–6, all showed Br deposition in small percentages. As a result, iron, chromium, and nickel elemental averages show small gains/losses depending on the testing conditions. Sulfur and silicon were affected in very small percentages in some coupons. Plotted in Figures 8–11 are the surface SEM images for U1–4 respectively. Compared to surface striations observed on U4, small surface cracks, pits, and chipping on coupons U1–3 were mainly caused by drilling during coupon preparation. Elemental analysis data of the U1–4 surfaces indicate enrichment of Fe and losses of Cr and Ni due to HBr attack. SEM data of U5 and 6 surfaces indicate no large changes in morphology and elemental composition after exposure testing. The complete data set is included in Appendix A.

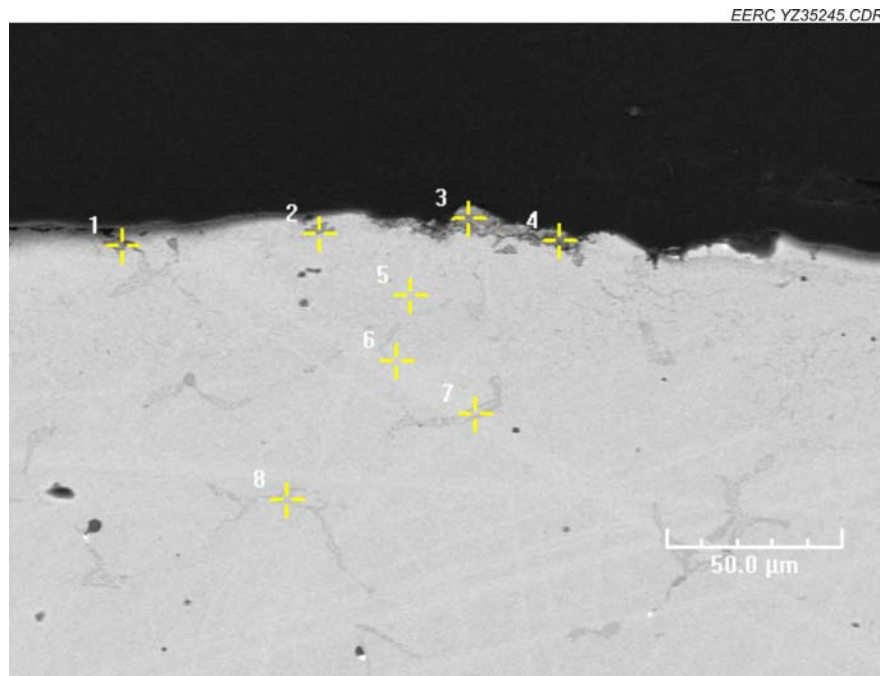
Figure 12. U4 cross-sectional SEM image.

The cross-sectional SEM data for United coupons, other than U4, indicate that bromine deposition was confined to the surface of the material and did not impact the elemental composition. Figure 12 is the cross-sectional SEM image for U4, and corresponding elemental distributions are listed in Table 7. The SEM data for U4 indicate slight penetration of bromine species with corresponding losses of Ni and Fe below the coupon surface under 500°C testing conditions. Other SEM cross-sectional data are reported in Appendix A.

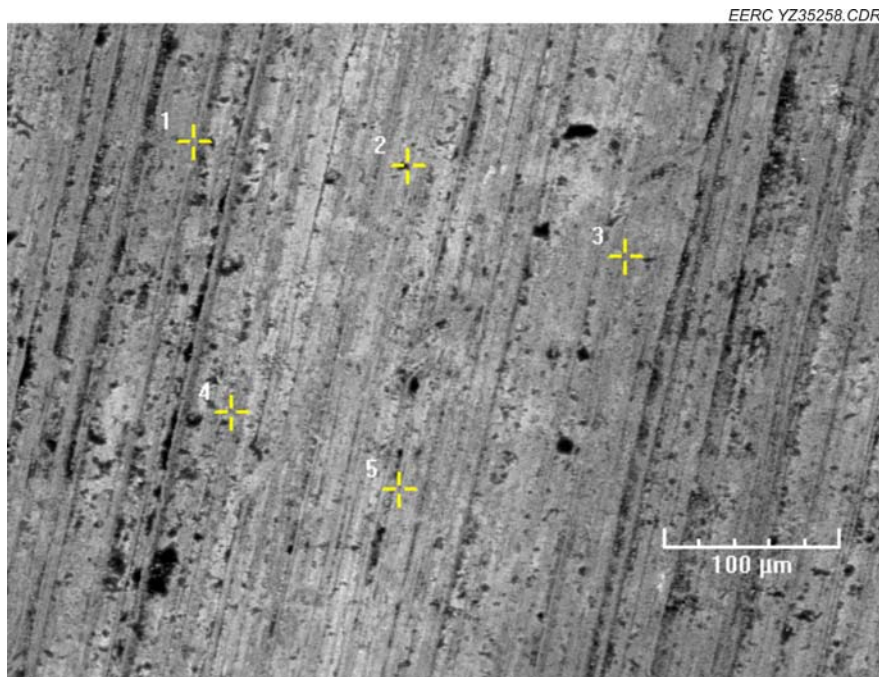
Figure 13. M7 surface SEM image.

SEM surface analysis of coupons M7–9, which were only exposed to taconite flue gas, indicates gain or loss of Ni, Fe, and Cr, depending on testing conditions. Both Fe and Ni were oxidized or vaporized on the M7 surface under 500°C testing conditions. This resulted in Cr enrichment while little elemental change was observed on M8 at 300°C. The M9 surface appears to have suffered sulfur attack, showing Fe and Cr losses. Plotted in Figures 13–15 are the microscopic surface images of coupons M7–9, respectively. No surface chips, cracks, or pits are visible, but surface striations were observed. Cross-sectional data for M7–9 (reported in Appendix B) show consistent elemental distribution similar to pretest data beyond the coupon surface, proving no penetrated corrosion occurred.

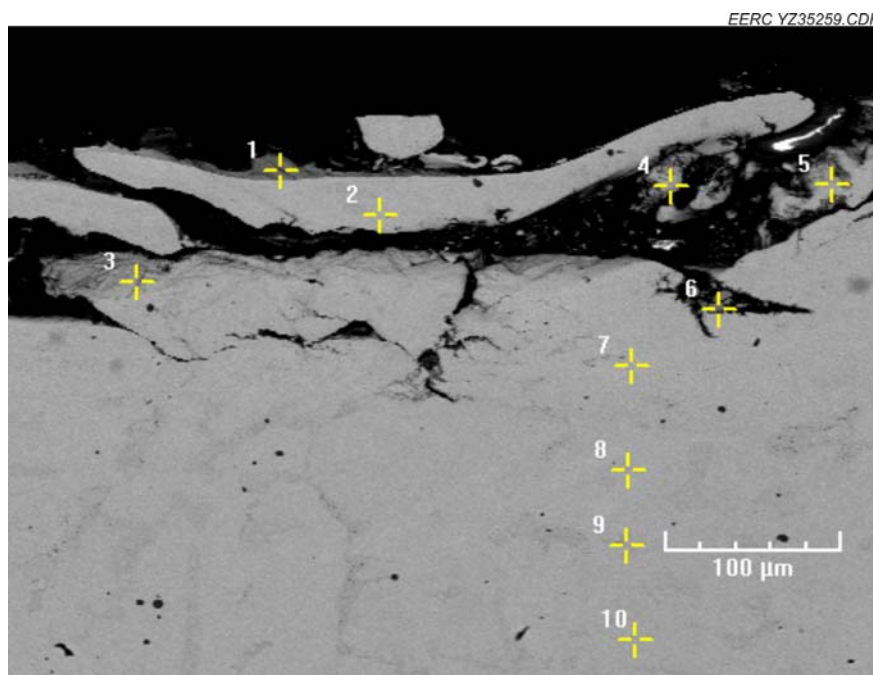
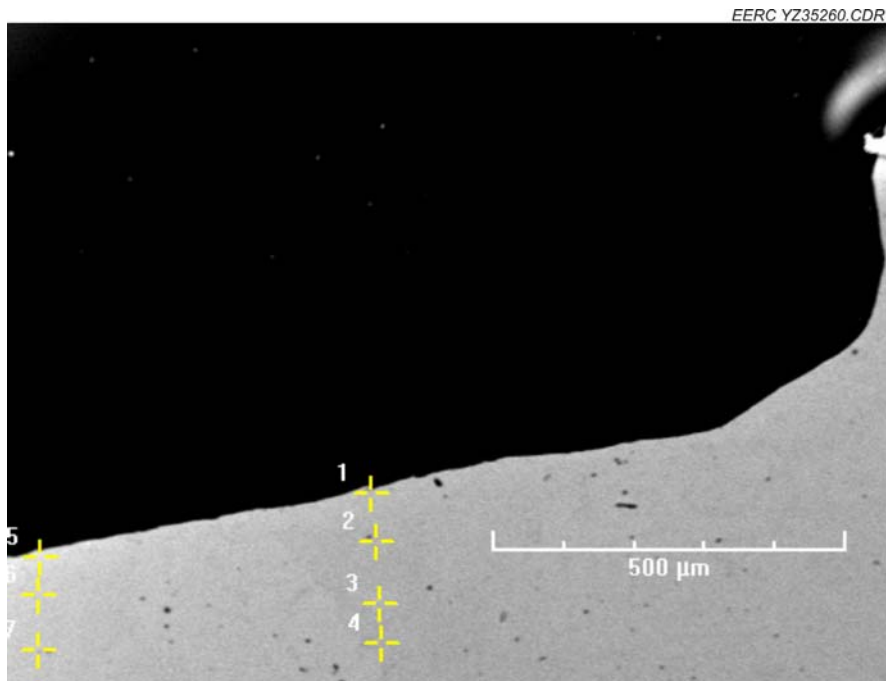
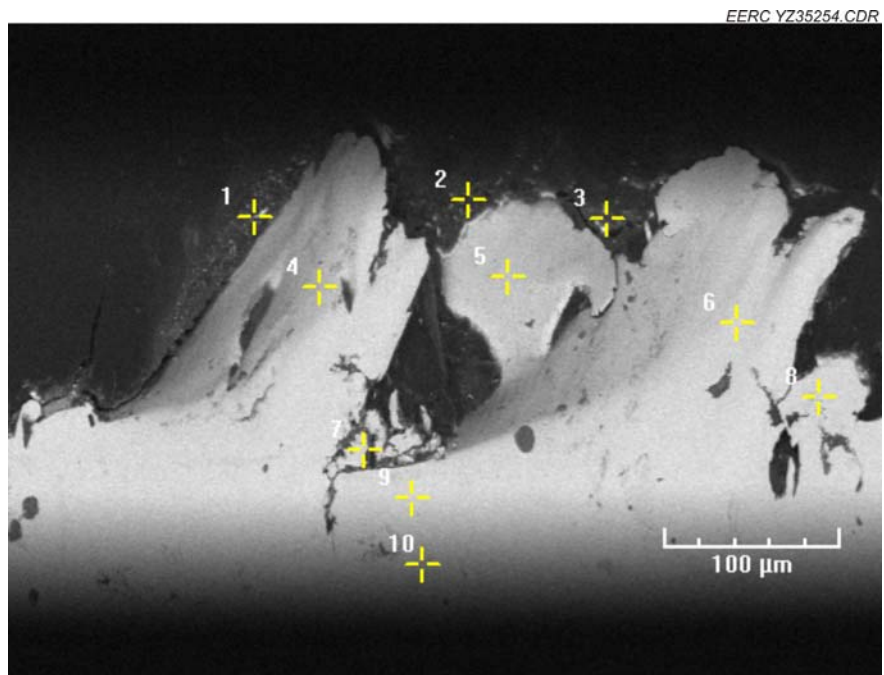
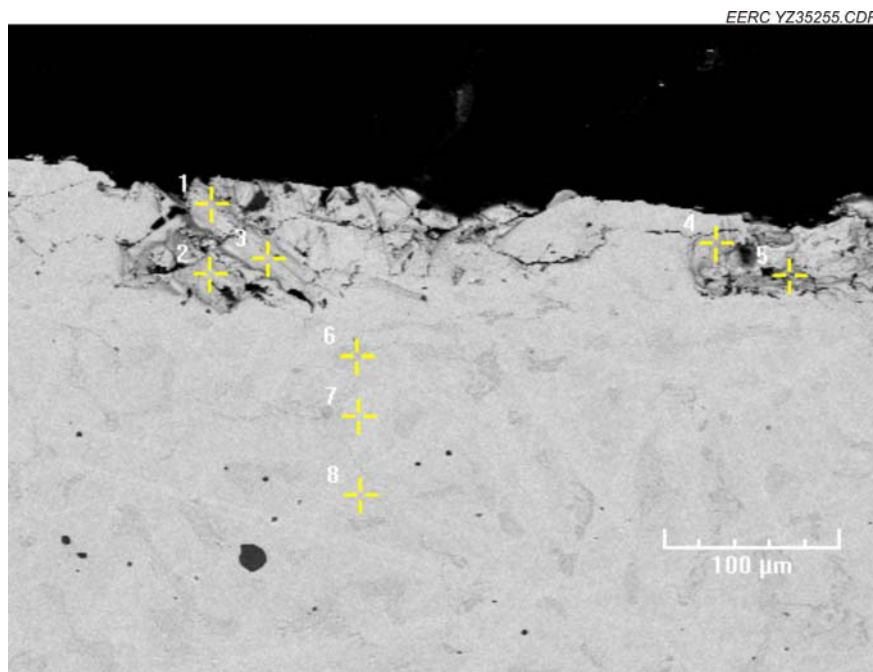
Cross-sectional SEM analysis on M1–6 was performed; the complete data set is included in Appendix B. Figures 22–25 are the cross-sectional SEM images for M1, 3, 5, and 6 and show notable changes. M2 and 4 cross-sectional SEMs indicate no corrosion and/or elemental variation compared to pretest data. Cracking through the M1 cross section was due to drilling. However, elemental data (Table 9) show HBr deposits on the surface and no further penetration occurred. Cross-sectional data of M3 (Figure 23 and Table 10) indicate slight Br penetration through intact surface with corresponding Ni loss. Both M5 and M6 cross-sectional SEMs show slight cracking on the coupon surface with elevated Br deposition, but no further elemental changes were observed beyond the surface as listed in Tables 11 and 12.

Overall, microscopic analysis data have confirmed that all bromine attack and corrosion activity did not penetrate beyond the face of the Minorca coupons, although SEM cross sections showed small surface chips, cracks, and pits on several coupons. The wells containing iron oxide/sodium sulfate deposits showed no more corrosion than the flat areas surrounding them. Cracks from drilling the wells were observed in several coupons, although this surface did not attract any additional corrosive activity. All tested coupons have shown minor losses of Fe and Ni on surface, depending on the coupon specific testing conditions. Additional HBr did not induce significant corrosion activities on Minorca coupons under varied testing temperatures.

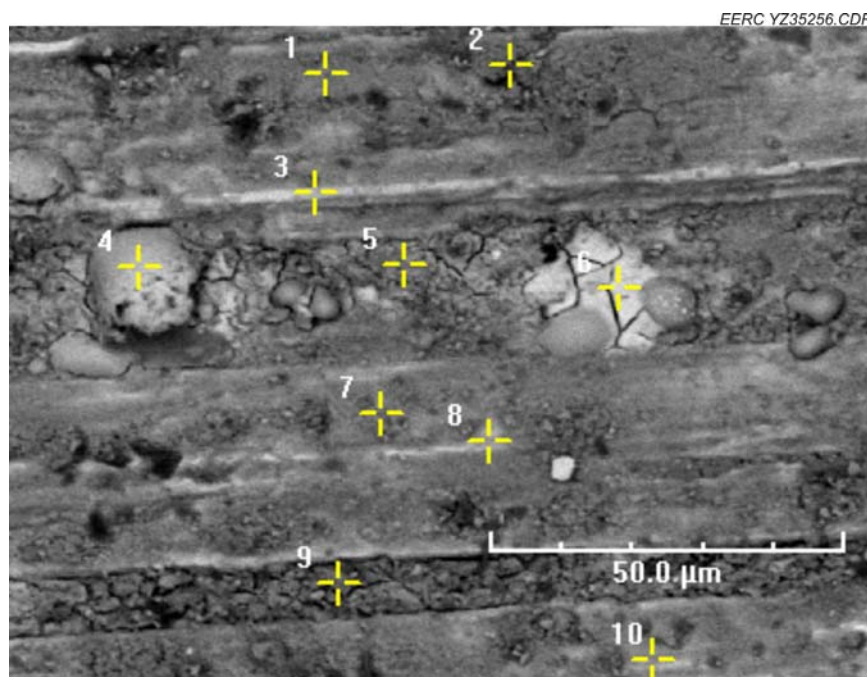
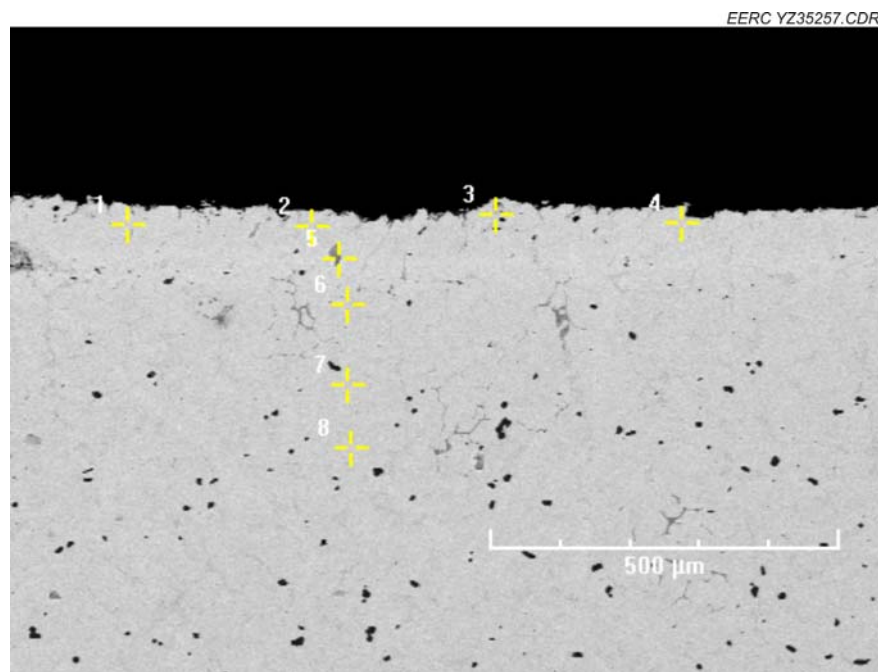
The coupons exposed to bromine, UM1–6, all showed Br deposition with Ni, Fe, or Cr losses, depending on testing conditions. The highest Br surface concentration was 30.09%, measured on UM5. Figures 26 and 27 and Table 14 are the UM5 microscopic images and cross-sectional analysis, respectively. The UM5 surface shows blistering and cracking, with losses of Ni, Cr, and Fe. Further cross-sectional analysis indicates that although slight Br penetration occurred, no significant elemental disruptions occurred. All other UM coupons exposed to bromine show surface striation but no further corrosion beyond the surface.
