Coon Rapids Dam Fish Barrier and Improvements Preliminary Design

Minnesota Department of Natural Resources
St. Paul, Minnesota

FINAL

February 17, 2011

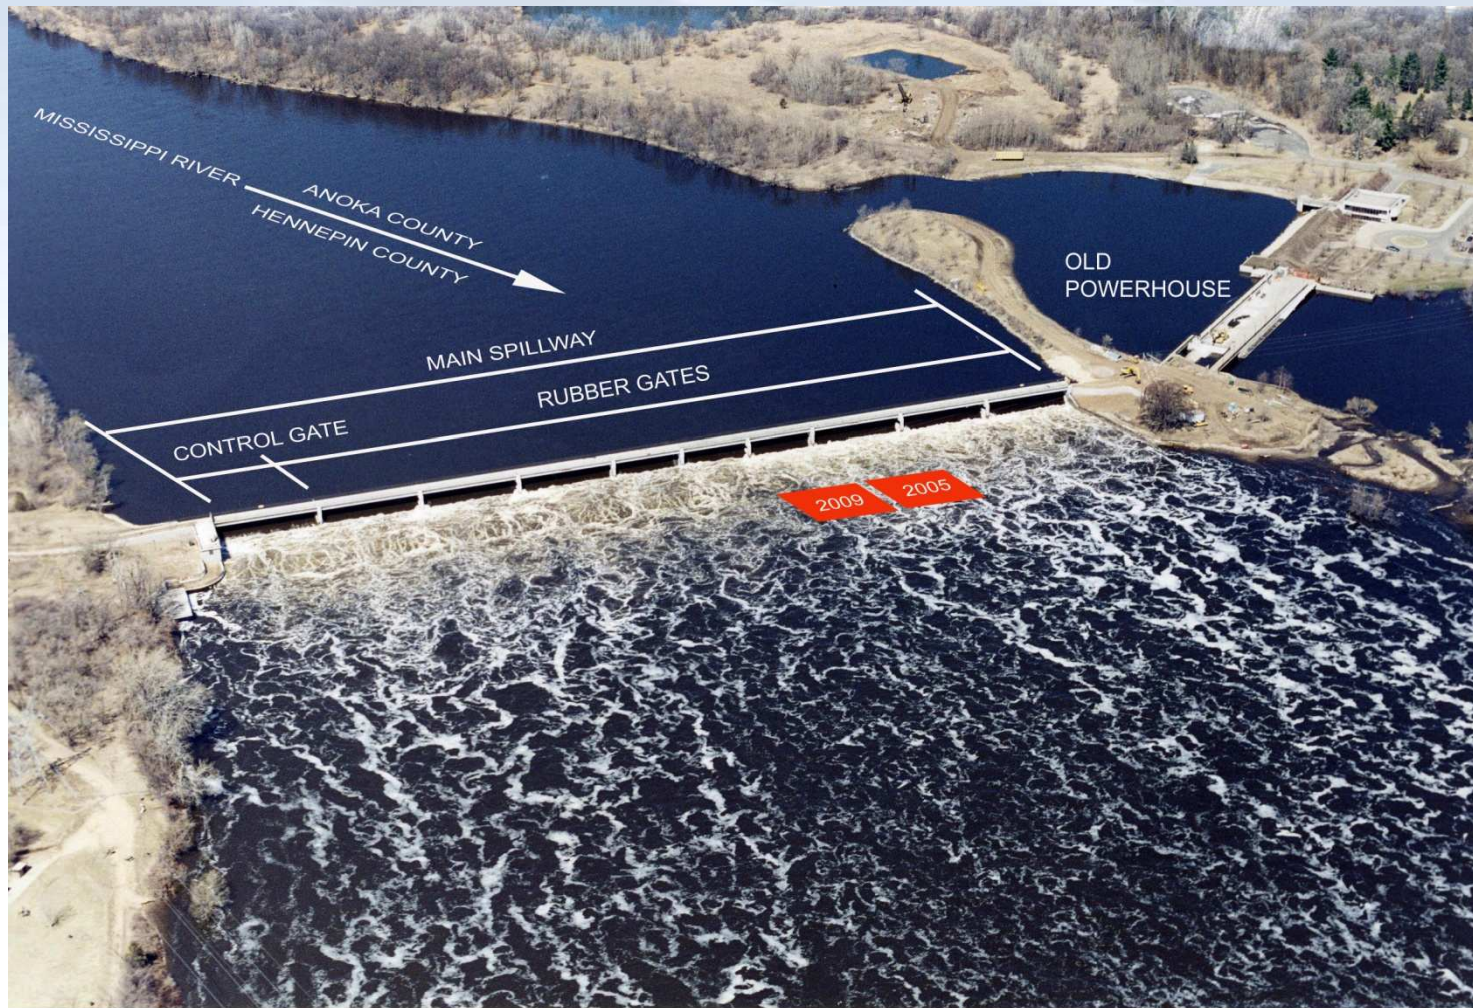
Apron Scour

On the Anoka side, the spillway flows across a series of more shallow concrete aprons that were intended to armor the river channel and contain the hydraulic jump within the protected area. Although the length of aprons is adequate, over time, these apron features have been undermined and portions have collapsed and subsequently been repaired.

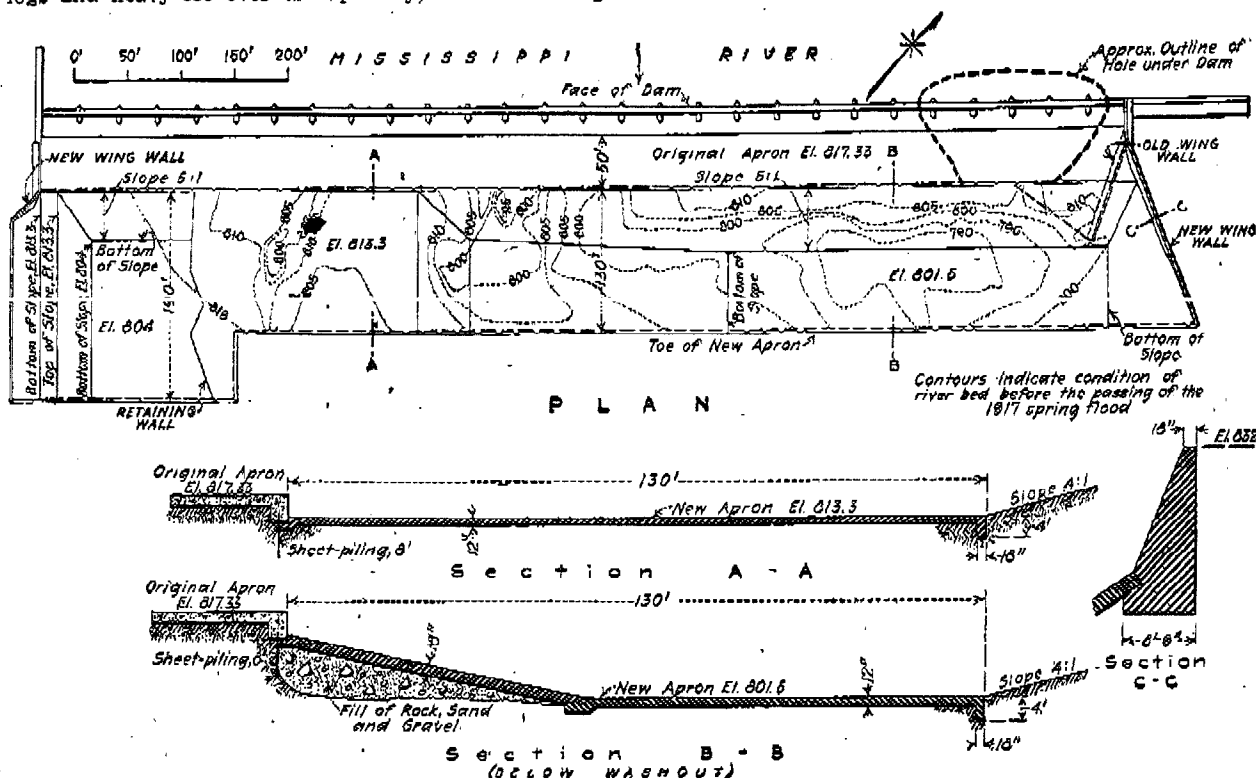
FIG. 2. FIVE RAYS OF DAM UNDERMINED BY WASHOUT—NEW APRON BUILT OVER SCoured-OUT AREA
