MILE POST 7 WEST RIDGE RAILROAD RELOCATION, DAM EXTENSIONS, AND STREAM
MITIGATION PROJECT ENVIRONMENTAL ASSESSMENT WORKSHEET (EAW)

CASAGRANDE CONSULTANTS

FINAL REPORT
ON EVALUATION OF PROPOSED DESIGN
MILEPOST 7 PROJECT

AUGUST 1975

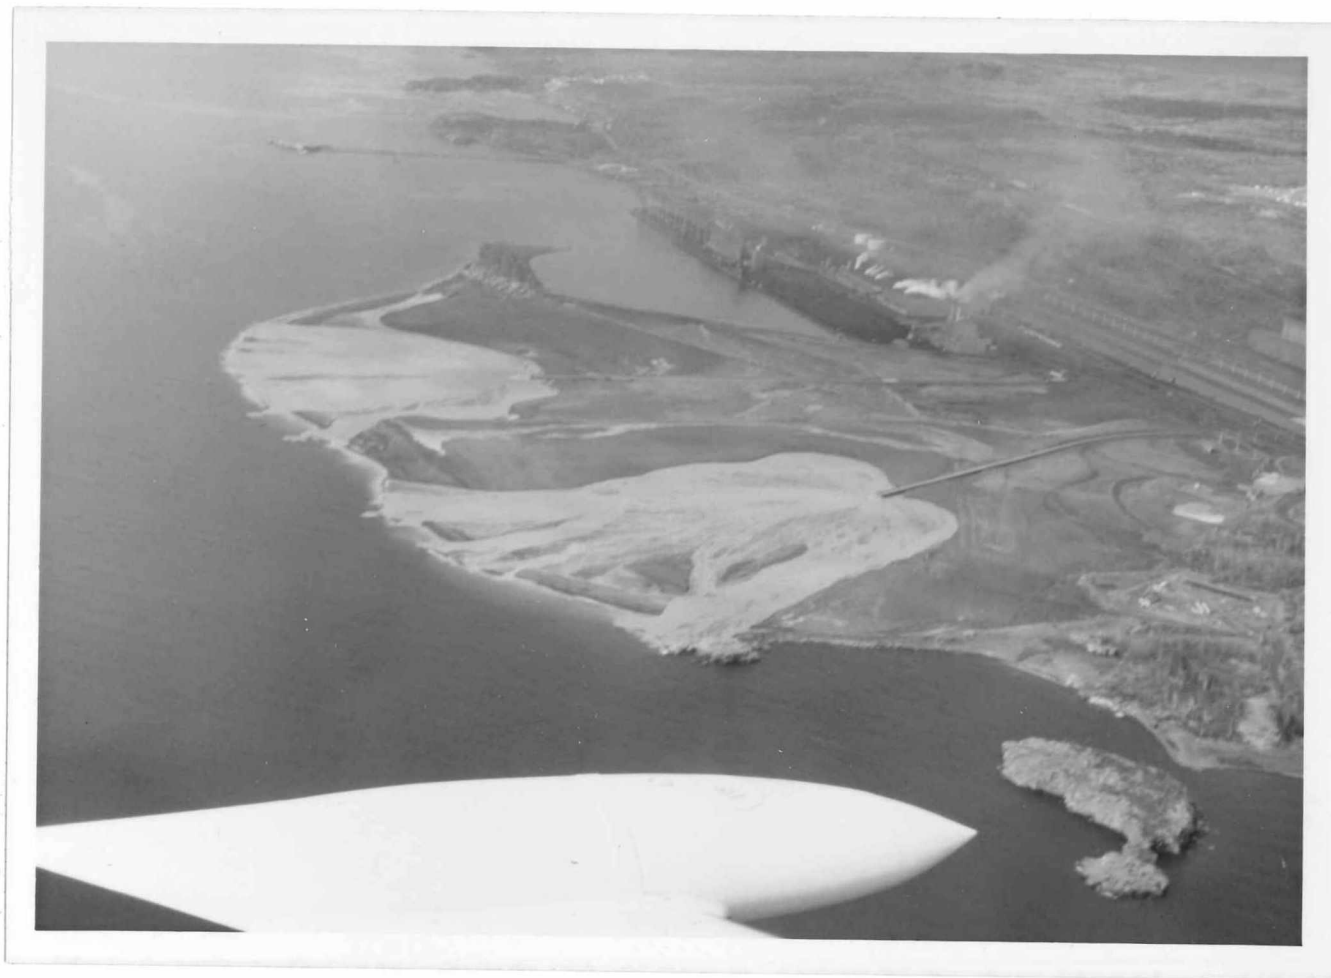
Photo 1: Reserve Mining Company's Tailings Delta in Lake Superior at Silver Bay, Minnesota; May 3, 1975.

We recommend that the question of erosion of the Delta front be studied by a board of specialists with extensive experience in control of beach erosion.
