# MILE POST 7 WEST RIDGE RAILROAD RELOCATION, DAM EXTENSIONS, AND STREAM MITIGATION PROJECT ENVIRONMENTAL ASSESSMENT WORKSHEET (EAW)

RECORD OF DECISION – FINDING OF FACT 28.i 1975 BAKER REPORT

# GEOTECHNICAL EVALUATION ON-LAND TAILINGS DISPOSAL PLAN RESERVE MINING COMPANY Mile Post No. 7 Site

PREPARED FOR STATE OF MINNESOTA AUGUST, 1975

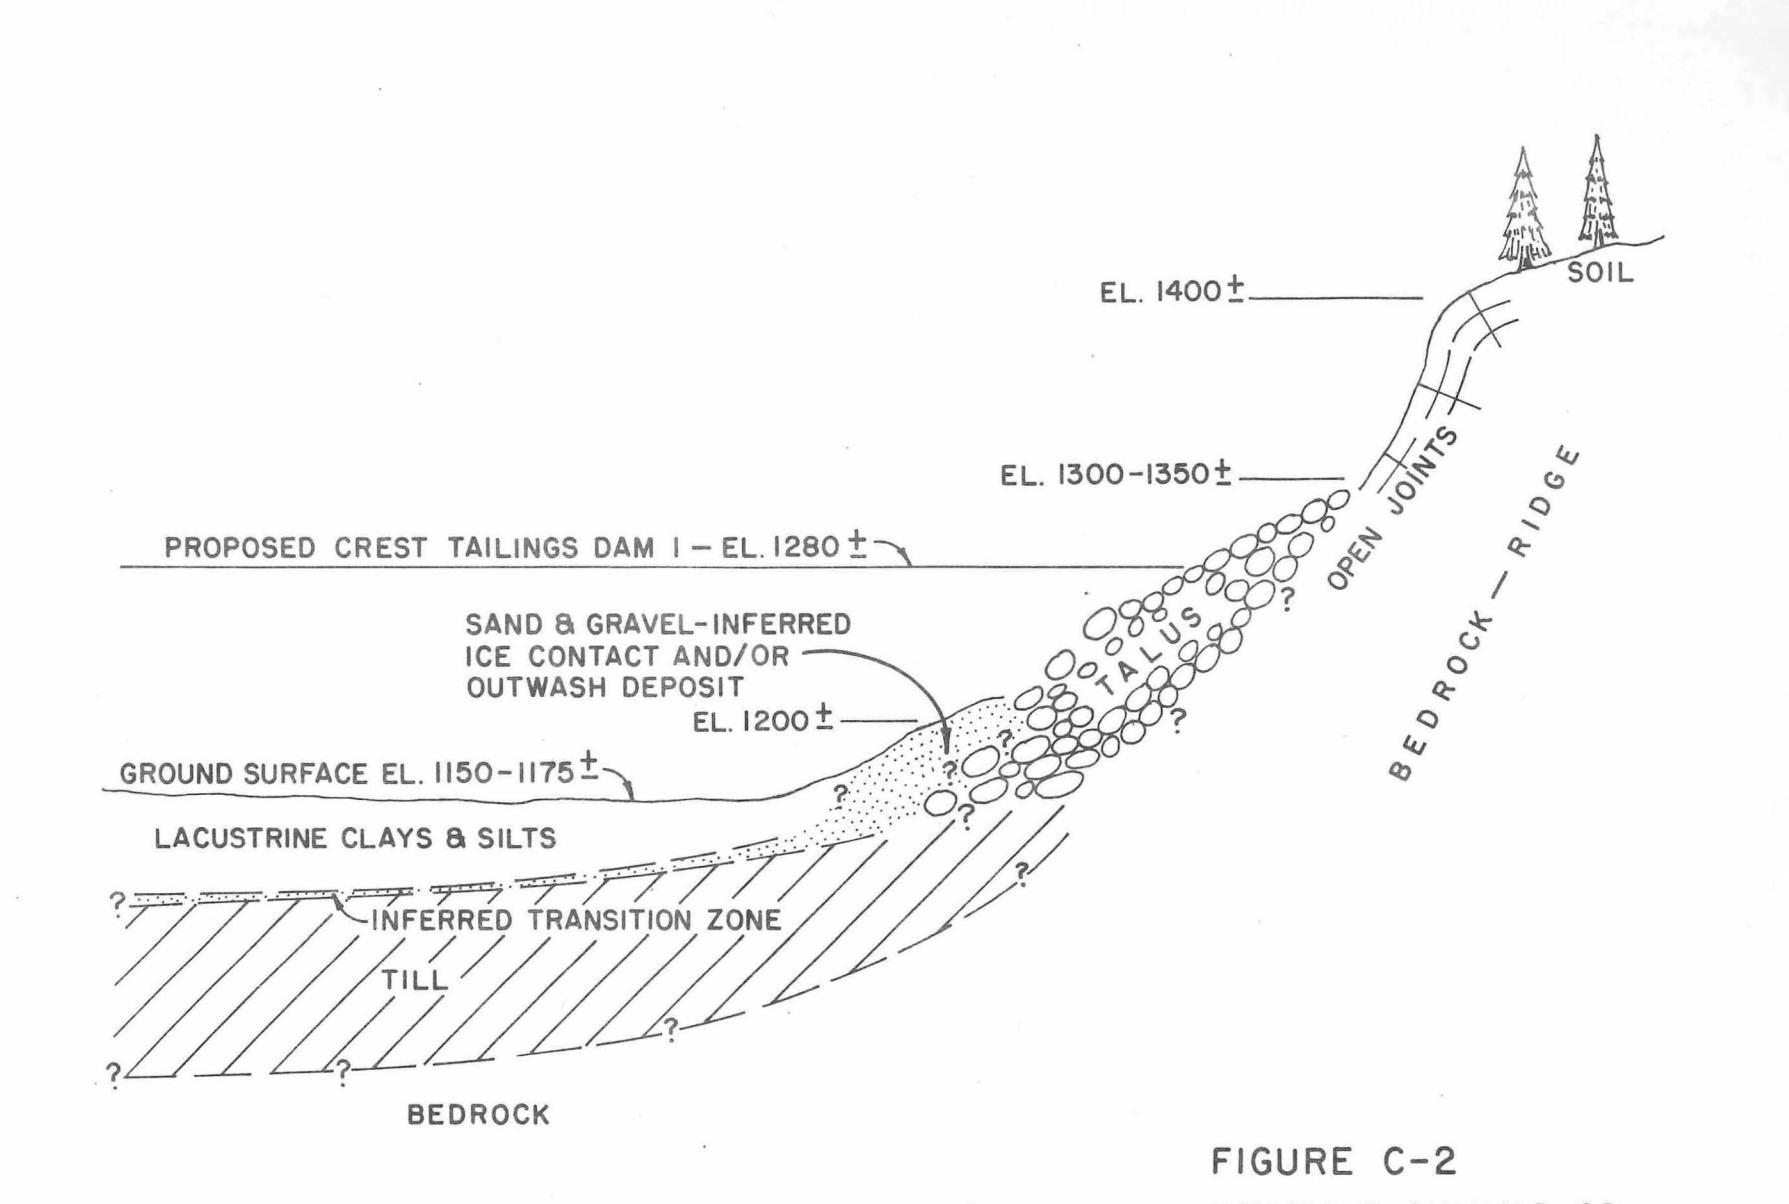
GENERALIZED GEOLOGIC SECTION THRU EAST ABUTMENT DAM I-LOOKING NORTH Not to Scale, Aug. 1975
