MILE POST 7 WEST RIDGE RAILROAD RELOCATION, DAM EXTENSIONS, AND STREAM  
MITIGATION PROJECT ENVIRONMENTAL ASSESSMENT WORKSHEET (EAW)

RECORD OF DECISION – FINDING OF FACT 28.i  
1975 WAHLER REPORT

Evaluation of  
**MILE POST 7 ON-LAND  
TAILINGS DISPOSAL PLAN**  
Proposed by Reserve Mining Company  
Performed by W.A. Wahler and Associates  
For the State of Minnesota

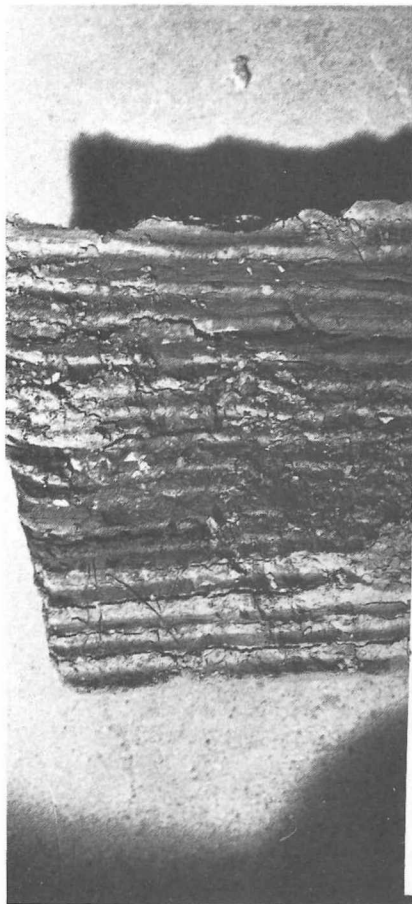
PHOTO A. PHOTO ILLUSTRATING VARVED NATURE  
OF FOUNDATION MATERIALS. CUT FROM SAMPLE  
NO. PS-2 (DRILL HOLE NO. WAWA-1076).

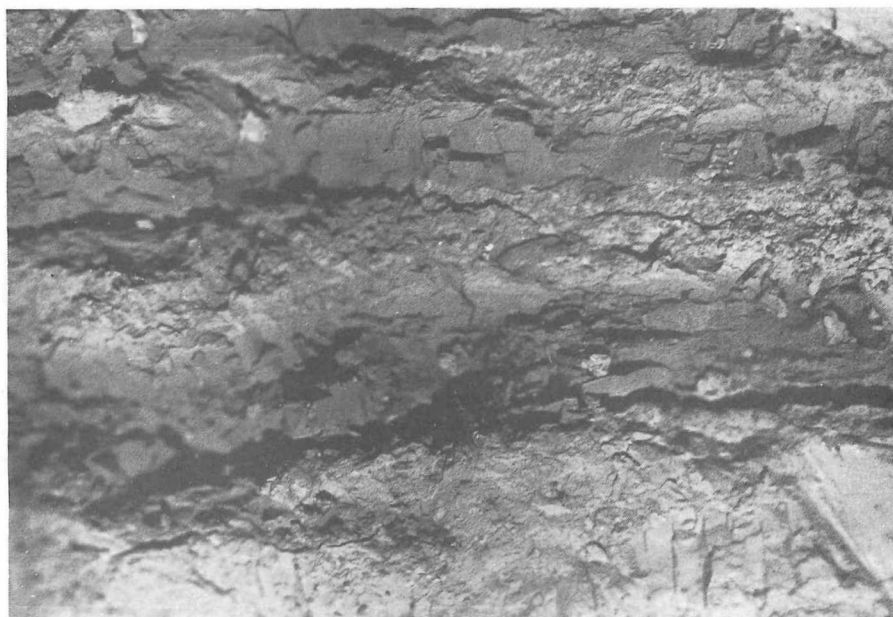
PHOTO B. CLOSEUP OF VARVED MATERIAL. CUT FROM SAMPLE NO. PS-4  
(DRILL HOLE NO. WAWA-1076).
