MINNESOTA DEPARTMENT OF NATURAL RESOURCES
DIVISION OF FISHERIES

IDENTIFICATION OF GROUND WATER INTRUSION AREAS ON
THE LAKE SUPERIOR SHORELINE AND SELECTED
TRIBUTARIES IN MINNESOTA

2004

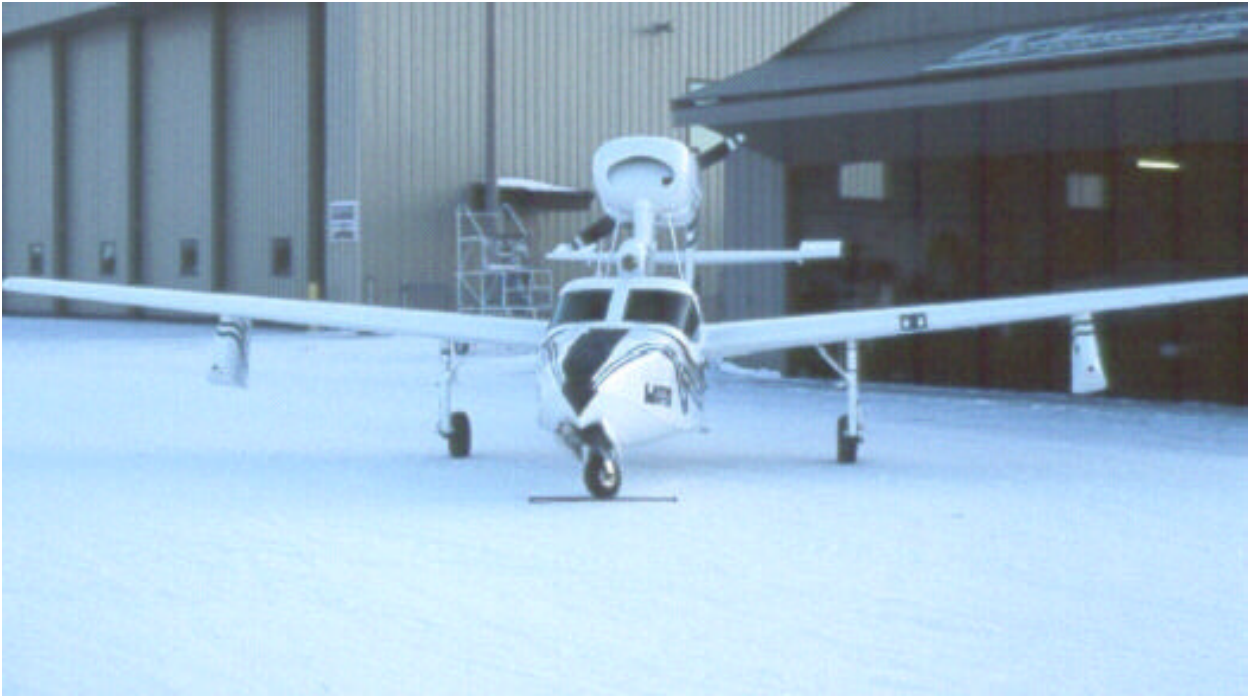
Figure 3. Lake Buccaneer model, remote sensing aircraft, A.W. Research Laboratories Inc. photo.

Aerial surveys were conducted by A.W. Research Laboratories, Inc. of Brainerd, Minnesota (AWR) using a fixed-wing “push-type” Lake Buccaneer aircraft (Figure 3). Flight speed and elevation averaged 95 miles per hour and 1300 feet above ground level. The contractor flew preliminary flights over each area taking 35 mm color Fujichrome slides with a handheld SLR camera. Subsequent flights used four wing-mounted video cameras, which were tuned to different wavelengths or bands of the spectrum. These hyperspectral bands were specific to the frequency at which chlorophyll “a” absorbs energy (670 nanometers), a “water-penetrating” frequency (710 nanometers), and a thermal infrared frequency (adjustable from 0.95 to approximately 16 microns). The chlorophyll “a” and “water-penetrating” bands have been used by the contractor in the past to collect additional information about a site’s plant community and

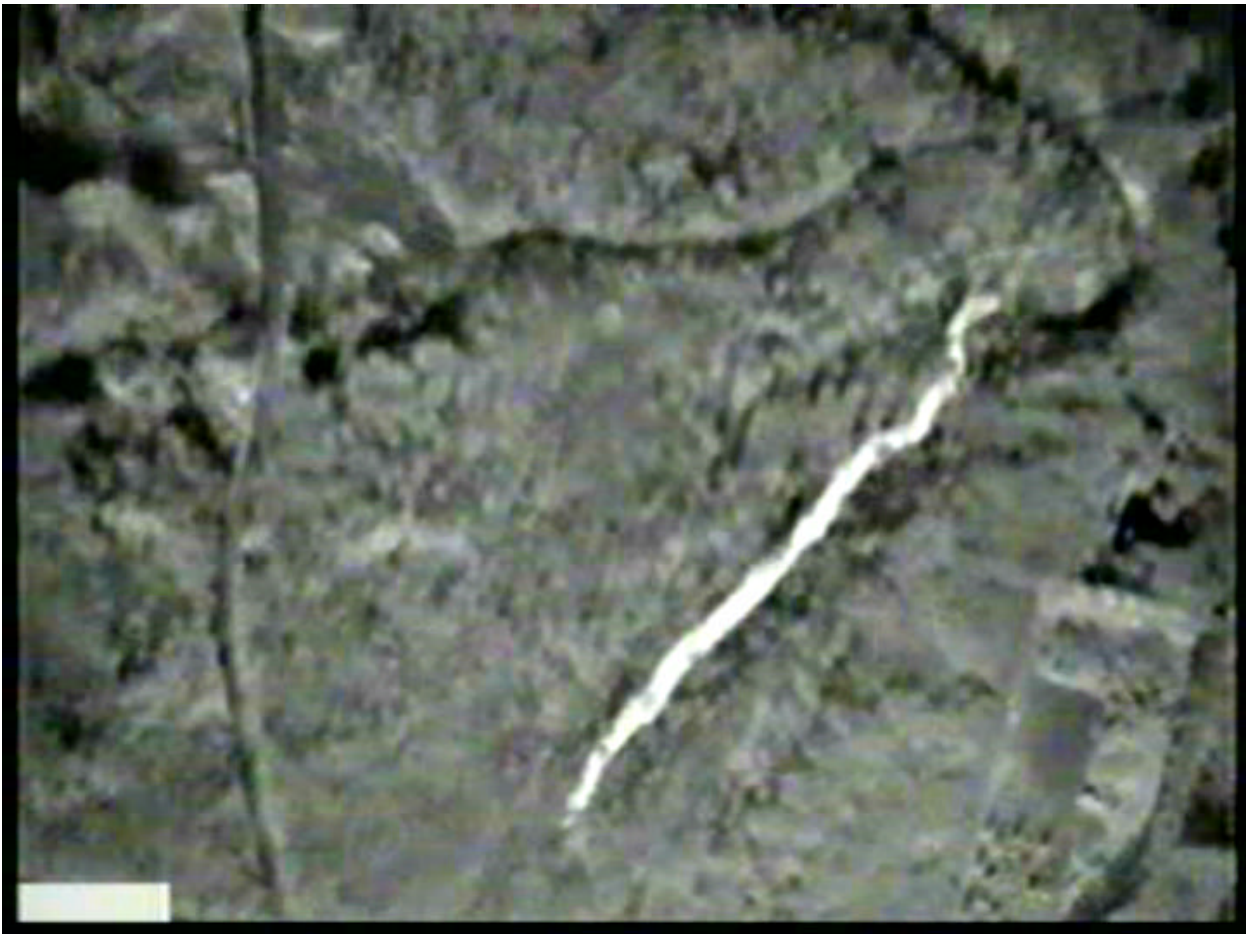
Figure 4. Mainstem Knife River, showing thermal signature of water flowing over the ice, January 2003.

The timing for the TIR data collection on the Knife River system, originally scheduled for fall of 2002, was delayed until January and February of 2003 because the contractor was either unavailable or conditions were not suitable. The TIR data from this survey showed multiple warm areas distributed throughout the system, but mostly concentrated in the upper portion of the river system. Field assessment showed these signals to be primarily water flow on top of the ice. At the time TIR data were collected, stream channels were frozen and the bitterly cold winter and sparse insulating snow cover caused cracks in the ice, allowing stream flow on top of the ice creating "false positives," areas on the TIR data that appeared warm, but were not clearly associated with groundwater (Figure 4). These areas were groundtruthed again in early September 2003 and no evidence of groundwater intrusion was found.

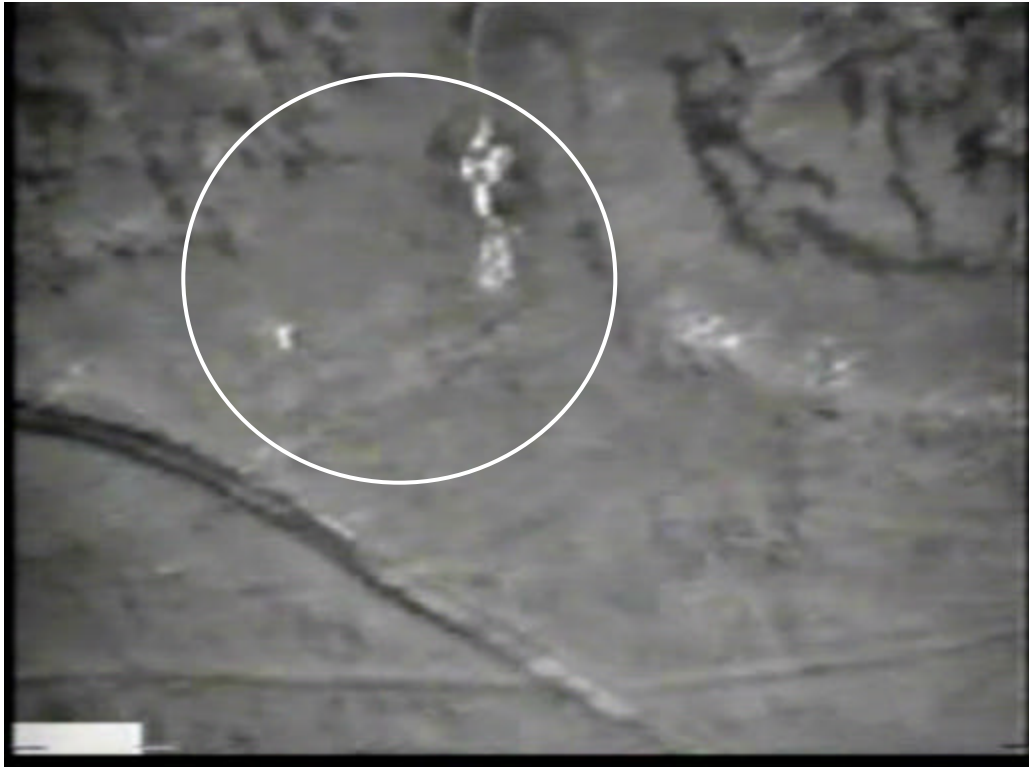
Figure 5. Thermal image of Knife River and Old Drummond Road, C (Figure 2), taken on February 29, 2003, showing a region of ground water intrusion indicated by white.

Areas of potential groundwater identified with TIR were investigated, and in all but one case, field assessment failed to find groundwater. At location C, near the intersection of Old Drummond Road and the Knife River (Figure 2), groundwater was positively identified during field assessment. TIR imagery taken on February 29, 2003, showed a possible area of ground water intrusion at this site (Figure 5). This area was initially visited February 19, 2003 and evidence of groundwater consisted of some water on top of the ice, slush and little snow depth. Location C was revisited on September 9, 2003 after a summer of drought. A bryophitic wetland plant community surrounded an off channel spring emanating from the base of a slope (Figure 6). Additional aerial data of the Knife River mainstem were gathered in conjunction with the December 4, 2003 flight of the Lake Superior tributaries. Thermal imagery taken over area C (Figure 2) showed little contrast (Figure 7). It is unclear why the thermal sensor did not detect the presence of groundwater at this site, given the temperature differences that existed at the time of the imaging. This site was visited on December 10, 2003 and showed evidence of groundwater seeping to the surface causing snowmelt (Figure 8).

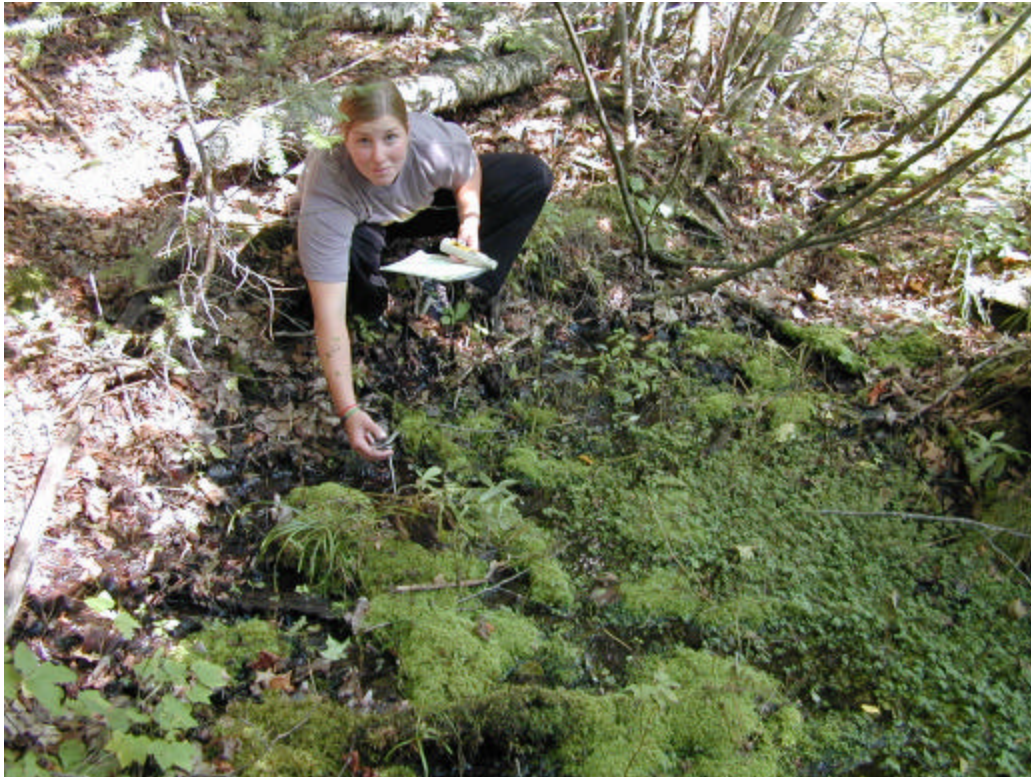
Figure 6. Groundwater intrusion area near the intersection of Old Drummond Road and the Knife River, site C, showing seeping groundwater feeding a bryophitic plant community. Photo taken on August 9, 2003.

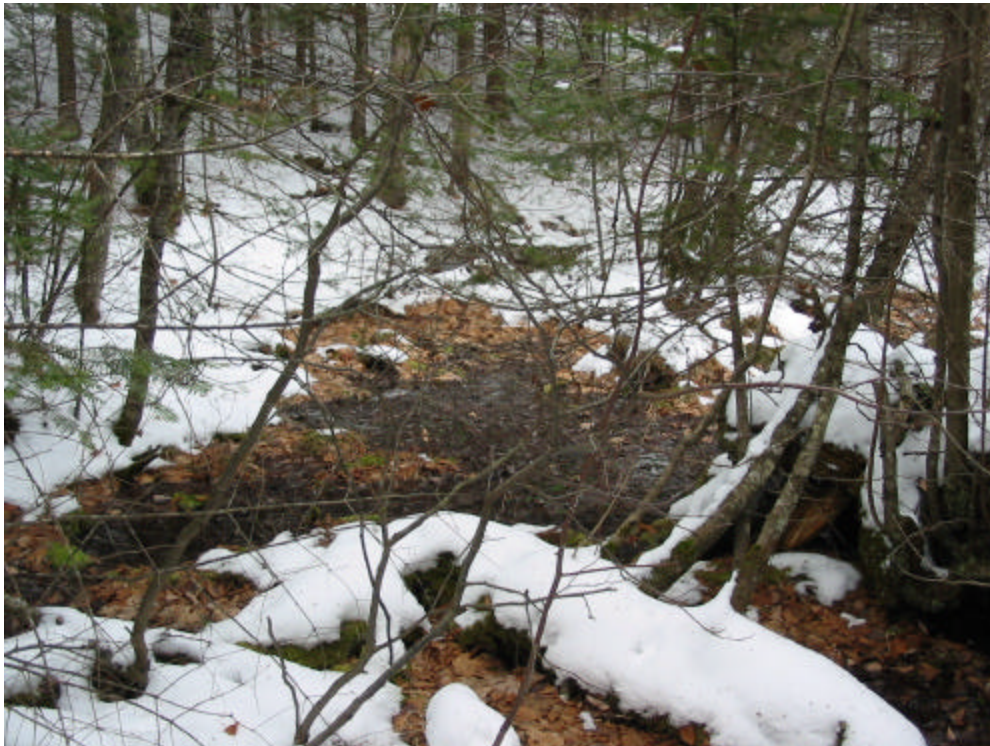
Figure 8. Groundwater intrusion area near the intersection of Old Drummond Road and the Knife River, site C, showing exposed ground and seeping groundwater on December 10, 2003.

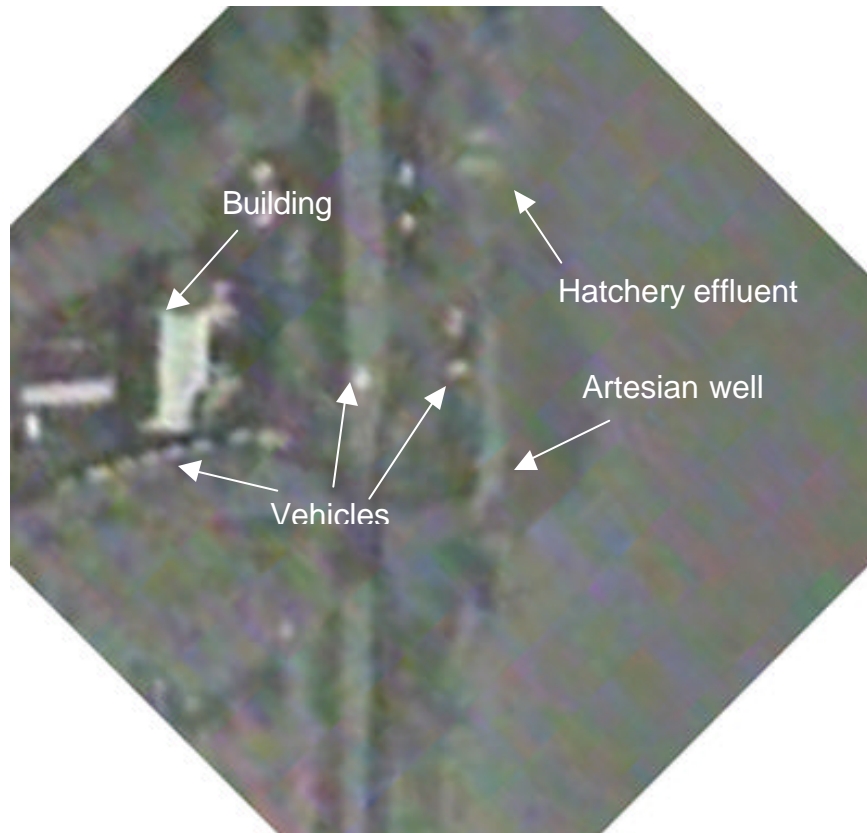
Figure 11. French River showing warm water hatchery effluent and artesian well taken on December 4, 2003.

The contractor agreed to resurvey the Lake Superior coastline because of the ambiguity in the interpretation resulting from the shadow artifact following the coastline in the April 29, 2003 dataset. The lower portion from the Lester River to Two Harbors was flown again on December 4, 2003. The TIR imagery of this dataset was without this nearshore shadow and appeared flat with less marked contrast. The data appeared to have fewer artifacts due to solar warming and shadows facilitating interpretation of the data. The hatchery effluent and small artesian well at the French River were indicated (Figure 11).

distinct light areas in the TIR footage that would indicate a plume of warm groundwater coming to the surface in the nearshore areas. No areas of groundwater intrusion were identified from the Lake Superior shoreline part of this project, although the hatchery effluent at 42-46°F is clearly indicated (Figure 11).

This method proved to be sensitive in detecting groundwater intrusions at the Knife River and Lester River sites. Minor flows of warmer water in the example of the artesian well and the hatchery effluent were detected (Figure 9, Figure 11). The technique also detected water flowing over the ice in frozen stream channels.

of conditions as the unknown intrusion areas. As an example, Site C on the Old Drummond Road and the artesian well at the French River were poorly resolved in the December 4, 2003 dataset (Figure 7 and Figure 11), yet the groundwater intrusion on the Lester River was detected under similar conditions in data gathered on the same day (Figure 13). All three sites appeared to have similar flows of groundwater. The Lester River site seems to be the most clearly resolved. From observing the poor resolution of the known groundwater intrusion sites on this dataset, the Old Drummond Road and artesian well sites, we would incorrectly assume that this dataset offers little resolution of additional sites. Unique characteristics of the local environment at a site such as surrounding substrate, snow and ice conditions influence whether a site is detectable.

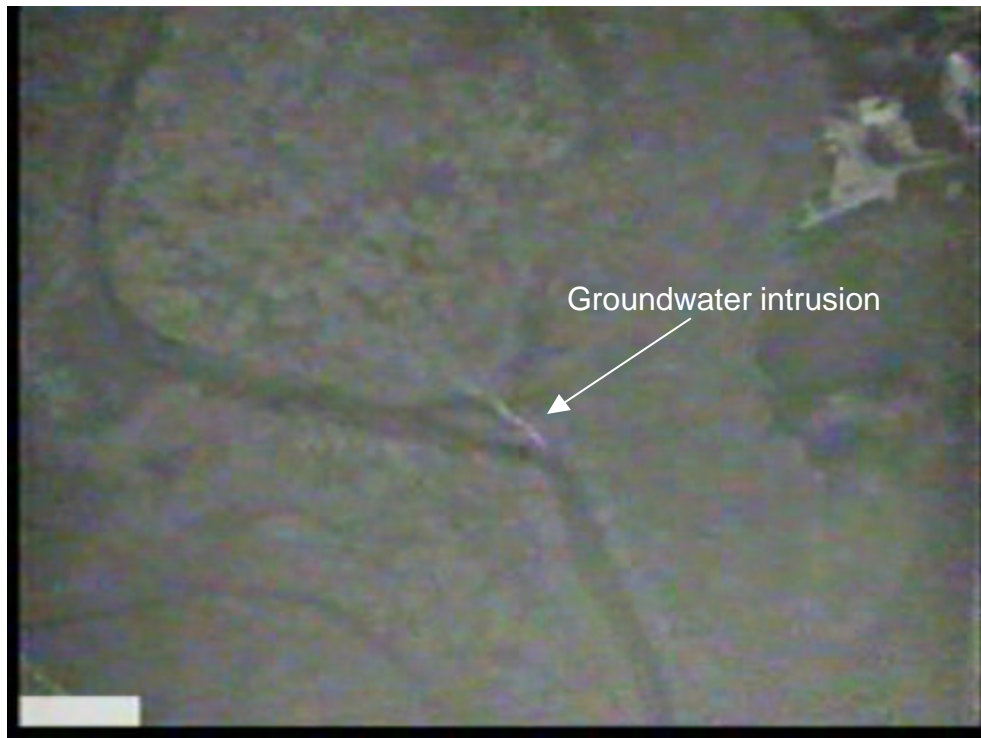
Figure 13. Thermal image of small groundwater intrusion area on the Lester River taken December 4, 2003.

The below barrier tributary portions of the Lester River, Talmadge Creek, French and Sucker rivers were flown on December 4, 2003. Streams were partially frozen with an open channel remaining in many areas. The ground and ice surfaces were snow covered. Air temperature was approximately 30 °F. Conditions were mostly overcast on December 4, 2003 resulting in TIR imagery of low contrast and few shadows. A light area appeared in the TIR data on the Lester River from the December 4, 2003 flight indicating a possible groundwater intrusion area from a small side channel (Figure 13, Figure 14). This site was visited on July 9, 2004. The afternoon water temperature in the main river channel was 70 °F, while the temperature of the small side channel was 51 °F indicating the presence of groundwater (Figure 15).

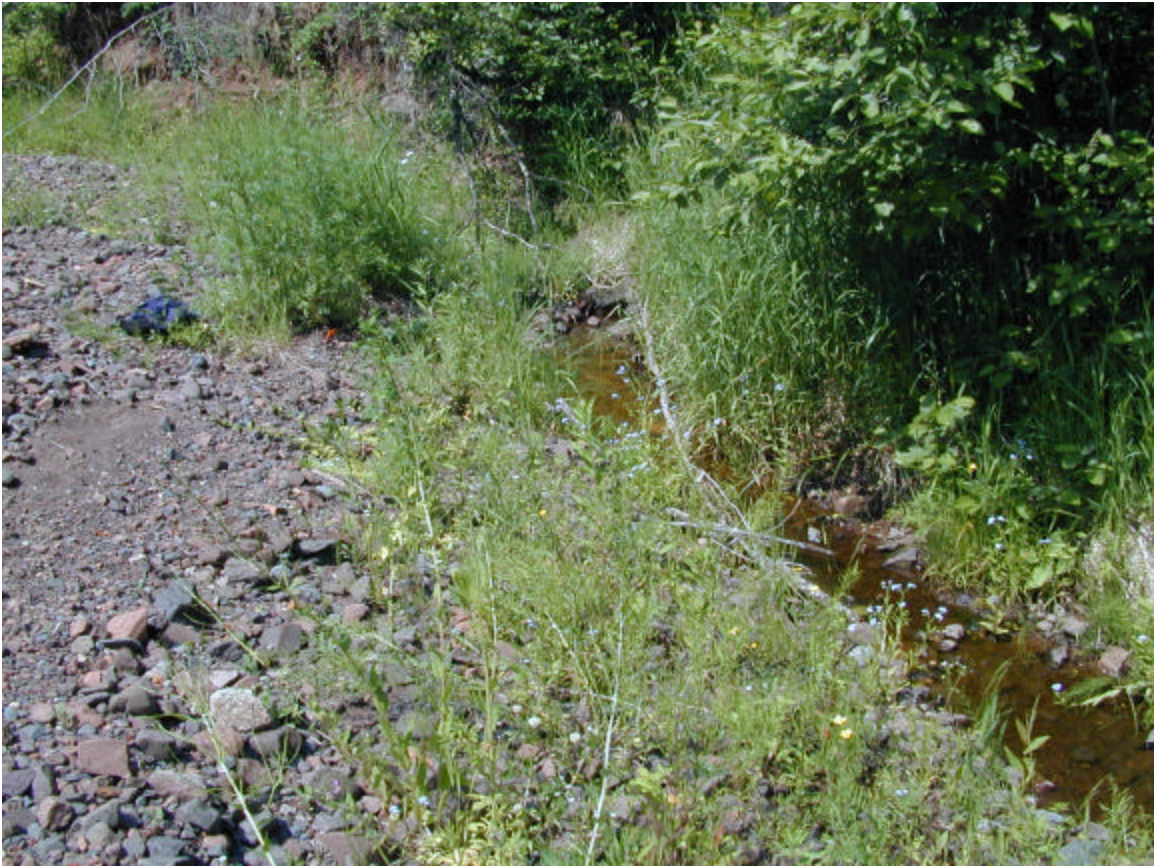
Figure 15. Groundwater intrusion area on the Lester River, July 9, 2004.
