# Pelican Lake Outlet Feasibility Study

Ducks Unlimited, Inc.

April 2006

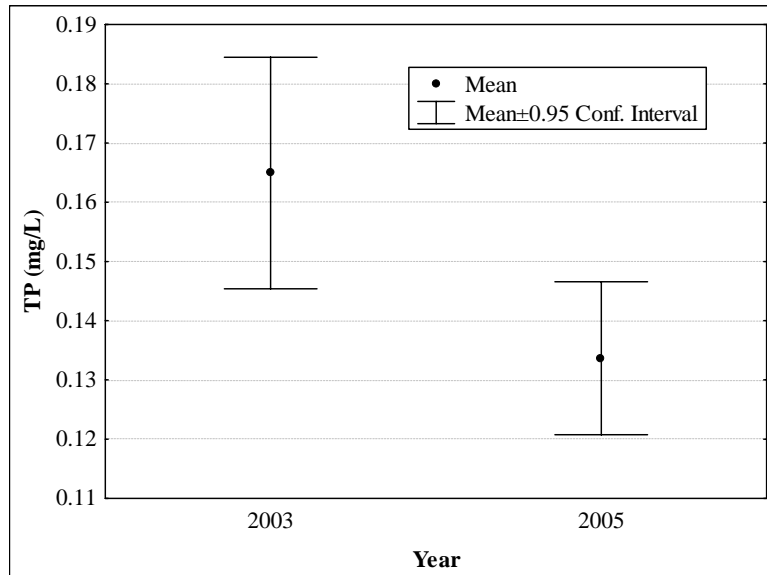
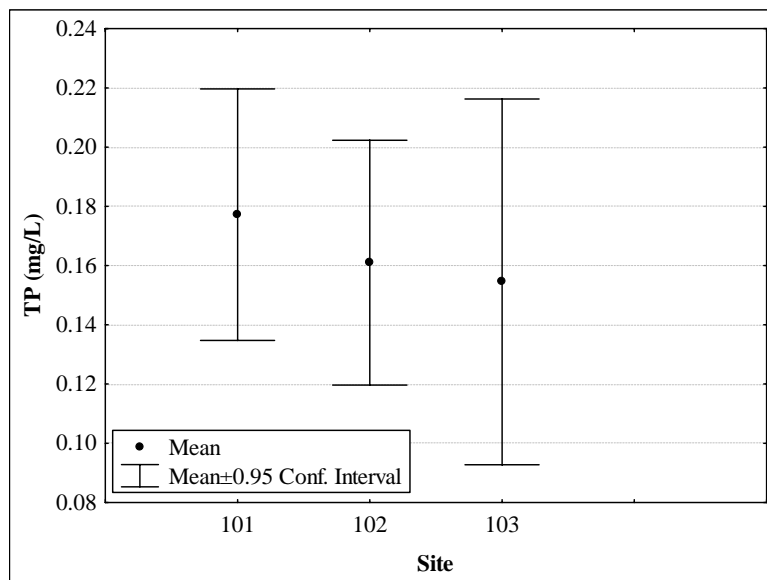
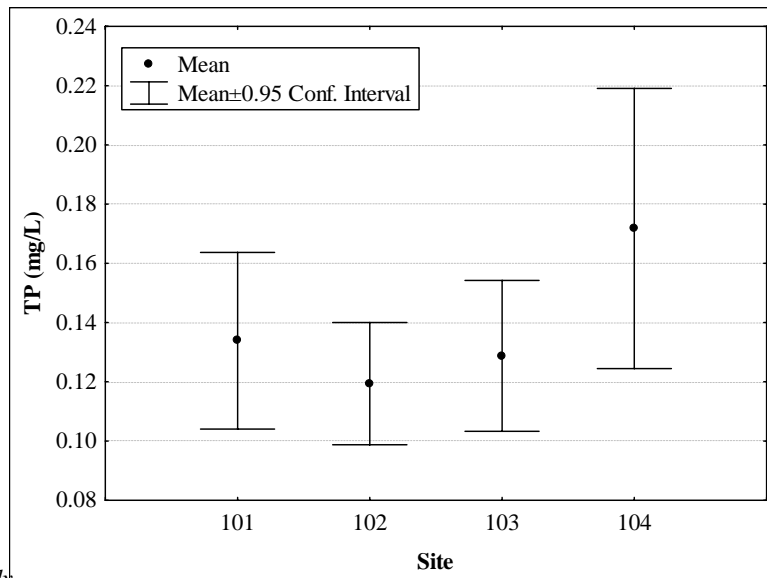
**Figure II.B-1. In-lake TP growing season (June through September) means**

**Figure a.  
2003 and 2005 averages**

**Figure b.  
2003 data, categorized by site**

**Figure c.  
2005 data, categorized by site**

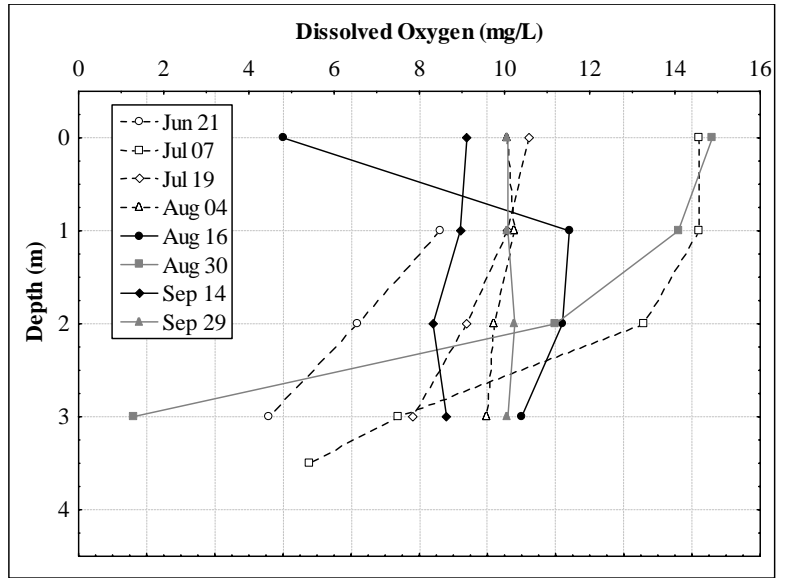
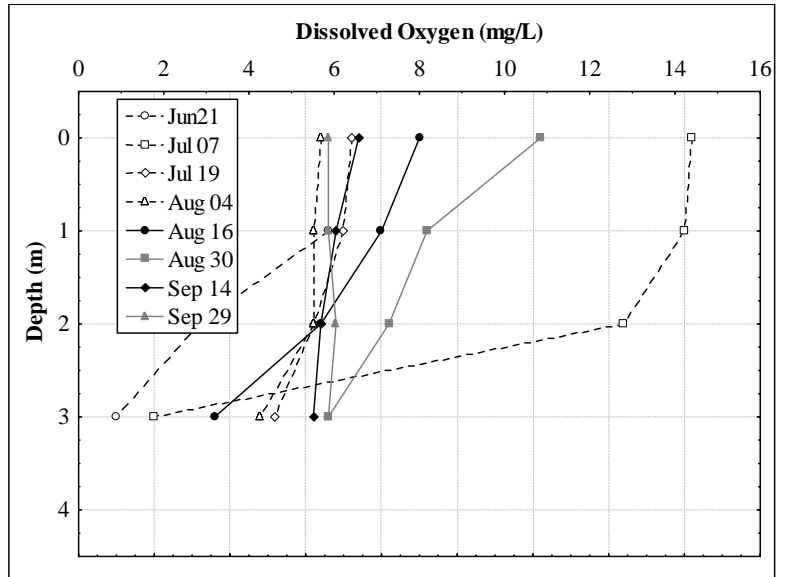
**Figure II.B-3. Dissolved oxygen-depth profiles, June through September, 2005.**

**Figure a.  
Site 101**

**Figure b.  
Site 102**

**Figure c.  
Site 103**

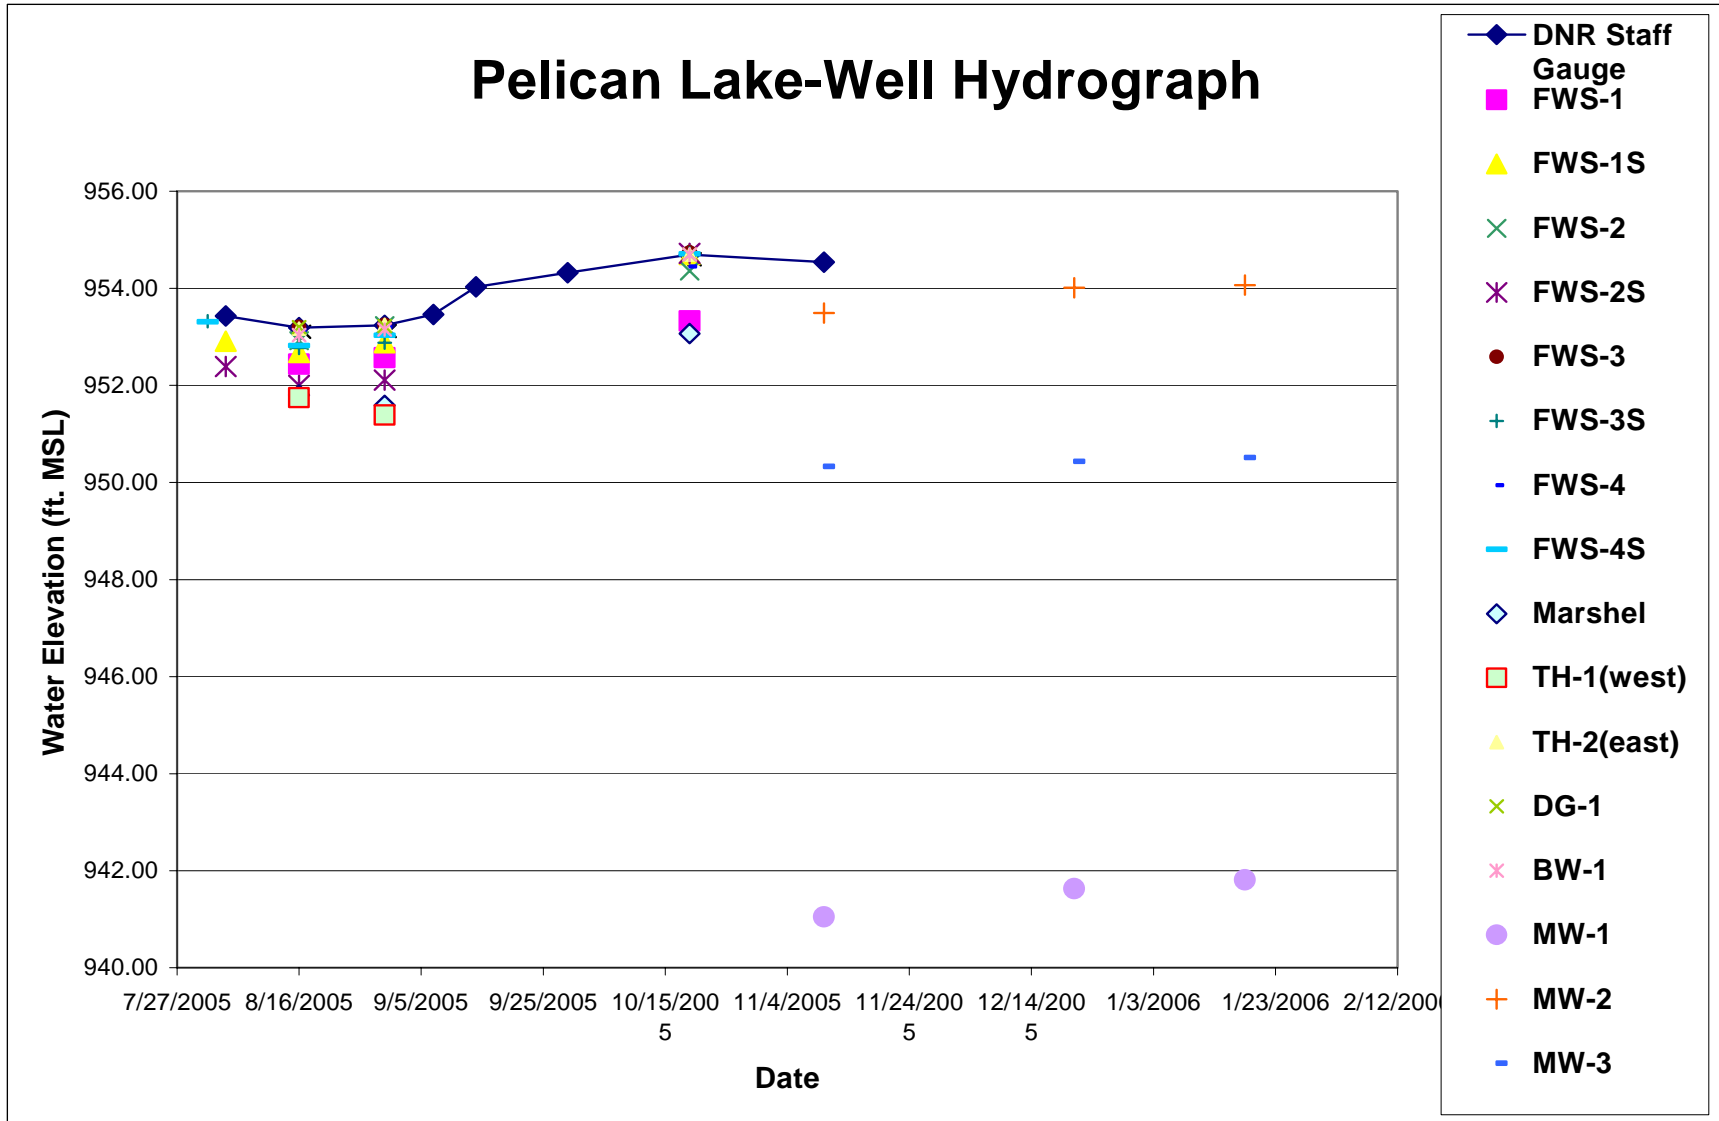
Figure III.B-2 Lake Surface and Groundwater Hydrograph

Well locations are identified in Figure III.B-1

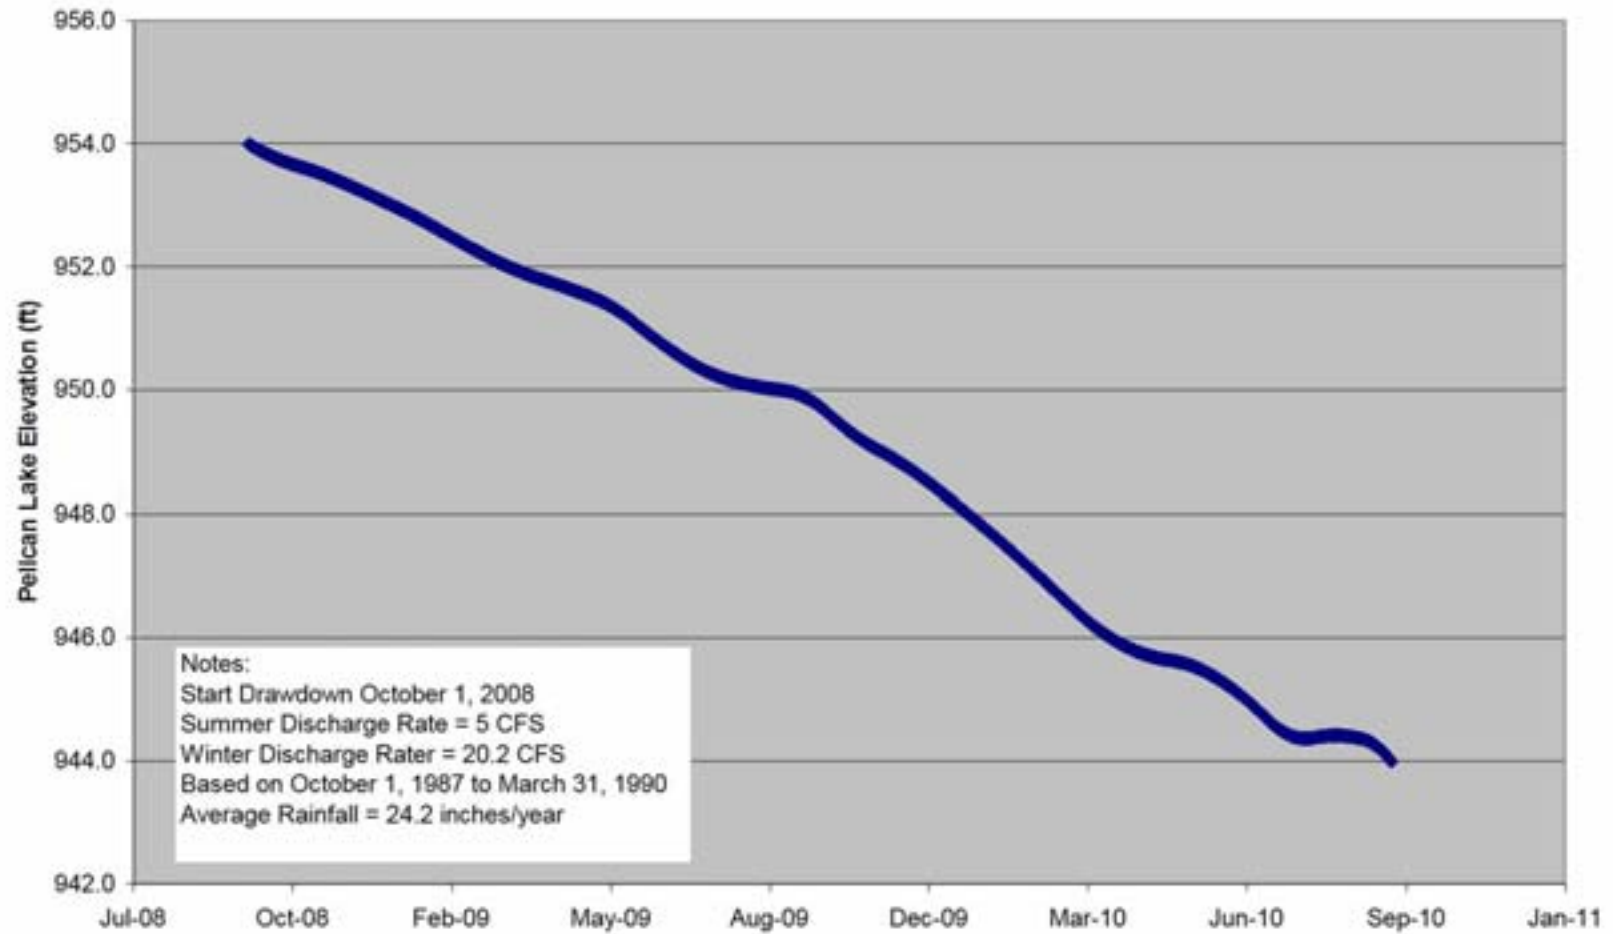
Figure III.C-6. Pelican Lake Drawdown Schedule for Dry Conditions

Figure III.C-7. Pelican Lake Drawdown Schedule for Average Conditions

Figure III.C-8. Pelican Lake Drawdown Schedule for Wet Conditions

Figures III.C-6 through III.C-8 show a simulation of drawdowns under dry, average, and wet conditions starting in 2008 using the above parameters. The original drawdown scenario called for a 12 cfs winter and 5 cfs summer discharge rate. The winter discharge rate was increased to 21 cfs to shorten the initial drawdown time. Figure III.C-9 shows historic Pelican Lake levels as they would have been with these outlet parameters.

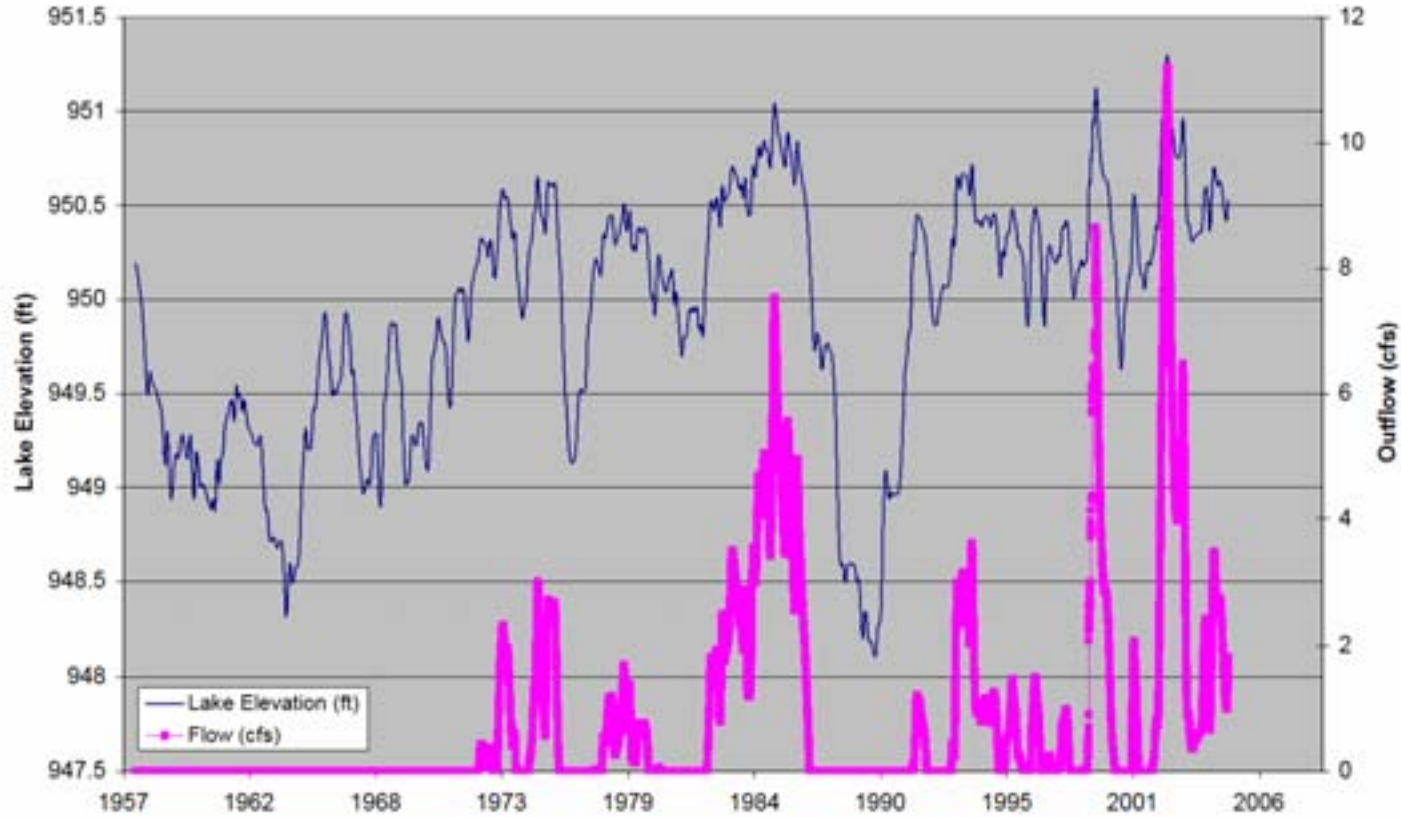
**Figure III.C-9. Simulation of Historic Elevation and Outflow**

- 1) Theoretical operation based on historical water elevations since 1958
- 2) 3' sharpcrested weir with end contractions
- 3) Max Elevation = 951.3 Feet
- 4) Average Yearly Outflow = 487 AC-FT (0.67 CFS)
- 5) Maximum Flow = 11 CFS
- 6) Maximum Yearly Outflow = 3200 AC-FT
- \*Actual outflows will be based on operating plan

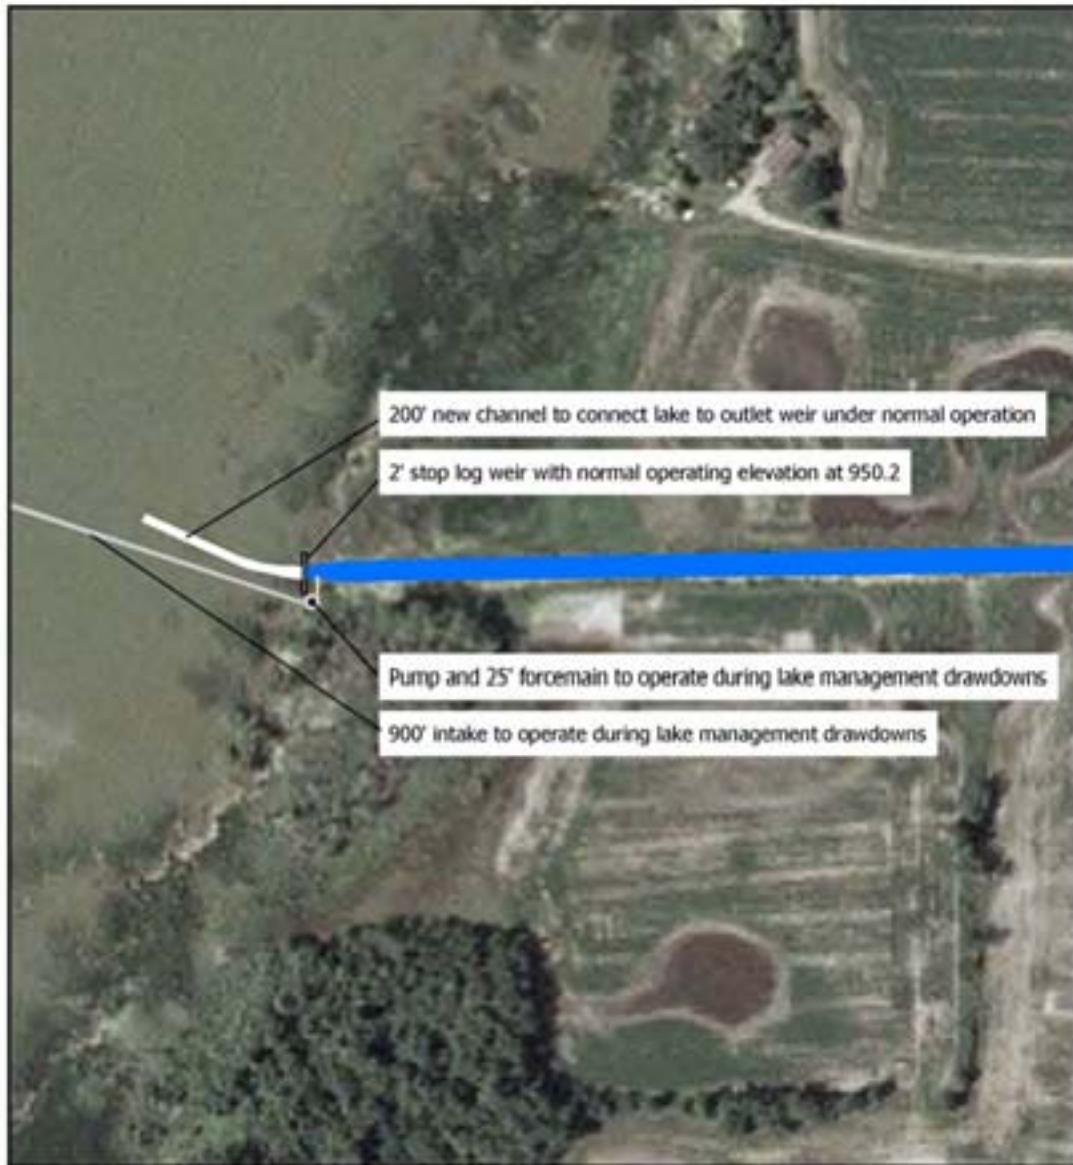
## Figure V.B-1 Lake Outlet Controls

- Outlet Controls**
- Open Channel
  - New Channel
  - Pump
  - Weir
  - Intake and force
