Management Plan and Aggregate Resource Notes for the Proposed Esker Trail Road West Pit, St. Louis County, Minnesota

Project 334-41
By Glenn D. Melchert
June 2013

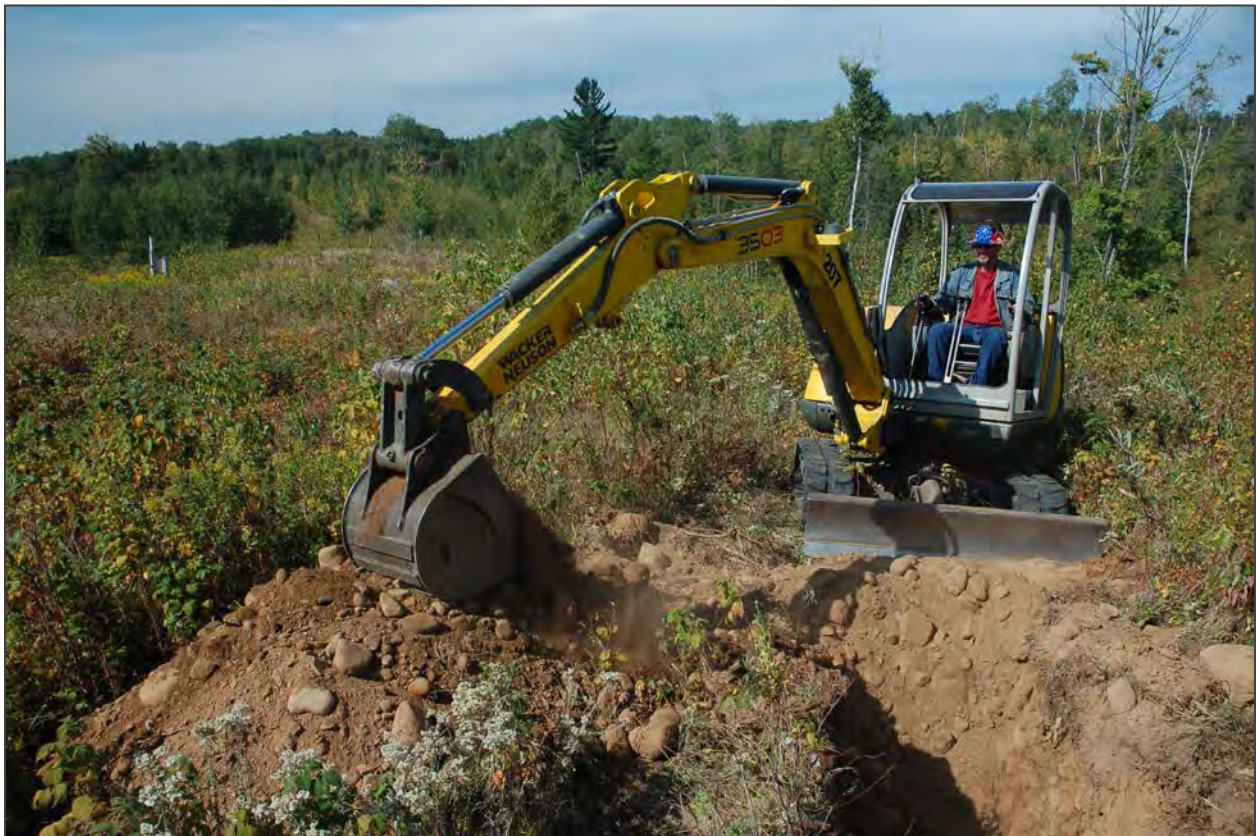
This photo shows the general terrain of the lease area looking southwest at test hole 1. The photo was taken September 6, 2012 by C. Jennings.

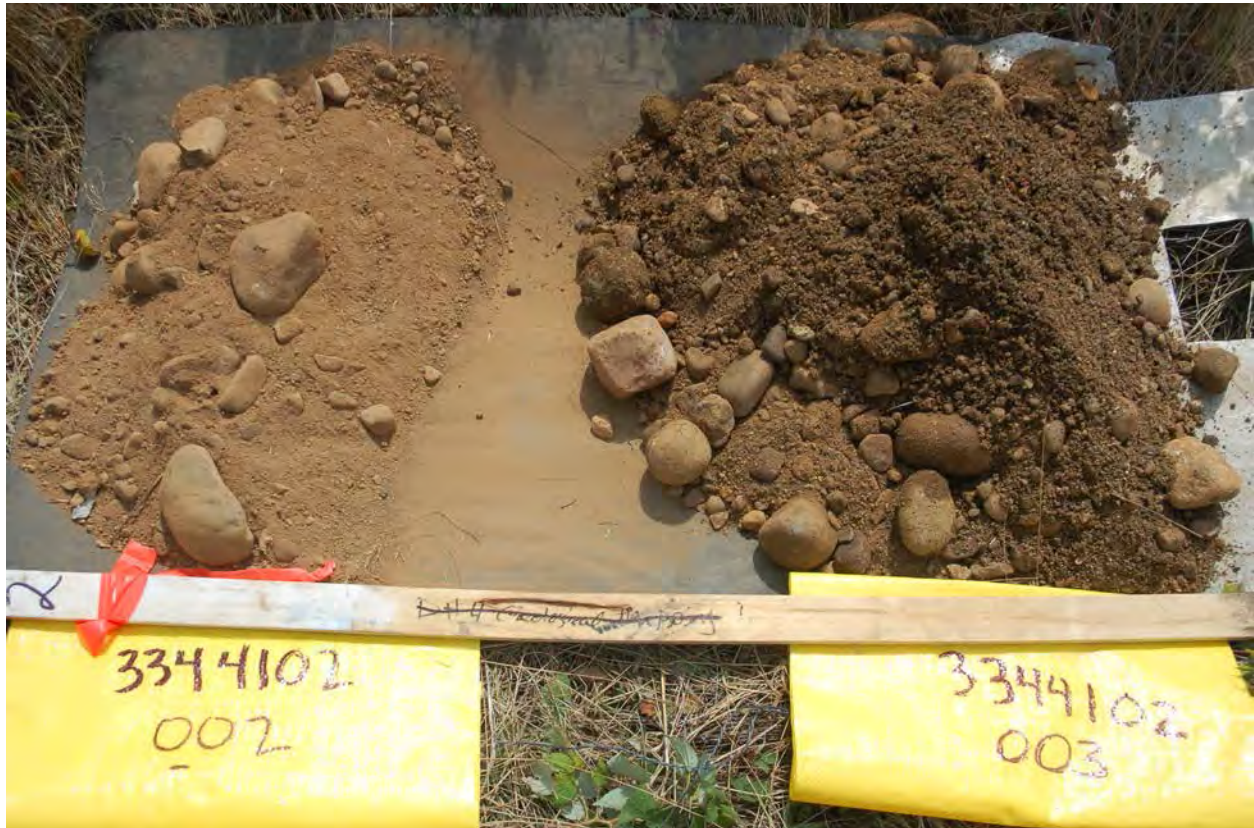
Figure 3. This photo shows the difference in the upper few feet of the gravel deposit compared to the deeper gravel in Test Hole 2. The light colored sample on the left is from the upper 2 feet of the hole and has a high percentage of fine sand. The gradation test indicates the sample on the left had 6.8% passing 200 sieve and the sample on the right had 2.0% passing 200 sieve.

and 14 ranged from 8.1 to 12%. Multiple samples were collected from two holes, holes 2 and 6 (Figure 3). One sample from each hole represented the upper few feet that was influenced by the fine sand, and the other sample represented the apparently cleaner gravel beneath. The minus 200 for the samples representing the upper several feet was about three times greater than the samples representing the deeper gravel.

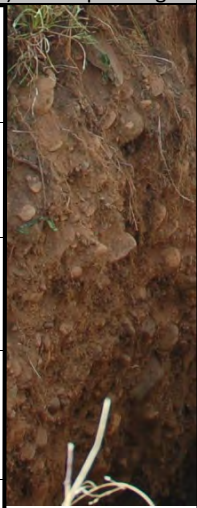
Description Sediment/Color/Grading/Texture	Drilling		Sampled? Interval	Gravel size (in")	Predominant	Interpretation Geological
	Depth (FT)	Graphic Log		Range		
Very silty rd-brn pbl-cbl gravel with boulders. Oxidized, dry. Abund. crushable. Lacks sand.	0.0-2.0

Y-02002	up to 4"	1"	Glaciofluvial (prob. subglacial) with eolian silt sieved into matrix
Grad. to drk crs s and g, si dec. w/ depth. Pred. pbl but occ cbls and bldrs. Well graded.	2.0-7.0		Y-02003	up to 12"	3"	Subglacial fluvial
Clean m-crs gr sand with pbls, trace silt. Occas larger clasts	7.0-9.0		Y-02003	up to 8"	1"	Subglacial fluvial
Total Depth	9 FEET		H2O Table Depth	>9 FEET	Aggregate Thickness	9+ FEET
Ended in	SAND AND GRAVEL

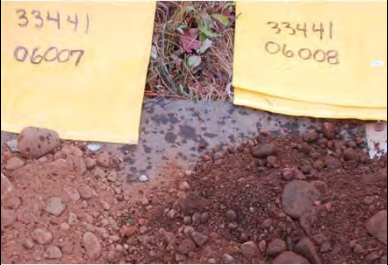
N			Eolian silt.
Graded clast supp. pbl to cbl gvl w/ s. Silt to 4' >65-70% rock? Well rd.	1.5-5.0		Y-06007	.2-8"	5"	High energy glaciofluvial with sieved silt
As above but cleaner. S- supp gvl with bldrs as max but smaller pred size	5.0-8.0		Y-06008	.2-12"	3"	High energy glaciofluvial

Total Depth	8 FEET		H2O Table	>8 FEET	Aggregate	6.5+ FEET
Ended in	SAND AND GRAVEL		Depth		Thickness

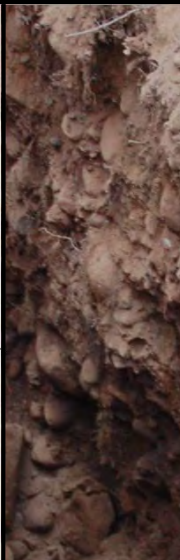
GSOC #: NA			Coordinates		Owner	School Trust
Township St. Louis County					Date drilled	9/6/2012
Site Description			Date called/Date ready NA		Start time	6:45 PM
Esker Rd, west, hilltop, in Maple but not raspberries					End time	19:30
Utilities NA						
Description	Drilling		Sampled?	Gravel size (in")		Interpretation
	Depth (FT)	Graphic Log		Interval	Range	
Sediment/Color/Grading/Texture						Geological
3-4" O horiz, rbr silty dry fs. w/ scndry Fe,cly at 6", cbly silt at 1', gradl. Soil perches water	0.0-2.5

.2-2"	1"	Windblow silt mixed by seiving, frost & bioturb
Clast supp. cbl gvl with well graded sand.	2.5-8.0		Y-08010	.2-12"	7"	High energy glaciofluvial
Total Depth	8 FEET		H2O Table	>8 FEET	Aggregate	5.5+ FEET
Ended in	SAND AND GRAVEL		Depth		Thickness

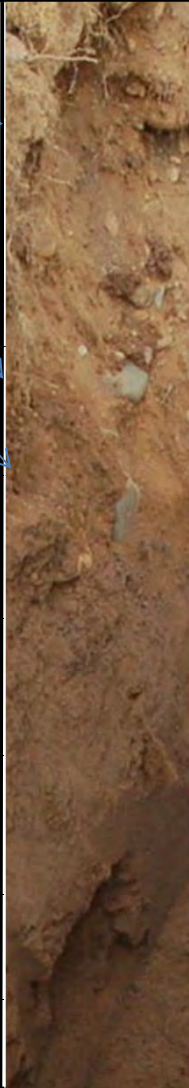
GSOC #: NA Coordinates Township St. Louis County Site Description Esker Rd, west, down trail to edge of open area Utilities NA			Owner	School Trust			
			Date drilled	9/7/2012			
			Start time	9:35 AM			
			End time	10:30			
Description	Drilling		Sampled?	Gravel size (in")	Interpretation		
Sediment/Color/Grading/Texture	Depth (FT)	Graphic Log	Interval	Range	Predominant Geological		
Silty fs, dry, r br w/ pbls	0.0-2.5

N			Windblow silt mixed by seiving, frost & bioturb with glac fluv	
Cleaner cbl gvl w/ sdy matrix	2.5-3.5		Y-10012			High energy glaciofluvial	
vfs layer, .5' thick, r br, darker, smooth	3.5-4.0		Y	↓			Quiet water, part of fining up sequence
s, clean, w- sorted (beach) varying from pred. ms to crs s but few to no pbls below 3.5'	4.0-9.0		Y-10012				deltaic or slow glac fluvial
Total Depth	9.0 FEET		H2O Table	>9 FEET	Aggregate	6.5 FEET	
			Depth		Thickness		
Ended in	SAND

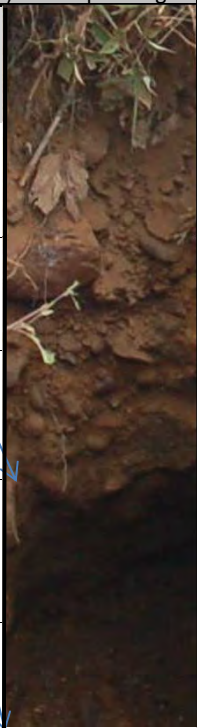
GSOC #: NA		Coordinates		Owner	School Trust	
Township St. Louis County				Date drilled	9/7/2012	
Site Description		Date called/Date ready NA		Start time	10:30 AM	
Esker Rd, west, farthest S transect, w off trail, 380deg panorama of site				End time	11:30	
Utilities NA						
Description Sediment/Color/Grading/Texture	Drilling		Sampled? Interval	Gravel size (in")		Interpretation Geological
	Depth (FT)	Graphic Log		Range	Predominant	
Lt r br silty clast sup cbl gvl, rd and spher clsts, some sm bldrs	0.0-2.5

N	.2-14"	3"	Windblow silt mixed by seiving, frost & bioturb with glac fluv
pbl gvl w/ si matrix w/ some bldr and cbl outliers	2.5-4.5		Y-11013	.2-12"	1.5"	High energy glacio fluvial
sand, m-crs w/ pbls, 30-40% gvl	4.5-8.0		Y-11013	.2-5"	2"	Lower energy glaciofluvial
Total Depth	8.0 FEET		H2O Table Depth	>8.0 FEET	Aggregate Thickness	5.5+ FEET
Ended in	SAND AND GRAVEL

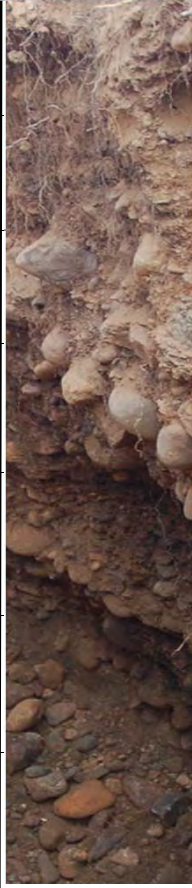
Description	Drilling		Sampled?	Gravel size (in")		Interpretation
	Depth (FT)	Graphic Log		Interval	Range	
Si cbl gvl w/ bldrs, s and gran, clast sup, most over size crushable, 2ndry clay, Fe2.5'	0.0-8.0

Y-16018	.2-10"	8"	High energy glaciofluvial with eolian seive deposits
Difficult excavation, just as clast rich but dec size w/ depth.						
Total Depth	8.0 FEET		H2O Table	>8 FEET	Aggregate Thickness	8.0+ FEET
Ended in	SAND AND GRAVEL
