## Memorandum

**To:** Jon Ahlness, Stuart Arkley  
**From:** Mark Jacobson; Cheryl Feigum  
**Subject:** Wetland Impacts – Tailings Basin Mitigation Alternative, Revised June 2, 2008  
**Date:** June 2, 2008  
**Project:** 23/69/-862-006-001  
**c:** John Borovsky, Jim Scott, ERM

Figure 1  
 IMPACTED WETLANDS  
 Tailings Basin Area  
 PolyMet Mining  
 Hoyt Lakes, Minnesota

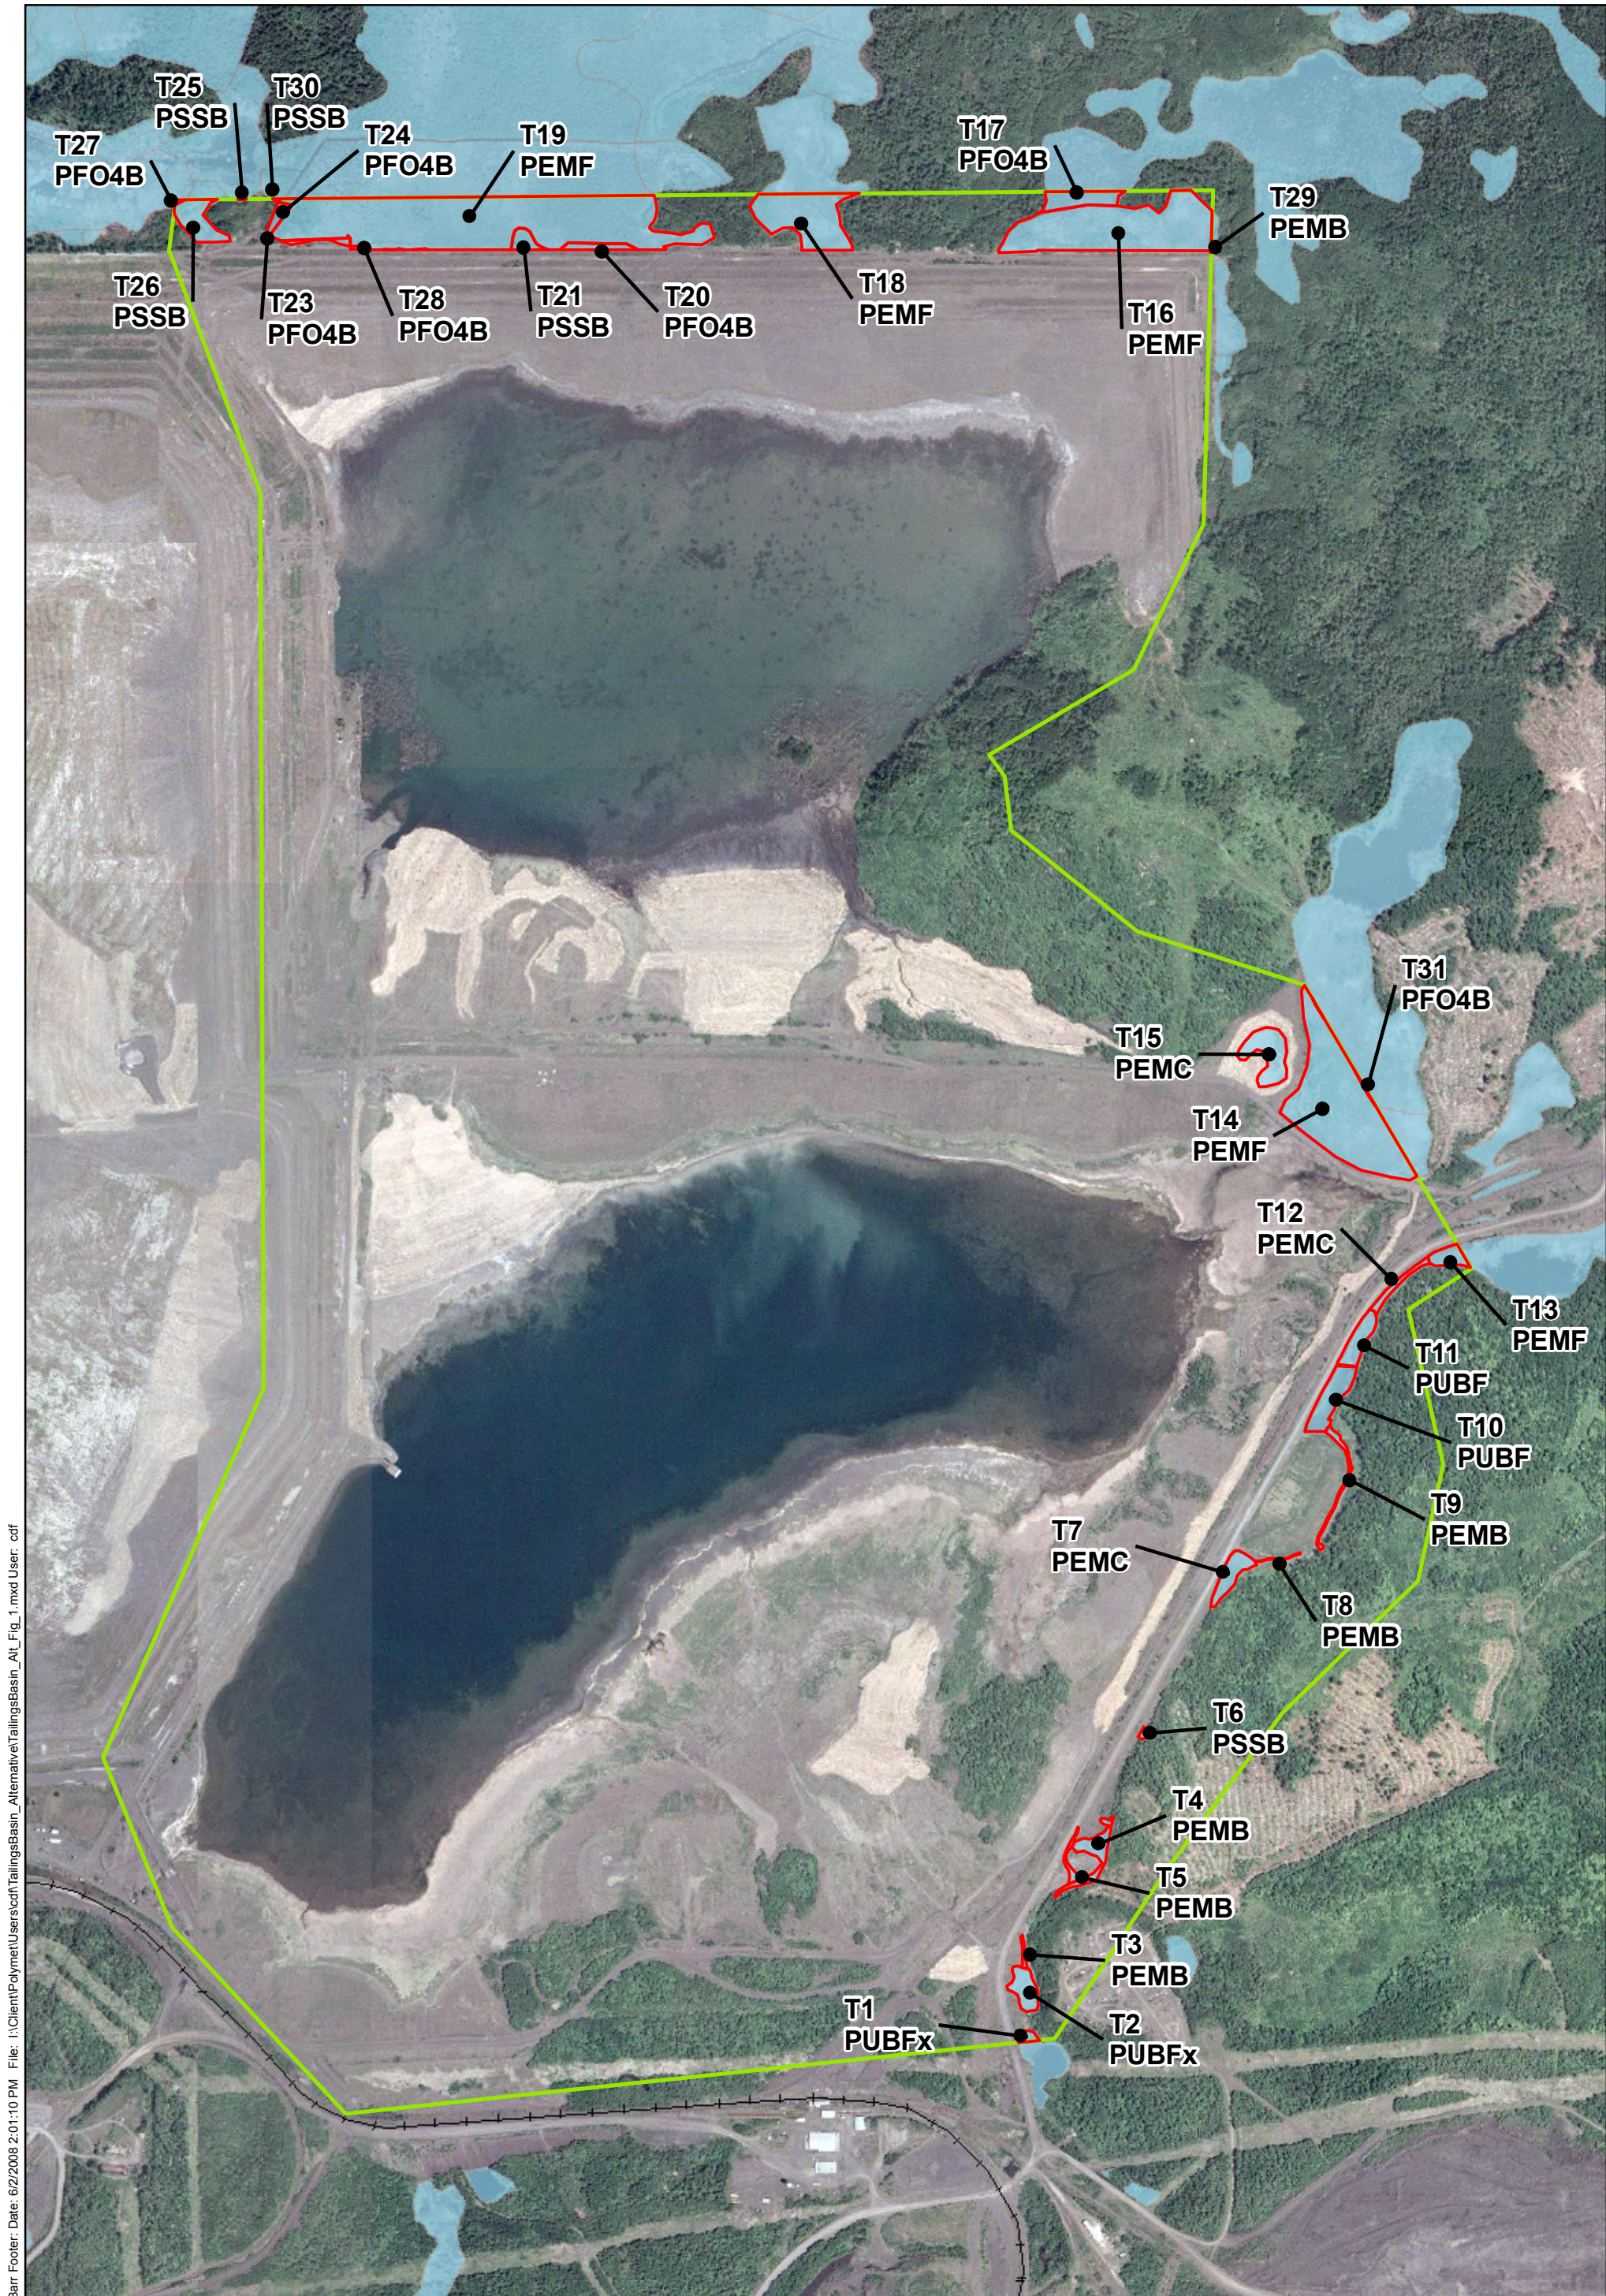
Figure 1 shows the evaluation area around Tailings Basin Cells 2E/1E. Two areas were evaluated for potential wetland impacts including:

- 1) the Buttress Area – this is a 300-ft wide area located along the length of the north side of Tailings Basin Cell 2E and would provide space to construct the buttress required to implement the mitigation; and
- 2) the East Basin Expansion Area – this area is located along the east and northeast side of the tailings basin and would be used to reduce the requirement for LTVSMC coarse tailings required for dam construction (natural terrain used as dam) and to provide an additional source (existing dams in this area) for LTVSMC coarse tailings required to implement the mitigation.

- Evaluation Area
- Wetland
- Impacted Wetland

There are about 36 acres of wetlands identified within the Buttress Area (Tables 2 and 3). Nearly 90 percent of the wetlands are classified as deep marsh (Circular 39 Type 4; Cowardin Type - PEMF). These wetlands are generally inundated with dead black spruce trees observed throughout the area. Other wetland types present in the area included wet meadow (Circular 39 Type 2; Cowardin Type - PEMB), shrub carr (Circular 39 Type 6; Cowardin Type - PSSB), and coniferous swamp (Circular 39 Type 7; Cowardin Type – PFO4B). The wetlands in the Buttress Area are low quality wetlands with the dominant vegetation including cattails and phragmites. This area has been historically impacted by seepage from the Tailings Basin. Black spruce is present throughout the area, however, the wetlands are generally inundated and most of the black spruce trees within the wetlands are dead.

There are about 19 acres of wetlands identified within the East Basin Expansion Area (Tables 2 and 3). Approximately 56 percent of the wetlands in this area are classified as deep marsh (Circular 39 Type 4; Cowardin Type - PEMF) and there are generally no trees present within these wetlands. Another 40 percent of the wetlands are classified as wet meadow (Circular 39 Type 2; Cowardin Type - PEMB), shallow marsh (Circular 39 Type 3; Cowardin Type - PEMC), and open water (Circular 39 Type 5; Cowardin Type - PUBF). The remaining wetlands include shrub carr (Circular 39 Type 6; Cowardin Type – PSSB) and excavated open water (Circular 39 Type 5; Cowardin Type - PUBFx). The wetlands in the East Basin Expansion Area are generally low quality wetlands with the vegetation dominated by cattails located within inundated areas.
