**Aquatic Vegetation of Blueberry Lake
Wadena County, Minnesota
(DOW 80-0034-00)**

June 15-16, 2005

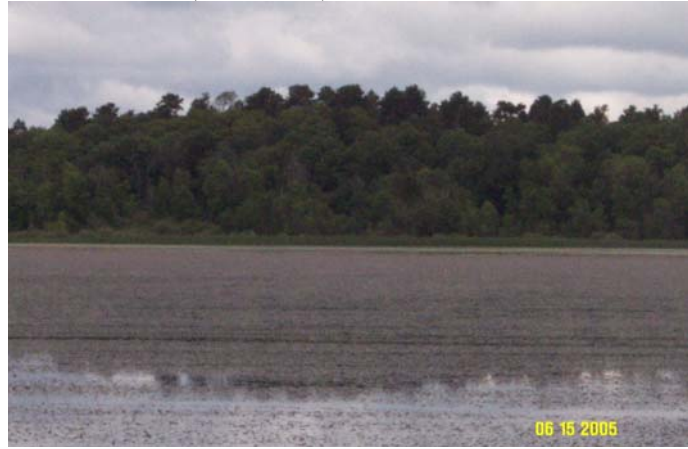
Figure 11. Surface mats of curly-leaf pondweed in Blueberry Lake (80-0034-00) June 15-16, 2005.

During its peak growth in spring, curly-leaf may reach the water surface at certain depths and create dense mats (Fig. 11). During the spring of 2005 in Blueberry Lake, curly-leaf formed surface mats in 28 percent of the sample sites (Fig 12). Surface mats occurred in depths from four to nine feet and covered an estimated 25 percent of the lake.
