Final Status Report of Well Sealing on State Land

**DNR Waters
2007**

Well Sealing Summary June 2007

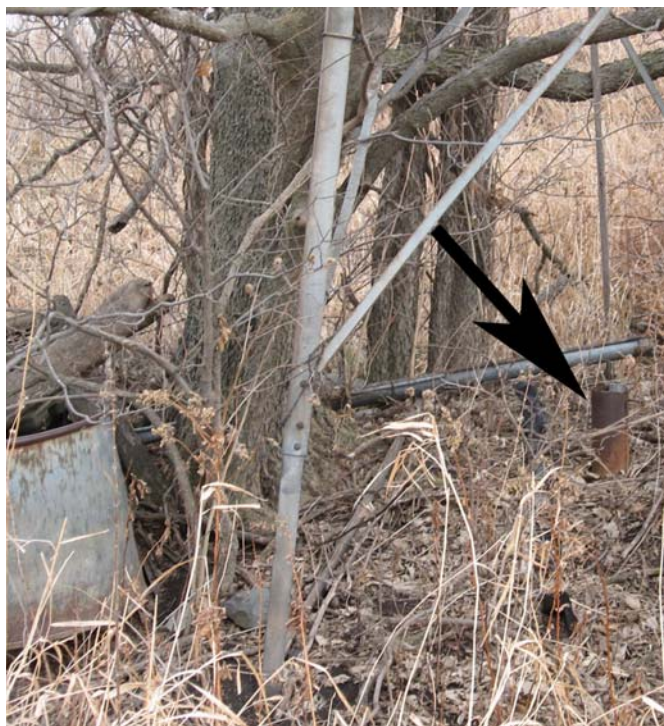
Figure 1. The windmill and open, rusty well casing (shown the by arrow) mark this abandoned well. This is a potential access point for contaminants.

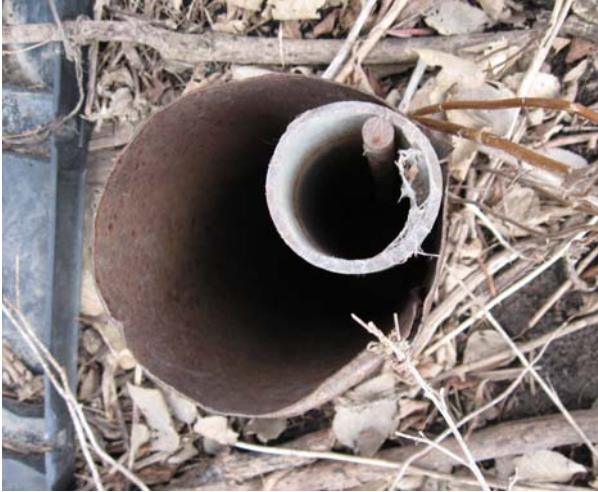
Figure 2. Looking down from above at the well casings and pump rod that have to be removed from the well before the well is sealed against contaminants.

casings begin to corrode and crumble from age (Figure 2). Surface runoff can then drain directly through the well into the aquifer, bypassing the natural filtration that normally occurs when surface water slowly percolates through the soil to the aquifer. A rapid transfer of surface water to the aquifer greatly increases the likelihood that natural or anthropogenic contaminants will be introduced into the ground-water system. One of the key strategies of the 1989 Minnesota Ground Water Protection Act is to protect ground-water quality by preventing its contamination, and this is exactly what the well sealing program has done.

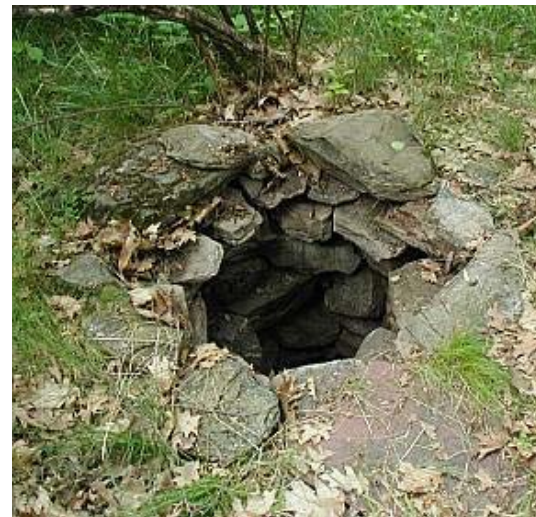
Figure 3. An uncovered dug well on an abandoned farmstead. Lined by stone, bricks, or concrete, well holes can be 3 feet to 10 feet in diameter and excavated below the water table. A dug well without a cover presents a hazard for humans and animals and a water contamination risk.

to state recreational areas (Figure 3). Animals or the unwary public can easily stumble into these open-holed structures that typically are covered by native vegetation that has grown undisturbed for years. These open-holed structures were filled as part of the well sealing effort. Consequently, the well sealing program has also contributed to the long-term physical management of state lands by locating and removing structures that could threaten the safety of the public.

Many of the abandoned wells, such as dug wells, cisterns, and well pits, pose a physical hazard to wildlife and unsuspecting visitors
