Historical Landslide Inventory for the Twin Cities Metropolitan Area

Minnesota Department of Natural Resources
Division of Ecological and Water Resources
2016

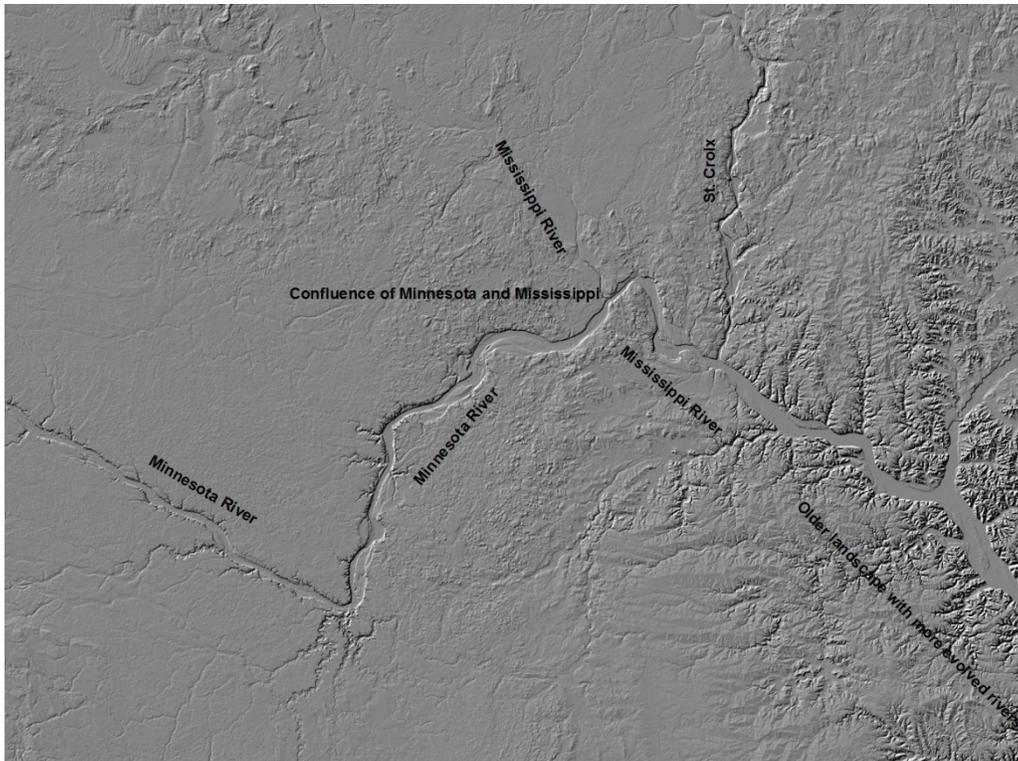
Figure 1. Shaded relief showing topography in southeastern Minnesota.

Late glacial events created a broad, deeply incised valley now occupied by the Minnesota River. It exposes layers of glacial sediment and rock.

Large drainage events dating to the end of the glacial period approximately 13,000 years ago have created deep trenches that modern rivers now occupy (Figure 1). The walls of the main glacial drainageway (the Minnesota and Mississippi below the confluence with the Minnesota) have stabilized during the varying climate and vegetation regimes of the past 13,000 years. It appears that the slopes were very active initially. Change is still ongoing in tributaries to this main channel.

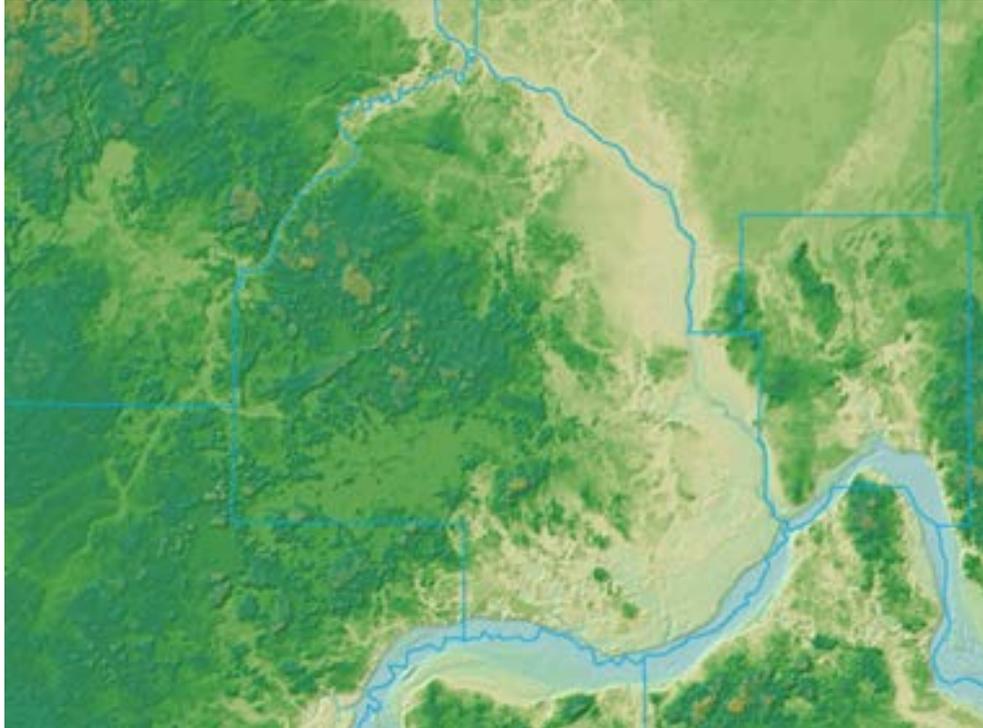
Figure 2: Hennepin County Hillshade Map

Map of Hennepin County hillshade indicates steep riverine slopes lie along most of Hennepin County's borders. Hummocky topography created by ice stagnation covers the interior and also creates steep slopes in glacial sediment.

Hennepin County has steep slopes along its river borders: Minnesota River to the south, Mississippi to the east and Crow River to the northwest (Figure 2). Broad glacial terraces lie on the upper surfaces of the Minnesota and Mississippi river corridors, in places supported by flat-lying bedrock. The western portion of Hennepin County is hummocky topography created by ice stagnation. Lakes, some very large, have steep slopes of glacial sediment.

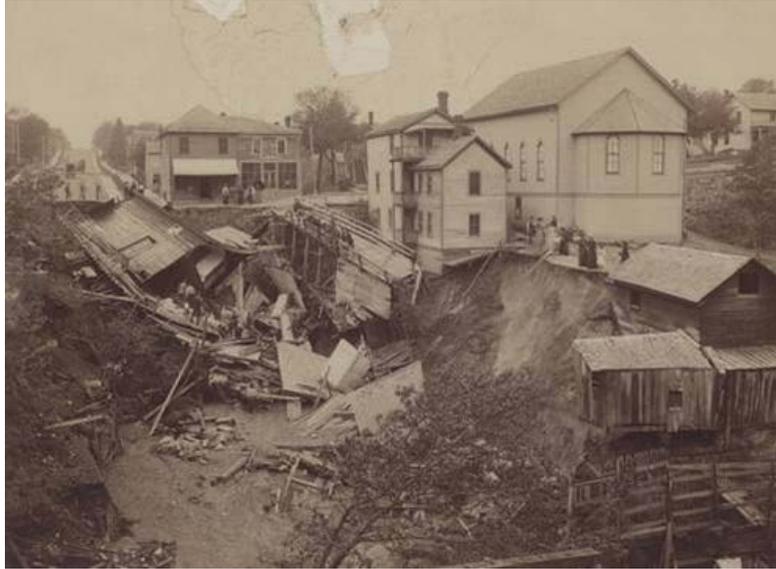
Figure 3: Stillwater, MN slide from May 9, 1894. (Photo Courtesy of the Washington County Historical Society)

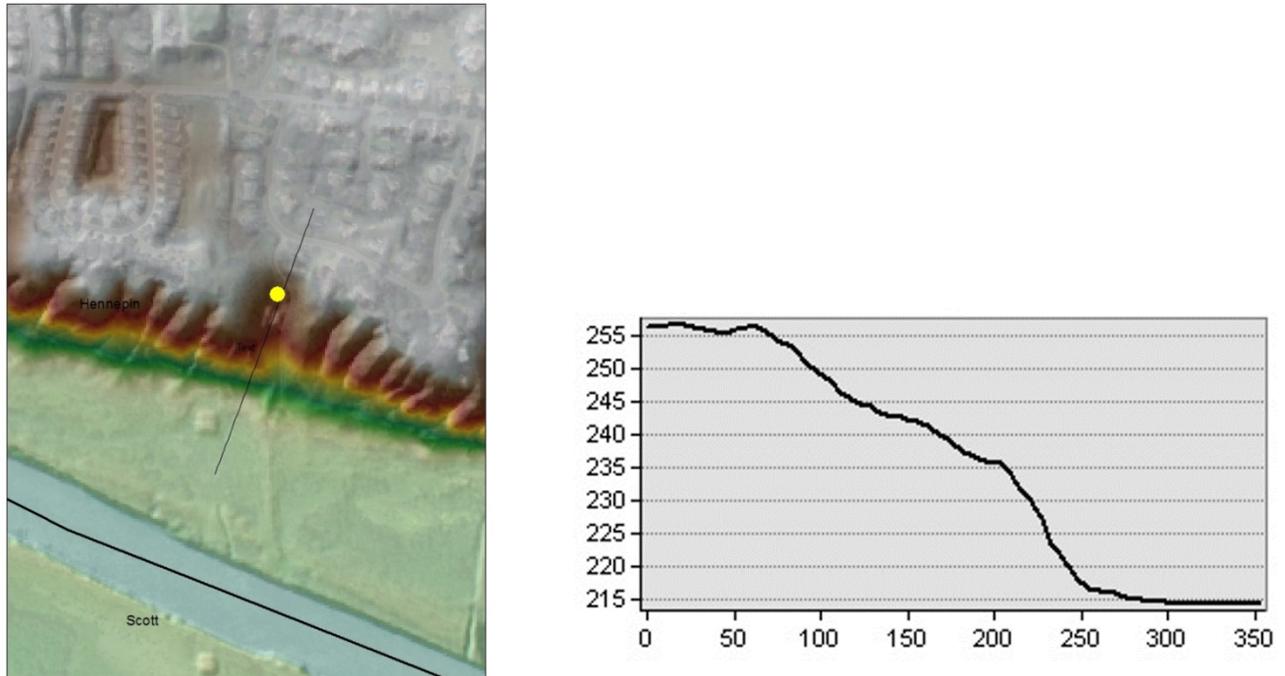
Figure 4. LiDAR DEM and Extracted Profile.

Failure sites were located on the elevation model and slopes (in meters) extracted using the profile tool of MnTOPO.

The slide profiles were examined using the cross section tool in ArcMAP to determine the steepness of the pre-failure slope. If the LiDAR was taken after the failure, the post-failure slope and a nearby reference slopes were recorded (Figure 4).

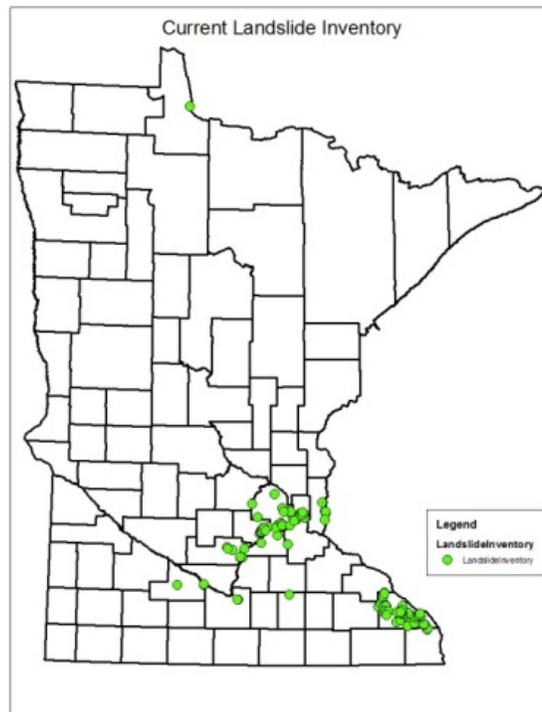
Figure 5. Landslide Inventory

The current distribution of historical slides. See Appendix A for the landslide database attribute table.

We focused our search on the metropolitan area centered on Hennepin County (Figure 5). However, this figure includes records for a single storm event in southeastern Minnesota in 2007.

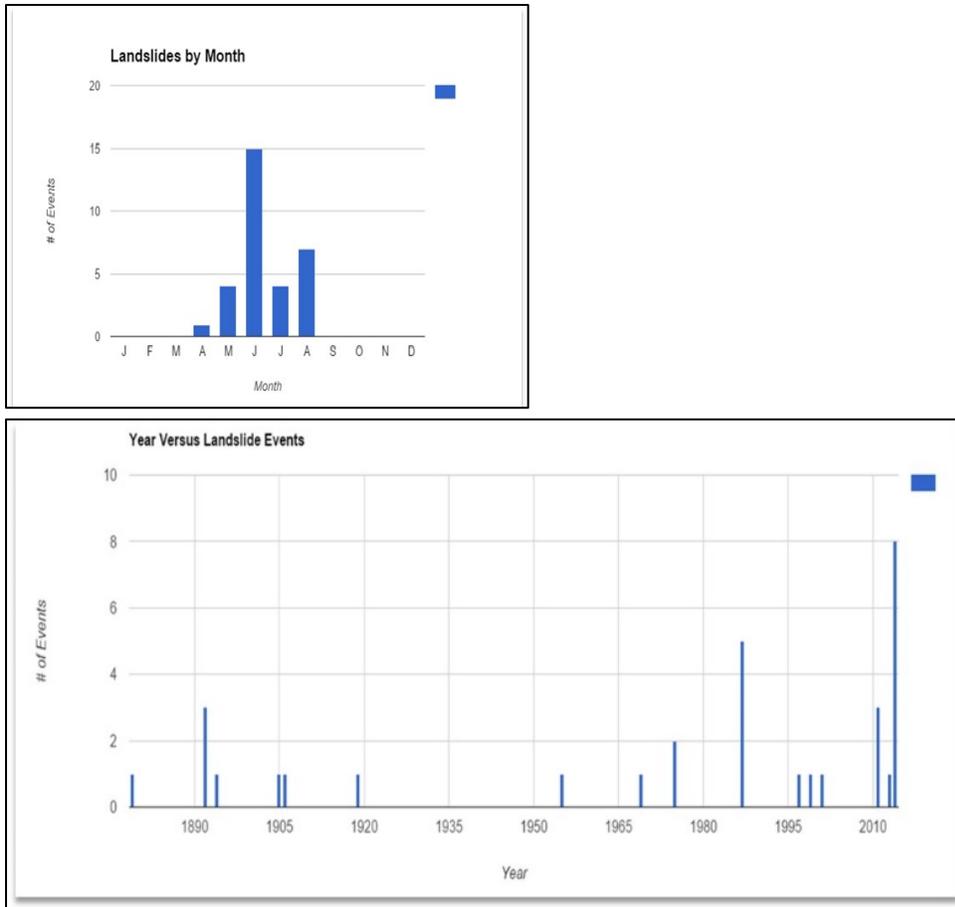
Figure 6. Distribution of failures over time

More failures were reported for the months with more intense rainfall events. Decades with wetter conditions stand out in the historical search.

Reported slides occur between April and September with peaks in the months of May, June and August that have more convective storms and large rainfall totals. Wetter periods in the last century and a half had more reports of slides (Figure 6). Some of this distribution may be affected by the quality of records and the ease of searching paper or microfiche records versus electronic databases. The apparent recent increase is certainly in part affected by online news sources and search tool

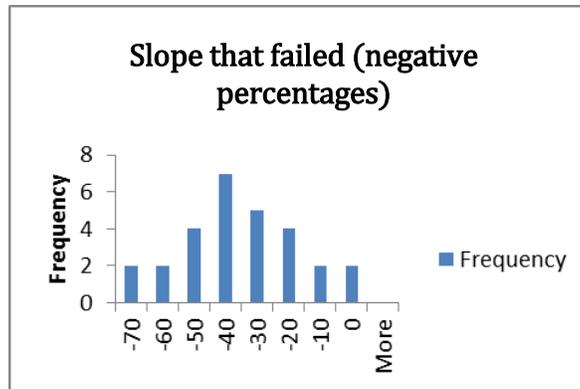
Figure 7 Range of Pre-Failure Slopes

Slopes greater than 20% are more likely to fail. A cutoff of 30% was chosen for presentation with project because a slope analysis was already available.

The greatest number of slopes that failed were at a 40% grade, however, slopes began to fail at lower grades (Figure 7). For convenience in our final product, we highlighted slopes of at least 30% because a coverage had already been developed with this threshold by Dr. Stephanie Day for a contract with the Minnesota Pollution Control Agency (S. Day, written comm., 2015) (Figure 8). A conservative approach may be to include slopes of approximately 20% or greater in a general susceptibility map. For site-specific rules, slopes associated with particular geologic units should be reviewed.

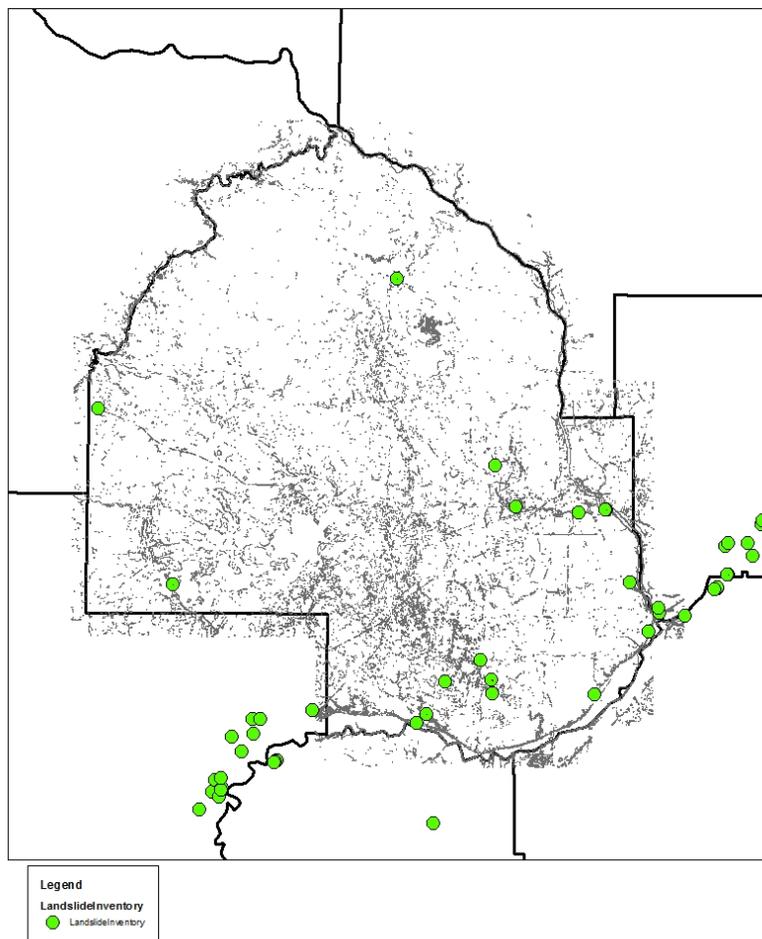
Figure 8. Landslide locations plotted on 30% slopes or greater (gray)

Artificial and natural slopes were extracted from a LiDAR DEM (S. Day, written comm.) and compared to slide locations.

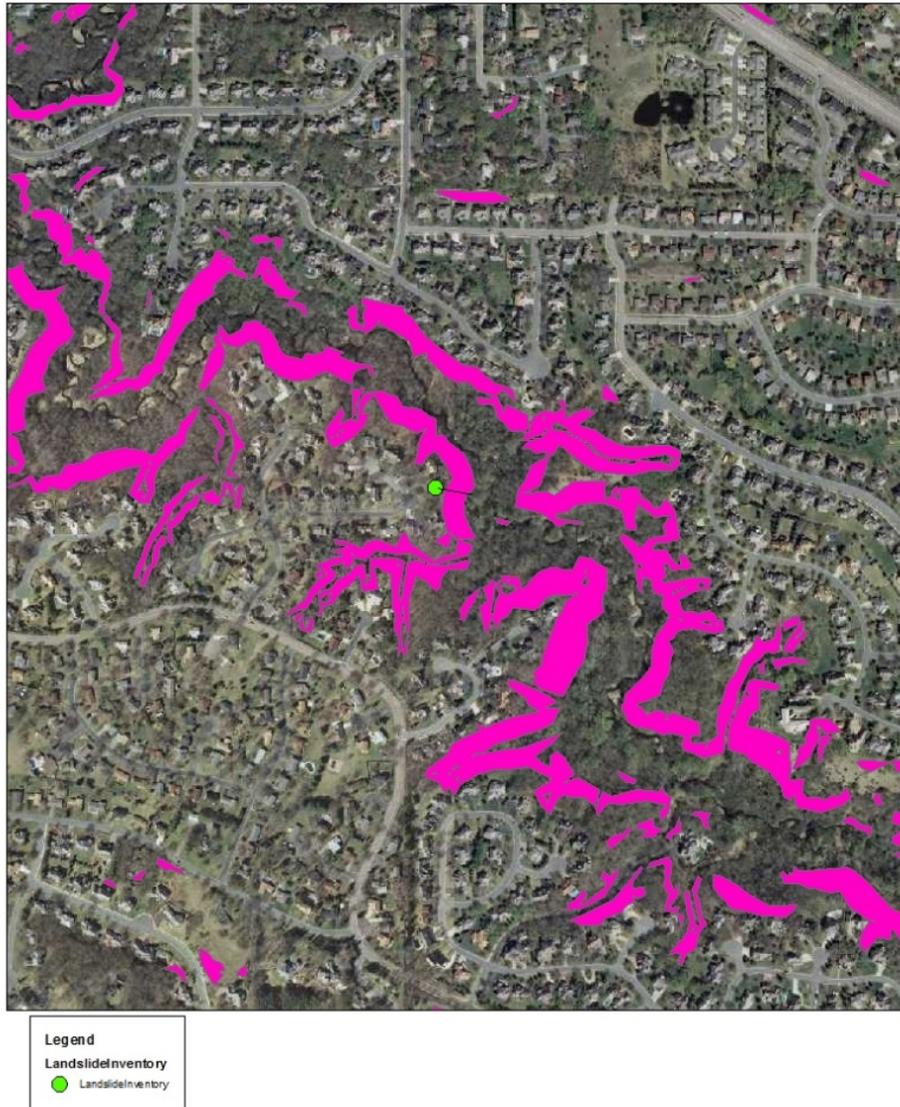
Figure 9. Purgatory Creek in Eden Prairie

This river valley is outlined by steep slopes. The material exposed is primarily dry sand and gravel. The green dot represents a failure location where a house had to be removed in 2014. Additional setbacks of 30' from the tops of slopes are encouraged by the Lower Minnesota River Watershed District (Linda Loomis, written comm., 2016).

Setbacks of different widths from the top of steep slopes may be required depending on the style of failure and geologic material (Figure 9). If a different slope threshold is desired, a new coverage can be extracted from the LiDAR DEM using the bluff analysis tool in ArcMAP. The specific steps are given below.

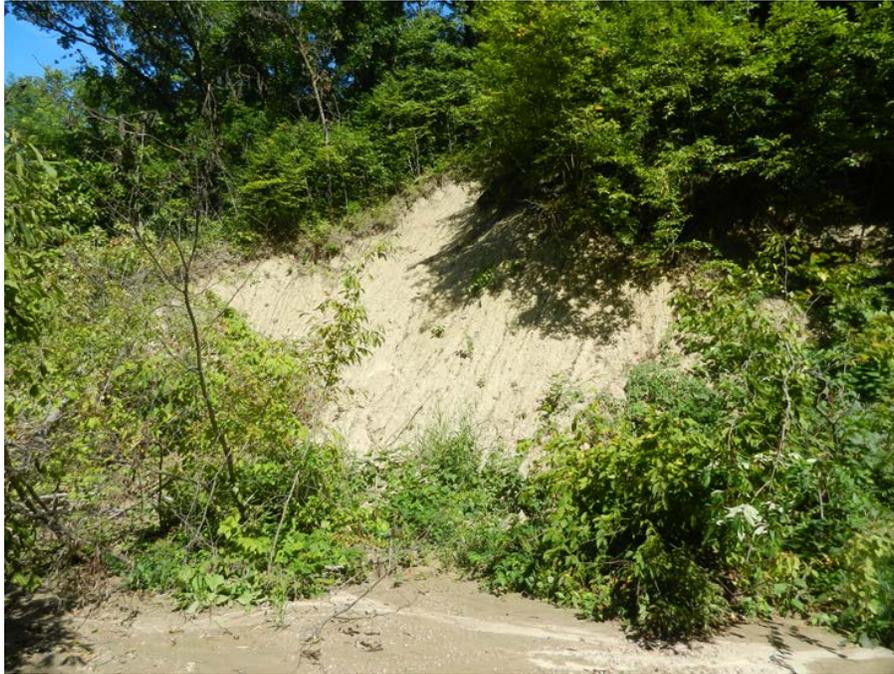
Figure 10. Scott County rotational failure in glacial sediment. Photo credit: Carrie Jennings, MN DNR.
 This loamy New Ulm Formation till failure has a steep scarp and the sediment has liquefied to flow across a road. Vegetation has moved with the sediment.

Loamy glacial sediment layers experienced rotational failure that resulted in a steep head scarp with a wedge of rotated sediment. In some cases the sediment at the toe was saturated enough that it flowed and formed a lobe of debris that slowly dewatered. Vegetation typically moved with the sediment, sometimes remaining nearly upright. Because of the location of this study, the units that failed typically were till of the New Ulm Formation, the Twin Cities Member of the New Ulm Formation or the Cromwell Formation. For complete descriptions of the texture and extent of these units the reader is directed to a recent publication of the Minnesota Geological Survey (Johnson et al., 2016). However, this volume does not include engineering properties. Older glacial units that failed in lower positions along the valley walls in Carver and Scott counties and western Hennepin County are similar in texture but may have different consolidation states (Figure 10).

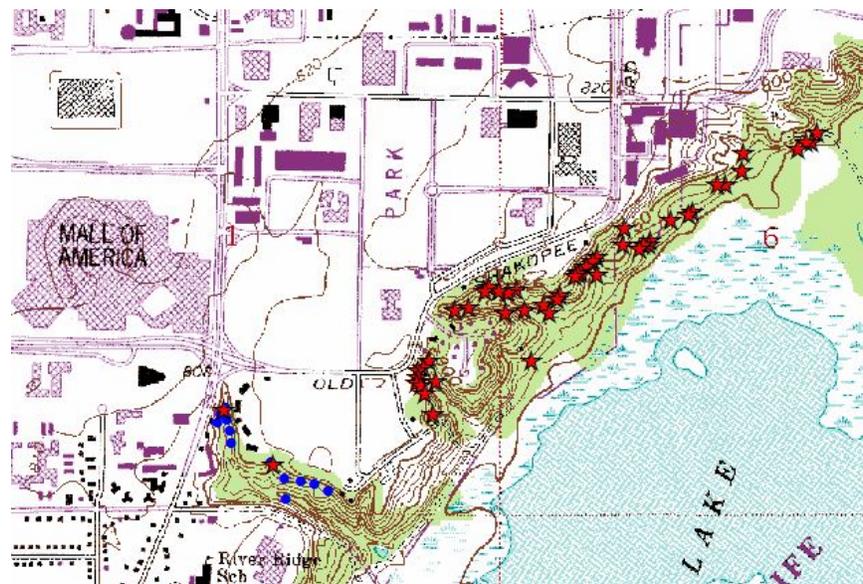
Figure 11. Draft map from the ongoing DNR Spring Inventory Project
 Red stars indicate where springs discharge from the bluff face. There are two distinct horizons and water appearance (and therefore chemistry) is different. Greg Brick, DNR, pers. comm., 2016.

The lack of detailed field work did not permit identification of a clear relationship between failure depth and contacts between glacial units. However, in Bloomington, there are two spring horizons in the glacial sediment that may mark significant material contacts (Greg Brick, pers. comm.) (Figure 11). This is the location of a very large slide that probably occurred shortly after the formation of the river valley (approximately 13,400 years ago). It is not known whether the area is currently moving. It is a location to watch.

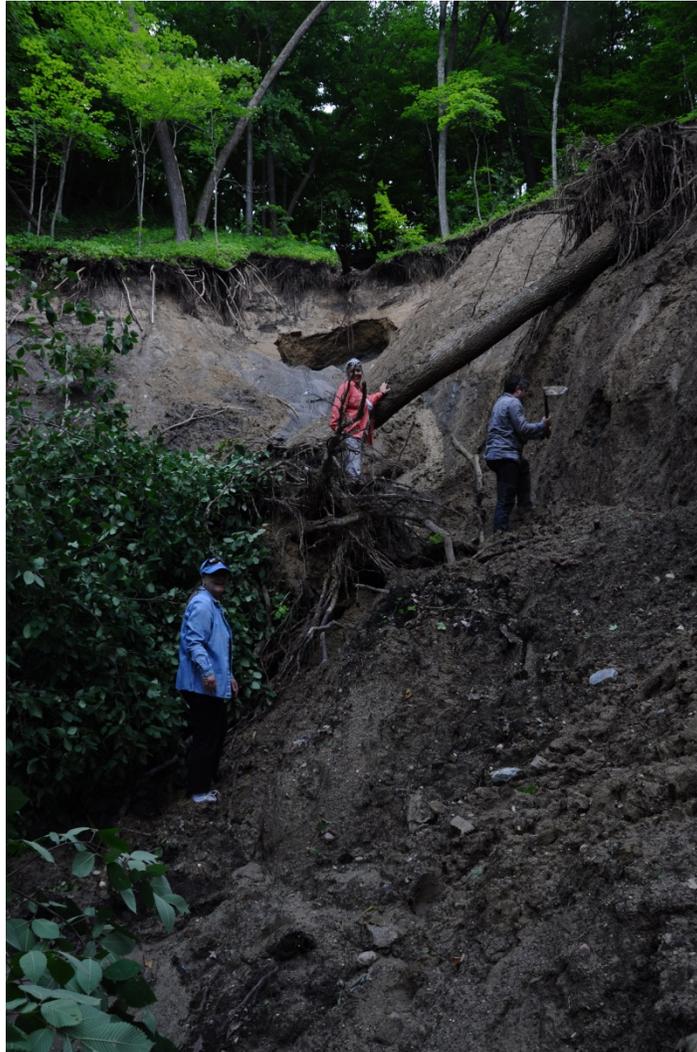
Figure 12. Ravine erosion creating unstable side slopes in Le Sueur County.

Water directed to a ravine will cause the headwall to move upstream ravine and the ravine may deepen. This creates the potential for the sides of the ravine to fail. Photo credit: Kristina Krklec

Head-cutting of ravines that were formed entirely in glacial sediment occurred owing to the infiltration capacity of the soil and glacial sediment being overwhelmed resulting in overland flow or from stormwater being focused by pipes. This resulted in newly created, oversteepened reaches of the ravines that were susceptible to failure on the side slopes (Figure 12). Shallow storm flow also weakened saturated slopes or led to failure by sapping. Ravines may be preferentially located where springs emerge from sediment layers. Once a deepening occurs, groundwater will discharge laterally into ravines.

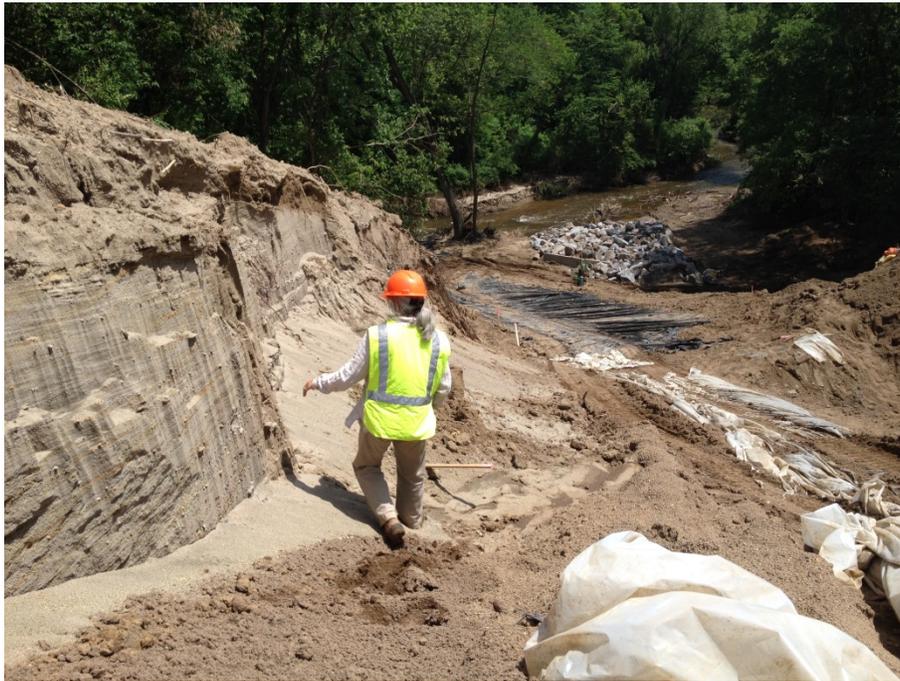
Figure 13. Dry sand and gravel slopes in Eden Prairie undergoing repair.

This deposit forms a high, flat terrace along the Minnesota River and Purgatory Creek. It is vulnerable to failure when incised by stormwater. Photo credit: Mary Presnail, MN DNR.

Dry sand and gravel lack cohesion and typically seek an angle of repose of approximately 30 to 45° depending on the average grain size and mixture. If stormwater is focused and creates a ravine in dry sediment, newly formed steep slopes quickly fail to the angle of repose. This style of failure has occurred along the high terraces of the Minnesota River in Eden Prairie both recently and historically (Figure 13).

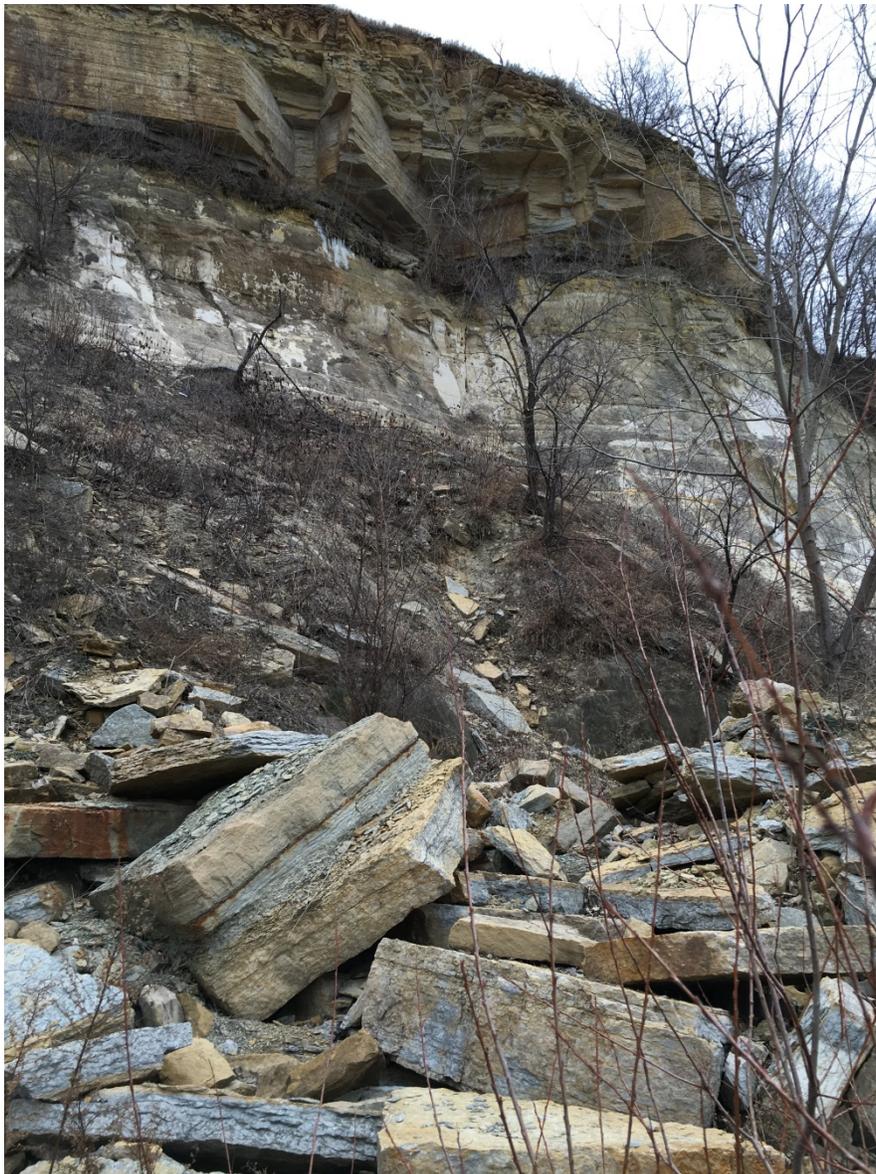
Figure 14. Slabs of the Mifflin member of the Platteville Formation beneath Indian Mounds Park, St. Paul.

The St. Peter Sandstone is visible in the lower portion of the exposure. It is easily eroded, which leads to undercutting of the fractured members of the Platteville Formation. Photo credit: Carrie Jennings, MN DNR.

The bedrock exposed in the Mississippi River corridor in St. Paul is a sequence of flat-lying to gently dipping marine sedimentary units. The style of bedrock failure occurs where the St. Peter Sandstone forms a reentrant in the bluff face, leaving an overhanging ledge of the Platteville Formation. Undercutting can be facilitated by springs, sapping and mechanical erosion. The overlying slab eventually topples, in some cases releasing glacial sediment layers lying above (Figure 14).

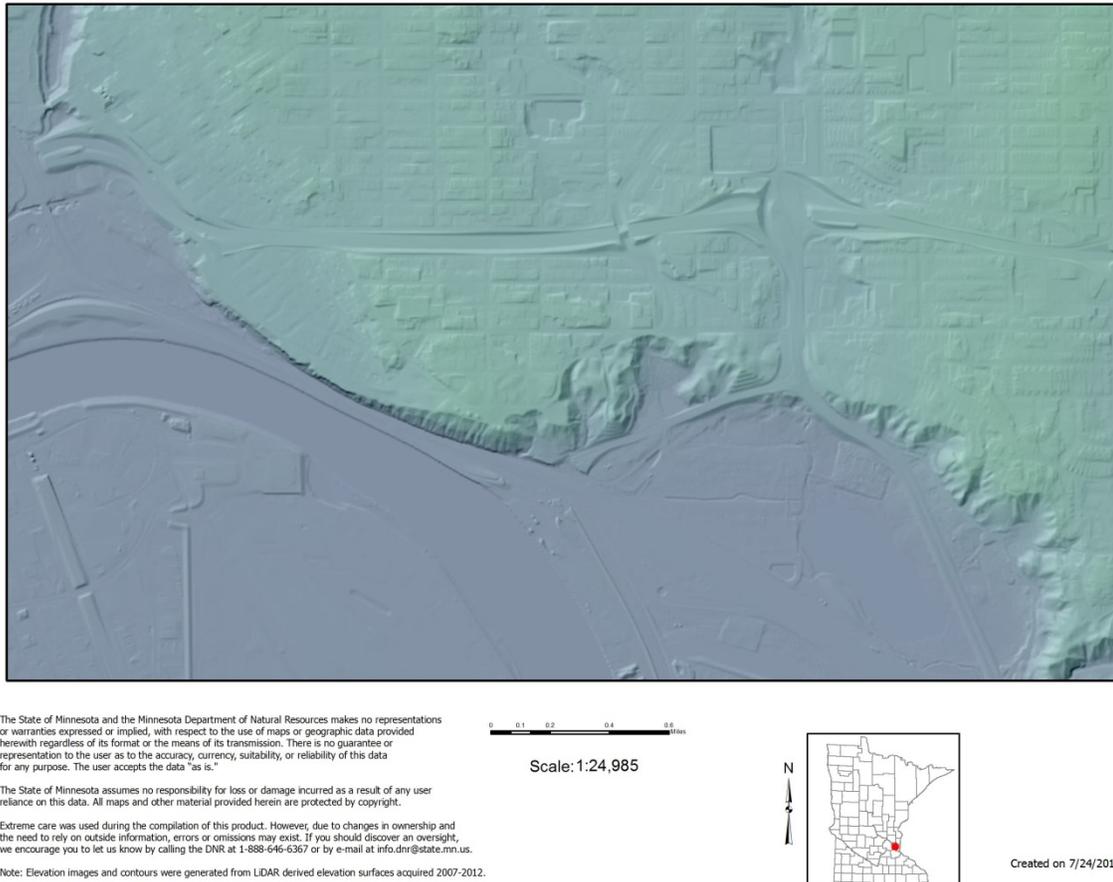
Figure 15. Bluff below Indian Mounds Park, St. Paul

The near-vertical bedrock face that is susceptible to topple is replaced by bowl-shaped hollows to the east where a valley in the bedrock focuses groundwater flow and causes rotational failure of the glacial sediment

Buried valleys in the bedrock that are filled with glacial sediment will receive groundwater moving laterally. The valley fill may show enhanced rotational failure. This is well displayed in the bluff beneath Indian Mounds Park in St. Paul. The near-vertical bedrock face that is susceptible to topple is replaced by bowl-shaped hollows to the east where a valley in the bedrock is filled with glacial sediment (Figure 15).

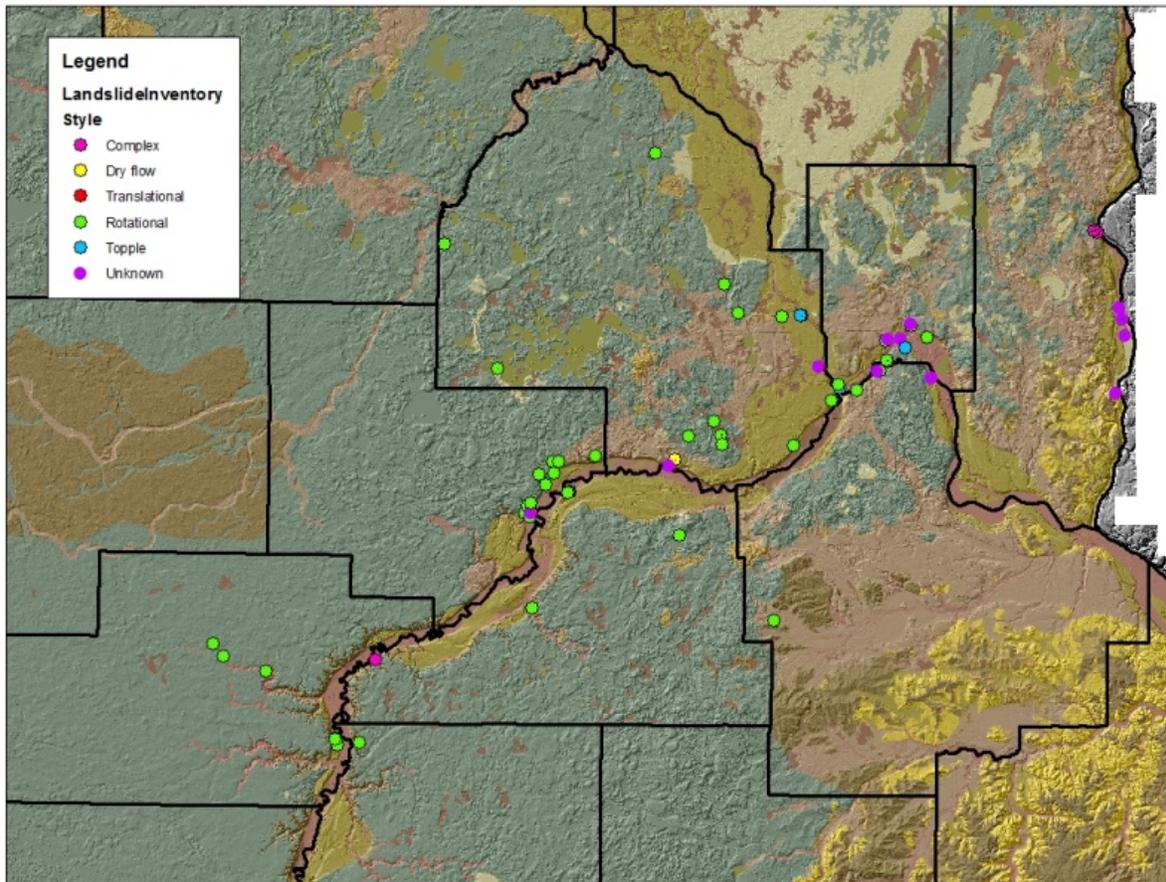
Figure 16. Slide Domain Map

Slides are colored by type and overlain on a Land Type Association map that is draped over a hillshade DEM. Green is glacial till, gold is glacial stream sediment in high terraces. Steep valleys between St. Paul and Minneapolis expose bedrock.

available on the Minnesota Geospatial Commons. When the landslides are displayed on this thematic layer draped over a hillshade DEM (Figure 16), it clearly shows the association of the failures with the river valleys and other steep slopes and helps group them by geology and geomorphology.

Steep till slopes in glacial sediment (green unit, green dot) along the Minnesota River and its tributaries and around Lake Minnetonka experience rotational failure. High glacial stream sediment terraces along the Minnesota and Mississippi (gold unit, yellow dot) do not become saturated. They fail when stormwater is not well controlled and is allowed to create a new gully or ravine. The nick zones of the steep tributaries to the Minnesota through this unit are especially vulnerable locations because these rivers are actively adjusting to the lower base level of the Minnesota River by incising and headcutting. Any extra water that they get speeds the process up (Gran et al., 2009).

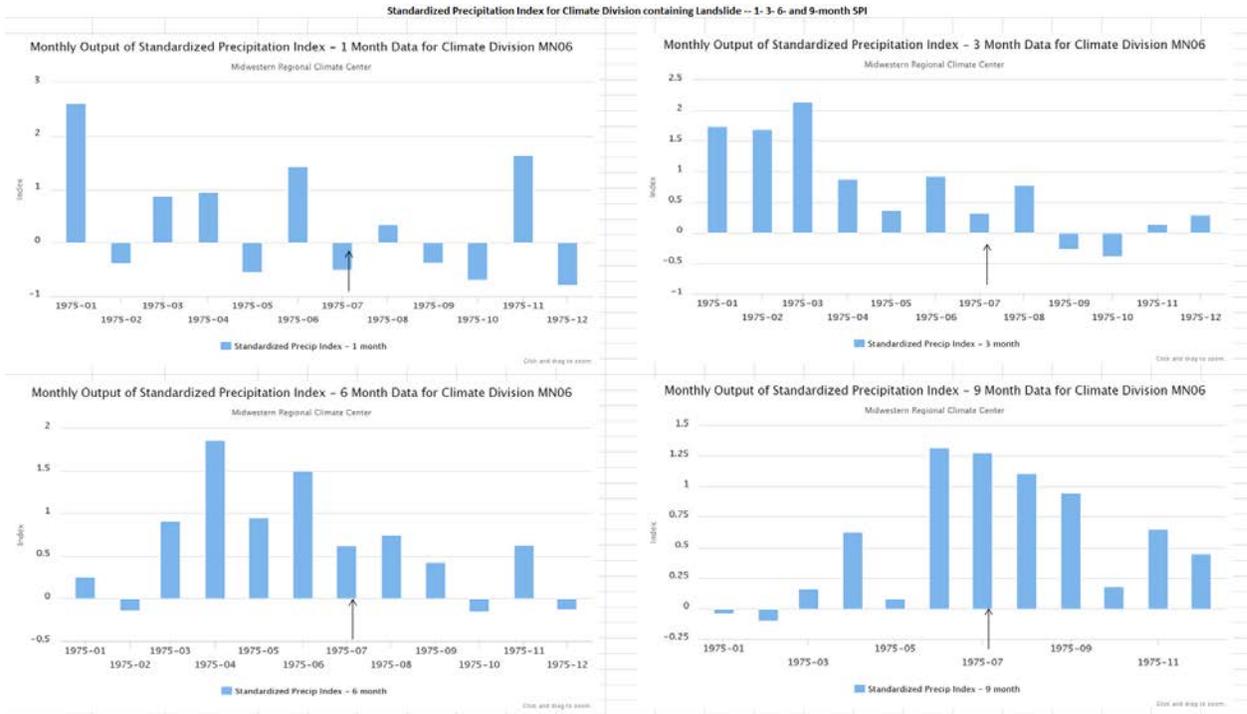
Figure 17a. SPI indexes for July 1975 slide for 1 month, 3 months, 6 months and 9 months. Timing of slide event is indicated by the black arrow.

The Standardized Precipitation Index (SPI) looks at long term precipitation patterns and may provide reasonable approximation for antecedent soil moisture. Once SPI reached a yet-to-be-determined threshold, we could then look for short-term (1-3 day) precipitation to act as a trigger. We compared three different July failure events for which we could find SPI data, and the SPI increased markedly toward the event time for the 6- and 9- month timescales as opposed to the shorter timescales. The SPI was very positive for two of the events, but not for one (which occurred in a very extreme short-term rainfall event). There was not always a short-term trigger. The SPI and trigger idea deserves more study in the future, especially if compared to NOAA Atlas 14 information (see next section) (Figure 17).

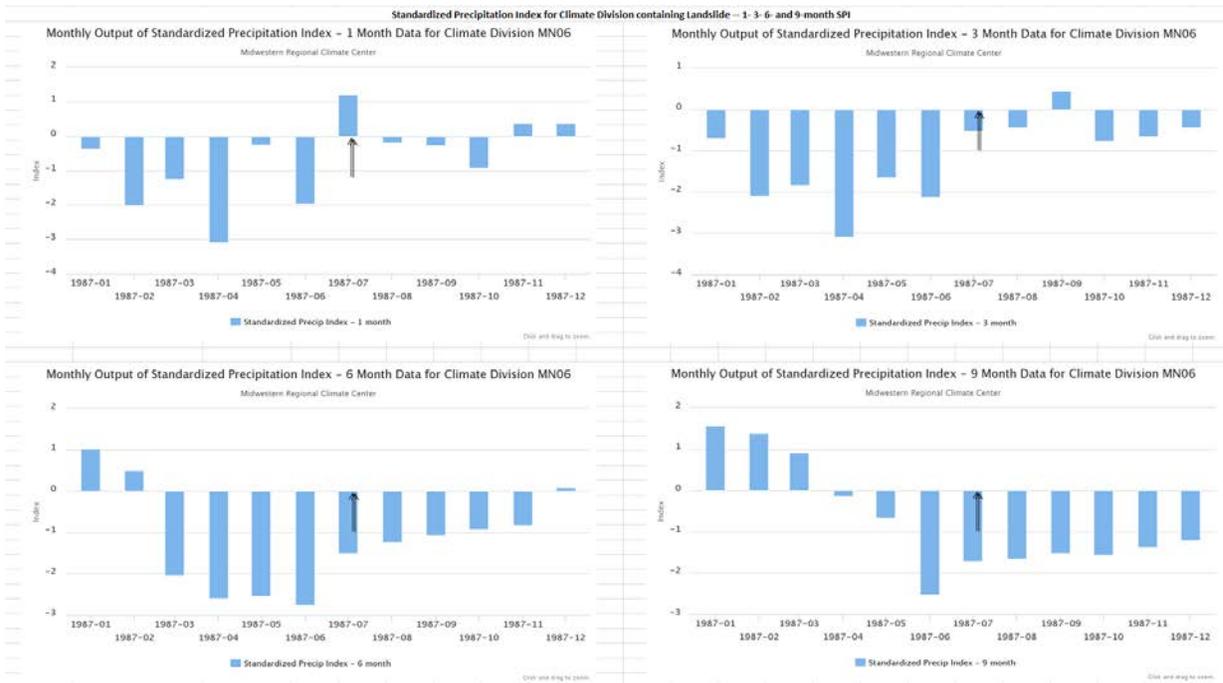
Figure 17b. SPI indexes for July 1987 slide for 1 month, 3 months, 6 months and 9 months. Timing of slide event is indicated by the black arrow.

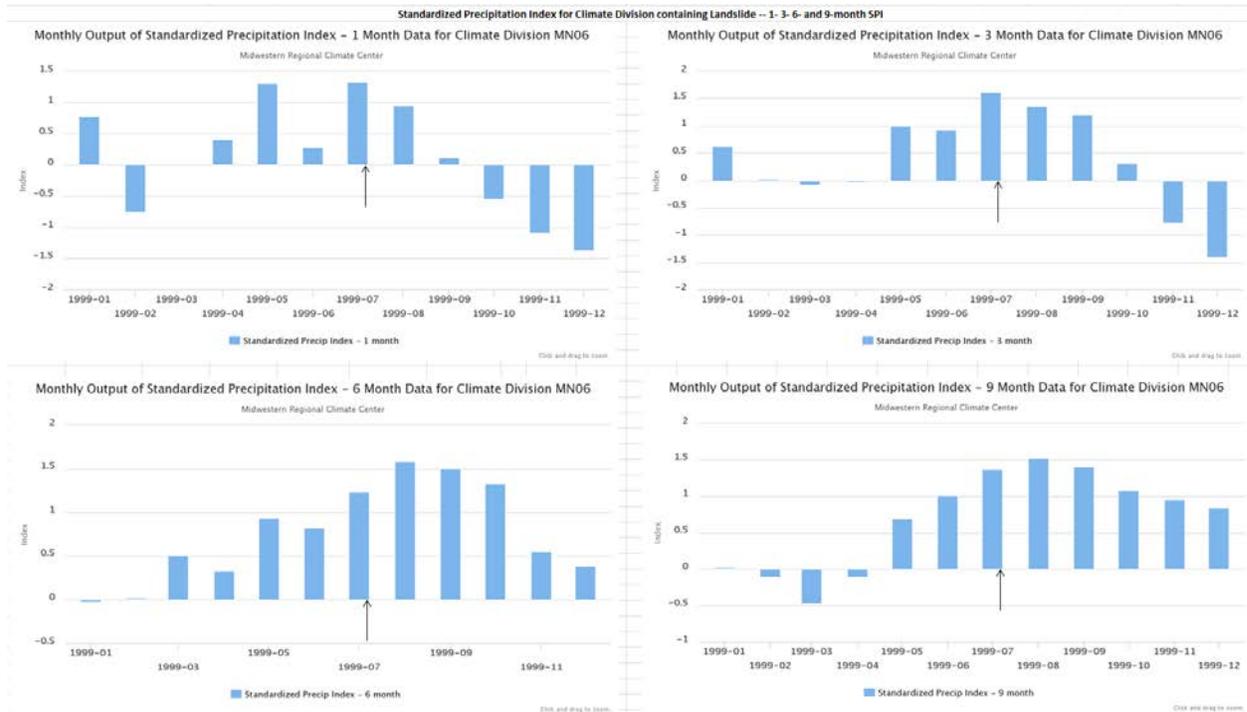
Figure 17c. SPI indexes for July 1999 slide for 1 month, 3 months, 6 months and 9 months.

Timing of slide event is indicated by the black arrow.

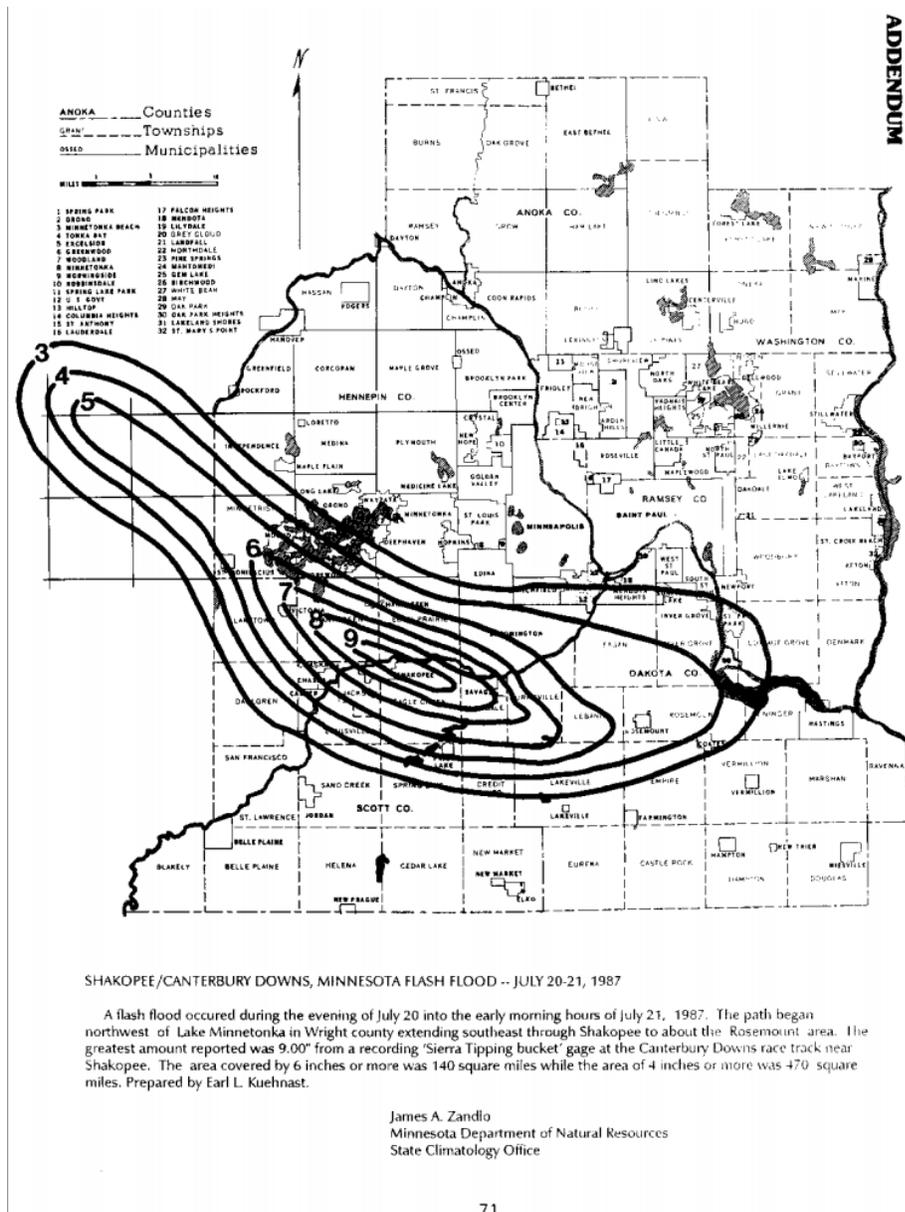
Figure 18a. Precipitation totals for July 21, 1987.

- July 20-21 1987 (FID 40). This was the first event of the two shown below (Figure 18a) which dropped between 3.5 and 9 inches of rain on Eden Prairie. Heavy rains fell from around 6 PM to 2 AM, with the highest intensities from 7 PM to midnight. Northeastern parts of Eden Prairie

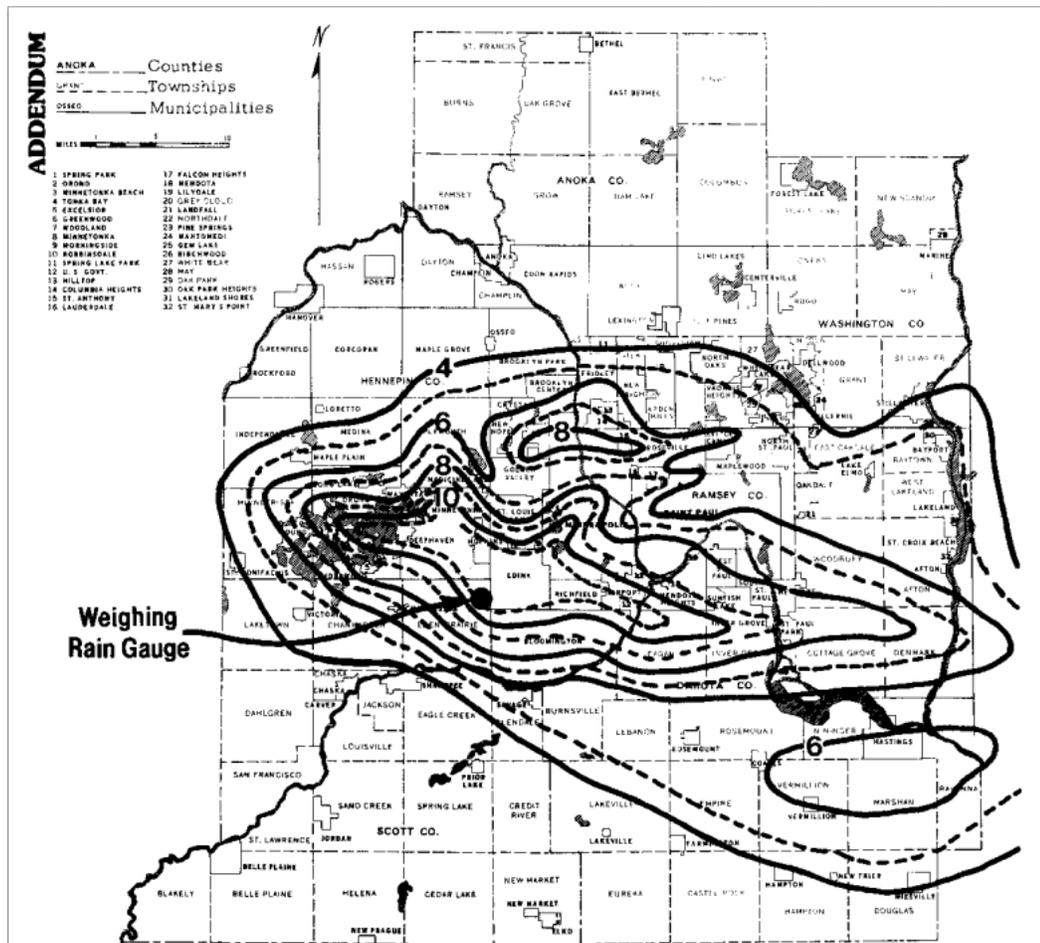
WESTERN AND SOUTH CENTRAL TWIN CITIES FLASH FLOOD - JULY 23-24, 1987

The flash flood occurred generally between 7PM 23 July to 1AM 24 July, 1987. It's path was on a line from Lake Minnetonka east-southeast through Edina, Inver Grove Heights and into Wisconsin; with rain fall amounts from 6 inches to more than 11 inches. The greatest amount was 11.32 inches documented on a standard weighing rain gage. There were some greater unofficial amounts. Some 335 rainfall reports were used to draw the isohyet map. The area covered by 10 inches or more of rainfall was 93 square miles; 6 inches or more was 574 square miles and by 4 inches or more was 1460 square miles. Much of the 6 inch and greater rainfalls occurred over residential parts of the Twin Cities. To date an estimated 7000 homes have reported water damage. At this time the known costs of damages are approximately 25 million dollars.

- July 23-24, (FIDs 42-44). The infamous "superstorm," ... with widespread 6-10" values across the central and southwestern TC area. Heavy rains fell from 7PM to 1 AM, with highest intensities from 7-10 PM. Three-hour totals of 7.58 inches were right around 500-year threshold for 3-hour rainfall, from NOAA atlas 14 (Figure 18b).

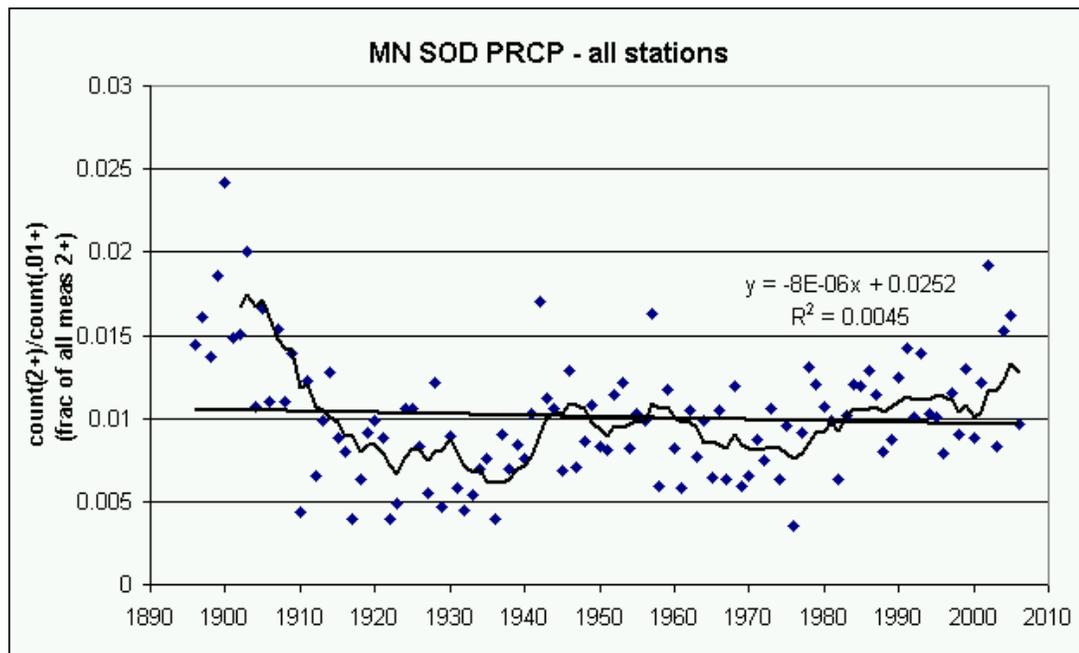
Figure 19. Precipitation events greater than 2" compared to all events vs. time
 There is a recent increase in the proportion of rainfall events that are greater than 2"

We do think that the collection of more data is warranted because climatologists show that the recent trend has been towards larger precipitation events (Figure 19). This suggests that precipitation-driven landslides will become more common until hillslopes stabilize in the new climate regime.
