Program Process and Project Evaluations

Appendix A: 2023 Legacy Fund Restoration Evaluation Report

May 2024

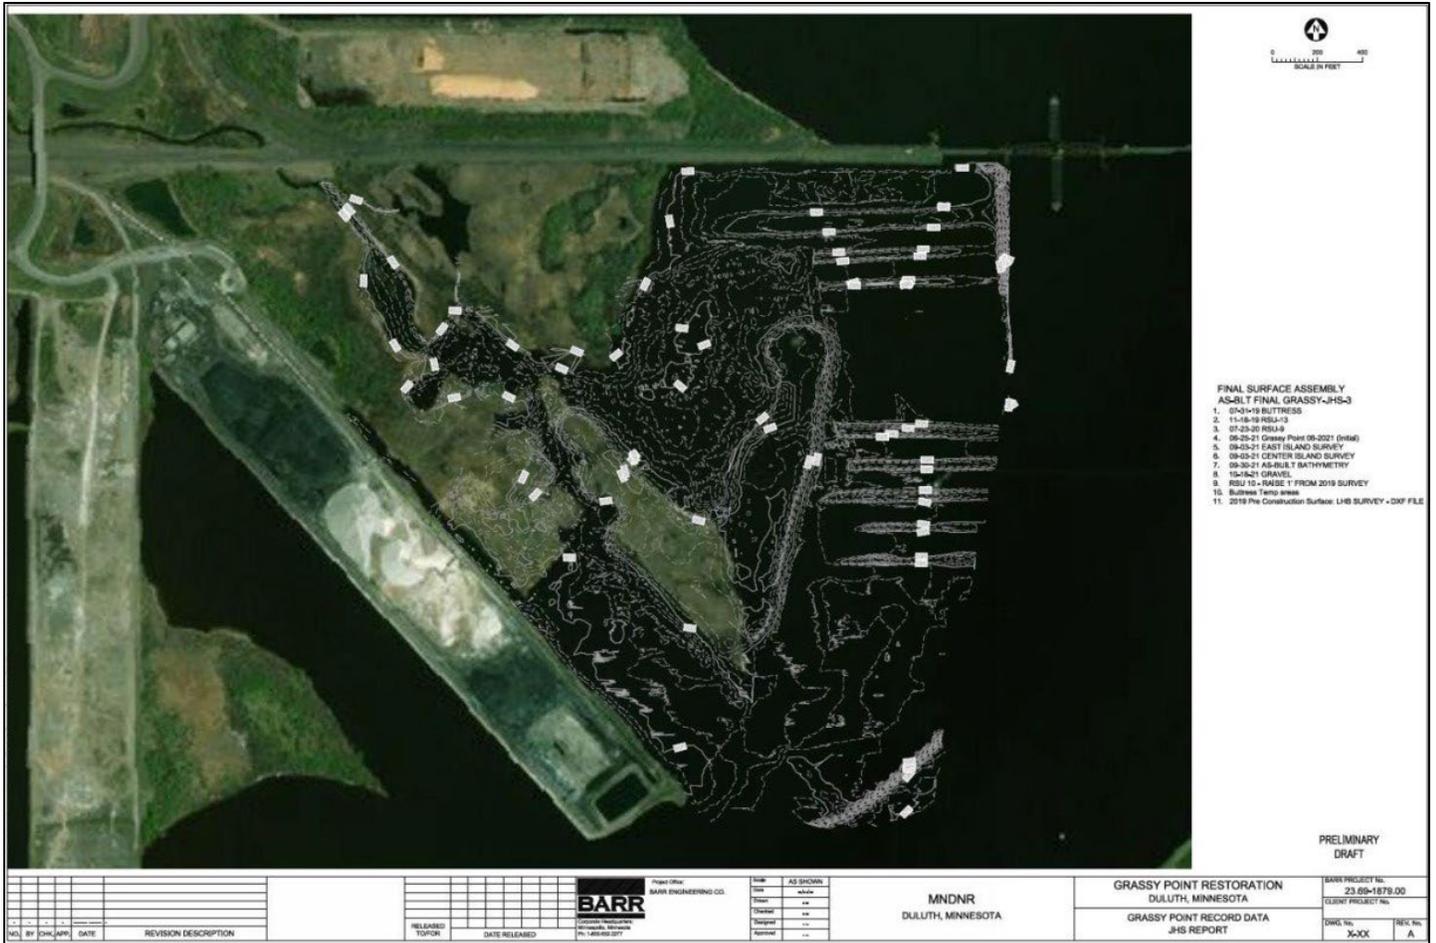
Figure 3. As-built condition contours for Grassy Point following restoration. (Contours were overlaid on an aerial photo taken from prior to restoration).

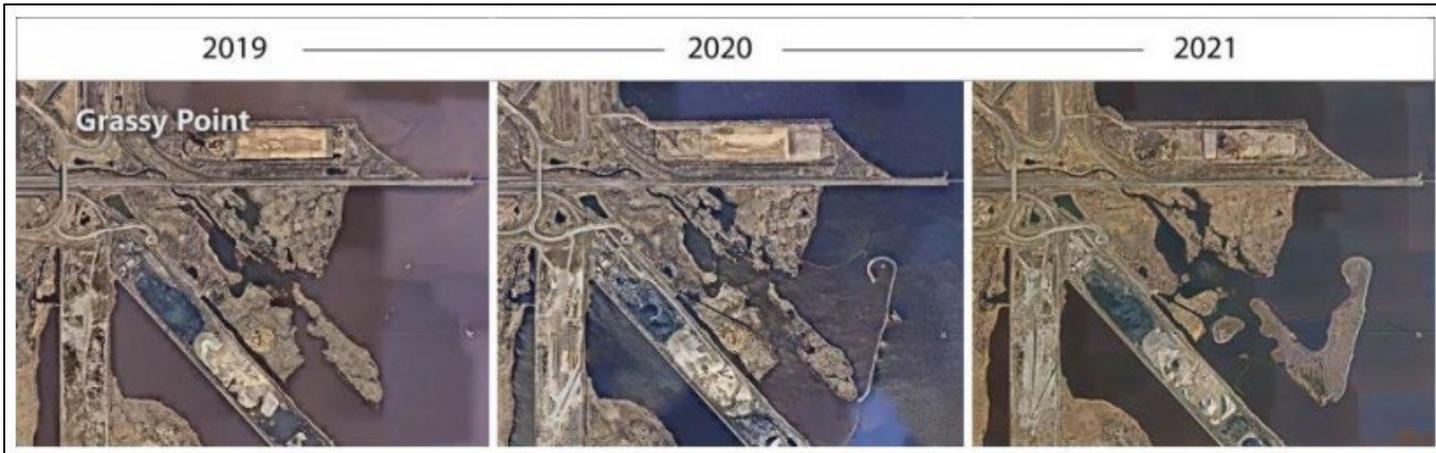
Figure 4. Aerial photo sequence of Grassy Point prior to construction (2019), during construction (2020), and following construction (2021). Photo sequence provided by MNDNR Lake Superior and St. Louis River Program.

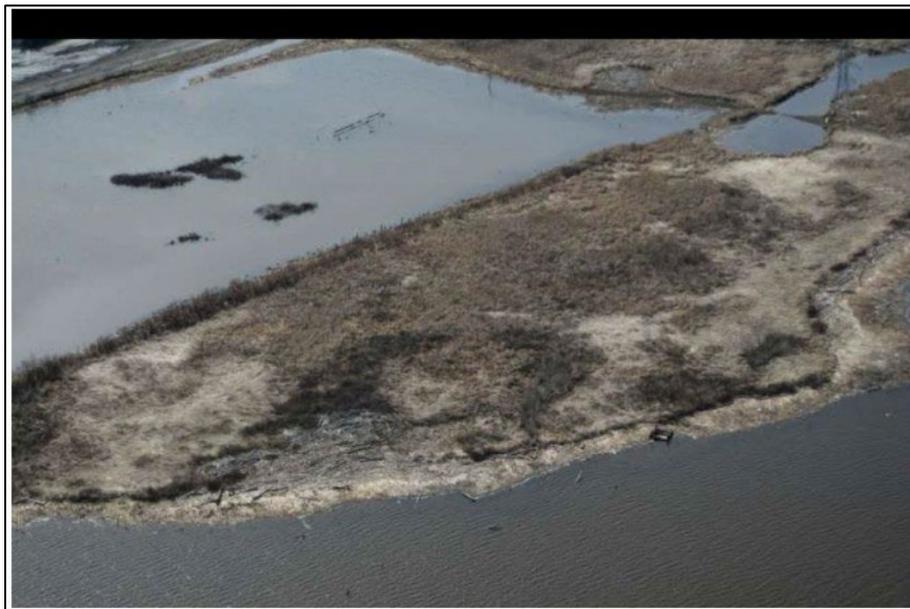
Photo 1. Aerial view of vegetation growing on legacy wood waste and sediment in Grassy Point. Photo provided by the Minnesota Lake Superior Coastal Program via MNDNR Lake Superior and St. Louis River Program.

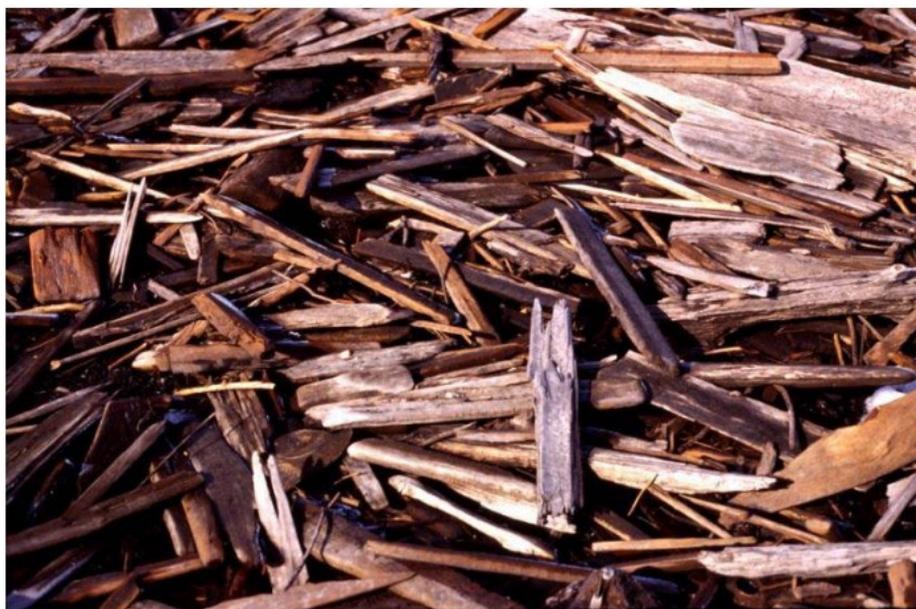
Photo 2. Example of legacy wood waste present in Grassy Point resulting from historic sawmill operations located in the bay disposing material into the wetland. Photo provided by MNDNR Lake Superior and St. Louis River Program.

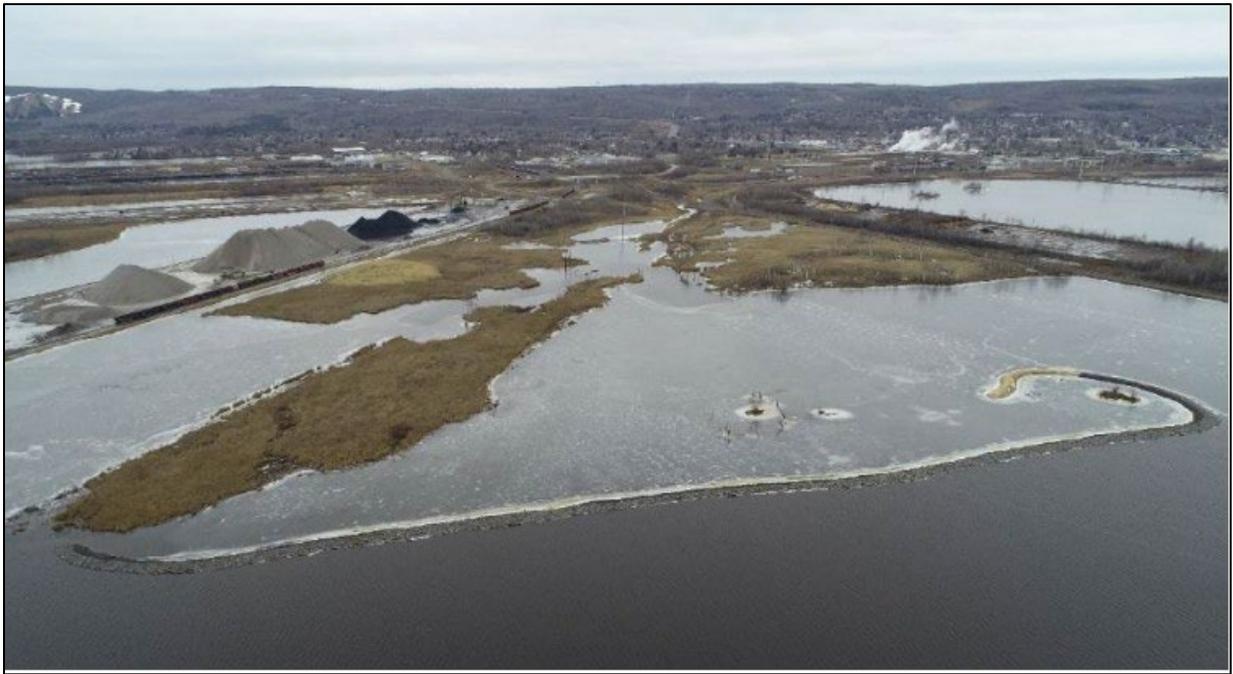
Photo 3. Aerial view of island construction at Grassy Point. A stone berm was established on the shoreline adjacent to the main St. Louis River channel to reduce erosion and set the perimeter. Photo provided by MNDNR Lake Superior and St. Louis River Program.

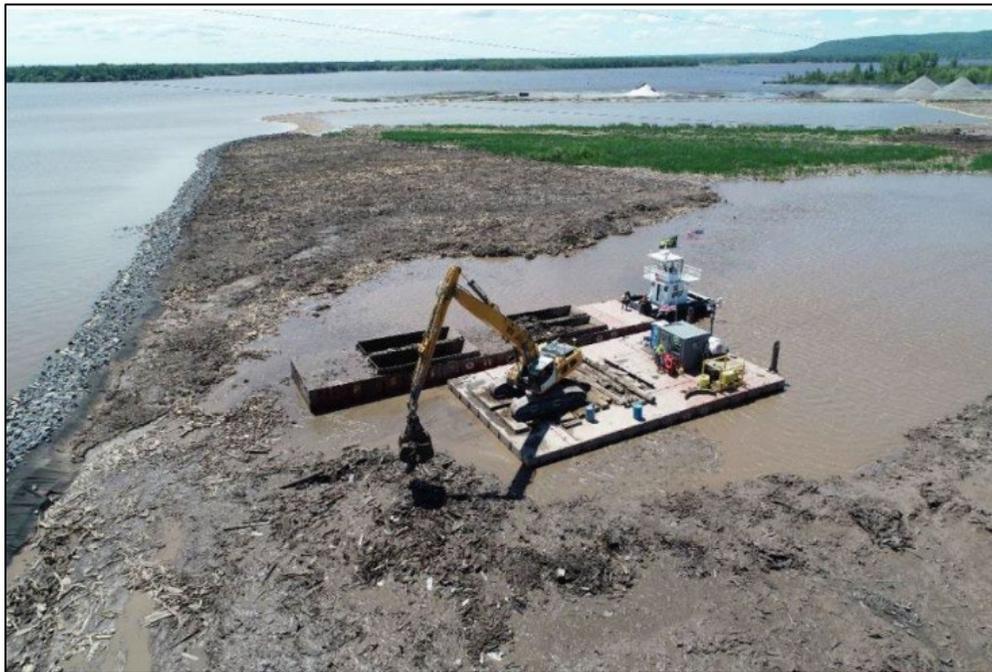
Photo 4. Example of wood waste excavated from the portions of Grassy Point that were deepened to restore the open water wetlands to a bathymetry similar to reference conditions being installed to build one of the two islands being created for the project. Photo provided by MNDNR Lake Superior and St. Louis River Program.

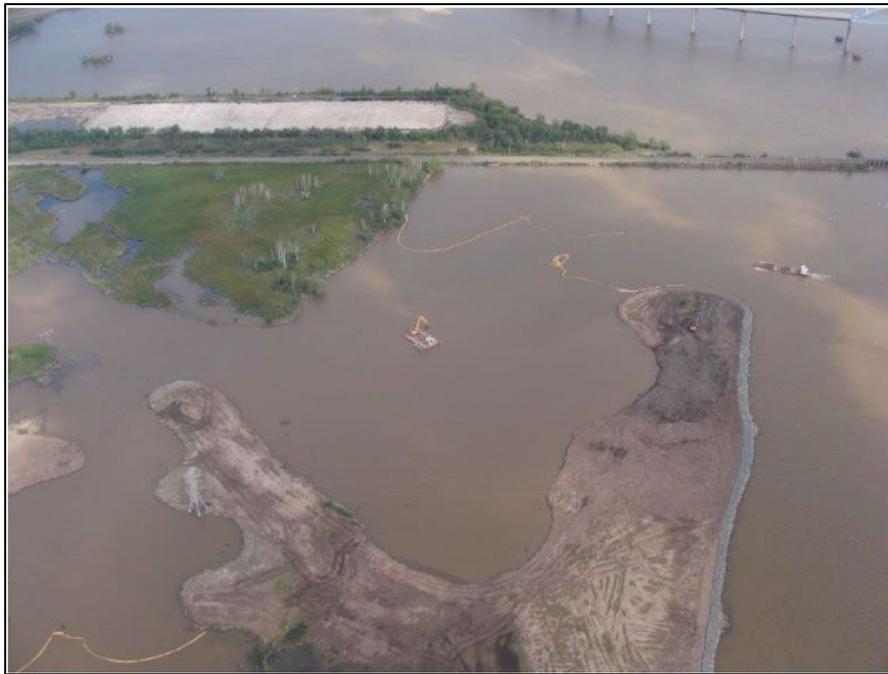
Photo 5. Aerial view of operations to place material excavated from Kingsbury Bay as a biomedium within the open water portions of the Grassy Point wetland complex. Photo provided by 1854 Treaty Authority via MNDNR Lake Superior and St. Louis River Program.

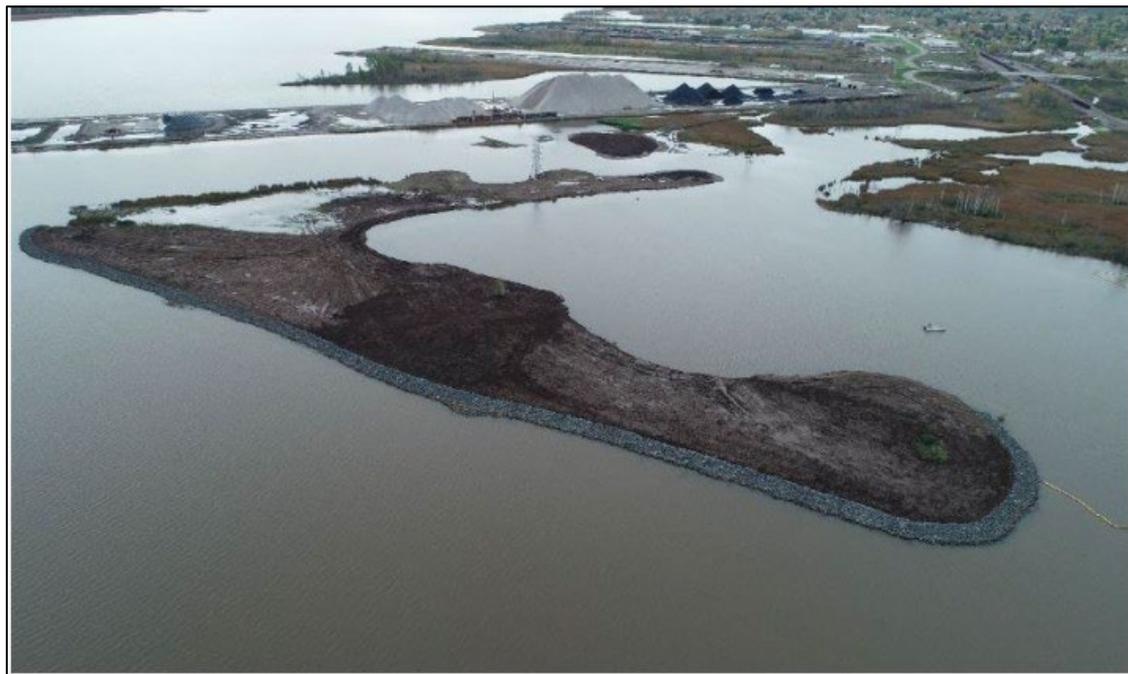
Photo 6. Aerial view of the larger Grassy Point island post-restoration in 2021. Photo provided by MNDNR Lake Superior and St. Louis River Program.

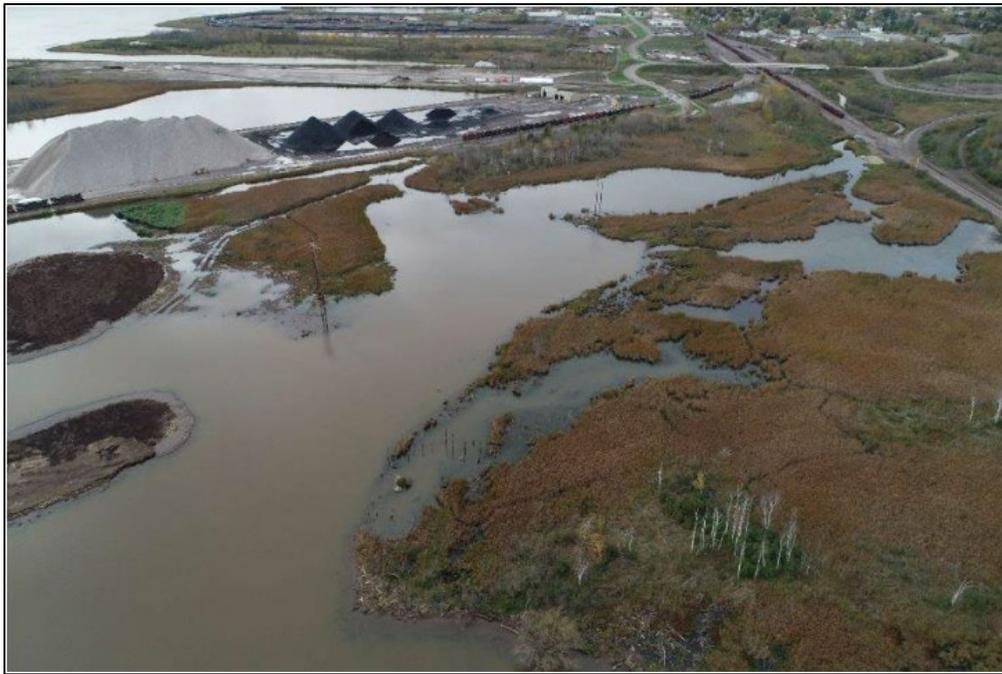
Photo 7. Aerial view of the interior of the Grassy Point wetland complex where legacy wood waste was removed to create deeper water depths more similar to historic and reference conditions. The mouth of Keene Creek in the upper right hand corner of the photo was dredged to increase water flow through the wetland. Photo provided by MNDNR Lake Superior and St. Louis River Program.

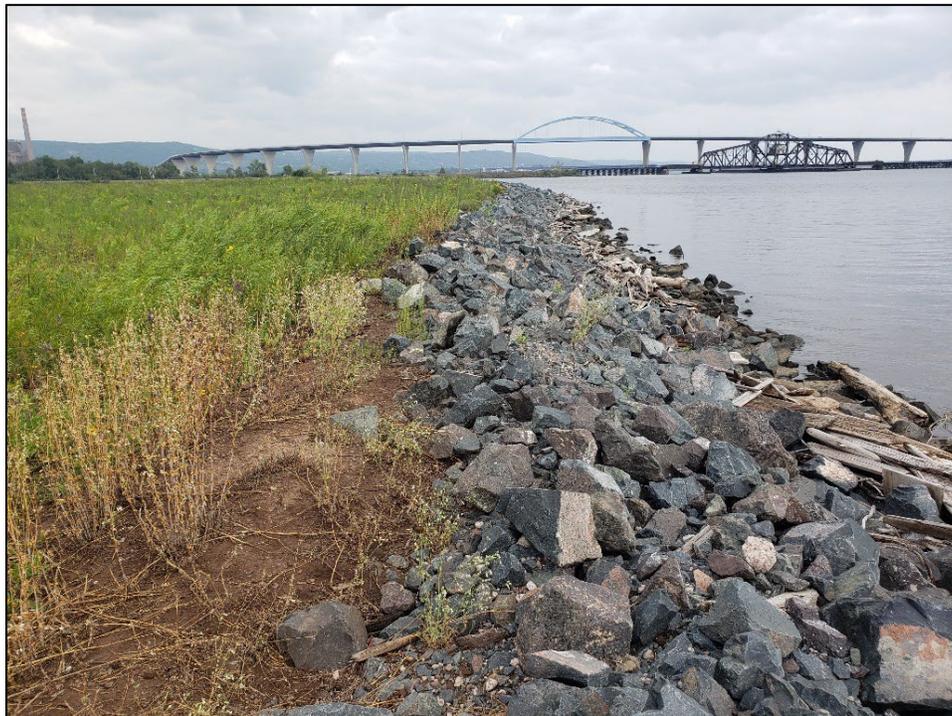
Photo 8. Example of the shoreline on the larger Grassy Point island that faces the main St. Louis River channel. A stone toe was added during construction to prevent wind and wave erosion. Photo taken by M. Pranckus (EOR) on August 17, 2023.

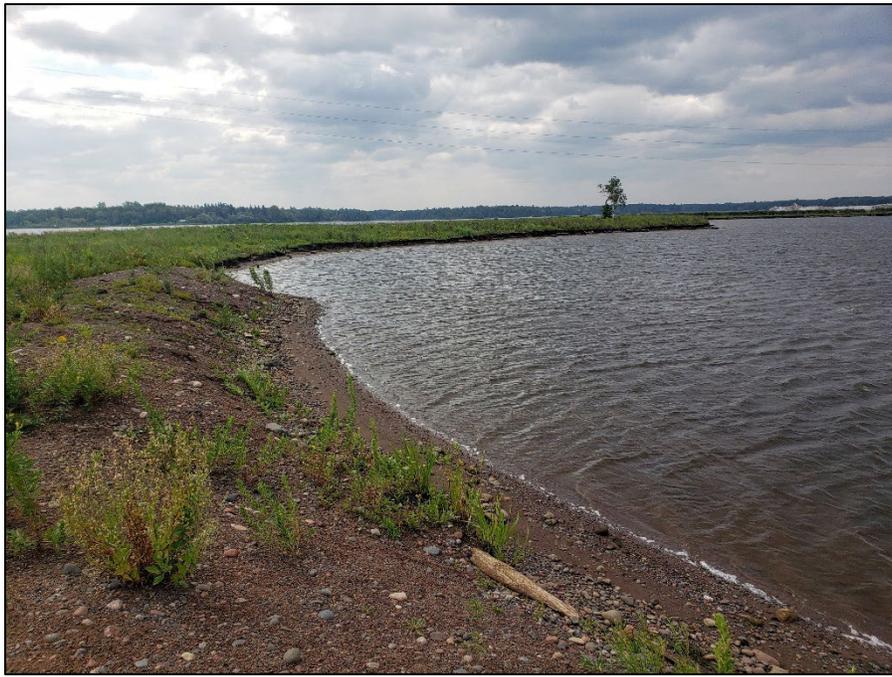
Photo 9. Example of the shoreline of the larger Grassy Point island that is within the sheltered bay. No stone toe was initially used to prevent wind and wave erosion. Photo taken by M. Pranckus (EOR) on August 17, 2023.

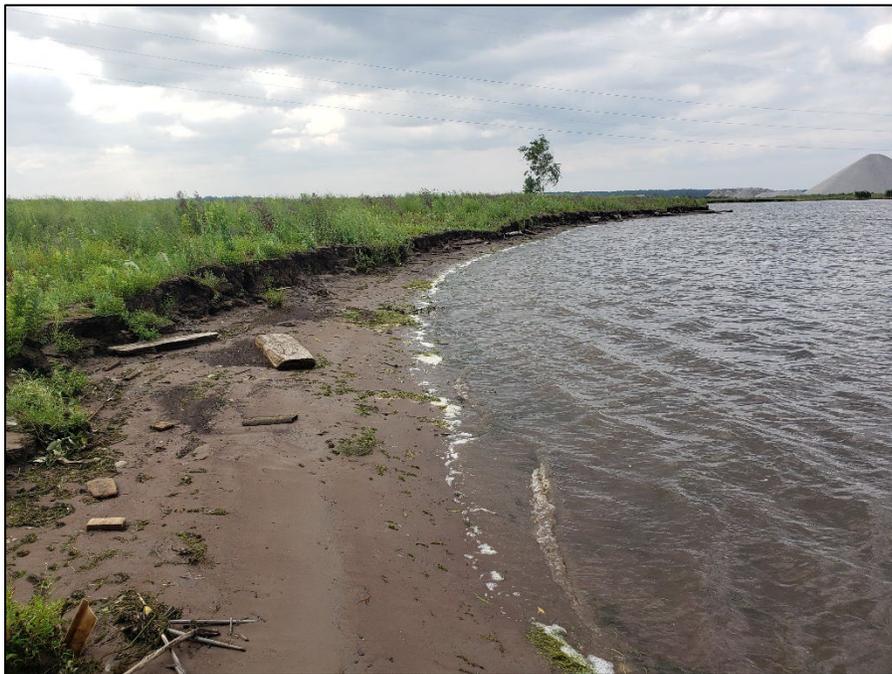
Photo 10. Example of minor shoreline erosion occurring along a portion of the larger Grassy Point island. Minor erosion may be expected as waves crash against a new shoreline that is not hard armored with stone or has existing vegetation. Over time, erosion may result in a bank angle that is stable and balances natural rates of erosion and deposition. Photo taken by M. Pranckus (EOR) on August 17, 2023.

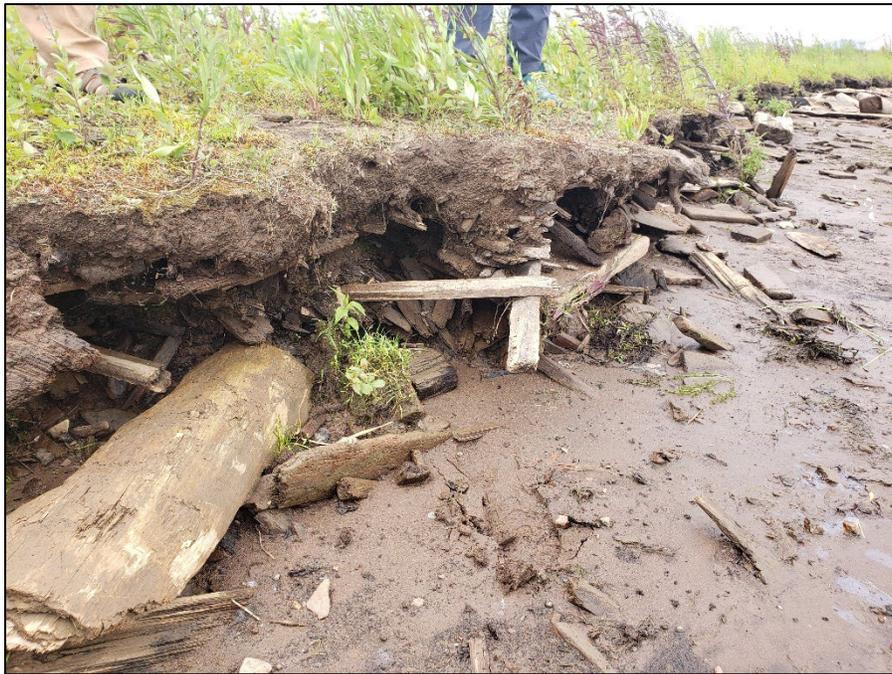
Photo 11. Example of where minor shoreline erosion is occurring on the larger Grassy Point island showing how the island was created using wood waste excavated from the project area and the top layer of biomedium excavated from Kingsbury Bay. Photo taken by M. Pranckus (EOR) on August 17, 2023.

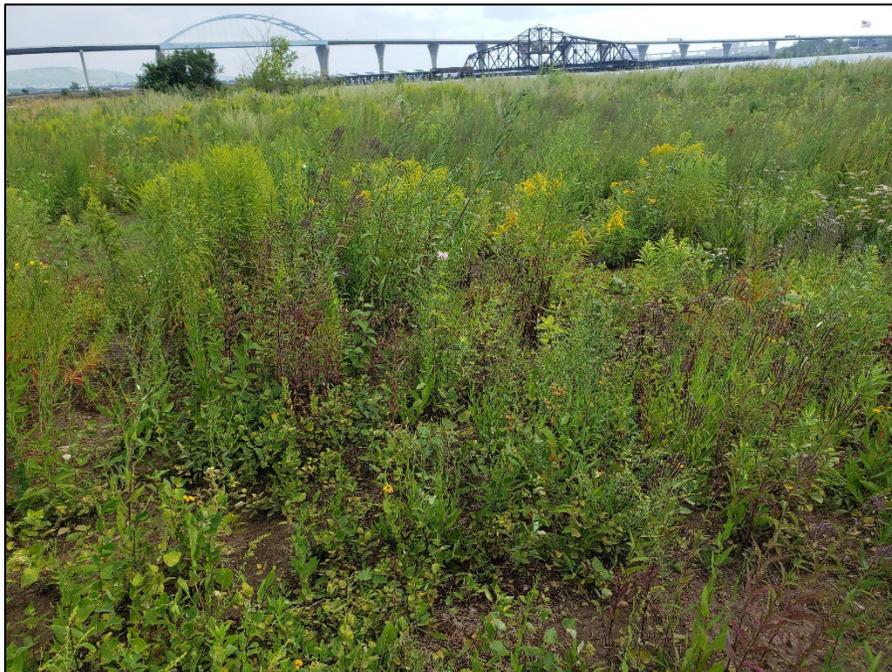
Photo 12. Example of vegetation that was installed on the Grassy Point island following restoration to improve habitat for migratory songbirds. Re-vegetation efforts were not included as a portion of the Grassy Point restoration project, but done as a separate project by a separate sponsor so an assessment of the vegetation was not included in this evaluation. Photo taken by M. Pranckus (EOR) on August 17, 2023.

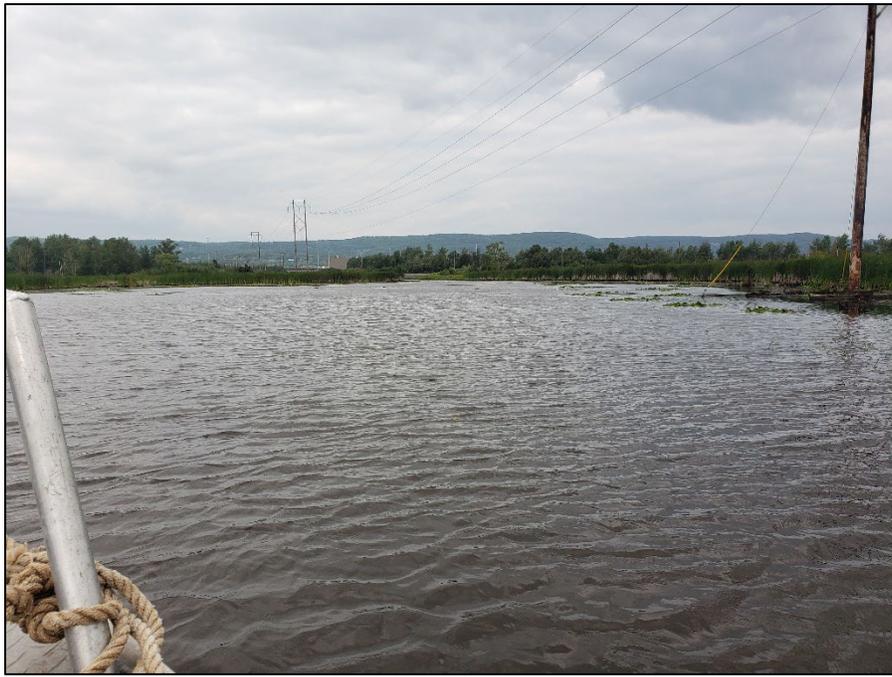
Photo 13. Example of the open water habitat created by removing legacy wood waste, which reduced water depths and aquatic habitat in the shallow, sheltered bay. Accumulated wood waste, sediments, and invasive cattail vegetation reduced water circulation between the bay, the St. Louis River, and Keene Creek. Photo taken by M. Prankus (EOR) on August 17, 2023.

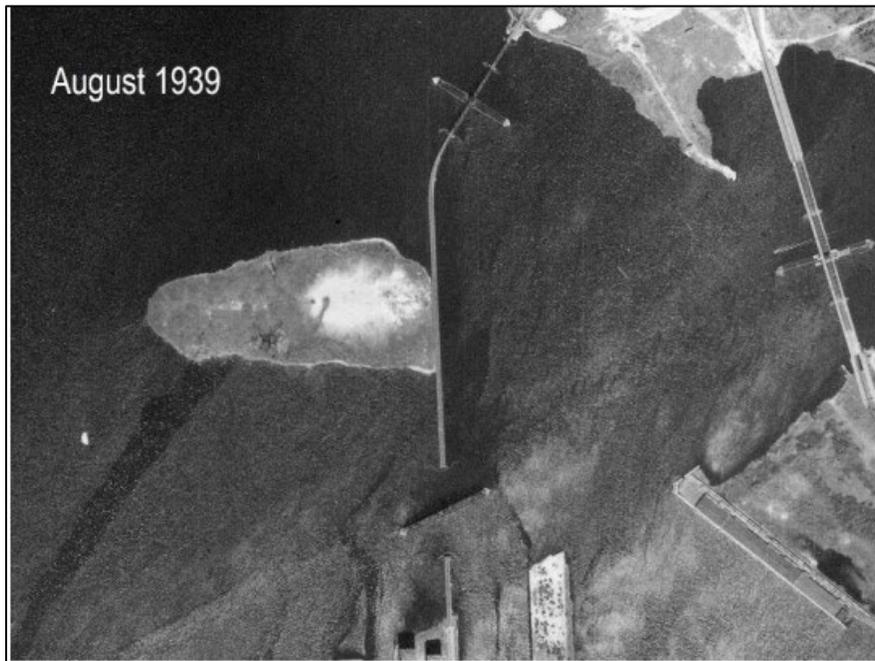
Photo 14. Aerial photo from 1939 showing the early footprint of Interstate Island after it was created and before sanding mining activities in the 1960s and wind and wave erosion reduced its overall size.

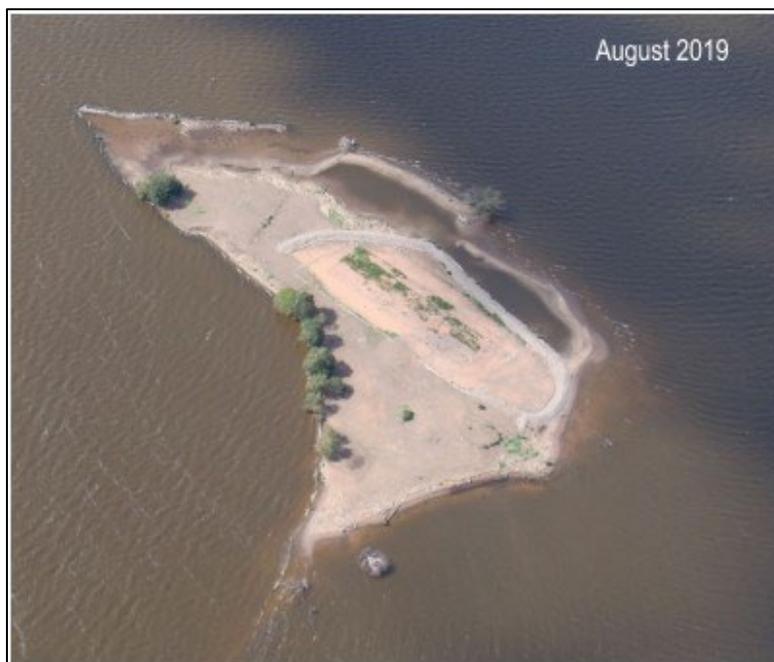
Photo 15. Aerial photo from 2019 showing the footprint of Interstate Island prior to design and construction. Previous efforts had occurred to stabilize the island size for migratory birds.

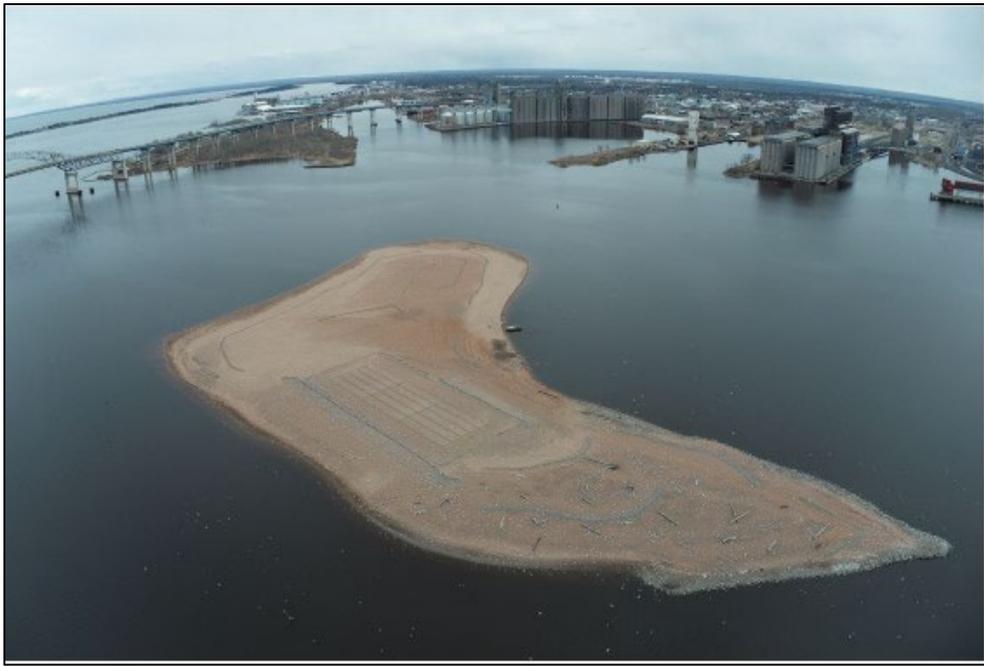
Photo 16. Aerial photo from 2021 following completion of construction at Interstate Island. Photo is from the Minnesota side of the island looking towards Superior, Wisconsin. Photo provided by JF Brennan via Minnesota Land Trust.

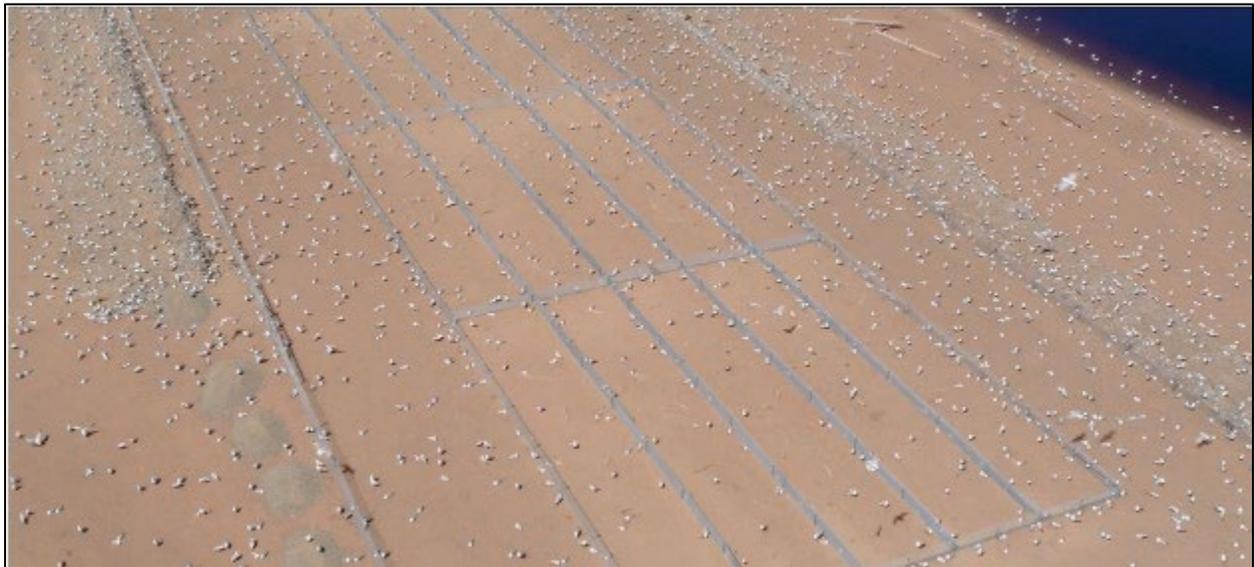
Photo 17. Aerial view looking down on Interstate Island after construction of fencing structures installed to provide nesting habitat for Common Terns where nest and chick predation by gulls would be reduced. Photo provided by SEH via Minnesota Land Trust.

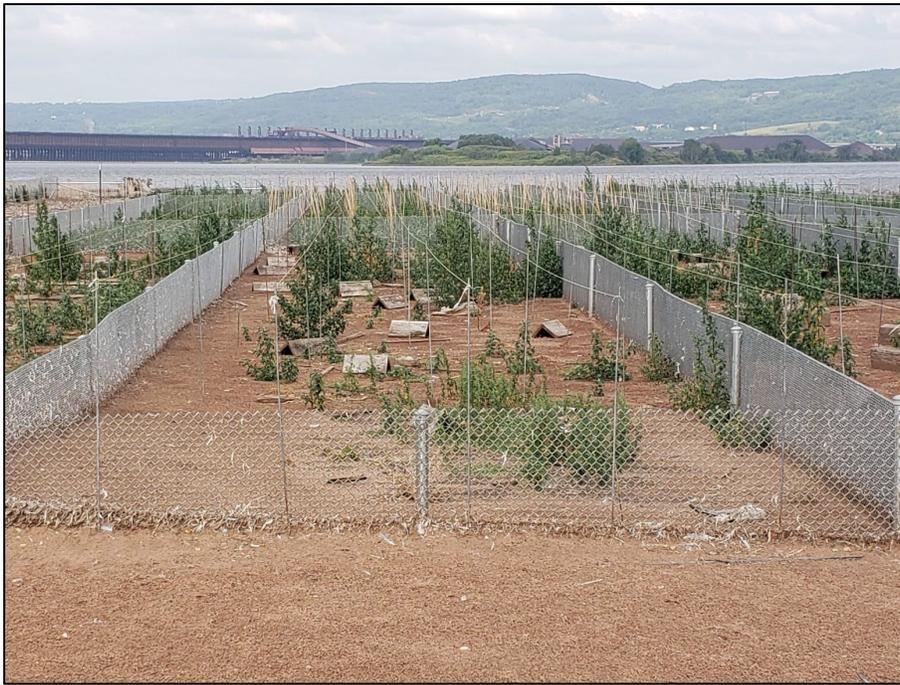
Photo 18. Looking at the nesting fence structures intended to reduce predation by gulls on Common Tern nests. String and posts along with fencing discourage gulls from landing. Vegetation is removed on an annual basis within the nesting areas to meet Common Tern nesting requirements. Photo provided by M. Prankus (EOR) 8/17/2023.

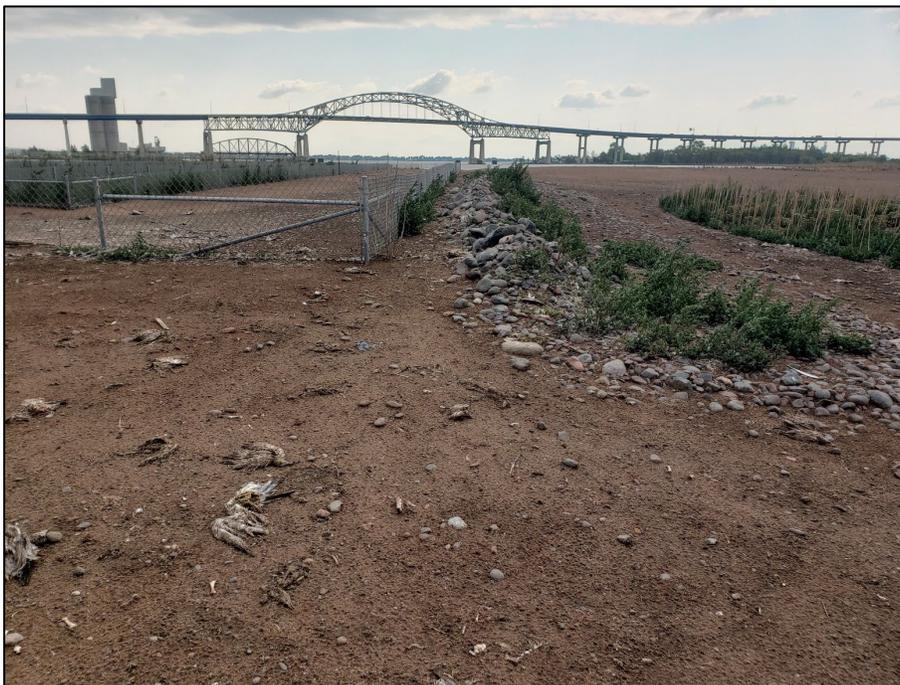
Photo 19. Looking the nesting fence structure along with a rip rap berm intended to reduce wind erosion on Interstate Island. Photo provided by M. Prankus (EOR) 8/17/2023.

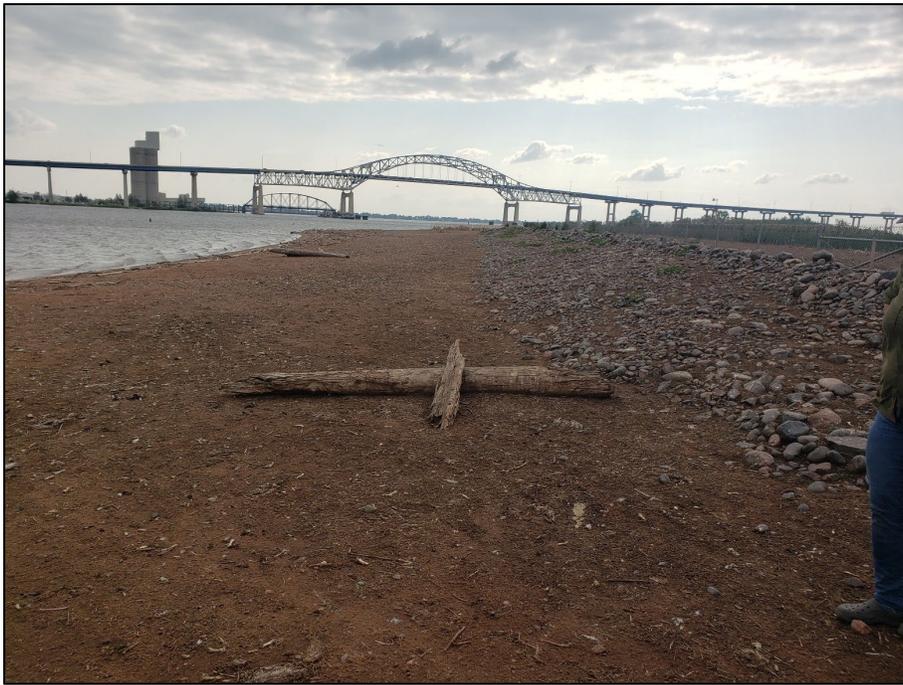
Photo 20. Looking at the shoreline of a restored Interstate Island. Driftwood and a rock berm are structures used to reduce wind and wave erosion and provide habitat for shorebirds. Photo provided by M. Pranckus (EOR) 8/17/2023.

Rock berms and driftwood for erosion control – The purpose of the project was to increase the available nesting habitat for Common Tern. The island is located on the main channel of the St. Louis River estuary near the inlet into Lake Superior. The area is wind-swept with wave energy due to the wide-open nature of the estuary at that point along with the erosive power of the river. Suitable nesting habitat for Common Tern includes sandy substrate relatively free of vegetation. Using rock berms and driftwood to break wind and wave energy is an appropriate approach to reducing erosion that causes loss of island elevation and size, while allowing the shoreline to be shaped by dynamic processes.

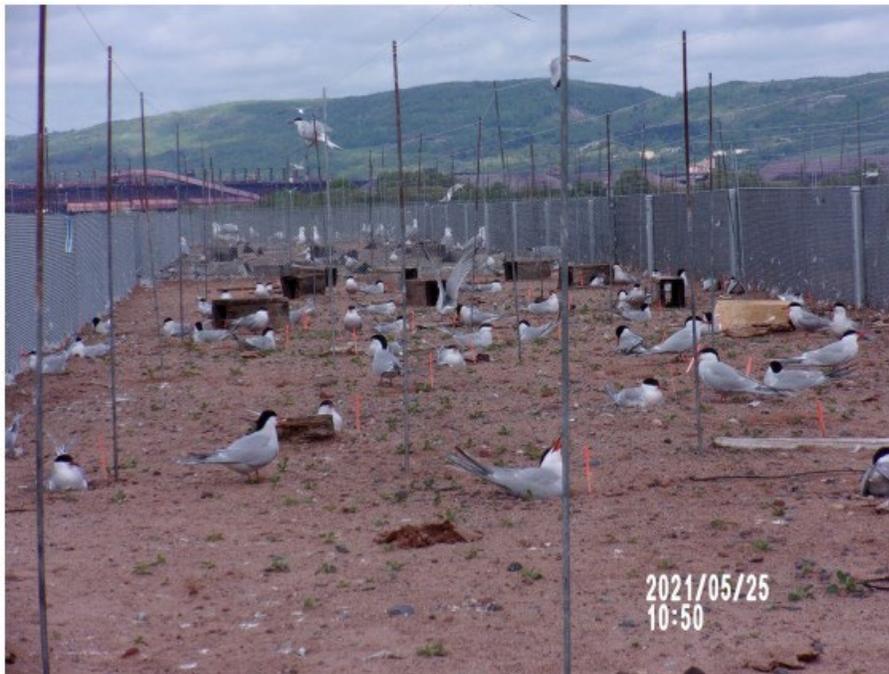
Photo 21. Example of habitat within fence nesting structure for Common Tern on Interstate Island. Common Tern need nearly bare soil for nesting. Posts and strings discourage gulls from landing within the nesting areas. Photo provided by Fred Strand via Minnesota Land Trust.

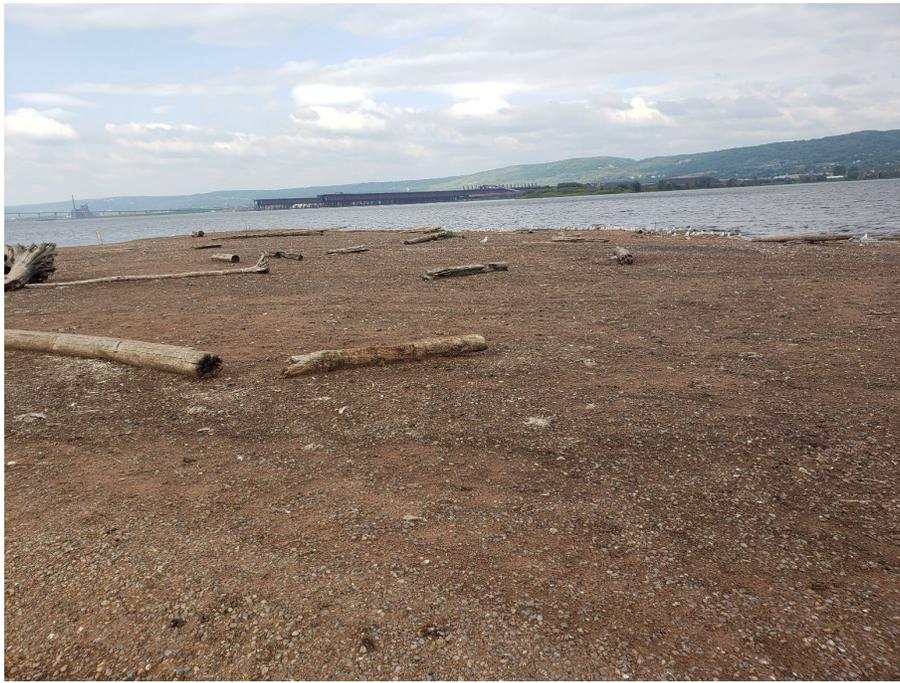
Photo 22. Example of the sandy and rocky shoreline following restoration of Interstate Island. Driftwood was intentionally and randomly placed to provide habitat for migratory shorebirds and reduce wind and wave erosion. Photo provided by M. Pranckus (EOR) 8/17/2023.

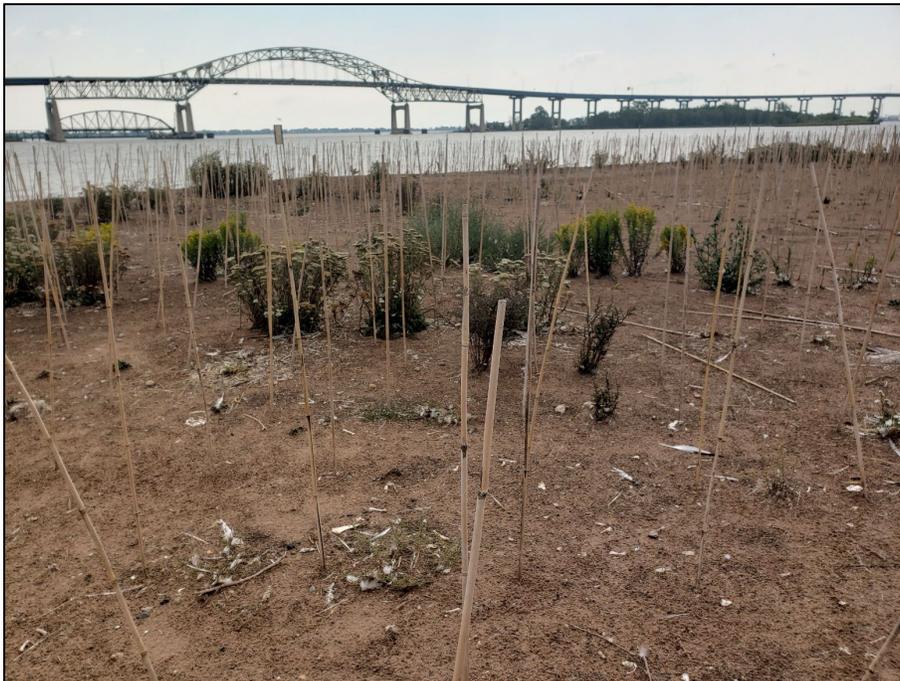
Photo 23. Example of posts installed outside of the nesting fence structures. As part of a post-restoration adaptive management strategy plant plugs were installed to enhance migratory shorebird habitat for Piping Plover. Posts are intended to reduce gull nest predation and Canada Goose herbivory. Photo provided by M. Pranckus (EOR) 8/17/2023.

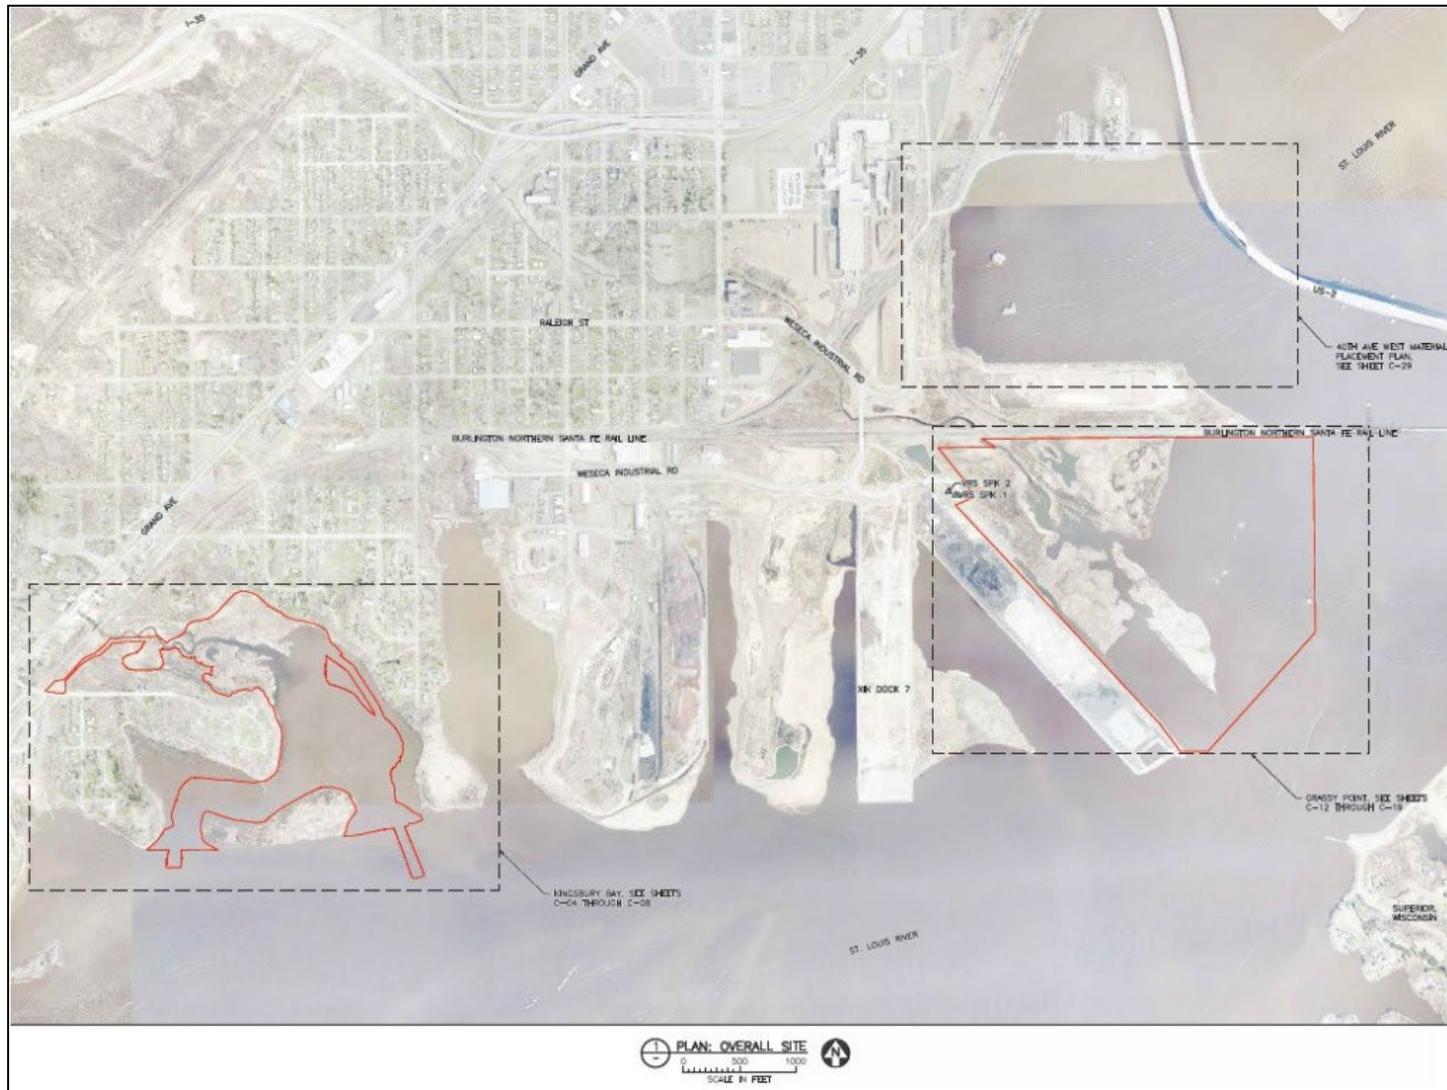
Figure 9. Aerial map of pre-construction conditions for Kingsbury Bay in the red box along the left hand side of the map and Grassy Point in the red box along the right hand side of the map. Dredged material from Kingsbury Bay was taken to Grassy Point and used as biomedium to improve aquatic and terrestrial vegetation growth post-restoration.

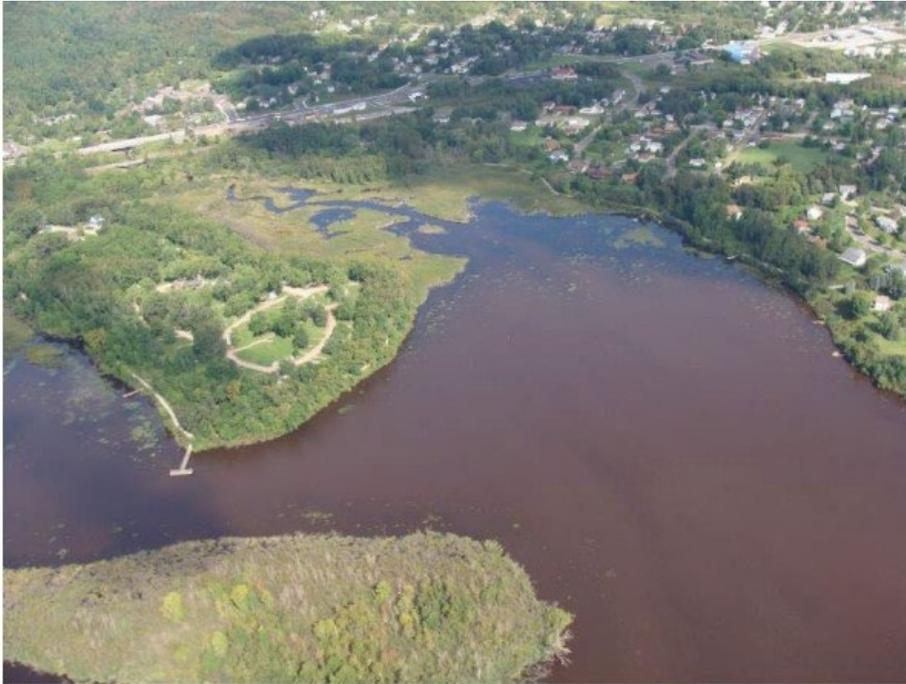
Photo 24 Aerial view of Kingsbury Bay prior to removal of sediments and accumulated cattail vegetation. Photo provided by 1854 Treaty Authority via MNDNR Lake Superior and St. Louis River Program.

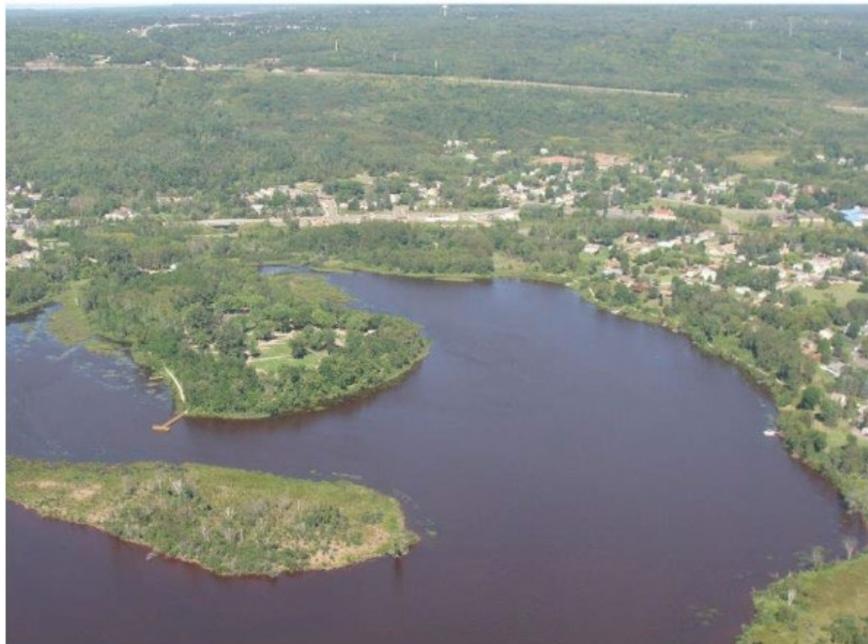
Photo 25. Aerial view of Kingsbury Bay following removal of sediments and accumulated cattail vegetation. Photo provided by 1854 Treaty Authority via MNDNR Lake Superior and St. Louis River Program.

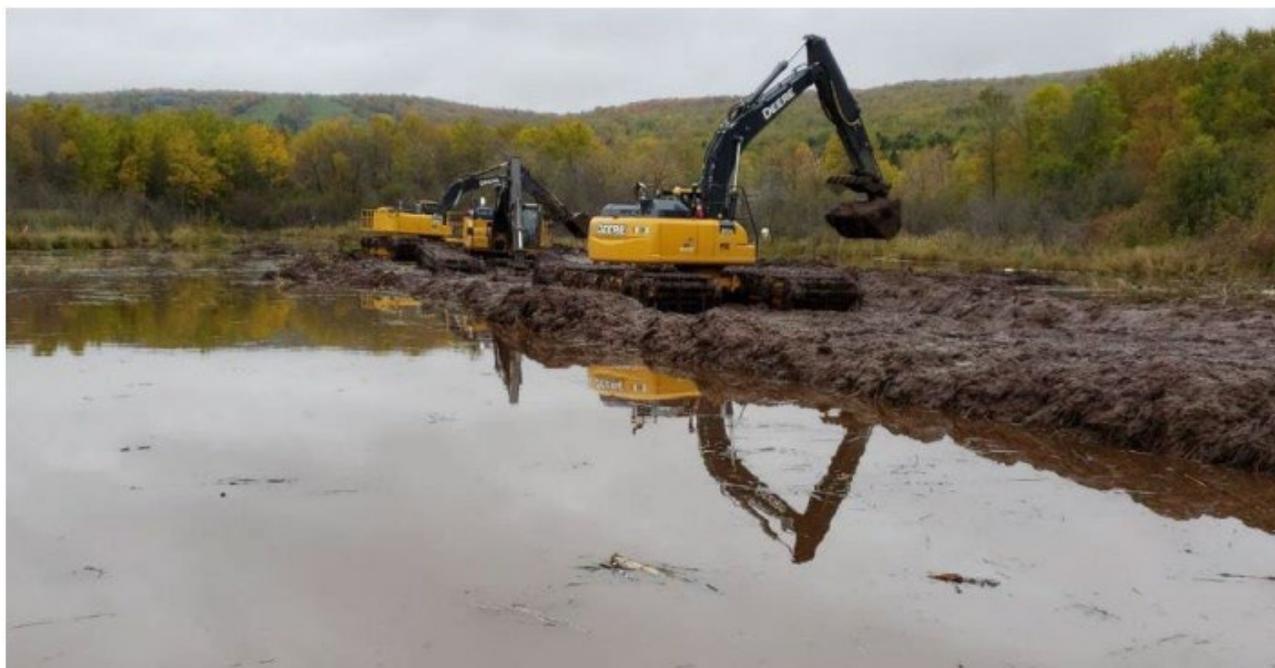
Photo 26. Example of excavation activities to removal cattail vegetation for off-site disposal at Kingsbury Bay. Photo provided by MNDNR Lake Superior and St. Louis River Program.
