Program Process and Project Evaluations

Appendix A: 2023 Legacy Fund Restoration Evaluation Report

May 2024

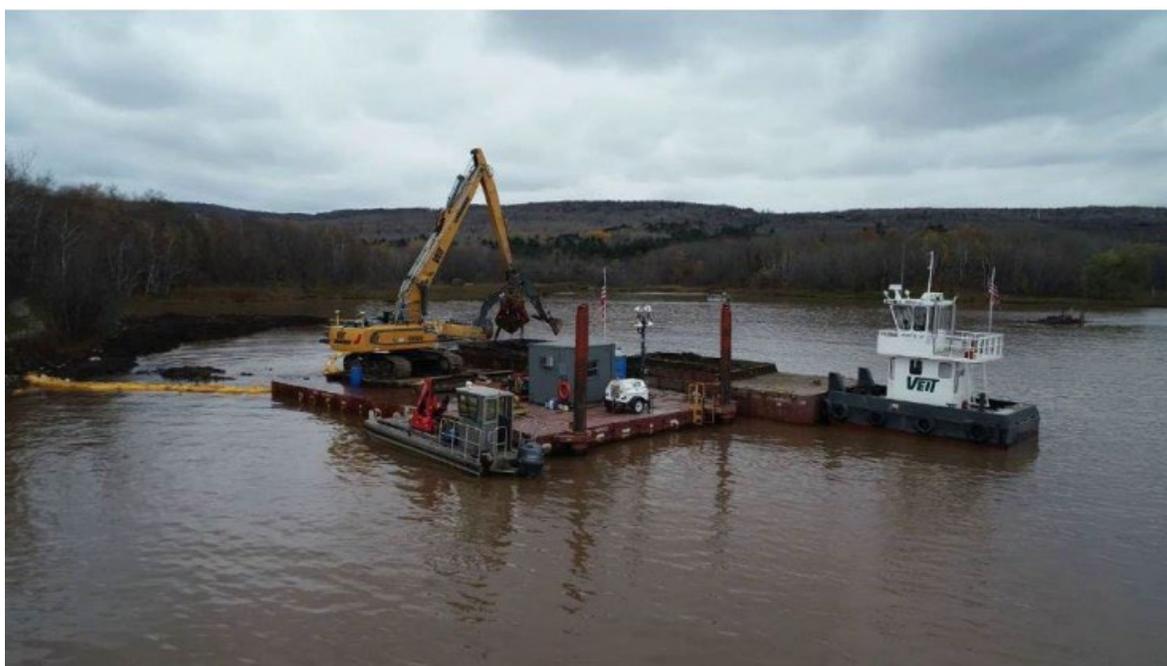
Photo 27. Example of excavation activities to removal accumulated sediment following cattail vegetation removal at Kingsbury Bay. Material was loaded in a barge and deposited at the Grassy Point restoration site on the St. Louis River. Photo provided by MNDNR Lake Superior and St. Louis River Program.

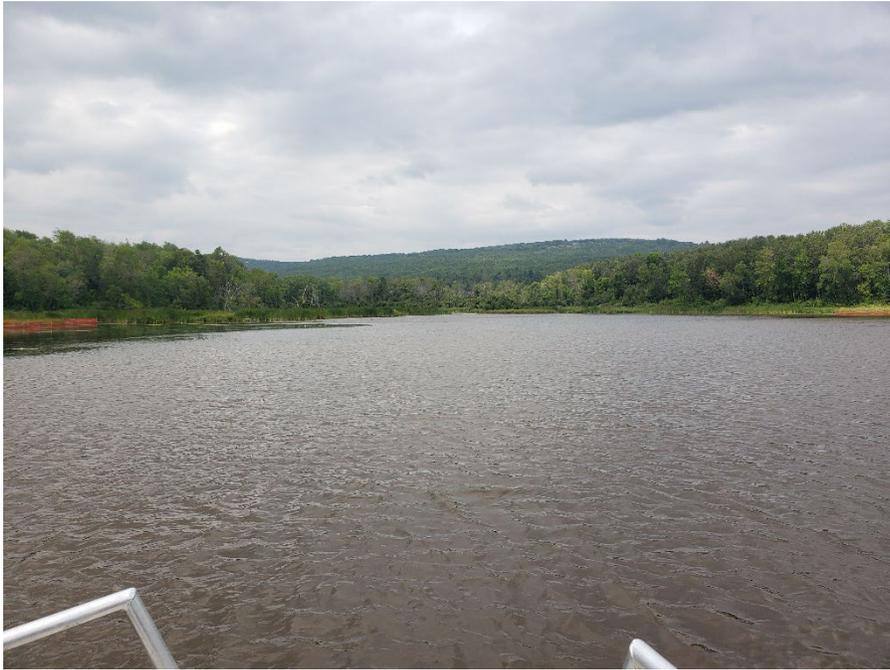
Photo 28. Example of the open water sheltered bay habitat created by the restoration project. A monoculture of cattails would have been present in this view prior to construction. Photo taken by M. Pranckus (EOR) on August 17, 2023.

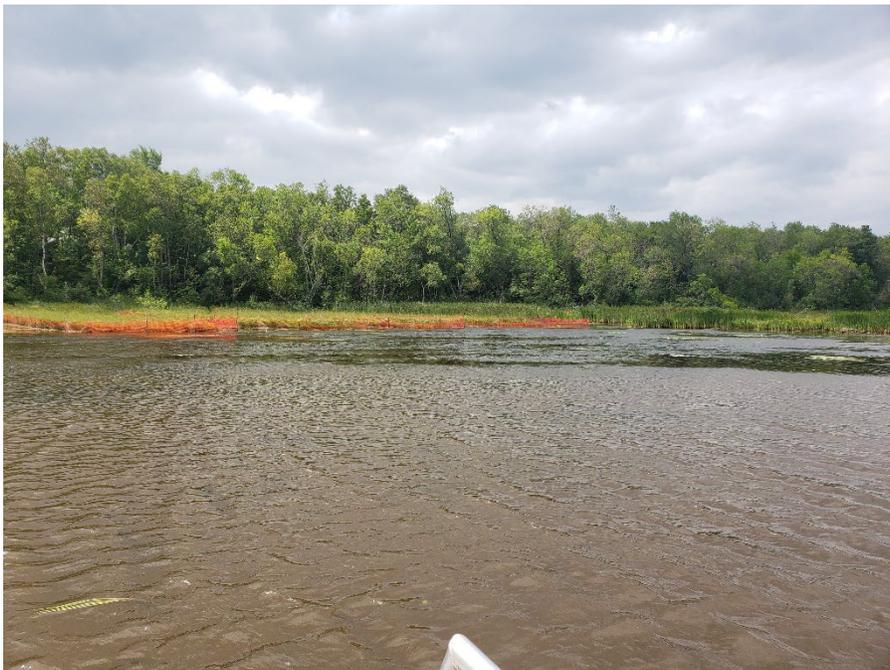
Photo 29. Example of the open water sheltered bay habitat created by the restoration project and the follow-up companion project to establish wild rice along the periphery of the bay. Wild rice is seeded in cages in the orange fence. Photo taken by M. Pranckus (EOR) on August 17, 2023.

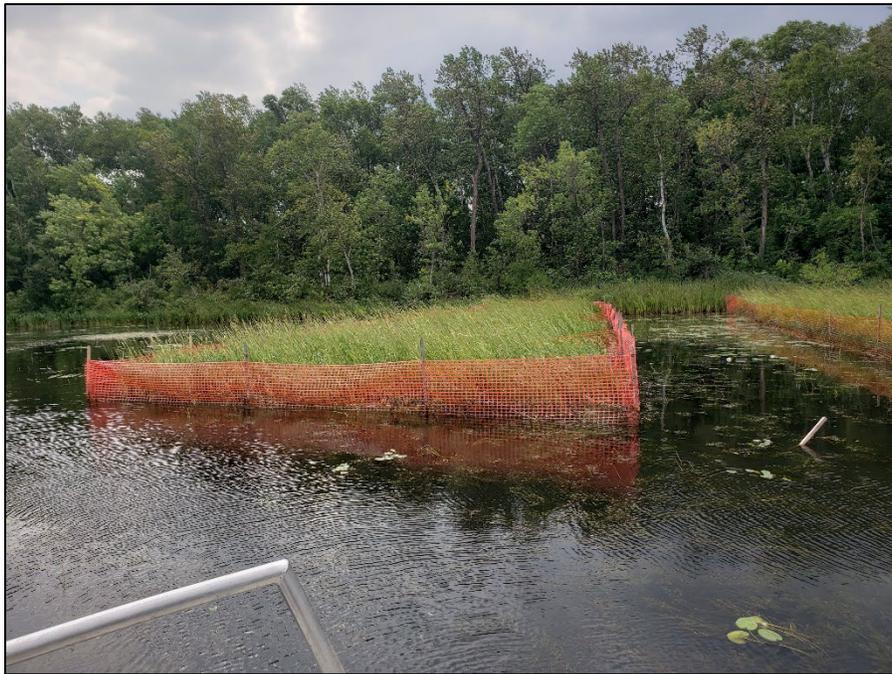
Photo 30. Example of wild rice seeding that is occurring along the periphery of Kingsbury Bay following removal of cattails and accumulated sediment. Wild rice is seeded annually and protected from herbivory by Canada geese until the rice has seeded out. Wild rice seeding is a follow-up companion project facilitated by completing the overall removal of vegetation and sediments in Kingsbury Bay. Photo taken by M. Pranckus (EOR) on August 17, 2023.

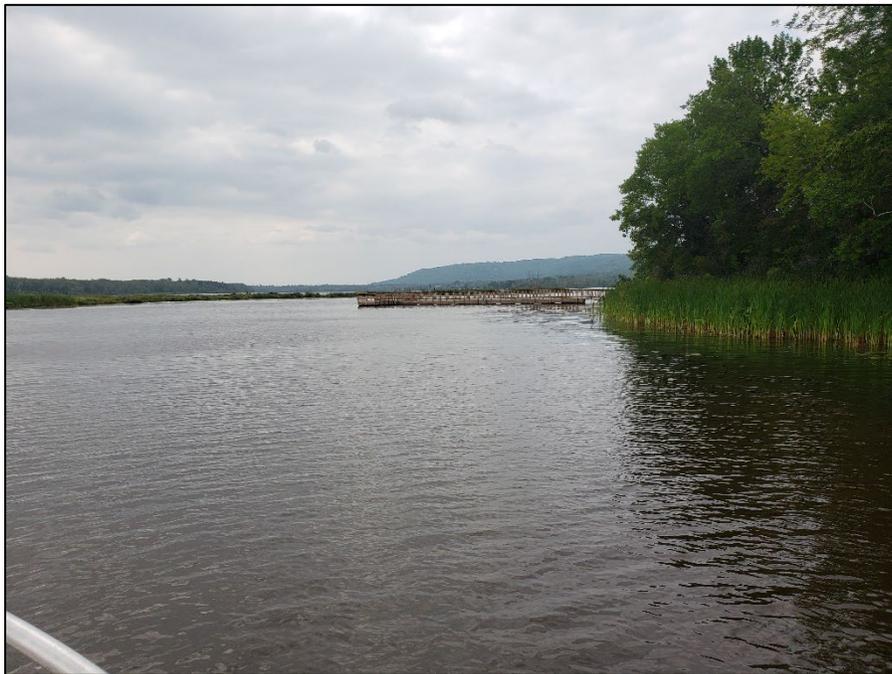
Photo 31. An existing public access fishing pier was present along the Kingsbury Bay project boundary. A planned deep water habitat feature was re-located during construction to be closer to the pier so anglers could be easily benefit from habitat restoration efforts associated with the project. Photo taken by M. Pranckus (EOR) on August 17, 2023.

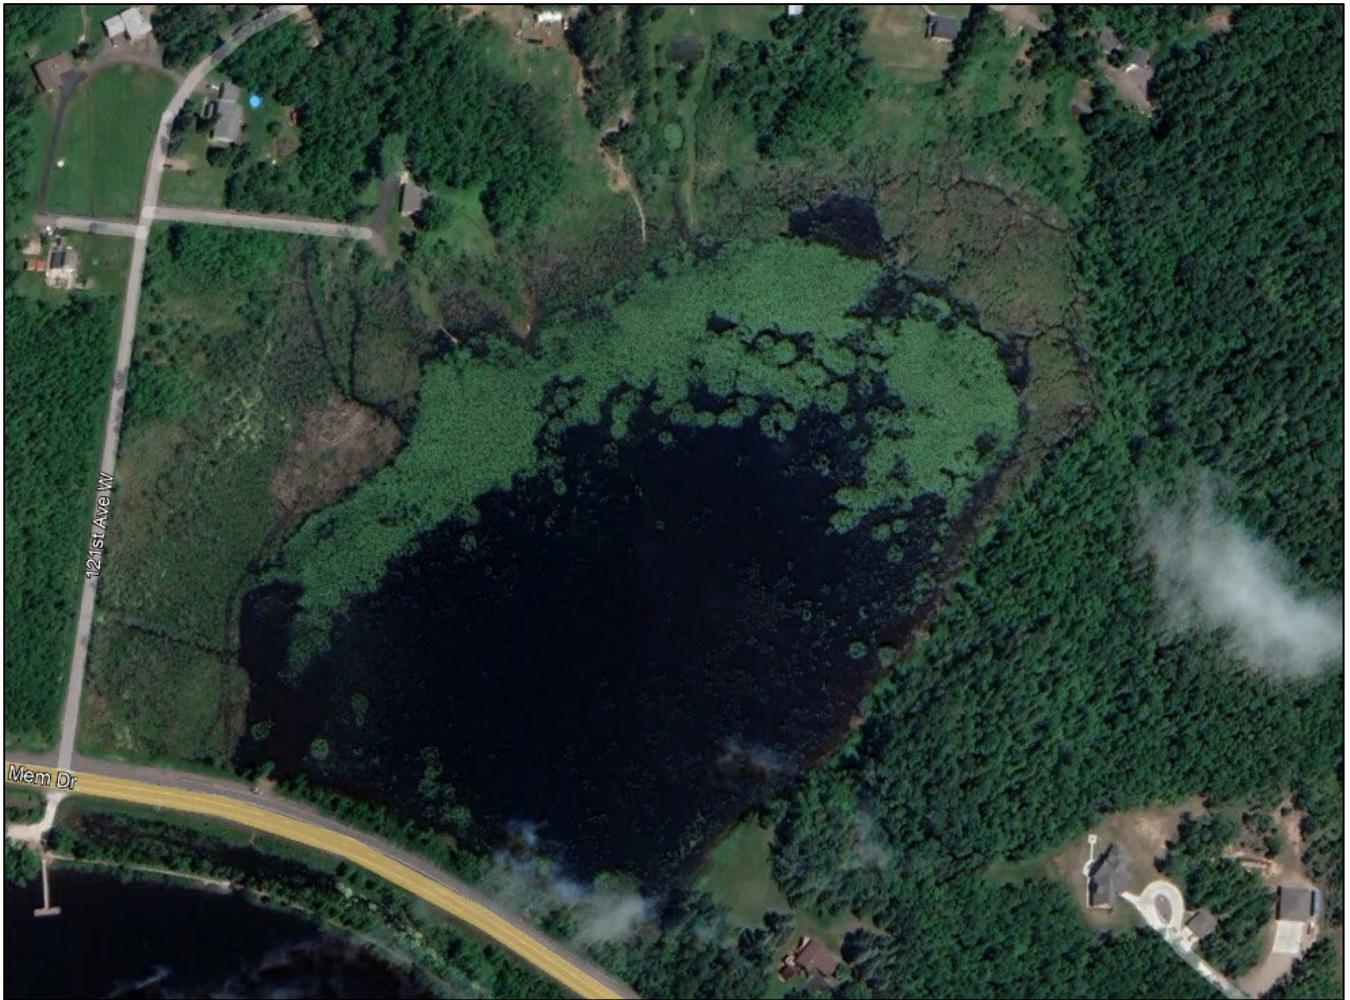
Figure 13. Aerial view from 2021 showing Perch Lake prior to restoration. Most of Perch Lake is covered in floating and submerged aquatic vegetation during the growing season, indicative of the shallow depths. Aerial photo courtesy of Google Earth (accessed October 2023).

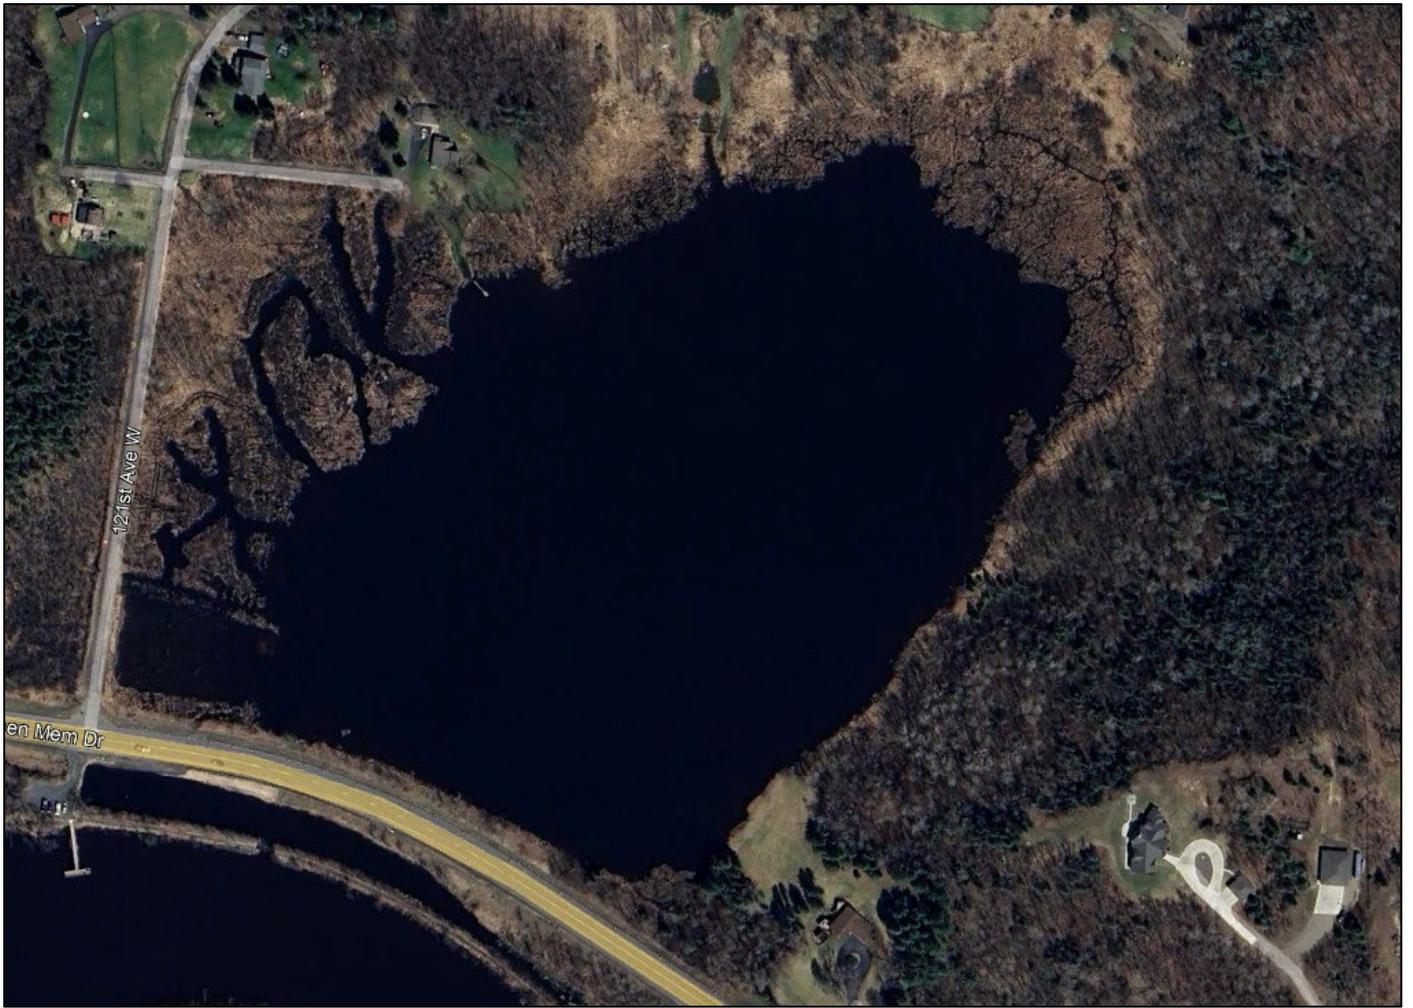
Figure 14. Aerial view from 2023 showing Perch Lake post-restoration. Areas along the eastern edge of the wetland show the hemi-marsh creation. Aerial photo courtesy of Google Earth (accessed October 2023).

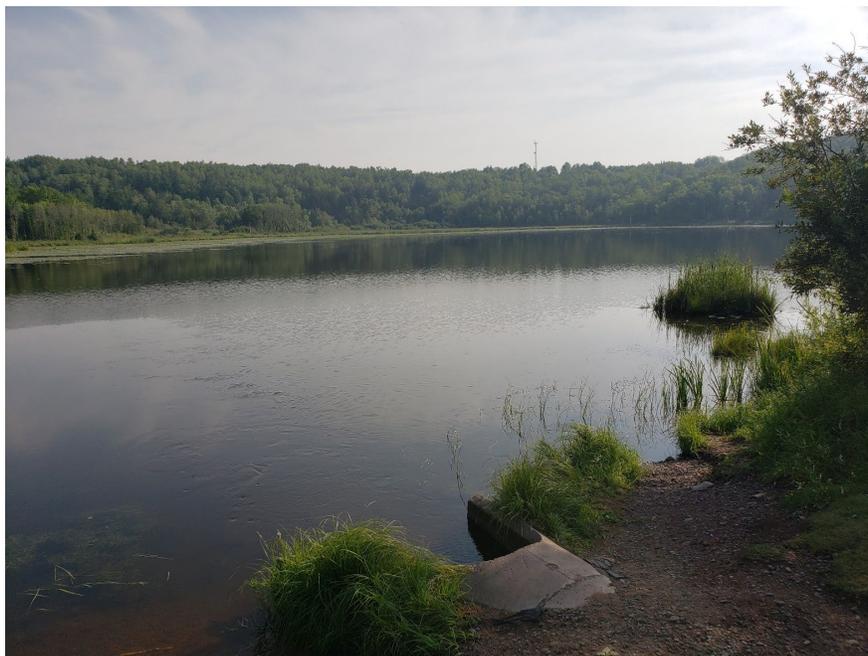
Photo 32. Overlooking Perch Lake at the existing culvert inlet following sediment removal. The culvert is the only connection between Perch Lake and the St. Louis River. Photo taken by M. Pranckus (EOR) on August 18, 2023.

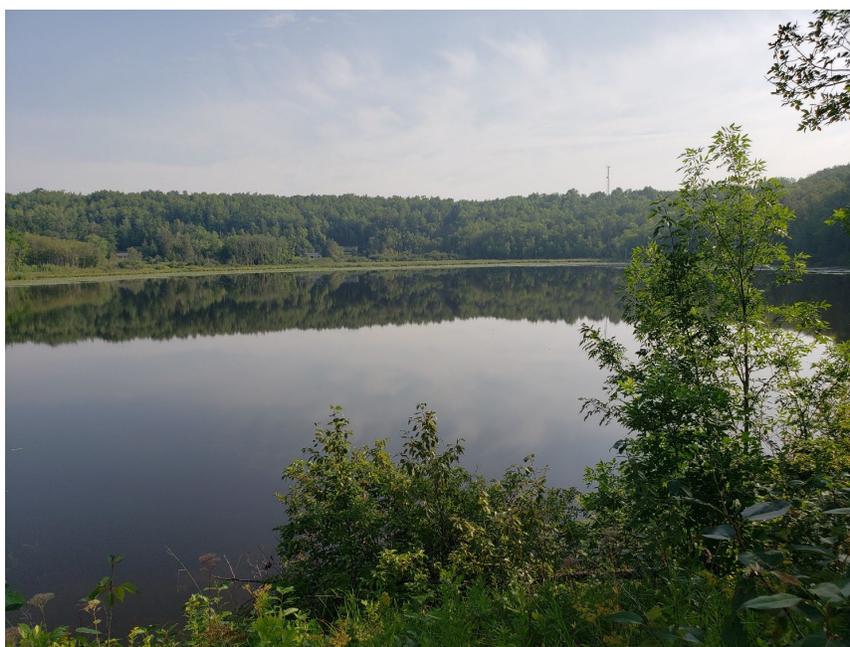
Photo 33. Overlooking Perch Lake following sediment removal. Prior to restoration, much of the open water area would be covered with submergent and floating aquatic vegetation. Photo taken by M. Pranckus (EOR) on August 18, 2023.

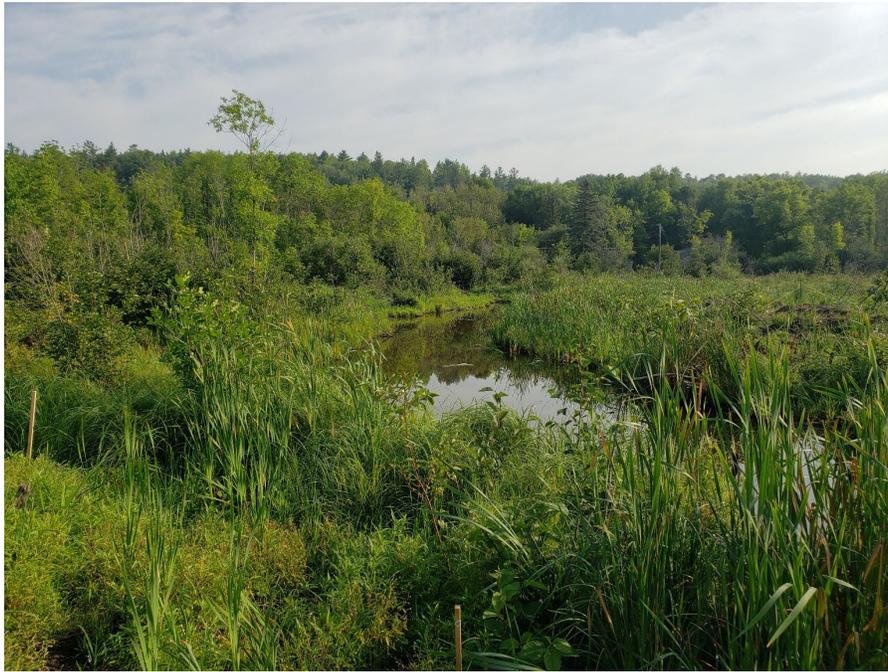
Photo 34. Example of hemi-marsh that was created by excavating open water areas in densely vegetated marsh areas. These open water areas are important to provide habitat for marsh birds. Photo taken by M. Pranckus (EOR) on August 18, 2023.

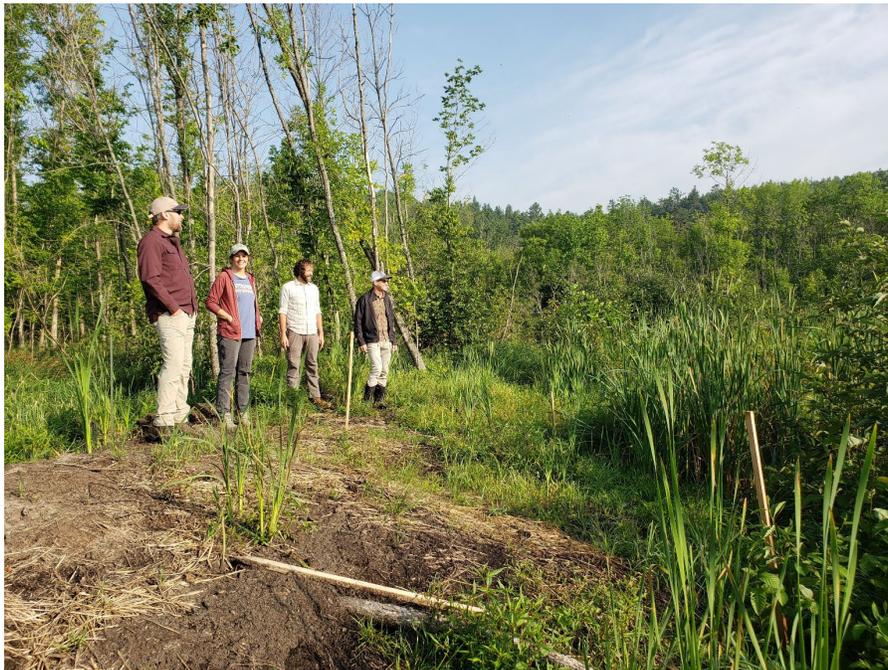
Photo 35. Example of habitat mounds created in conjunction with hemi-marsh creation. The mounds are composed of material excavated for the open water areas. The mounds slightly increase in elevation compared to the surrounding wetlands, which are important for wildlife use. Photo taken by M. Pranckus (EOR) on August 18, 2023.

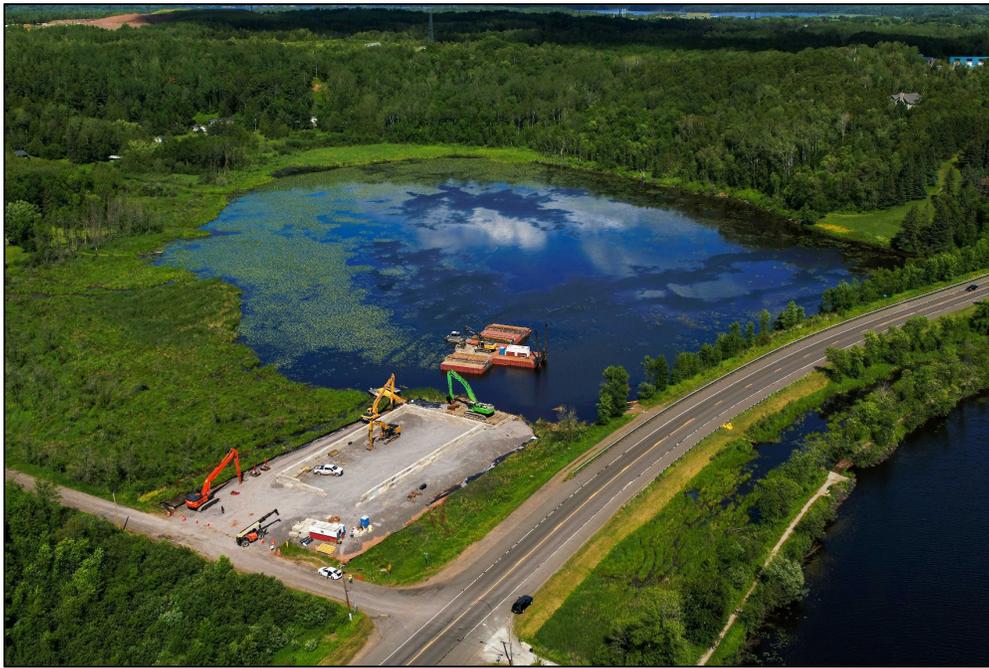
Photo 36. Example of sediment removal operations to restore Perch Lake bathymetry. Photo provided by Jeramy Pinkerton, MNDNR.

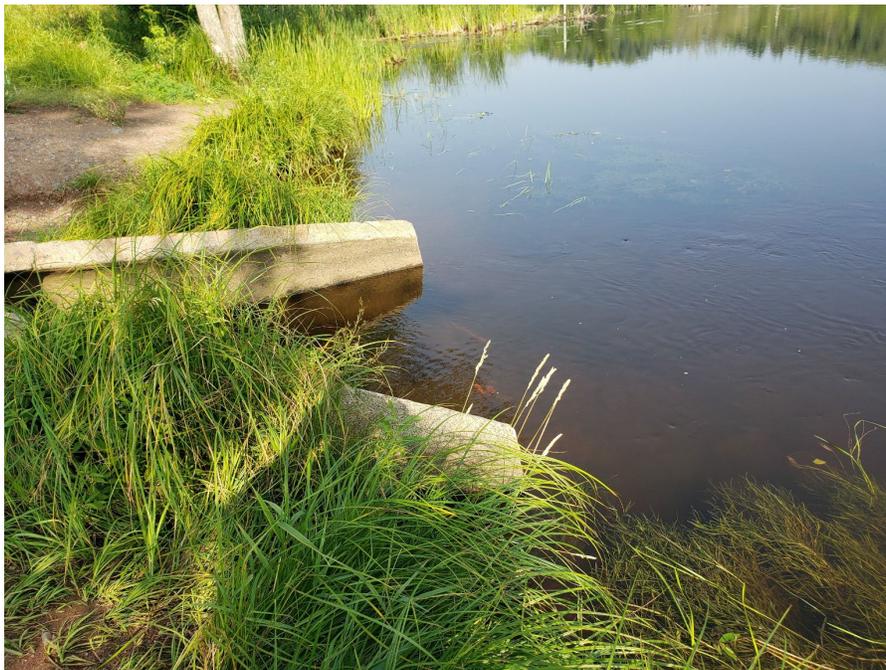
Photo 37. Example of the existing culvert outlet connecting Perch Lake with the St. Louis River. This culvert will remain in place following the installation of the new culvert at a second location under State Highway 23. Photo taken by M. Pranckus (EOR) on August 18, 2023.

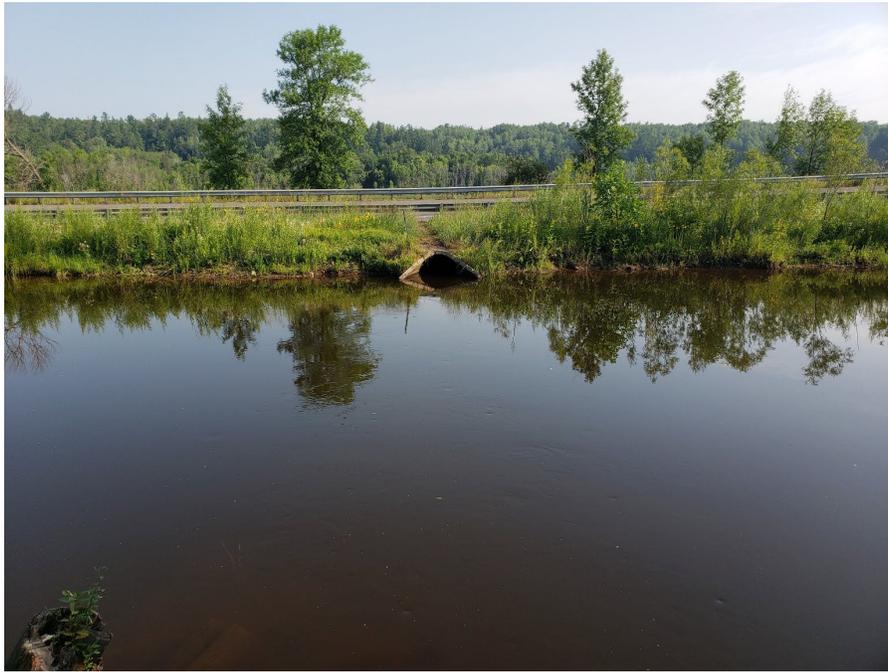
Photo 38. Looking at the existing culvert between Perch Lake and the St. Louis River via a narrow ditch. Water along with fish and other aquatic organisms, sediments, and nutrients are required to pass through this narrow pipe as the only connection. The newly installed culvert will be approximately four times wider than this culvert. Photo taken by M. Pranckus (EOR) on August 18, 2023.

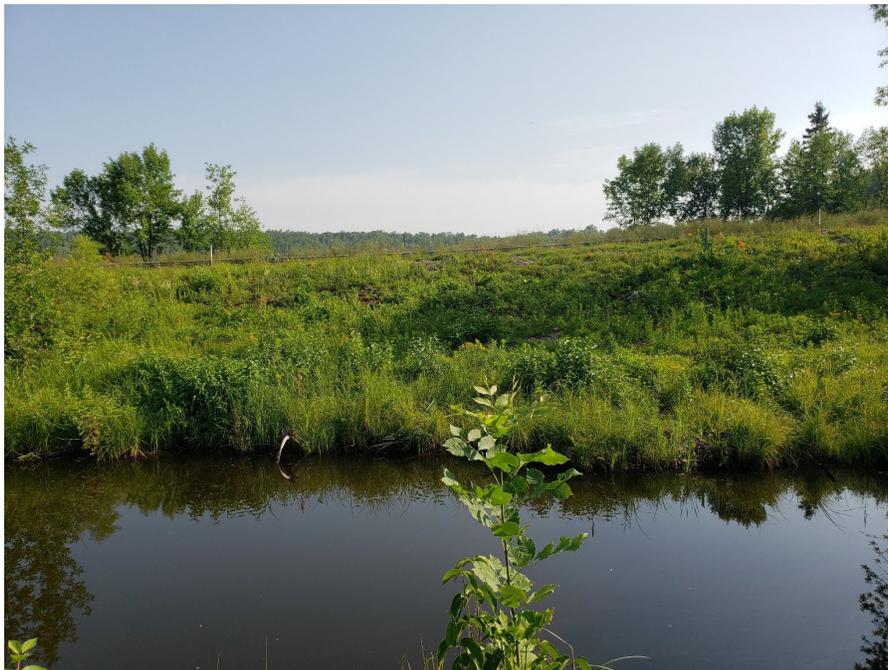
Photo 39. Looking at the future location of the new culvert crossing under State Highway 23. The new culvert will be 16 feet wide, or four times the width of the existing culvert and provide the ability for water to flow through Perch Lake, similar to other shallow sheltered bays along the St. Louis River. Photo taken by M. Pranckus (EOR) on August 18, 2023.

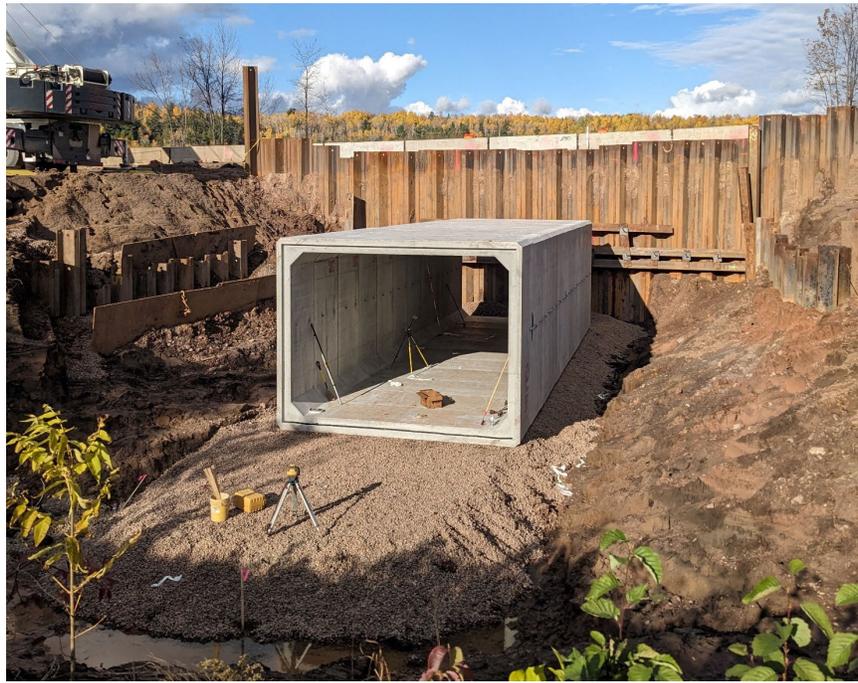
Photo 40. Installation of the new culvert connecting Perch Lake with the St. Louis River. The photo was taken after the initial site assessment visit. Photo provided by Jeramy Pinkerton, MNDNR.

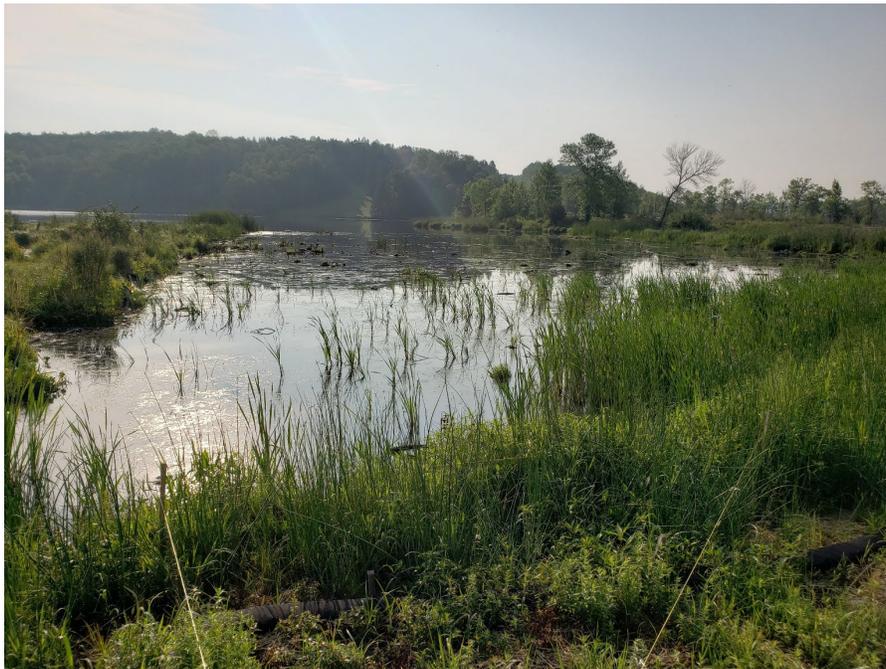
Photo 41. Example of the equipment access pad post-construction. Timber mats were placed on wetland vegetation to minimize impact during construction. Photo taken by M. Pranckus (EOR) on August 18, 2023.

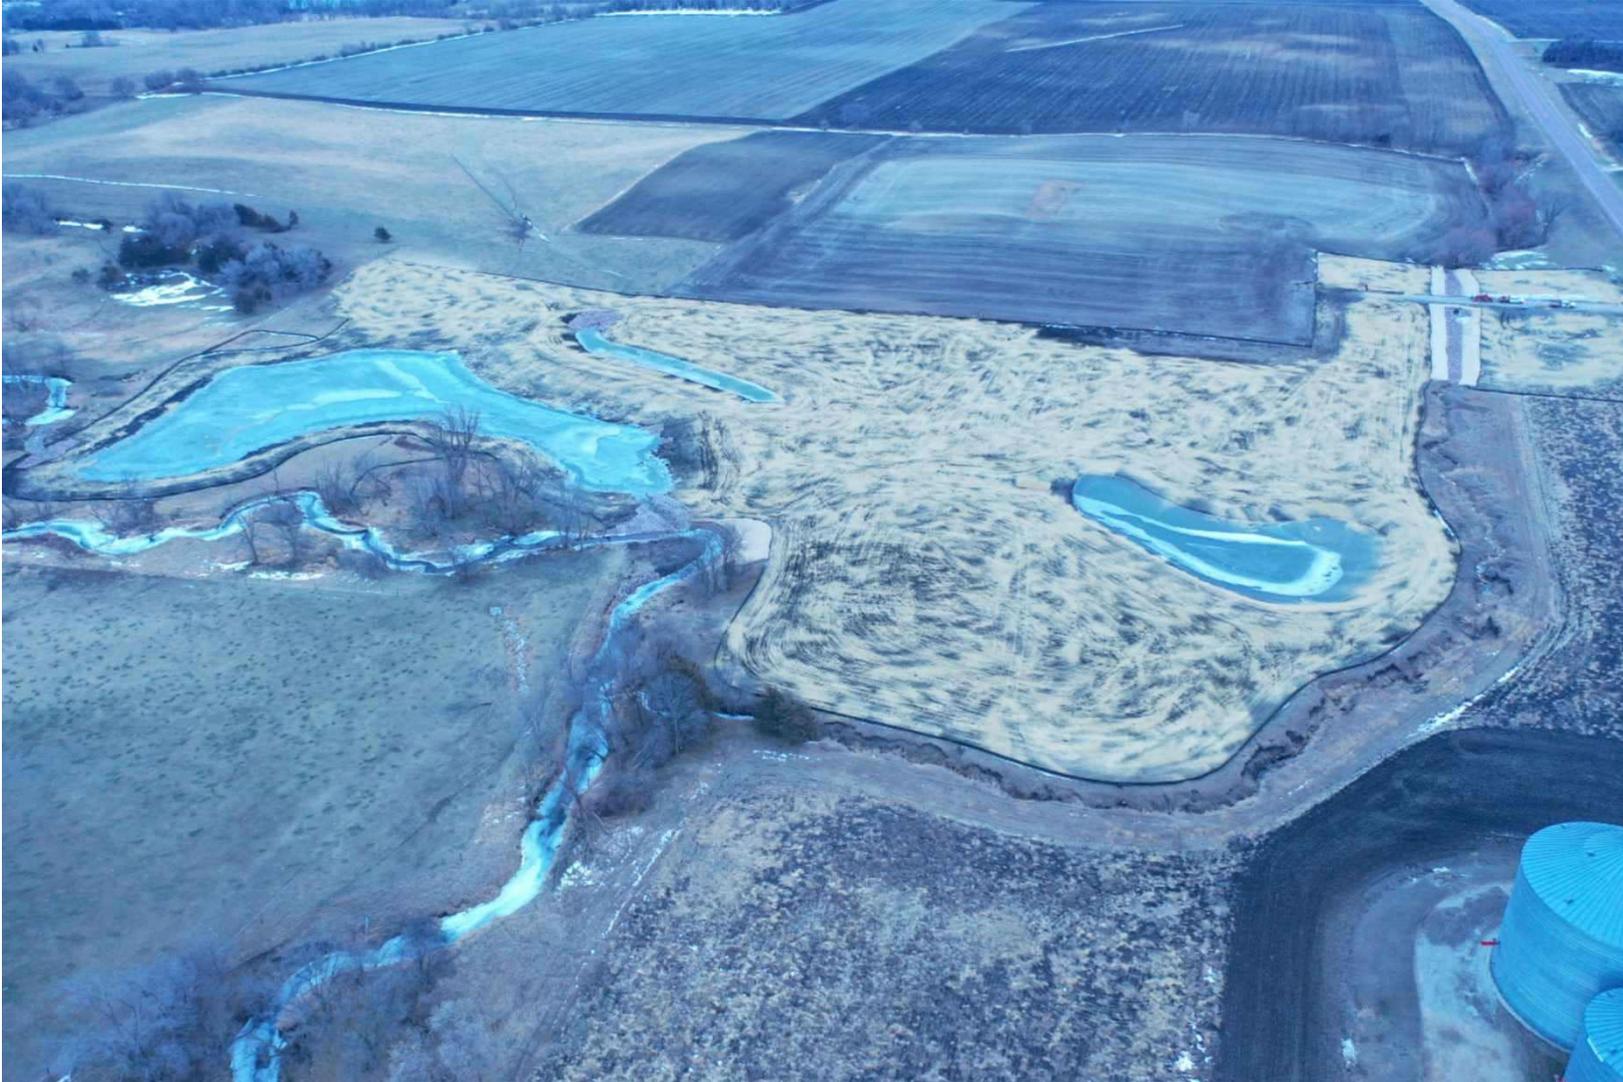
Figure 20 Aerial view of project's south lot facing south with Dutch Creek and the offline habitat wetland pond left of the image. Photo taken in December 2021.

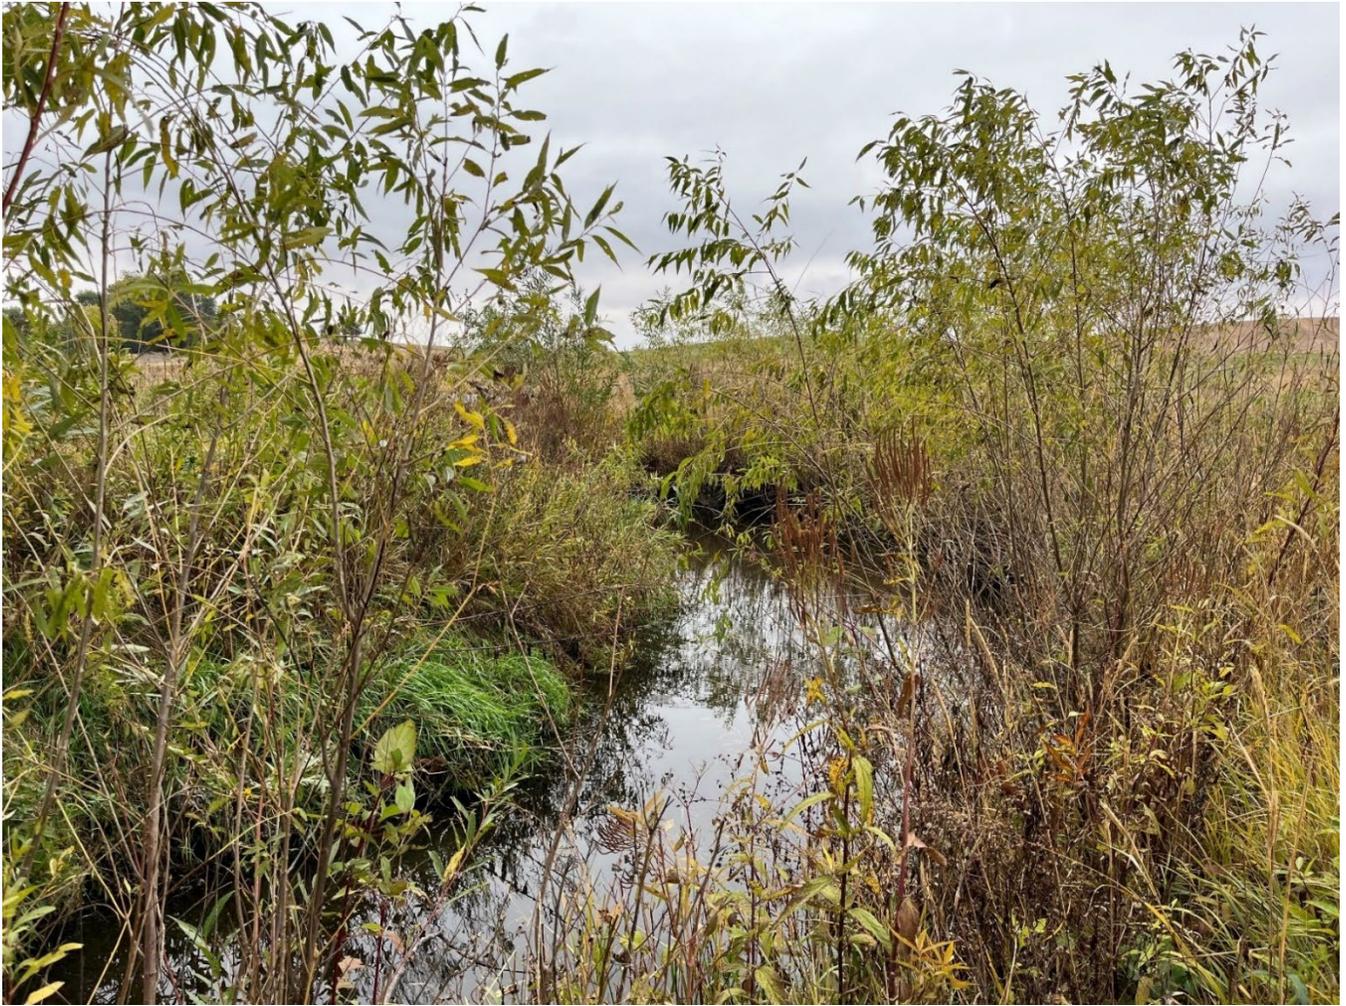
Figure 22 Restored section of Dutch Creek. Live staked willow and other wetland vegetation was well-established in the Vegetated Reinforced Soil Slope (VRSS) and installed toe wood was well-covered below water level. Site visit 10/19/2024.

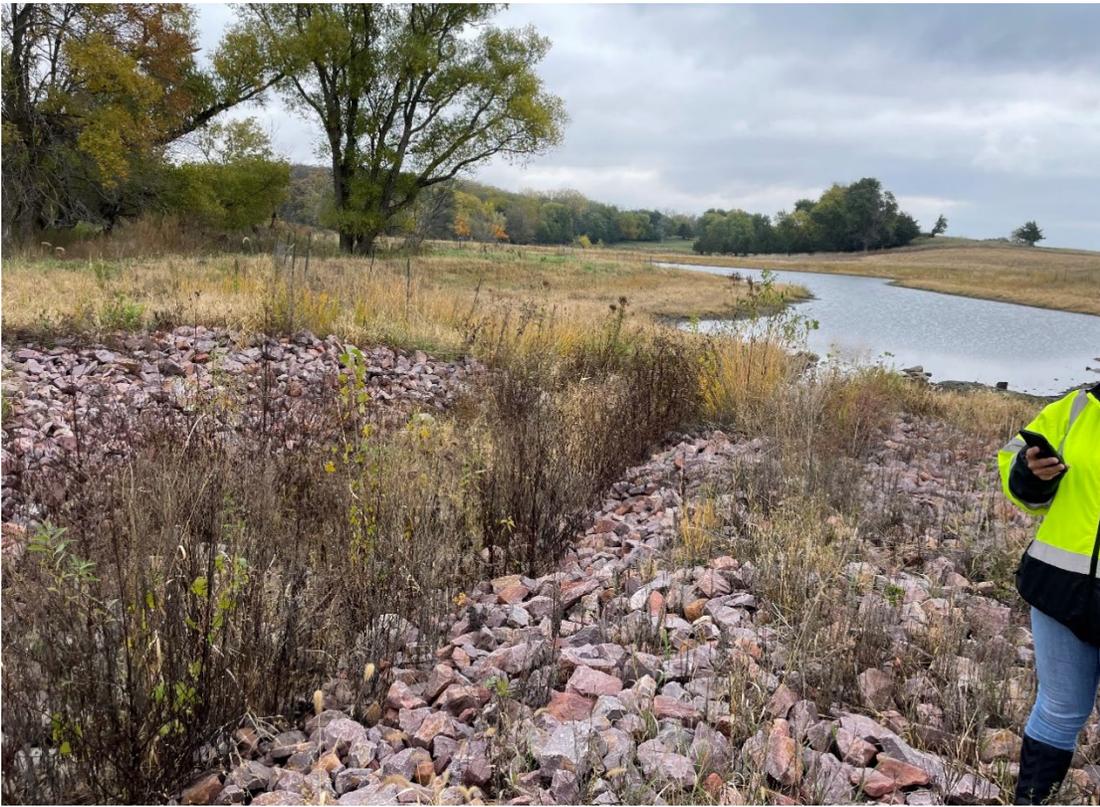
Figure 23 Rock inlet to spawning habitat wetland.

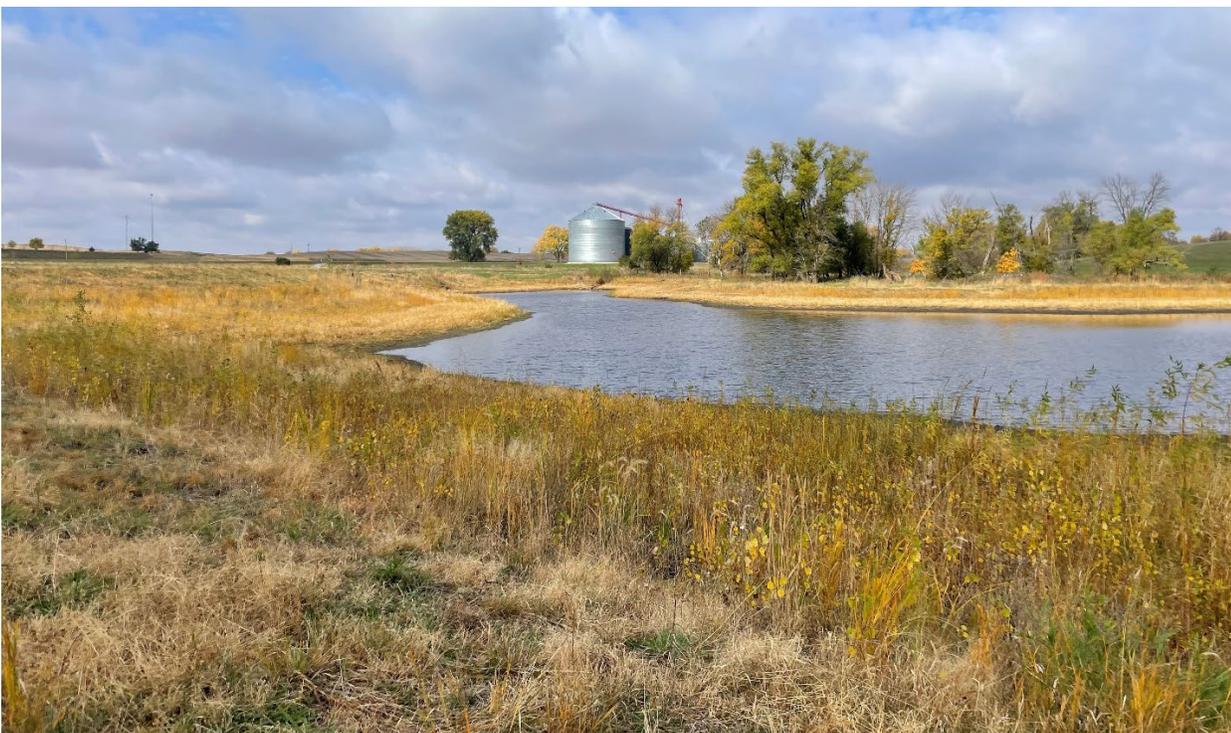
Figure 24 Spawning habitat wetland facing northwest towards inlet.

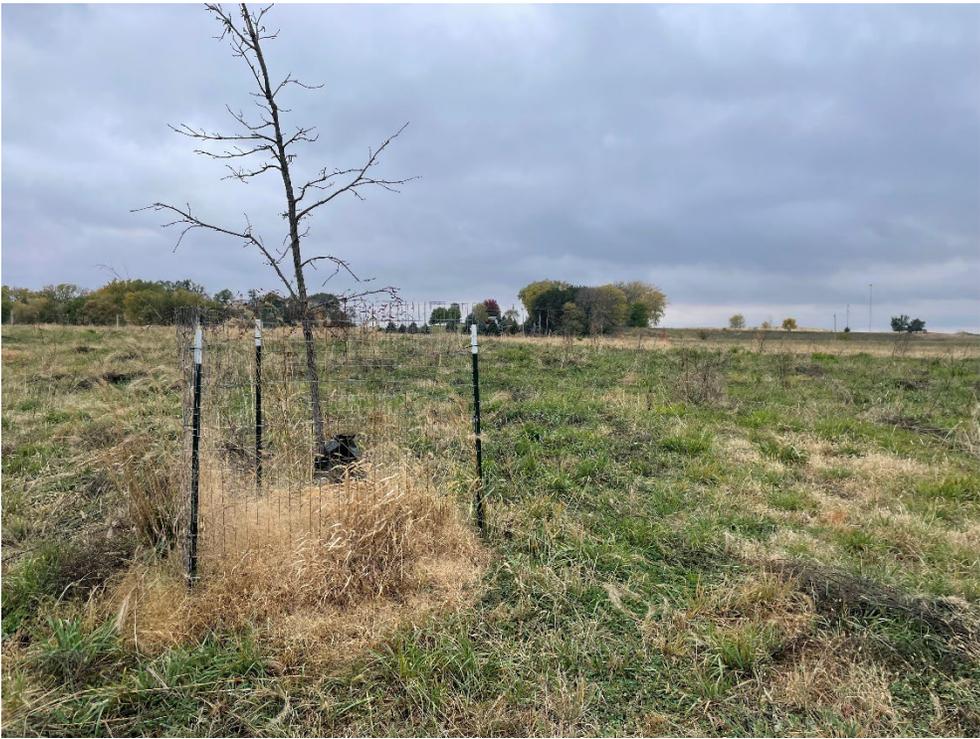
Figure 25 Caged Oak tree in South planting area.

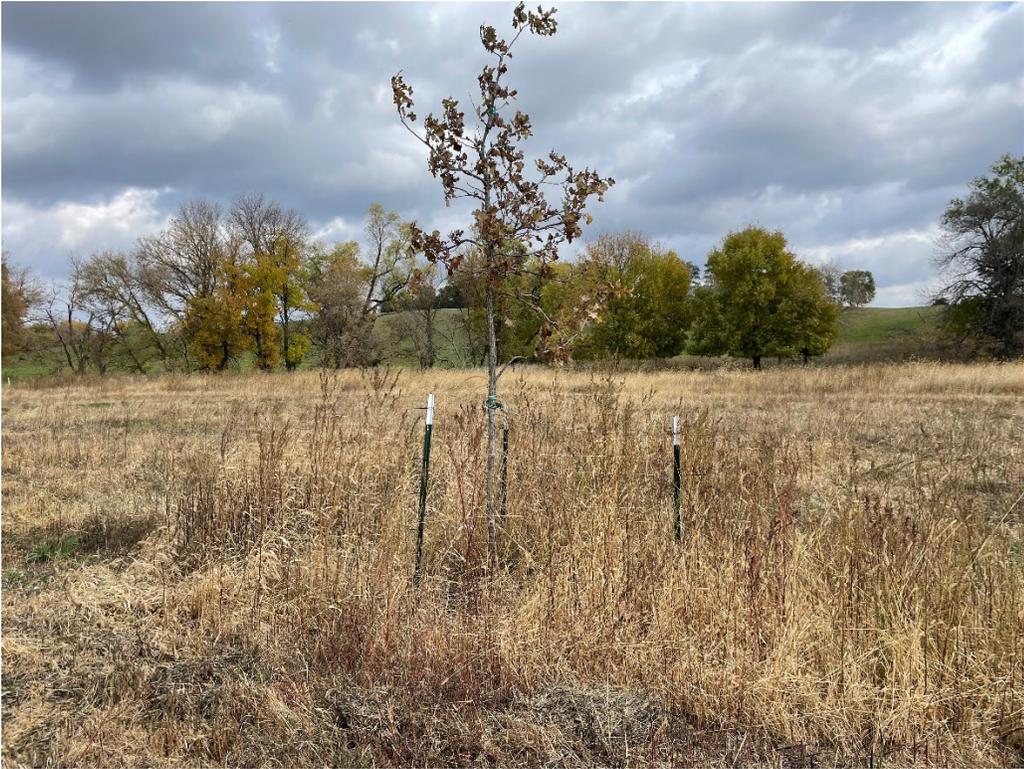
Figure 26 Caged Oak tree in northern planting area.

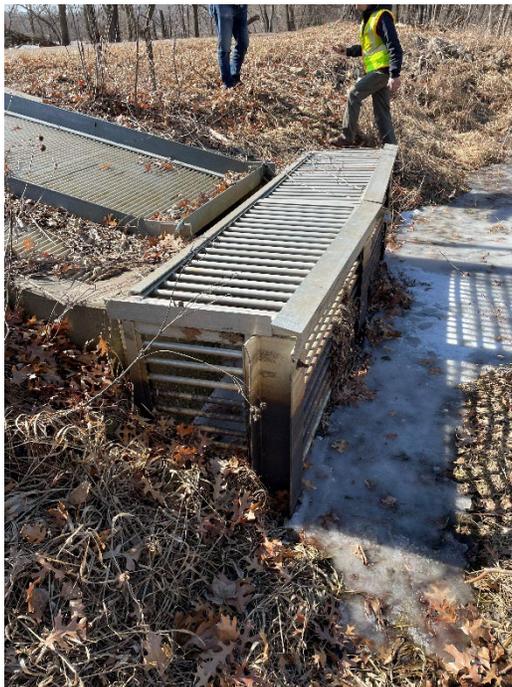
Photo 42. Barrier with retrofit at inlet of Bone Lake, photo taken during site visit 3/1/24.

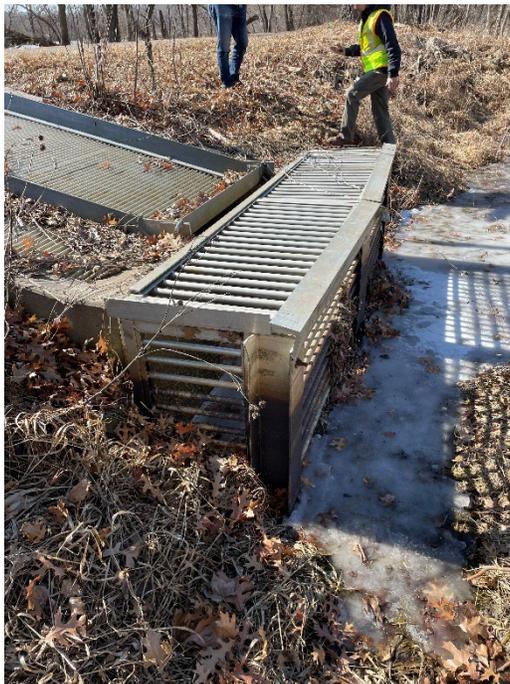
Photo 43 Barrier with retrofit at inlet of Bone Lake, photo taken during site visit 3/1/24.

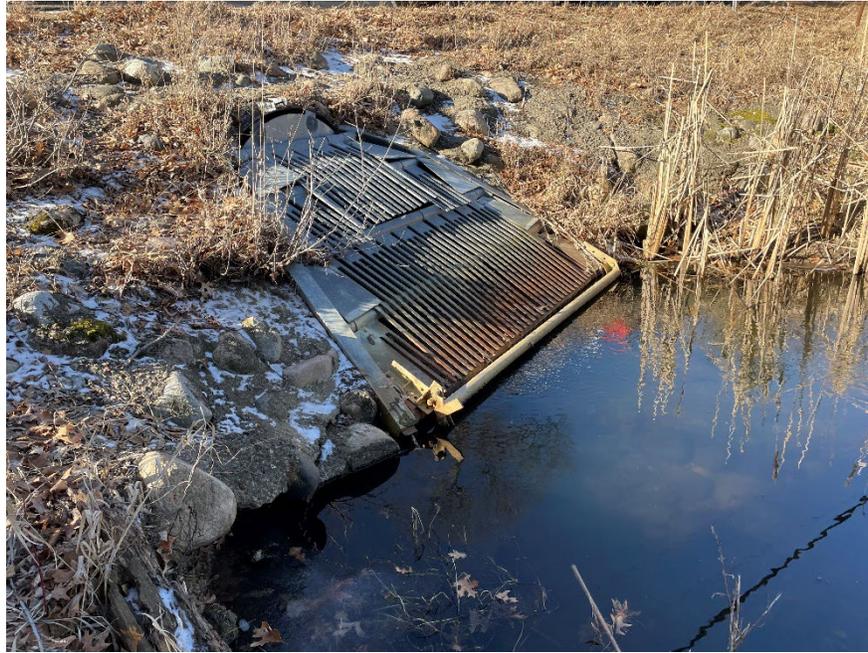
Photo 44. Martin Lake inlet barrier, photo taken during site visit 3/1/24.

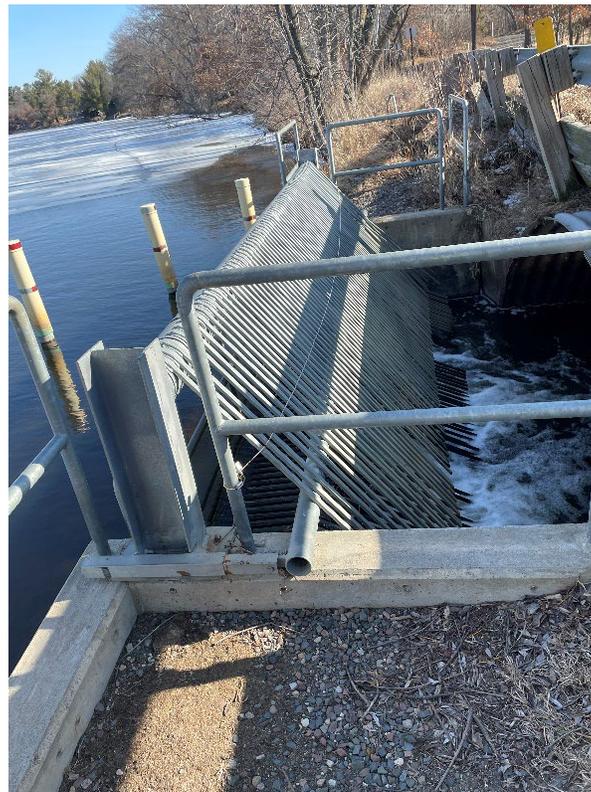
Photo 45. Martin Lake outlet barrier, photo taken during site visit 3/1/24.

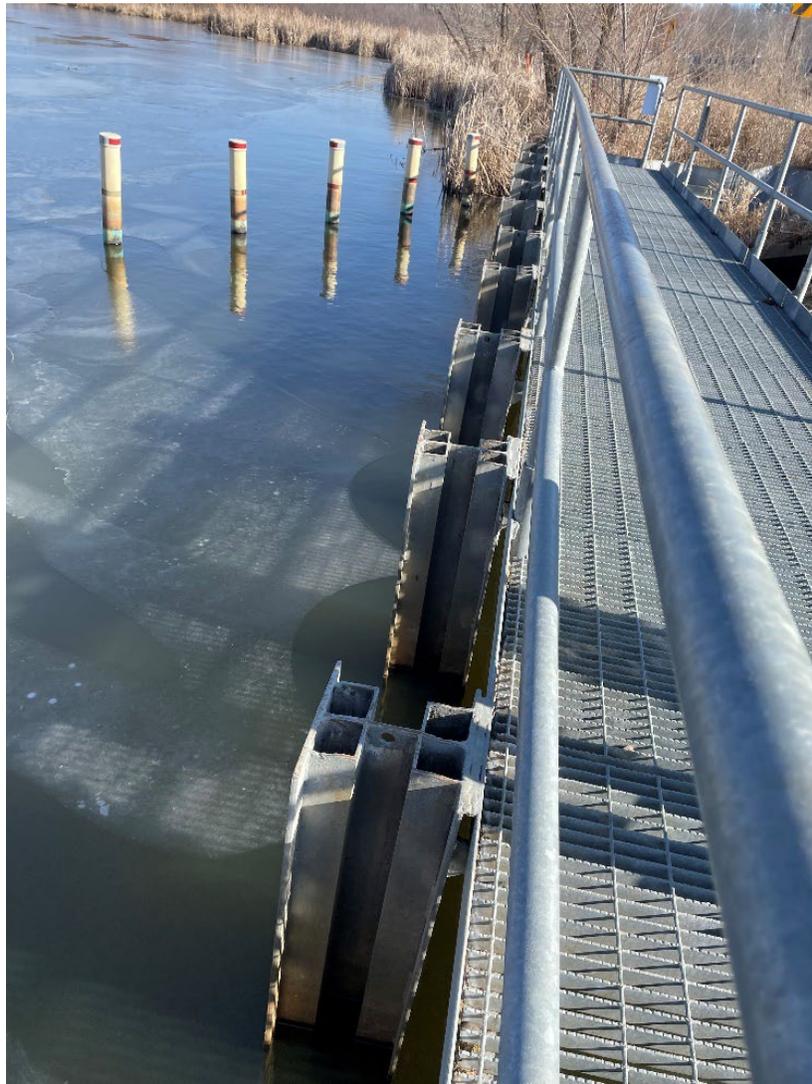
Photo 46. Typo Creek barrier with barrier grates not currently in place, photo taken during site visit 3/1/24.
