Program Process and Project Evaluations

Appendix A: 2023 Legacy Fund Restoration Evaluation Report

May 2024

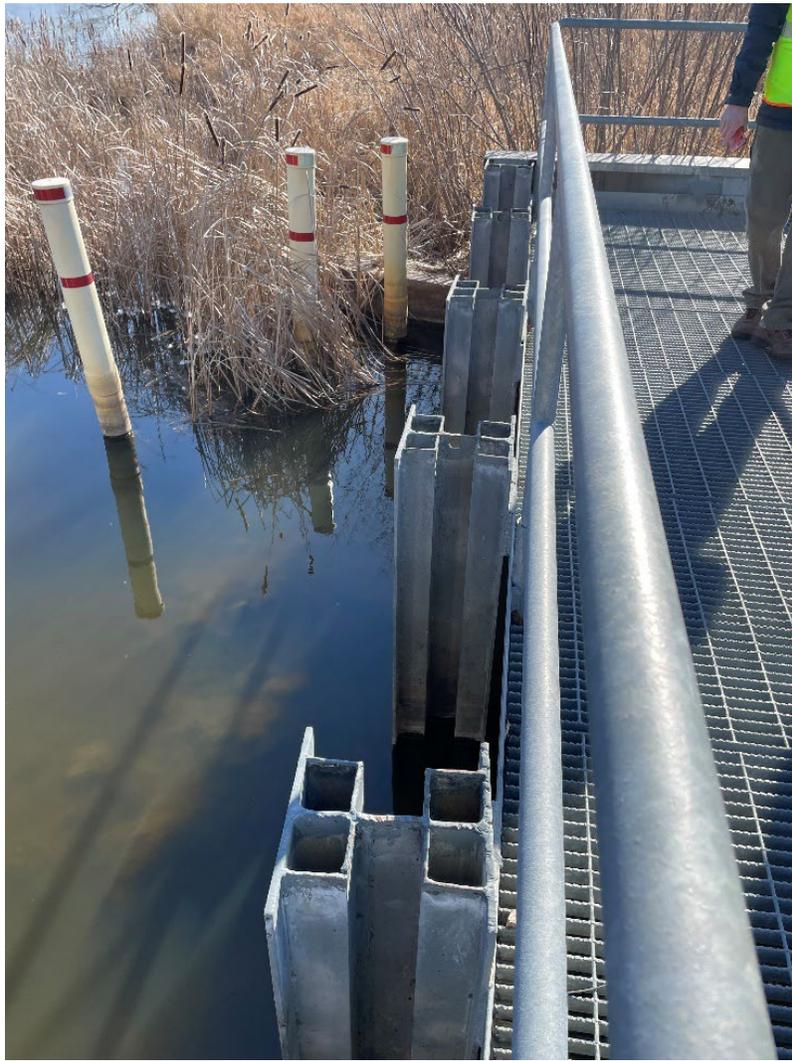
Photo 47. Typo Lake outlet barrier with barrier grates not currently in place, photo taken during site visit 3/1/24.

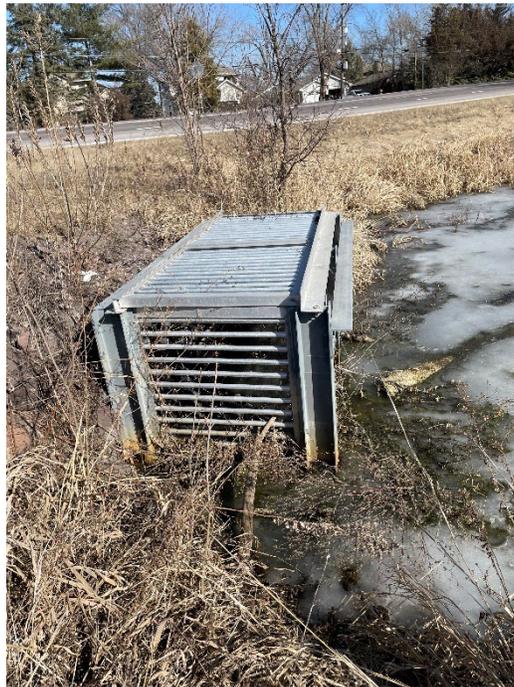
Photo 48. Barrier between Shields Lake and Forest Lake, photo taken during site visit 3/1/24.

The goal of blocking rough fish migration between Shields and Forest Lake was successfully met with the barrier installed; however, assessing the success of the desired outcome of preserving the sport fishery and water quality in Forest Lake is difficult. Continued maintenance of the barrier, aeration of Shields Lake and carp survey and removal efforts in Shields Lake will help control the carp population and prevent migration into Forest Lake. A common carp survey was conducted in 2023 in Forest Lake and found carp densities to currently be below the 100kg/ha threshold.

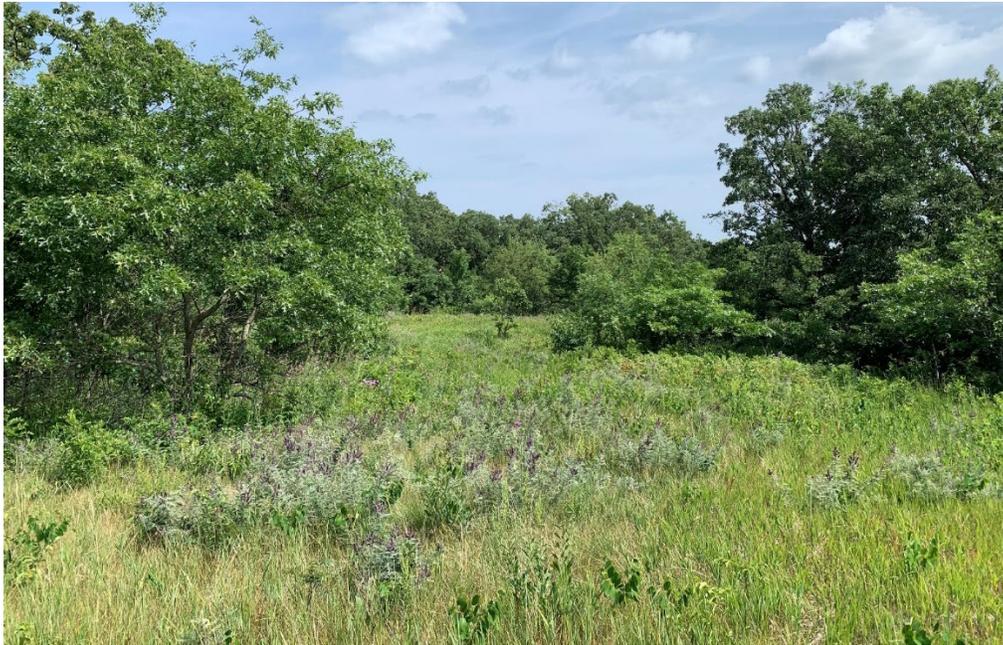
Photo 49 Picture of the north portion of the project area looking through a narrows that leads to a larger hilltop prairie opening. Invasive brush management has opened up the prairie as well as clearing the shrub layer back into the oaks. Smooth sumac resprouts persist in the center of the photo (narrows) but is being managed on an ongoing basis. Native prairie graminoids and forbs are responding positively to the more open conditions. Leadplant (foreground) is a codominant in portions of this remnant sand-gravel hill prairie. Photo taken 7/18/2023.

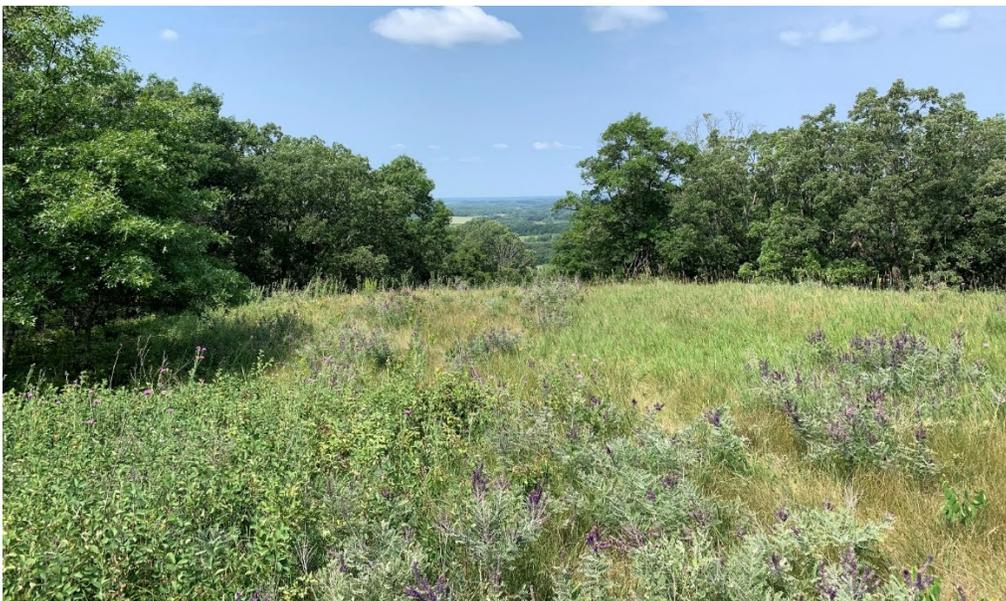
Photo 50 Hilltop area in the northernmost portion of the prairie, looking north. The areas on the left side of the photograph have been actively managed to reduce invasive brush – In this case buckbrush (*Symphoricarpos*). In other areas where brush is being “feathered back” on the prairie edge and into the oak woodland, smooth sumac and red raspberry are common. Photo taken 7/18/2023.

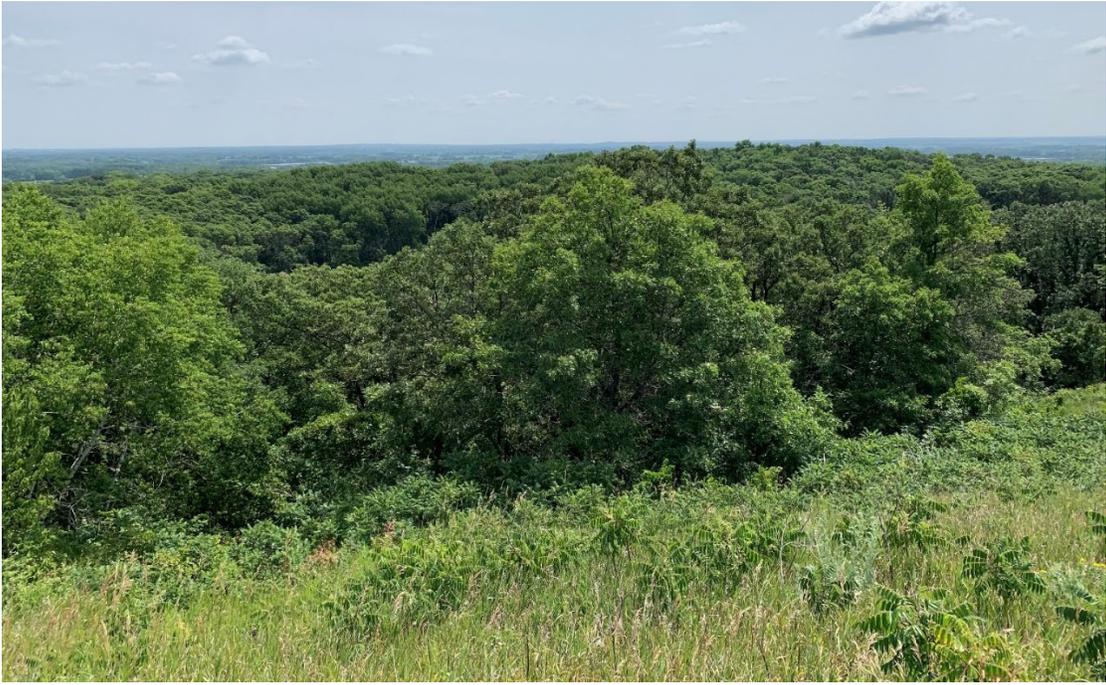
Photo 51 View looking southeast showing the relative size and density of smooth sumac following management. Photo taken 7/18/2023.

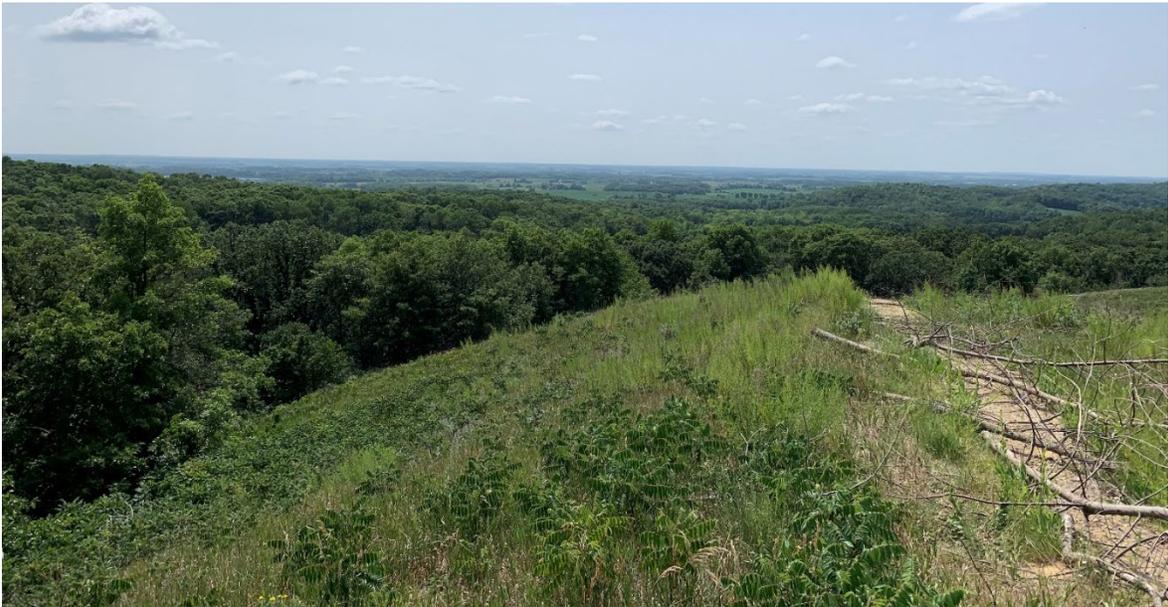
Photo 52 South portion of the north-south ridge, looking south-southeast. The prairie extending to the south of this point supports high quality sand-gravel prairie, including conservative and rare plant species. The lower right portion of the photo shows cut tree saplings placed to discourage visitors from using a foot trail that had significant rill/gully erosion that MN DNR staff recently repaired. Photo taken 7/18/2023.

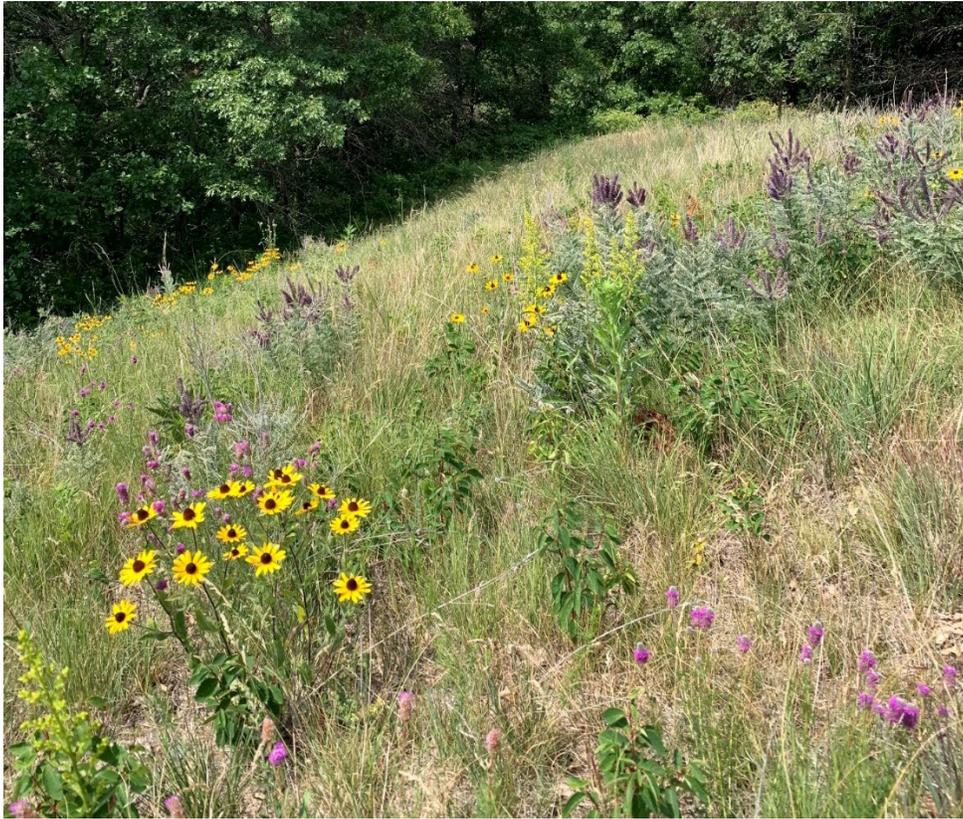
Photo 53 View of a forb rich portion of the remnant dry, sand-gravel prairie. Feathering back of invasive brush has taken place along the edge of the oak woodland in the background. Photo taken 7/18/2023.

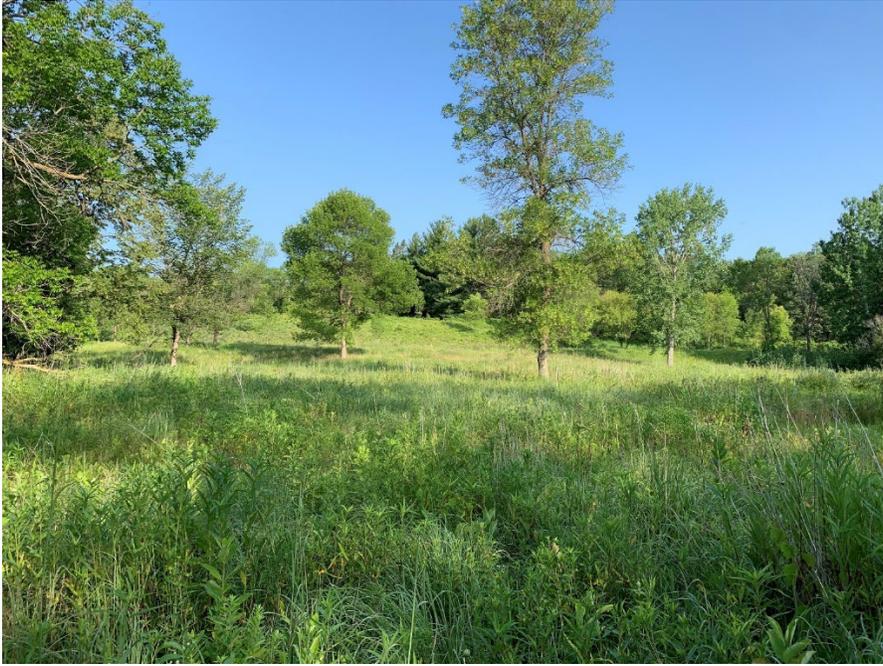
Photo 55 View of mesic prairie portion of project area, looking toward the northwest. Site preparation for this area included selective tree and shrub removal, prescribed burn and herbicide application to control previously dominant nonnative grasses. Photo taken 7/18/2023.

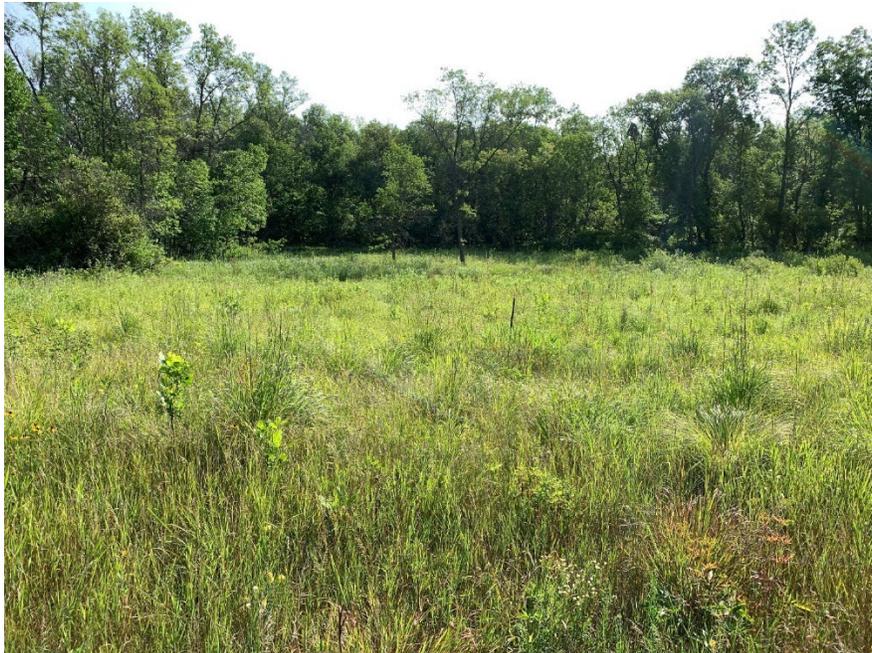
Photo 56 View from north portion of the restoration, looking south. This area has a high percentage of total cover from native grasses. Photo taken 7/18/2023.

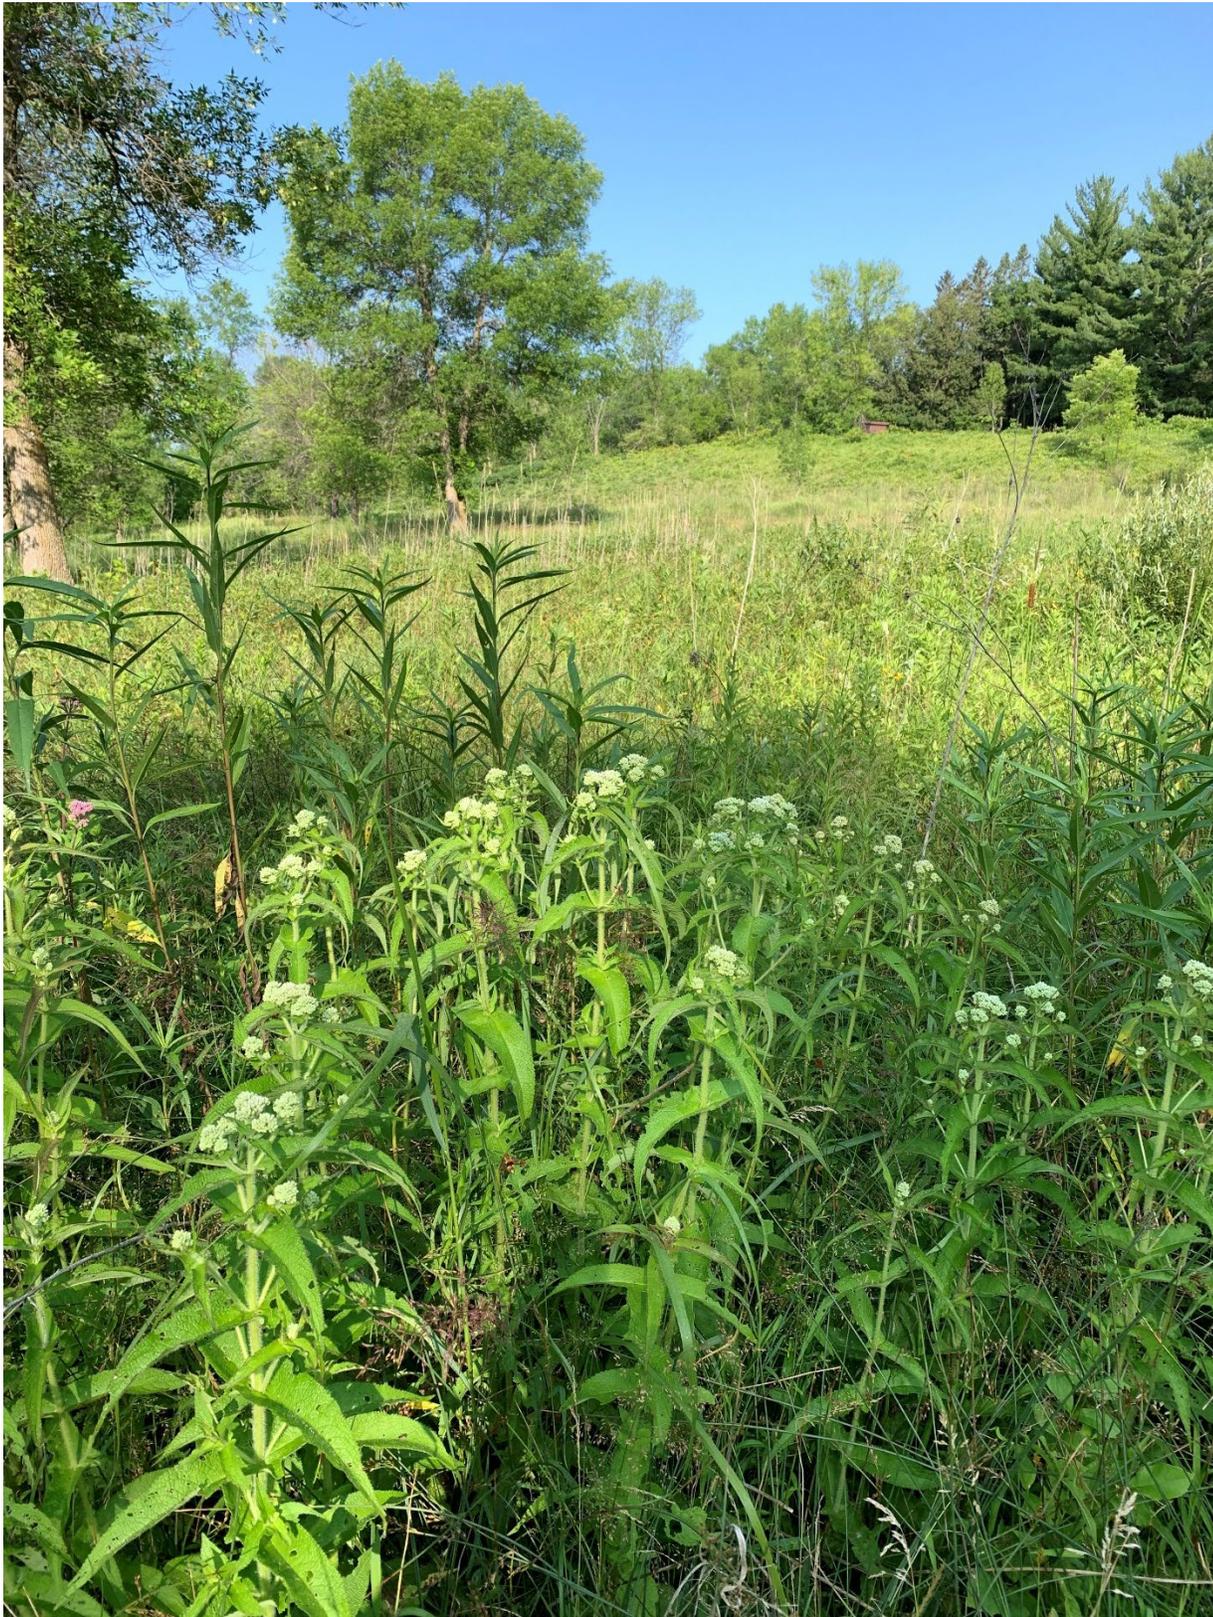
Photo 57 from the wet meadow/wet prairie swale looking northwest. The native forbs boneset, marsh milkweed, and sawtooth sunflower are prominent in the foreground of the photo. Photo taken 7/18/2023.

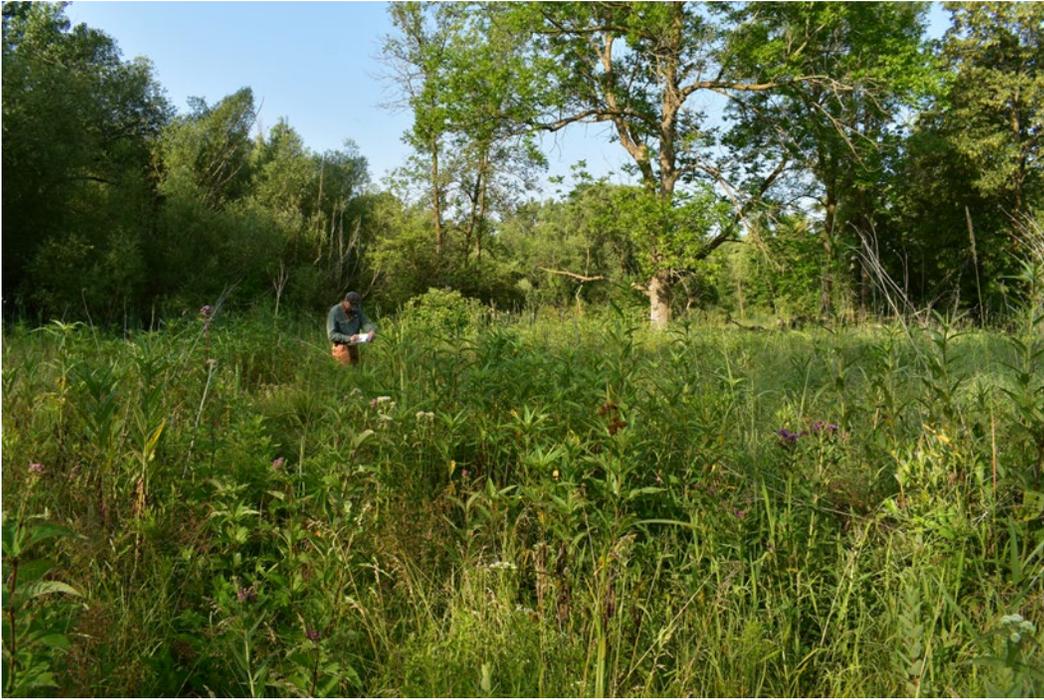
Photo 58 View of mesic prairie portion of project area, looking toward the west. This portion of the site was densely vegetated with a 2 – 4 foot tall mix of forbs and grasses.

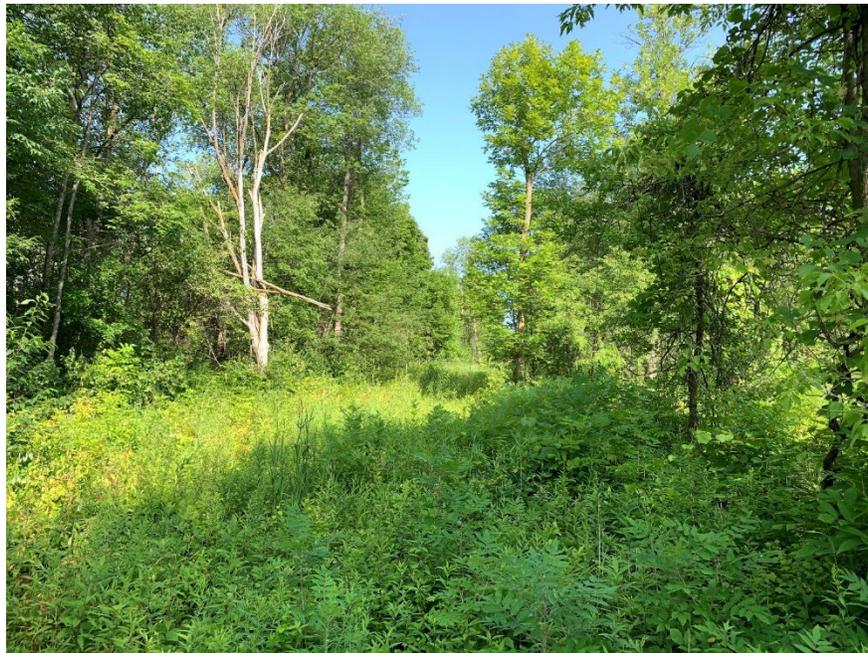
Photo 59 View of project area from gravel road, looking southwest. Area was brush mowed and was spot foliar sprayed for invasive woody brush resprouts in the weeks prior to field visit (indicated by yellow vegetation in left center of photo). Photo taken 7/18/2023.

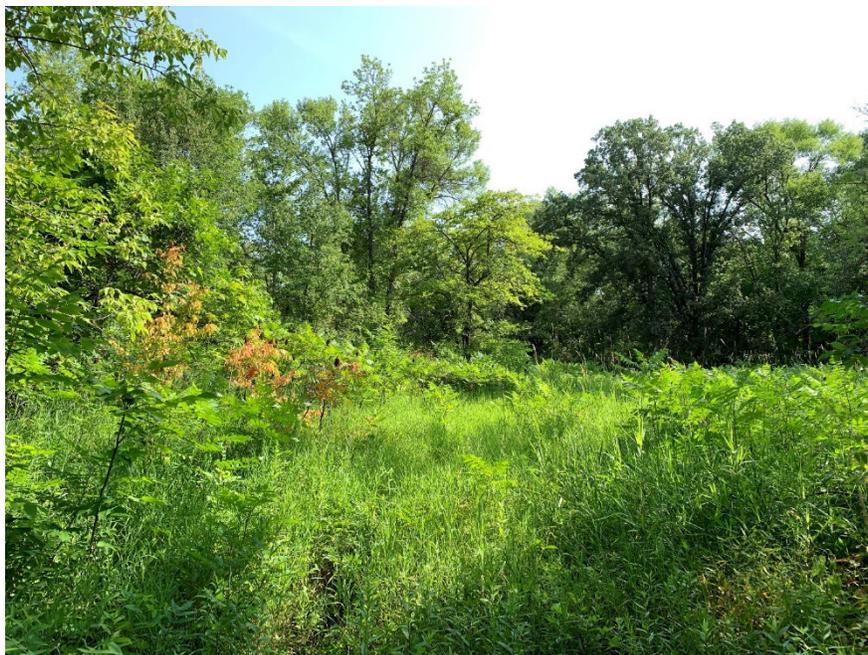
Photo 60 View from approximate center of project looking northeast. Area was brush mowed and was spot foliar sprayed for invasive woody brush resprouts in the weeks prior to field visit (indicated by yellow vegetation in left center of photo). Photo taken 7/18/2023.

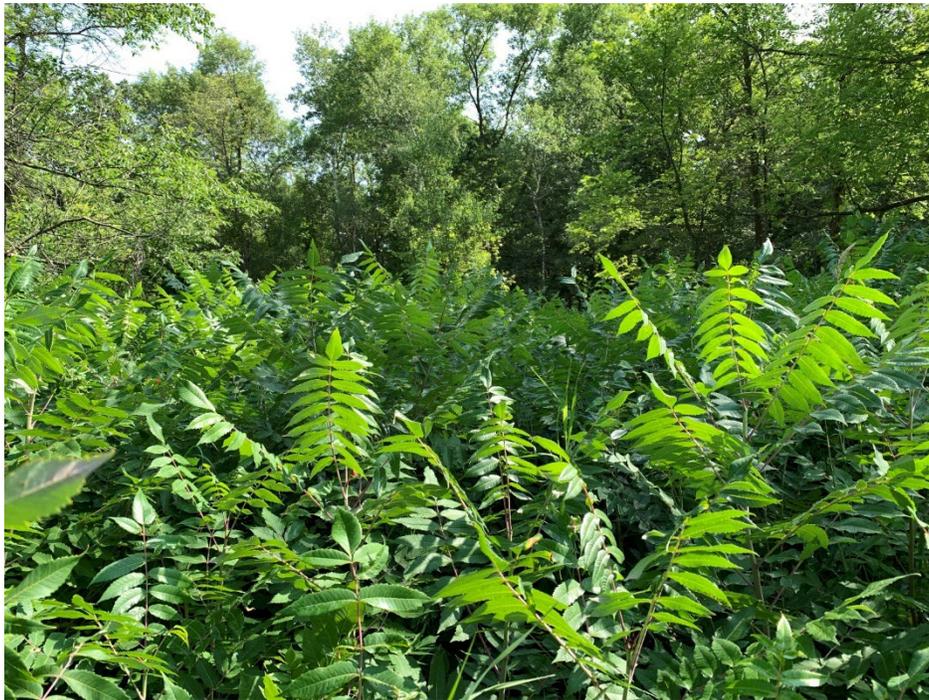
Photo 61 View of a portion of the project area with thick regrowth of smooth sumac (approximately six to eight feet tall) following brush mowing. Photo taken 7/18/2023.

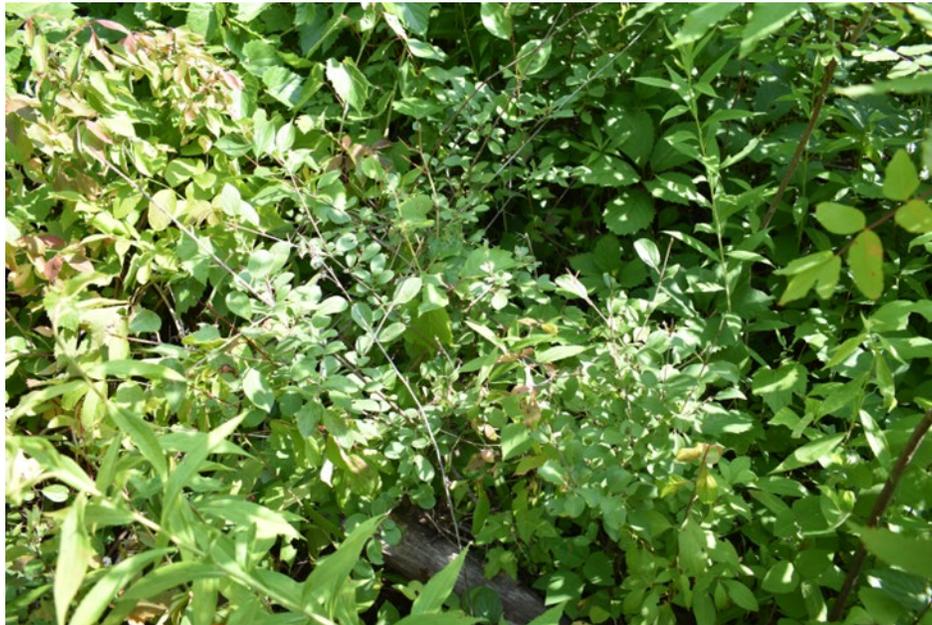
Photo 62 A view of the two to three foot tall shrub regrowth in the treated area. Photo taken 7/18/2023.

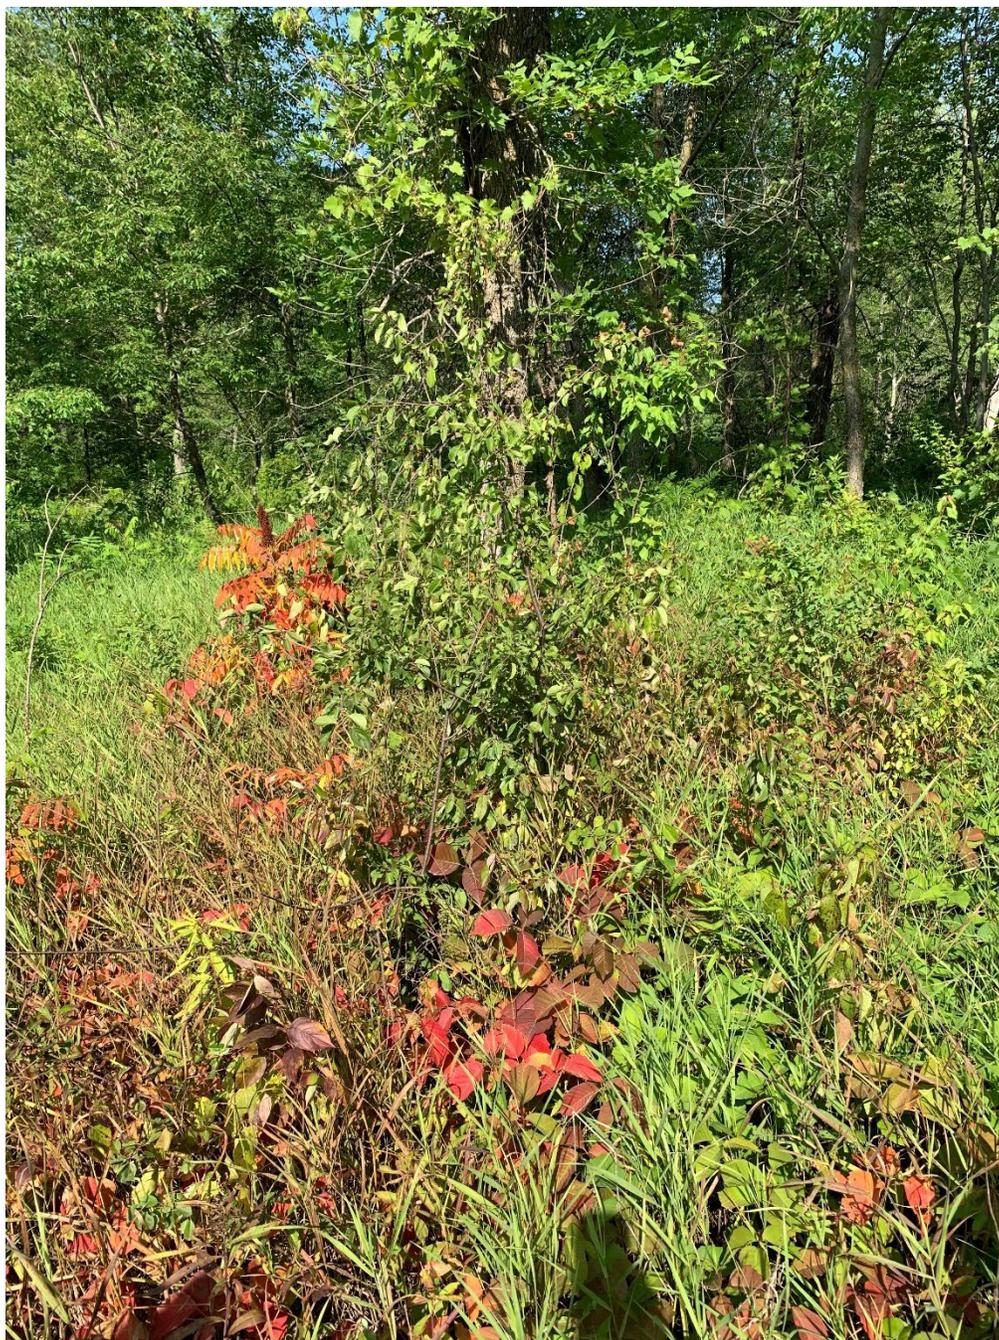
Photo 63 Portion of the project area that was recently spot foliar sprayed to treat common buckthorn (shrub in center of photo) and poison ivy (red foliage in foreground). Despite still being green at the time of the field visit, the buckthorn leaves showed signs of herbicide uptake (leaf wilting and cupping). Photo taken 7/18/2023.

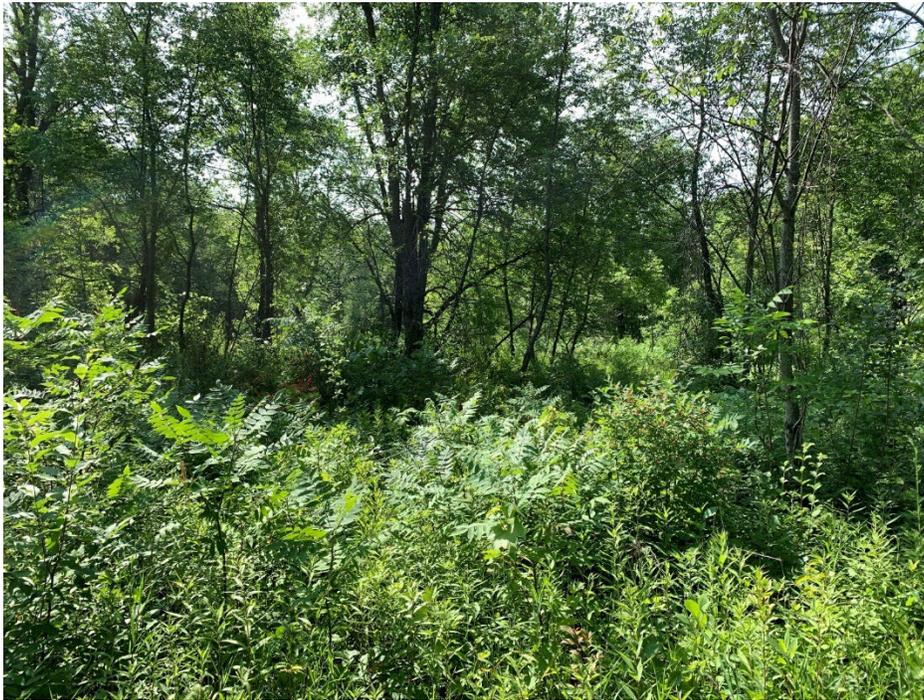
Photo 64 View of a portion of the forestry mowed project area that showed limited regrowth of woody vegetation and vigorous growth of herbaceous species that were present before brush mowing began.

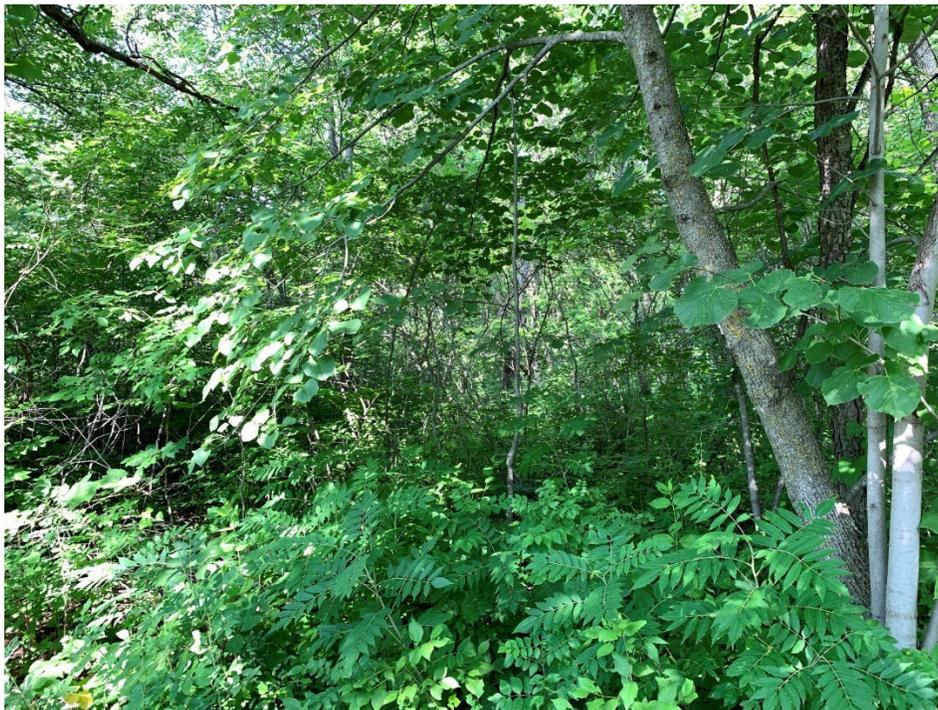
Photo 65 A view of an untreated area immediately adjacent to the project area which likely gives a good indication of the density of brush and small trees prior to brush mowing and follow-up foliar treatment management in the project area.

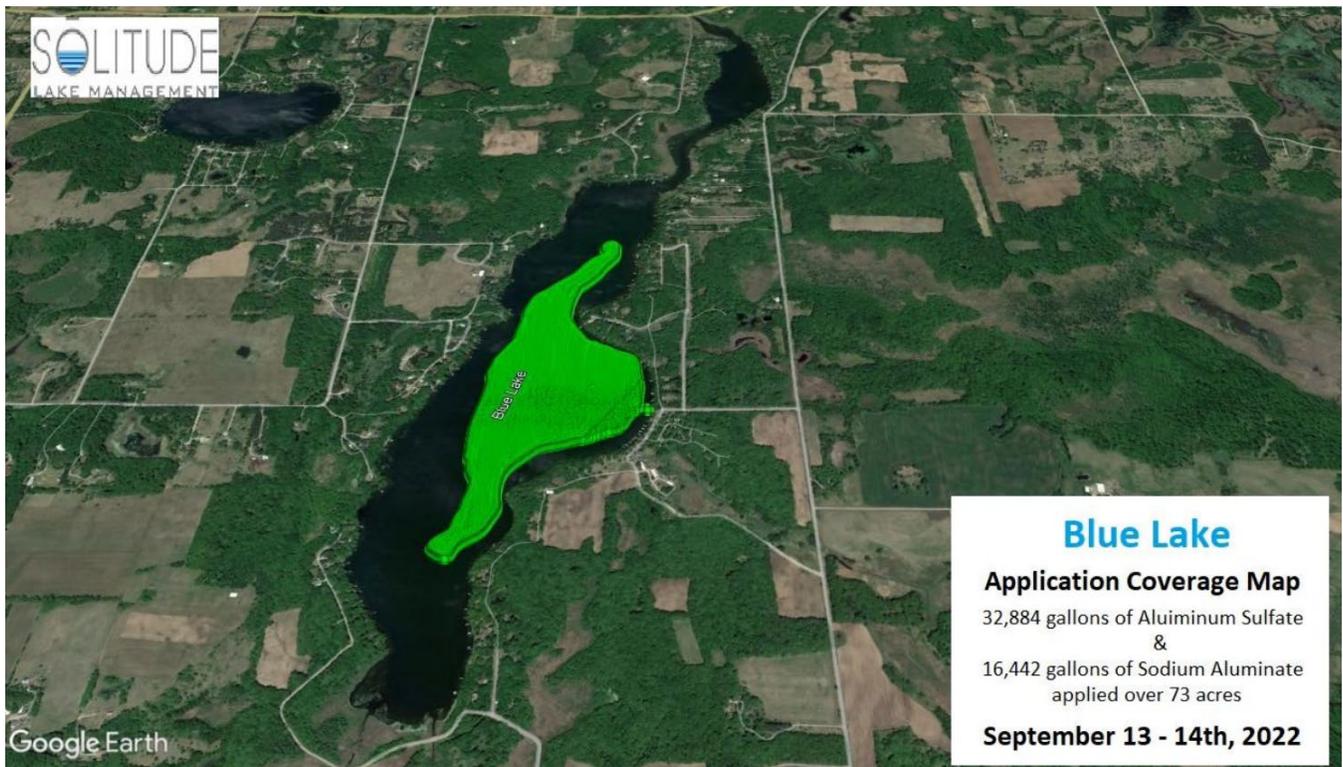
Figure 35 Application coverage map for 2022 alum treatment in Blue Lake

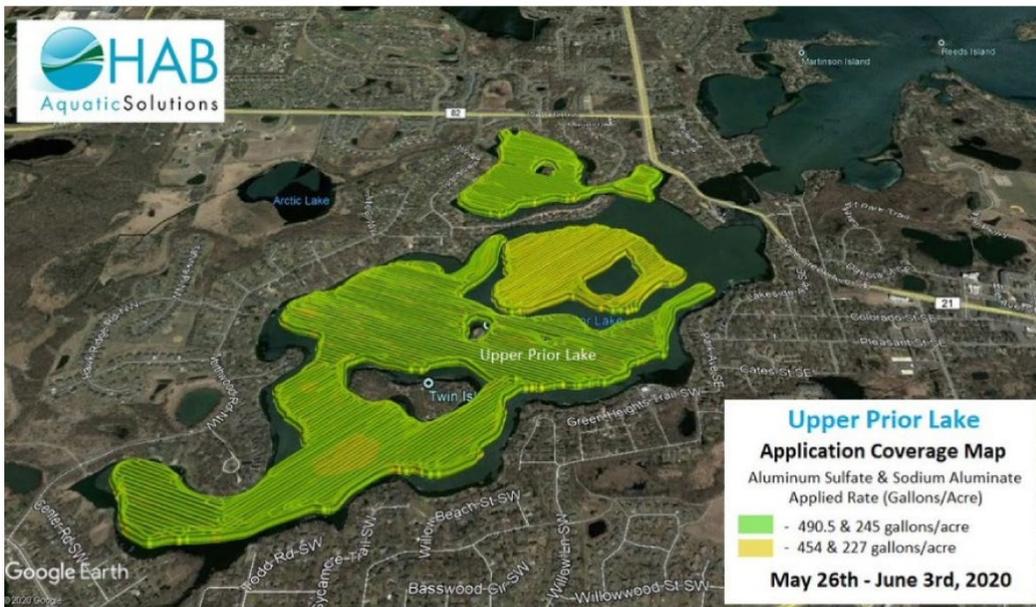
Figure 49. Application area for Upper Prior Lake (2020).
