Observing Boater Actions at Public Water Accesses to Prevent the Spread of Aquatic Invasive Species

Prepared for Minnesota Department of Natural Resources
12/27/2023

By
Bolton & Menk, Inc.
Minnesota
Project OT7.130245

December 27, 2023

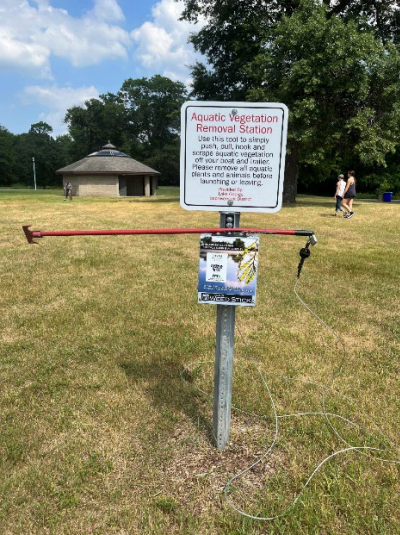
Figure 1. Lake George Aqua Weed Stick Station

Three types of AIS prevention tool stations were observed, 1) Aqua Weed Stick stations: dual or single reel landing station with multi-use weed removal tool designed to remove weeds from watercrafts and trailers, 2) CD3 stations: premade, user-operated equipment station with multiple tools to assist with removal of weeds and watercraft drainage, and 3) Homemade stations: stations assembled by access owners or lake association with individually purchased weed removal tools. The CD3 stations had the highest rate of usage followed by the Aqua Weed Stick stations, with the homemade stations showing a much lower rate of use.

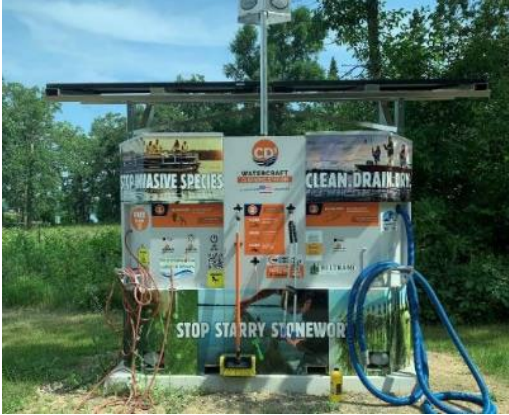
Figure 2. Cass Lake CD3 Wayside Solar Station

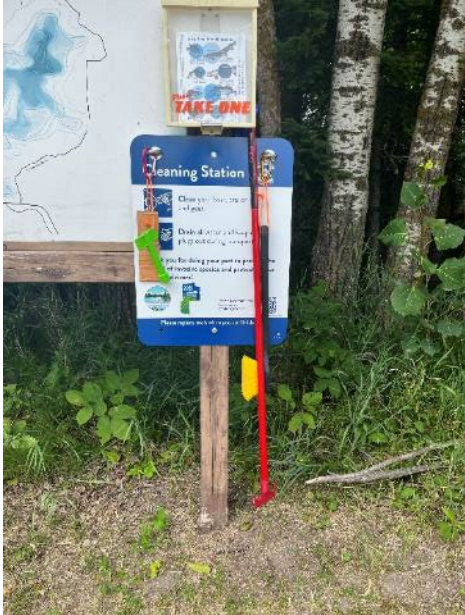
Figure 3. Lake Wabedo Homemade Station

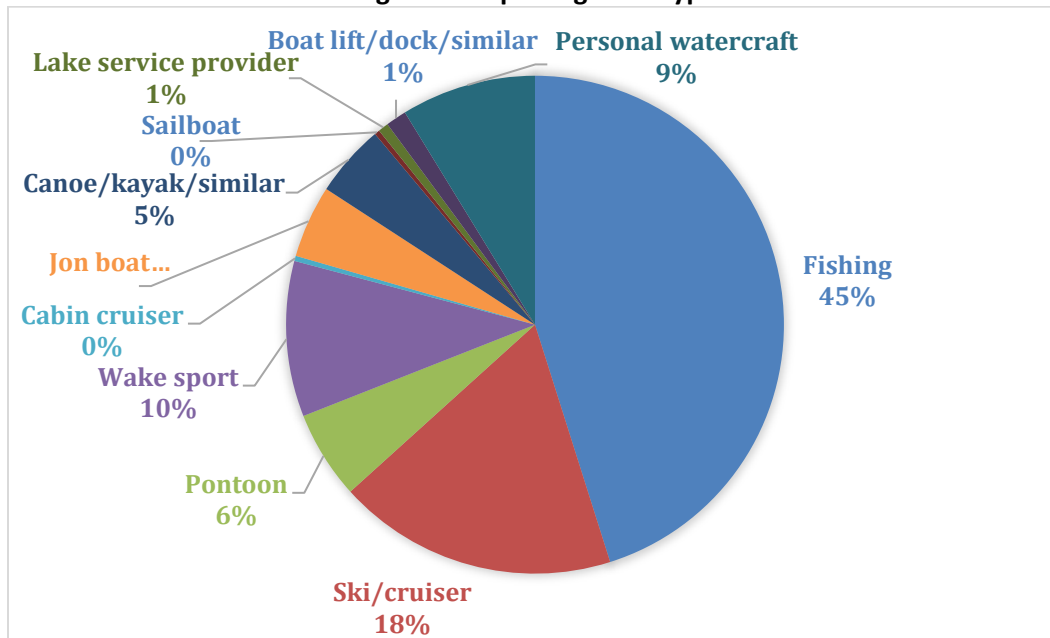
Boat types were recorded for the boats observed. The majority of boats observed were fishing boats (45%), followed by ski/cruiser boats (18%). One sailboat was observed.

Figure 7. Departing Boat Type

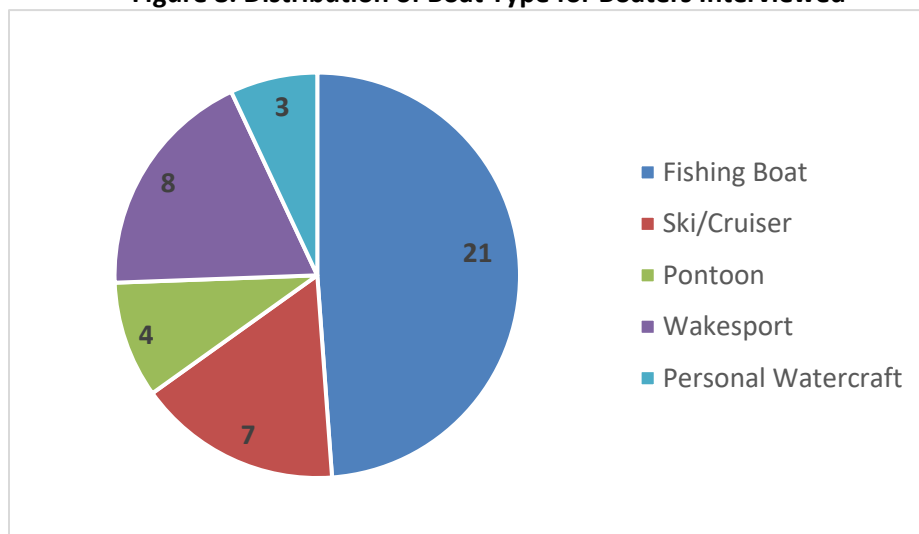
The majority of boaters (49%) interviewed were owners of fishing boats. Boats that fell into the “Personal Watercraft” category were jet skis.

Figure 8. Distribution of Boat Type for Boaters Interviewed

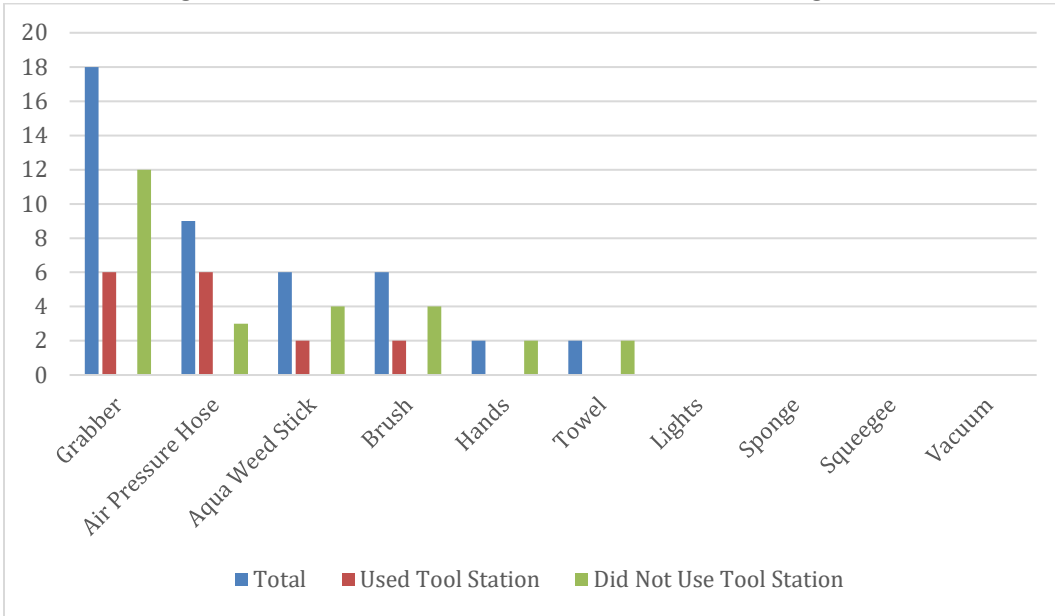
The grabber tool was rated as the preferred tool to remove vegetation (42% of all interviewed). The plug wrench was rated as the preferred tool for aiding in draining equipment (33% of all

Figure 9. Preferred AIS Prevention Tool to Remove Vegetation

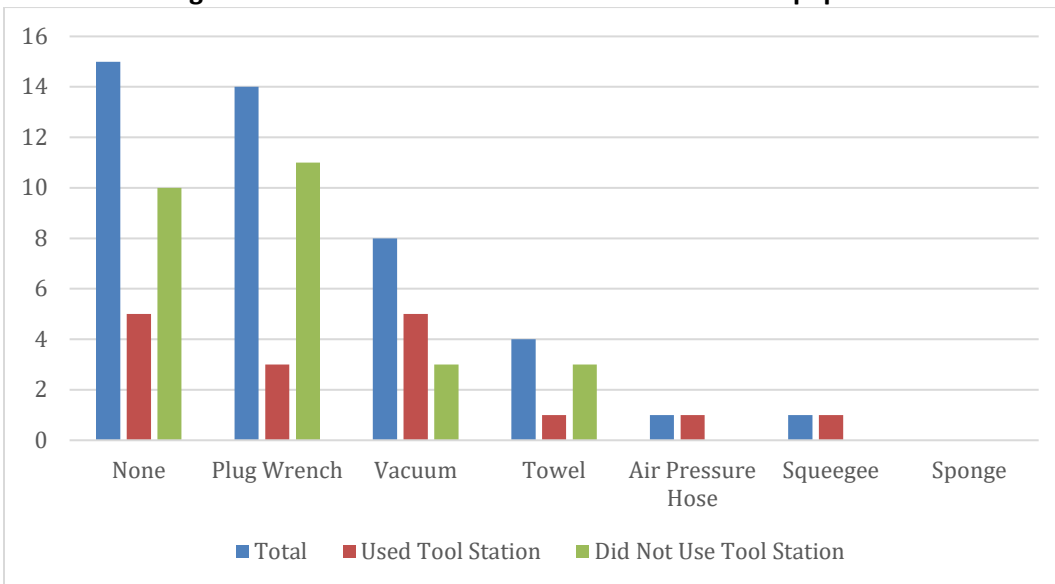
Figure 10. Preferred AIS Prevention Tool to Drain Equipment

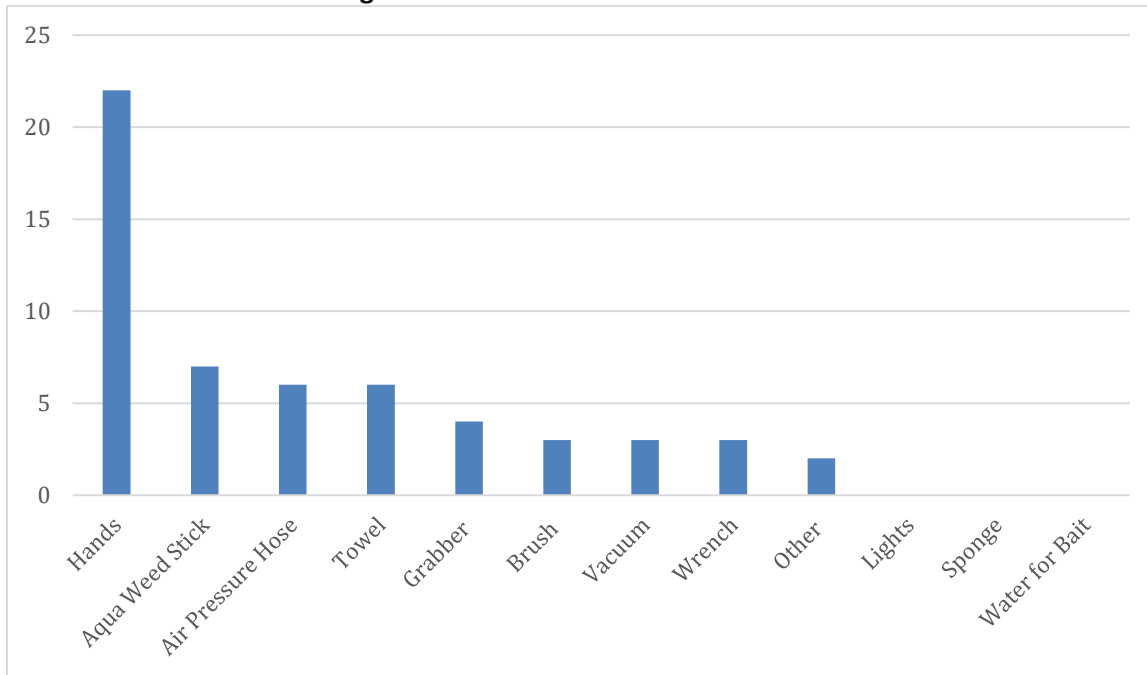
Figure 11. Interviewee AIS Prevention Tool Uses

The most used cleaning tool of those interviewed was identified as hands. Of tools provided at accesses, the Aqua Weed Stick was used the most (40% of those who used tools provided at accesses). While the grabber was rated as the preferred tool to use by all and air pressure hose by tool users interviewed, they were not available at the majority of sites. One boater interviewed noted that the Aqua Weed Sticks “are good when you need to use one,” for instance when you need to clean deep underneath a trailer. The grabber is preferred for general removal of vegetation.

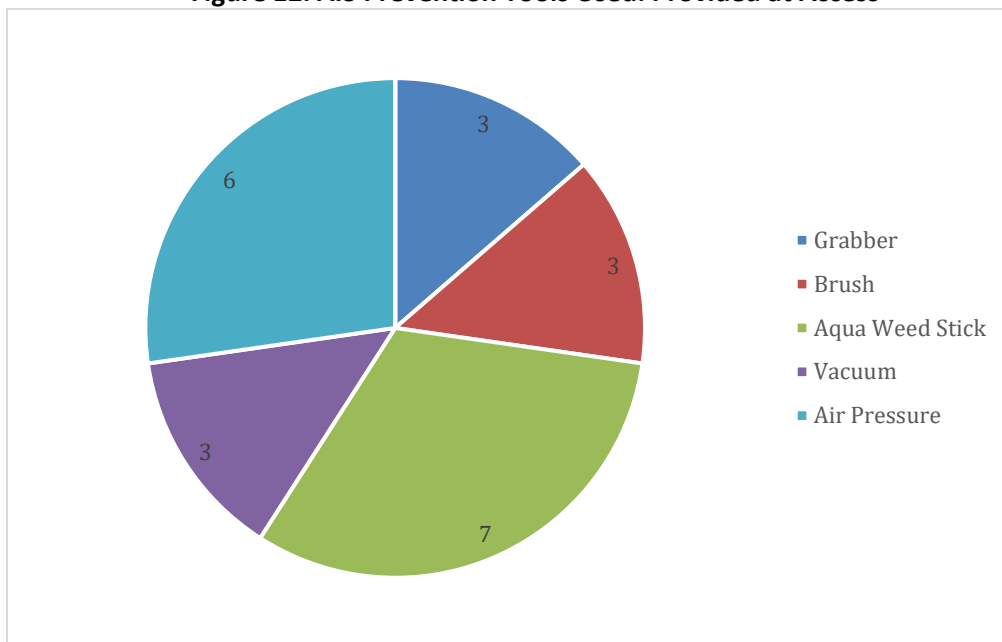
Figure 12. AIS Prevention Tools Used: Provided at Access

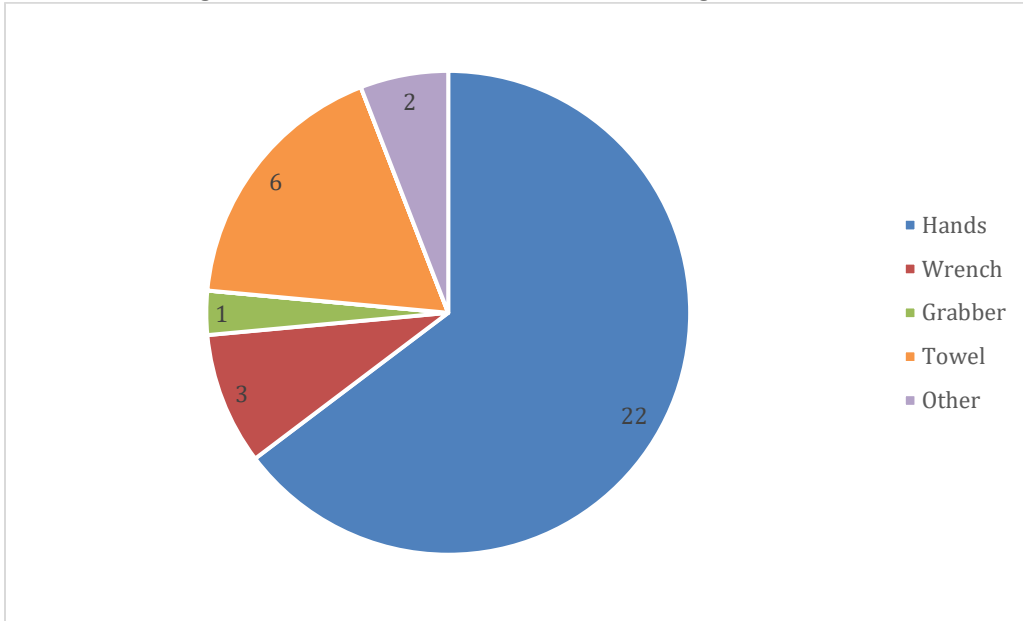
Figure 13. AIS Prevention Tools Used: Brought with Boater

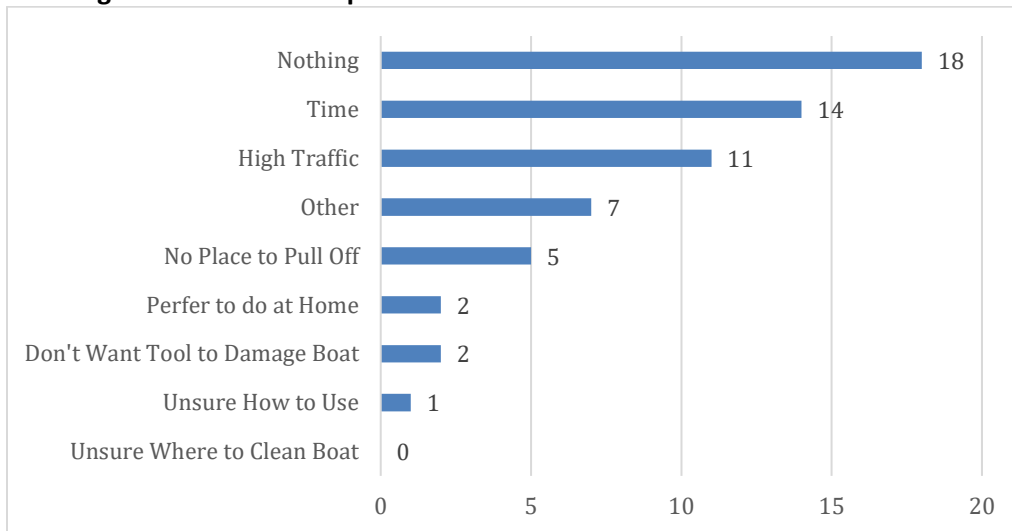
The barriers to using tools stations were time (having to wait in line and/or using the station took too much time) and too much traffic around the station. However, almost half (42%) of those interviewed said that nothing made it difficult to use the tool station. This was supported by additional comments from boaters interviewed. A handful noted that they would like to have more space to stop near a tool station or would like more than one station available for use. There were a few instances of boaters noting that having untethered tools would increase the likelihood of tool use since they would be able to bring the tool to wherever they were able to park in the access. The motivators to using tools were that it prevents the spread of AIS, it is the right thing to do, and they liked a clean boat.

Figure 14. Boaters Responses to: "What Makes it Difficult to Use Tools?"

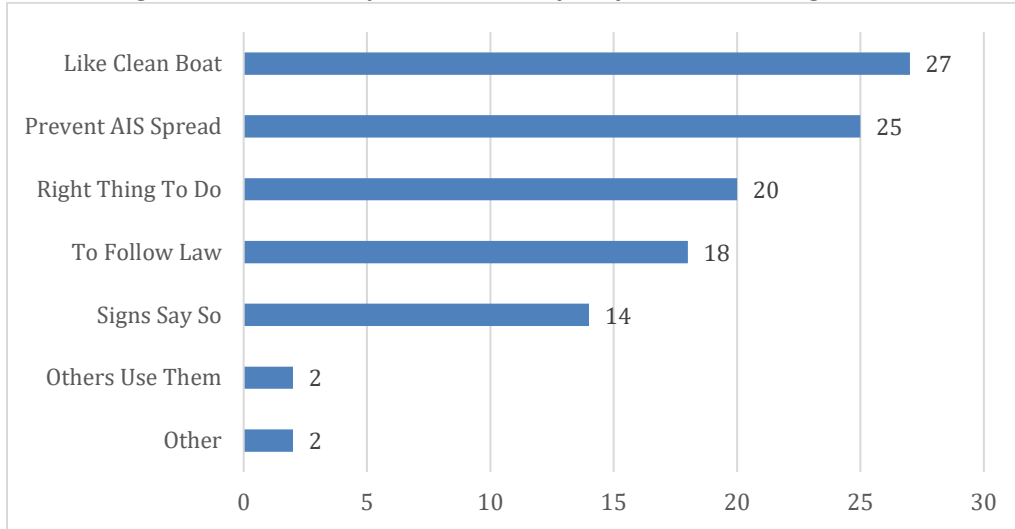
Figure 15. Boater responses to: “Why do you Use Cleaning Tools?”

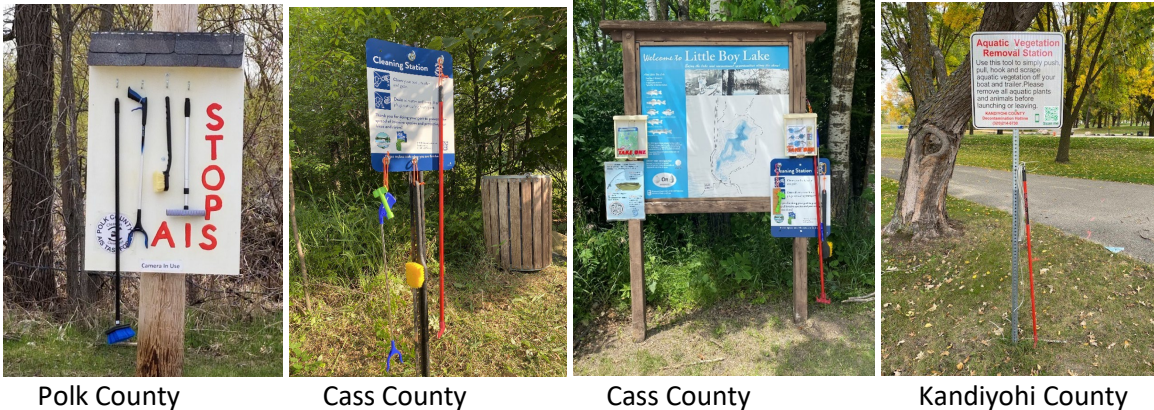
Figure 16. AIS Prevention Tool Station Examples

Additional materials for the installation of a homemade station may include an AIS sign, metal post/U-channel post, wire, paracord or retractable cord to tether tools, hardware, and a foundation. Signs can be designed and produced by the interested organization, the landowner, and/or tool station provider (e.g., Aqua Weed Stick). A new standard “Cleaning Station” sign design is available from the DNR. Often signs and tools will be attached to an existing kiosk or post.

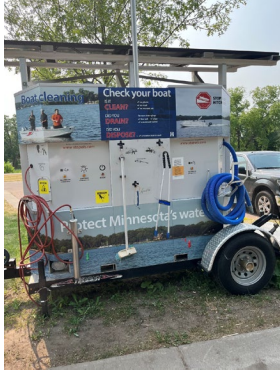
System	Image	Tools	Cost
CD3 Mobile Trailer

Air pressure hose, vacuum, brush, grabber, plug wrench, light	\$40,000
CD3 Station

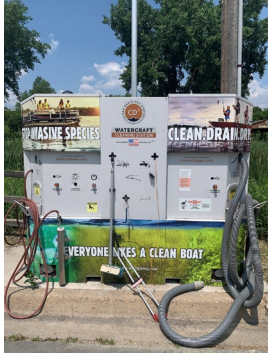
Air pressure hose, vacuum, brush, grabber, plug wrench, light	\$38,000
CD3 Wayside Solar

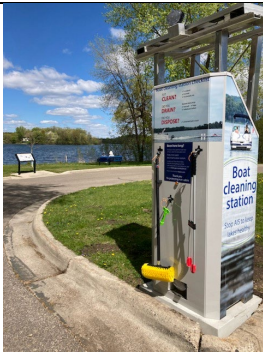
CD3 Outpost

Brush, plug wrench, grabber, light	\$15,000
CD3 Roadside
