Loon Lake Habitat Erosion Mitigation

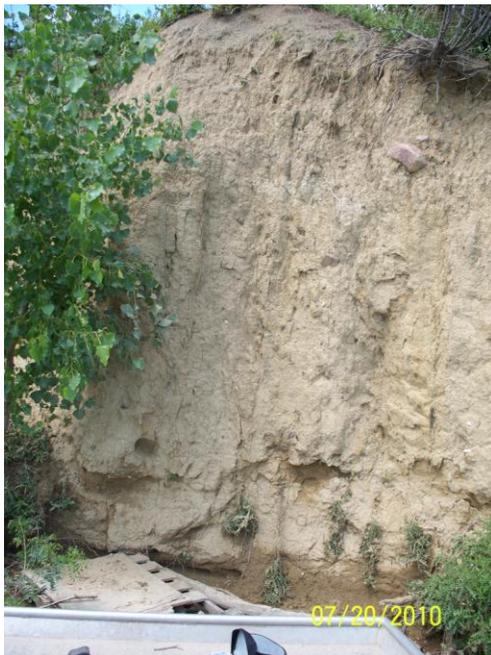
Pictures of the Loon Lake Island prior to installation of cedar tree revetment:

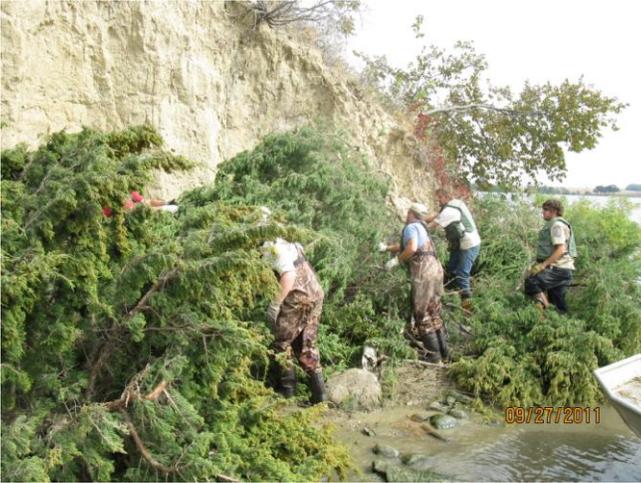
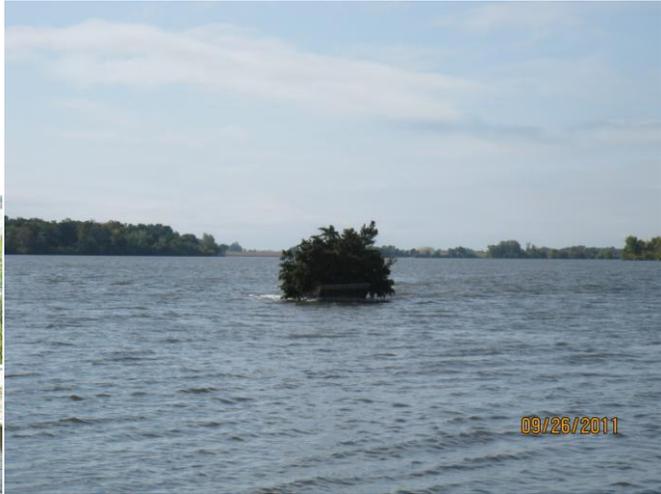
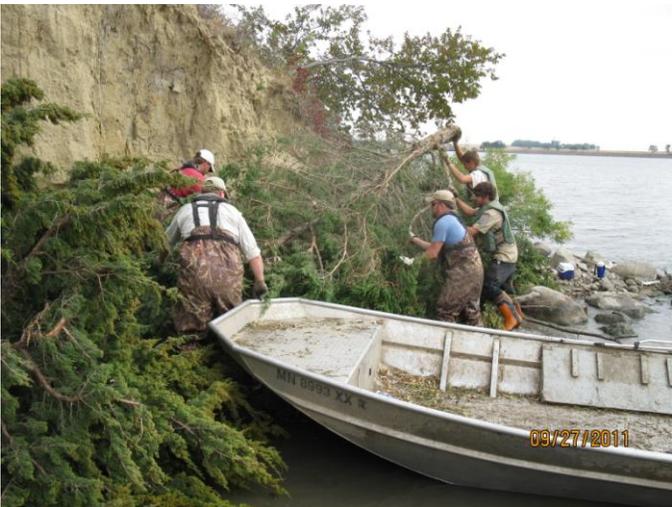
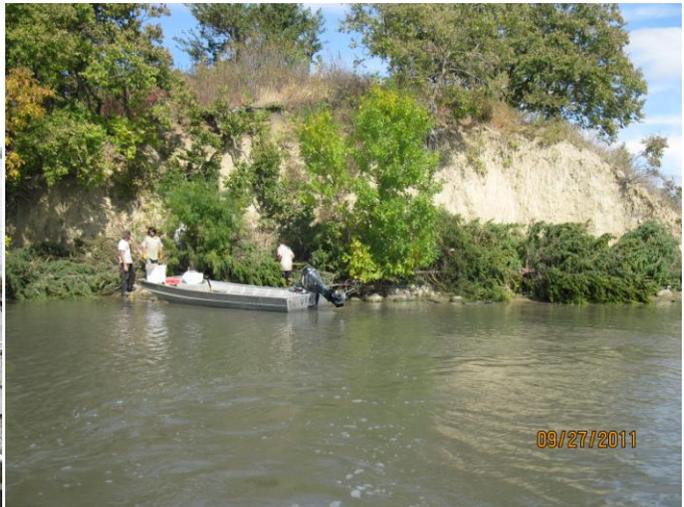
Pictures following are the installation of the cedar tree revetment:

In the summer of 2011, MN DNR Fisheries secured funding to try and mitigate erosion on the Loon Lake Island AMA. Windom Fisheries Staff and the MN/IA Conservation Corps began installing a cedar tree revetment on the Loon Lake Island AMA. Cedar trees have extensive branches, decay slowly, and are readily abundant in the area. The objective of the project was not to stop erosion but to mitigate slumping that occurs on the island. The cedar trees were obtained from local wildlife management areas. The 40 or so trees were transported to the public water access point on Loon Lake. Using MN DNR Fisheries boats, the large trees were boated across the lake to the island. Once at the island, staff used Duck Bill Anchors and cable to secure the trees to the toe of the bank. We are hopeful that the trees and their many branches will capture soil as it slumps from the high 30 foot bank to create another natural stable toe for other vegetation to become established.
