In this concept, the trailhead improvements and the disposition of the Interpretive Center remain the same as shown in Concept 01. A new picnic shelter has been added to the southwest of the building footprint. The shelter is oriented to highlight the views to the south and take advantage of the protection offered by the Sioux quartzite bluff directly to the north.

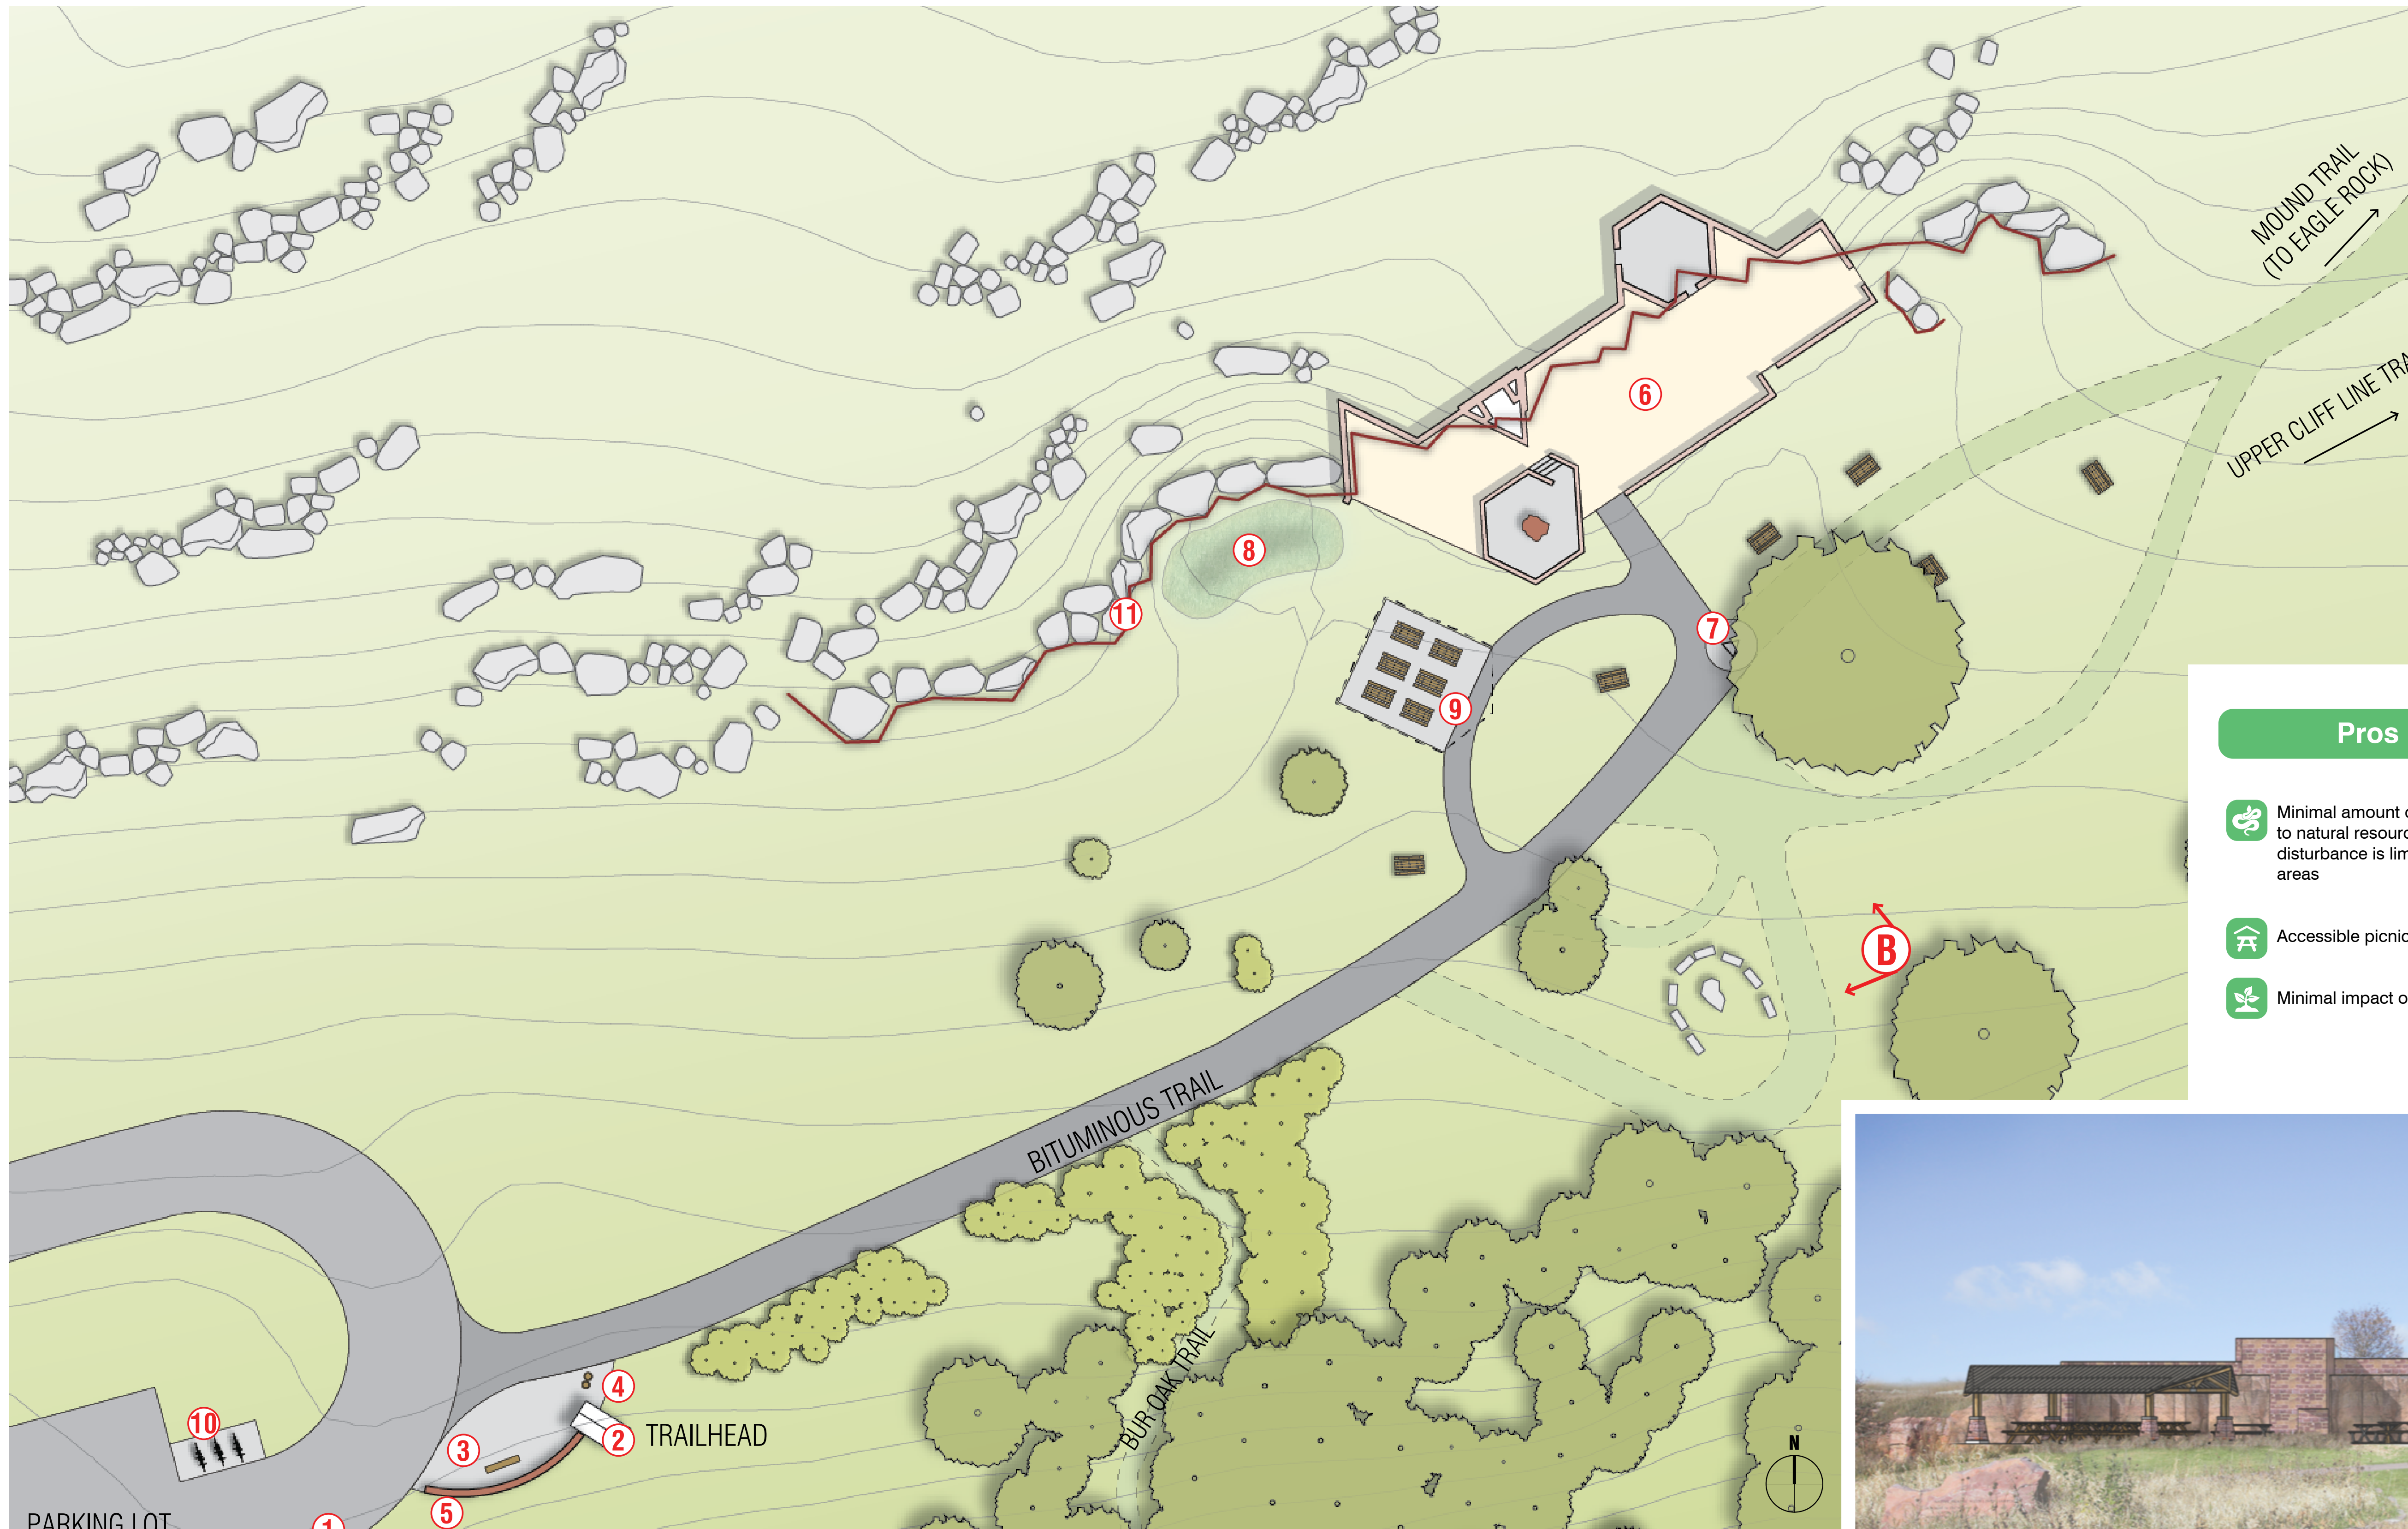
- ① PARKING LOT IMPROVEMENTS
- ② VAULT TOILET
- ③ PAY BOX/ WAYFINDING
- ④ TRASH/RECYCLING
- ⑤ STONE WALL
- ⑥ INTERPRETIVE CENTER FOOTPRINT
- ⑦ INTERPRETIVE SIGN
- ⑧ EXISTING SMALL POND
- ⑨ SHELTER/EVENT (~36-60 PEOPLE)
- ⑩ BIKE RACKS
- ⑪ SIOUX QUARTZITE BLUFF

- Minimal amount of disturbance to natural resources of habitat; disturbance is limited to turf areas
- Accessible picnic shelter
- Minimal impact on landscape

- Majority of Interpretive Center structure removed due to structural deficiencies
