Dam Removal

Case Examples

The Sandstone Dam – Simple removal with no restoration

Appleton Milldam, Pomme de Terre River – Dam Removal and River Restoration

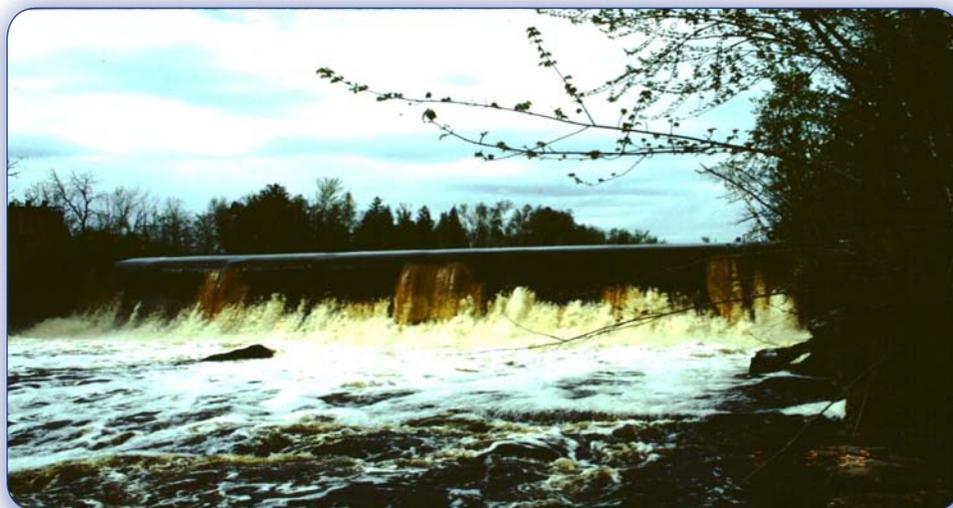
Figure 17. Sandstone Dam on the Kettle River.

The Sandstone Dam on the Kettle River in East-Central Minnesota was originally built in 1908 and generated electricity until 1963 (Figure 17). It was the only dam on the designated Wild and Scenic River and was located within Banning State Park (Figure 18). The 20-foot high dam was owned by the Department of Natural Resources. The Kettle River has a diverse fish and mussel assemblage and the dam blocked migration of lake sturgeon and other species, including mussel hosts, from upstream spawning habitat. Discussions about removal began in the early 1990s. Among issues evaluated were releases of sediment, effects on recreational opportunities,

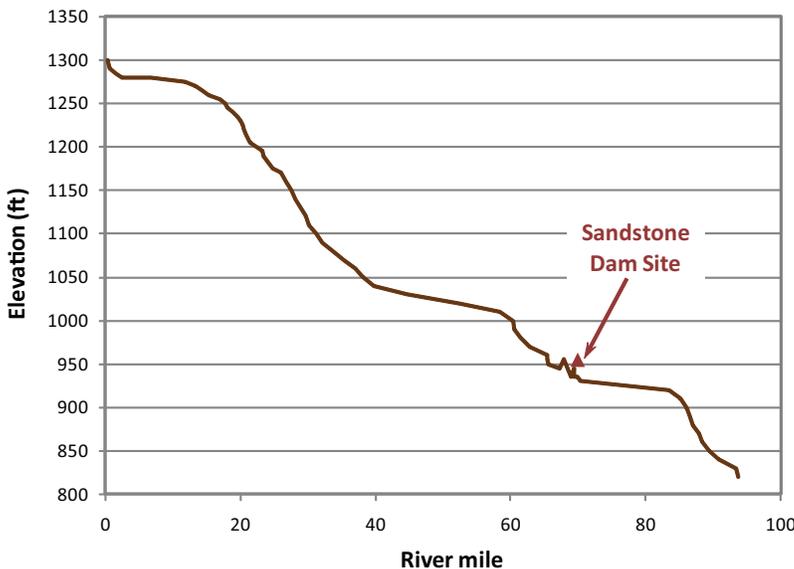
Figure 19. Elevation profile of the Kettle River showing the former dam site.

The dam was located just downstream of some of the steepest reaches of the Kettle including Hell's Gate rapids (Figure 19). It is known as one of the best whitewater boating rivers in the Upper Midwest. The reservoir created by the dam inundated Sandstone Rapids on which the dam was built, Big Spring Falls, about a half mile upstream of the dam, and partially inundated Quarry Rapids about two miles upstream of the dam at the upper end of the reservoir.

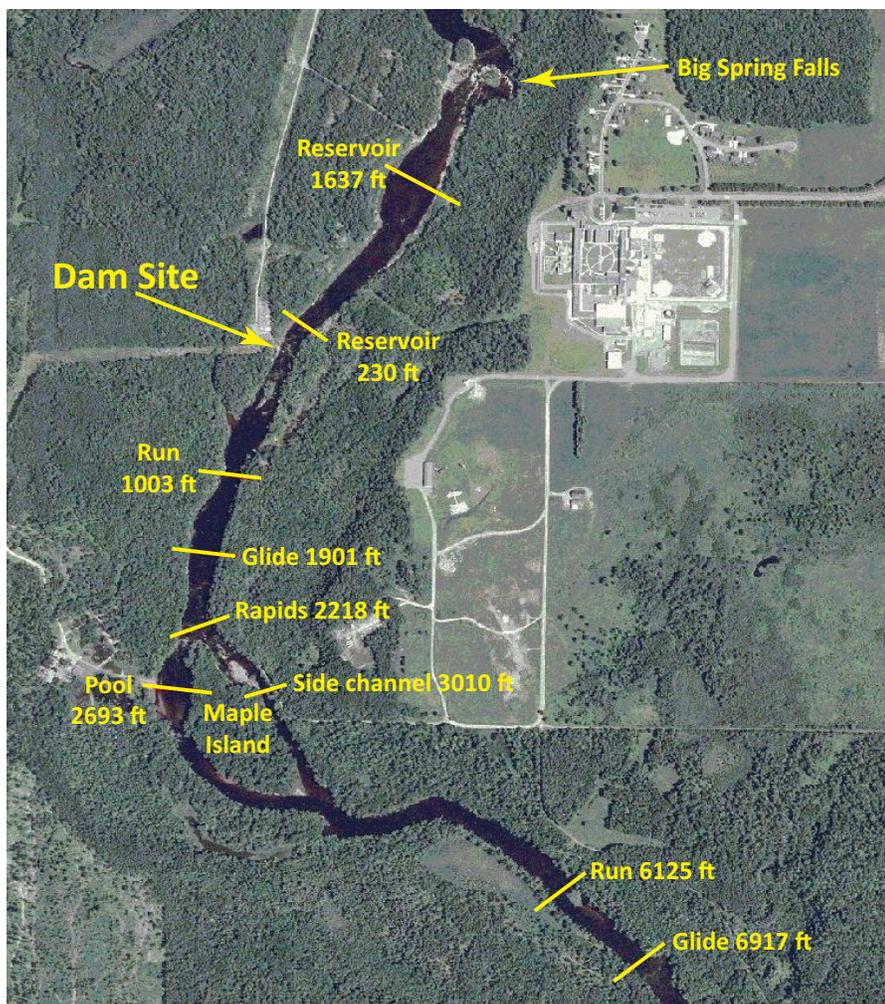
Figure 20. Aerial photo showing transect locations and distances from the dam site.

dam where substrate composition, depth, velocity, and mussel densities were recorded within 30 - four ft² quadrats randomly located along these transects using SCUBA (Figure 20).

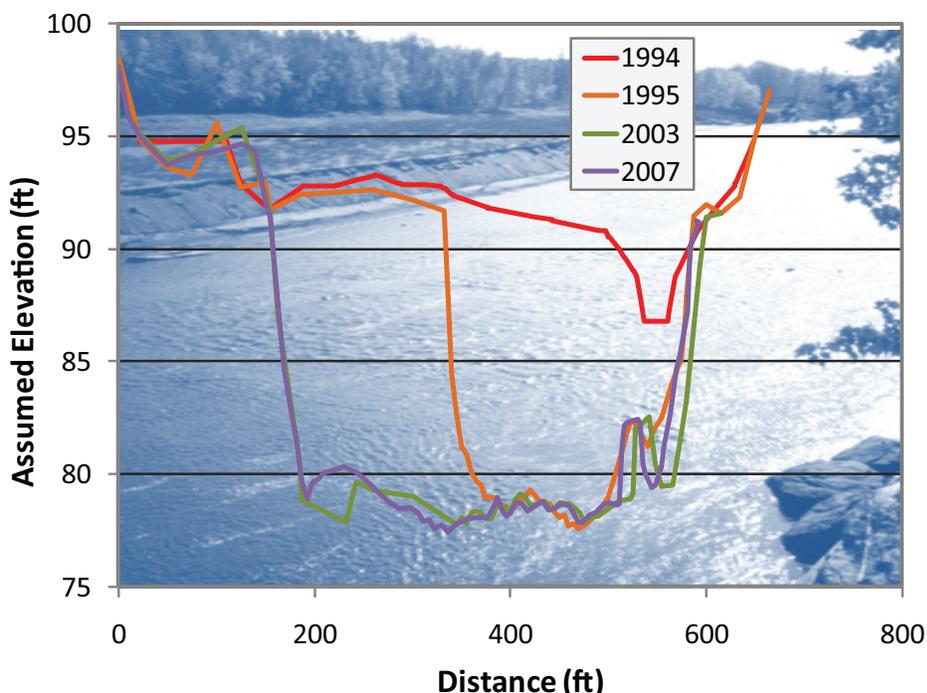
Figure 21. A cross-section within the reservoir 230 feet upstream of the dam, showing changes following removal.

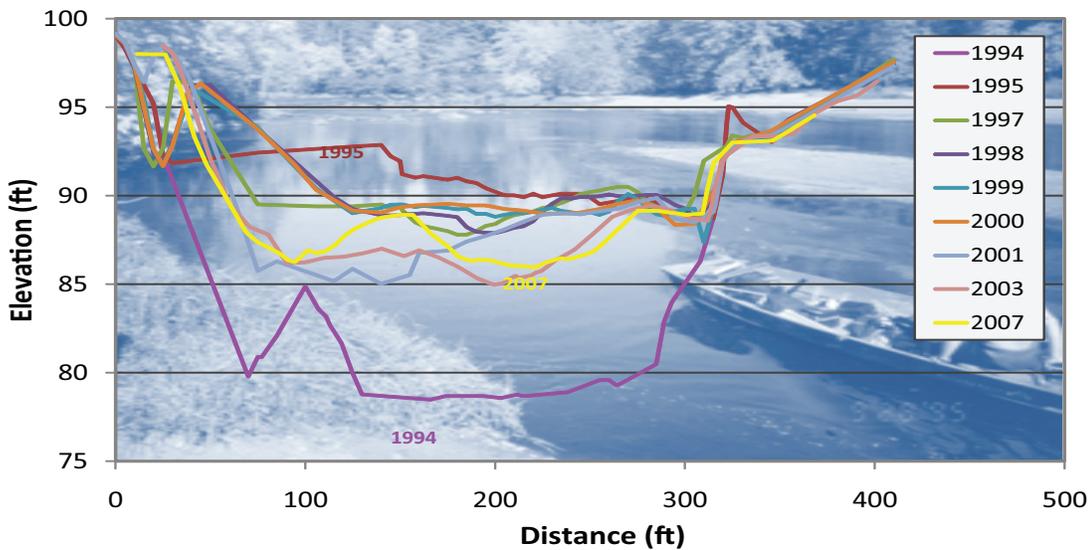
Figure 22. A pool cross-section, 2,693 ft downstream of the dam, showing sedimentation following removal. The background photo is looking upstream, cross-section stationing is left to right looking downstream.

As predicted, the greatest sedimentation occurred in the deep pool by Maple Island. This pool was about 19 feet deep at bankfull prior to the removal. The pool initially filled with about 15 feet of sand that has subsequently scoured to a 12-foot bankfull depth in the 2007 survey. The greatest scour occurred between the 2000 and 2001 surveys when the pool deepened by about four feet to a depth of about 13 feet at bankfull. This was probably due to a 25-year flood (14,800 cfs) that occurred that spring. Subsequently, there have been relatively low flows and the pool actually lost about a foot of depth (Figure 22).

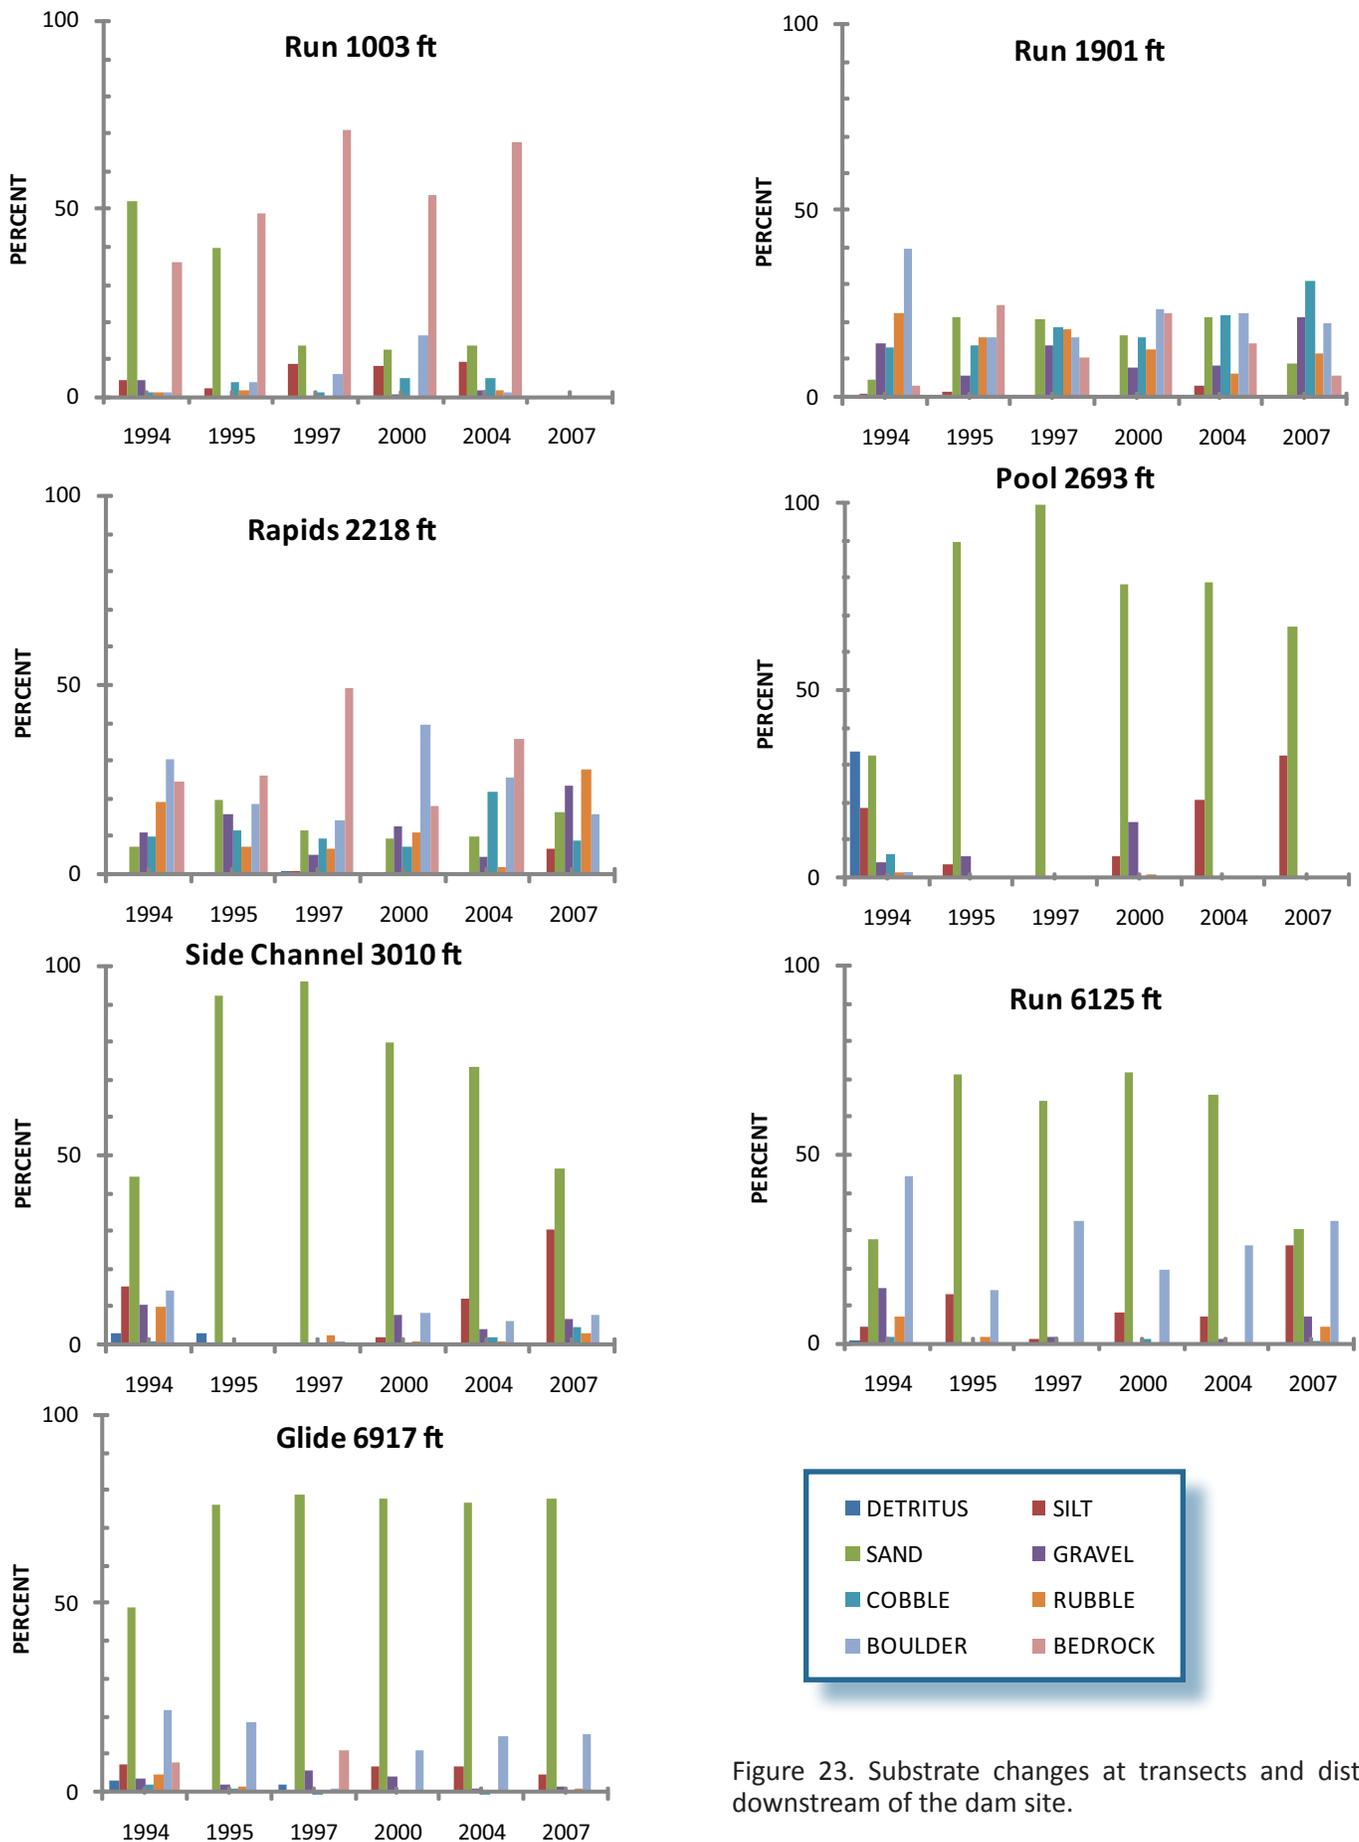
Figure 23. Substrate changes at transects and distance downstream of the dam site.

The proportion of substrates comprised by sand increased in most habitats after the removal but has approached pre-removal composition in some transects (Figure 23).

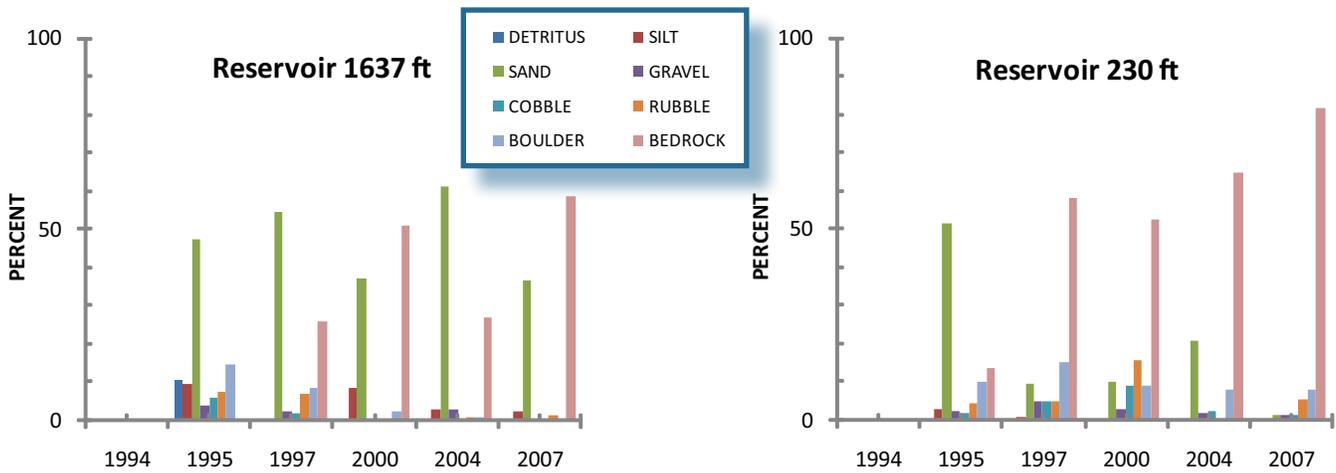
Figure 24. Substrate changes in the reservoir following removal and distance upstream. No data was collected prior to removal in 1994 but based on exposed flats it was likely near 100 percent sand.

Substrates within the reservoir have also changed. While our sampling of sediments upstream of the dam did not begin until the dam had been removed, it is likely that it was almost entirely sand based on flats visible immediately after removal. Following removal, the river quickly downcut to bedrock and subsequently widened (Figure 24).

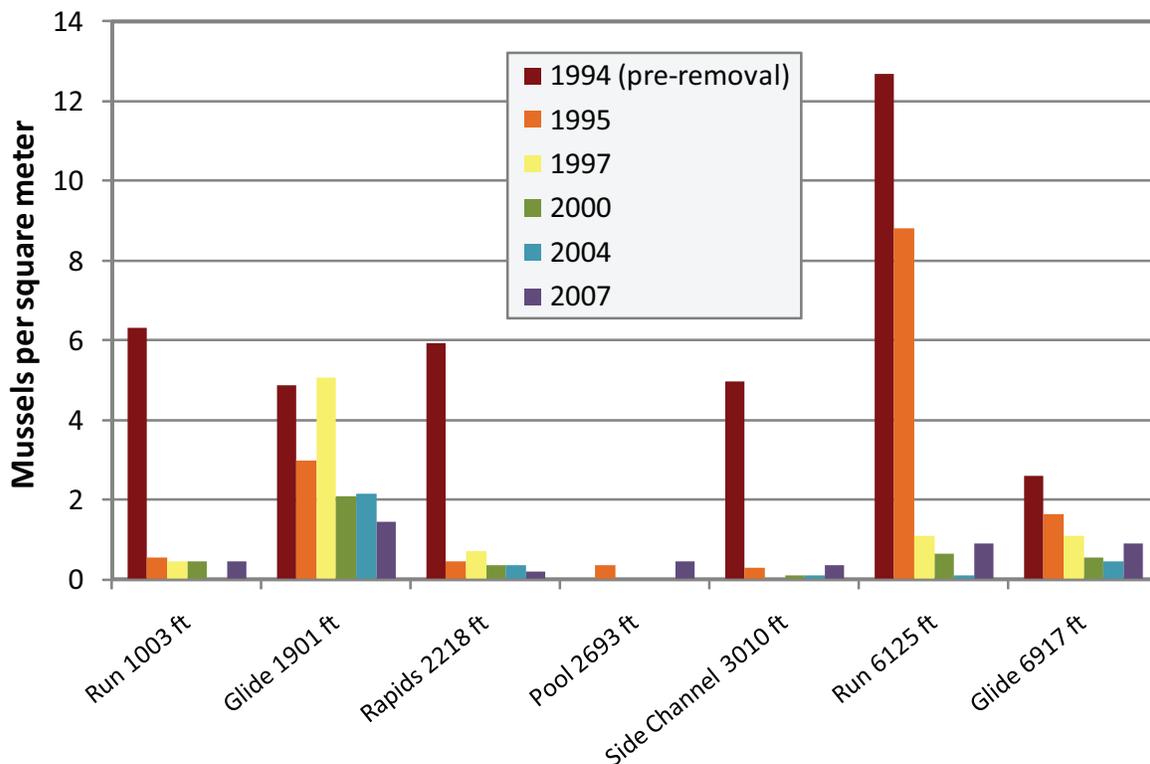
Figure 25. Mussel density along transects with distances downstream of the dam site.

Mussel density observed along habitat transects declined in all habitats except for that in the deep pool where only one mussel was observed (Figure 25). It is unclear whether the reduction in mussel density was due to mortality from elevated sediment loads, being covered by sand, or habitat changes due to sedimentation or if the mussels were carried downstream with the sand load. Mussel surveys within the reservoir have shown no change in density as only one mussel has been collected along the two transects. This is probably due to predominance of bedrock and the lack of stable alluvial substrates.

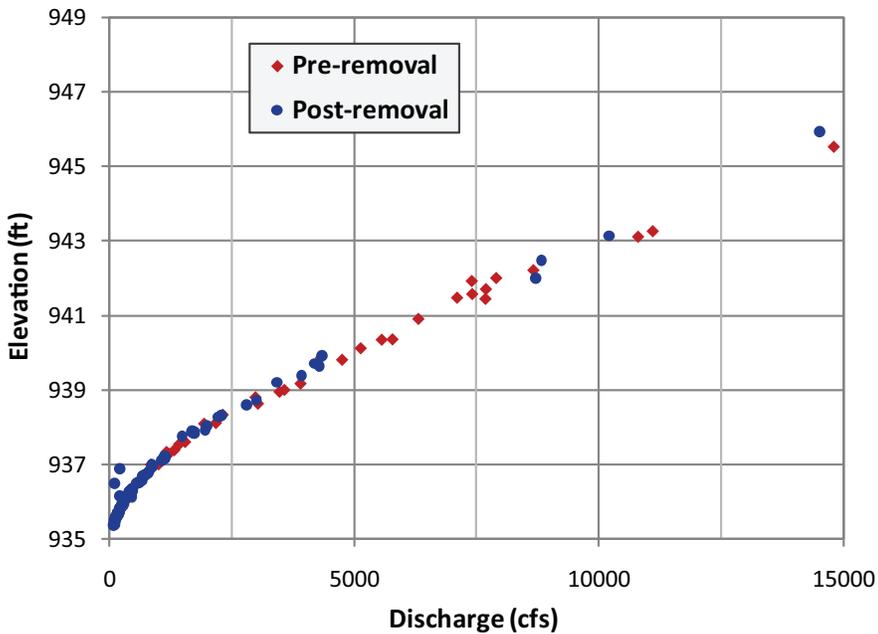
Figure 26. Measured stage and discharge values at the Kettle River gage before and after removal of the Sandstone Dam. The gage is 850 feet downstream of the dam site. Data from USGS gage 05336700.

the dam was removed (Figure 26). The gage is 850 feet downstream of the dam site. This indicates that the hydraulic control of the gage has remained at a similar elevation. While further downstream reaches may be different, substrate composition included boulder throughout the study timeframe suggesting that sand may have embedded larger substrates rather than changing hydraulic capacity of the channel. The banks have well-established riparian forest vegetation and appear stable.

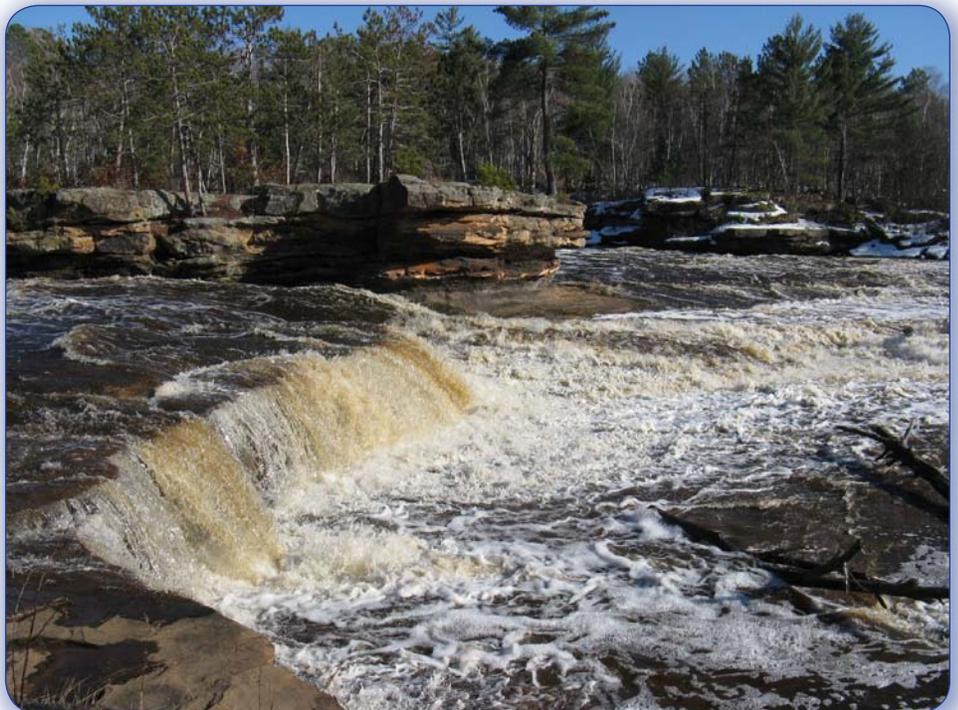
Figure 27. Big Spring Falls, inundated by the reservoir for 87 years, following removal of the Sandstone Dam.

Big Spring Falls, inundated by the reservoir, now provides potential spawning habitat for lake sturgeon (Figure 27). Tagged lake sturgeon have also been observed moving upstream of the dam site and through the falls. Numerous riffles, rapids, and falls upstream of the former dam are now accessible for sturgeon and other species.

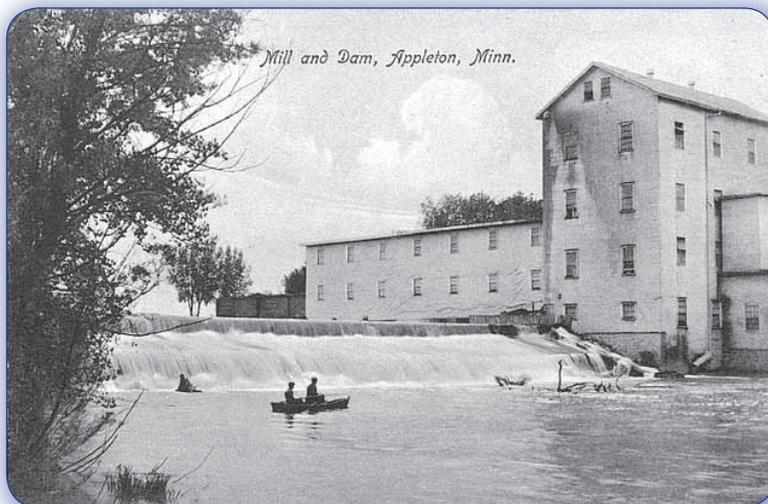
Figure 28. The Appleton Milldam as it appeared in 1910. Photo courtesy of the Minnesota Historical Society.

The Appleton Milldam was originally built in 1872 (Figure 28). The dam had significant ties to the community. The mill provided the industrial roots for the small town of 2,871 people. An island in the reservoir was a popular site for weddings. An elderly resident talked of diving from the railroad bridge into a 15-foot deep pool.

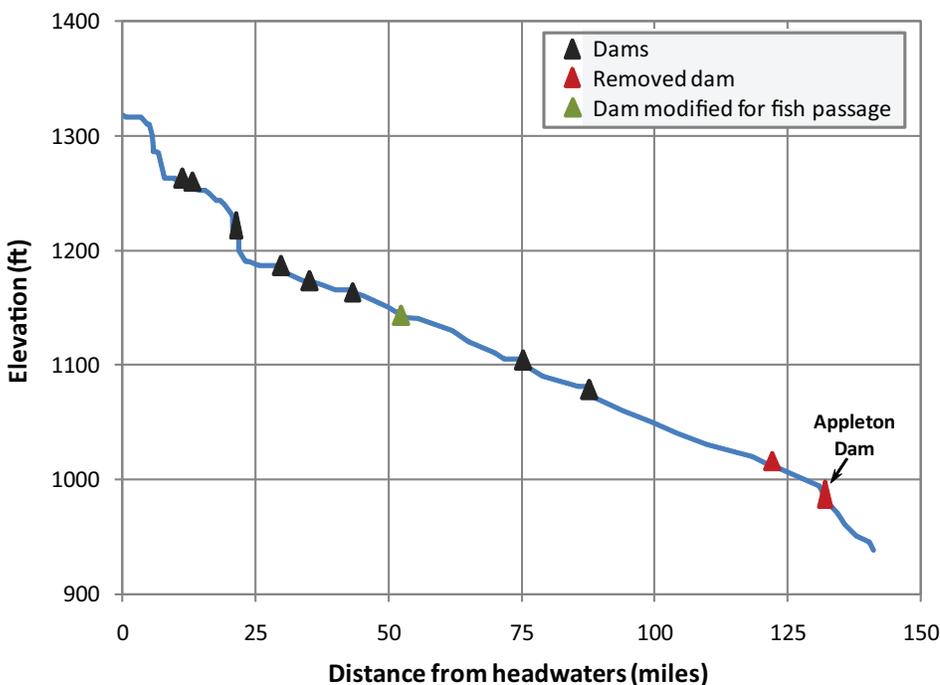
Figure 30. Elevation profile of the Pomme de Terre River showing dam locations.

The dam’s location, only nine miles from its confluence, was a complete barrier to fish migration (Figure 30). The dam was also situated in one of the steeper reaches of the river where it inundated gravel riffles important for spawning habitat of a number of fish species. Eleven dams were built on the Pomme de Terre River, most of which are at natural lake outlets. Appleton dam and another dam six miles upstream blocked over 45 miles of river.

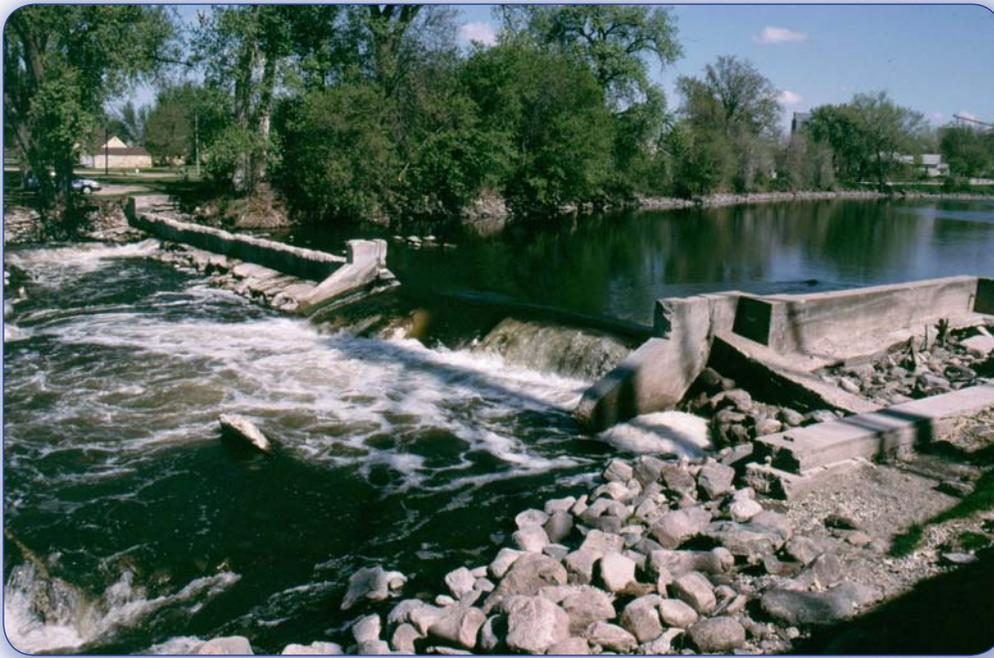
Figure 31. Appleton Dam following the 1997 flood. A breach is apparent on the left side of the photo.

The Minnesota Department of Natural Resources worked with the City in the process that included a series of public meetings to discuss whether to repair or remove the structure. While some favored repairing the dam, the reservoir, once a popular swimming lake, had filled with up to 15 feet of sediment and no longer performed its original functions. The dam no longer powered a mill. The 1996 Minnesota Legislature provided \$50,000 to study options. Cost of rebuilding the dam, would have been substantial leading the community to consider removal. The City of Appleton decided by January 9, 1997 to remove the dam. The dam spillway subsequently was undermined in the record April 1997 flood (Figure 31).

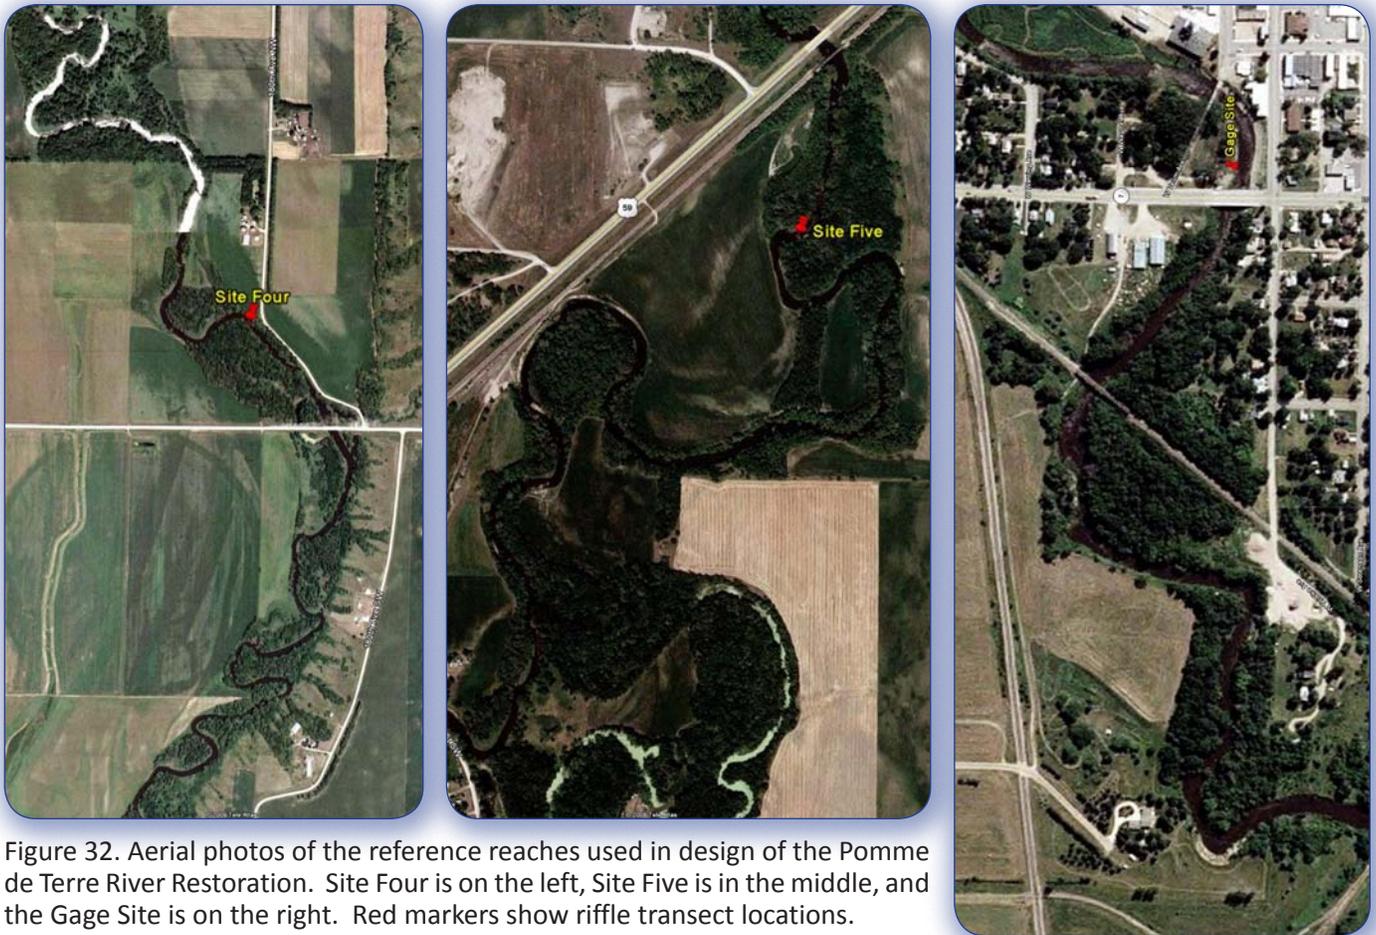
Figure 32. Aerial photos of the reference reaches used in design of the Pomme de Terre River Restoration. Site Four is on the left, Site Five is in the middle, and the Gage Site is on the right. Red markers show riffle transect locations.

We canoed the lower Pomme de Terre River to find and survey reference cross-sections (Figure 32). The lower 30 miles of the river has a relatively small variation in drainage area due to the shape of the watershed. Surveys were conducted during a bankfull event of 500 cfs and a discharge measurement was taken in the upper site. This allowed back-calculation of roughness coefficients and assurance of discharge associated with bankfull. The bankfull indicator used was the elevation of the depositional flat at the point bar or the incipient point of flooding. A Kevlar tagline was used for support but surveying while wading was still challenging since the gravel bed materials were mobile. A canoe was attached to the tagline for surveying and for collecting discharge measurements in deeper cross-sections. A USGS gage is located directly downstream of the dam allowing determination of the bankfull recurrence interval.

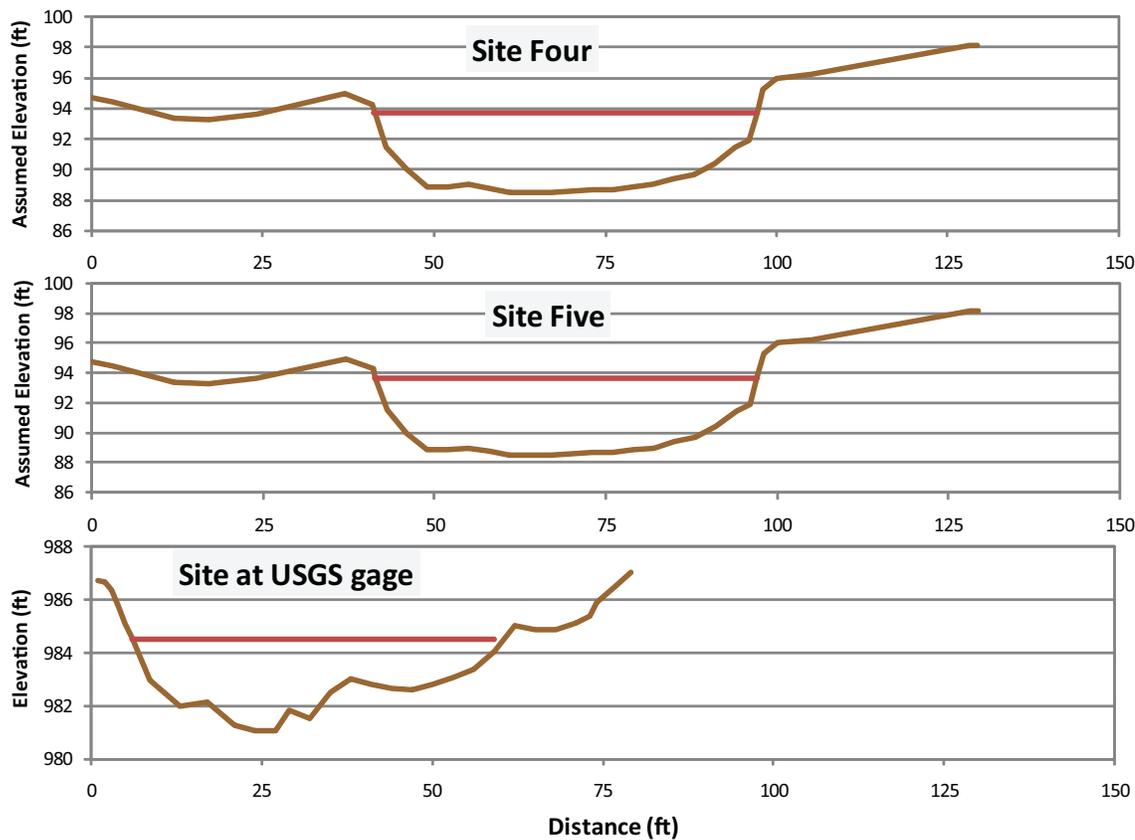
Figure 33. Riffle cross-sections at reference sites used for the design of the Pomme de Terre River.

Slope varied considerably among the reference sites but all riffle cross-sections were of the C4 type using Rosgen's stream classification (Figure 33). Slope and roughness differences explained differences in cross-sectional area.

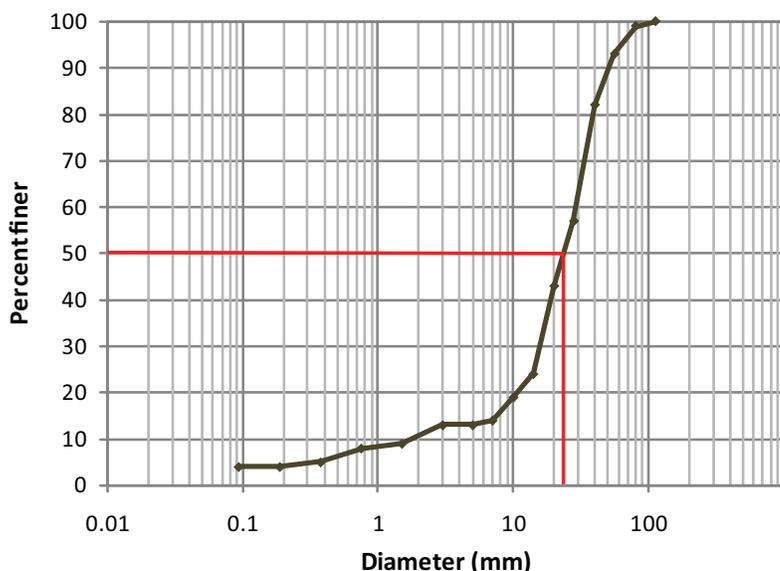
Figure 34. Pebble count from site five directly upstream of the Appleton Milldam Reservoir.

A pebble count directly upstream of the reservoir at site five shows a median particle size of 24 mm (coarse gravel) (Figure 34).

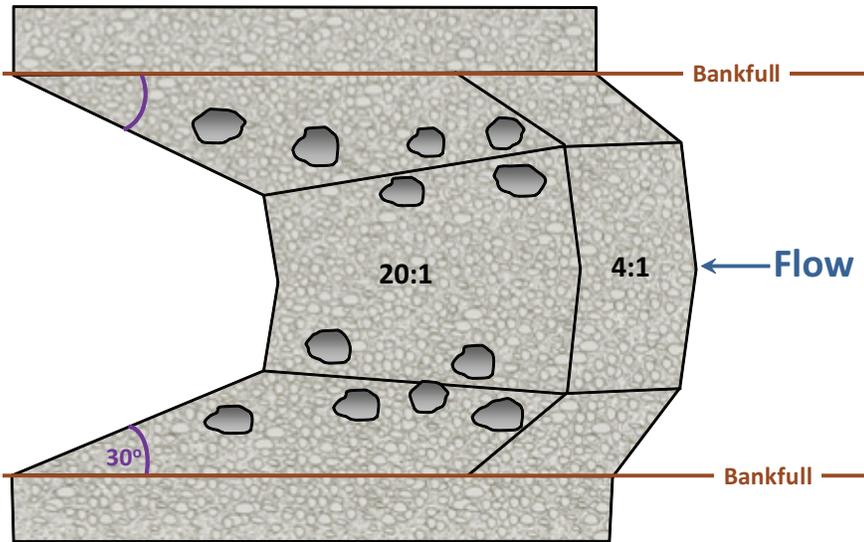
Figure 35. Riffle design used for grade control and habitat in the Pomme de Terre River restoration.

dominated by silt, while the upstream bed materials were dominated by gravel, fieldstone riffles were incorporated into the design as grade control to assure channel competence until bedload was carried into the new channel. The riffle design used is a hybrid of the Newbury Weir (Newbury and Gaboury 1993) and structures used by Rosgen (1996), and was developed to: emulate natural riffles in Minnesota, create flow convergence patterns and pool scour, provide habitat, and remain stable when constructed on fine sediments (Figure 35). The fieldstone was sized based on shear stress calculations using large enough stone to remain stable.

The fieldstone riffles were used to bring the channel grade up at a steeper slope in the downstream end of the restoration to match bankfull with the sediment elevation so that it would become the new floodplain. A rock arch rapids (discussed in Chapter Two) would be built at the footprint of the dam with two additional rapids within the lower 1,000 feet of channel to raise the bed approximately three feet.

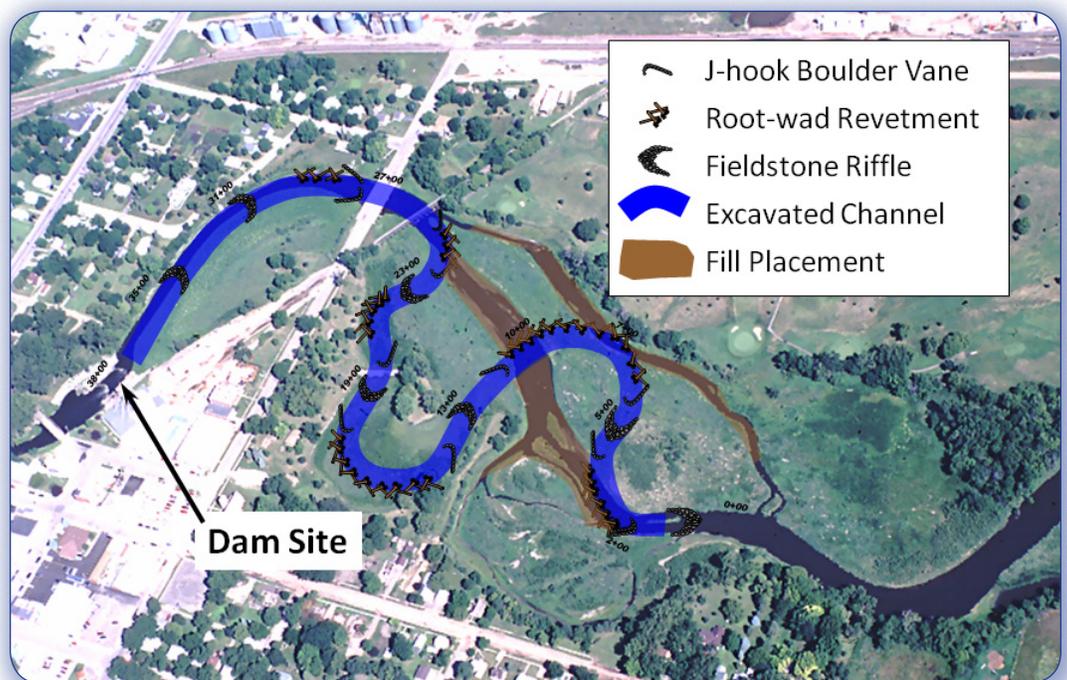
Figure 36. Planview of the Pomme de Terre River restoration in Appleton, Minnesota

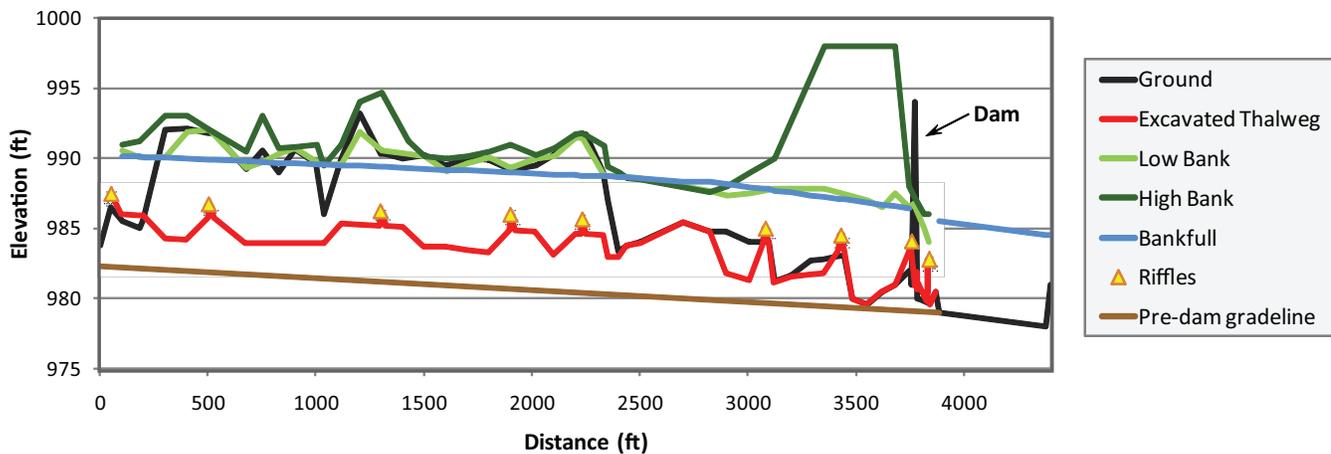
Figure 37. Profile of the Pomme de Terre River restoration showing pre-project sediment elevation at channel centerline, low and high banks, excavated channel thalweg, designed bankfull, and the approximate pre-dam grade-line.

The constructed channel was designed so that the estimated bankfull stage would approximately match the elevation of the reservoir sediments (Figure 37). Pre-dam channel elevations were approximated from thalweg elevations upstream and downstream of the reservoir. The channel slope was steeper downstream of the bridge.

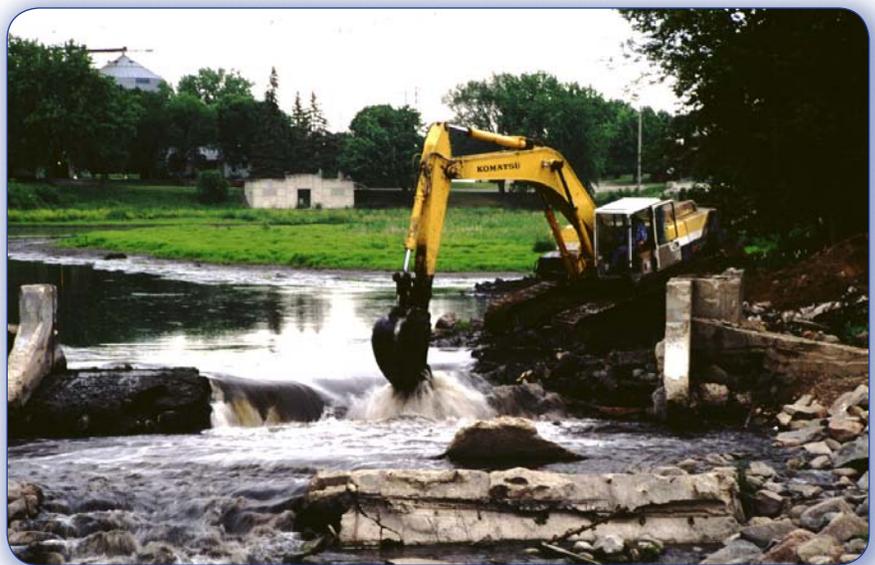
Figure 38. Partial removal of the dam spillway to allow the reservoir to drain (July 9, 1998).

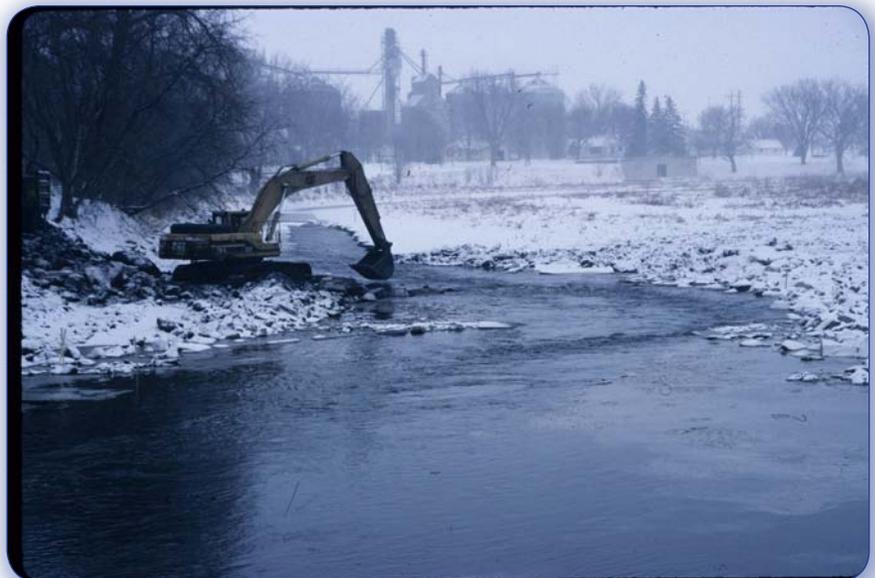
Figure 39. Construction of rapids following removal of the dam, March 4, 1999.

The dam was entirely removed by March 6, 1999 and replaced with a 2-foot high, 80-foot long, rock arch rapids for grade control and maintenance of the tailwater pool that was a popular fishing area (Figure 39). Two U-shaped boulder weirs were incorporated into the rapids to create flow convergence. Quarried boulders

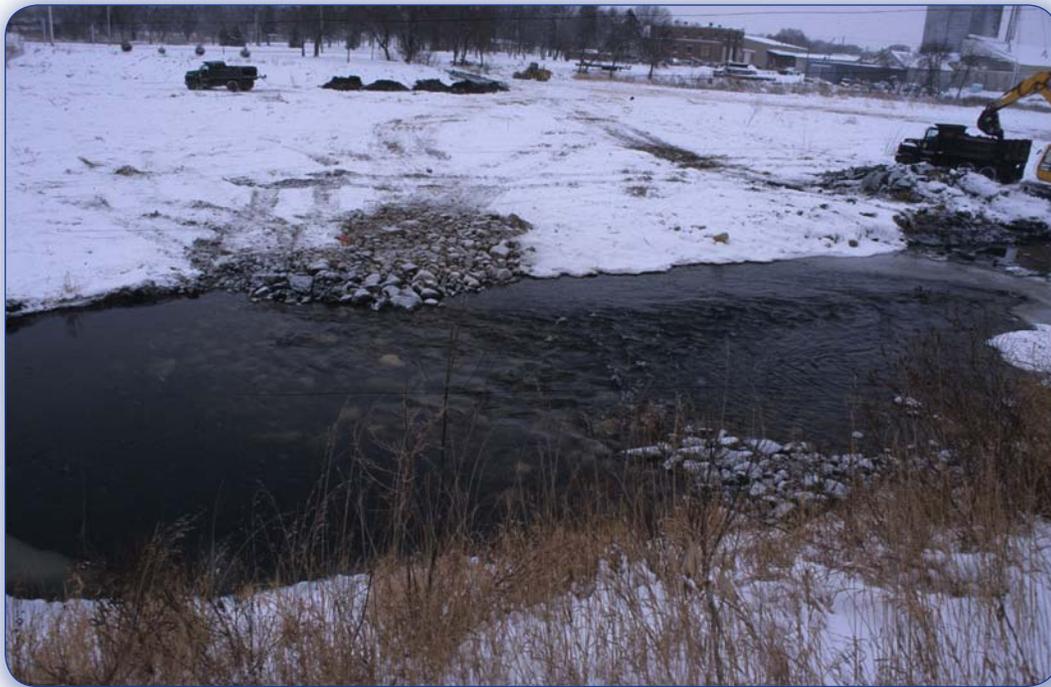
Figure 40. Construction of a fieldstone riffle, January, 2000.

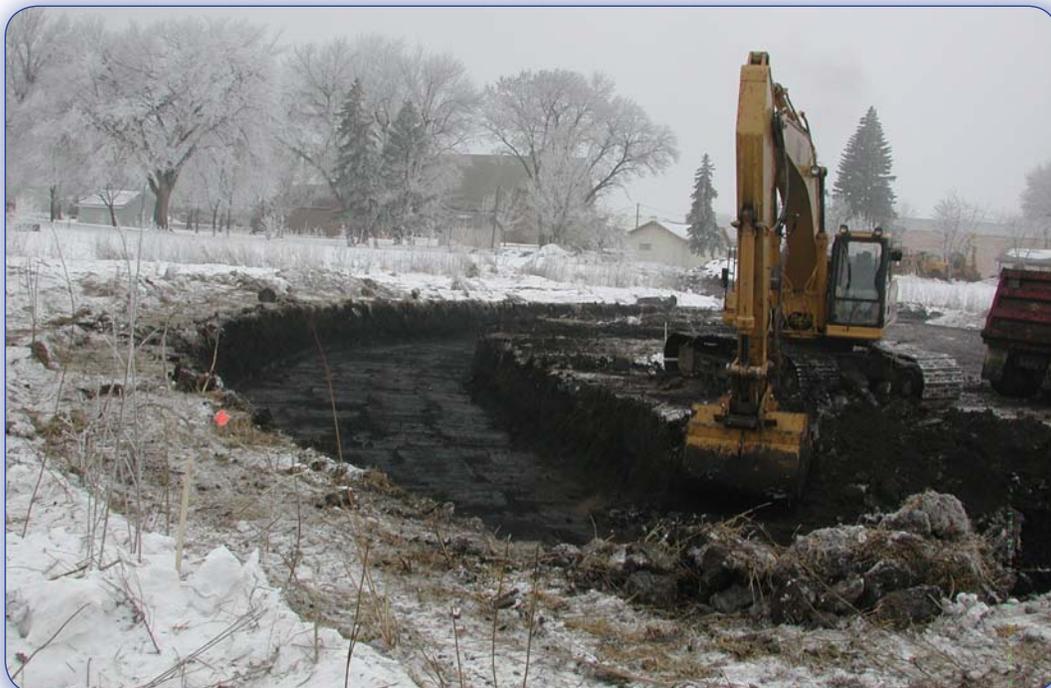
Figure 41. Excavation of the downstream meander, January 12, 2001.

Excavation of the new channel was done in January 2001 (Figure 41). Winter construction was chosen because flows were low and stable without risk of sudden rains and the ground was frozen allowing trucks to access the work area. Most of the channel

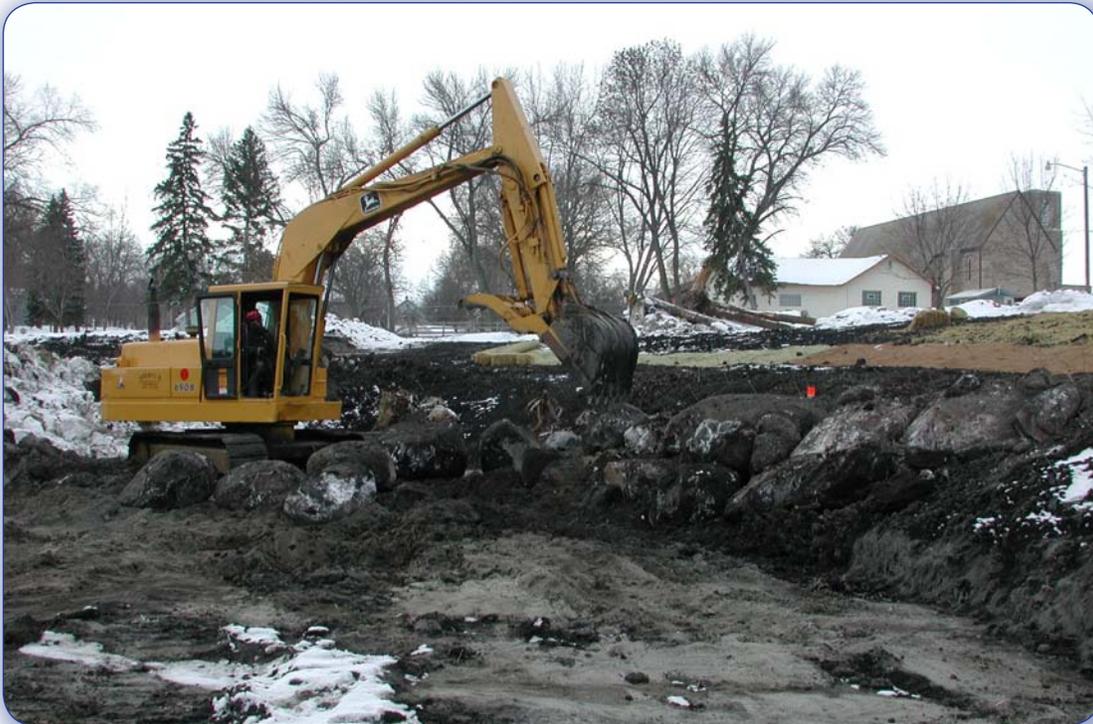
Figure 42. Building a J-hook vane in the new channel, January 23, 2001.

excavation and placement of structures was separated from river flows and could be done in the dry (Figures 42 & 43).

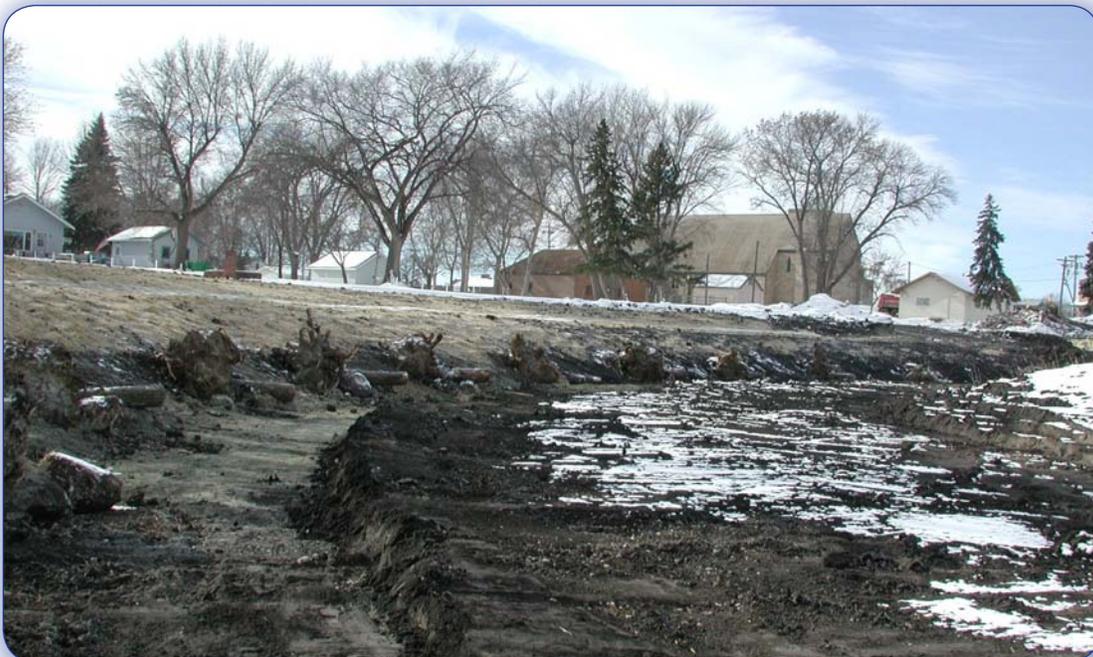
Figure 43. Root-wad revetments in the new channel, January 26, 2001.

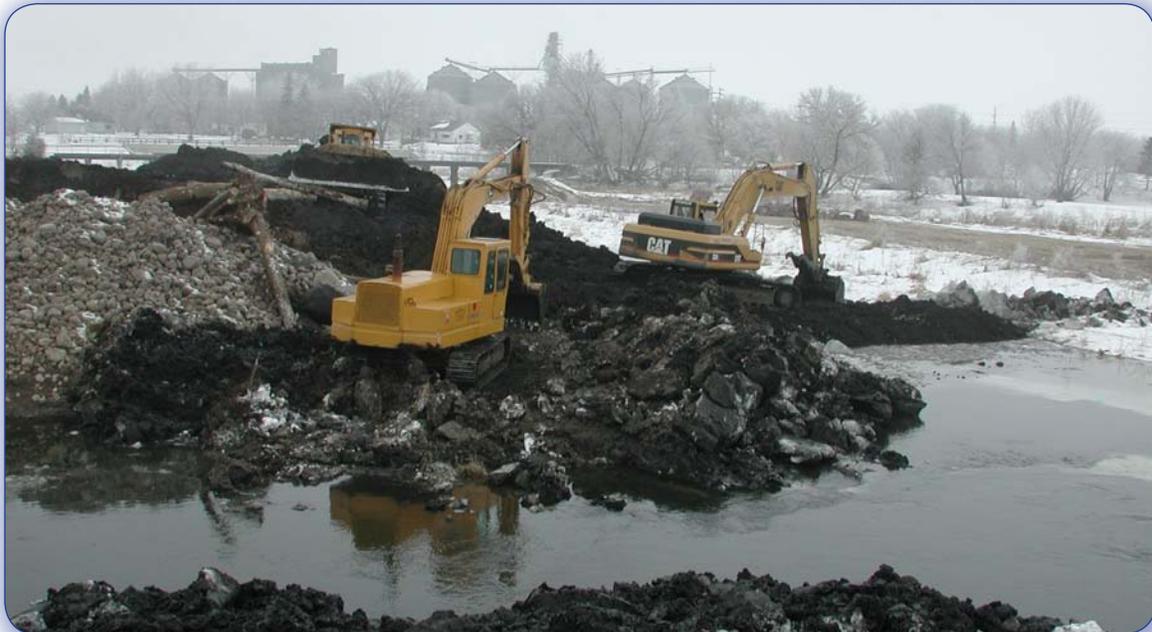
Figure 44. Diversion of flows into the downstream meander and simultaneous plugging of the straight gully, January 29, 2001.
