Dam Removal

Case Examples

The Sandstone Dam – Simple removal with no restoration

Appleton Milldam, Pomme de Terre River – Dam Removal and River Restoration

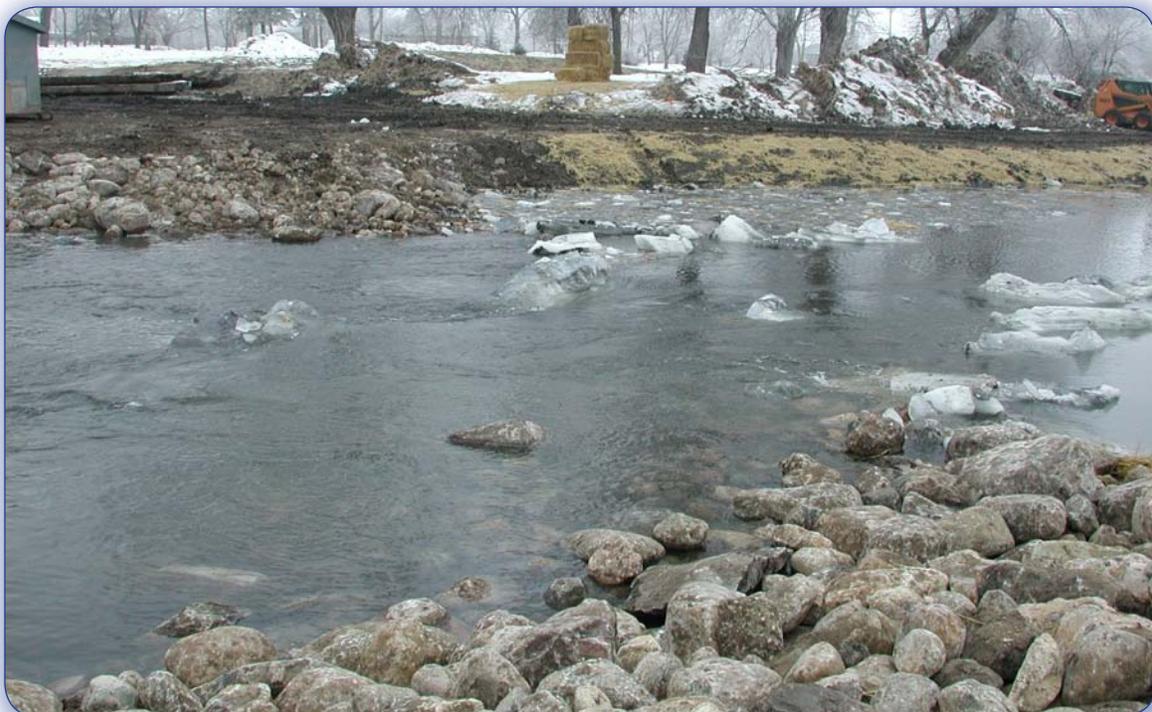
Figure 45. Constructed riffle in the downstream meander just after flows were diverted into it on January 29, 2001.

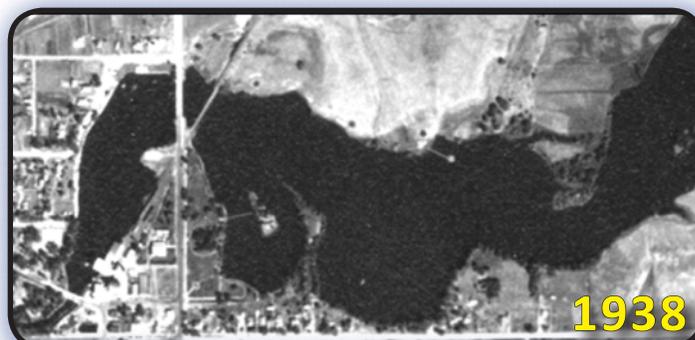
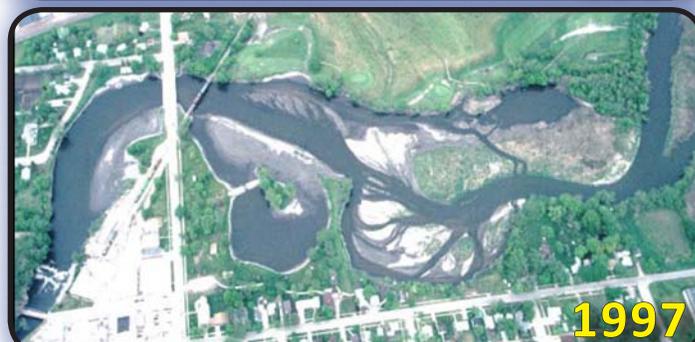
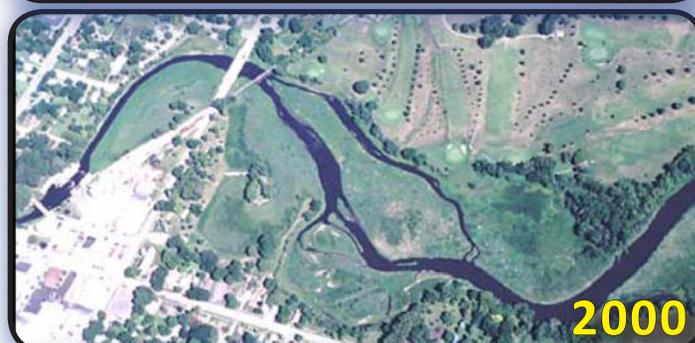
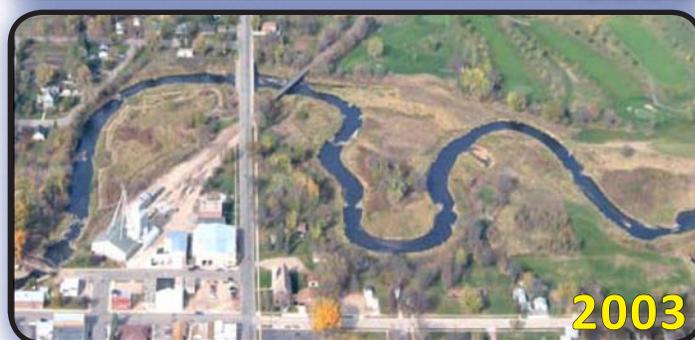
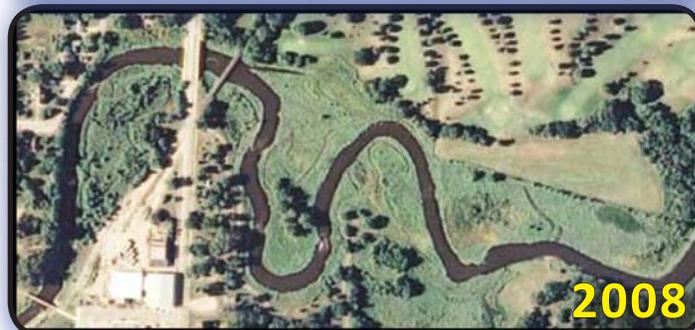
Figure 46. Aerial photos of the Appleton Reservoir in 1938, 1997, 2000 after dam removal, 2003 after river restoration, and 2008.

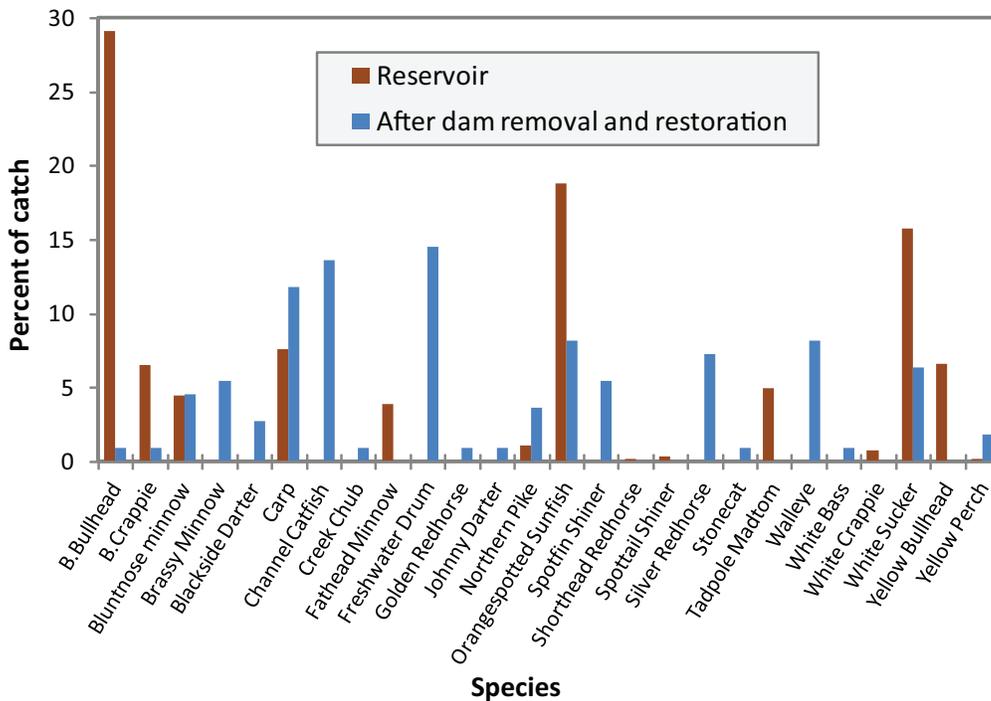
Figure 47. Relative abundance of fishes in the Lower Pomme de Terre River upstream of the dam site before (brown) and after (blue) removal of the dam. Fish were collected with trap-nets and electrofishing. Minnesota Section of Fisheries Data.

Sections of Fisheries surveys of the river upstream of the dam have shown a shift in the fish community since the dam was removed and the river restored towards native riverine species (Figure 47). Black bullheads *Amieurus melas* and common carp had dominated the silt-laden reservoir. Surveys subsequent to the dam removal have collected channel catfish, freshwater drum, stonecat, walleye, silver redhorse, golden redhorse, and other species not collected in pre-removal surveys (Data provided by Chris Domeirer, Section of Fisheries). These shifts are likely due to the combination of restored connections to the Minnesota River as well as habitat changes. The deepest areas of the reservoir were about four feet while the restored river has pools that have deepened to as much as eight feet during low flow conditions (10 ft bankfull depth). Substrates have shifted from predominantly silt in the reservoir to more diverse materials including gravel and cobble.

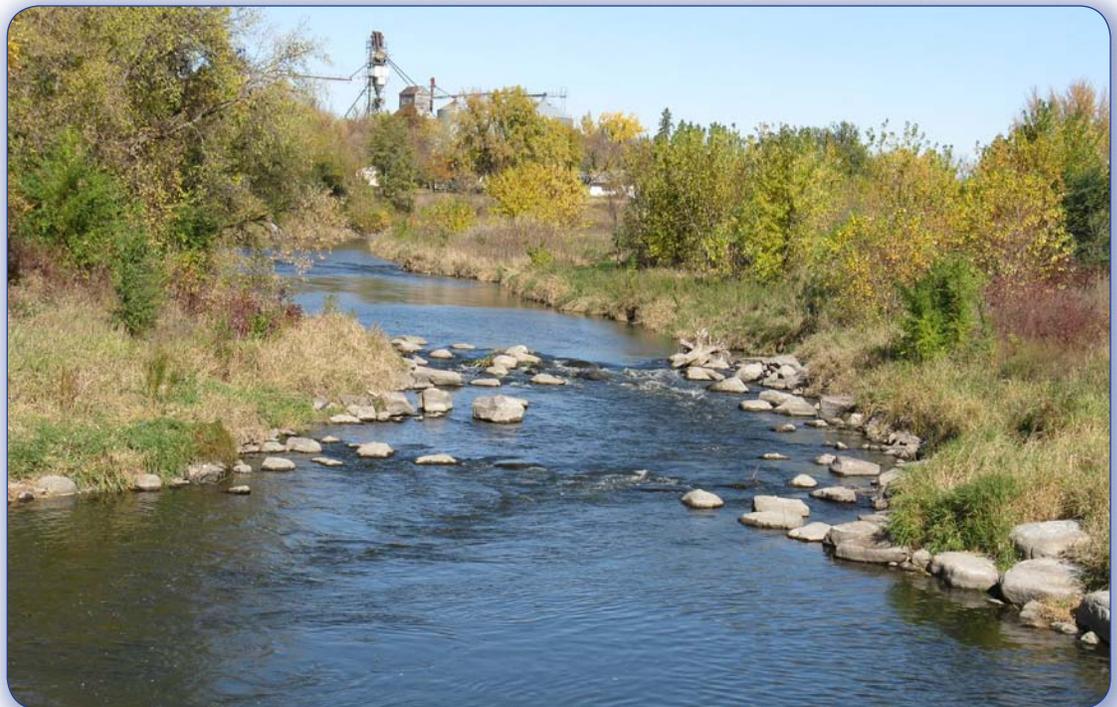
Figure 48. A photo showing rapids at the former dam site as it looked on October 10, 2008.
