**MDNR ID No. 36: MP 981.7; Unnamed Basin**

**Line 3 Replacement Project**  
**Crossing Plan**  
 ID# 36  
 Survey No. HUC5165a1W  
 Unnamed - PWI Basin  
 Hubbard County, Minnesota

| <b>ENBRIDGE LINE 3 REPLACEMENT PROJECT</b><br><b>SITE-SPECIFIC RESTORATION PLAN</b><br><b>BIG SWAMP CREEK - MP 1000.5 - MDNR ID 41</b><br><b>RE-VEGETATION PLAN: EXPANDED EXTENT</b> | | | | | |

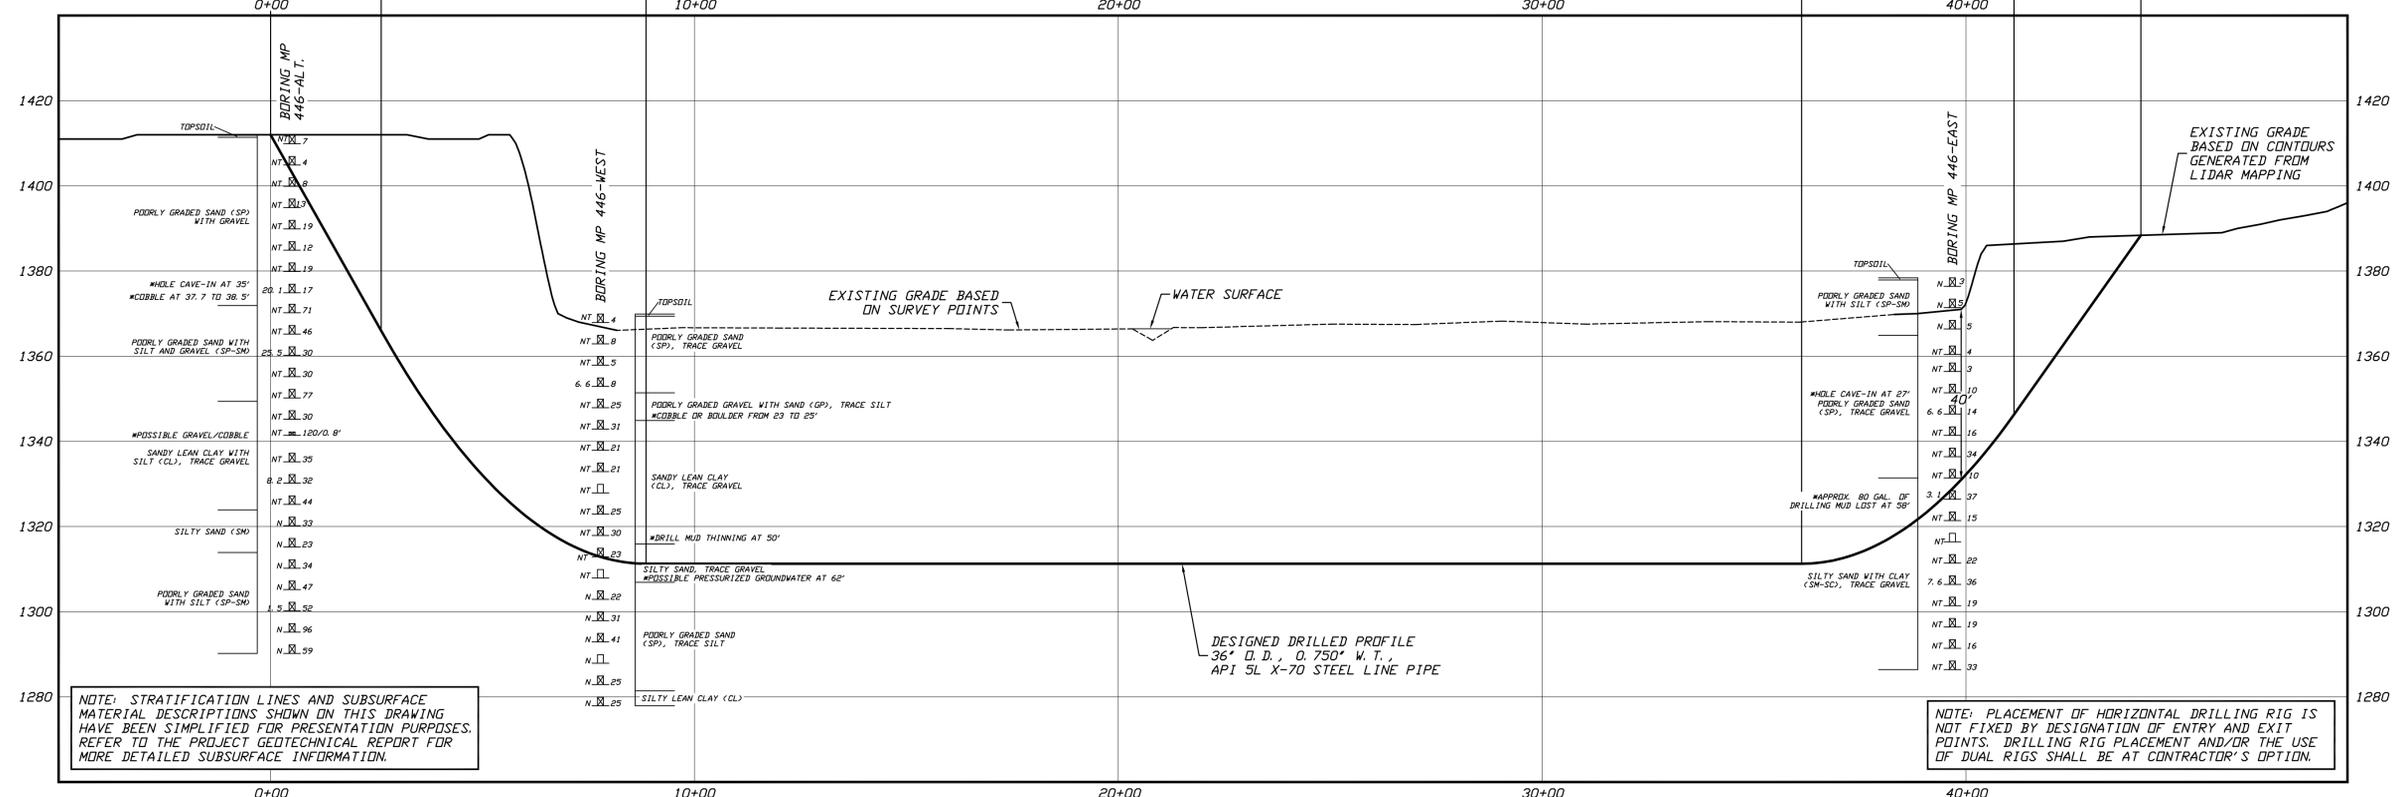
**PLAN**  
SCALE: 1"=200'

HORIZONTAL LENGTH = 4,413'  
TRUE DRILLED LENGTH = 4,425'

ENTRY POINT @ 10°  
0+00.00, 1412.00  
N 450812.32, E 2140688.54

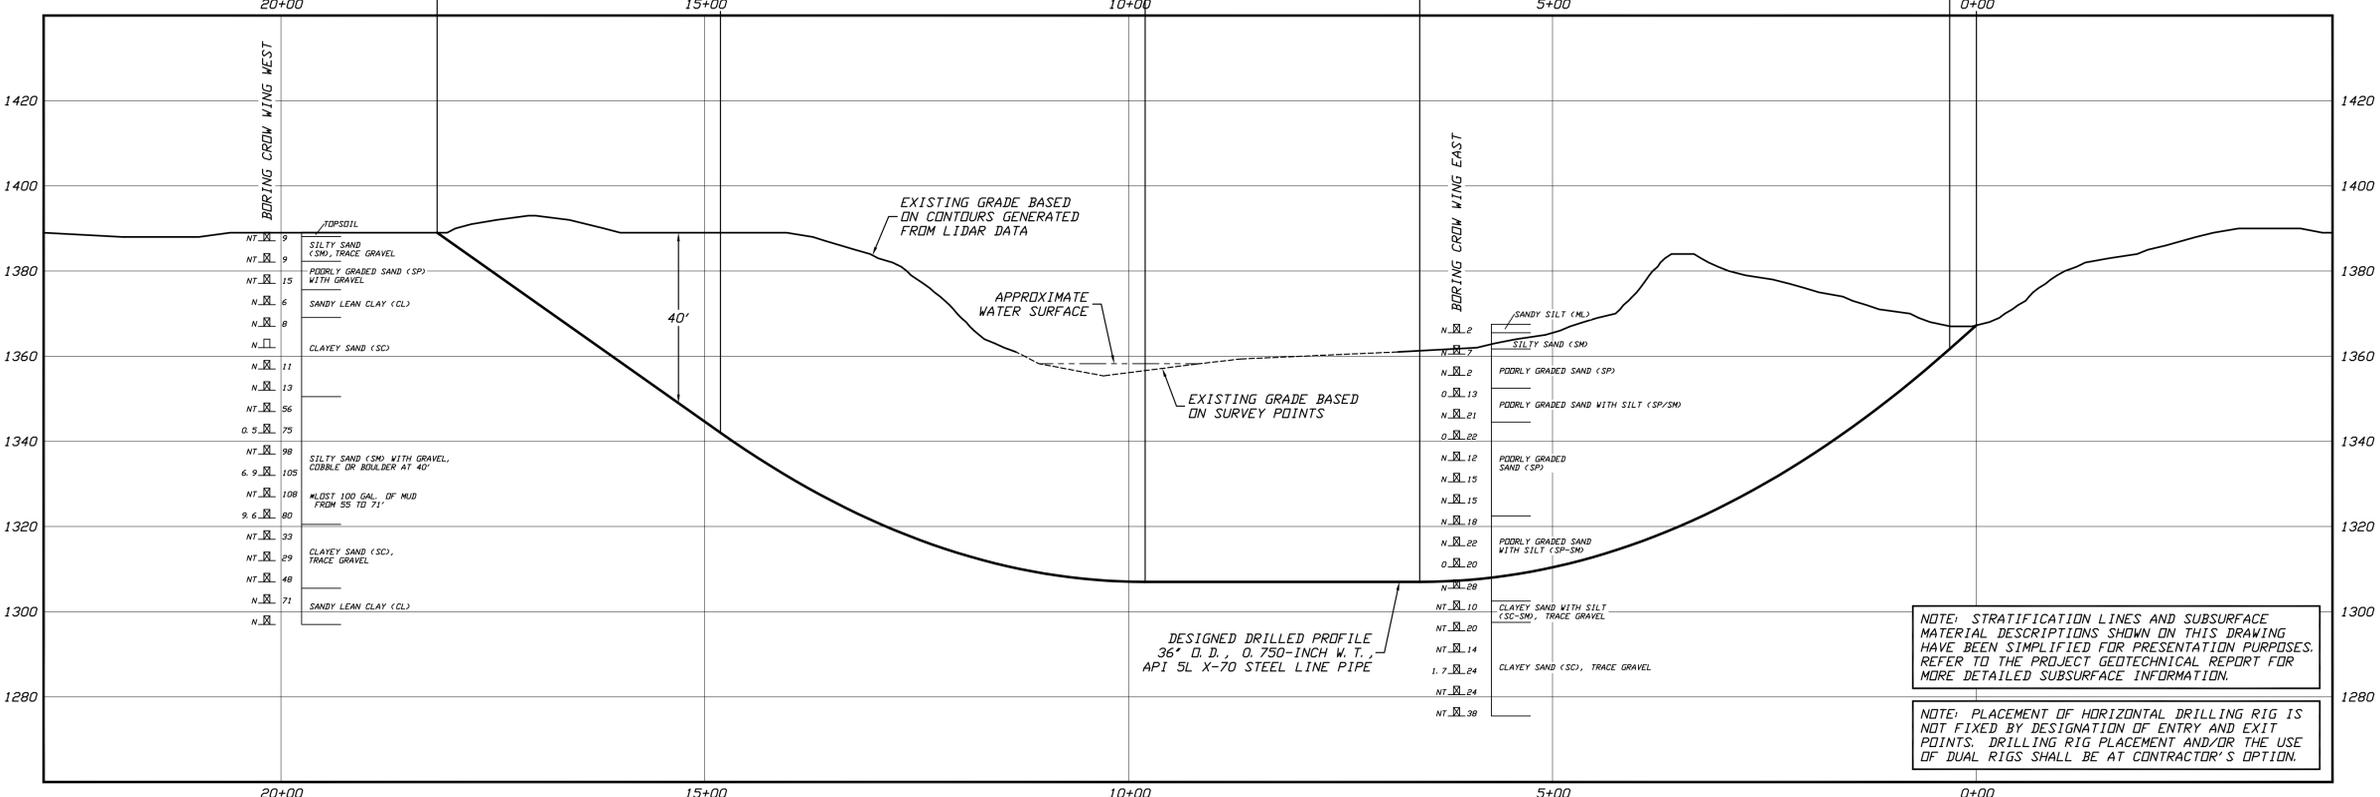
**PLAN**  
SCALE: 1"=100'

EXIT POINT @ 8°  
18+15.73, 1389.00  
N 440707.37, E 2179112.67

ENTRY POINT @ 10°  
0+00.00, 1367.26  
N 440694.80, E 2180928.35

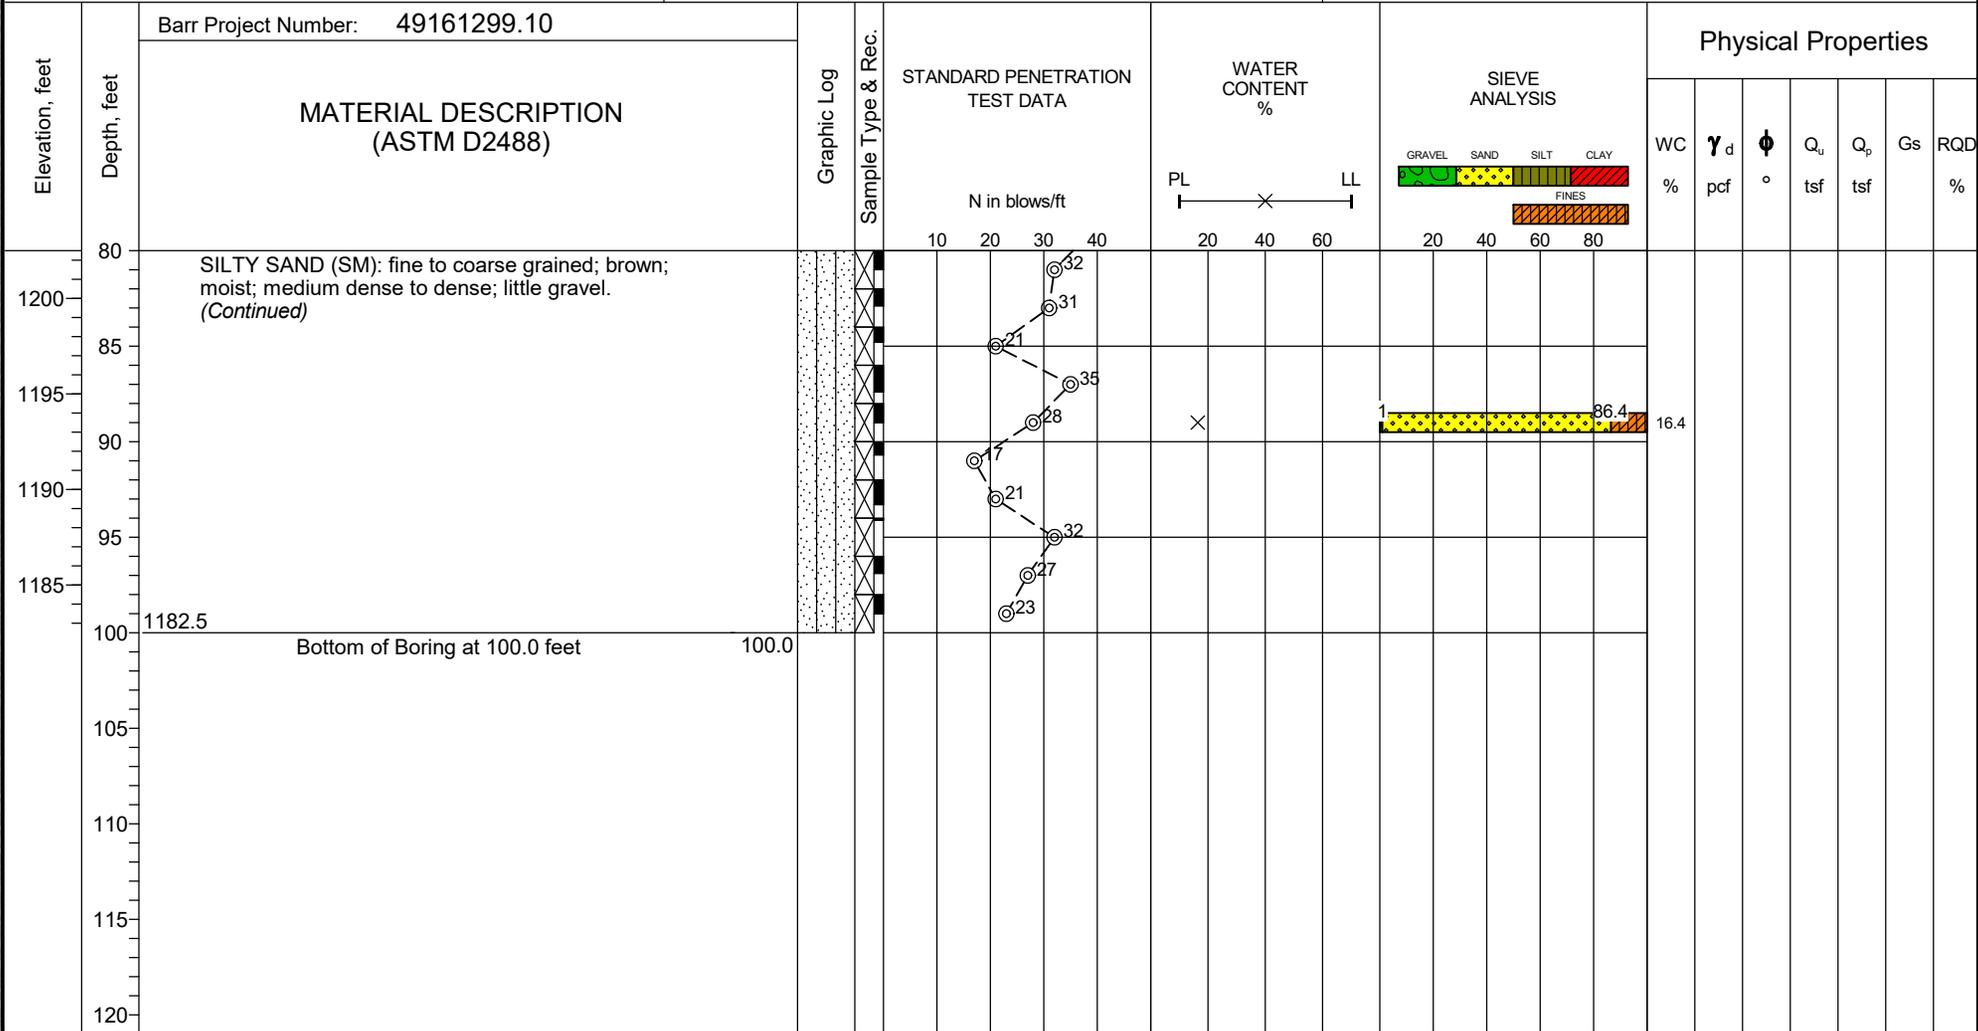
Completion Depth: 100.0      Remarks: Piezometers installed at 15, 49.5, and 89.5 feet. Hole caved at 72 feet and redrilled. Boring terminated at 100 feet as planned.  
 Date Boring Started: 9/10/19  
 Date Boring Completed: 9/13/19  
 Logged By: PMD/RWO

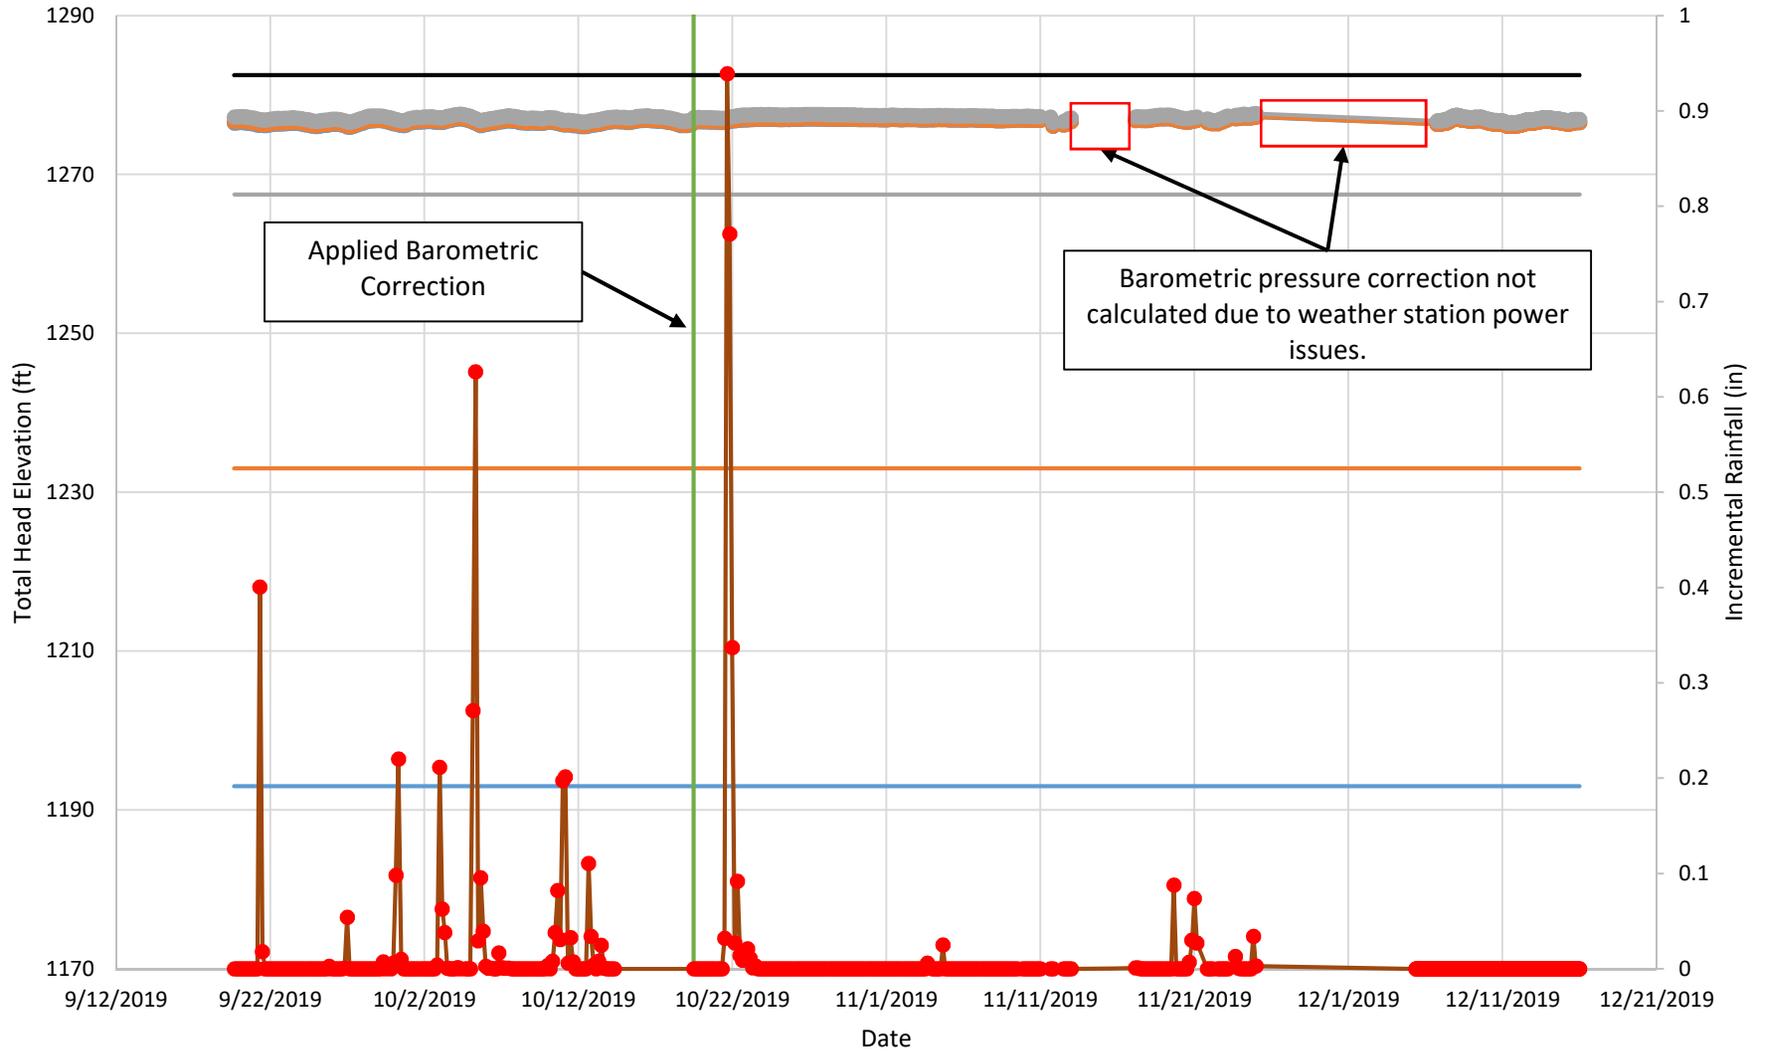
## Line 3 Replacement Spire Valley Middle Total Head vs Time

● SV\_19\_MiddleA\_THead   
 ● SV\_19\_MiddleB\_THead   
 ● SV\_19\_MiddleC\_THead   
 — SV19\_MiddleA Tip Elev  
— SV19\_MiddleB Tip Elev   
 — SV19\_MiddleC Tip Elev   
 — Ground Surface Elev   
● Rainfall

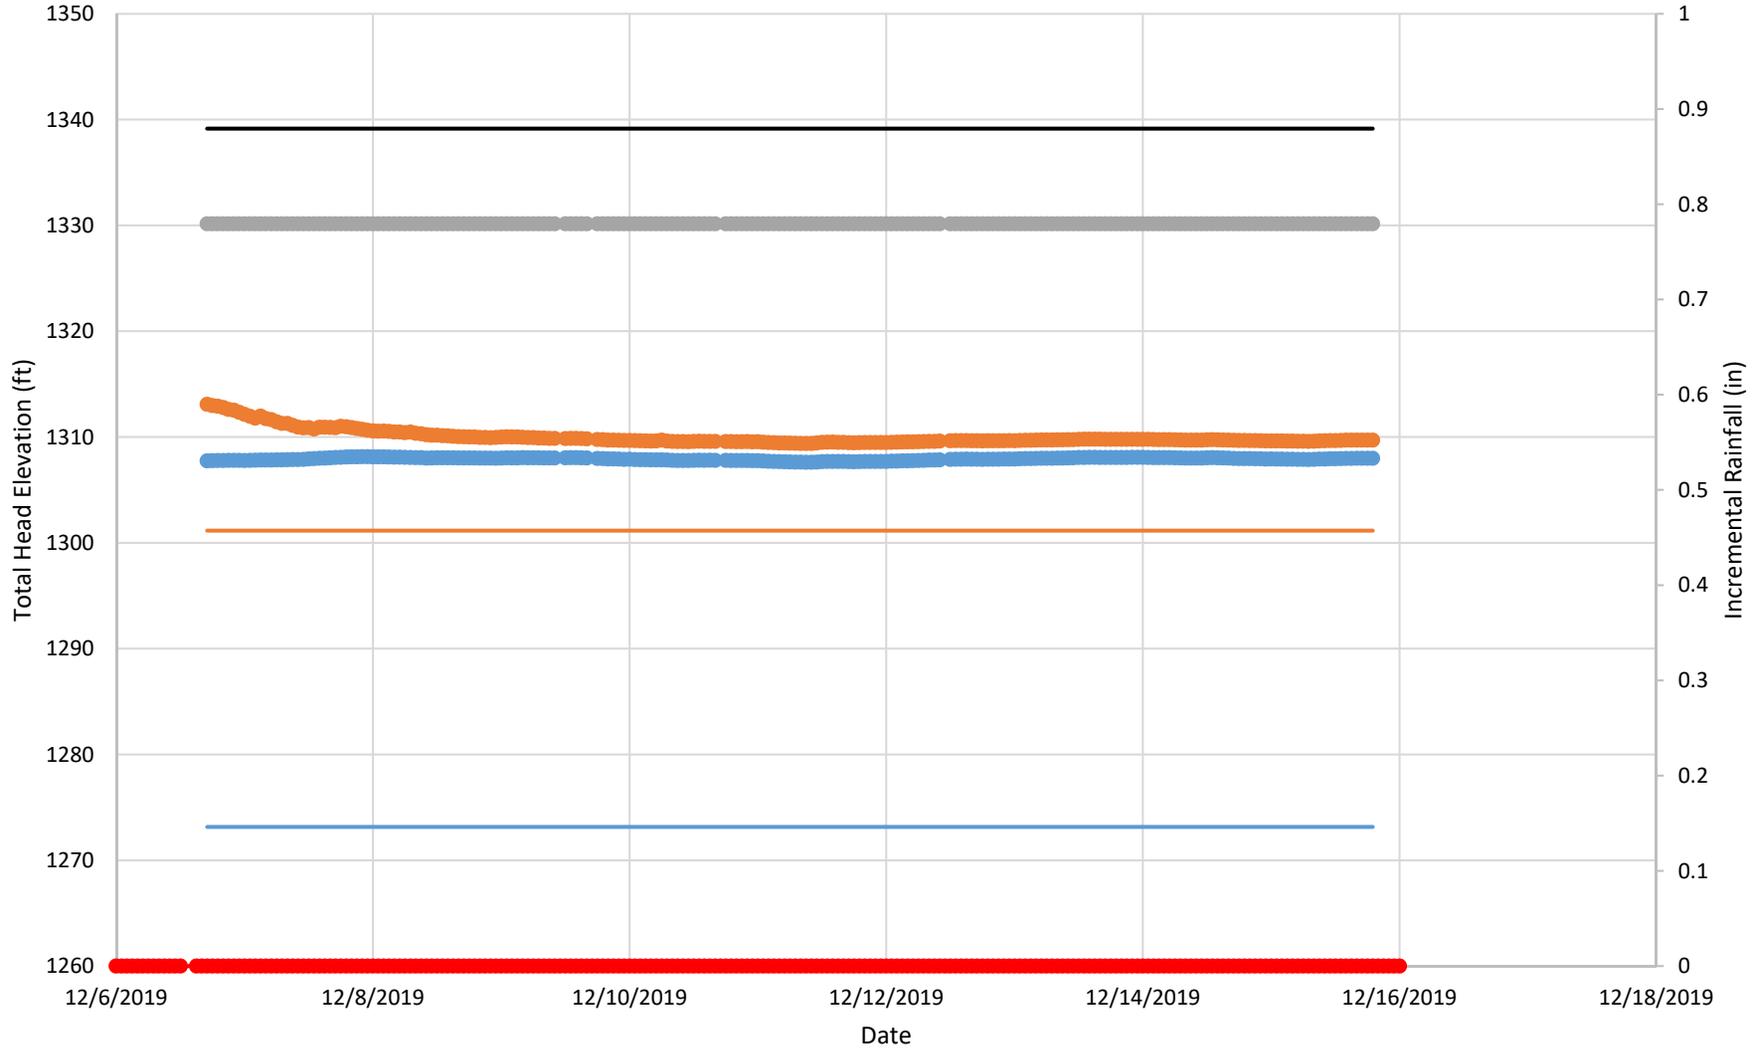
## Line 3 Replacement Spire Valley West Total Head vs Time

● SV\_19\_WestA\_Thead\_Corr   
 ● SV\_19\_WestB\_Thead\_Corr   
 ● SV\_19\_WestC\_Thead\_Corr   
 — SV19\_WestA\_Tip Elevation  
— SV19\_WestB\_Tip Elevation   
 — SV19\_WestC\_Tip Elevation   
 — Ground Surface Elevation   
 ● Rainfall

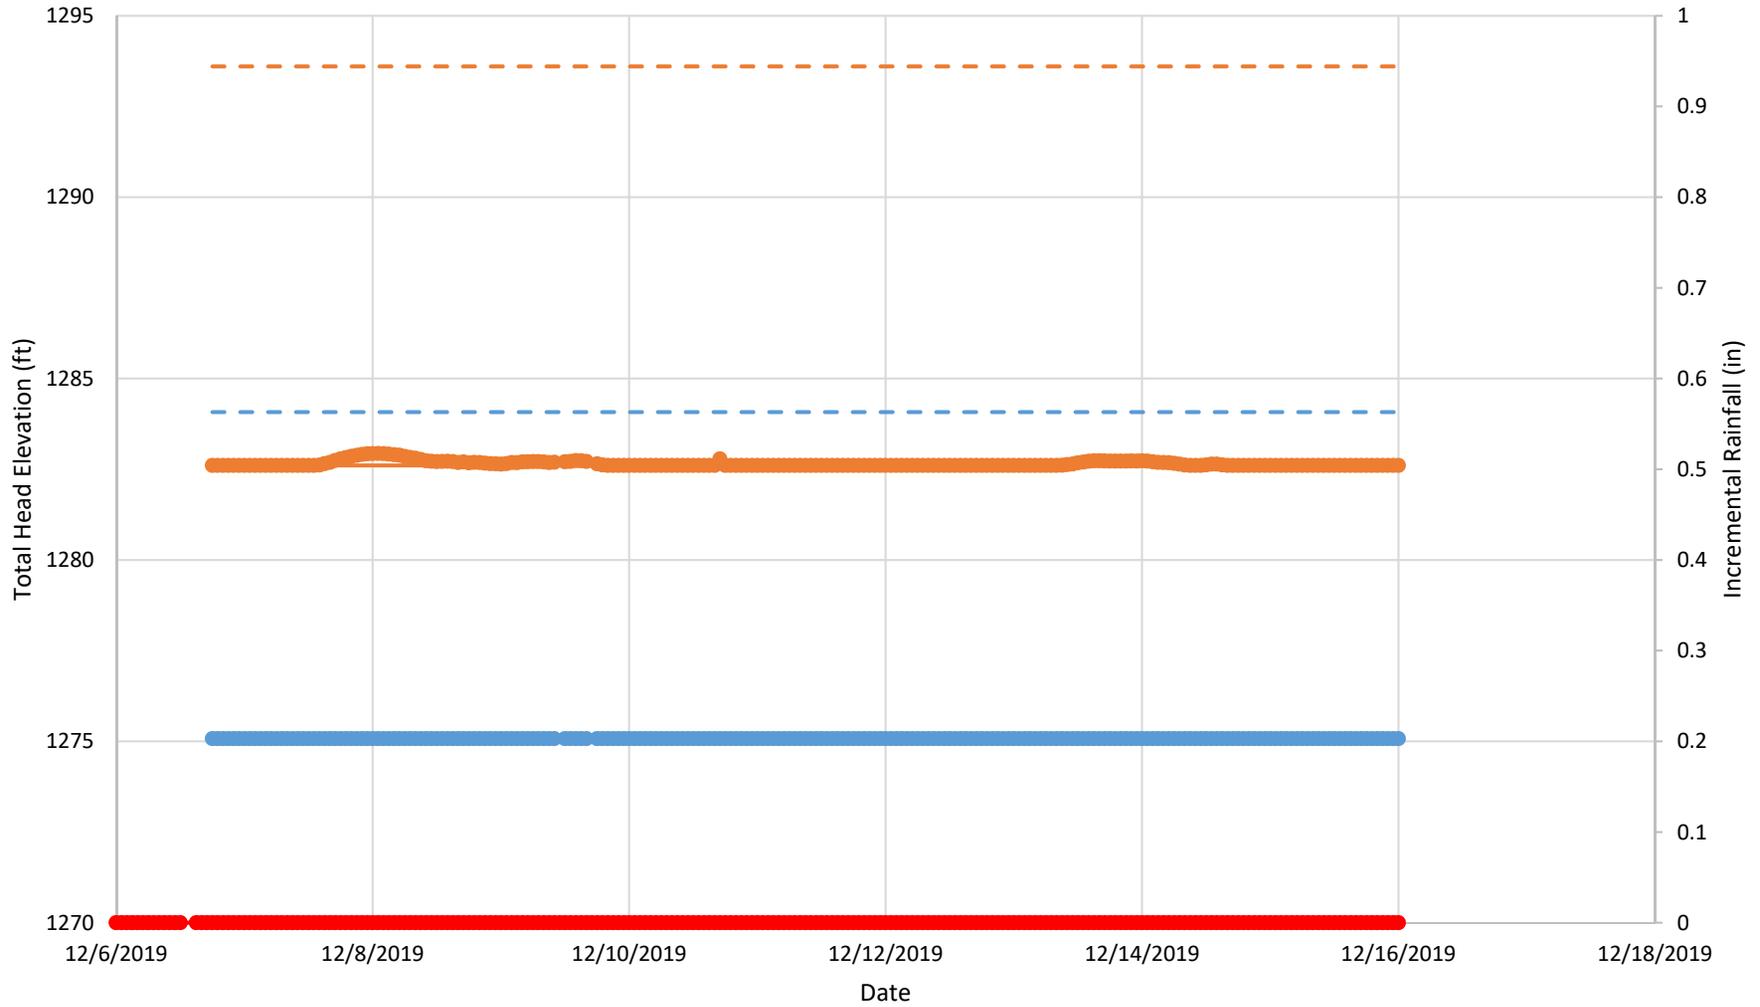
## Line 3 Replacement Spire Valley West Bank Total Head vs Time

- SV\_19\_HA\_4\_Thead\_Corr
- SV\_19\_HA\_3\_Thead\_Corr
- SV\_19\_HA\_4\_Tip Elev
- SV\_19\_HA\_3\_Tip Elev
- - SV\_19\_HA\_4\_Ground Surface Elev
- - SV\_19\_HA\_3\_Ground Surface Elev
- Rainfall

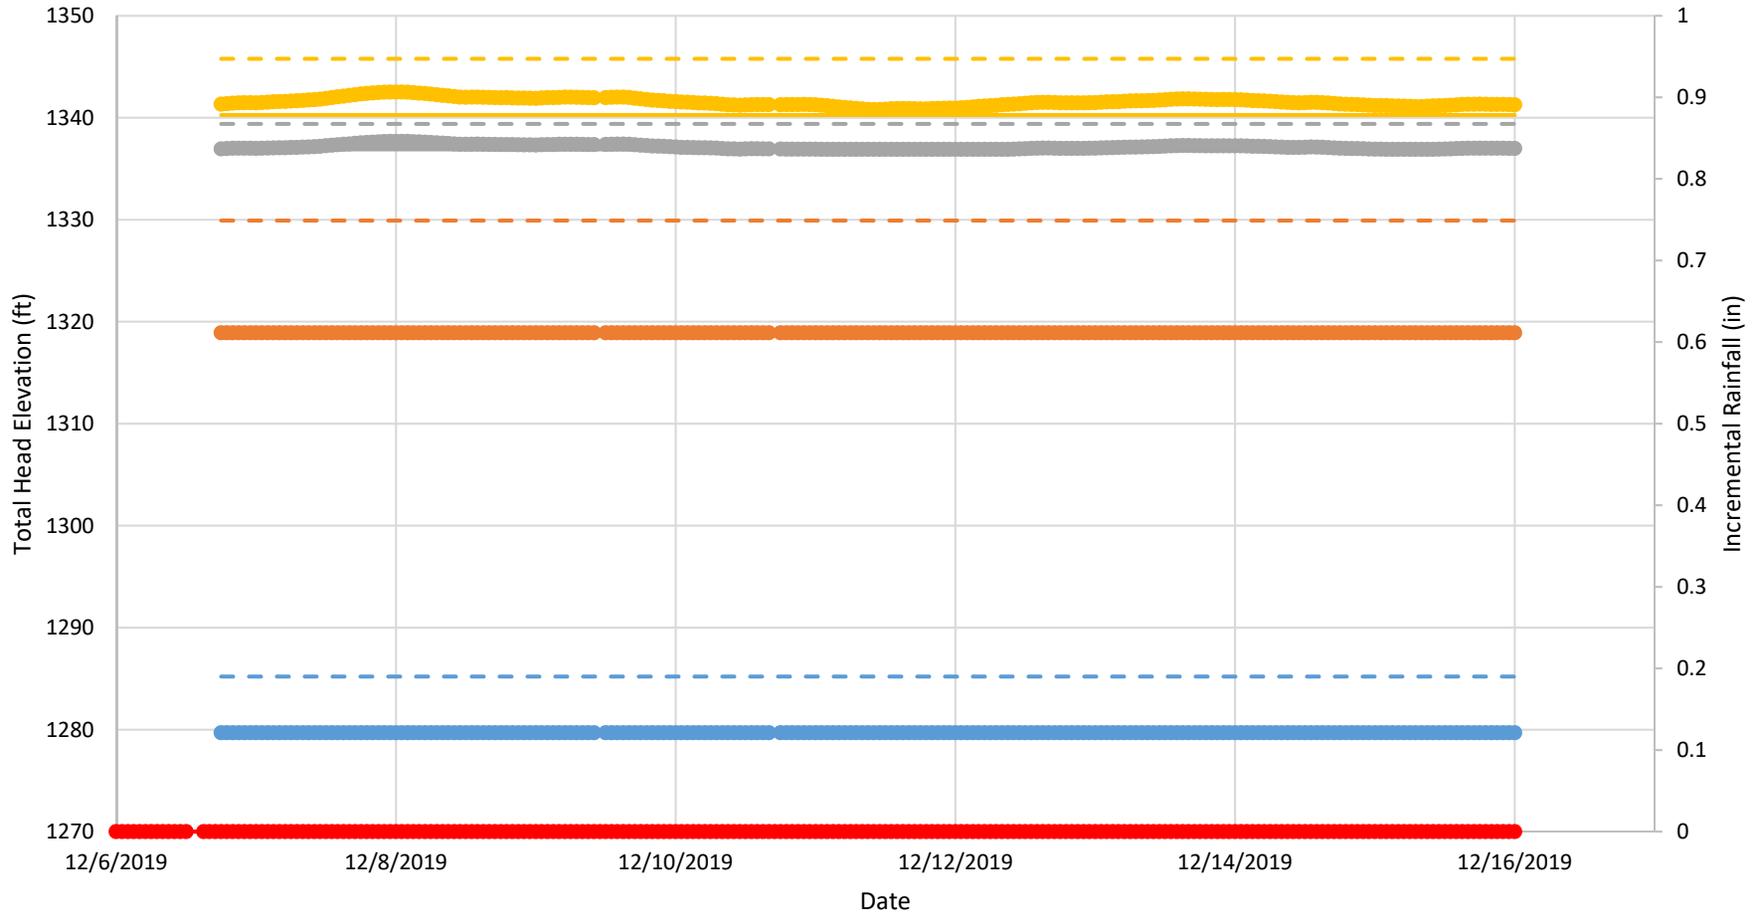
### Line 3 Replacement Spire Valley Middle Spine Total Head vs Time

- SV\_19\_HA\_5\_Thead\_Corr
- SV\_19\_HA\_8\_Thead\_Corr
- SV\_19\_HA\_5\_Tip Elev
- SV\_19\_HA\_8\_Tip Elev
- - SV\_19\_HA\_5\_Ground Surface Elev
- - SV\_19\_HA\_8\_Ground Surface Elev
- Rainfall
