**Heron Lake Management Plan
DOW #32005700
December 2021**

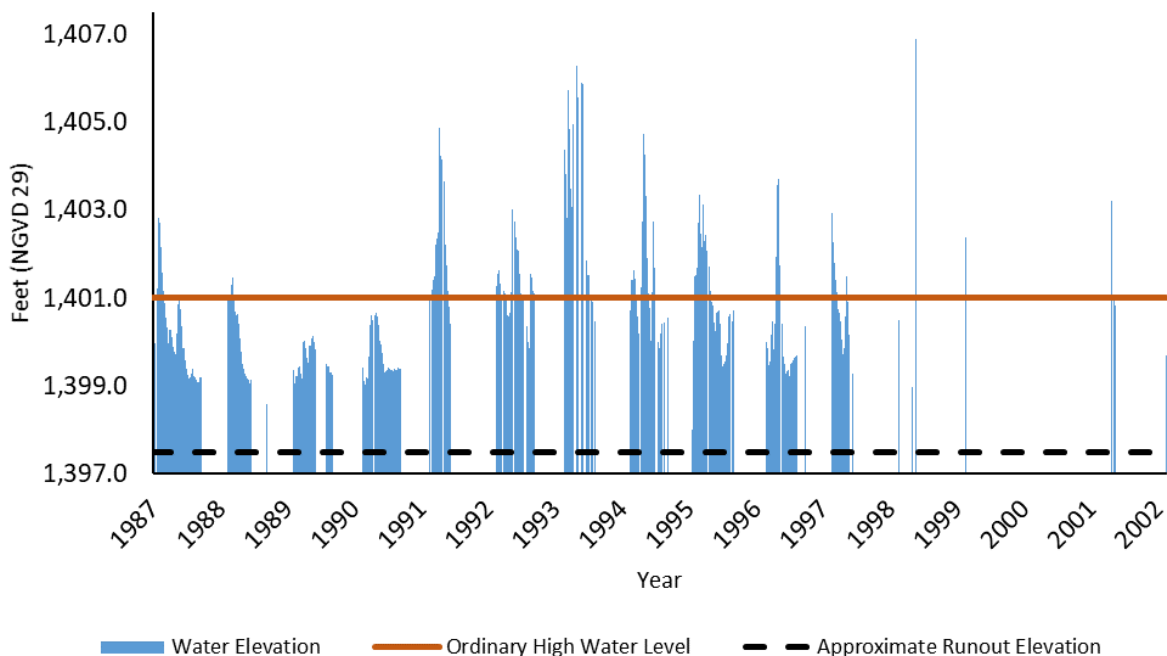
Figure 2. Water level readings, ordinary high water level, and approximate runout elevation for North Heron from 1987 to 2002.

4. South Heron (established in 1979) – 1403.0 ft.
- Water level readings: Water level readings have been taken periodically since 1907 on North Marsh (Figure 1), North Heron (Figure 2), and South Heron (Figure 3). Water level readings are only displayed from 1987 onward because the Heron Lake water control structure was significantly modified in 1987.

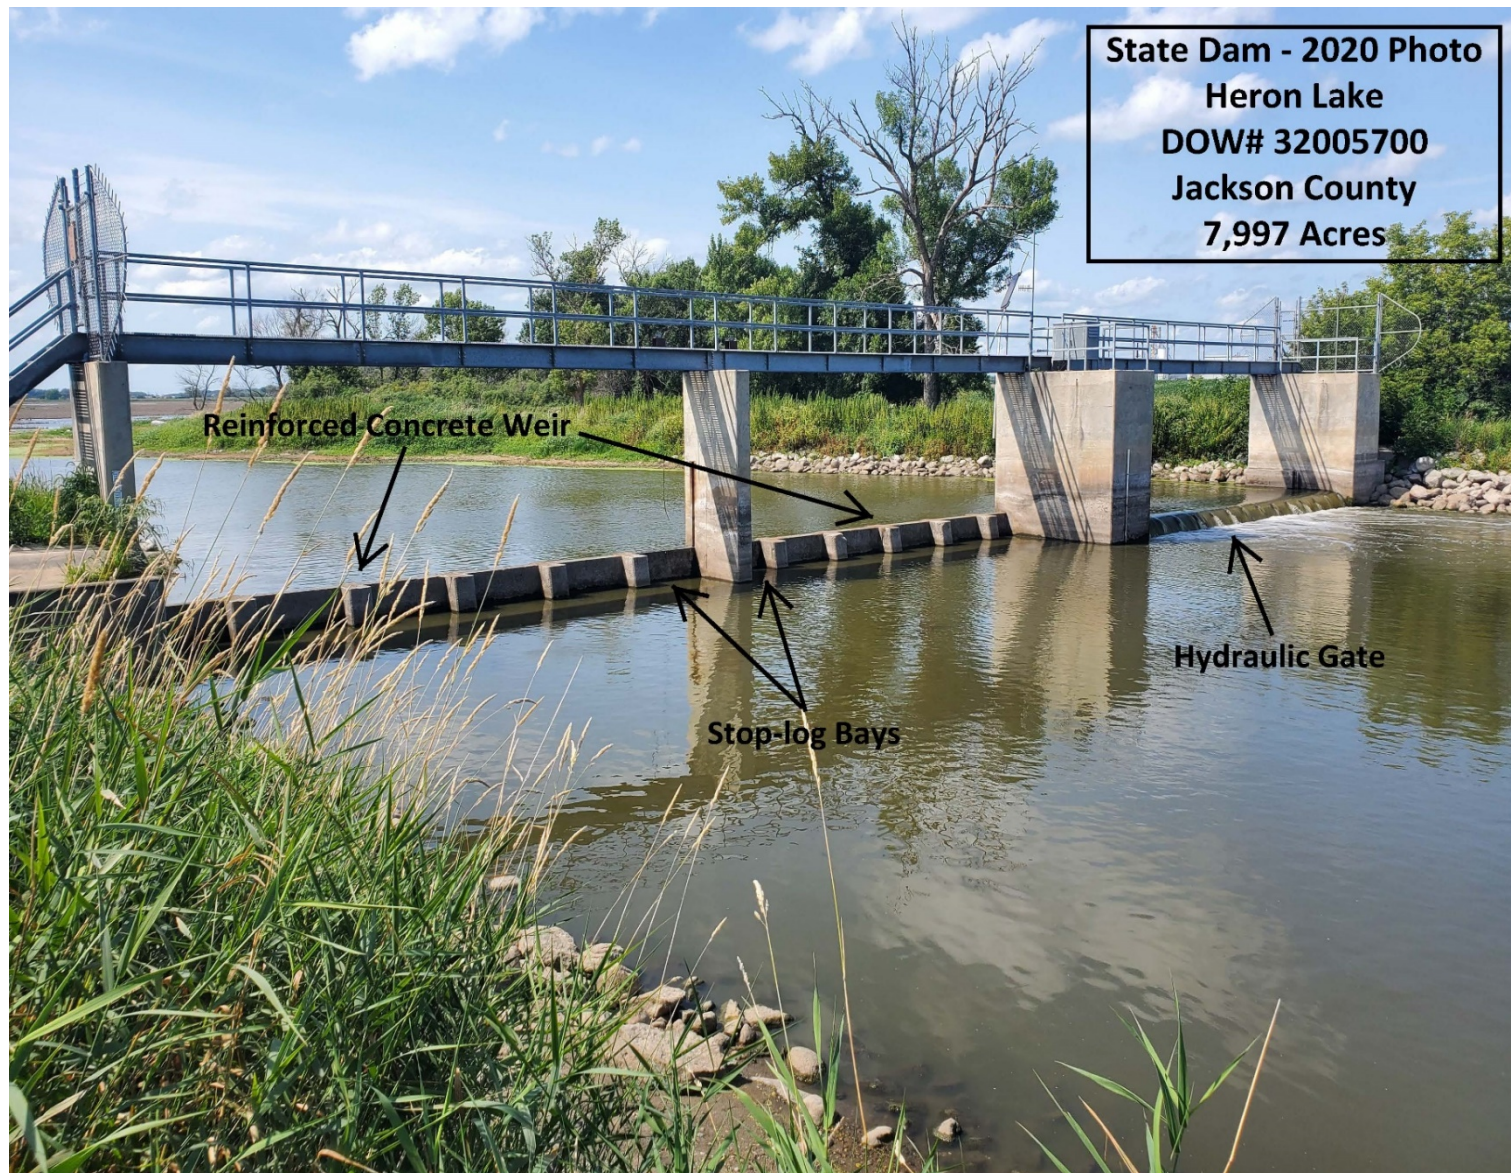
Attachment B. Picture of the State Dam that displays the location of the concrete weir, stop-log bays, and hydraulic gate.

- Water control structure: The outlet for Heron Lake is controlled by a dam that consists of a 60.25 ft. reinforced concrete weir, two 5 ft. stop-log bays fitted with removable steel gates, and a 40 ft. hydraulic gate (Attachment B). The hydraulic gate can be operated between 1400.2 ft. and 1396.2 ft. (i.e., the sill elevation). The concrete weir and the stop-log bays have a crest elevation of 1399.5 ft.

The State Dam was renovated in 1987. The existing in-stream piers were cut down from 1401.2 ft. to 1400.2 ft. and ten of the original 19 stop-log bays were filled with concrete to an elevation of 1400.2 ft. Of the remaining nine stop-log bays, two were fitted with removable steel maintenance gates and seven were converted to one 40 ft. wide bay with a hydraulic gate capable of being opened to any level between 1400.2 ft. and 1396.2 ft. (Attachment B). Additionally, an electric fish barrier was installed downstream of the State Dam in 1991 (Attachment C). The fish barrier was installed to inhibit destructive bottom-feeding fish from migrating into Heron Lake from the West Fork of the Des Moines River. The most recent modification to the State Dam occurred in 2006 when the concrete weir was lowered to 1399.5 ft. This modification reduced the head-to-tail water elevation difference and improved water flow.

The 40 ft. hydraulic gate is currently inoperable because the hydraulic cylinders that raise and lower the gate need replacement. Therefore, the hydraulic gate is presently fixed at an elevation of 1399.8 ft. The DNR will hire an engineering consultant to evaluate design options for repair or modification.

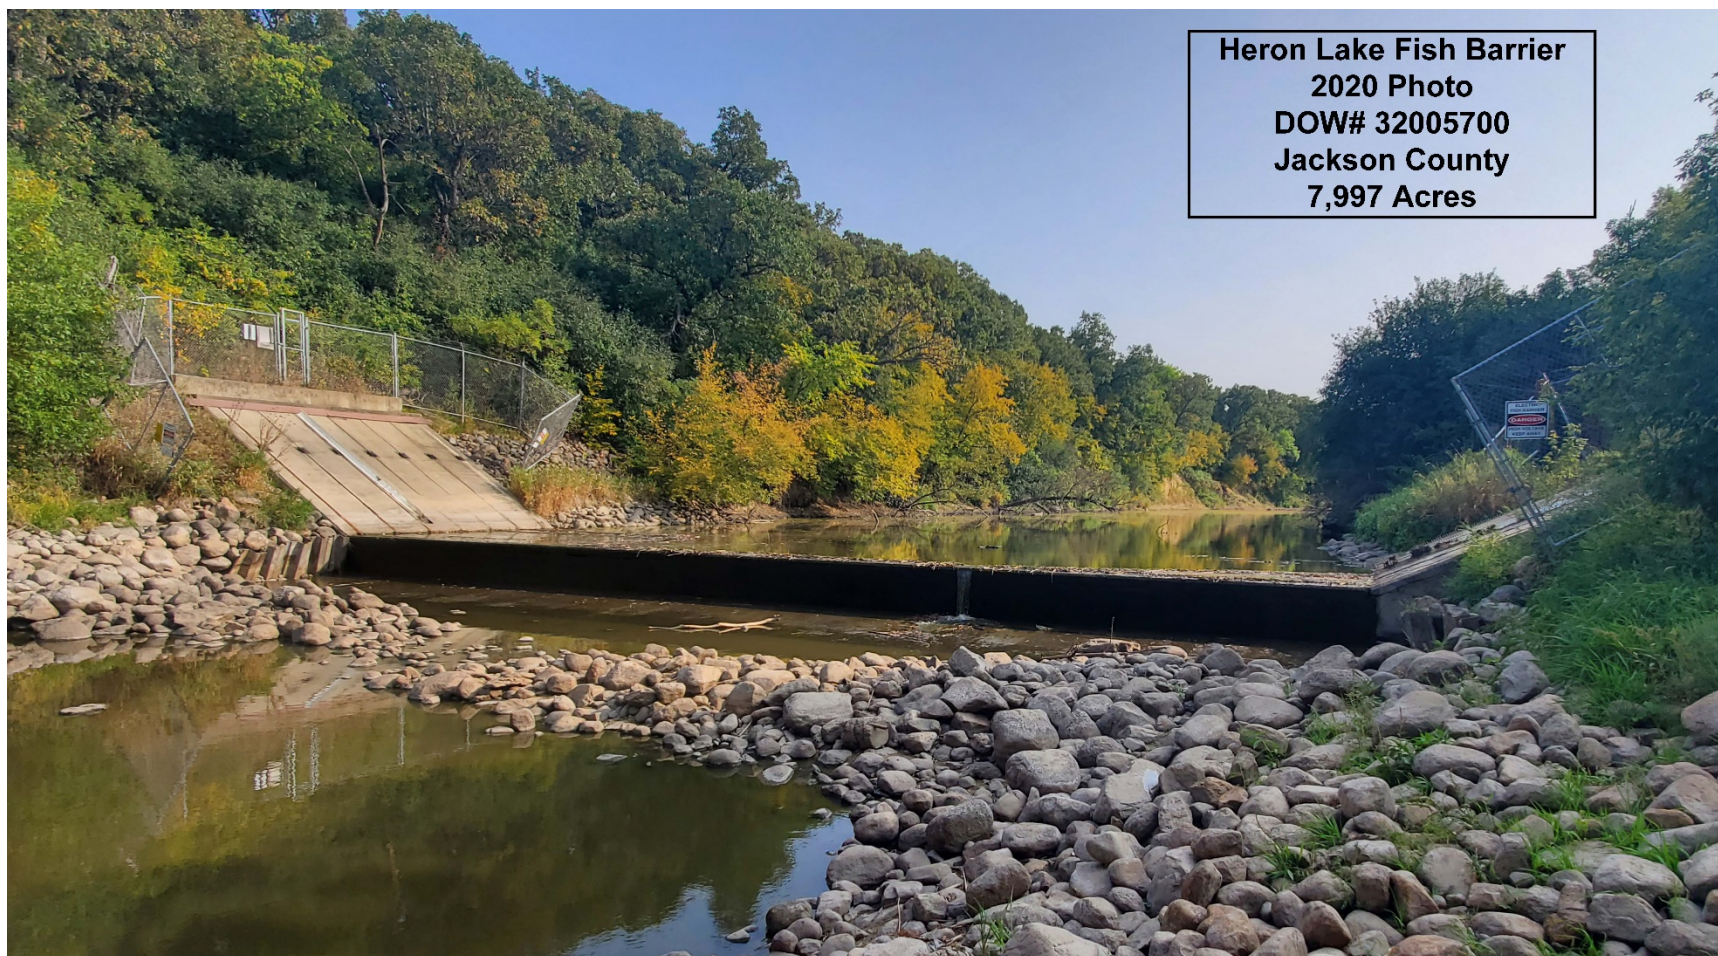
Attachment C. Photo of the Heron Lake electric fish barrier.
