## MEMORANDUM

RE: Cedar Lake Wild Rice Restoration Design Memo  
SEH No. SEHDB 186202 14.00

CEDAR LAKE  
MANOOMIN HABITAT RESTORATION

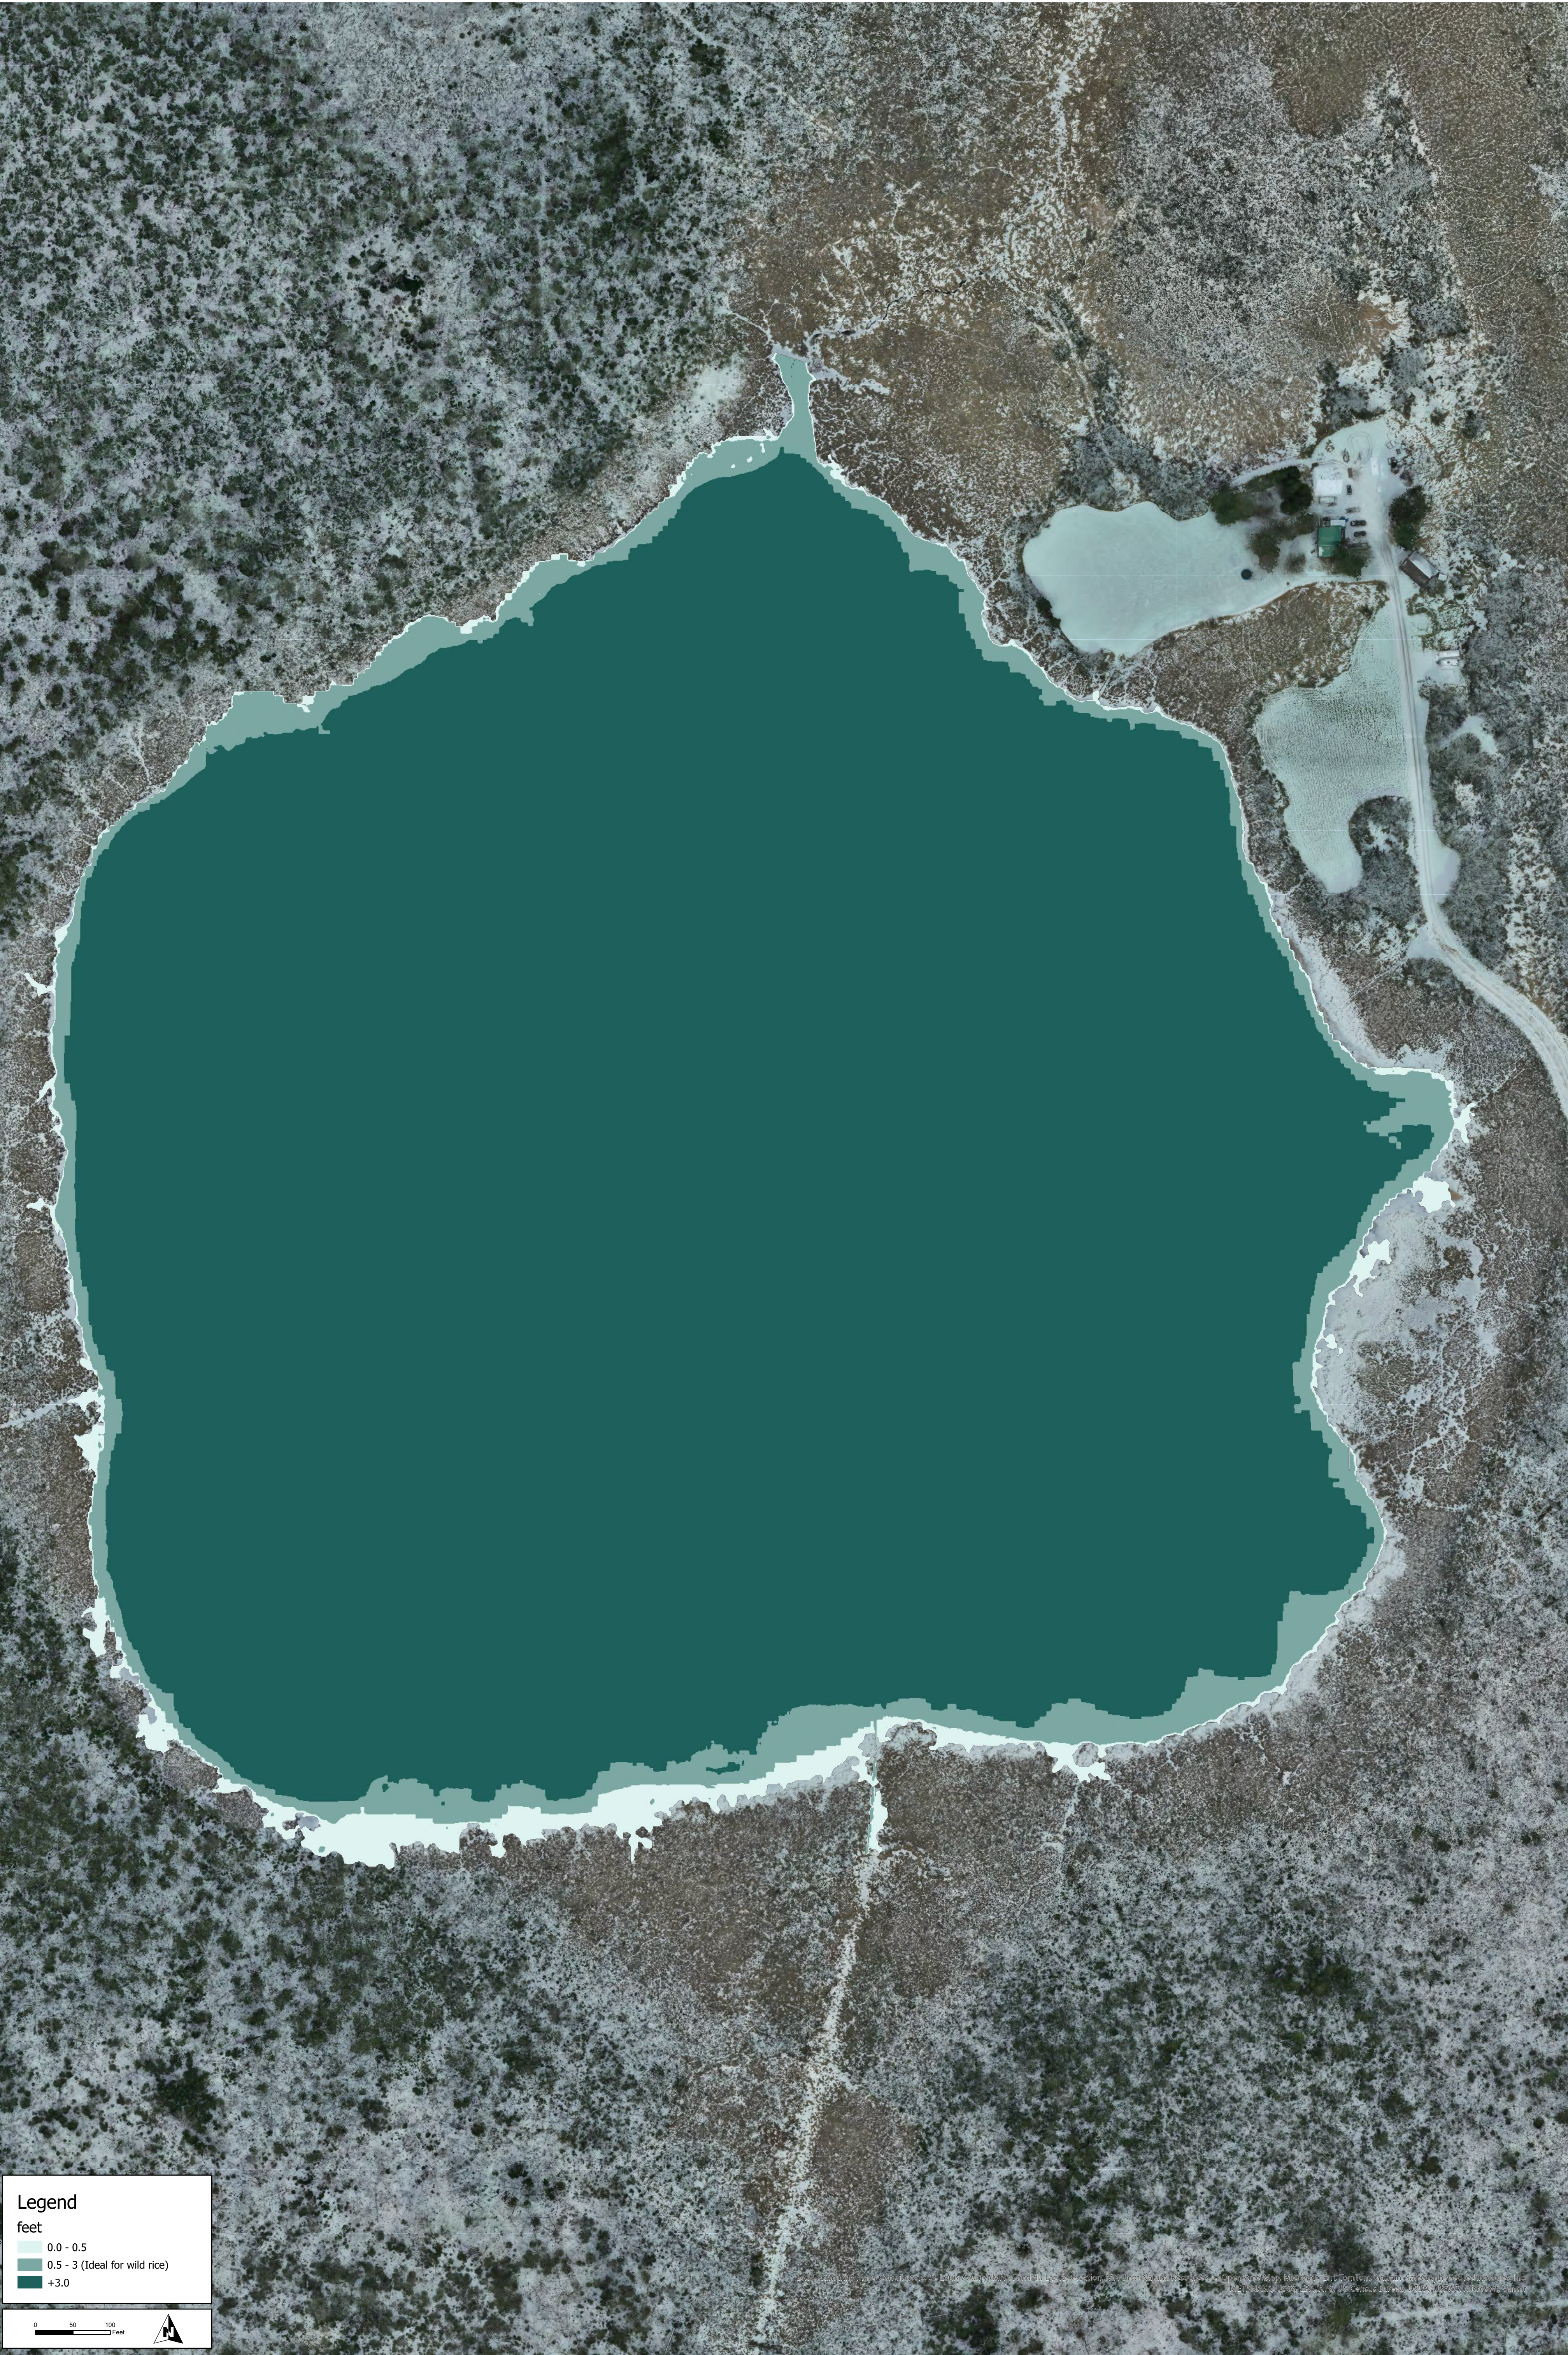
FIGURE 6a

Cedar Lake Existing Water Levels

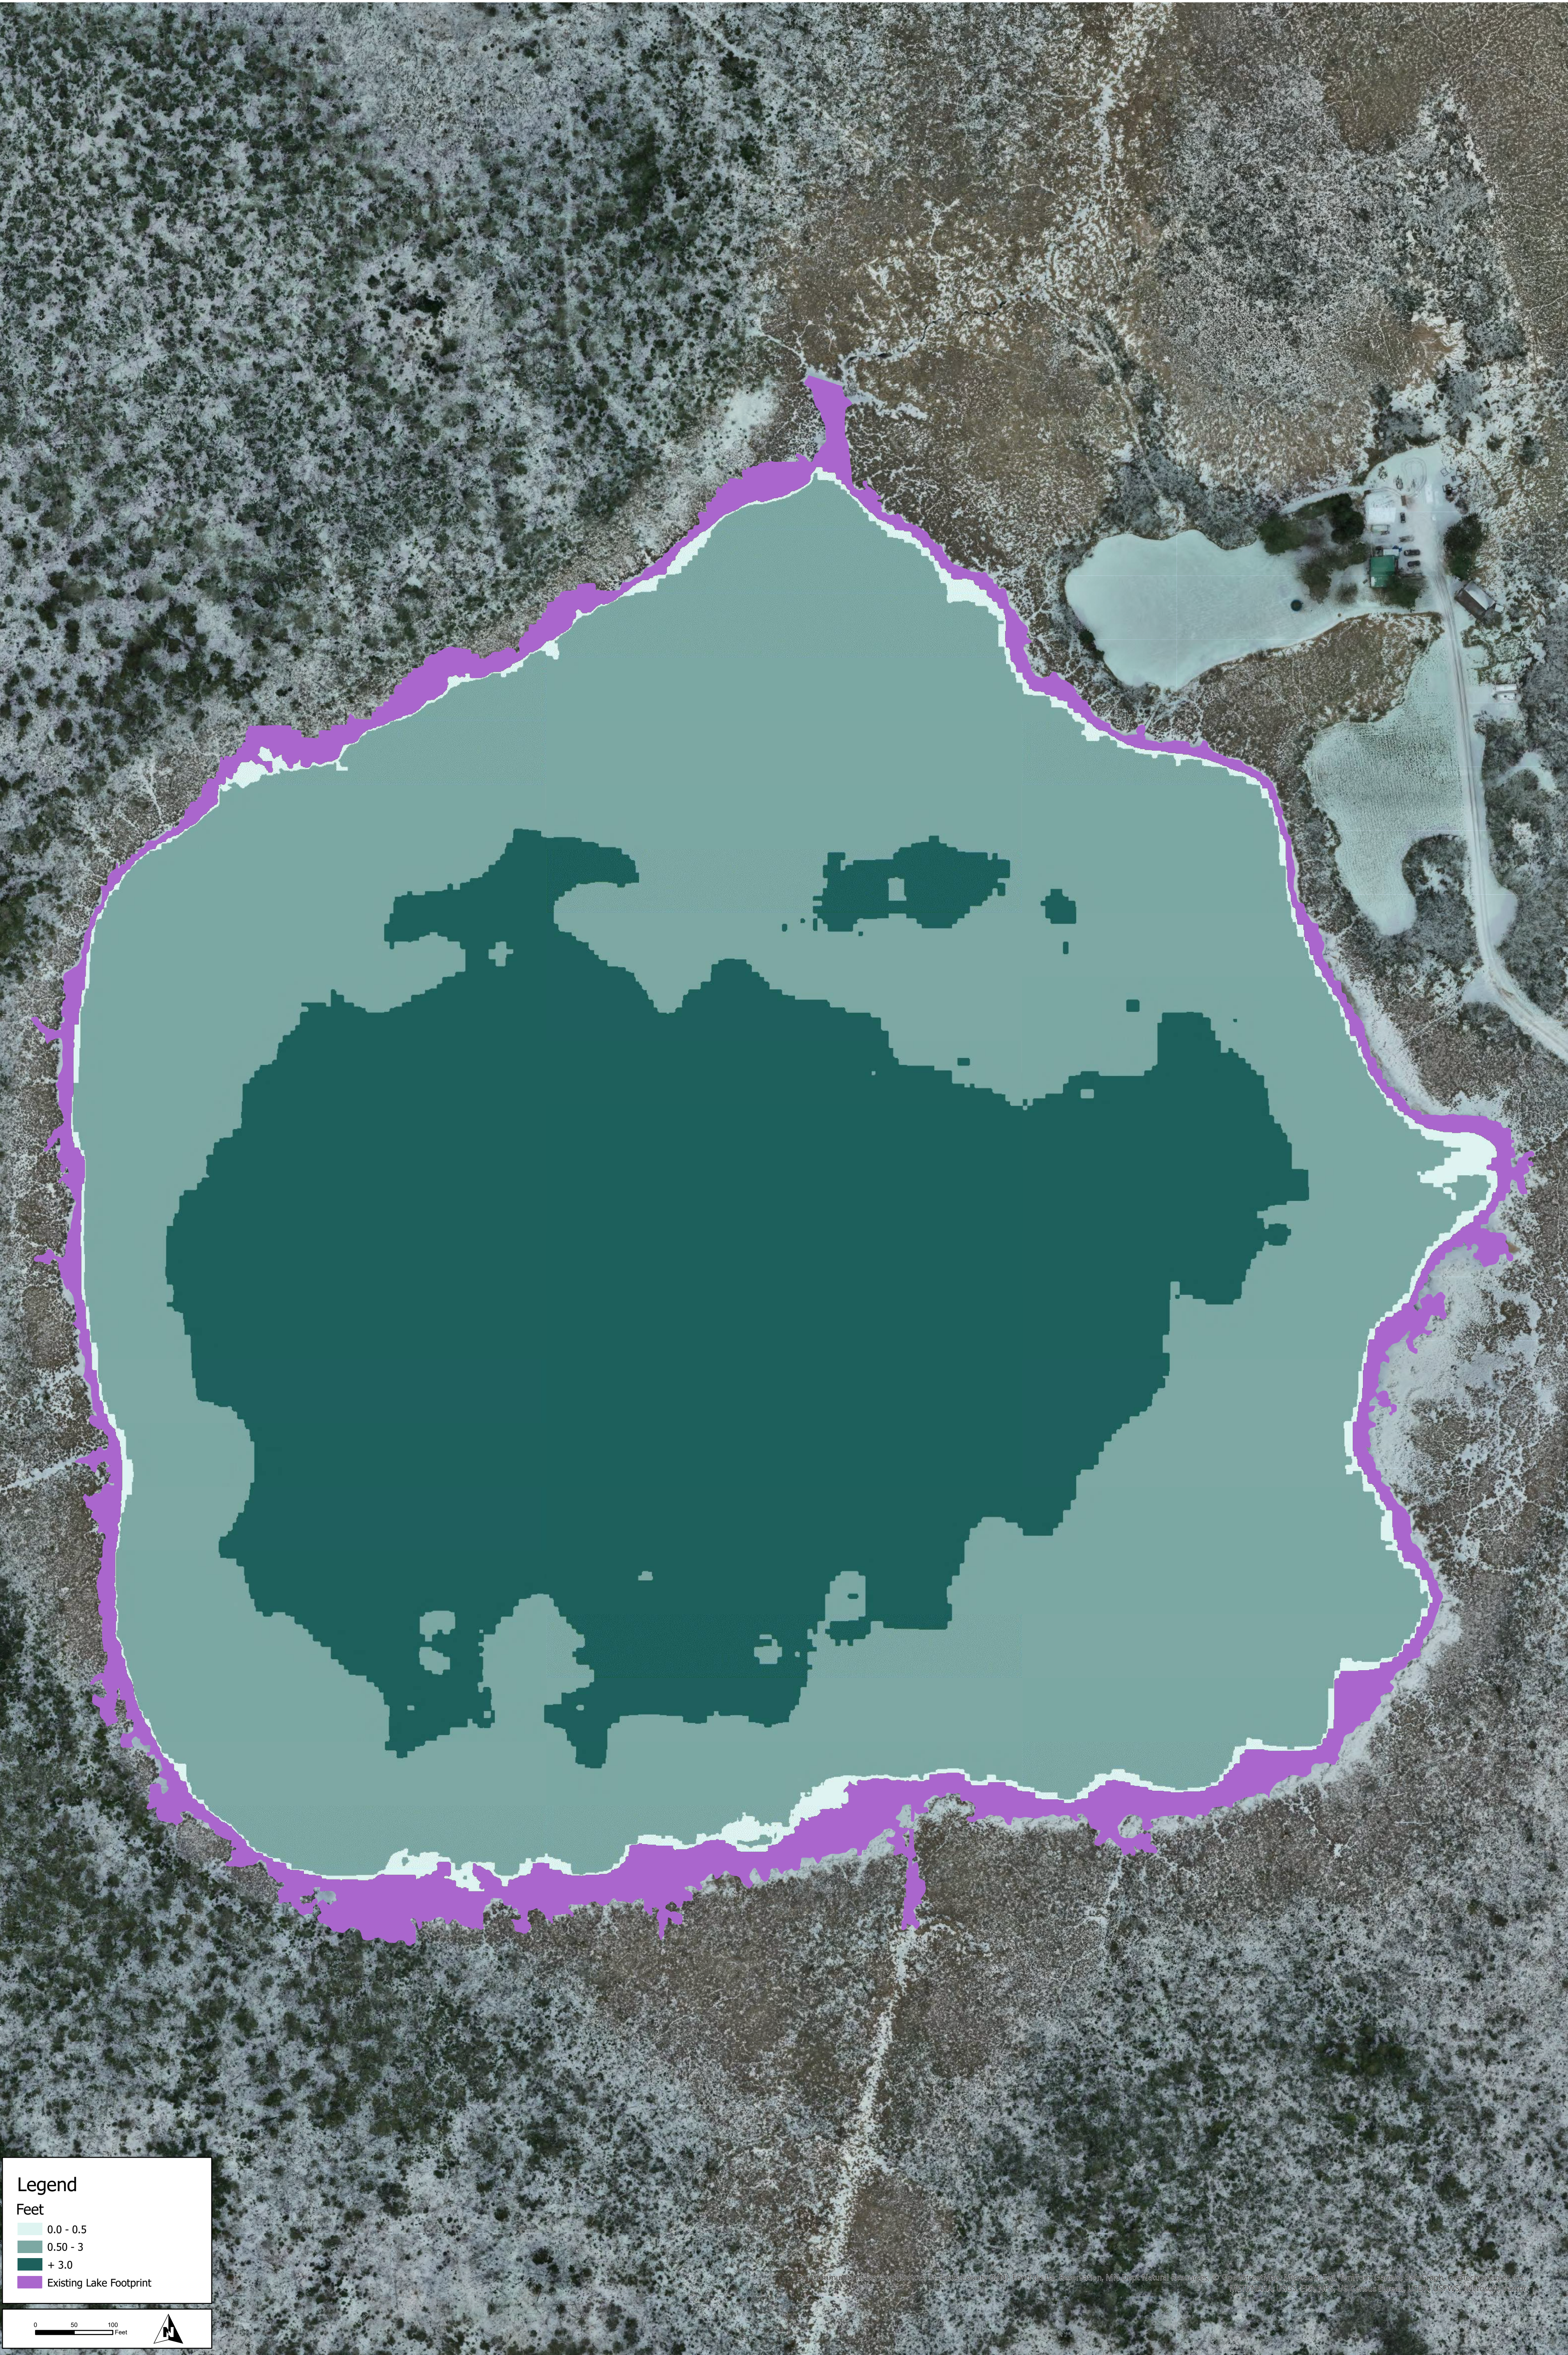
**FIGURE 6b**  
Cedar Lake Proposed Lake Level: 1302

Analysis of the available data shows that the cause for elevated lake levels in Cedar Lake is obstructions to flow primarily due to beaver activity. Lowering the lake level to 1301 would significantly increase the area of suitable water depths for wild rice growth (Figure 6a through Figure 6d). Lowering the lake level by the proposed 3 ft would reduce the overall area of the lake from 59.6 acres to 54.6 acres. This reduction will bring the lake back to its historic wild rice producing and likely pre-beaver dam influence lake elevation. Impact on the lake shore or surrounding wetlands is not expected and will be monitored by the Fond du Lac Natural Resource team. The overall lake area reduction and wild rice habitat increase for all interim lake levels are summarized in Table 3. The modeling indicates capacity of the channel is not a factor and the best course of action to return lake levels to those appropriate for wild rice growth is to remove these obstructions along the alignment of Simian Creek. The most effective course of action is to travel upstream from Twin Lakes Drive and remove channel obstructions as they are found. Minor obstructions like logs, branches and vegetation can be cleared and major obstructions like beaver dams should be breached along the channel alignment.
