APPENDIX F. GRINDSTONE RIVER DAM REMOVAL DRAFT ENVIRONMENTAL IMPACT STATEMENT

Geology and Geophysical Survey of the Grindstone Dam Reservoir Area

**Hydrogeology and Groundwater Unit
Ecological and Water Resources Division
Minnesota Department of Natural Resources**

October 2021

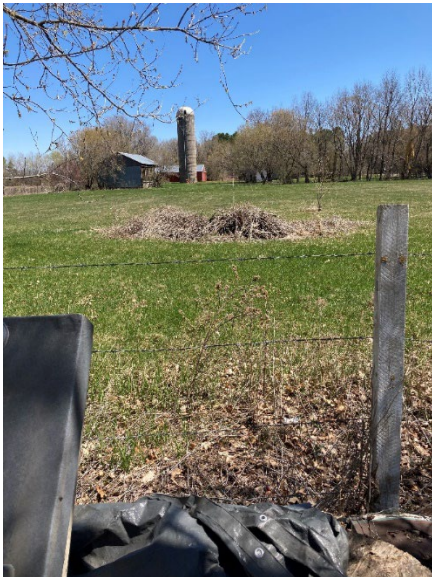
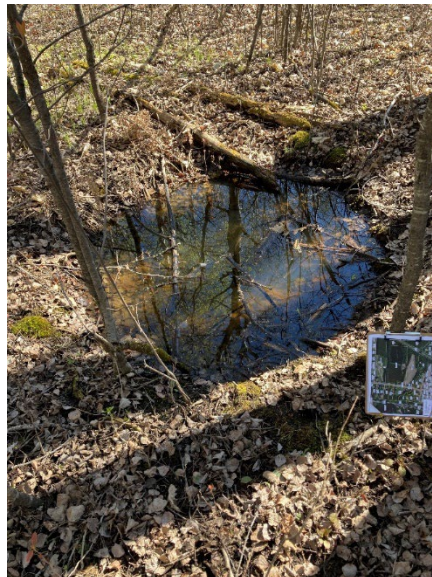
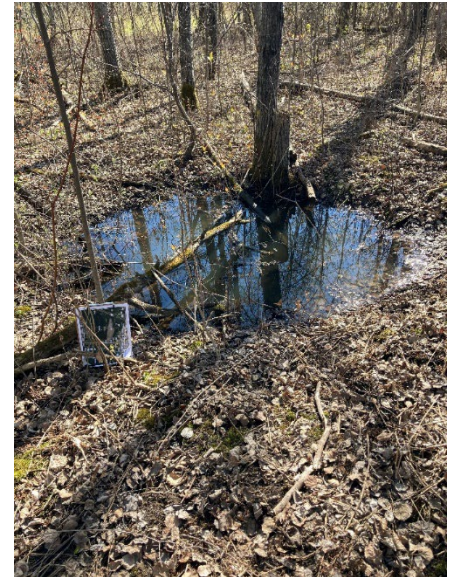
Figure 2. LIDAR surface anomaly locations 6, 18-1, and 18-2 interpreted as probable and possible sinkholes.

In the County Geologic Atlas of Pine County Part A (Plate 6, Shade and others, 2001) the authors write;” Although the sinkholes in Pine County occur in a variety of shapes and sizes, a common morphology is a sinkhole a few meters in diameter and less than two meters deep that is a concave downward funnel. The debris filled hole at location 6 (**Figure 2**, left photo) seemed like a probable sinkhole to Dr. Alexander based on the similarity of this feature to sinkholes that he has seen in southeastern Minnesota and other parts of Pine County. The two water-filled holes at location 18 (**Figure 2**, right two photos) could have been sinkholes since they are closed depressions (possible sinkholes, photos included). Three seep or spring features were found (locations 2, 14, and 20) which may or may not be related to karst features. One of the limitations of trying to find karst features from LIDAR anomalies is the age of the LIDAR coverage (2006, <https://gisdata.mn.gov/dataset/elev-lidar-pine2006>). It is possible that some of the locations that might have been holes in 2006 have since been filled in this urban area.

Ideally the surface and subsurface phases of the project (LIDAR anomaly evaluation and electrical resistivity survey) would have been integrated and complementary by locating the resistivity lines near the possible or probable sinkholes. Unfortunately, LIDAR surface anomaly location 6 was located on land where the MNDNR staff were denied access permission. LIDAR surface anomalies 18-1 and 18-2 were in a forested area that could not be directly accessed with resistivity survey equipment and the nearby areas (proposed resistivity lines 3 and 4) were not suitable for the resistivity survey method due to buried metal pipes and crushed rock.
