Joint Permit Application and Wetland Replacement Plan

**West Ridge Railroad Relocation and Tailings Basin
Progression**

**Prepared for
Northshore Mining Company**

April 2019

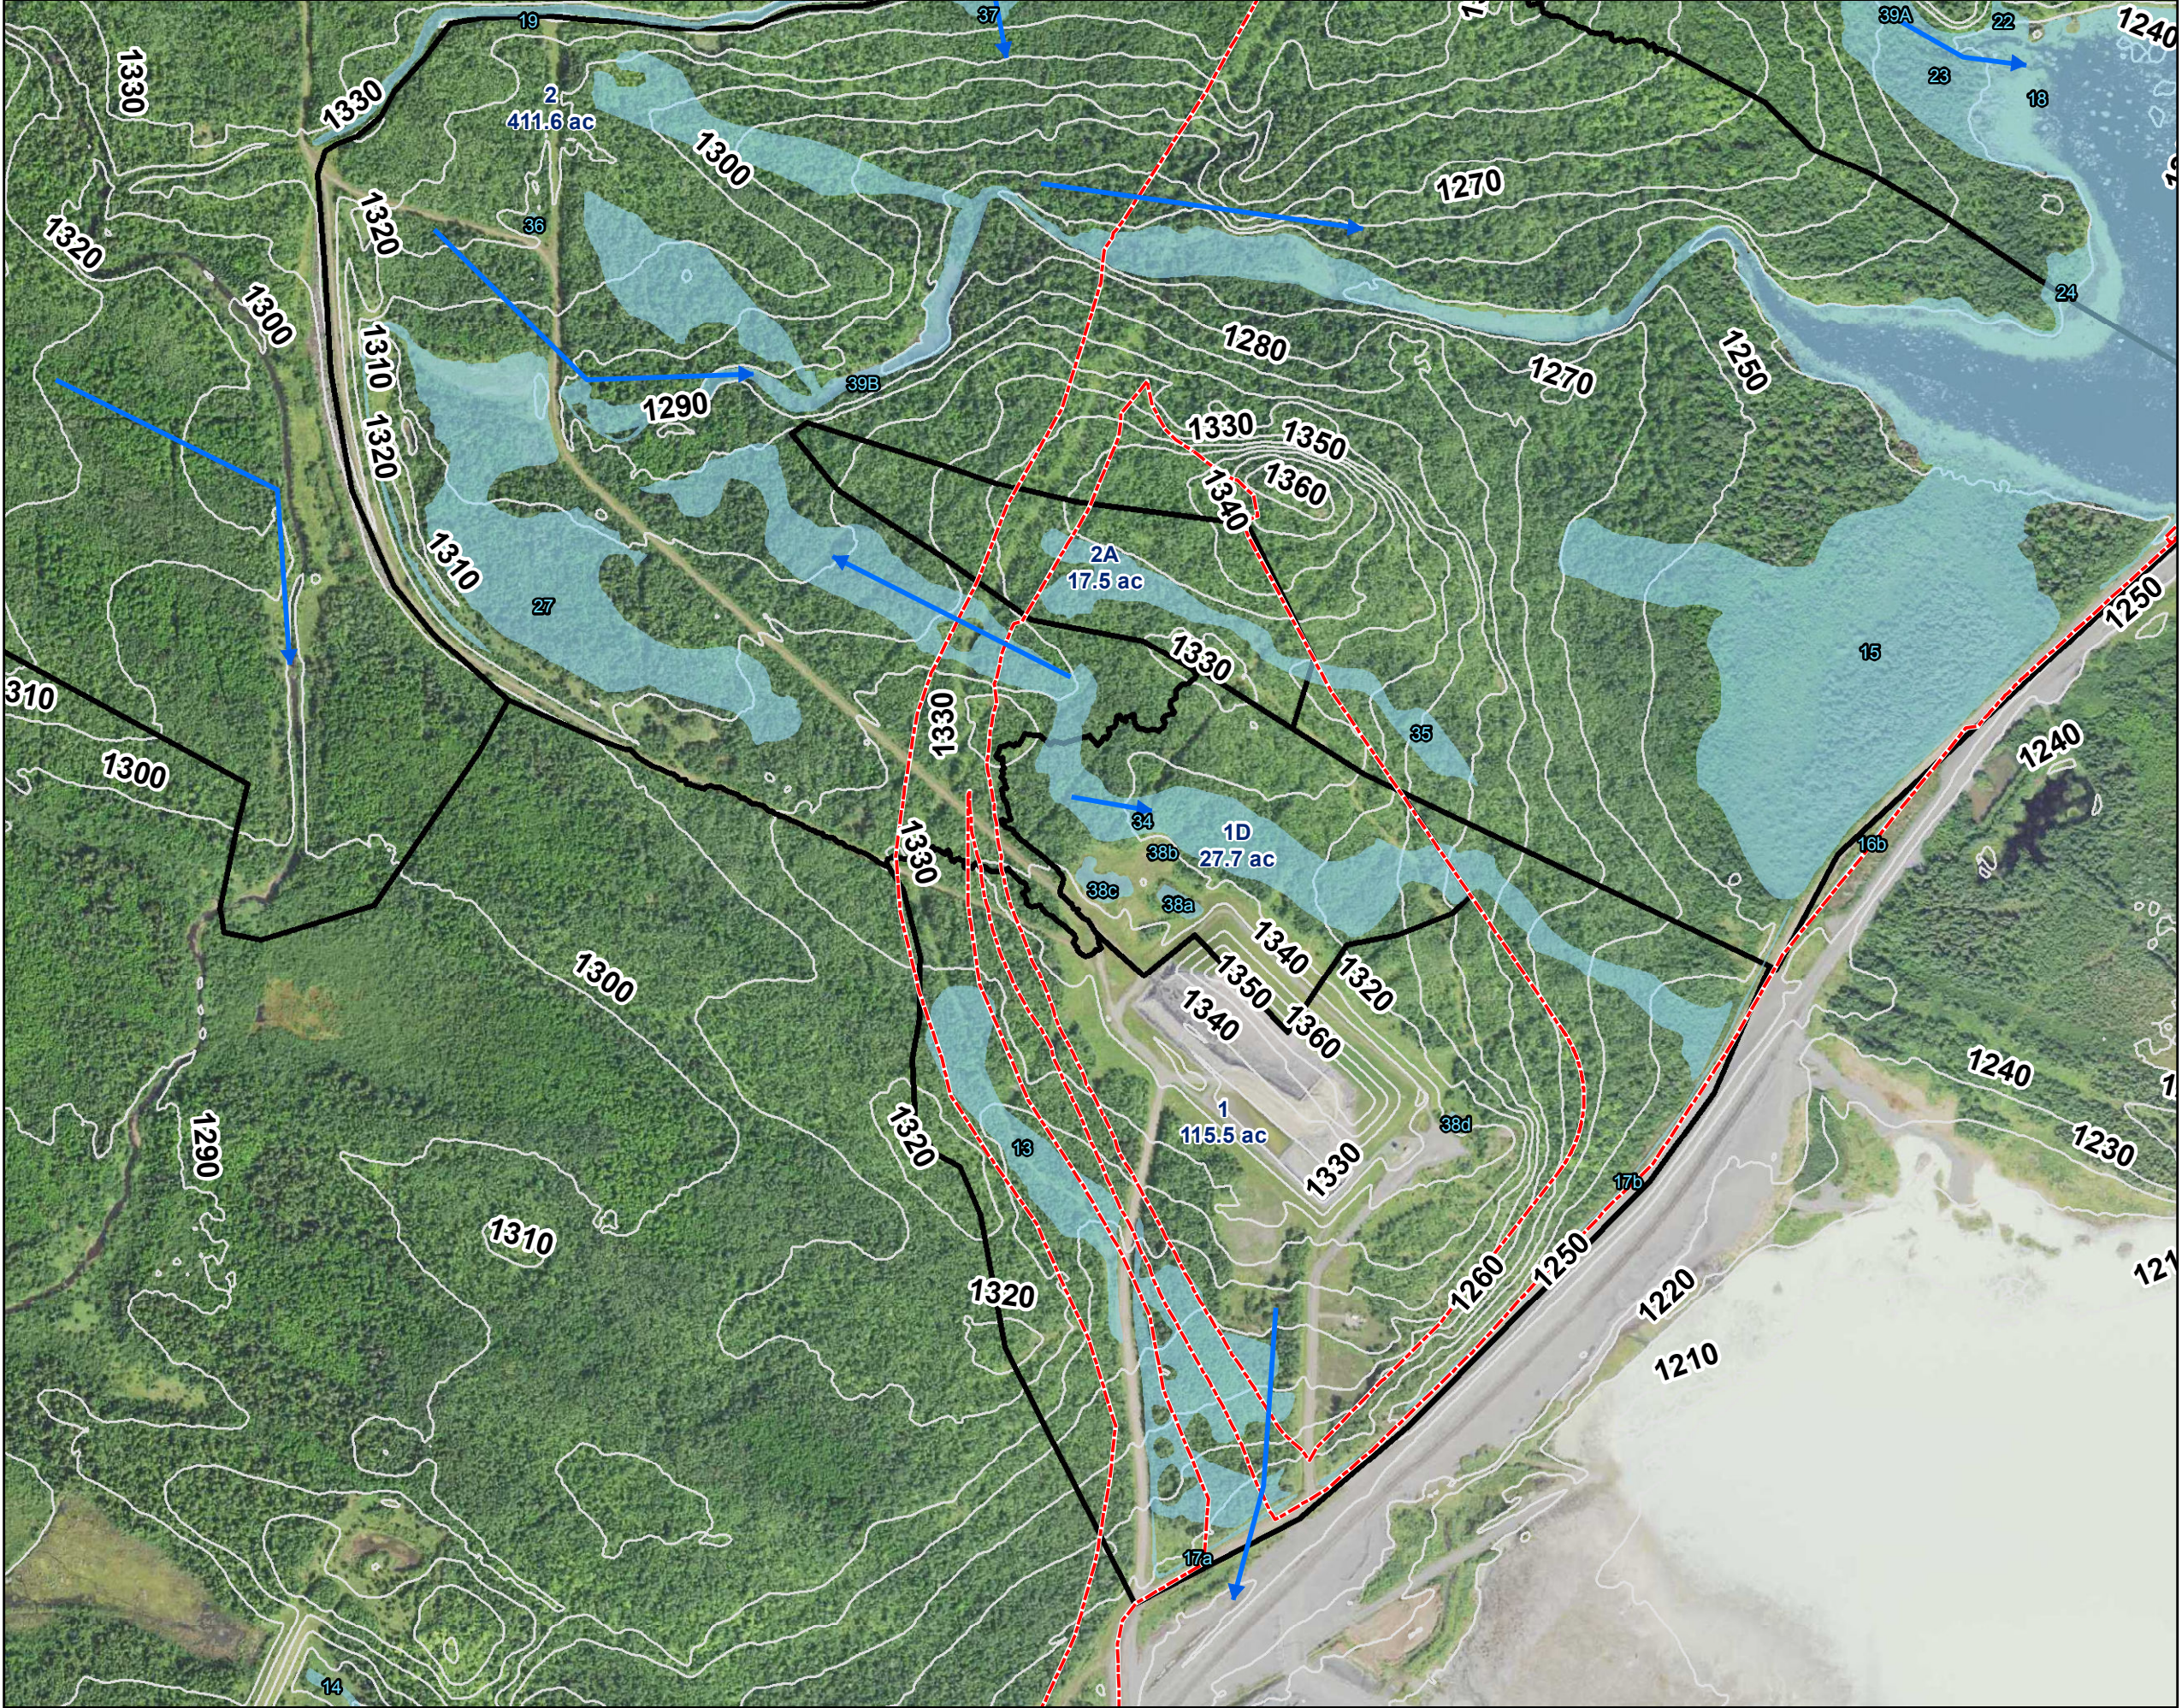
Figure 21
Existing Conditions Watersheds
and Wetlands

West Ridge Proposed Railroad
Realignment and Tailings Basin
Progression
Northshore Mining Company
Lake County, MN

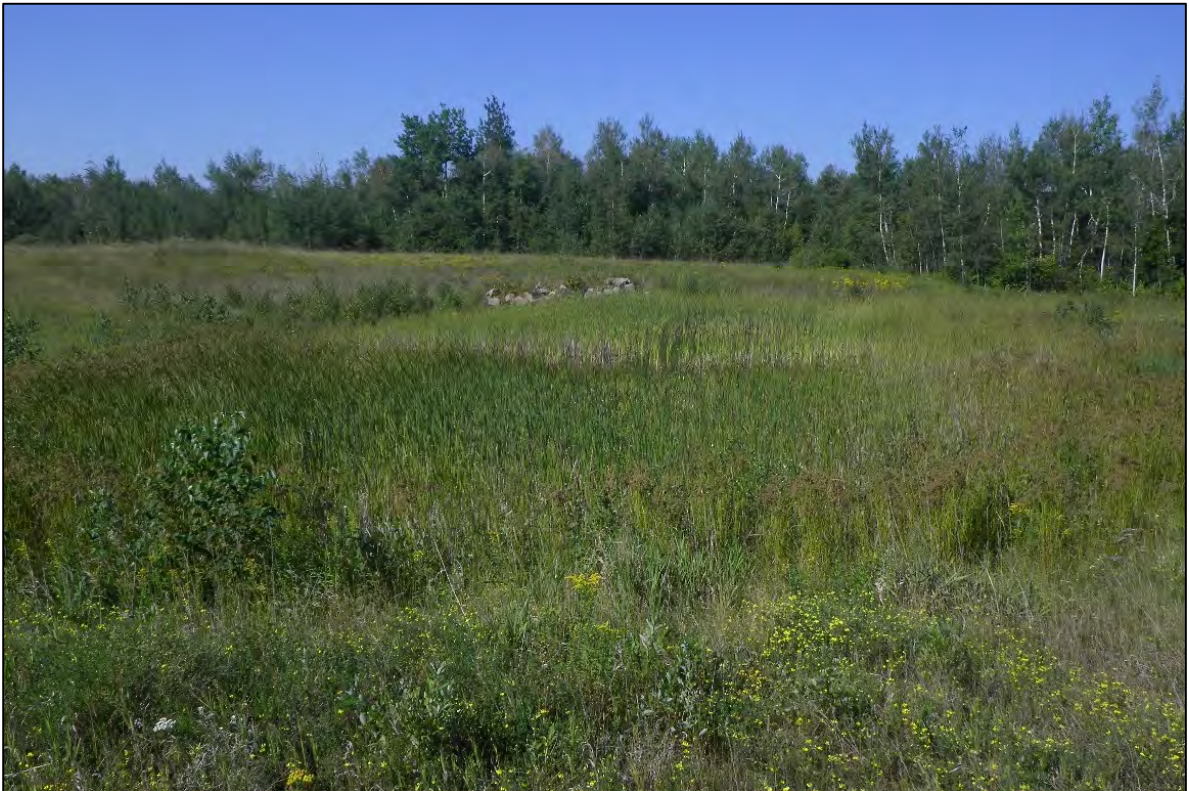
Photograph 9 (#R0016751): Photo around West Borrow Area taken on July 24, 2015.

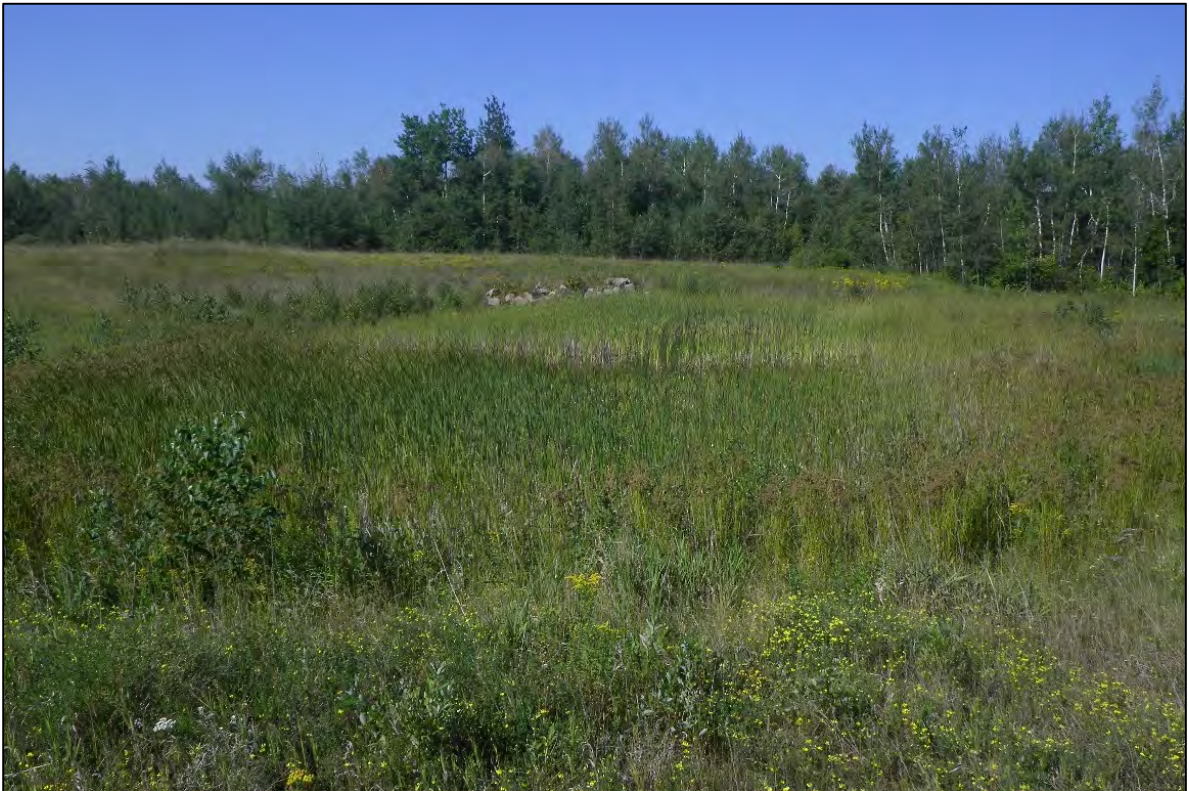
Photograph 9 (#R0016751): Photo around West Borrow Area taken on July 24, 2015.

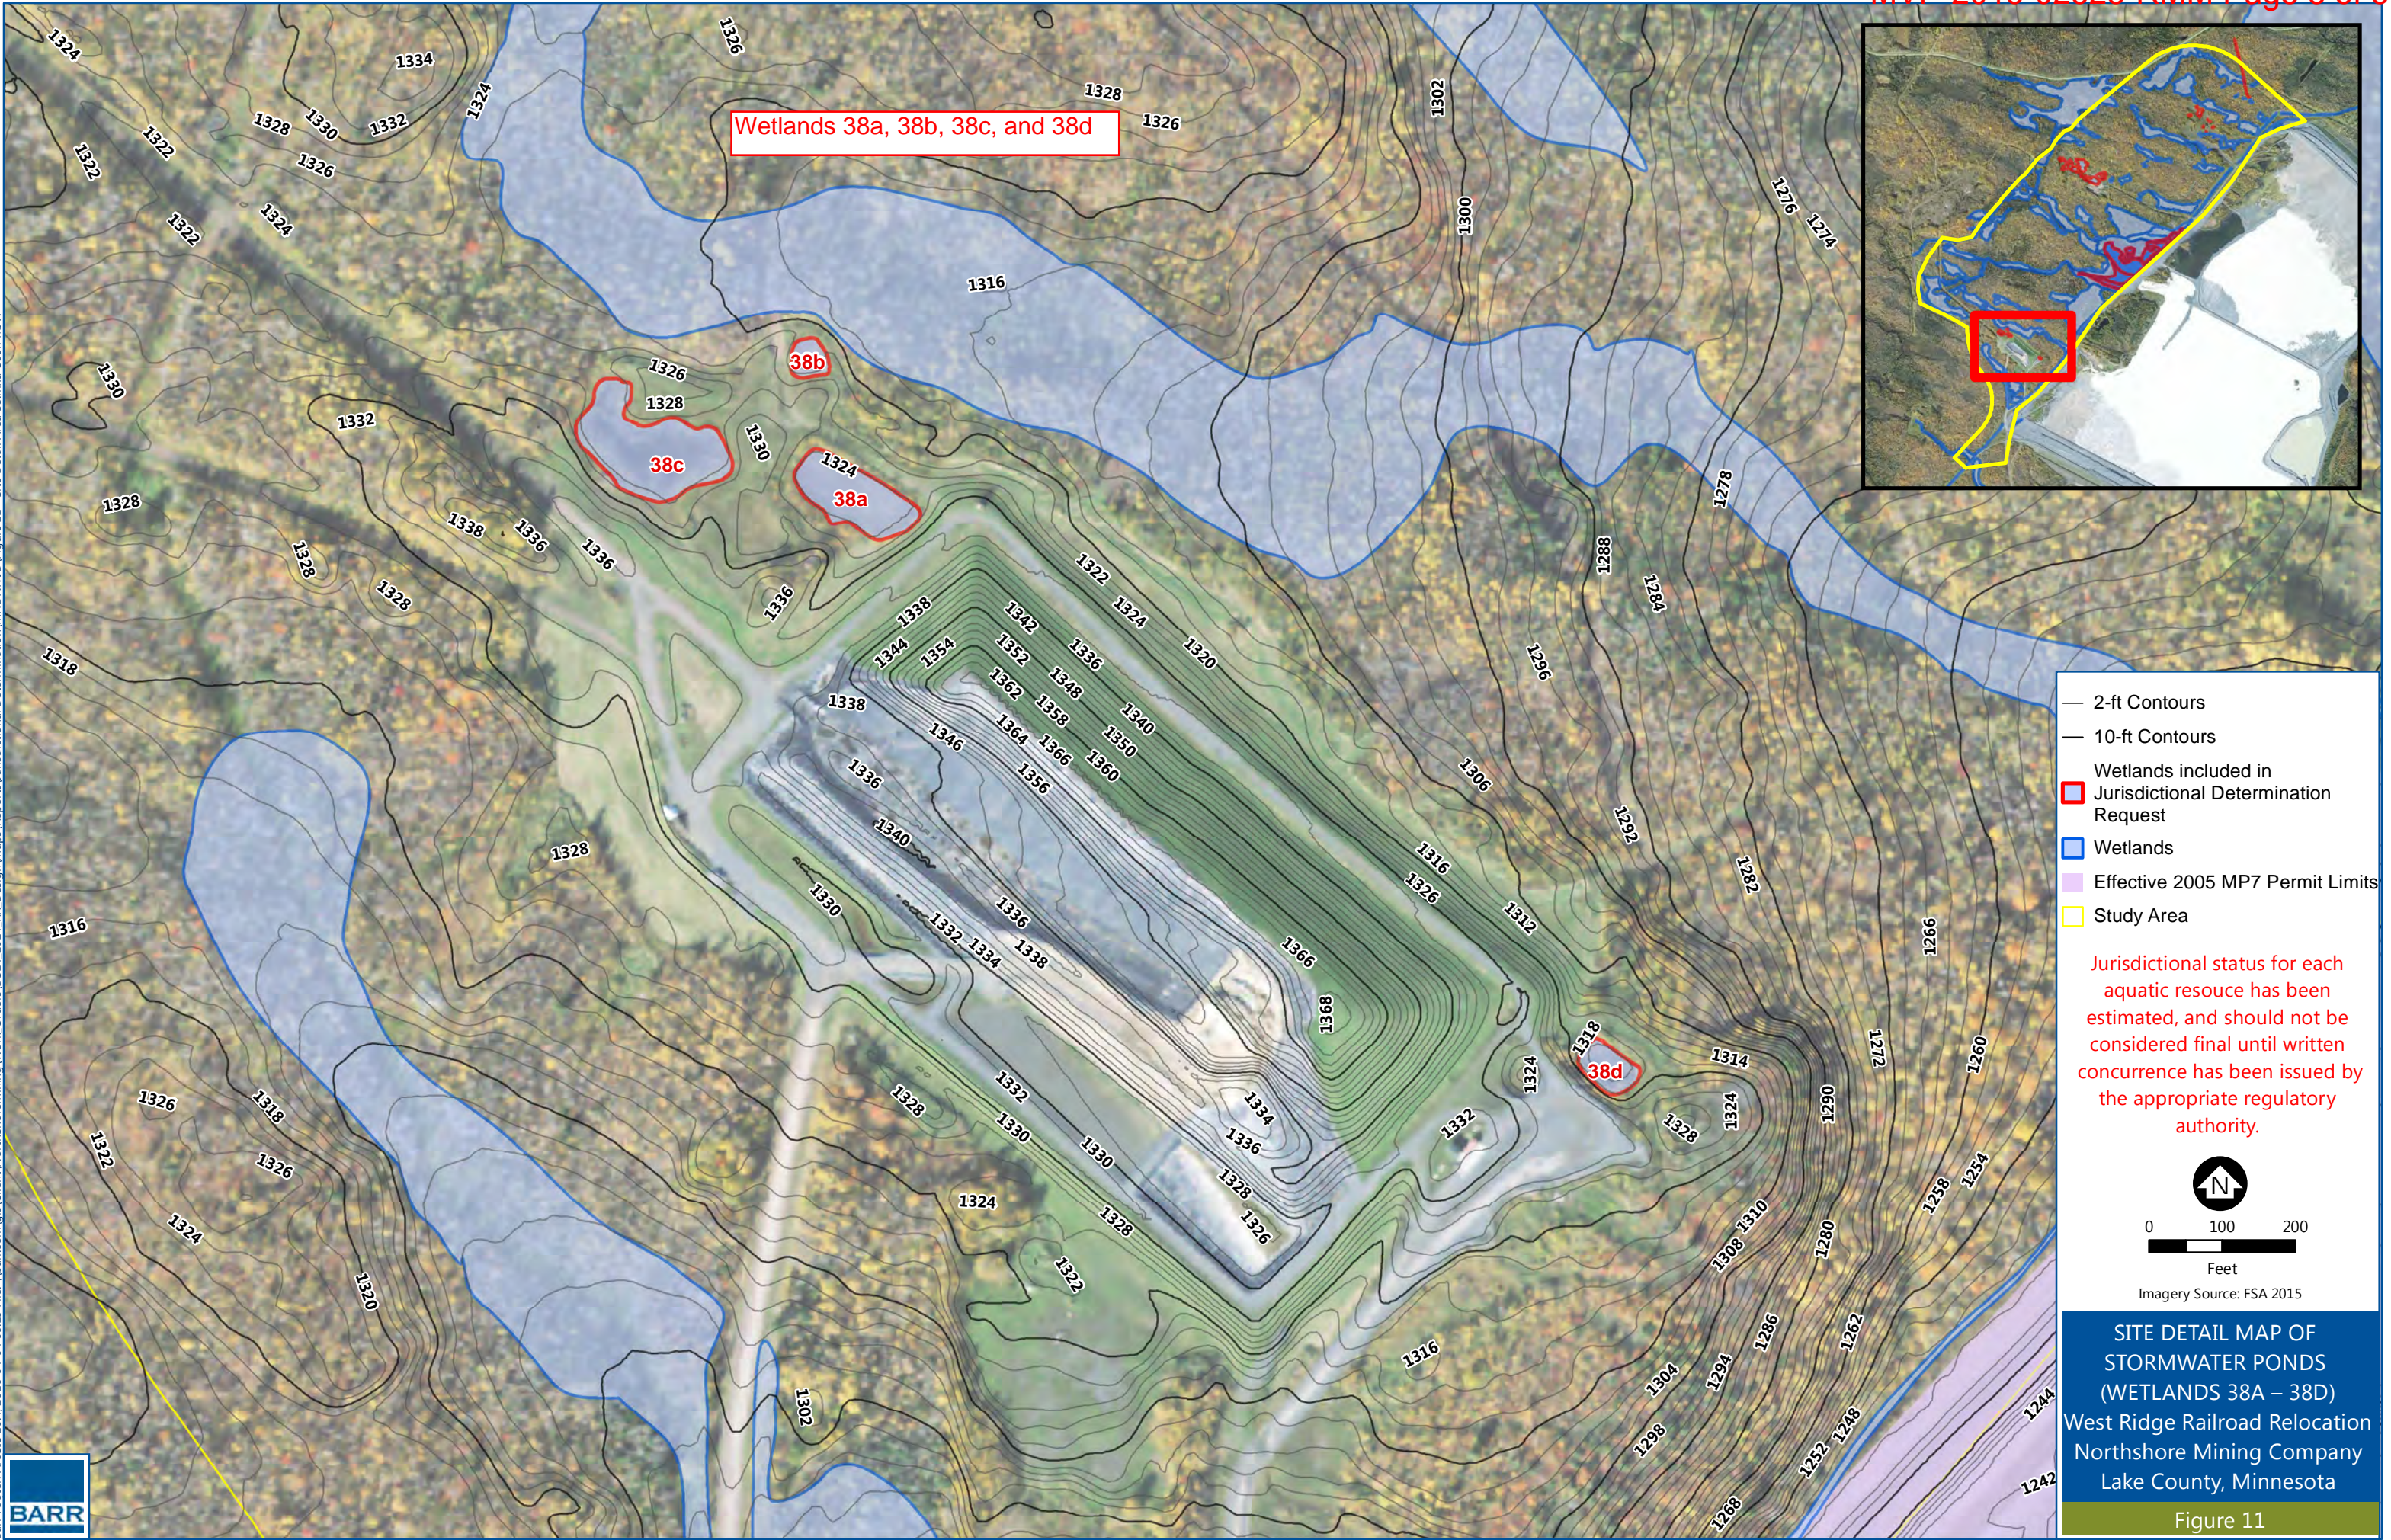
Wetlands 38a, 38b, 38c, and 38d
