Vermillion River AMA
(Petrofske Parcel)
Dakota County, Minnesota
TWP 114N, R 18W, S 20
2019 Bank Stabilization
Project Location

Vermillion River AMA
(Petrofske Parcel)
Dakota County, Minnesota
TWP 114N, R 18W, S 20
2019 Bank Stabilization
Sheet 1

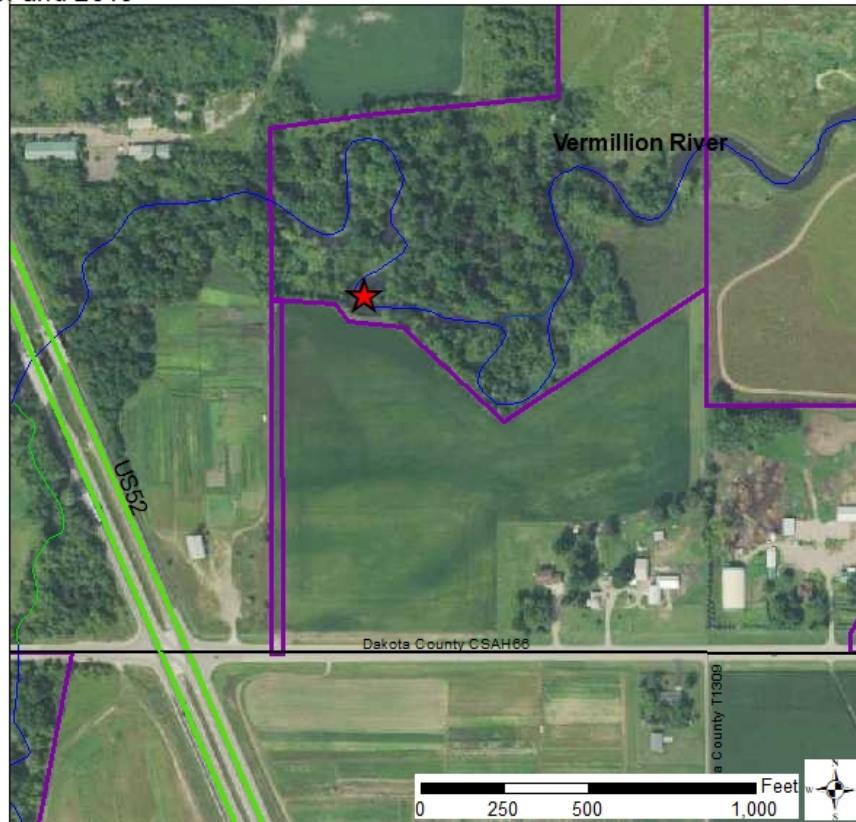
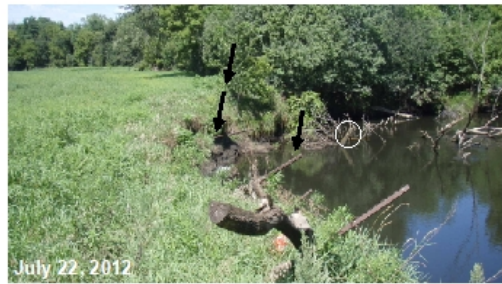
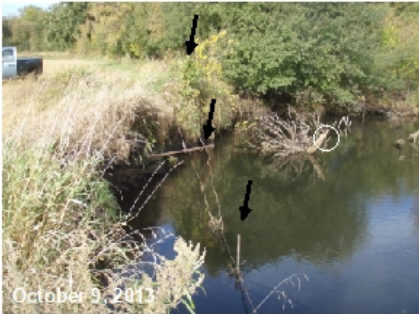
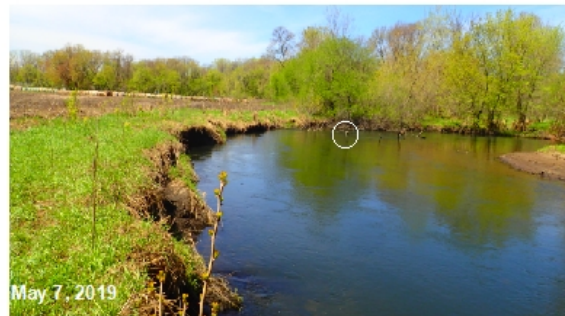
Figure 3. Project site images from 2012, 2013, and 2019.

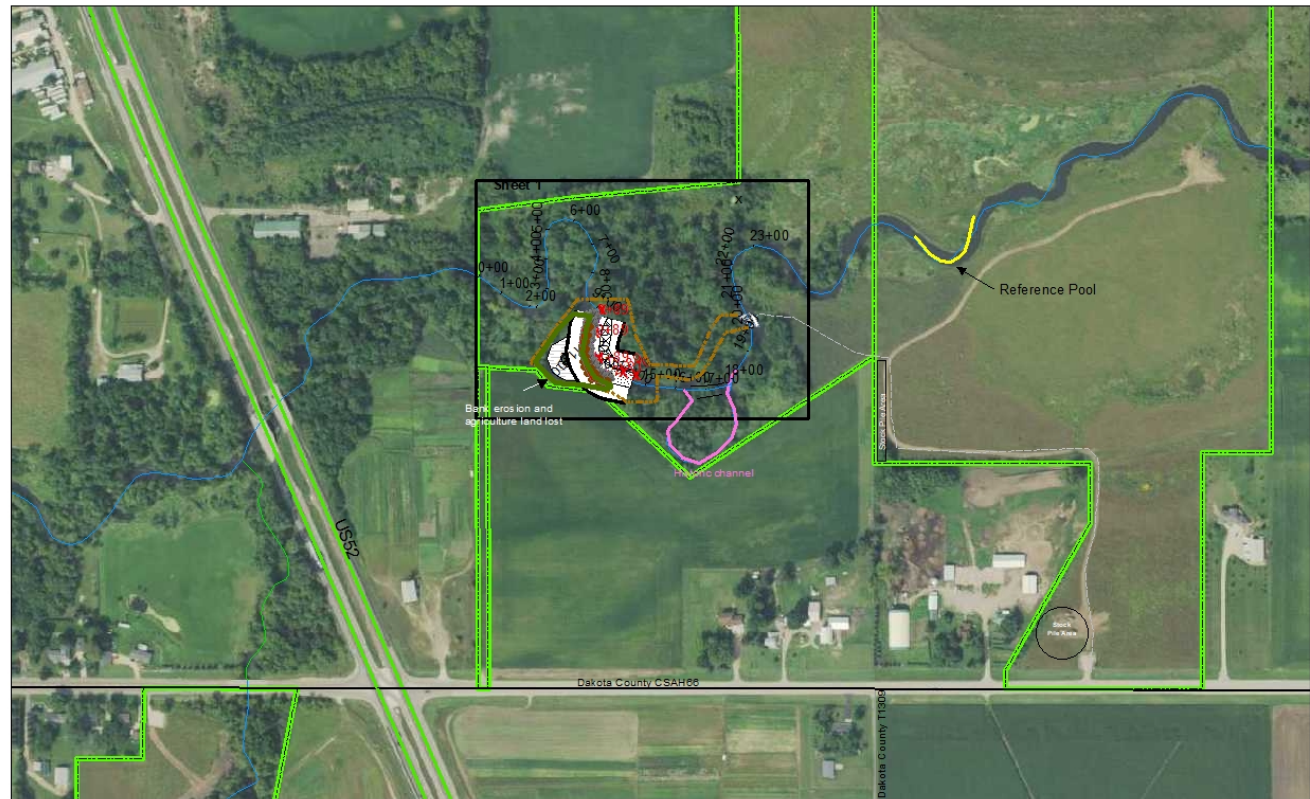
Figure 4. Project Overview with reference pool.

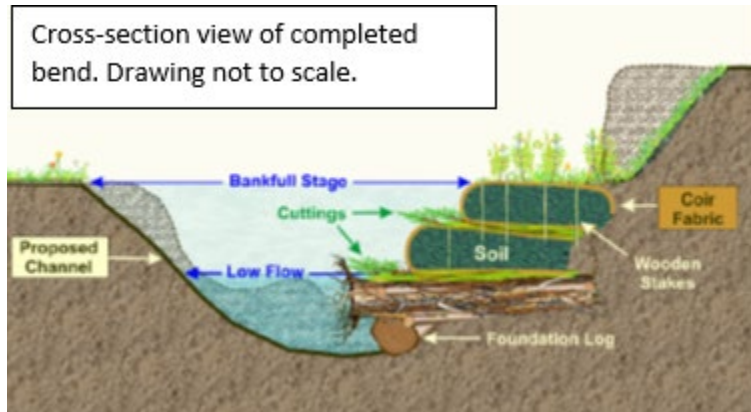
Figure 6. Typical wood bank stabilization.

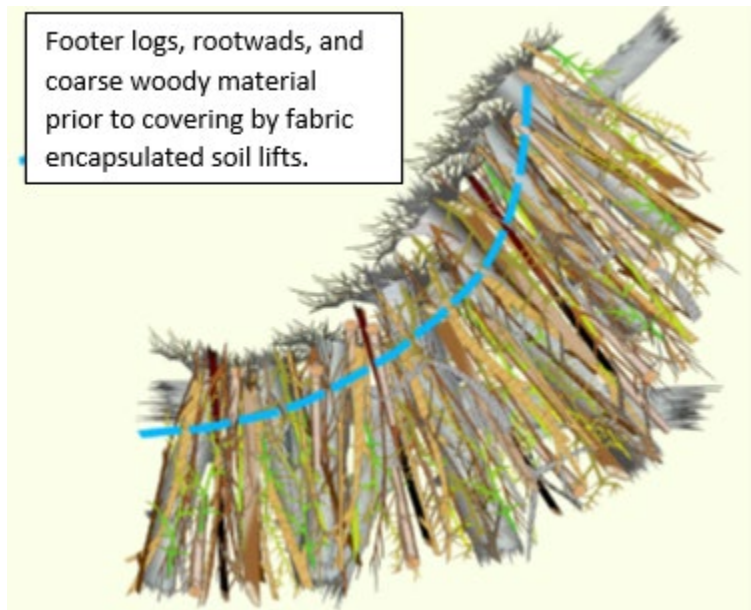
Figure 7. Footer logs, rootwads, and coarse woody material prior to covering by fabric encapsulated soil lifts.

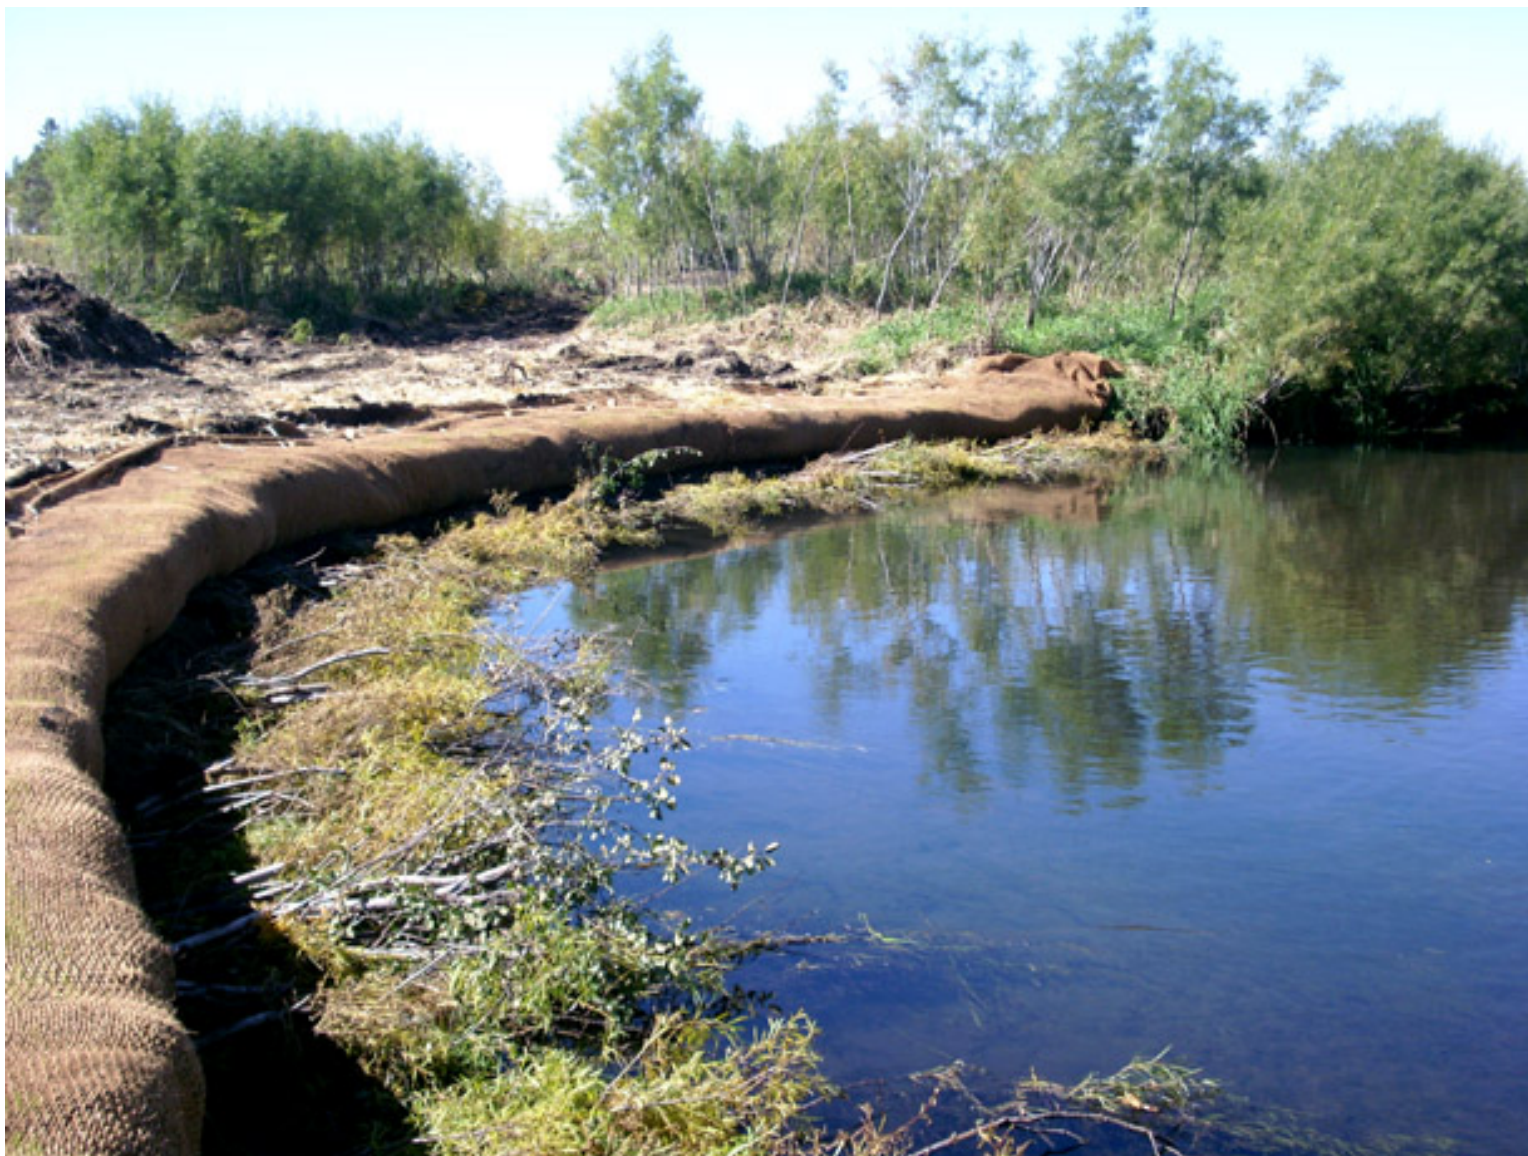
Figure 8. Toewood bank stabilization with encapsulated soil lift.

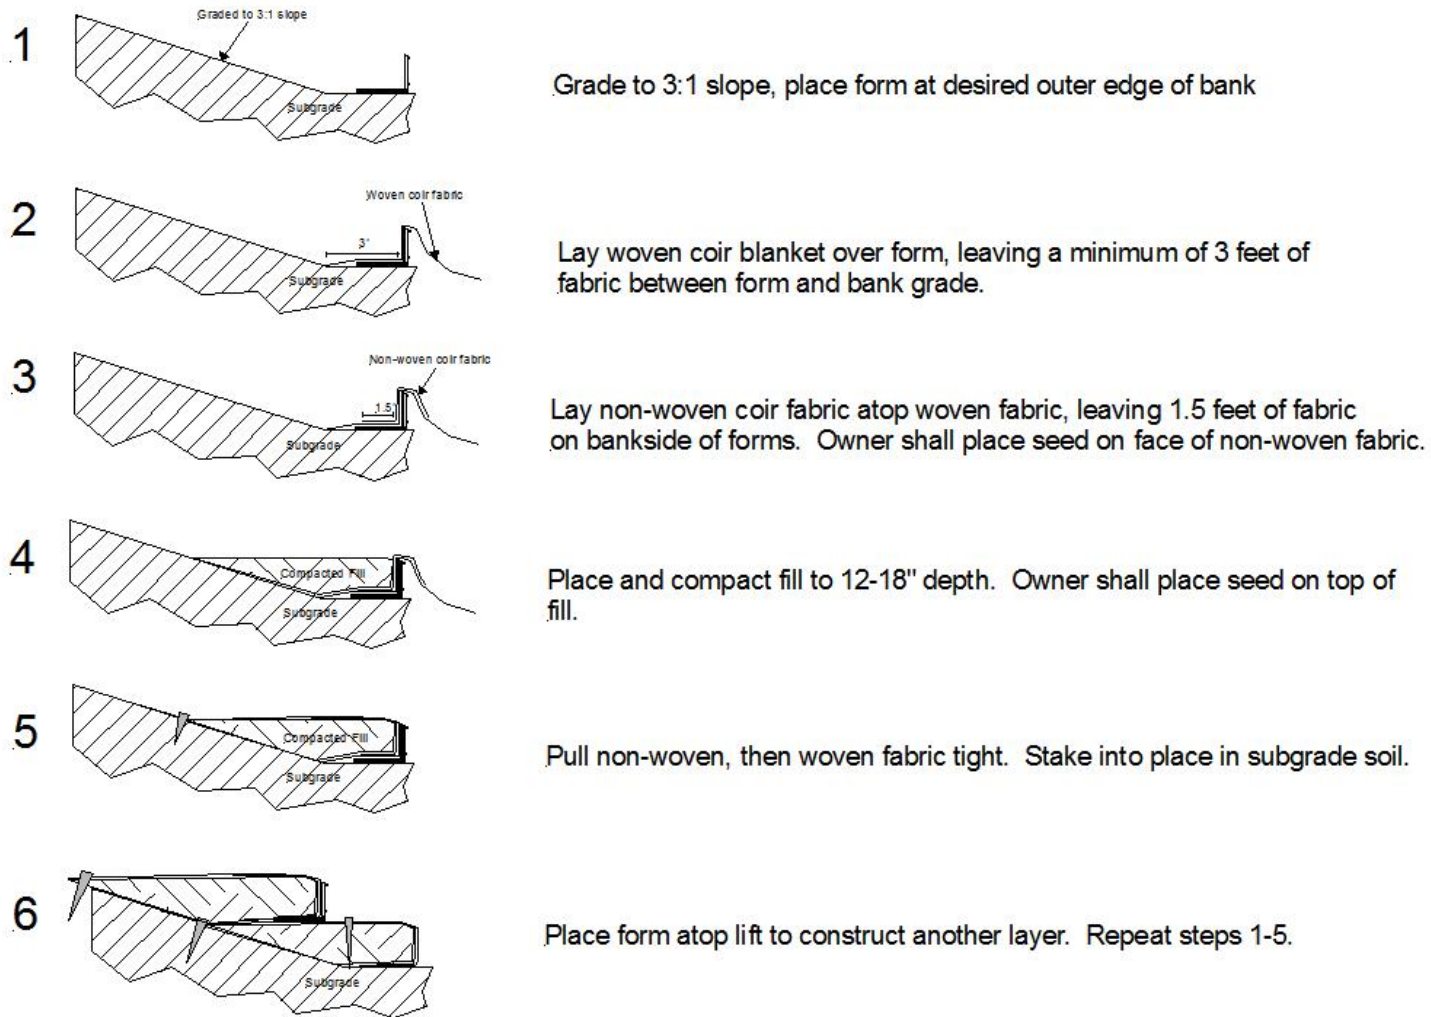
Encapsulated soil lift installation details

Figure 9. Encapsulated soil lift installation details.

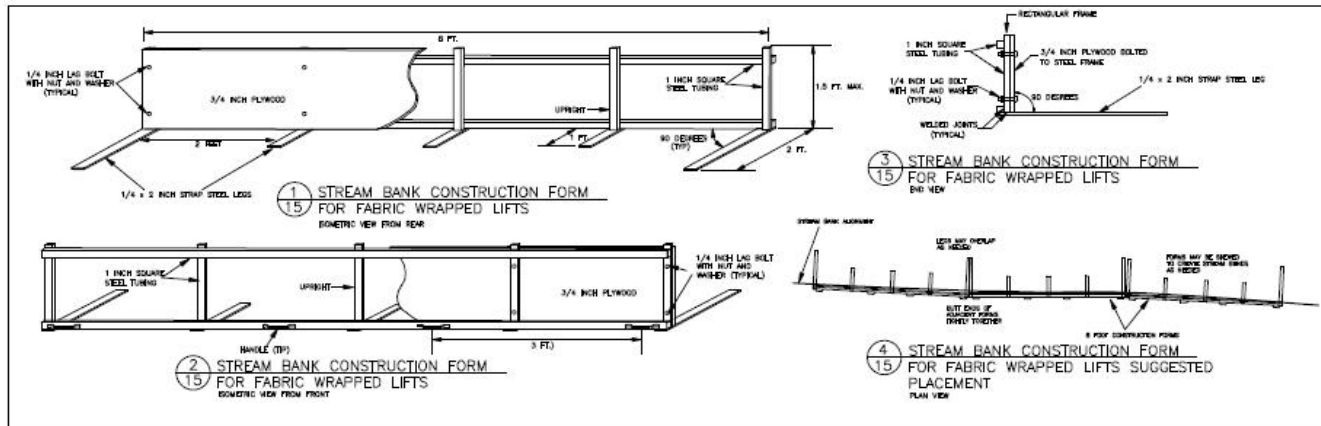
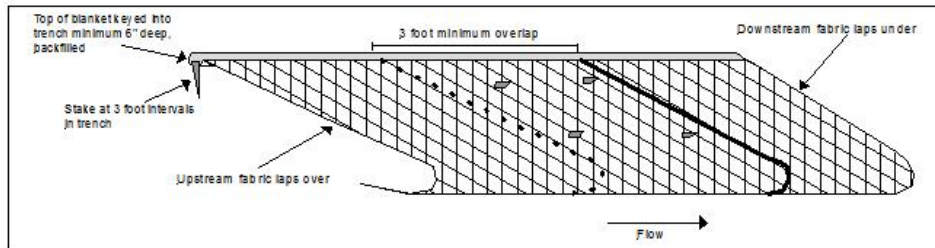
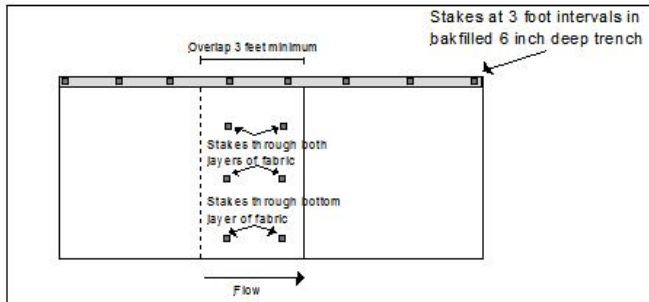
Encapsulated soil lifts installation details

Figure 10. Encapsulated soil lift installation details continued.

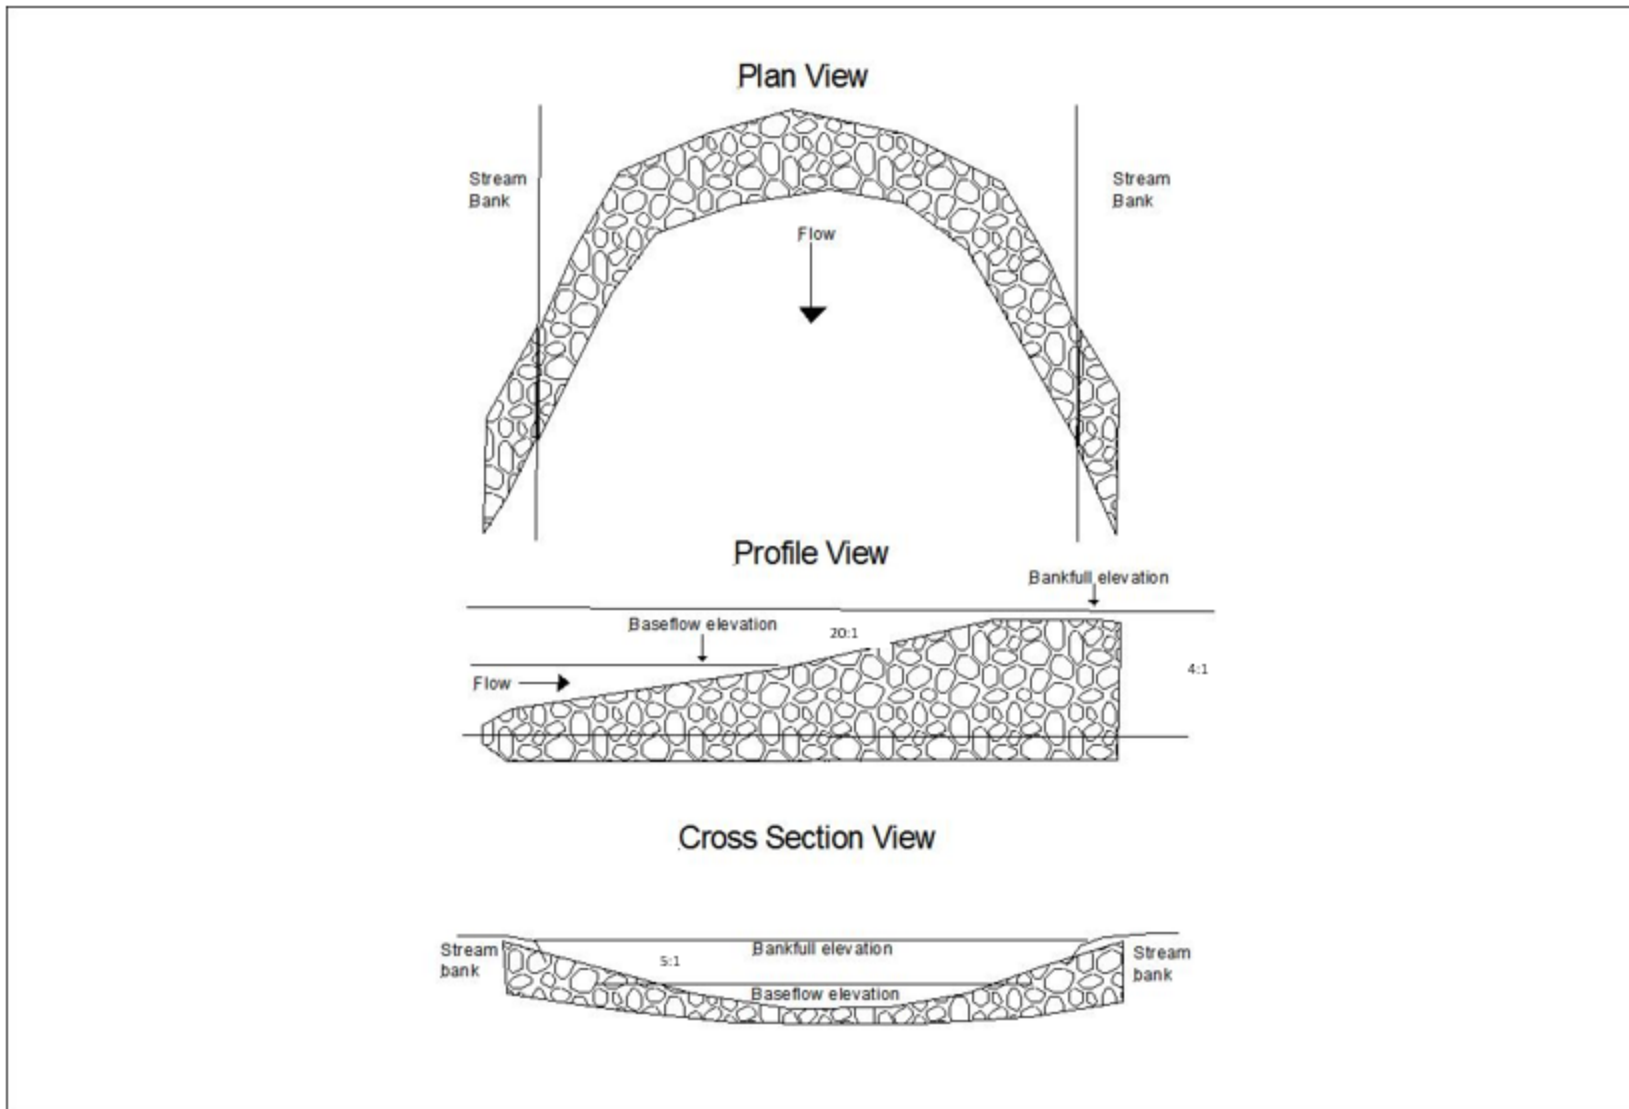
Figure 11. Typical constructed riffle.
