Appendix D: Environmental Survey Report

WETLANDS & VEGETATION REVIEW

Minnesota Power 15 Line Reroute Project

SE $\frac{1}{4}$, Section 1, T. 48N. – R. 16W. Carlton County, Minnesota

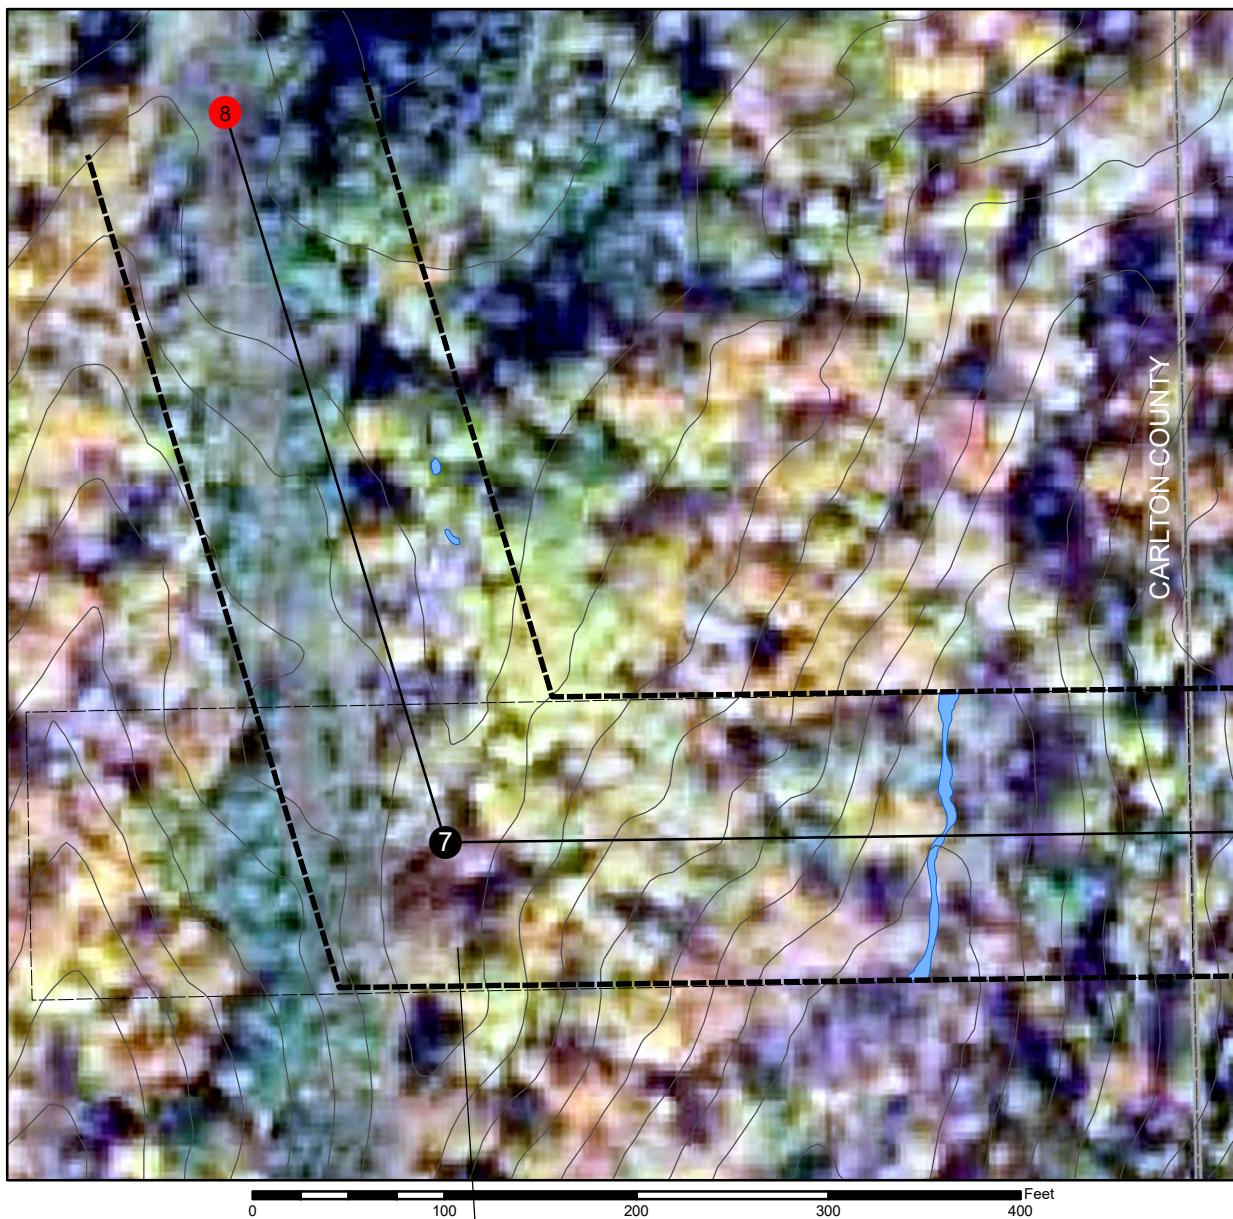
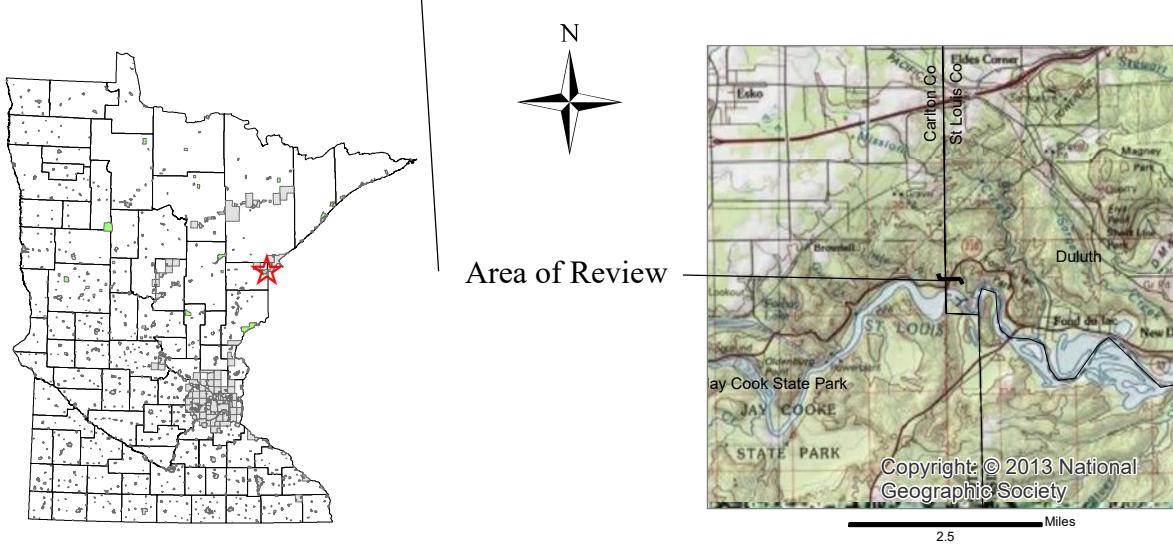
Figure 1

Proposed Transmission Line Relocation - Carlton County, Jay Cooke State Park
Northeast Quarter of the Southeast Quarter Section 1, Township 48 North, Range 16 West, Carlton County (9)

This 2.1-acre wetlands and vegetation review report was part of a 10-acre study along a proposed powerline corridor. The 2.1-acre area of review is in Carlton County; north of the St. Louis River, near Highway 210, within Jay Cooke State Park (Figure 1).

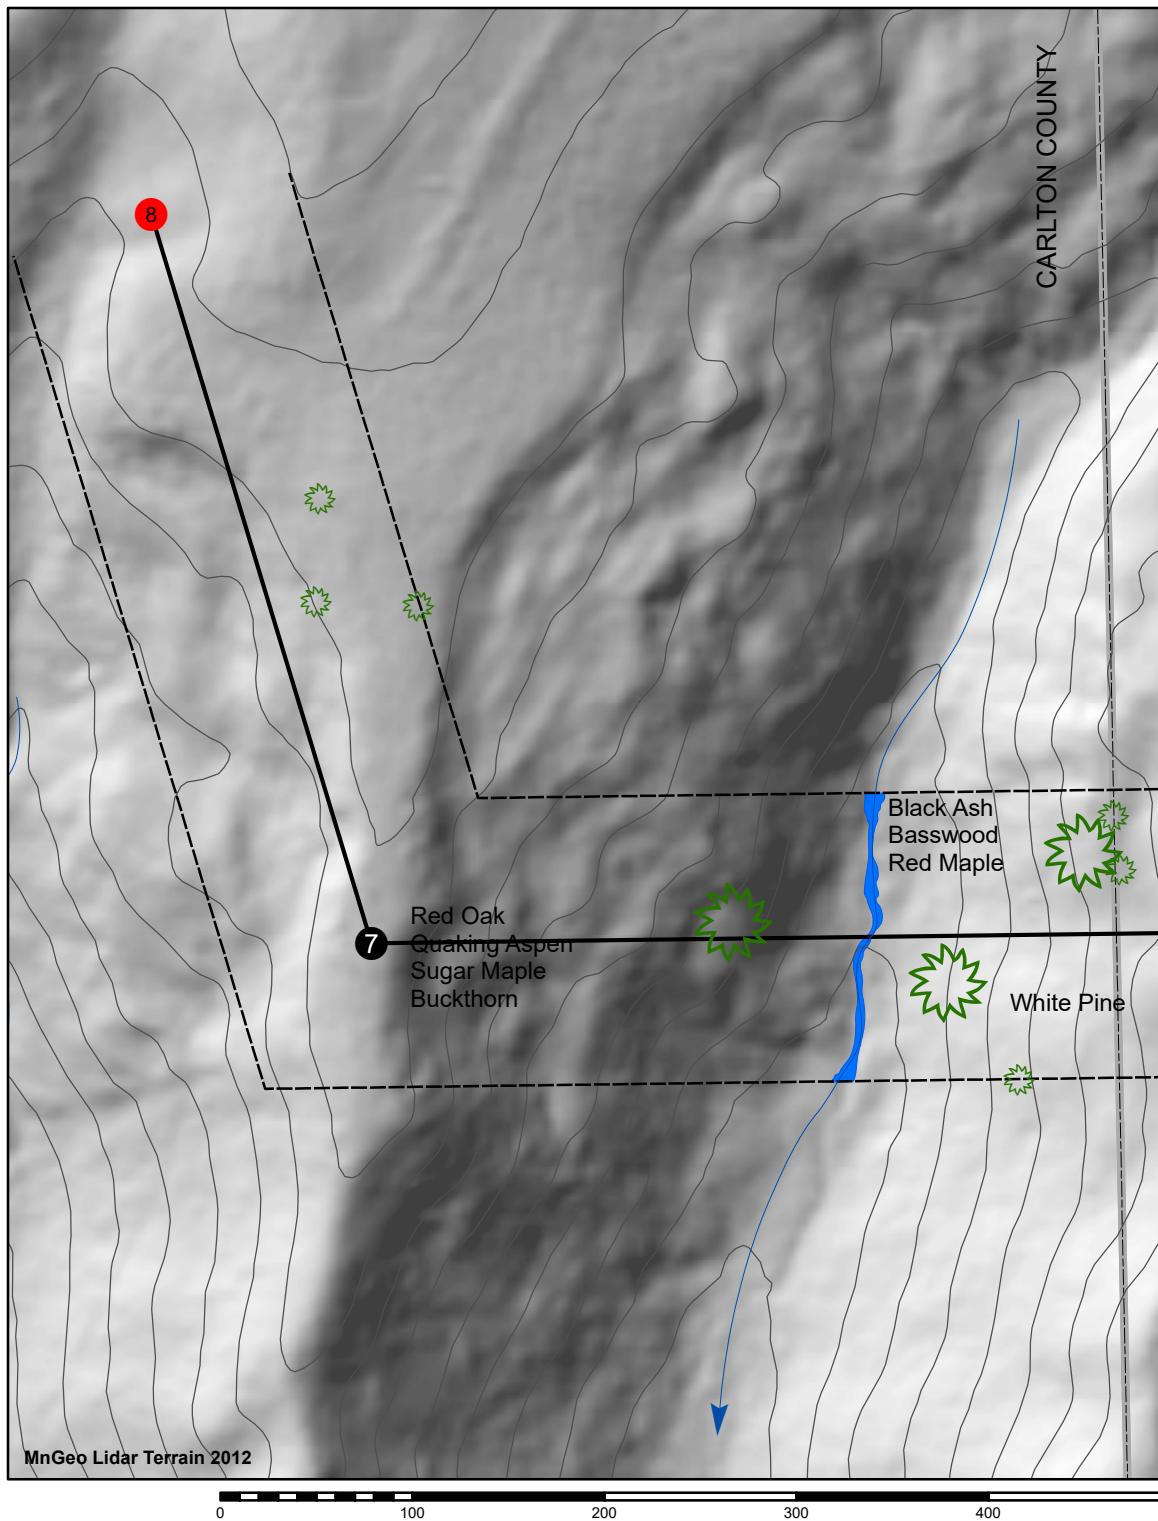
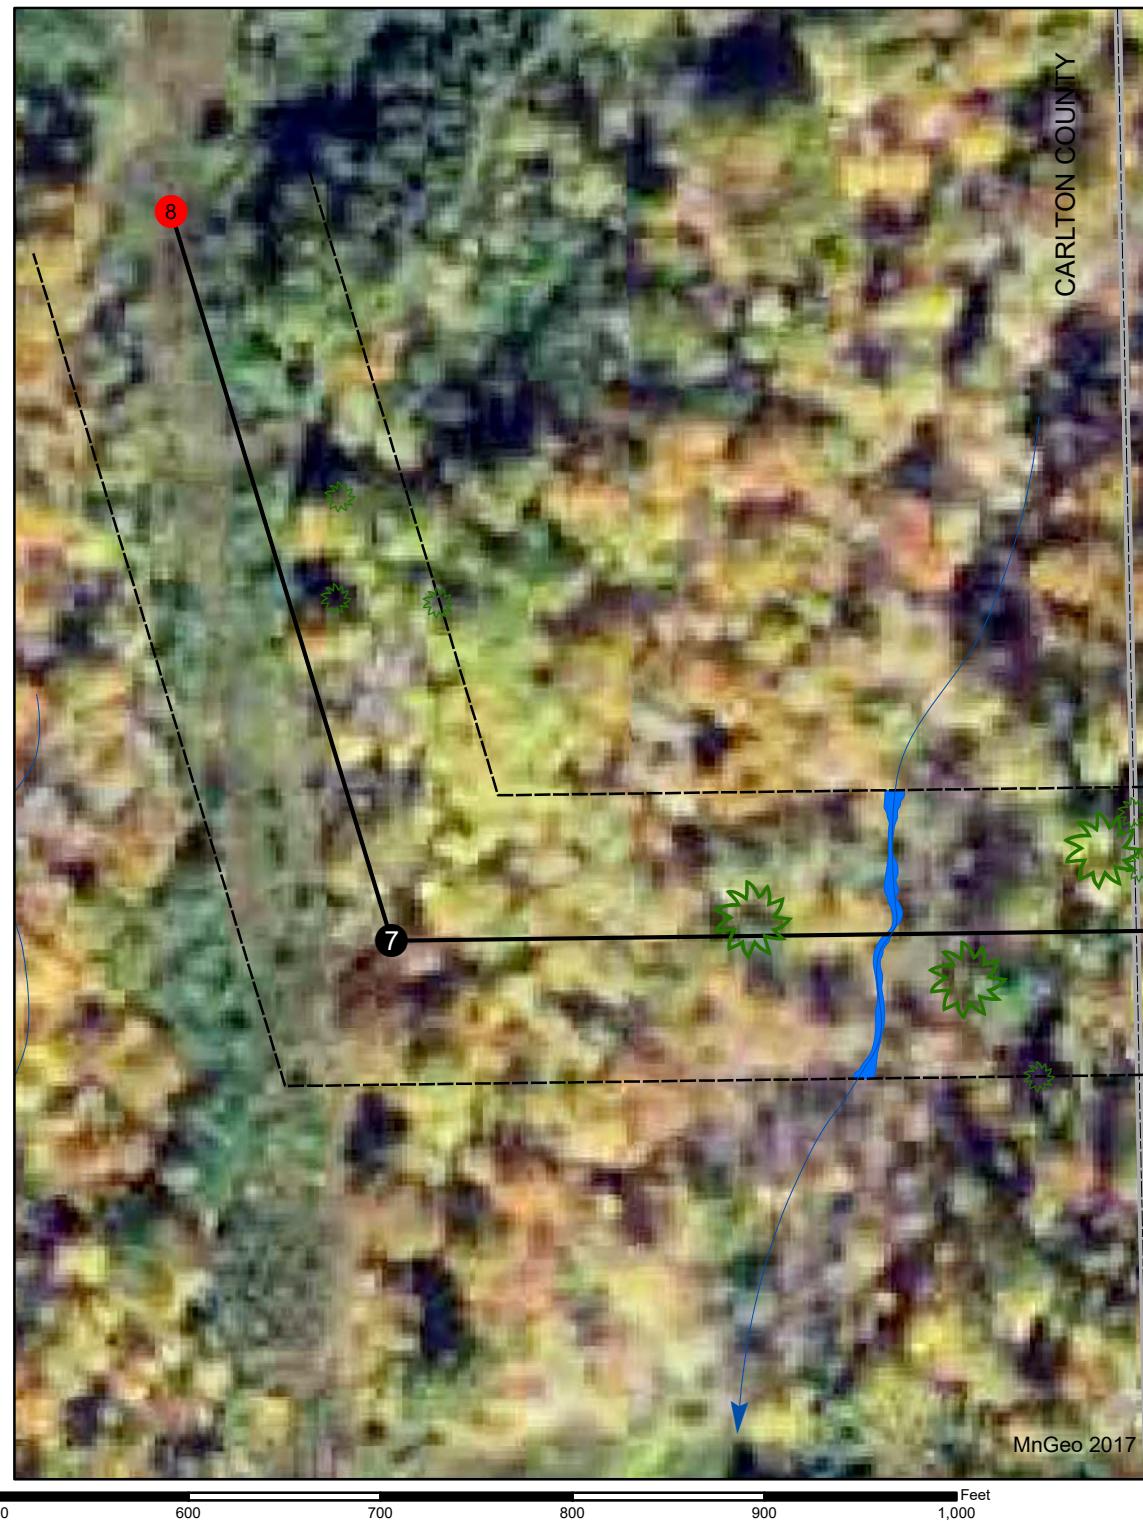
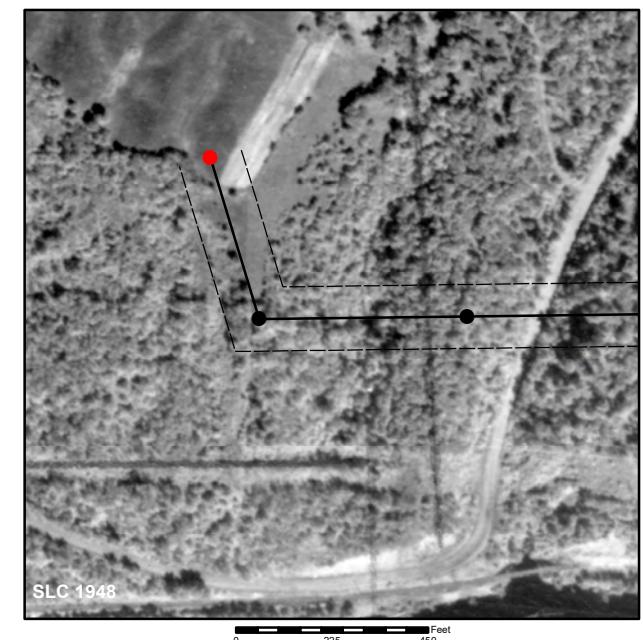
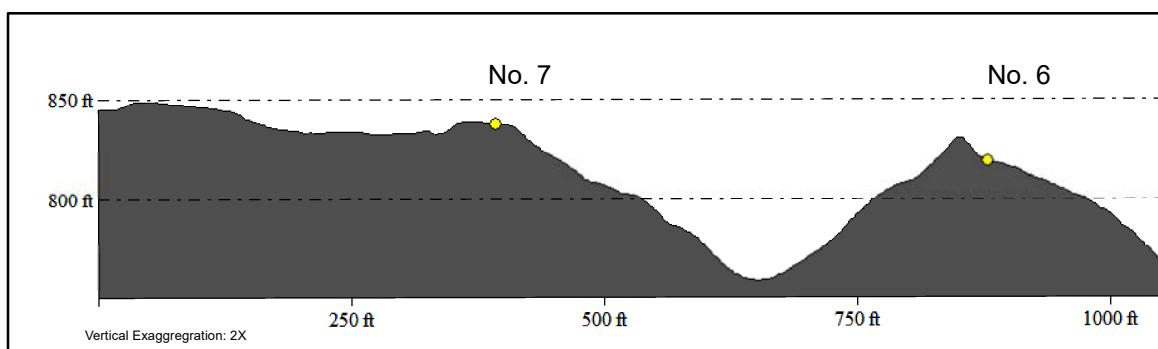
Figure 2

Proposed Transmission Line Re-Alignment
Carlton County, Jay Cooke State Park

Wetland
Surface Water Flow Direction

The proposed powerline corridor is located in the northwest quarter of the southwest quarter of Section 6, Township 48 North, Range 15 West, St. Louis County (69), and the northeast quarter of the southeast quarter & the southeast quarter of the northeast quarter Section 1, Township 48 North, Range 16 West, Carlton County (9) (Figure 2).

The area of review is within the Nenadji-Duluth Lacustrine Plain, clayey geomorphic region. There are a series of ridge tops and ravine bottoms. The lowest elevation of 760 feet is at the ravine bottom between proposed Pole No. 7 and Pole No. 6 (Figures 2). Slopes range from relatively flat and concave at the valley bottoms to greater than 40 percent on the ridge side slopes on these dissected lake plain sediments.

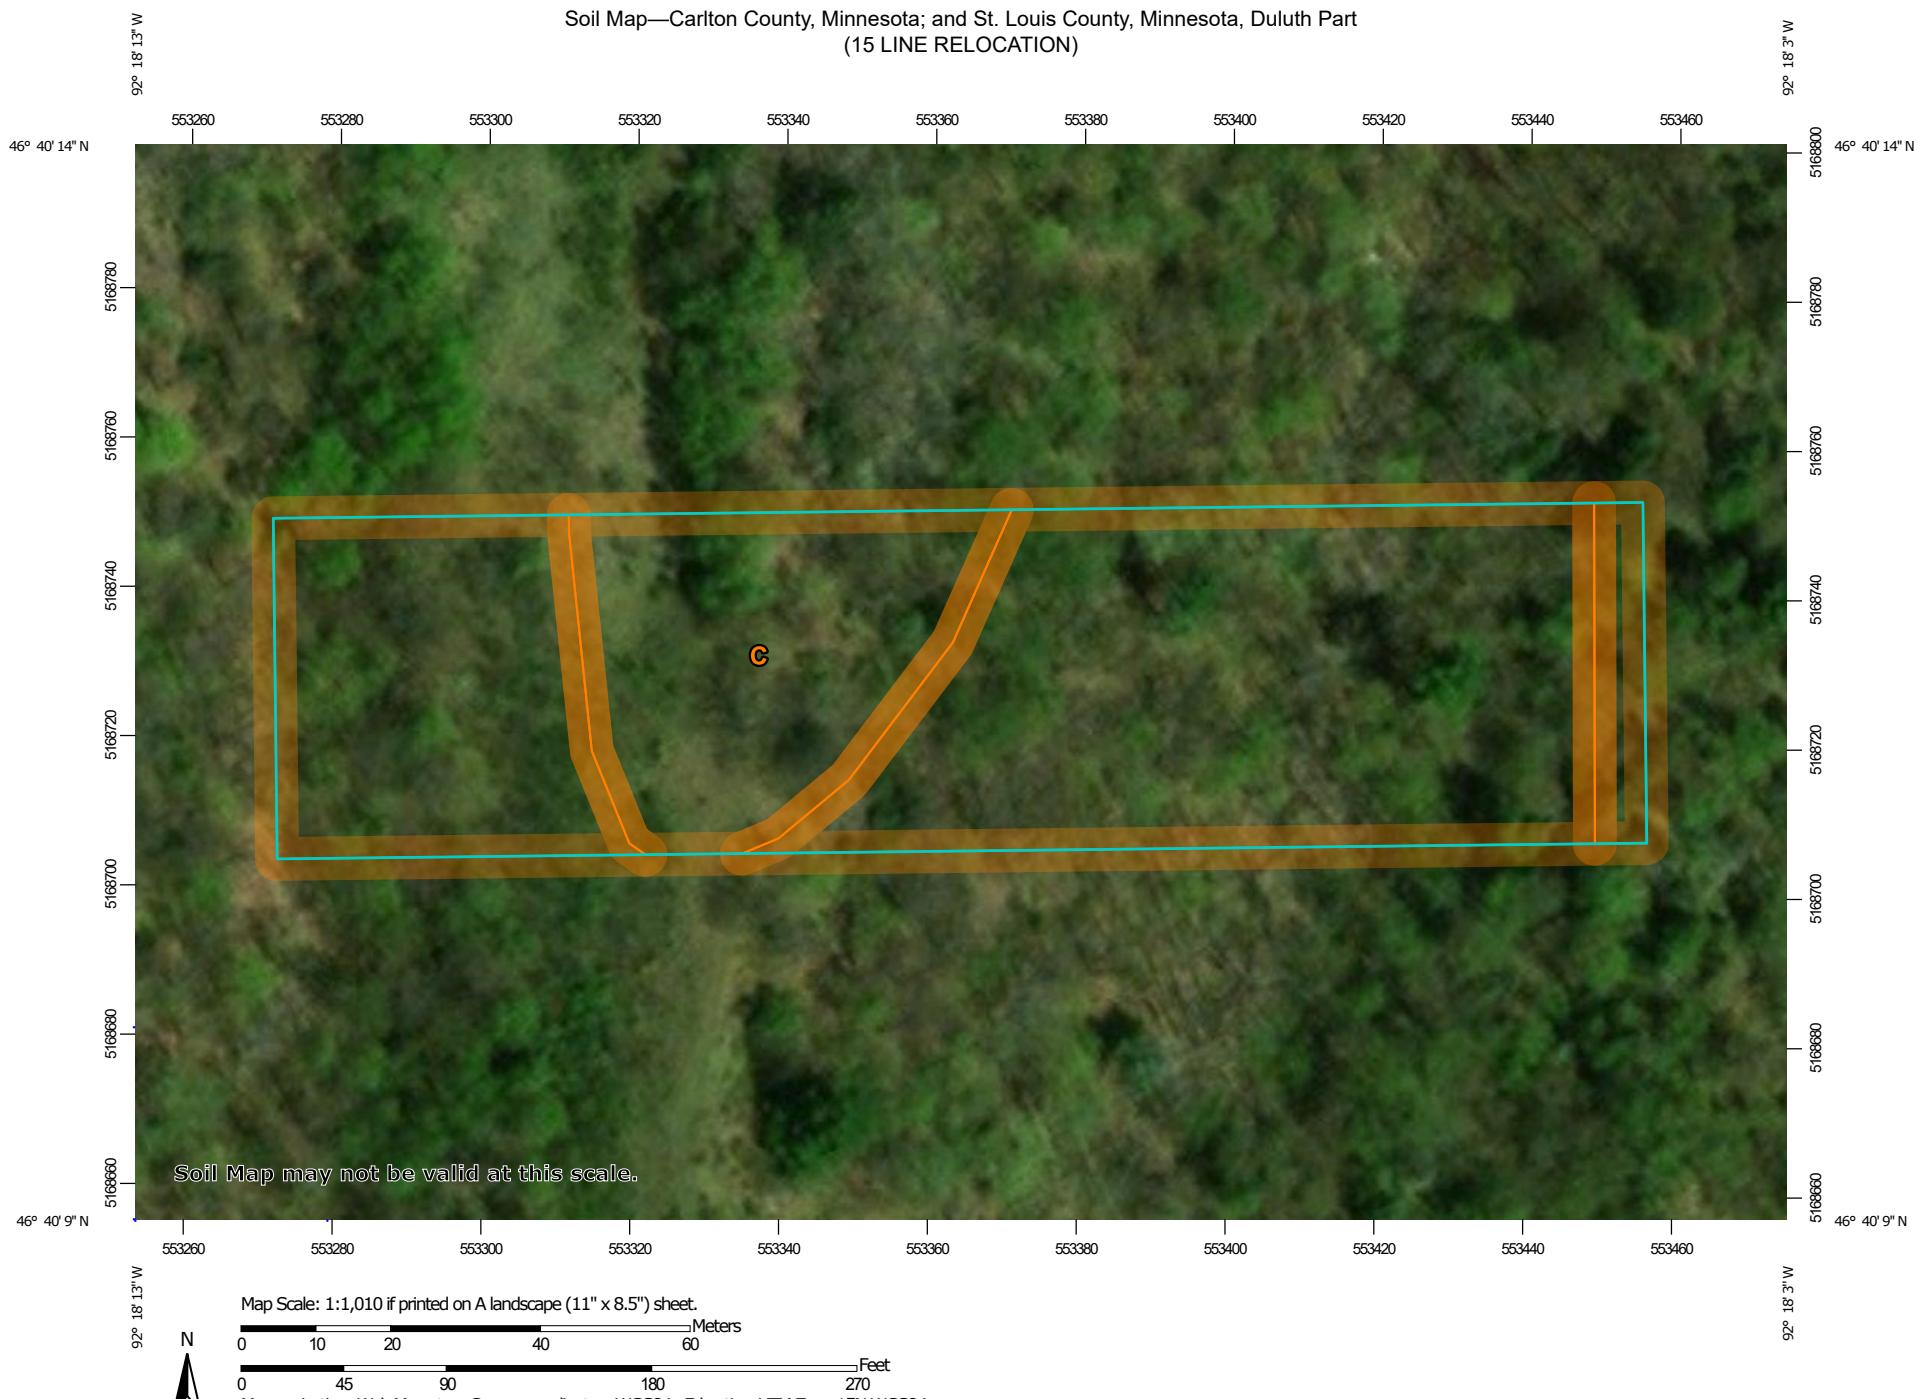
Soil Map—Carlton County, Minnesota; and St. Louis County, Minnesota, Duluth Part
(15 LINE RELOCATION)

Map Unit Symbol	Map Unit Name	Acres in AOI	Percent of AOI
367C	Campia silt loam, 2 to 12 percent slopes	0.5	23.5%
1020	Udorthents	1.5	72.8%
Subtotals for Soil Survey Area		2.0	96.3%
Totals for Area of Interest		2.1	100.0%

Map Unit Symbol	Map Unit Name	Acres in AOI	Percent of AOI
F155G	Udalfs-Eutrudepts complex, 25 to 70 percent slopes	0.1	3.7%
Subtotals for Soil Survey Area		0.1	3.7%
Totals for Area of Interest		2.1	100.0%

The terrain is ridge and valley along the proposed powerline corridor. Three soil units mapped by USDA NRCS for the property are described in the table below. Two of the soils are included on the NRCS hydric soil list. Based on the soil units mapped potentially one-half acre of hydric soils may be found in the area of review (Appendix B).

SYMBOL	SOIL UNIT	ACRES	PERCENT HYDRIC	POTENTIAL HYDRIC ACRES
1020	UDORTHENTS	1.5	10	0.15
F155G	UDALFS-EUTRDEPTS complex, 25 to 70 percent slopes	0.1	5	0.005
367C	CAMPIA SILT LOAM, 2 to 12 percent slopes	0.5	0	-
TOTAL				0.16

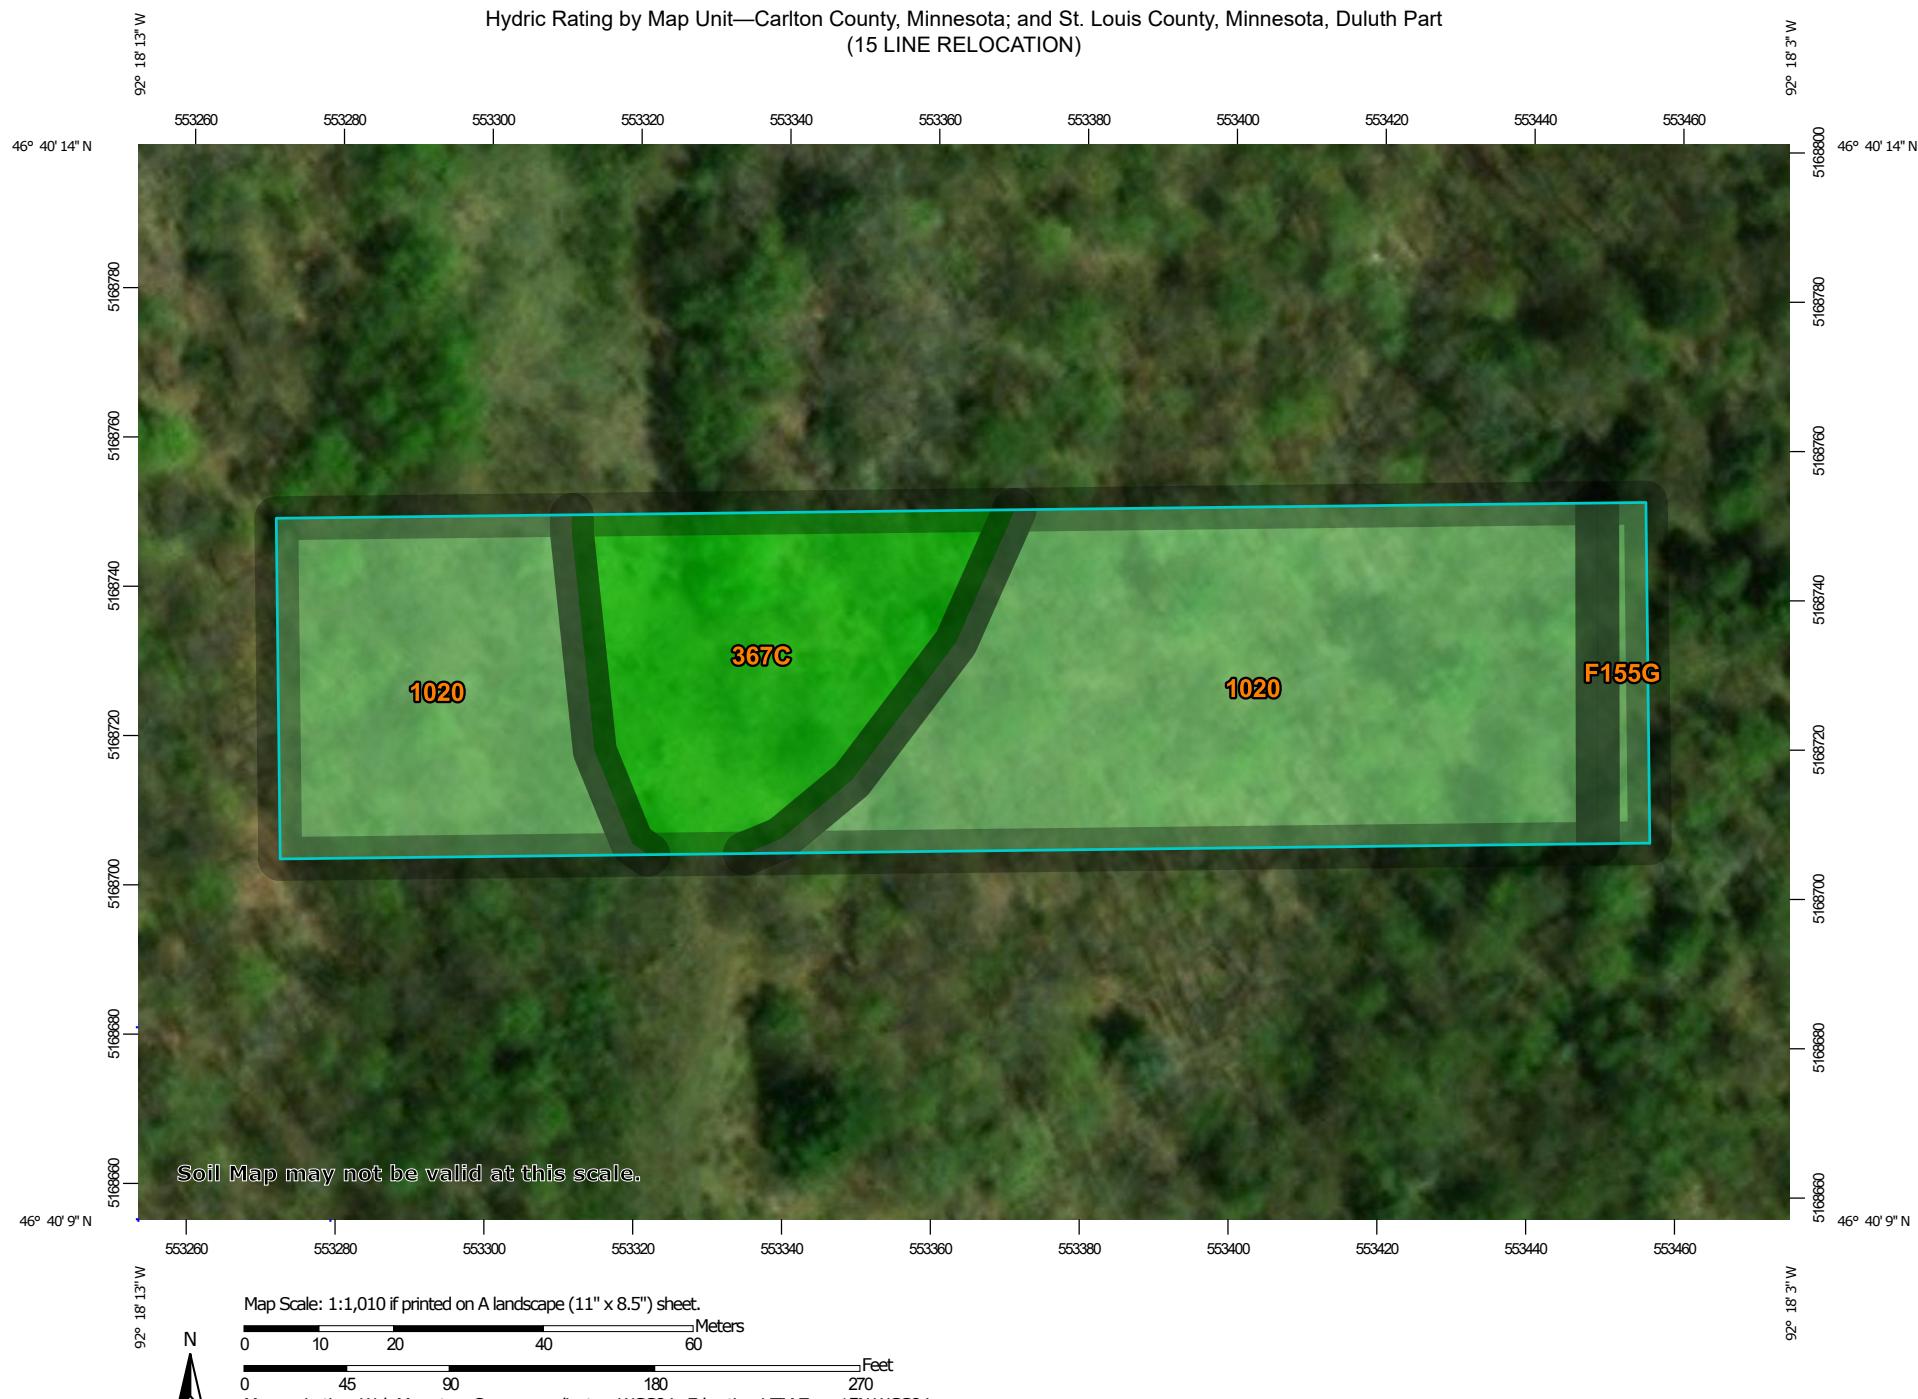
Hydric Rating by Map Unit—Carlton County, Minnesota; and St. Louis County, Minnesota, Duluth Part
(15 LINE RELOCATION)

Map unit symbol	Map unit name	Rating	Acres in AOI	Percent of AOI
367C	Campia silt loam, 2 to 12 percent slopes	0	0.5	23.5%
1020	Udorthents	10	1.5	72.8%
Subtotals for Soil Survey Area			2.0	96.3%
Totals for Area of Interest			2.1	100.0%

Map unit symbol	Map unit name	Rating	Acres in AOI	Percent of AOI
F155G	Udalfs-Eutrudepts complex, 25 to 70 percent slopes	5	0.1	3.7%
Subtotals for Soil Survey Area			0.1	3.7%
Totals for Area of Interest			2.1	100.0%

The thematic map is color coded based on the composition of hydric components. The five color classes are separated as 100 percent hydric components, 66 to 99 percent hydric components, 33 to 65 percent hydric components, 1 to 32 percent hydric components, and less than one percent hydric components.

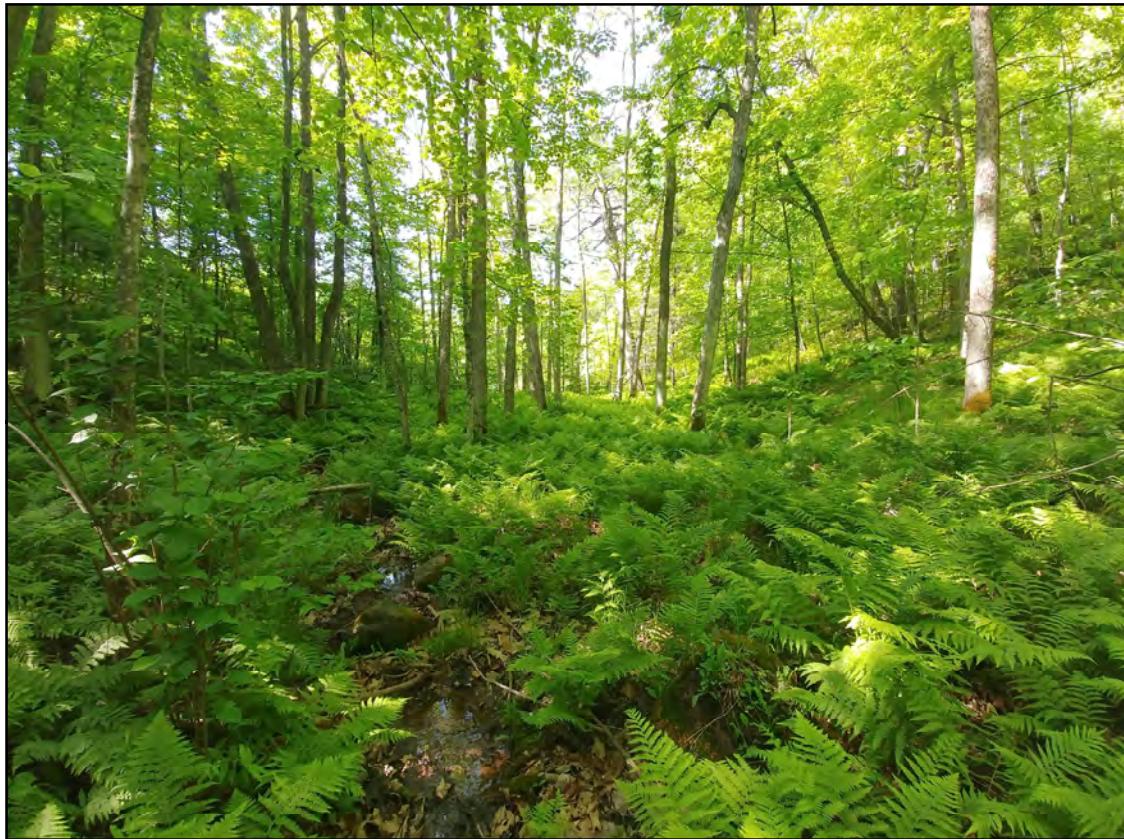
Valley Bottom, Between Pole No. 6 & No. 7

Hydrophytic vegetation present? <u>Y</u> Hydric soil present? <u>Y</u> Indicators of wetland hydrology present? <u>Y</u>	Is the sampled area within a wetland? <u>Y</u> If yes, optional wetland site ID: _____
Remarks: (Explain alternative procedures here or in a separate report.) Dry Conditions

Field Observations: Surface water present? Yes <u>X</u> No _____ Depth (inches): <u>4</u> Water table present? Yes <u> </u> No <u>X</u> Depth (inches): _____ Saturation present? Yes <u>X</u> No _____ Depth (inches): <u>0</u> (includes capillary fringe)	Indicators of wetland hydrology present? <u>Y</u>
Describe recorded data (stream gauge, monitoring well, aerial photos, previous inspections), if available:	
Remarks: Concentrated stream flow

Restrictive Layer (if observed): Type: _____ Depth (inches): _____	Hydric soil present? <input checked="" type="checkbox"/> Y
Remarks: Saturated ground. Cobbled channel flow

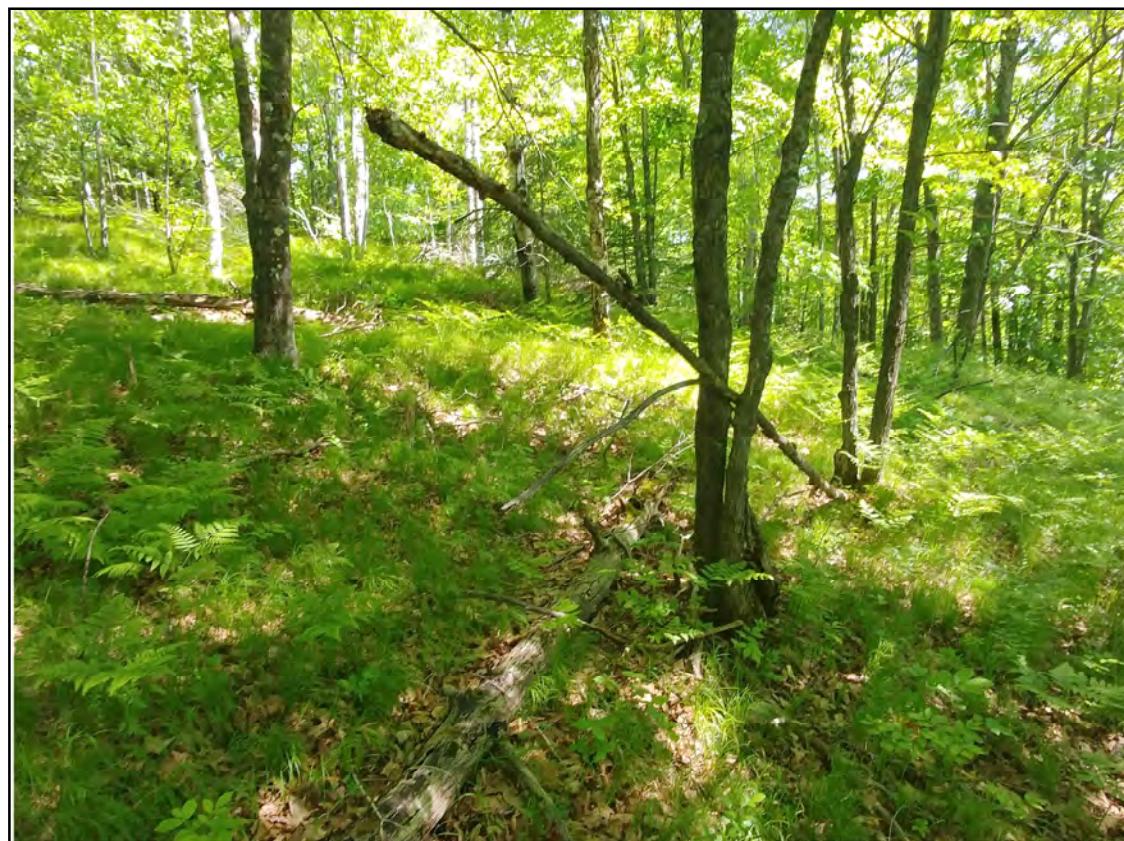
Hillside
