AGGREGATE RESOURCE EVALUATION OF THE RAKO, BIRCHDALE, AND BIRCHDALE EAST PITS NEAR BAUDETTE, MN

BIRCHDALE AND BIRCHDALE EAST PITS

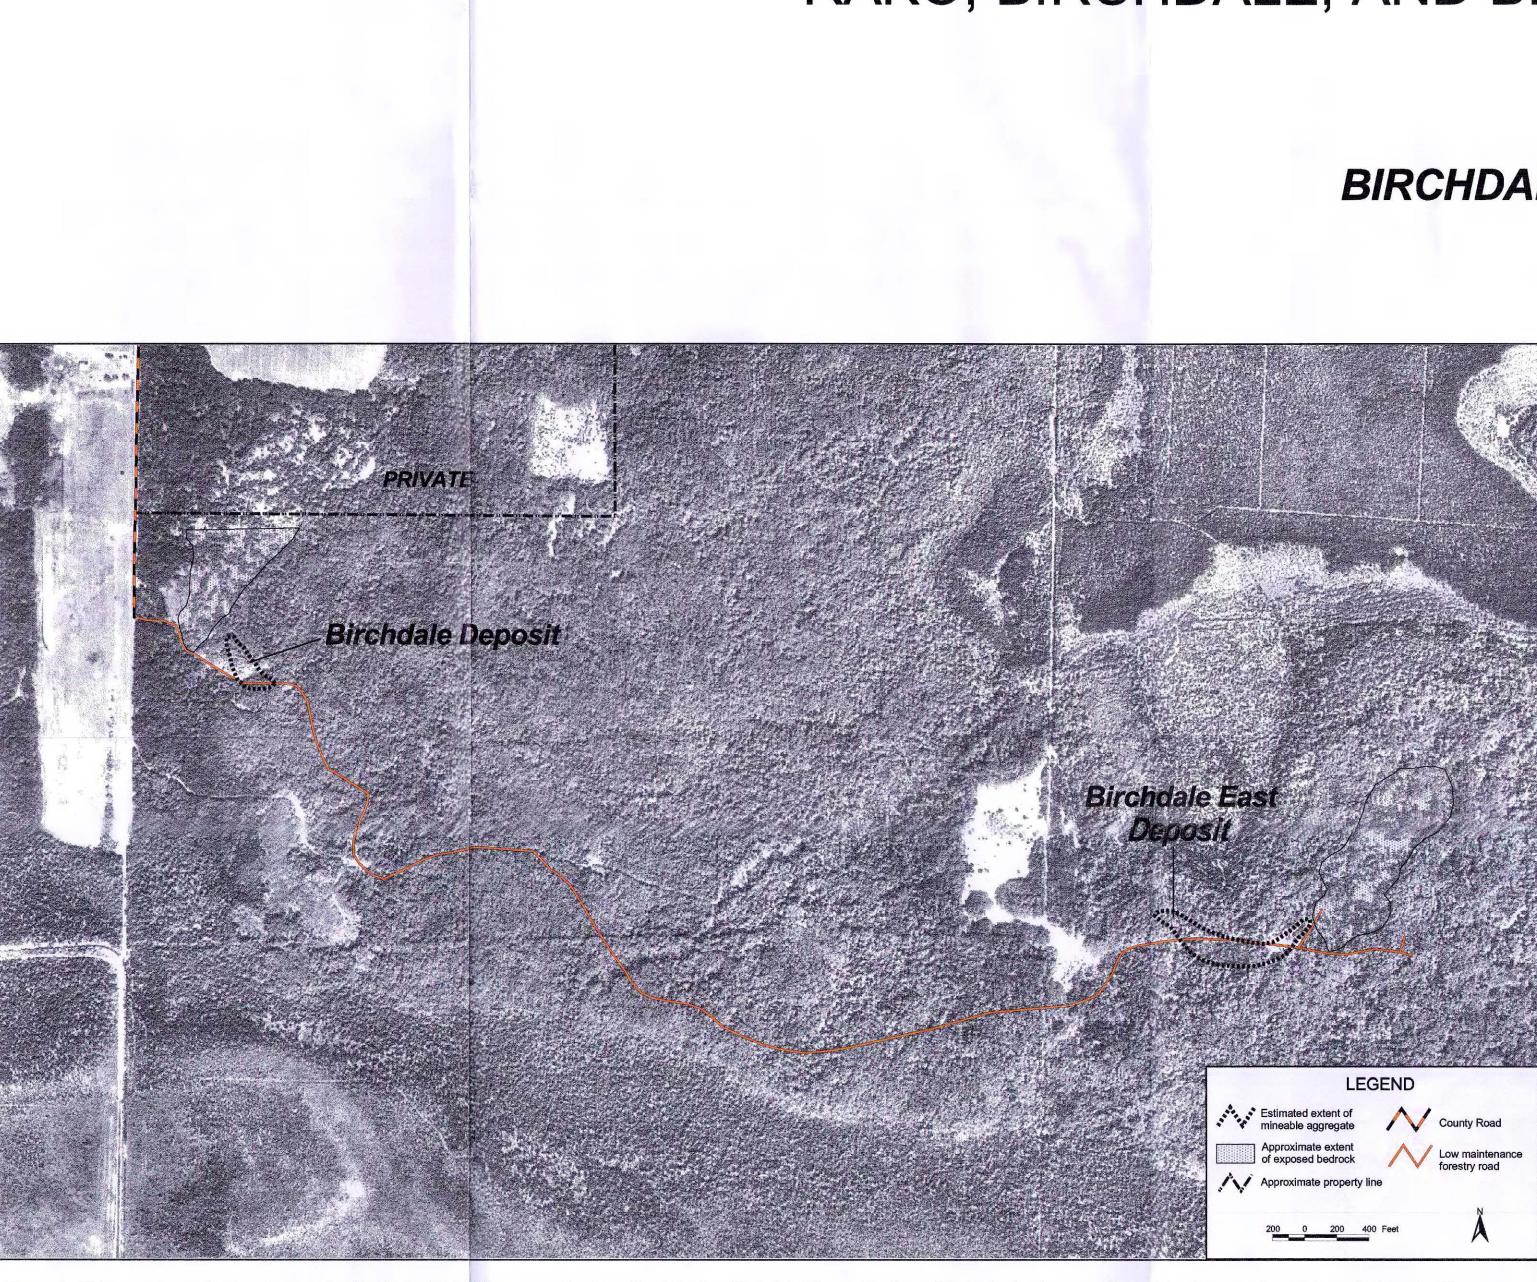
Figure 1. This map shows the locations and estimated extent of the aggregate deposits at the two Birchdale Pits and their position in the landscape. Bedrock knobs are adjacent to each deposit. The background aerial photo was taken in 1991.
