## BALD EAGLE LAKE, RAMSEY COUNTY: 2023 AQUATIC VEGETATION REPORT

Report by the Invasive Species Program – Division of Ecological and Water Resources  
Minnesota Department of Natural Resources

**Lake:** Bald Eagle (DOW# 62000200)

**Survey Type:** Point-intercept

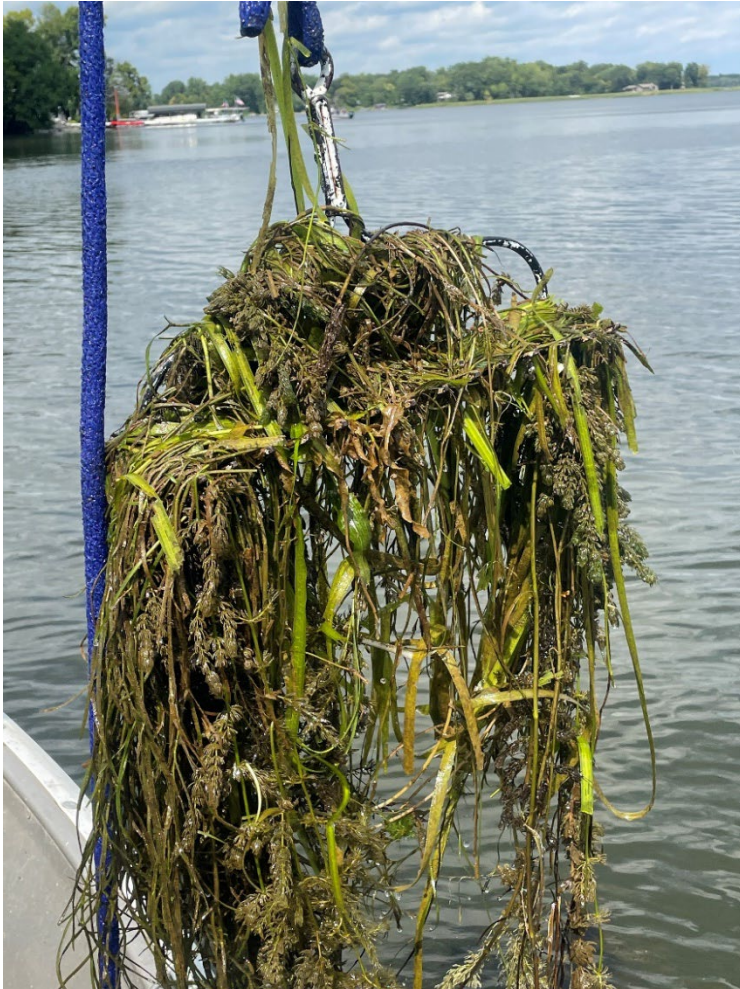
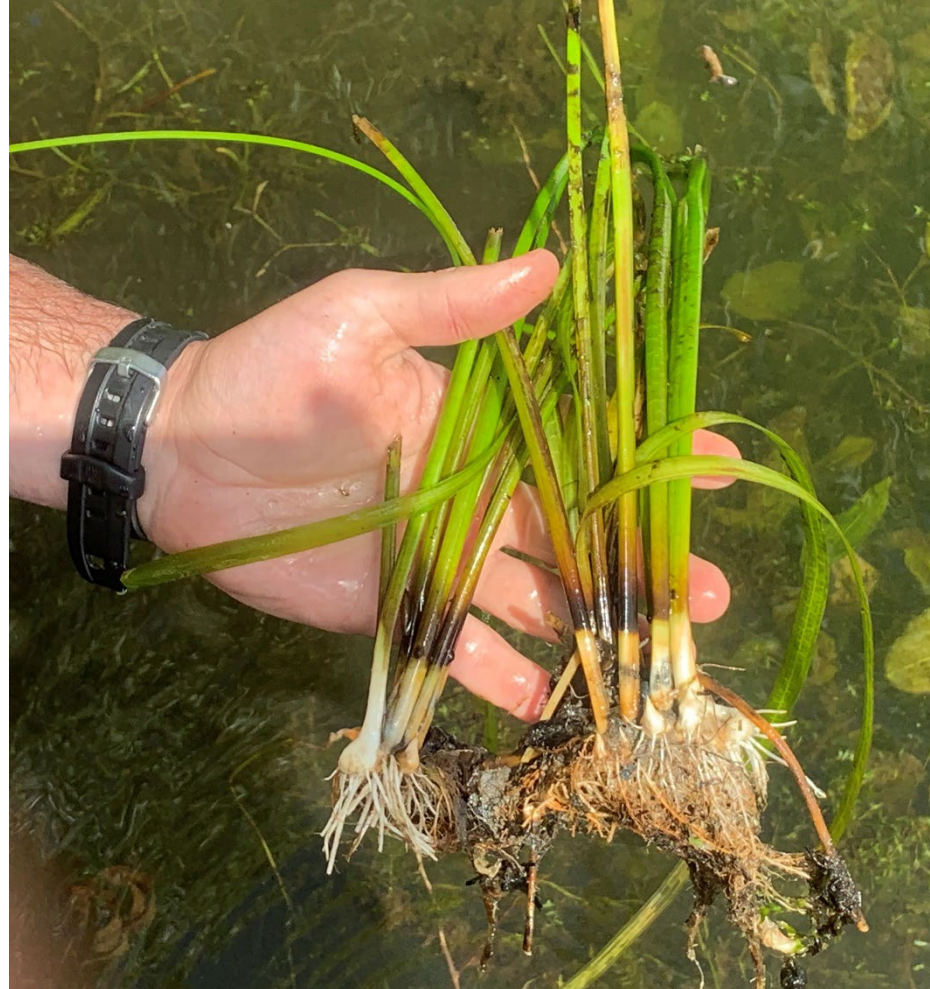
**Photos 1 & 2.** Left (1): Point intercept survey rake full of native plants in 2022. Right (2): Sparse flowering rush plants found in the 2019 aquatic plant survey of Bald Eagle Lake, Ramsey County, Minnesota (DOW # 62000200).

Flowering rush is an emergent invasive plant that has been managed in Bald Eagle Lake since 2013 by the MNDNR and the RCWD. Flowering rush plants have been removed by hand on the west-central shoreline annually (August – September; see **Photos 1 & 2** below). Since the discovery of the plant in August 2013, management efforts have reduced the density and distribution of flowering rush in Bald Eagle Lake (from roughly 200 wet weight pounds of flowering rush to a few single plants pulled in 2021), no plants have been observed since 2021.
