BALD EAGLE LAKE, RAMSEY COUNTY: 2025 AQUATIC VEGETATION REPORT

Report by the Invasive Species Program – Division of Ecological and Water Resources
Minnesota Department of Natural Resources

Lake: Bald Eagle (DOW# 62000200)

Date of Survey (most recent): August 12, 2025

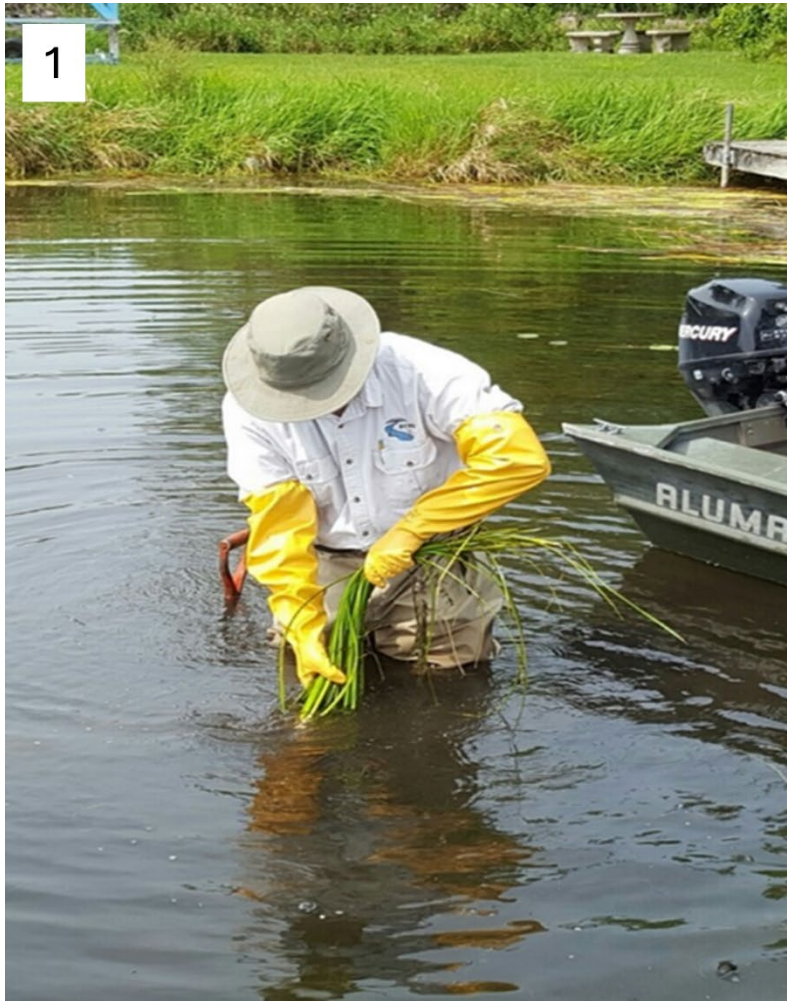
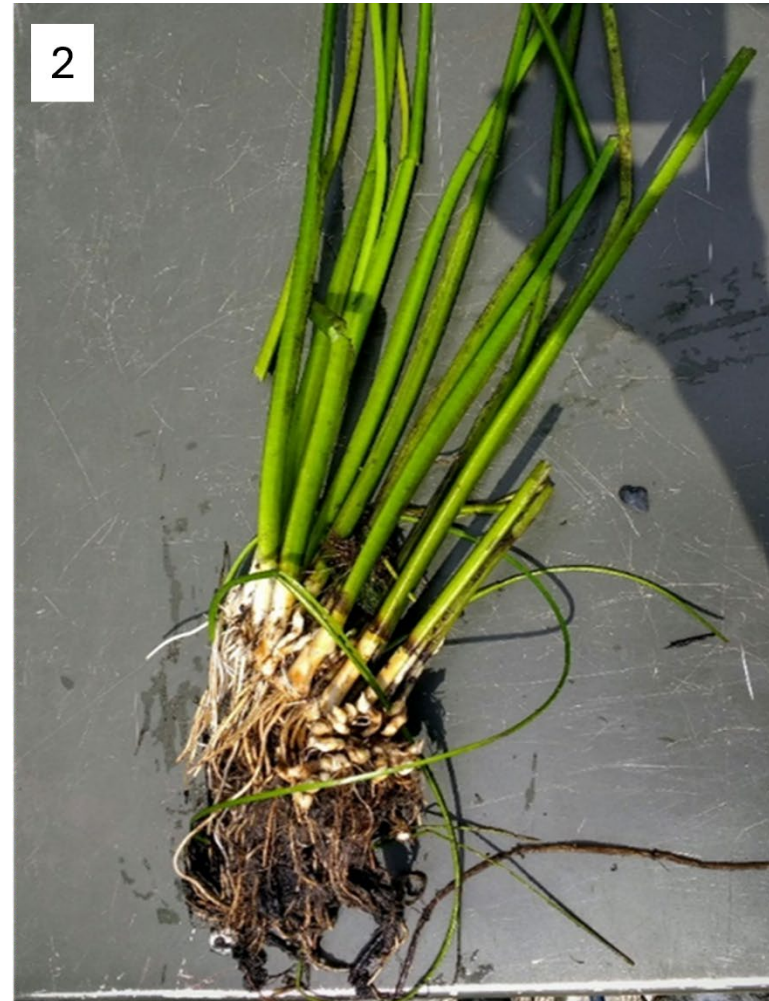
Photos 1 & 2. Left (1): Rice Creek Watershed District staff removing flowering rush from Bald Eagle Lake in 2016. Right (2): Flowering rush plant showing root mass and stems in Bald Eagle Lake, Ramsey County, Minnesota (DOW # 62000200)

Flowering rush is an emergent invasive plant that has been managed in Bald Eagle Lake since 2013 by the MNDNR and the RCWD. Flowering rush plants have been removed by hand on the west-central shoreline annually (August – September; see **Photos 1 & 2**). Since the discovery of the plant in August 2013, management efforts have reduced the density and distribution of flowering rush in Bald Eagle

Lake (from roughly 200 wet weight pounds of flowering rush to a few single plants pulled in 2021). There were no plants observed during the 2023 point-intercept survey but there were several plants observed in the 2025 survey. Staff from RCWD and MNDNR hand pulled the plants and will continue to monitor the population.

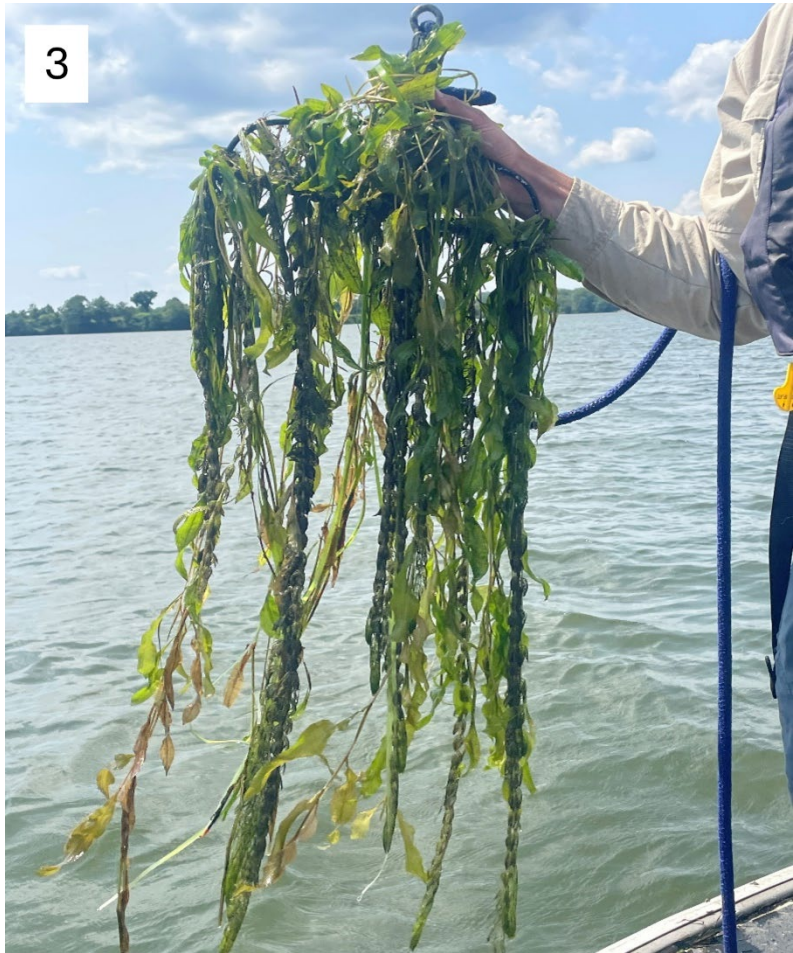
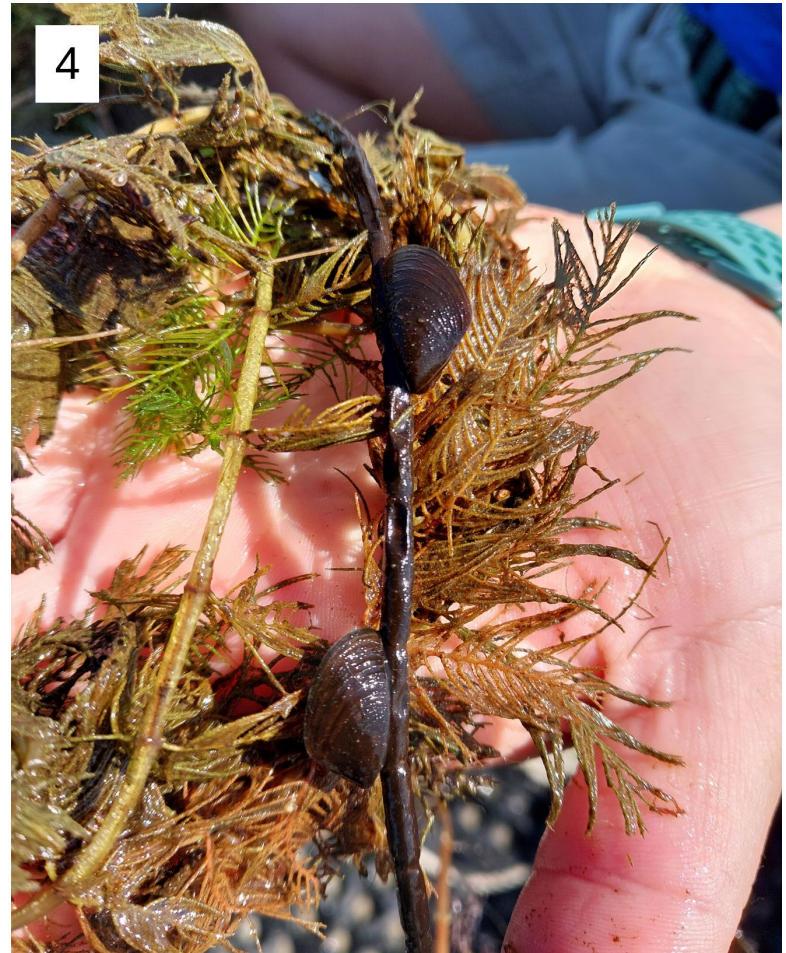
Photos 3 & 4. Left (3): Healthy native plants and Eurasian watermilfoil found during the 2025 point-intercept survey on Bald Eagle Lake, Ramsey County, Minnesota. Right (4): Eurasian watermilfoil retrieved from rake toss with zebra mussels attached to plant stem.
