## COON LAKE WEST, ANOKA COUNTY: 2024 AQUATIC VEGETATION REPORT

Report by the Invasive Species Program – Division of Ecological and Water Resources  
Minnesota Department of Natural Resources

**Lake:** Coon (DOW# 02004200)

**Date of Survey (most recent):** July 31, 2024

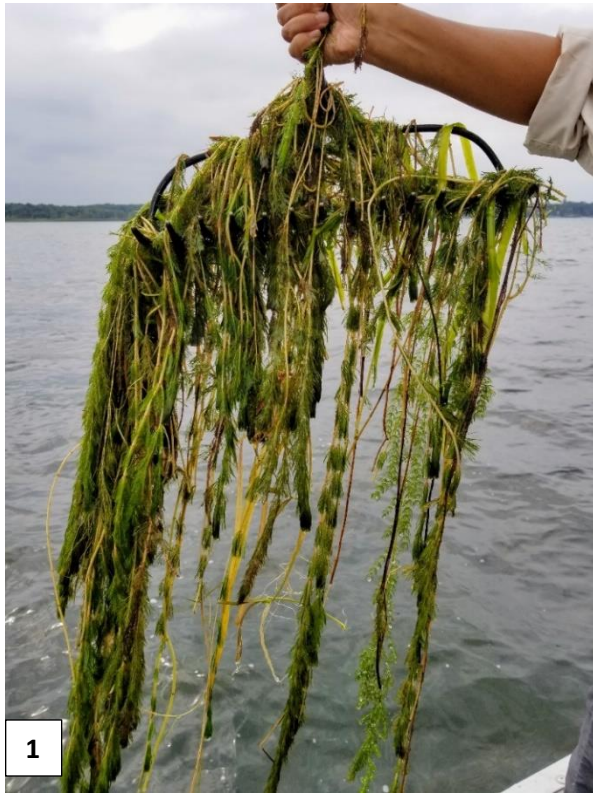
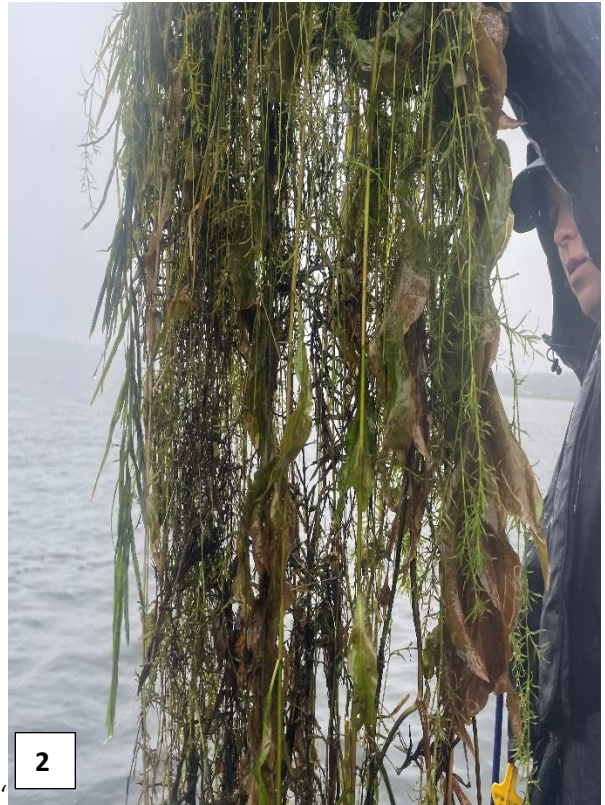
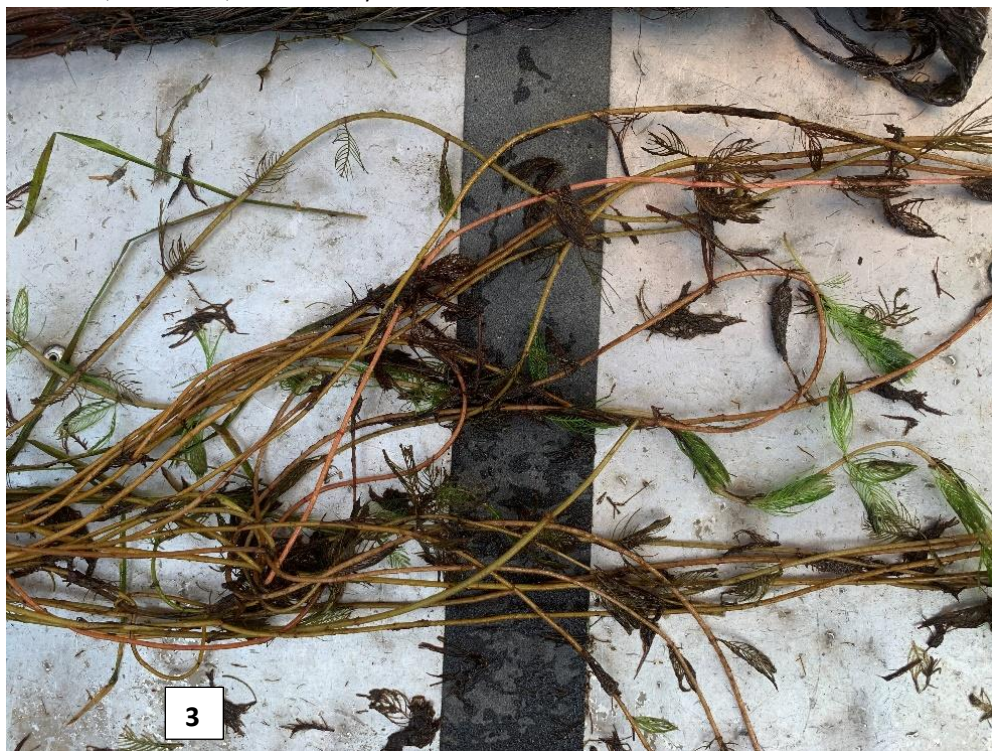
**Photo 1.** Rake throw showing EMW growing in high densities in 2018. **Photo 2.** July 2024- Diverse native plants during the summer survey. **Photo 3.** July 2019 - Plants showing signs of degradation and discoloration impacted by the fluridone treatment Coon Lake, West Basin, Anoka County.

Following the fluoridone treatment in the spring of 2019, a few plants became less abundant (coontail, naiad, and elodea), which is a consistent finding when compared to other fluoridone-managed lakes. Since, naiads have recovered to pre-fluoridone treatment frequency of occurrences levels, whereas coontail and elodea have still not rebounded fully (**Table 3**). Mean Native Taxa/Point tied its highest record (4.0) in 2024 and remains a diverse metro lake (**Table 2**; 24 native submersed plant species observed in 2024).
