## COON LAKE WEST, ANOKA COUNTY: 2021 AQUATIC VEGETATION REPORT

Report by the Invasive Species Program – Division of Ecological and Water Resources  
Minnesota Department of Natural Resources

**Lake:** Coon (DOW# 2004200)

**Date of Survey (most recent):** August 2, 2021

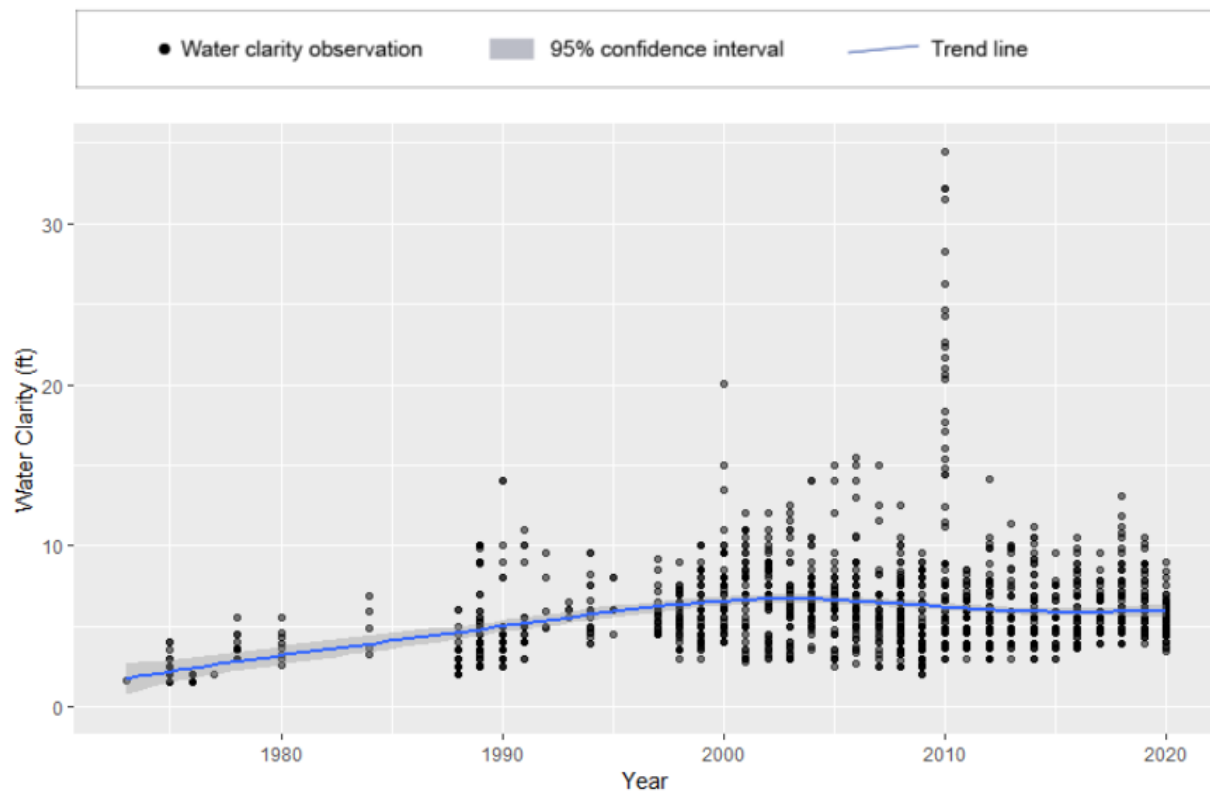
**Figure 1-Secchi Averages.** Secchi disk observations in meters for Coon Lake (both basins; DOW #02004200) from 1973 to 2020. Figure obtained from the Minnesota Pollution Control Agency (MPCA).

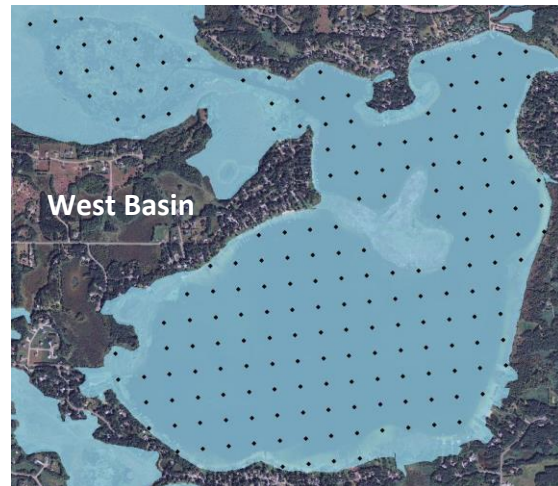
We used a point-intercept survey method developed by John Madsen in “Aquatic Plant Control Technical Note MI-02, 1999”. Survey points were placed 100 meters apart using a Geographic Information System (GIS). Note: surveys from 2010 were 175 meters apart, respectively. This spacing allowed for the placement of 162-170 points, depending on the year. Plant samples were collected by throwing and dragging a double-sided rake along the lake bottom

at each point for approximately 3 meters. Plant samples were assessed on the boat to determine species and rake fullness as a surrogate for density (scale of zero [no plants] to 3 [dense, matted on the surface]). Frequencies of occurrence percentages (i.e., how often a plant species was found in the lake) were calculated based on the littoral zone (the portion of the lake is less than 15 feet in depth).

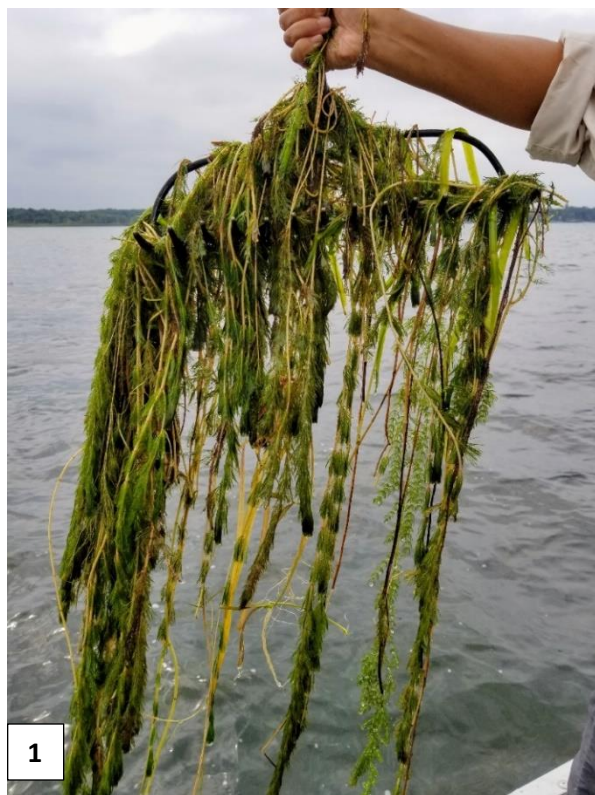
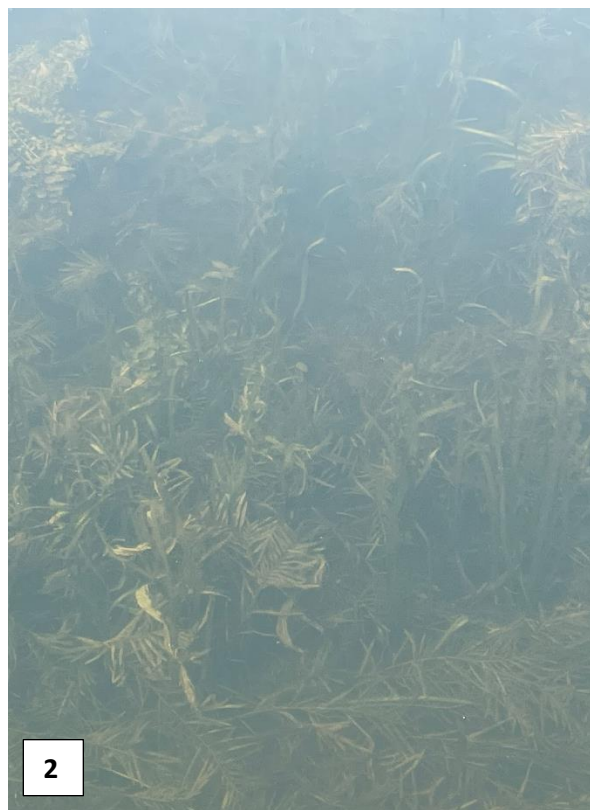
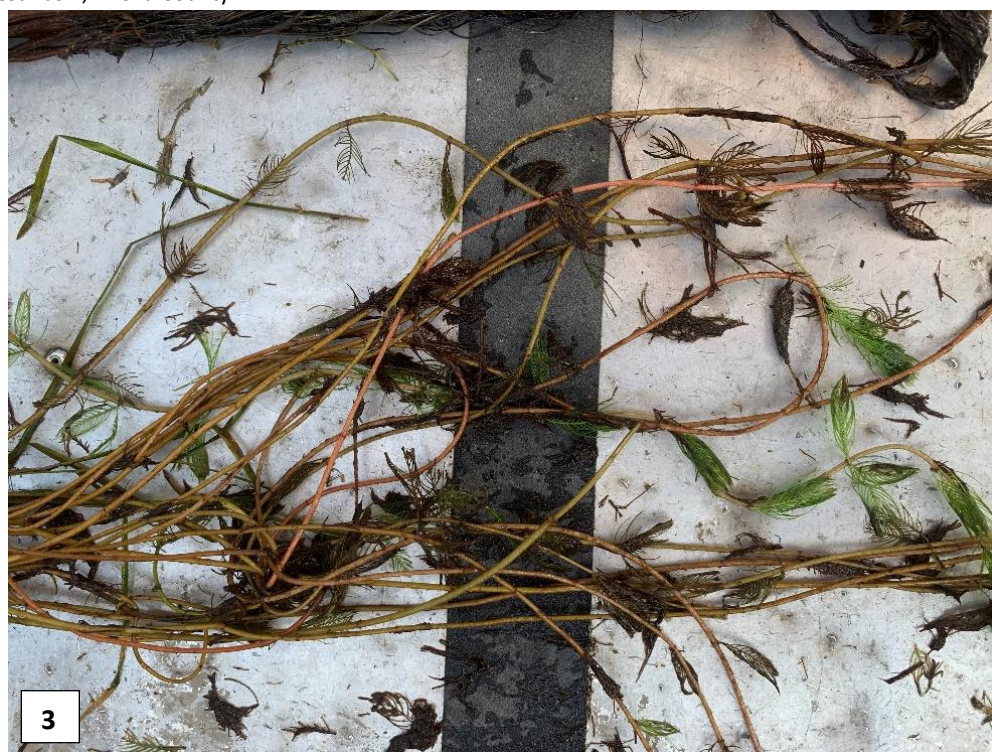
**Photo 1.** Rake throw showing EMW growing in high densities in 2018. **Photo 2.** Aug 2021- Diverse native plants during the summer survey. **Photo 3.** July 2019 - Plants showing signs of degradation and discoloration impacted by the fluridone treatment Coon Lake, West Basin, Anoka County.

Since the fluridone treatment in spring 2019, a few plants were less abundant (coontail, naiad, and elodea) which is a consistent finding when compared to other fluridone-managed lakes. Of the eight native pondweeds observed in Coon West five native taxa remained stable or increased in frequency of occurrence from 2019 to 2021 (**Table 3**). Mean Native Taxa/Point has stayed constant and Coon Lake continues to be a diverse north metro lake (**Table 2**; 22 native submersed plant species observed in 2021). In addition, a less common native aquatic plant species to Minnesota, bearded stonewort (*Lychnothamnus barbatus*), was observed in the 2018 and 2021 surveys.
