DIAMOND LAKE, HENNEPIN COUNTY: 2019 AQUATIC VEGETATION REPORT

Report by the Invasive Species Program – Division of Ecological and Water Resources
Minnesota Department of Natural Resources

Lake: Diamond (DOW# 27012500)

Date of Survey (most recent): July 8, 2019

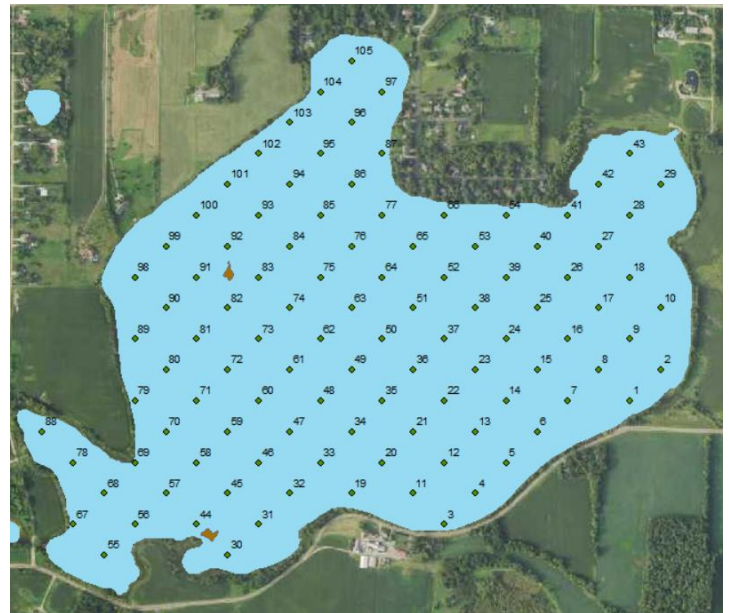
We used a point intercept survey method developed by John Madsen in [“Aquatic Plant Control Technical Note MI-02, 1999”](#). Survey points were placed approximately 122 meters apart using a Geographic Information System (GIS), allowing for placement of 105 points. Plant samples were collected by throwing and dragging a double-sided rake along the lake bottom at each point for approximately 3 meters. Plant samples were assessed on the boat to determine plant species and rake fullness was used as a surrogate for density (scale of zero [no plants] to 3 [dense plants])

was used in 2019 (MnDNR survey) and a zero to 5 scale in 2011, 2012 and 2018 (Three Rivers Park survey years). Frequencies of occurrence percentages (i.e. how often a plant species was found in the lake) were calculated based on the littoral zone (the portion of the lake that is less than 15 feet in depth).

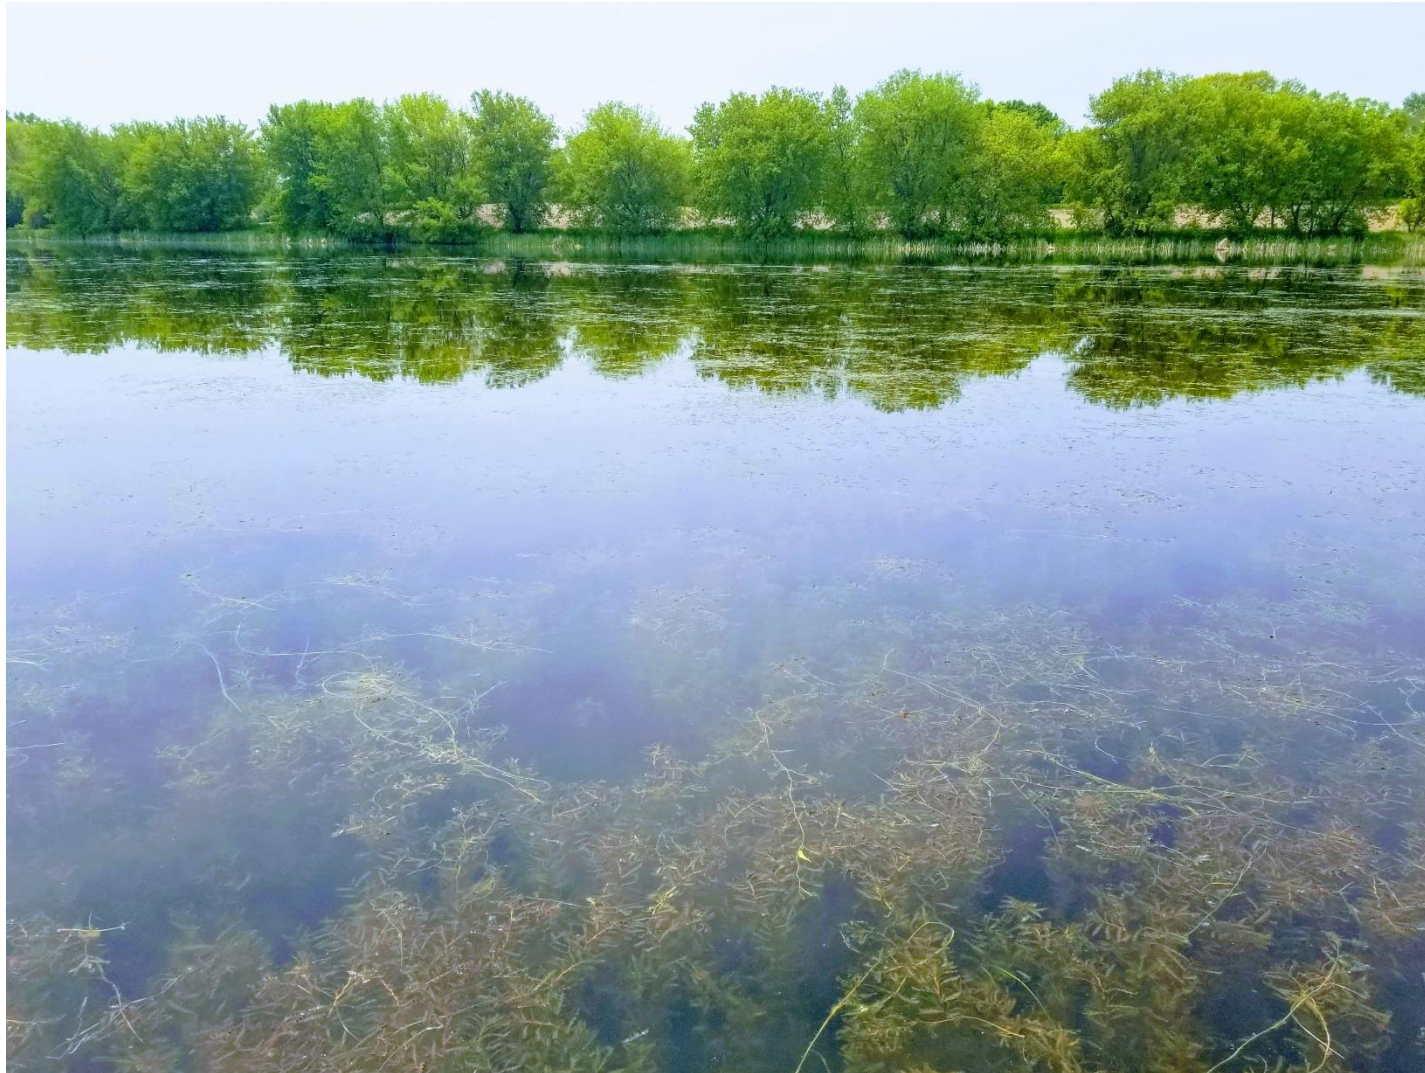
Photo 1 Curly-leaf pondweed growing in surface matting abundance during the spring 2019 survey on Diamond Lake, Hennepin County.

In early spring 2019, CLP was found throughout the lake and observed at 74% frequency of occurrence (FOO, **Photo 1**). Historically, CLP has been observed as high as 92% FOO in 2011. The timing of spring surveys vary in relation to treatment timing and it is likely the 2018 survey occurred post-treatment and CLP had already died off. Minimal impacts to native plants were observed post fluridone treatment, although coontail did show signs of degradation (**Photo 2**).

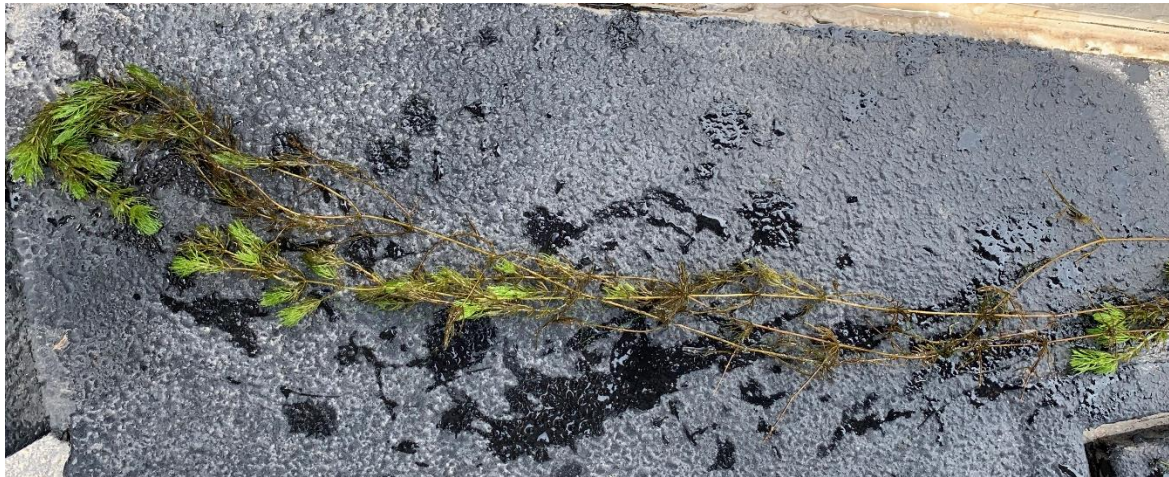
Photo 2 Coontail during the summer 2019 point intercept survey showing signs of fluridone effects.

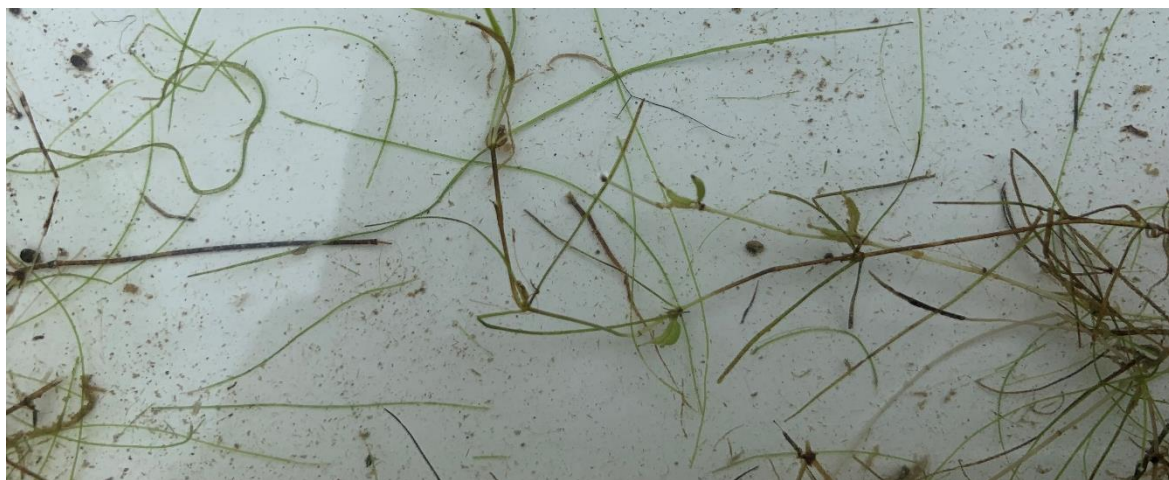
Photo 3 Horned pondweed found in several locations throughout the lake during the summer 2019 survey

Eleven native submersed plants were observed during the 2019 summer survey which occurred on July 8th. The most abundant native plants included coontail, Canadian waterweed and sago pondweed and most recently horned pondweed (**Table 4b- Plant Frequency Occurrence**). Less common plant species observed include leafy pondweed, small pondweed, water stargrass and flat-stem pondweed. The first observation of horned pondweed was documented during the 2019 survey (**Photo 3**). Monitoring of aquatic plants will continue through 2021 in Diamond Lake.

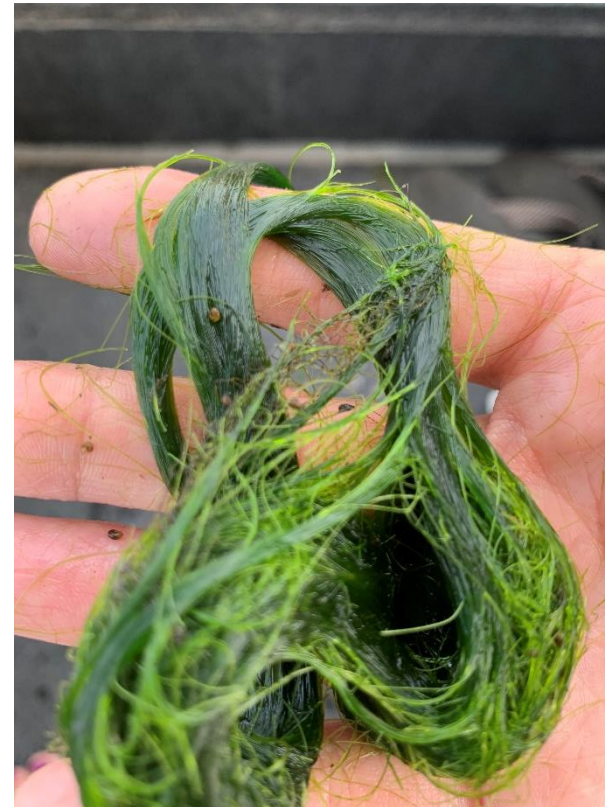
Photo 4 Filamentous algae was found in high densities and was present at most sampling locations in the summer 2019 survey
