LAKE COON, ANOKA COUNTY: 2019 AQUATIC VEGETATION REPORT

Report by the Invasive Species Program – Division of Ecological and Water Resources
Minnesota Department of Natural Resources

Lake: Coon (DOW# 2004200)

Date of Survey (most recent): July 17, 2019

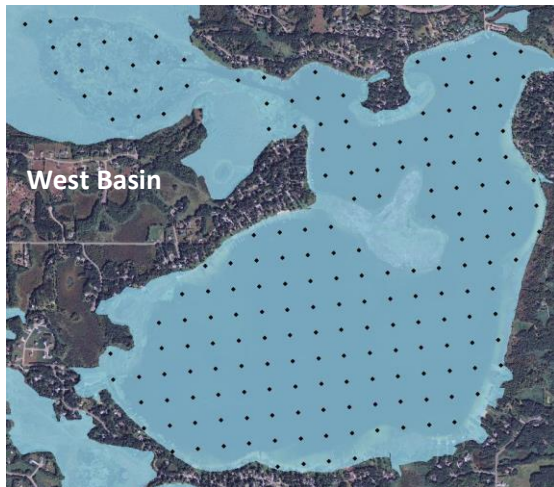
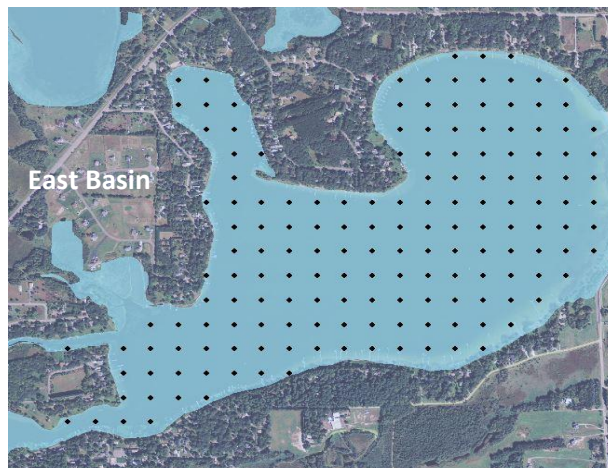
We used a point-intercept survey method developed by John Madsen in “Aquatic Plant Control Technical Note MI-02, 1999”. Survey points were placed 100 meters (East basin) and 150 meters (West basin) apart using a Geographic Information System (GIS). Note: surveys from 2010 were 175 meters apart, respectively. This spacing allowed for placement of 162-170 points, depending on basin and year. Plant samples were collected by throwing and dragging a double-sided rake along the lake bottom at each point for approximately 3 meters. Plant samples were assessed on the boat to determine species and rake fullness as a surrogate for density (scale of zero [no plants] to 4 [dense, matted on the surface] was used in 2012-2014 and a zero to 3 scale in 2018 and 2019). Frequencies of occurrence percentages (i.e., how often a plant species was found in the lake) were calculated based on the littoral zone (the portion of the lake is less than 15 feet in depth).

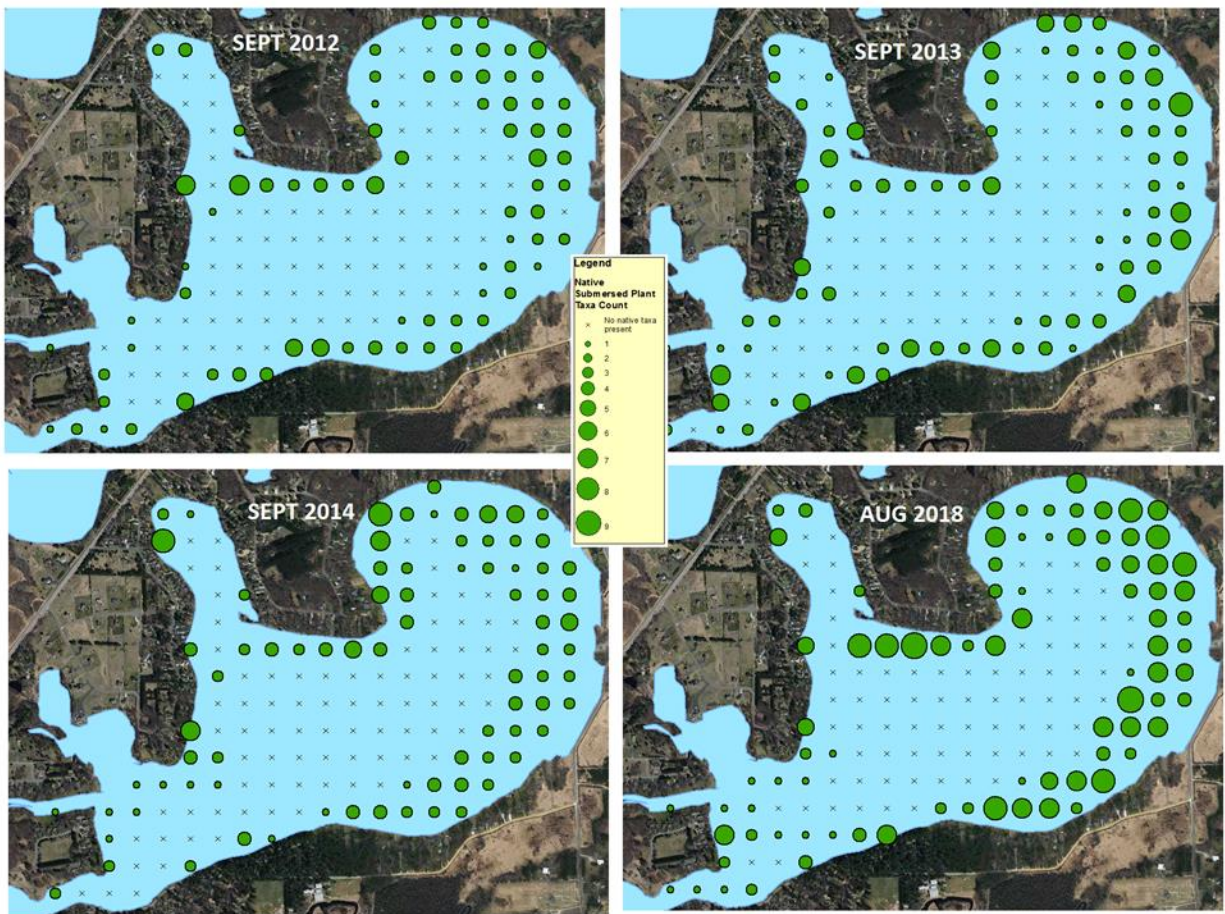
Figure 1a. Spatial distribution and species richness (# of native submersed taxa per sample point) in the **East Basin**. Dates correspond to month of point intercept survey. Coon Lake, Anoka County (DOW # 02004200).

No point intercept survey was conducted in 2019. The most recent point intercept survey was completed on August 16, 2018. 2018 survey data showed a maximum depth of rooted vegetation was observed at 8 feet, but historically has been observed growing up to 15 feet in depth (**Table 3a; Figure 3a**). Native plant distribution and abundance has been fairly consistent in the last 6 years with an increase observed in mean native submersed taxa per point in 2019 (**Figure 1a**). A total of fourteen native plant species were found within the littoral area which included coontail, naiad, water celery, and flat-stem pondweed as the most predominant species in the basin. Eurasian watermilfoil has remained at or under 17% frequency of occurrence in Coon East. The majority of EWM has been observed on the northeast side near the public water access and on the southwest side near the channel connecting the two basins.

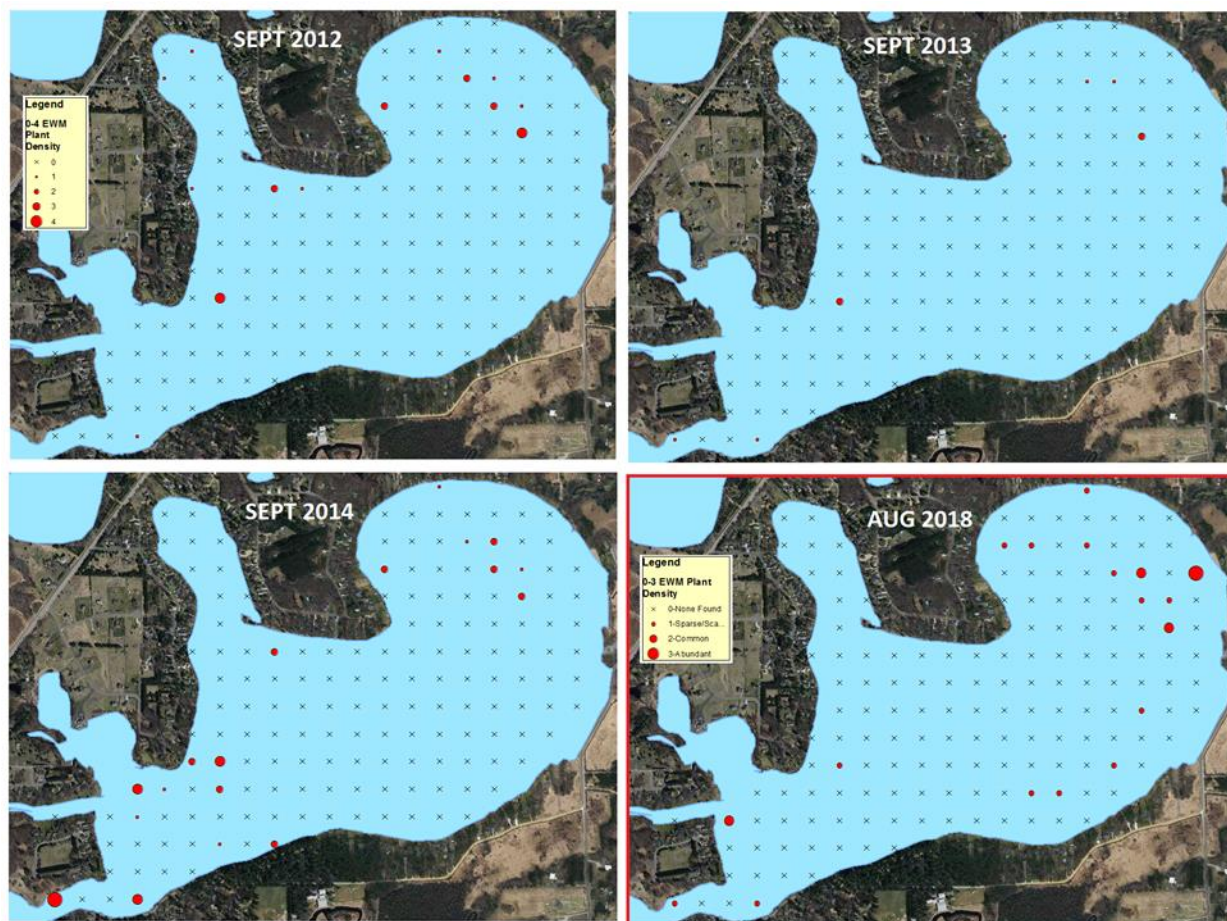
Figure 2a. Spatial distribution and species richness (Density of Eurasian watermilfoil per sample point) for 2012-2014 and 2019 in the **East Basin**. Dates correspond to month of point intercept survey. Years 2012-2014 were surveyed on a 1-4 density rake rating scale while 2018 was rated on a 1-3 density rake rating. Coon Lake, Anoka County (DOW # 02004200).

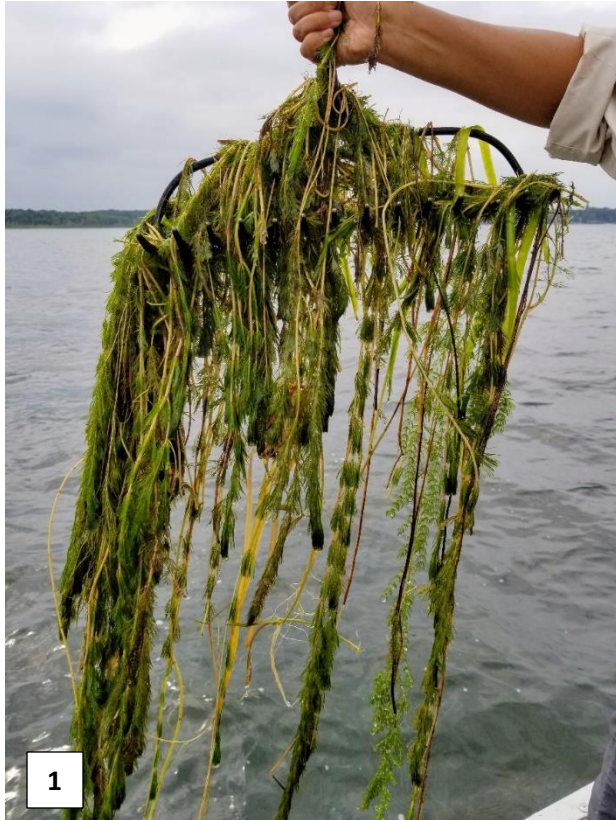
Photo 1. Rake throw showing EMW growing in high densities in 2018.

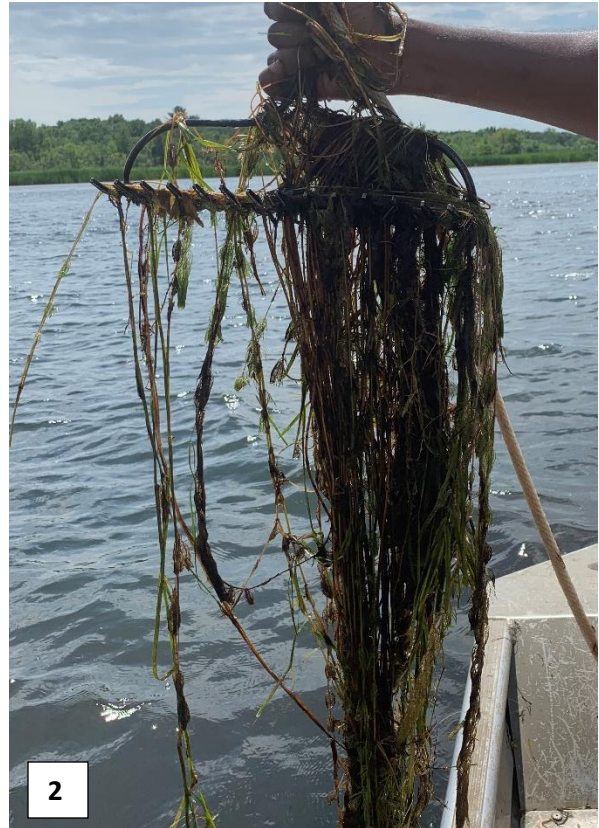
Photo 2. EWM starting to senesce in June from fluridone treatment in Coon West.

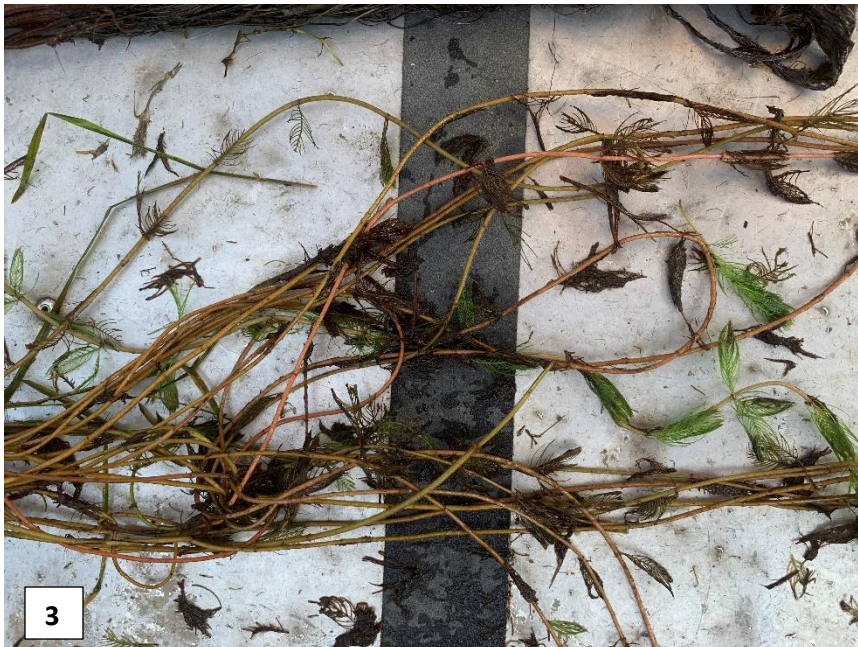
Photo 3. Defoliation observed during 2019 summer survey, Coon Lake, West Basin, Anoka County.

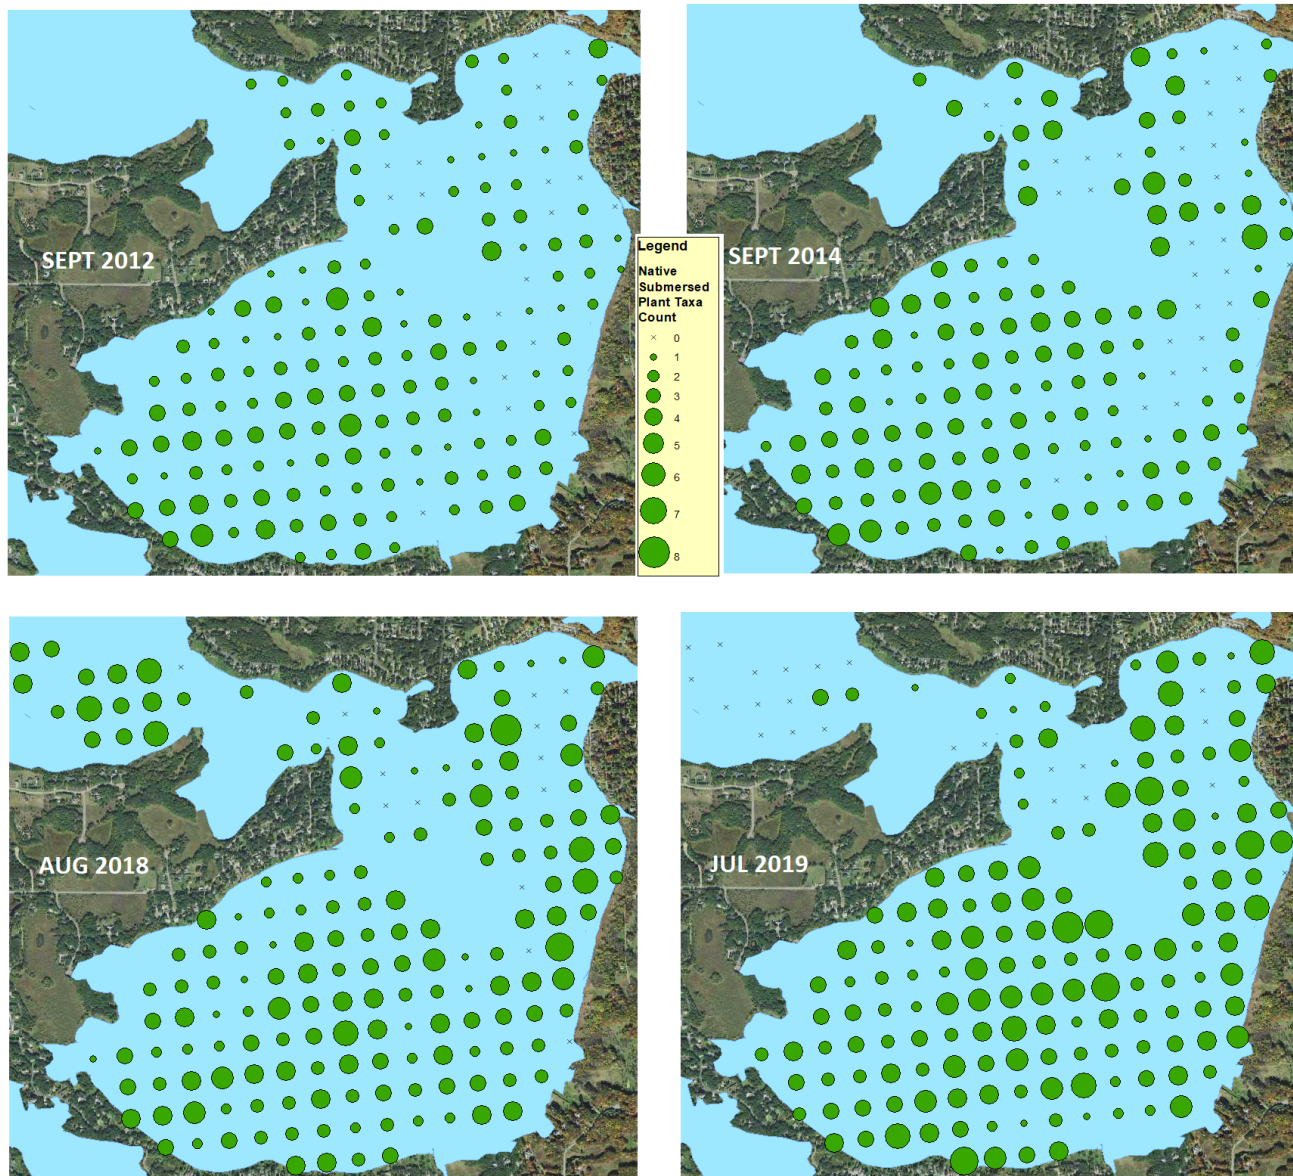
Native plants have remained stable while EWM has expanded (from 3% FOO in 2014 to 39% FOO in 2018) within the last six years (**Figures 1b&2b**).

Figure 1b. Spatial distribution and species richness (# of native submersed taxa per sample point) in the West Basin. Dates correspond to month of point intercept survey. Coon Lake, Anoka County (DOW # 02004200).

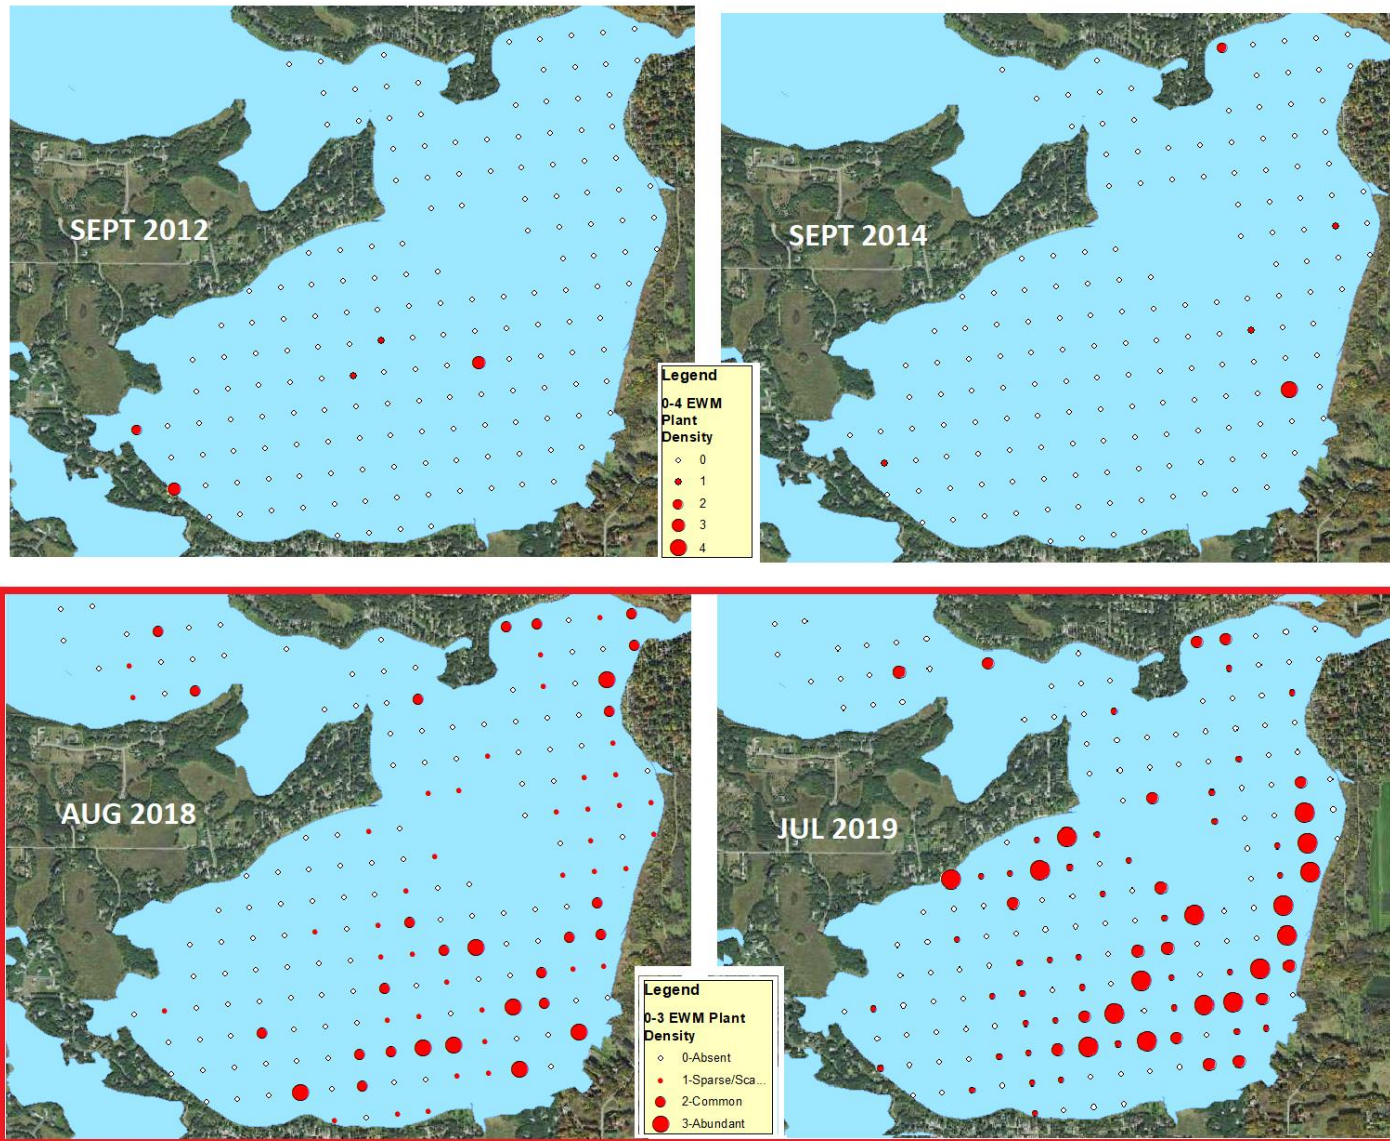
Figure 2b. Spatial distribution and species richness (Density of Eurasian watermilfoil per sample point) for 2012-2014 and 2019 in the **West Basin**. Dates correspond to month of point intercept survey. Years 2012-2014 were surveyed on a 1-4 density rake rating scale while 2018-2019 was rated on a 1-3 density rake rating. Coon Lake, Anoka County (DOW # 02004200).
