# Hydraulic Impacts of Quarries and Gravel Pits

J.A. Green, J.A. Pavlish, R.G. Merritt, and J.L. Leete  
Minnesota Department of Natural Resources,  
Division of Waters

## Executive Summary

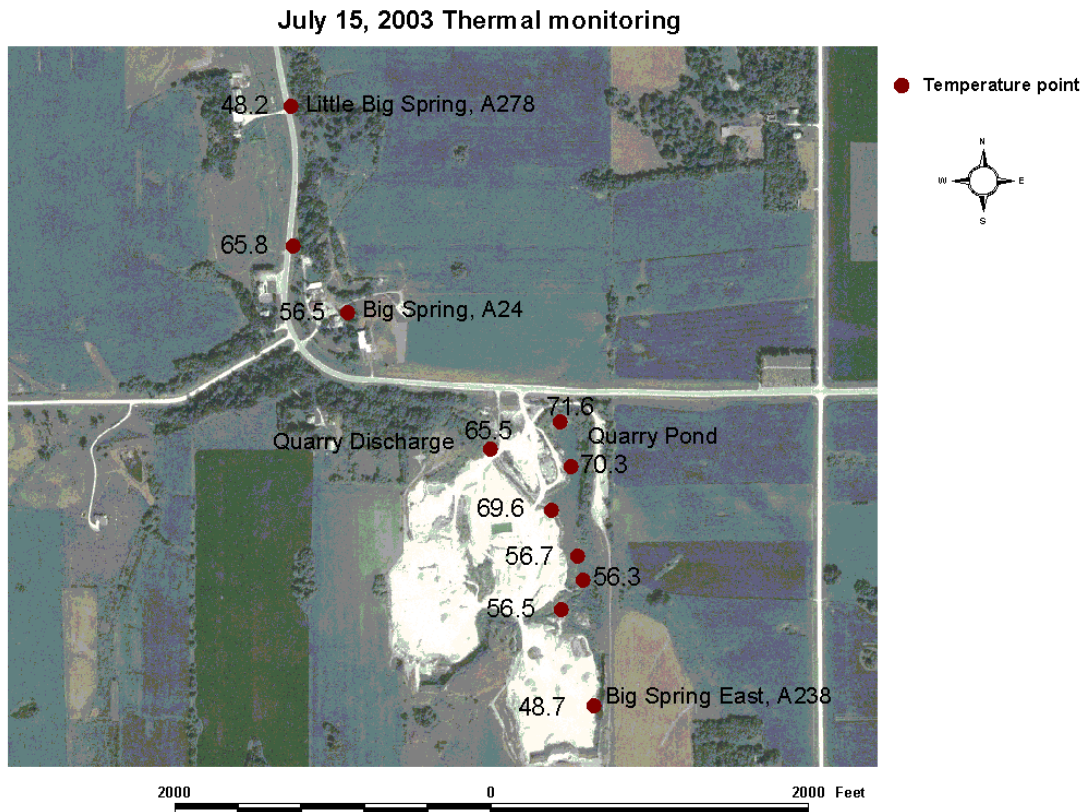
Figure 4. Temperature monitoring of water at Big Spring Quarry in Harmony.

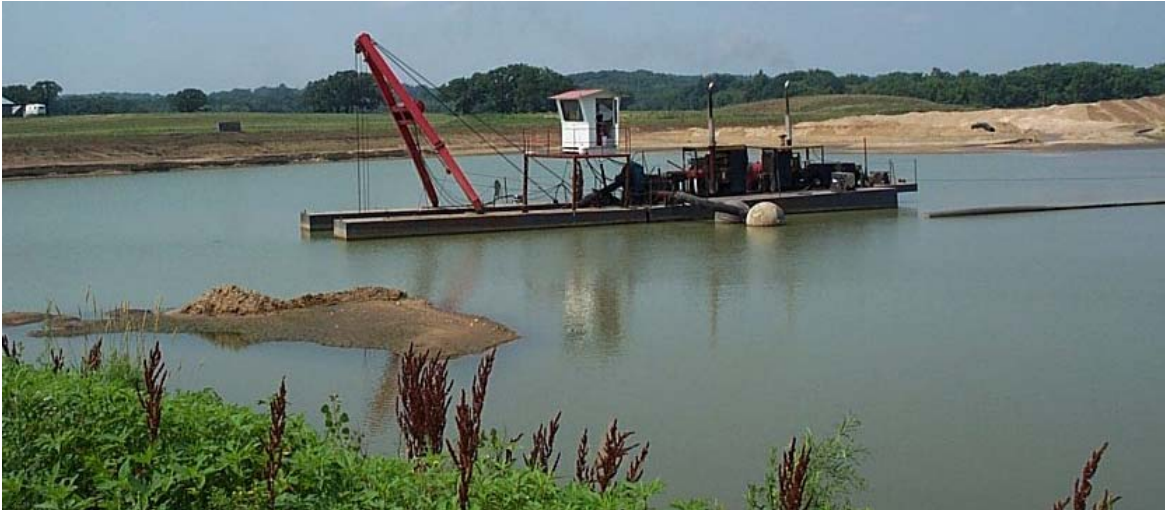
Figure 5. Donovan pit mining with a hydraulic dredge.

Two alluvial sand and gravel pits, Donovan pit and the Leitzen-Grabau pit, along the Zumbro River in Olmsted County were studied. The Leitzen-Grabau pit was only a few feet below the water table at its highest point after heavy rains or snowmelt. The Donovan pit had a pond area created by mining that is 500 ft by 400 ft by 30 ft deep; in this area, sand and gravel was mined by dredging (Figure 5). Neither pit was dewatered. At both sites, there was no significant impact on ground-water levels from mining. The fluctuations that were seen in the monitoring wells were due to precipitation events (Figure 6). A common concern about these operations is their impact

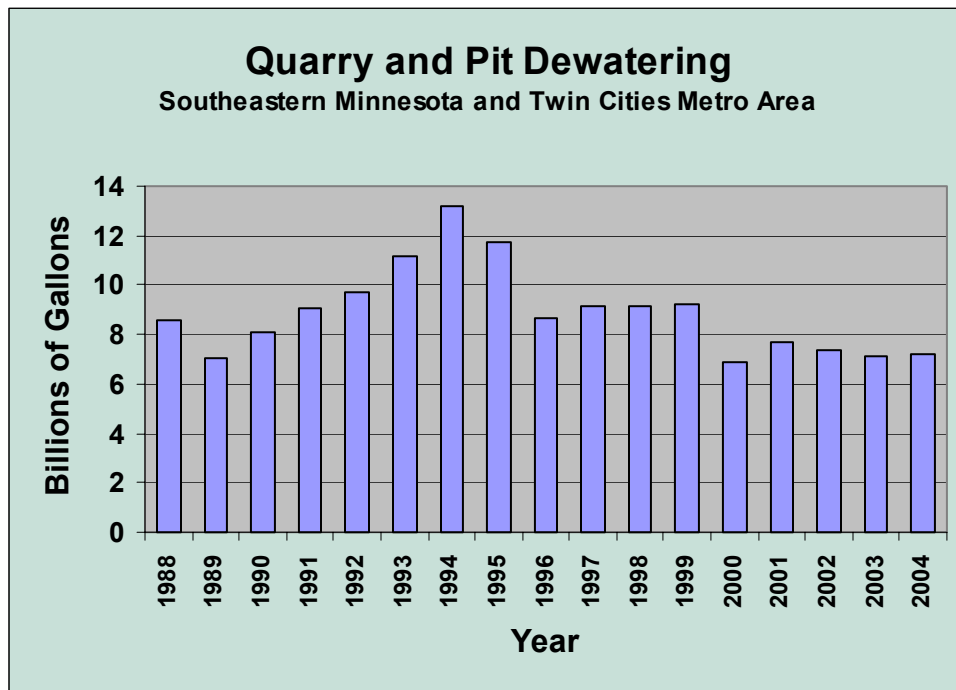
Figure 1.1. The extent of dewatering.

Crushed stone and sand and gravel, generally defined as natural aggregate resources, are the building blocks for much of modern society. Rock quarries and gravel pits are common features on Minnesota's landscape. Aggregate mining is an extractive use of resources that may result in the landscape and its hydrology being altered. Operation of quarries and pits has the potential to cause impacts on ground-water and surface-water systems in various ways. This potential causes concerns about mining operations by citizens and state and local officials, as well as mine and pit operators. Quarries and gravel pits often are located in the aquifer itself; thus, water quality impacts can be direct and unmitigated. Ground-water levels surrounding many of these quarries and pits are drawn down to allow dry quarry operations, converting billions of gallons of ground water into surface water annually and reducing ground-water availability for nearby wells, wetlands, springs, streams, and lakes (Figure 1.1).

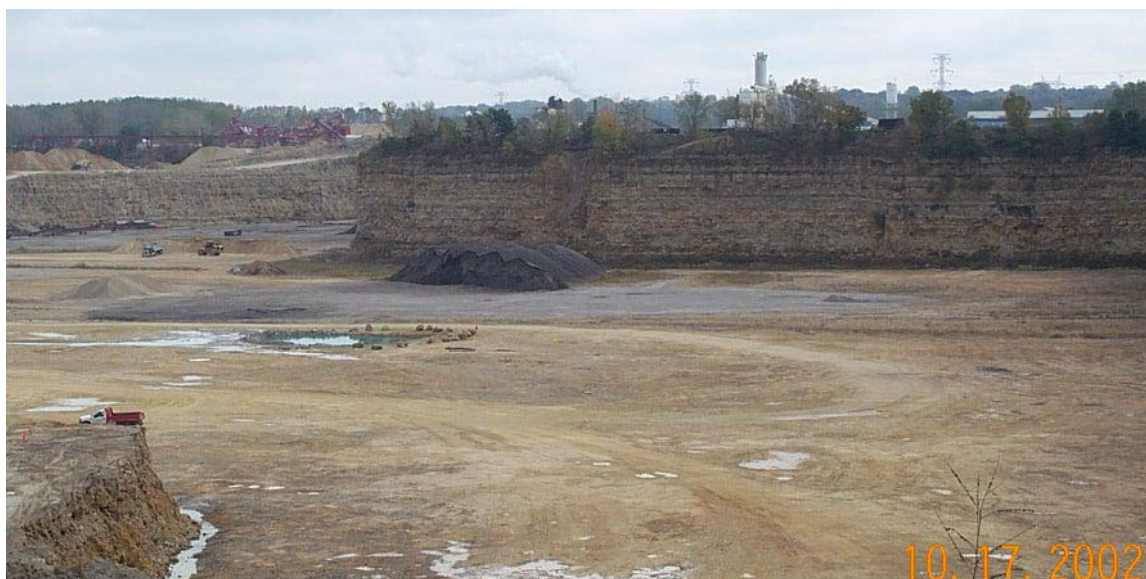
Figure 2.2. Kraemer quarry site photograph.

The Kraemer quarry (Figure 2.2) is located in township 27, range 24W, section 33, a half-mile north of State Highway 13, west of Interstate 35W, and a quarter-mile south of the Minnesota River in Burnsville, Dakota County.

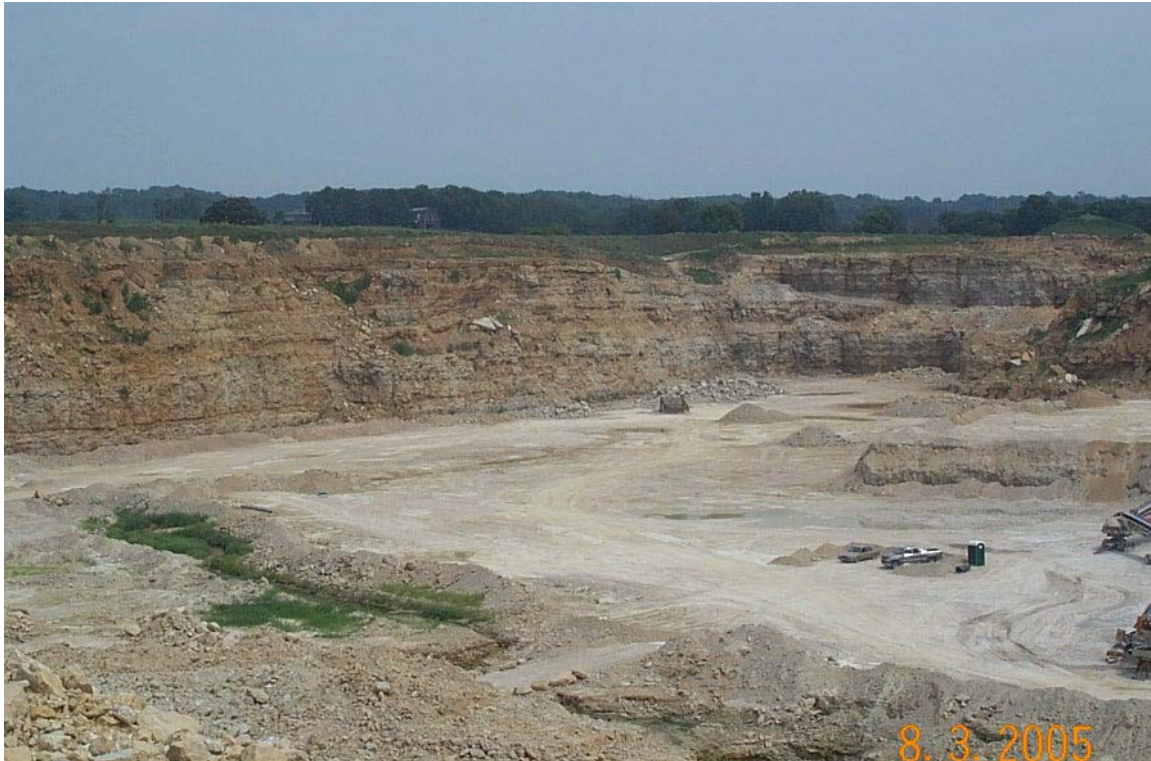
Figure 2.4. Golberg quarry site photograph.

The Golberg quarry (Figure 2.4) is located in township 108, range 14W, section 36, north of County Road 14 and along the banks of the Zumbro River in Olmsted County. The site is 5 miles northeast of the city of Rochester.

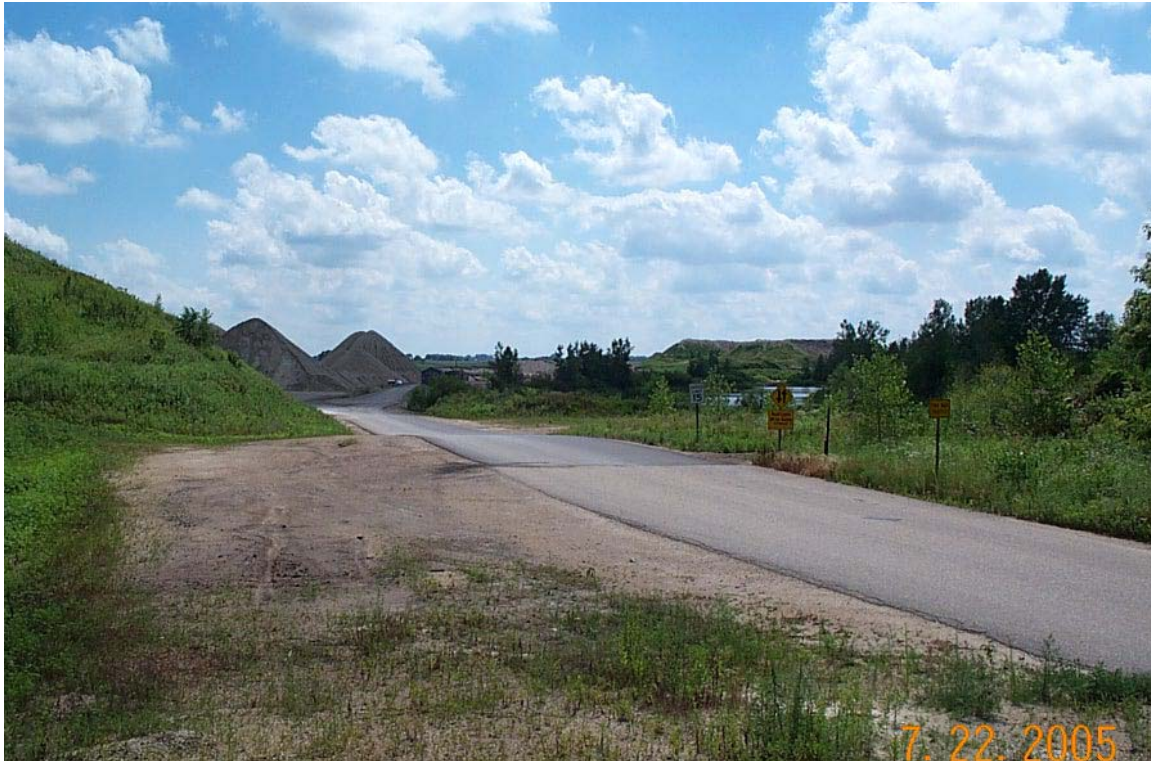
Figure 2.6. Spinler quarry site photograph.

The Spinler quarry (Figure 2.6) is located in township 106, range 21W, section 1, a half-mile west of County Road 30, two miles west of Interstate Hwy 35, south of 51<sup>st</sup> Road, and a half-mile west of the Straight River in Steele County. The site is 6 miles southwest of the city of Owatonna.

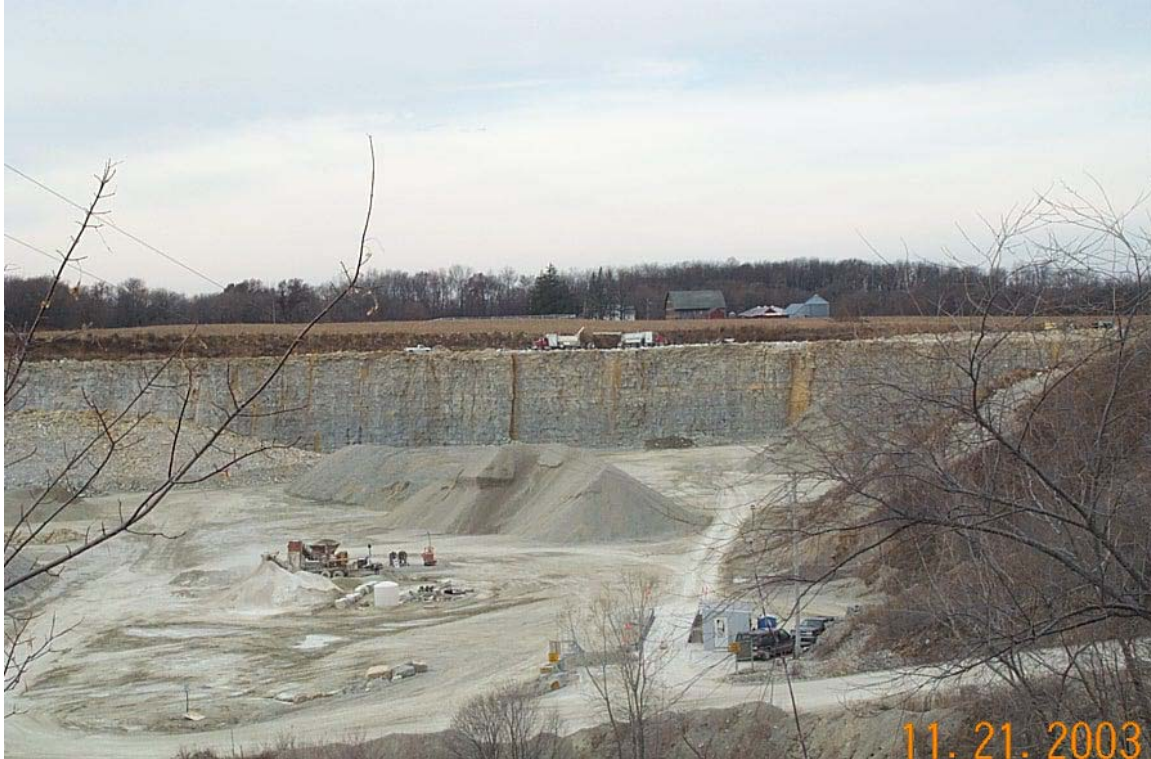
Figure 2.8. Fountain quarry site photograph.

The Fountain quarry (Figure 2.8) is located in township 103, range 11W, section 3, north of County Road 8, and a half-mile west of U.S. Highway 52 in Fillmore County. The site is 25 miles southeast of the city of Rochester.

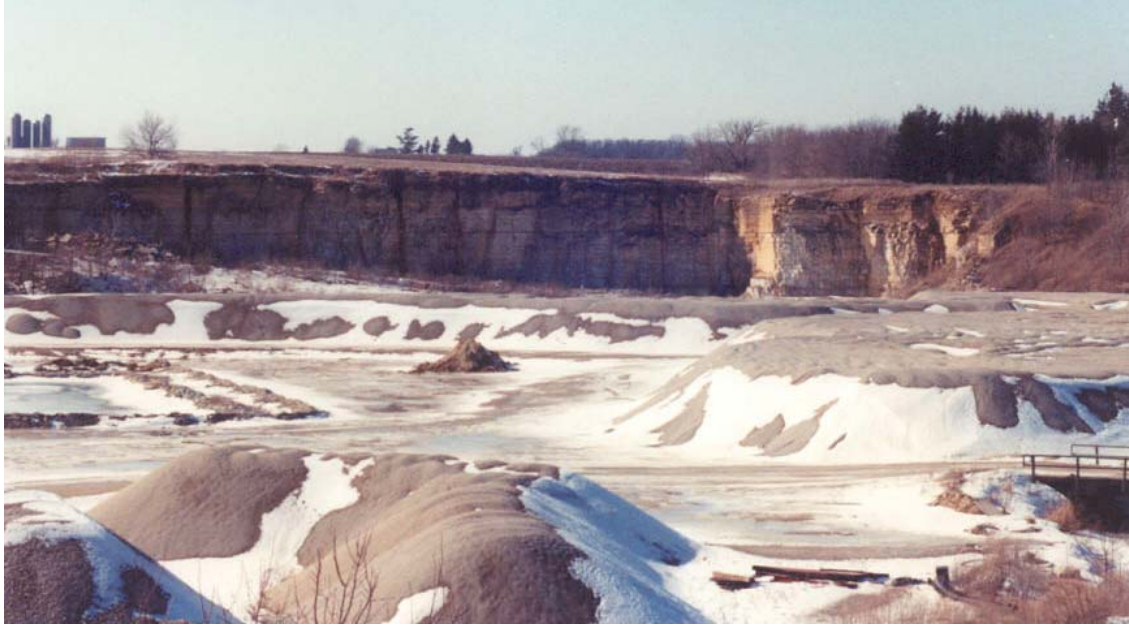
Figure 2.10. Big Springs quarry site photograph (2003).

The Big Springs quarry (Figure 2.10) is located in township 101, range 10W, section 9, south of County Road 22 and about 2 miles west of U.S. Highway 52 in Fillmore County. The site is near Harmony, Minnesota, 38 miles southeast of the city of Rochester. The primary resource being removed from the site by Pederson Brothers Construction is crushed limestone of various grades.

The Big Spring quarry is in the flat-lying Stewartville and Prosser Members of the Ordovician Galena Group. The Prosser is fine-grained, thin-bedded limestone with minor shale partings while the Stewartville is fine-grained dolomitic limestone and dolostone (Mossler, 1995). Both of these formations exhibit classic karst features when they are in a shallow setting as they are here. In this area they have numerous sinkholes, stream sinks, springs, and caves. In the quarry face, solution conduits up to 3 yards in diameter have been exposed as the quarry has expanded.

The area that is currently being mined is about 35 acres; however, the total disturbed area is closer to 47 acres. In the early 1960s, quarrying operations disrupted the conduits carrying flow to Big Spring (A24), the headwaters of a trout stream, Camp Creek, which lies 550 yards north of the quarry. The owners of the spring have stated that when this disruption occurred, the flow from the spring decreased. At that time, water started rising in the quarry at several different points; some flows overland to Camp Creek while the rest sinks back into the quarry and resurges in Big Spring (A24). This quarry is not actively dewatered. The ratio of overland flow versus resurging flow varies depending on spring stage and runoff events. As the quarry has expanded to the south, the points at which the water discharges in the quarry have migrated south also. Figure 2.11 below is a photograph of Big Spring East, A238, the main point where water discharges in the eastern part of the quarry.

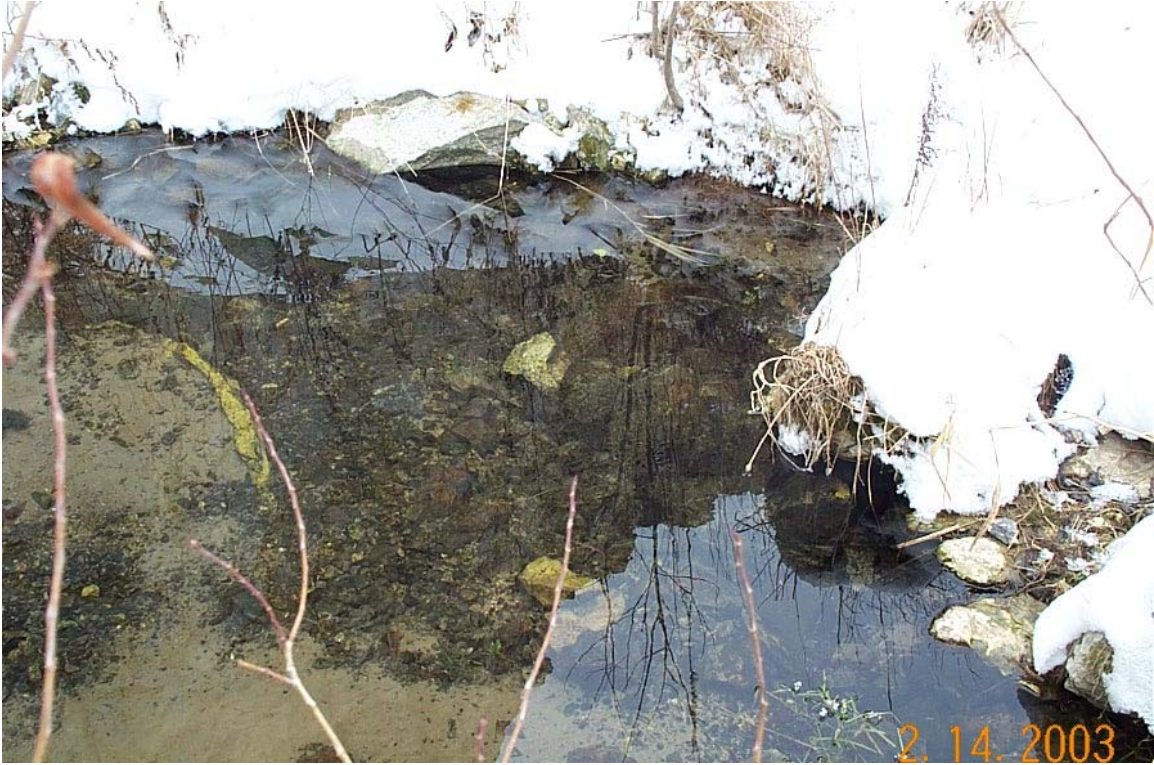
Figure 2.11. Big Spring East, the main discharge point in the eastern part of the quarry.

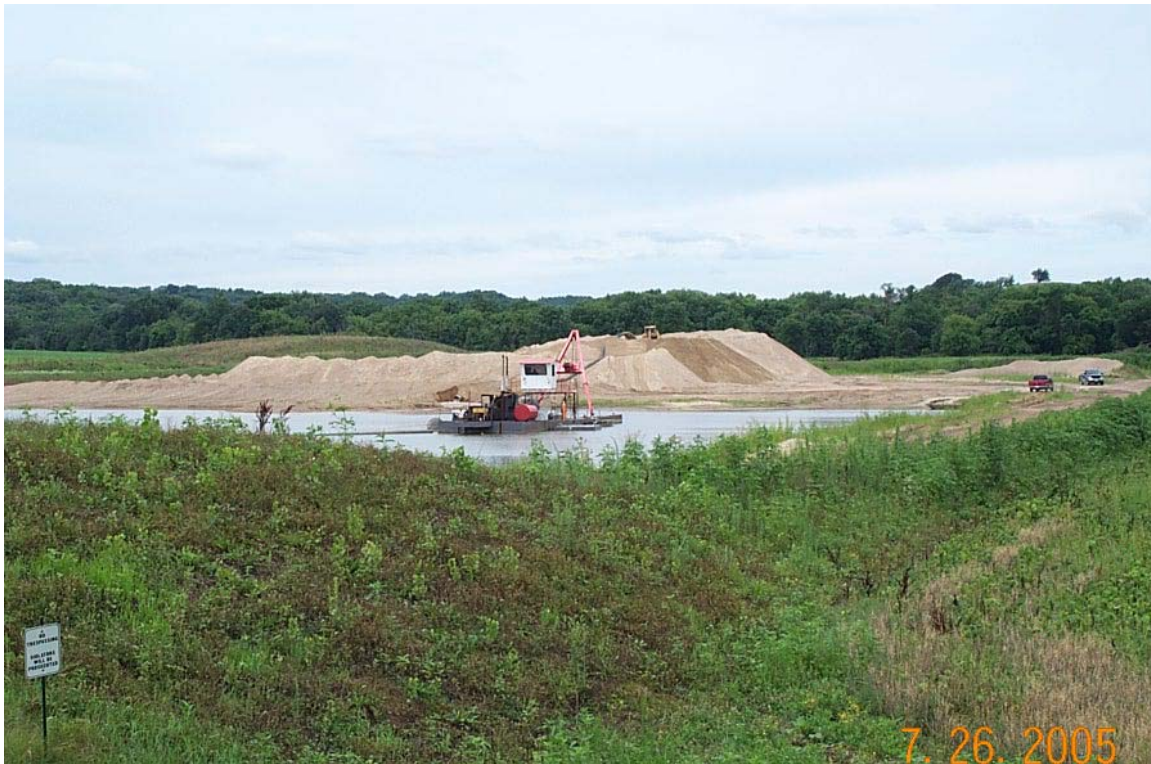
Figure 2.13. Donovan pit site photograph.

The Donovan pit (Figure 2.13) is located in township 106, range 15W, section 24, just west of County Road 104 and 250 feet south of the Zumbro River in Olmsted County. The site is in Salem Township, 5 miles southwest of the city of Rochester.

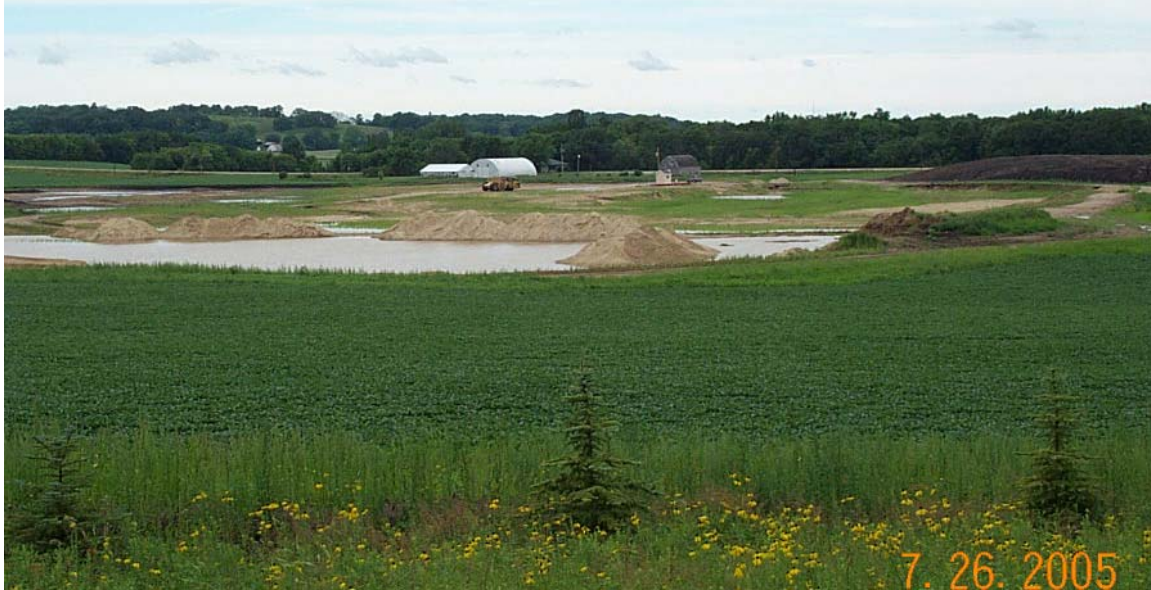
Figure 2.15. Leitzen-Grabau pit site photograph.

The Leitzen-Grabau pit (Figure 2.15) is located in township 106, range 15W, section 25, just west of 60<sup>th</sup> Ave SW and south of County Road 117 along the Zumbro River in Olmsted County. The site is in Salem Township, 5.5 miles southwest of the city of Rochester.

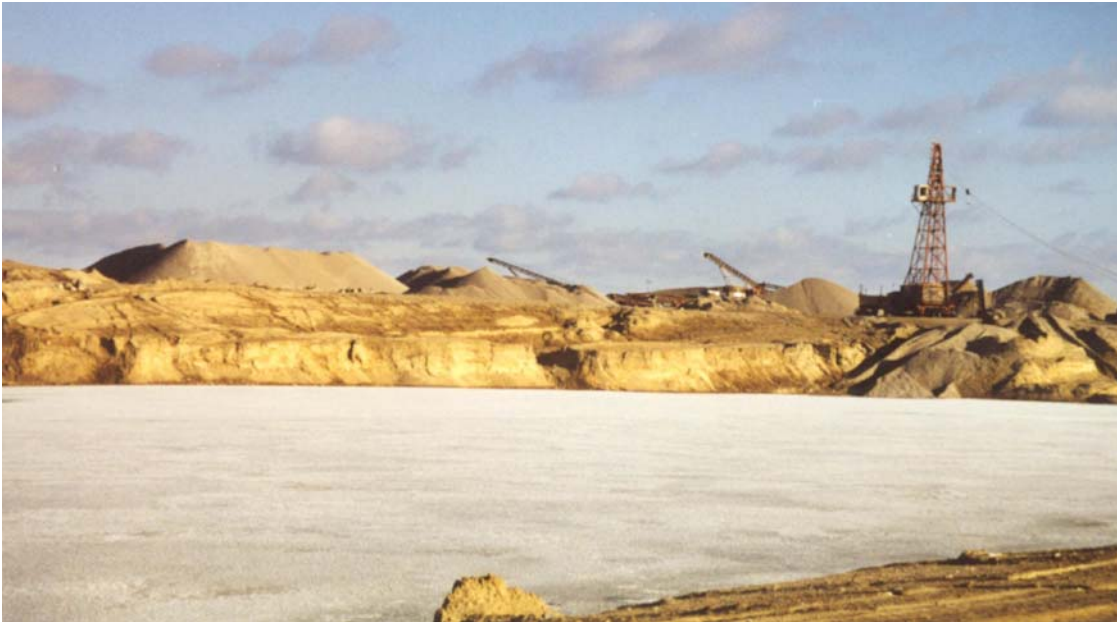
Figure 2.17. Felton pit site photograph.

The Felton study area has several active gravel pits, the largest of which are the Trust Fund Pit and the Clay County Pit. The first is a large open-water gravel pit (Figure 2.17), which is managed by the DNR Division of Forestry for the School Trust Fund. This pit is located in township 142N, range 45W, SW1/4 NW 1/4 section 32. Construction-grade gravel has been removed from the deposit on the Trust Fund parcel since 1959. The lease is currently held by Aggregate Industries. Mined to approximately the ground-water table, the Clay County Pit is situated in township 142N, range 45W, S1/2 section 6. Substantial gravel resources have been identified below the water table in and surrounding the pit.

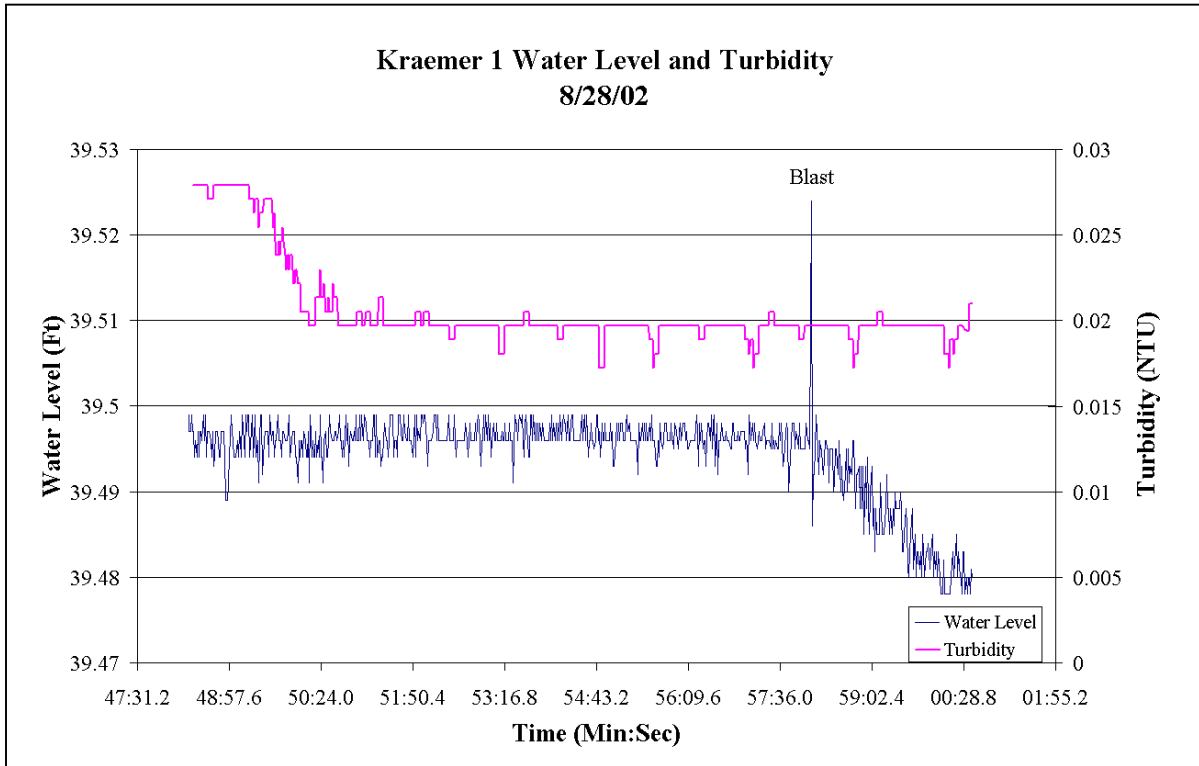
Figure 3.5. Comparison of water levels and turbidity in Kraemer quarry wells.

The blasting results shown in Figure 3.5 reveal a slight change in water level immediately following the blast. A drop in ground-water level is observed that we attribute to the removal of a portion of the rock matrix.

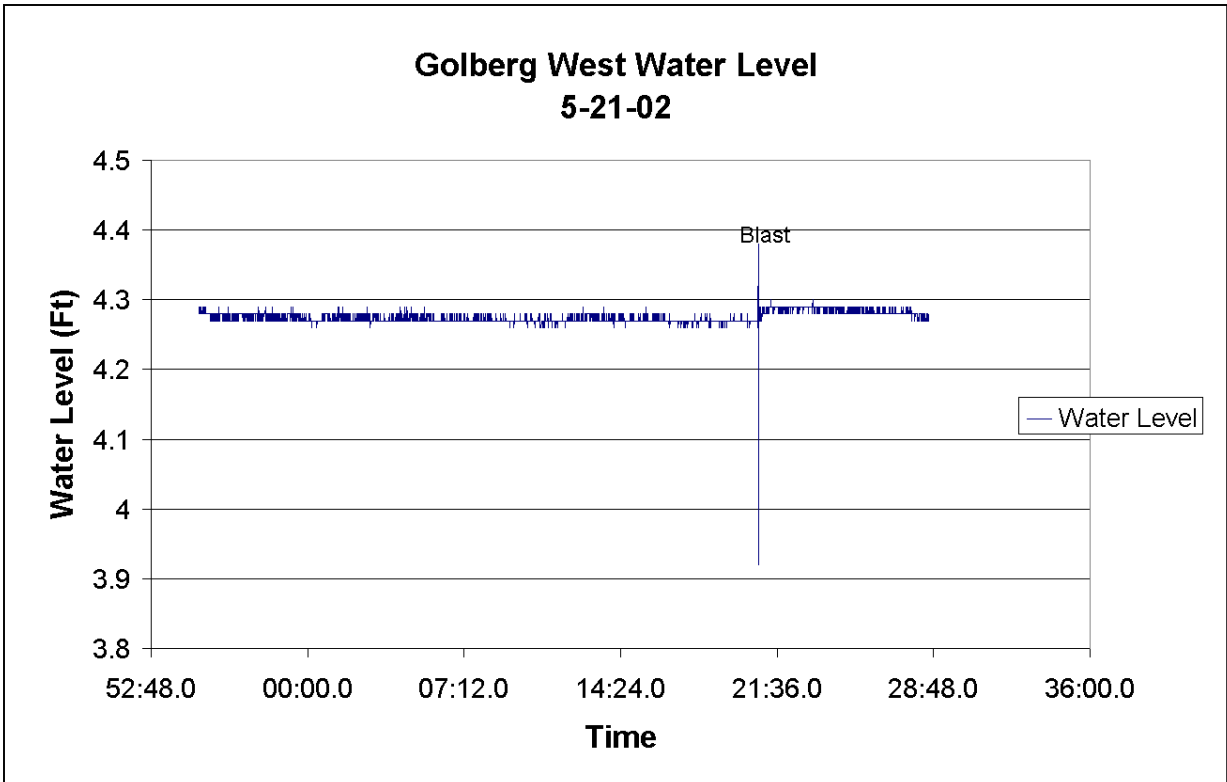
Figure 4.3. Impacts of blasting on water levels in Golberg quarry wells.

Blasting events were monitored during 2002 while the pit was expanded north. Similar to results at the Kraemer site, ground-water levels changed immediately following the blast (Figure 4.3). We were also interested in turbidity changes in response to blasting events. In theory, particles in or near the well could be dislodged by the energy of the blast and cause cloudiness in the water, that is, increased turbidity. Several blasting events were monitored during summer 2002 while active blasting occurred along the quarry face near the monitoring wells. There was no effect from blasting on turbidity levels. Because the wells that are monitored in this case are relatively new, there may be little material present to be dislodged.

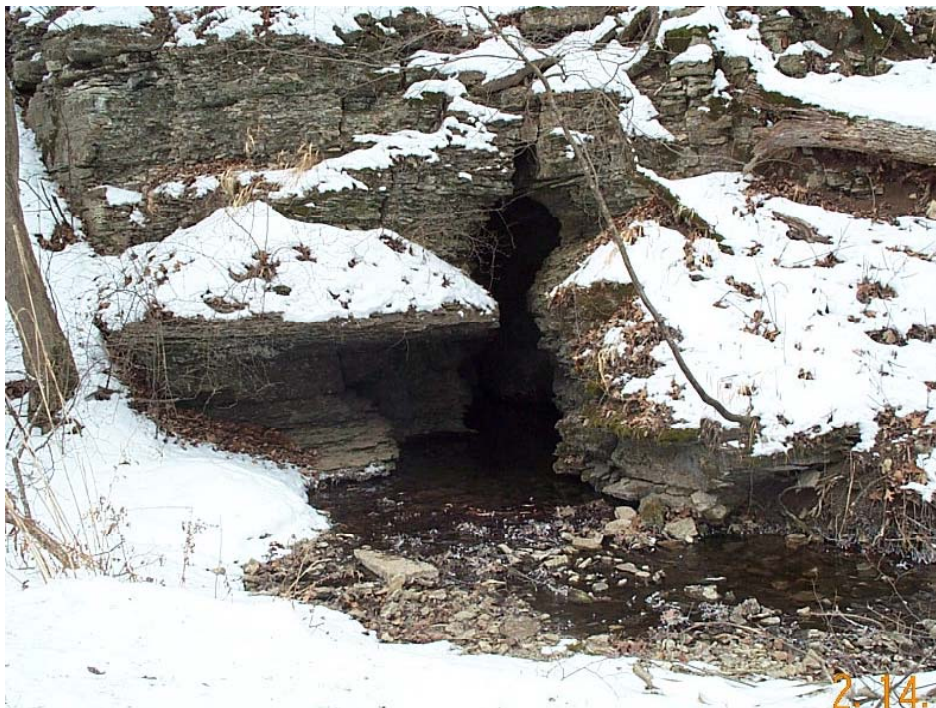
Figure 6.2. Fountain Big Spring.

Several hundred yards north and west of the Fountain quarry lies the Fountain Big Spring complex (Figure 6.2). These springs are the discharge point for the Fountain springshed. Water sinks in the uplands in sinkholes and through the soil mantle and flows through fractures and solution-enlarged conduits to the springs. The Fountain Big Spring is part of a complex of four springs that has a mapped springshed of approximately 2900 acres. This basin was delineated by

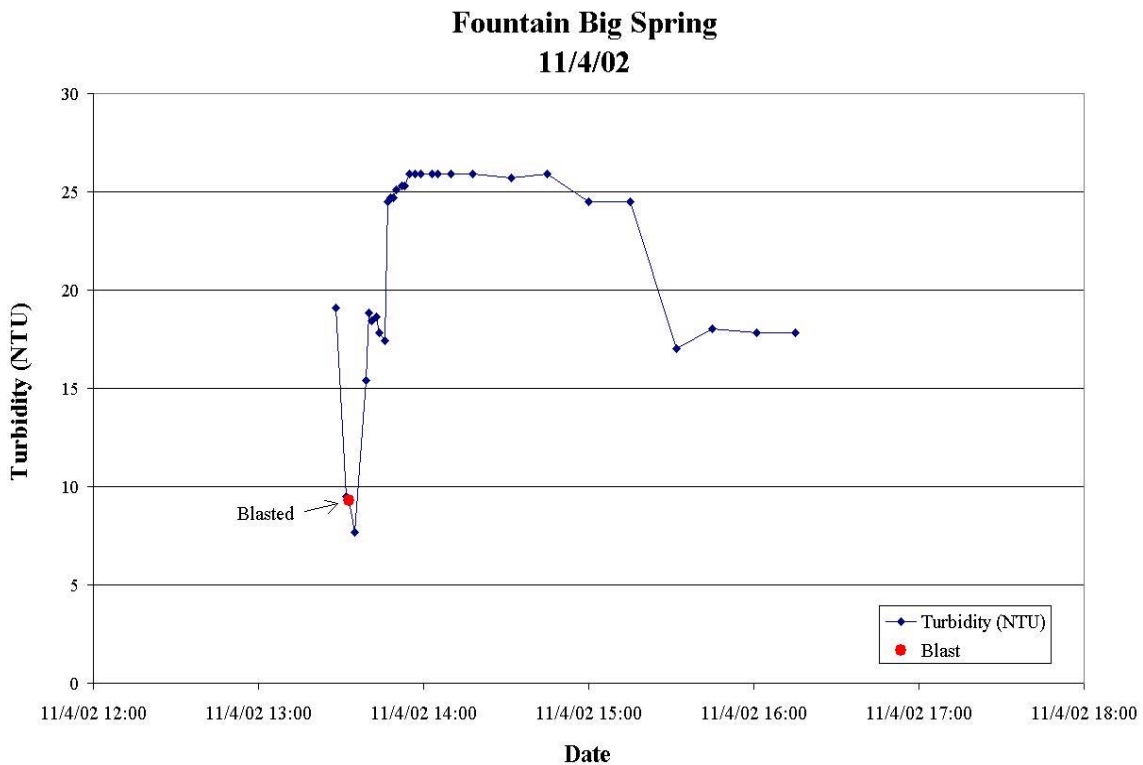
Figure 6.3. Fountain Big Spring turbidity after November 4, 2002 blast.

On November 4, 2002, Milestone Materials Division of Mathy Construction blasted rock on the west end of the Fountain Quarry. DNR staff at the Big Spring using a handheld turbidity meter made measurements prior to the blast, for approximately 2.5 hours after the blast, and the next day. Results in Figure 6.3 indicate that the turbidity level in the spring increased rapidly after the

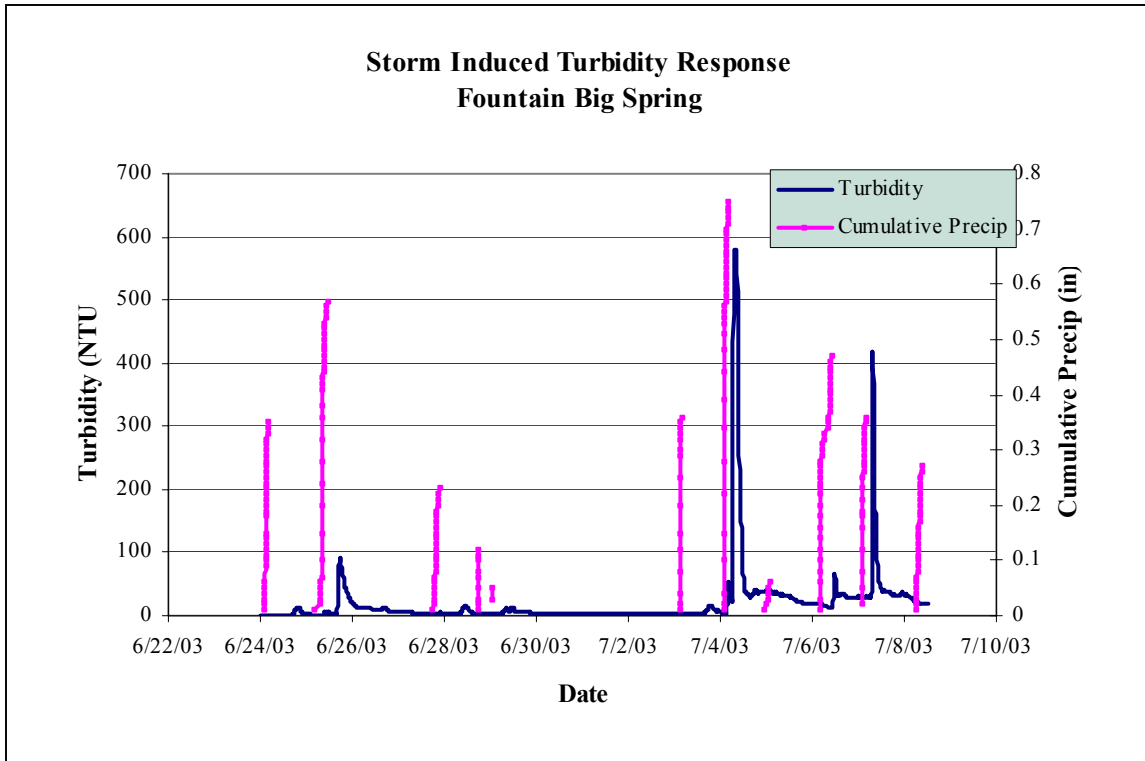
Figure 6.5. Fountain Big Spring turbidity response to rain.

Before it was stolen, the Greenspan TS series turbidity sensor recorded turbidity changes during spring from rain events (Figure 6.5). Several large rainfall events provided the opportunity to study the effects of precipitation on turbidity. The majority of the precipitation events caused the turbidity to rise between 12 hours and 16 hours following the onset of precipitation; however, when the system was primed by antecedent rainfall, the effect could be seen in less than 6 hours. Most increases in measurable turbidity were on the order of 10 NTUs, but the largest events increased the turbidity above 600 NTUs. The true magnitude of these events is unknown because the maximum turbidity exceeded the upper measurement limit of the turbidity sensor. In general, the response from precipitation is much larger than the response following blasting.

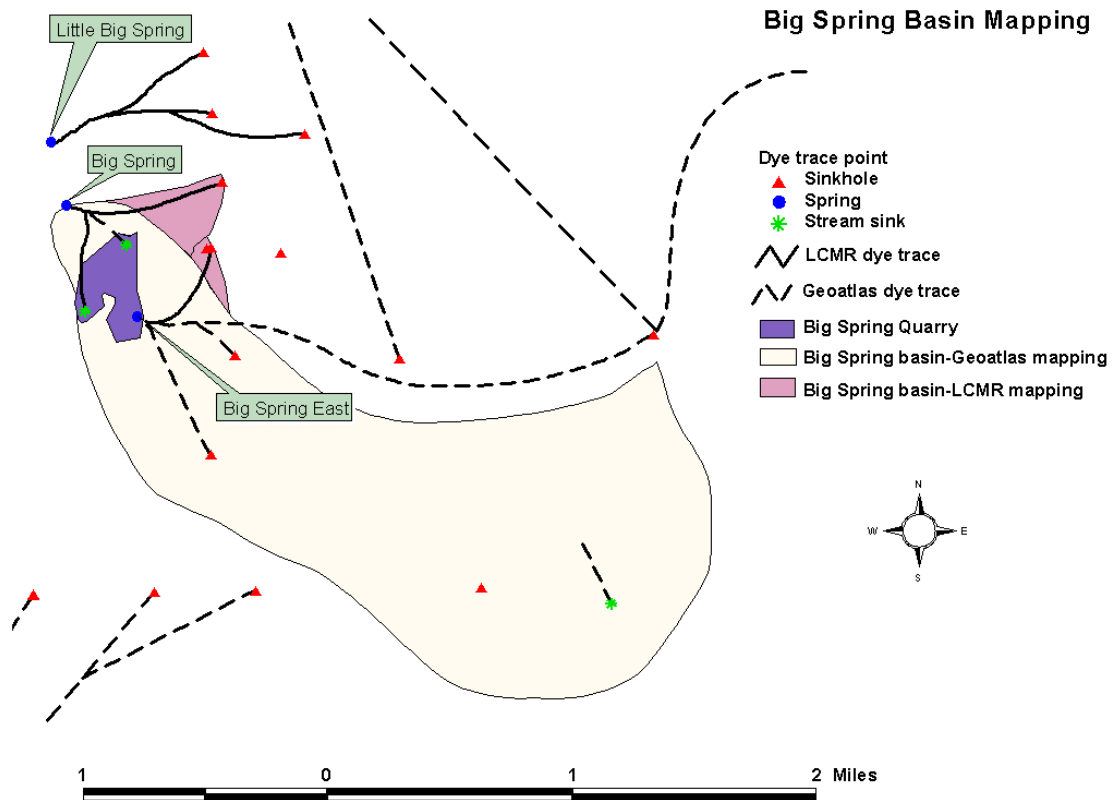
Figure 7.2. Springshed dye trace map.

The quarry has had a profound impact on the local ground-water flow system. Based on the 1995 springshed map in the geologic atlas and the additional tracing work done as part of this project, approximately 90% of the flow in the Big Spring basin is now being routed through the quarry. This exposes the conduit water to thermal impacts and makes it more vulnerable to pollution from quarrying activities.

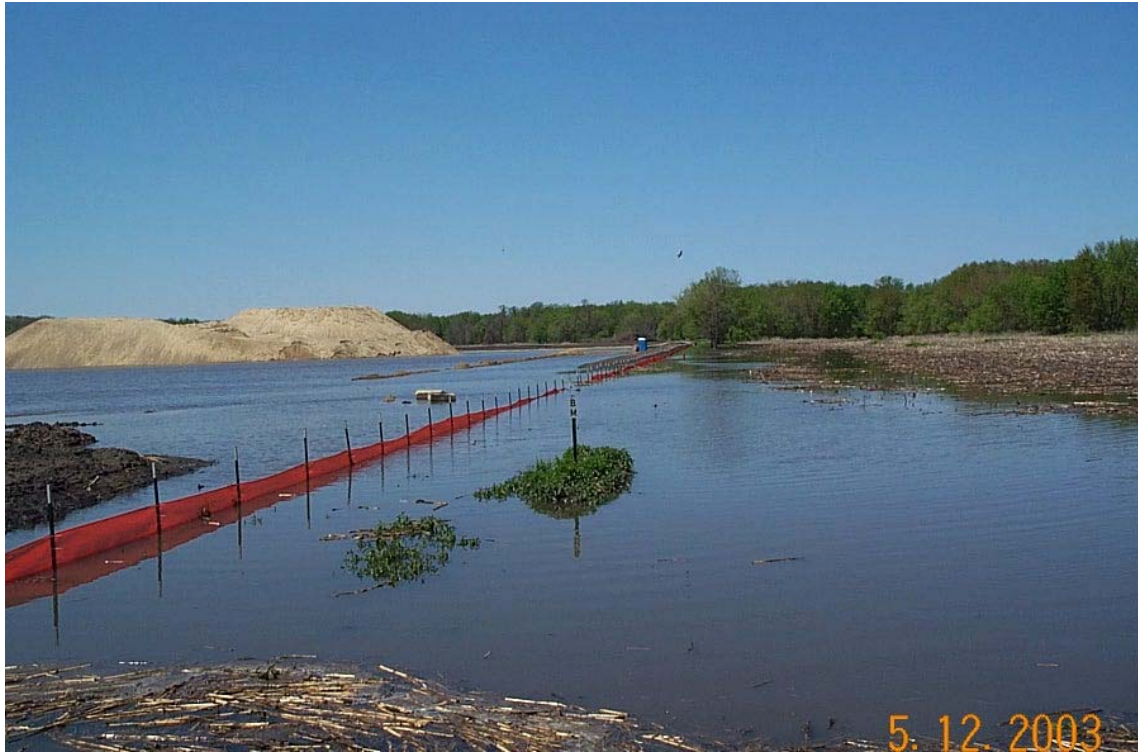
Figure 8.2. Floodwaters in the Donovan Pit in 2003.

Sand and gravel pits in alluvial settings are vulnerable to flooding. This highlights the importance of good surveys of site elevations and site planning before a pit opens. These preparations will help prevent flooding from inundating equipment and buildings on the site. Floods in May 2003 and September 2004 overtopped the banks of the Zumbro River and flooded the Donovan pit (Figure 8.2). These events resulted in ground-water levels rising more than 6 feet; however, at the peak, the floodwaters were much deeper and had completely flooded over the wells.

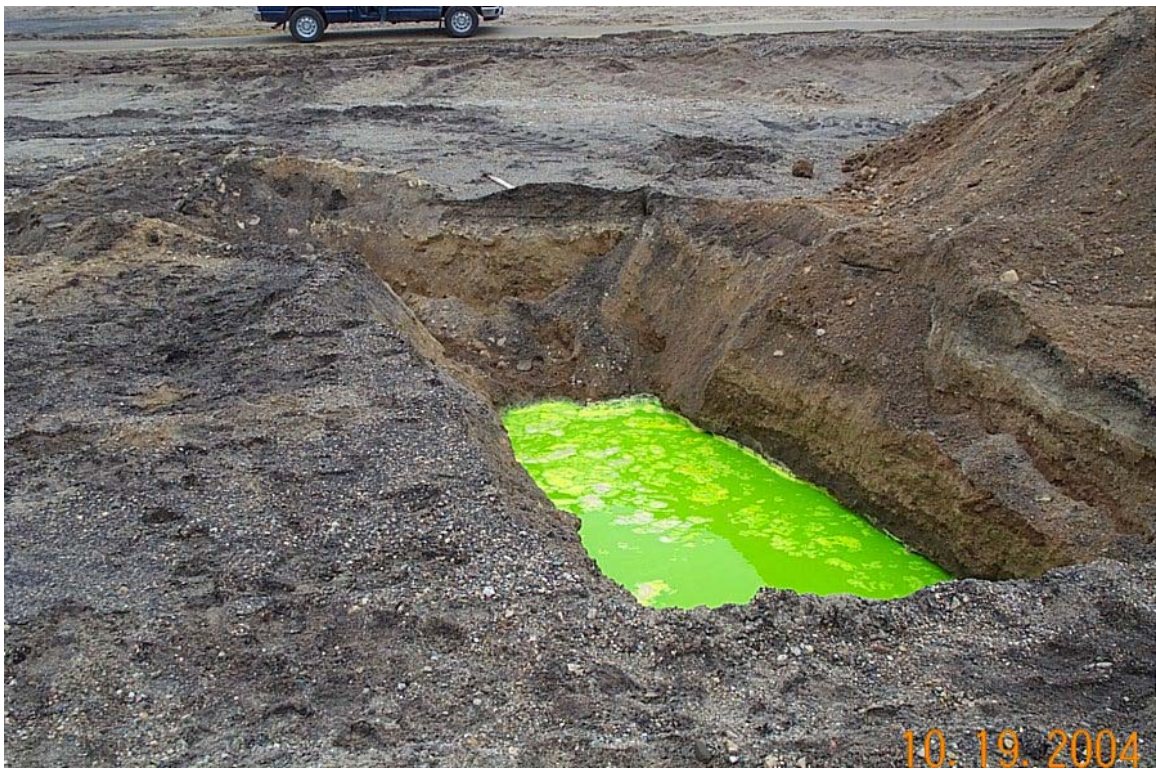
Figure 8.6. Trench 1, dye injection point.

Subsequently, staff decided to use open trenches in the water table perpendicular to the ground-water flow direction for dye injection and sampling. The trenches were excavated with a backhoe by Milestone Materials Division of Mathy Construction. Uranine C was poured into trench 1 (Figure 8.6); water samples were taken from trenches 2 and 3 daily. Six days after dye input, trench 2 had visible dye (Figure 8.7). The concentration visibly increased over the next several months. Sampling continued for several months after dye injection; no dye was detected in trench 3. Sample analysis was performed with an Aquafluor handheld fluorometer. In late December 2004, project staff had Milestone Materials staff fill the trenches so they would not remain open all winter and pose a safety hazard.

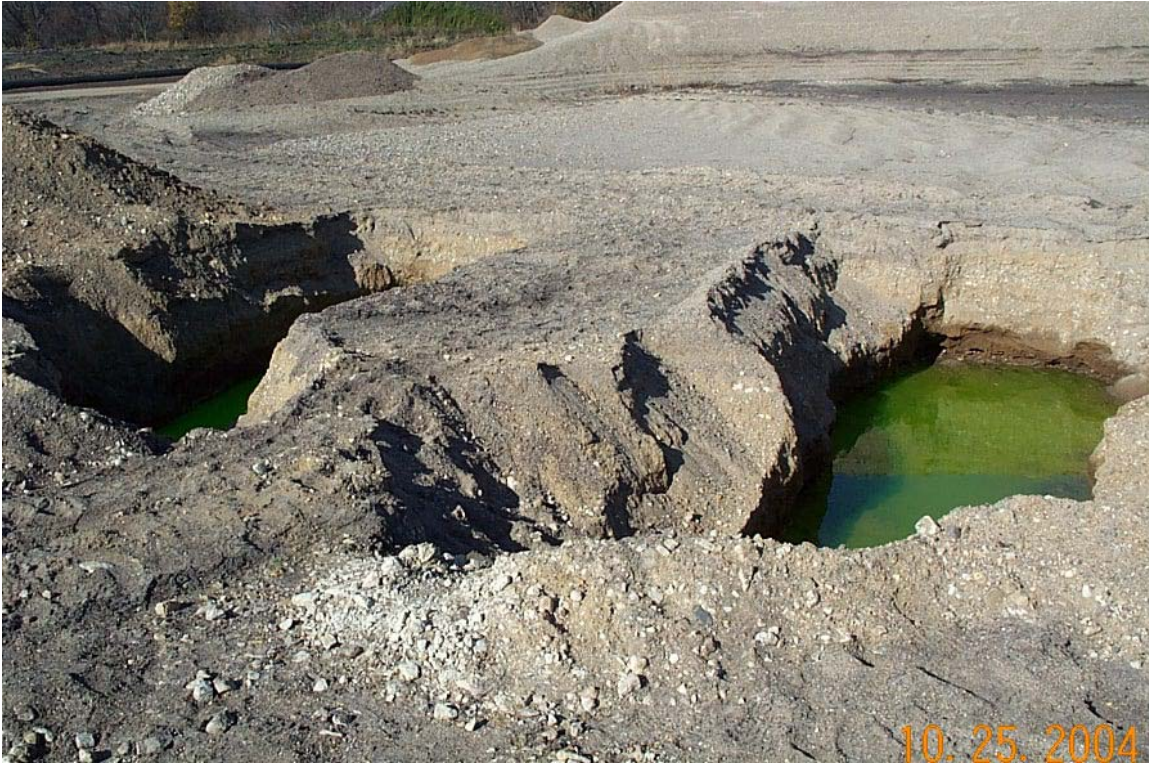
Figure 8.7. Trench 1 (left) and trench 2 (right) dye sampling point.

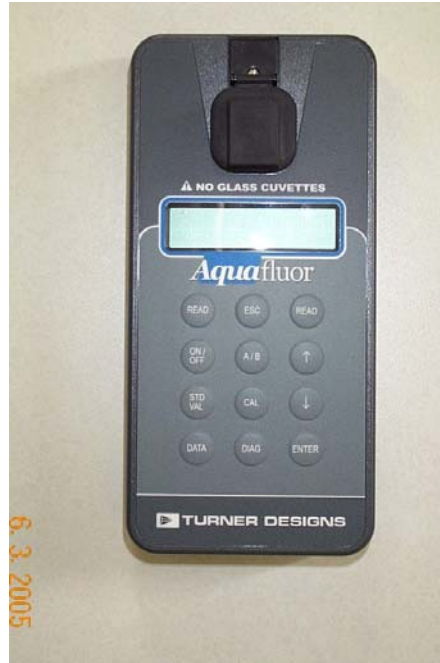
Figure 8.9. Handheld fluorometer.

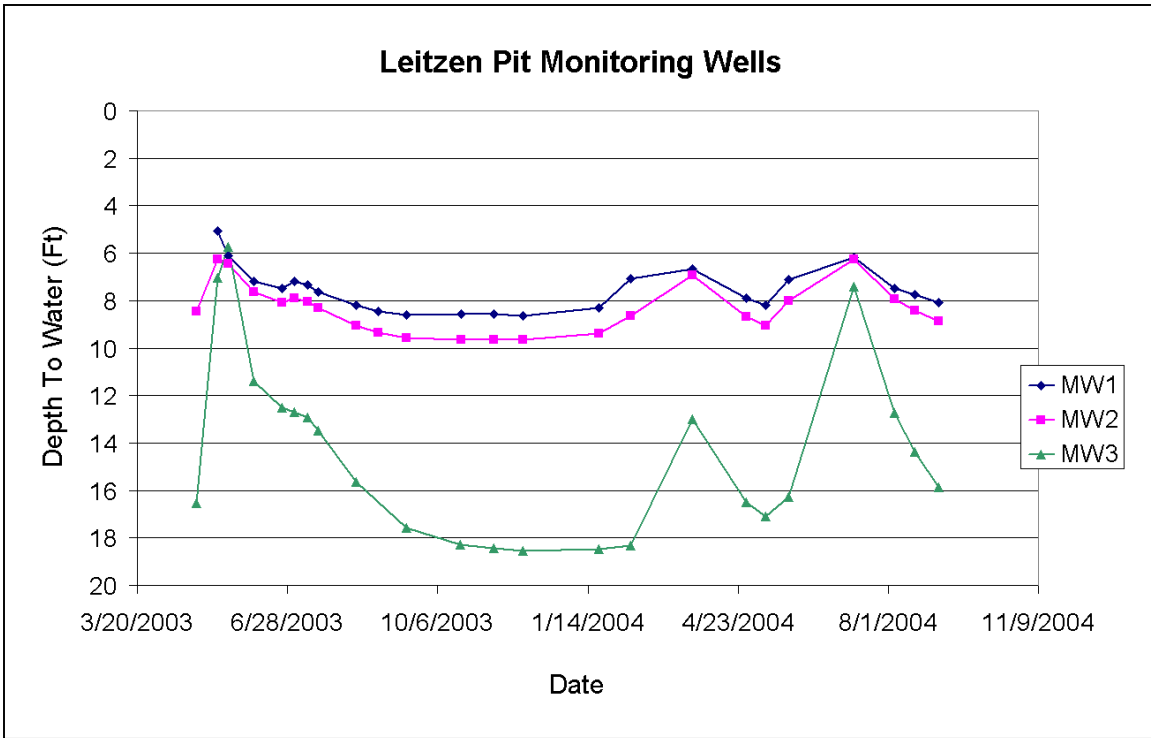
Figure 9.2. Depth to water in Leitzen-Grabau wells.

The peaks in monitoring well 3 (MW3) in 2003 and 2004 (Figure 9.2) are due to heavy rain events and show the natural variability of the ground water in the area. The ground water in the area functions similar to that found in the Donovan pit; however, it is higher on the landscape and above the floodplain. While ponding occurs frequently within the pit, it never floods more than 1 or 2 ft deep. There is no indication that the gravel mining has had any impacts on ground-water levels in the area.

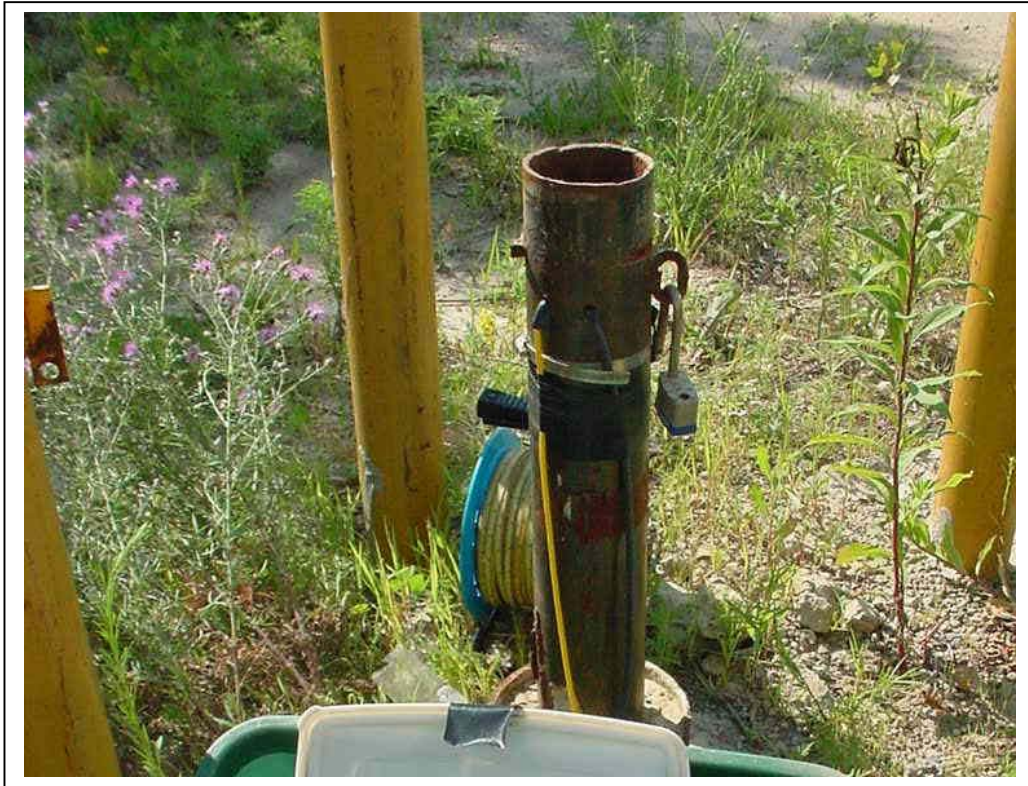
Figure 3. Water level measuring at a wellhead.

The wells were all surveyed and referenced to either a local or nationwide benchmark (mean sea level). In most cases, this was the highest point on the casing and became the measuring point for all future readings. The depth to water in the wells was measured by lowering the probe end of the Waterline down the well until an audible signal was heard. The point when the tone was heard is the depth to water; it is measured, to the nearest hundredth of a foot, from the probe end to the measuring point using the graduated scale on the instrument.
