# Hydraulic Impacts of Quarries and Gravel Pits

J.A. Green, J.A. Pavlish, R.G. Merritt, and J.L. Leete  
Minnesota Department of Natural Resources,  
Division of Waters

## Executive Summary

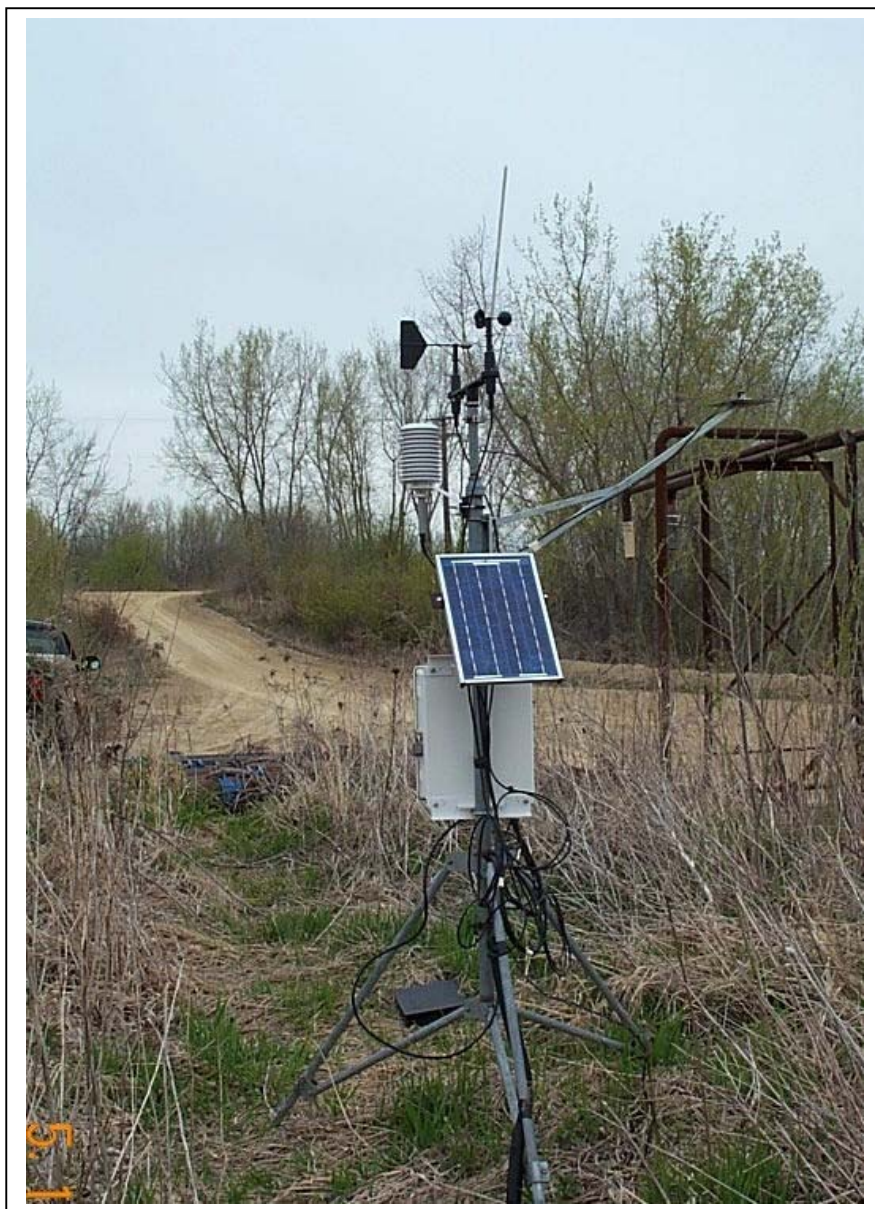
Figure 4. Climate monitoring equipment.

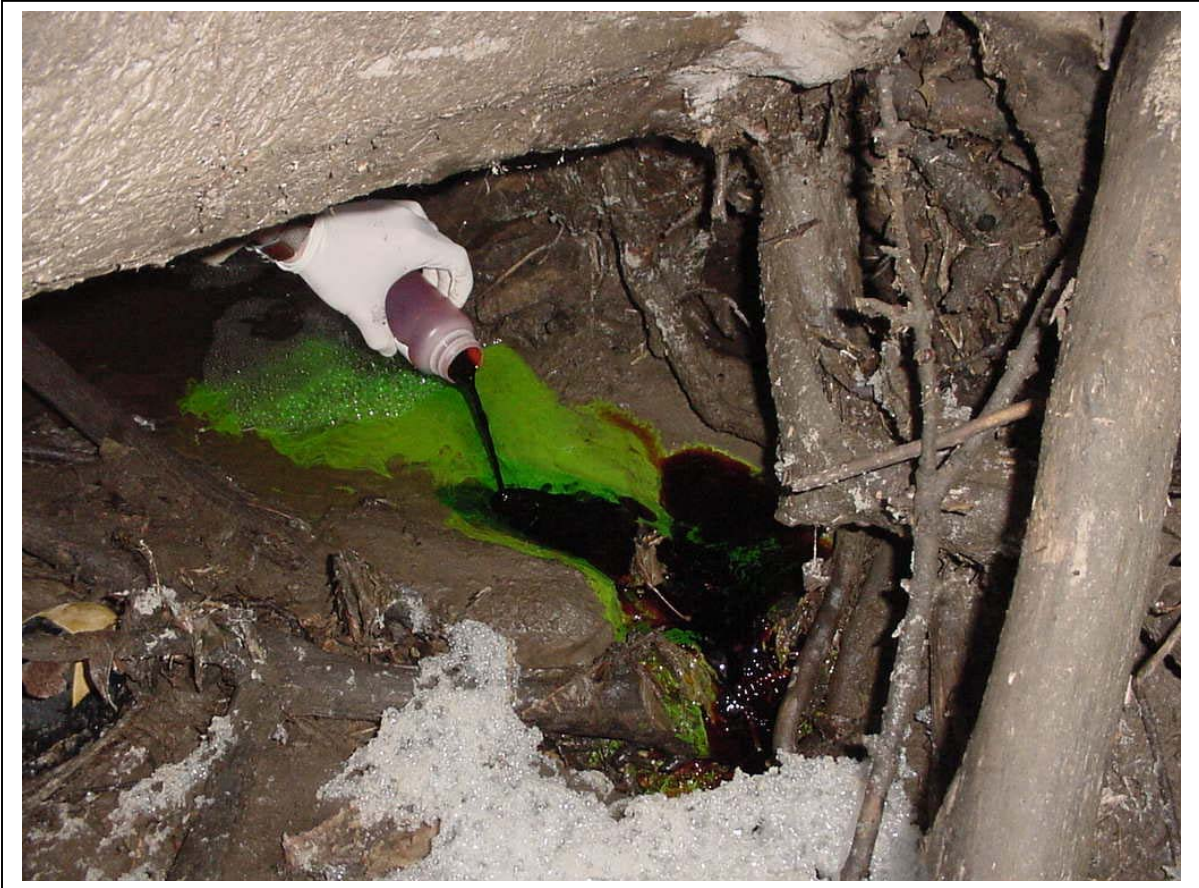
Figure 5. Introducing dye into the stream of water.

For traces outside of the quarry, 0.9 to 1.8 pounds of dye were flushed with approximately 9,000 liters of water from a tanker truck. The traces that were conducted in the quarry used water that was emanating from springs in it. The dye was poured into those streams of water which then

sank underground (Figure 5). Prior to dye input, samples of the spring water at Big Spring and other area springs were obtained to determine background levels of fluorescence in the ground-water system.

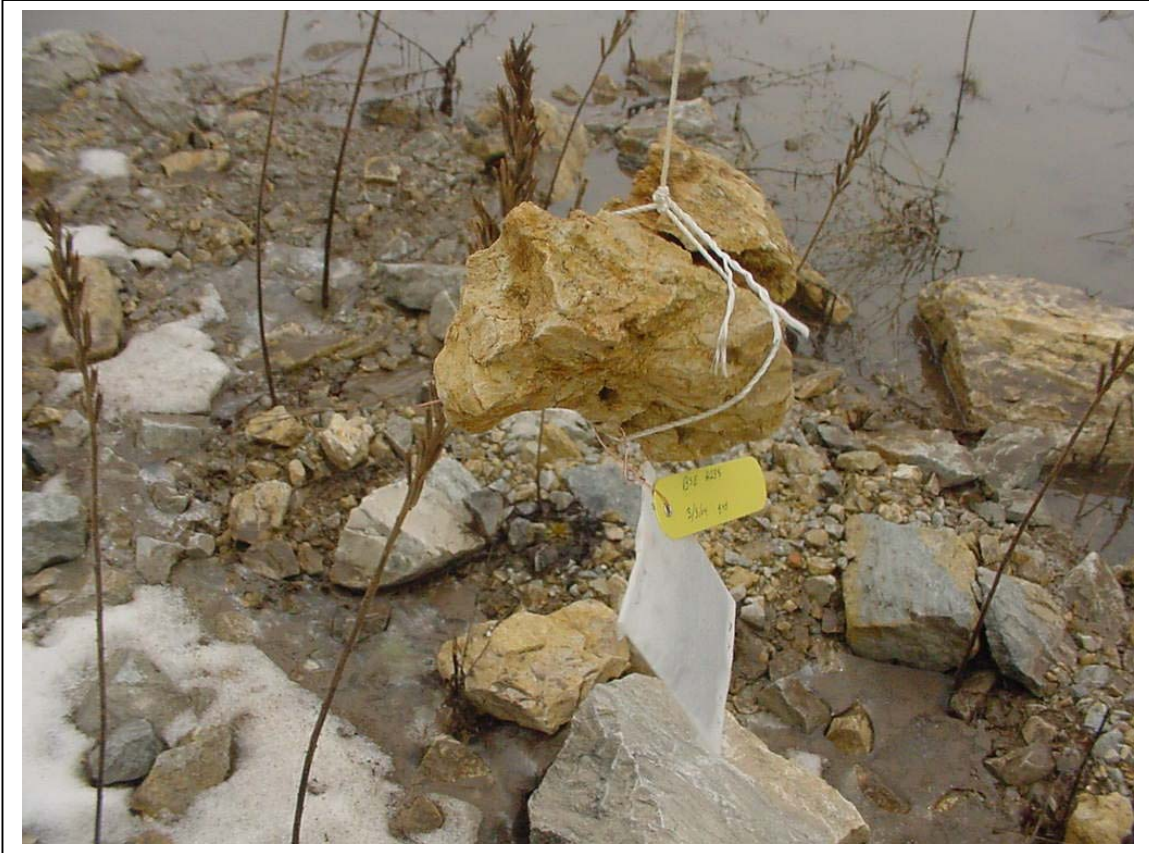
Figure 6. Sampling materials.

Passive charcoal detectors and direct water samples were used for sampling. Charcoal detectors were constructed by placing 0.01 ounce of activated carbon coconut shell in a 5 cm by 20 cm section of milk sock filter tube stapled on both ends. A tag was attached to the detector with a short wire. This wire also served to attach the detector to a weight, which prevents the detector from washing away (Figure 6). The tag was used to record the name and number of the spring being sampled and the time and date the detector was both put into the spring and when it was retrieved.

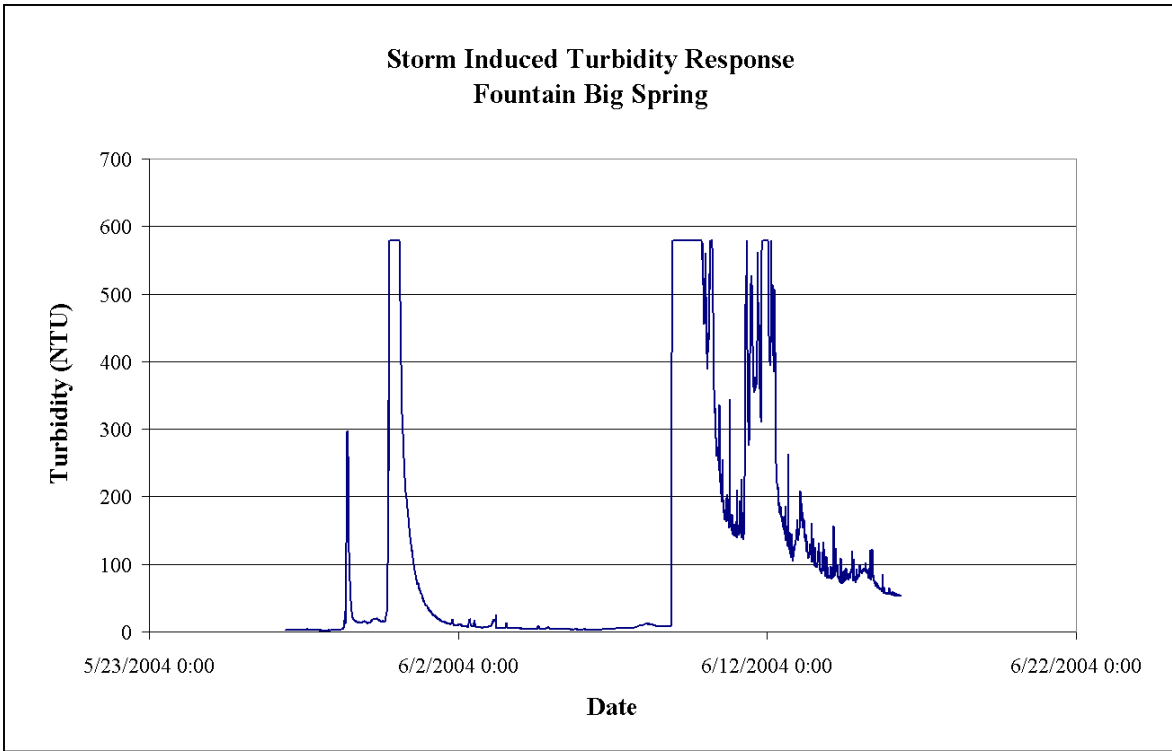
Figure 9. Storm induced turbidity response (2004).

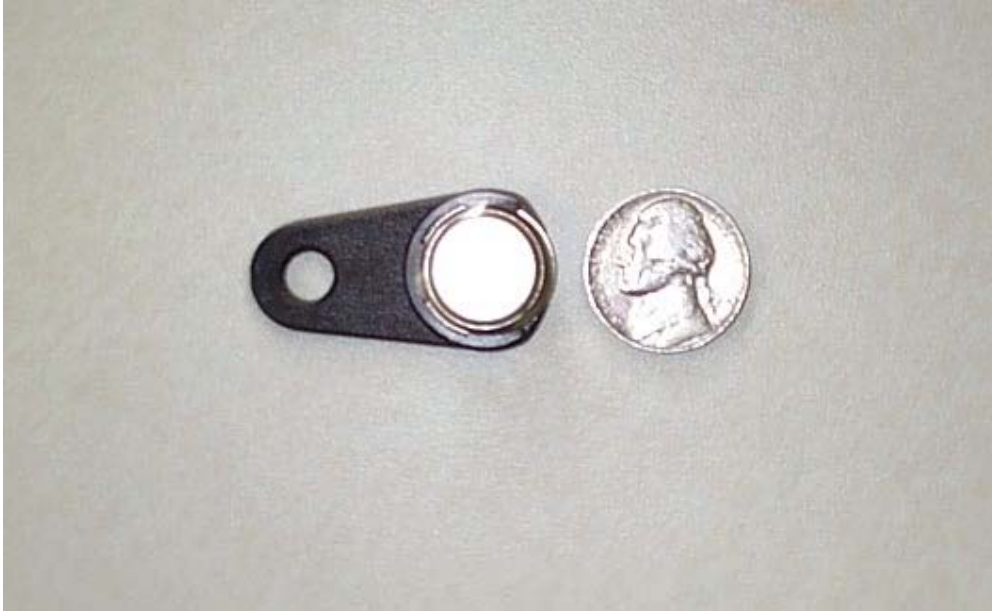
Figure 11. Thermochron digital recording thermometer compared with a nickel.

Thermochrons are digital recording thermometers (Figure 11). These relatively new devices are only about the size of two stacked nickels but include a temperature sensor and recording memory that can keep track of temperature changes for several months. They can be placed in shallow water, for example in streams, springs, or quarry ponds, and later retrieved for data recovery.

Thermochrons cost less than \$50 each and the equipment to communicate with them is also inexpensive and extremely portable, making temperature monitoring in gravel pits and quarries a real possibility.
