# Temperance River State Park Vulnerability Assessment

May 2022

*Temperance River State Park, Minnesota*

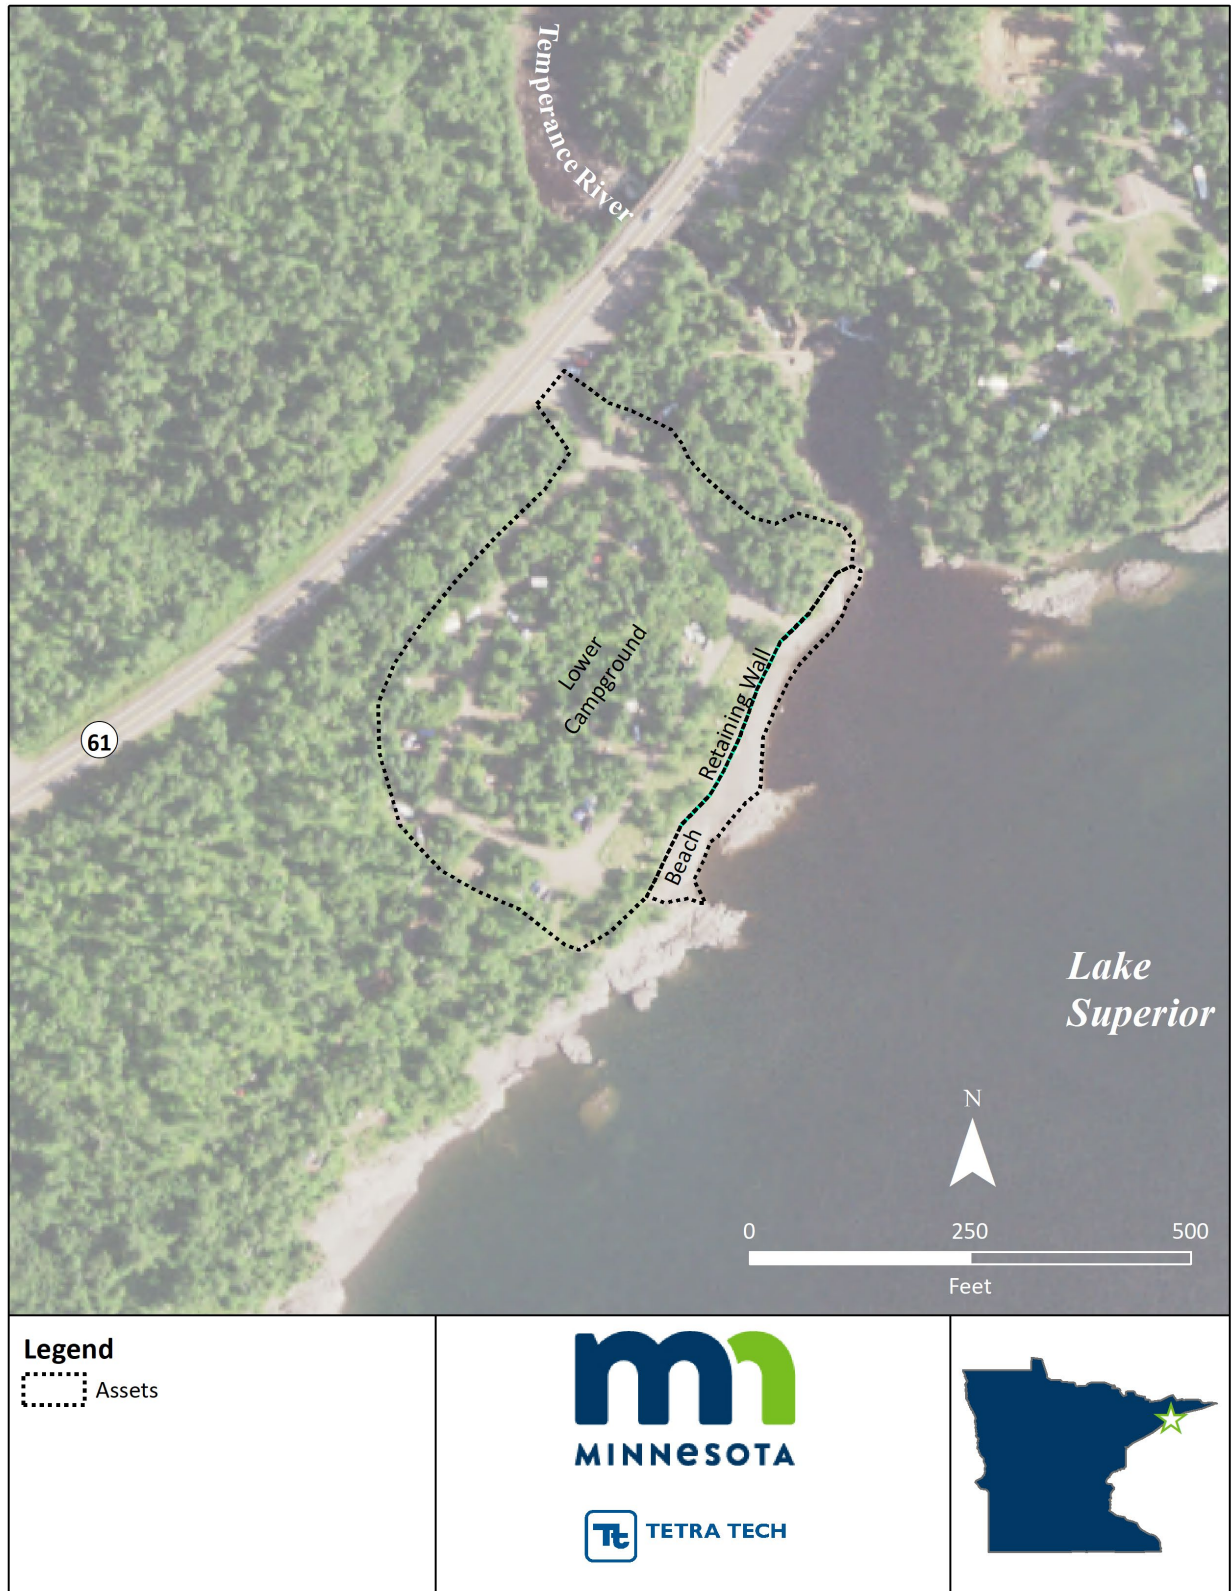
Figure 2. Temperance River State Park Location Map

TRSP is located along State Highway 61 between Schroeder and Tofte, Minnesota. The area became a state park in 1957 and features campsites on both sides of the river, numerous hiking trails and picnic areas, and beach access where the Temperance River meets Lake Superior (Figure 2).

The TRSP assessment identified three site assets (Figure 2) including the lower campground, beach, and retaining wall (Table 1). The assets were mapped utilizing a geo-referenced PDF provided by the MN DNR available online at [https://gdrs.dnr.state.mn.us/gdrs/apps/pub/us\\_mn\\_state\\_dnr/mndnr\\_geopdf\\_download/State\\_Parks/Temperance%20River%20GEO.pdf](https://gdrs.dnr.state.mn.us/gdrs/apps/pub/us_mn_state_dnr/mndnr_geopdf_download/State_Parks/Temperance%20River%20GEO.pdf).

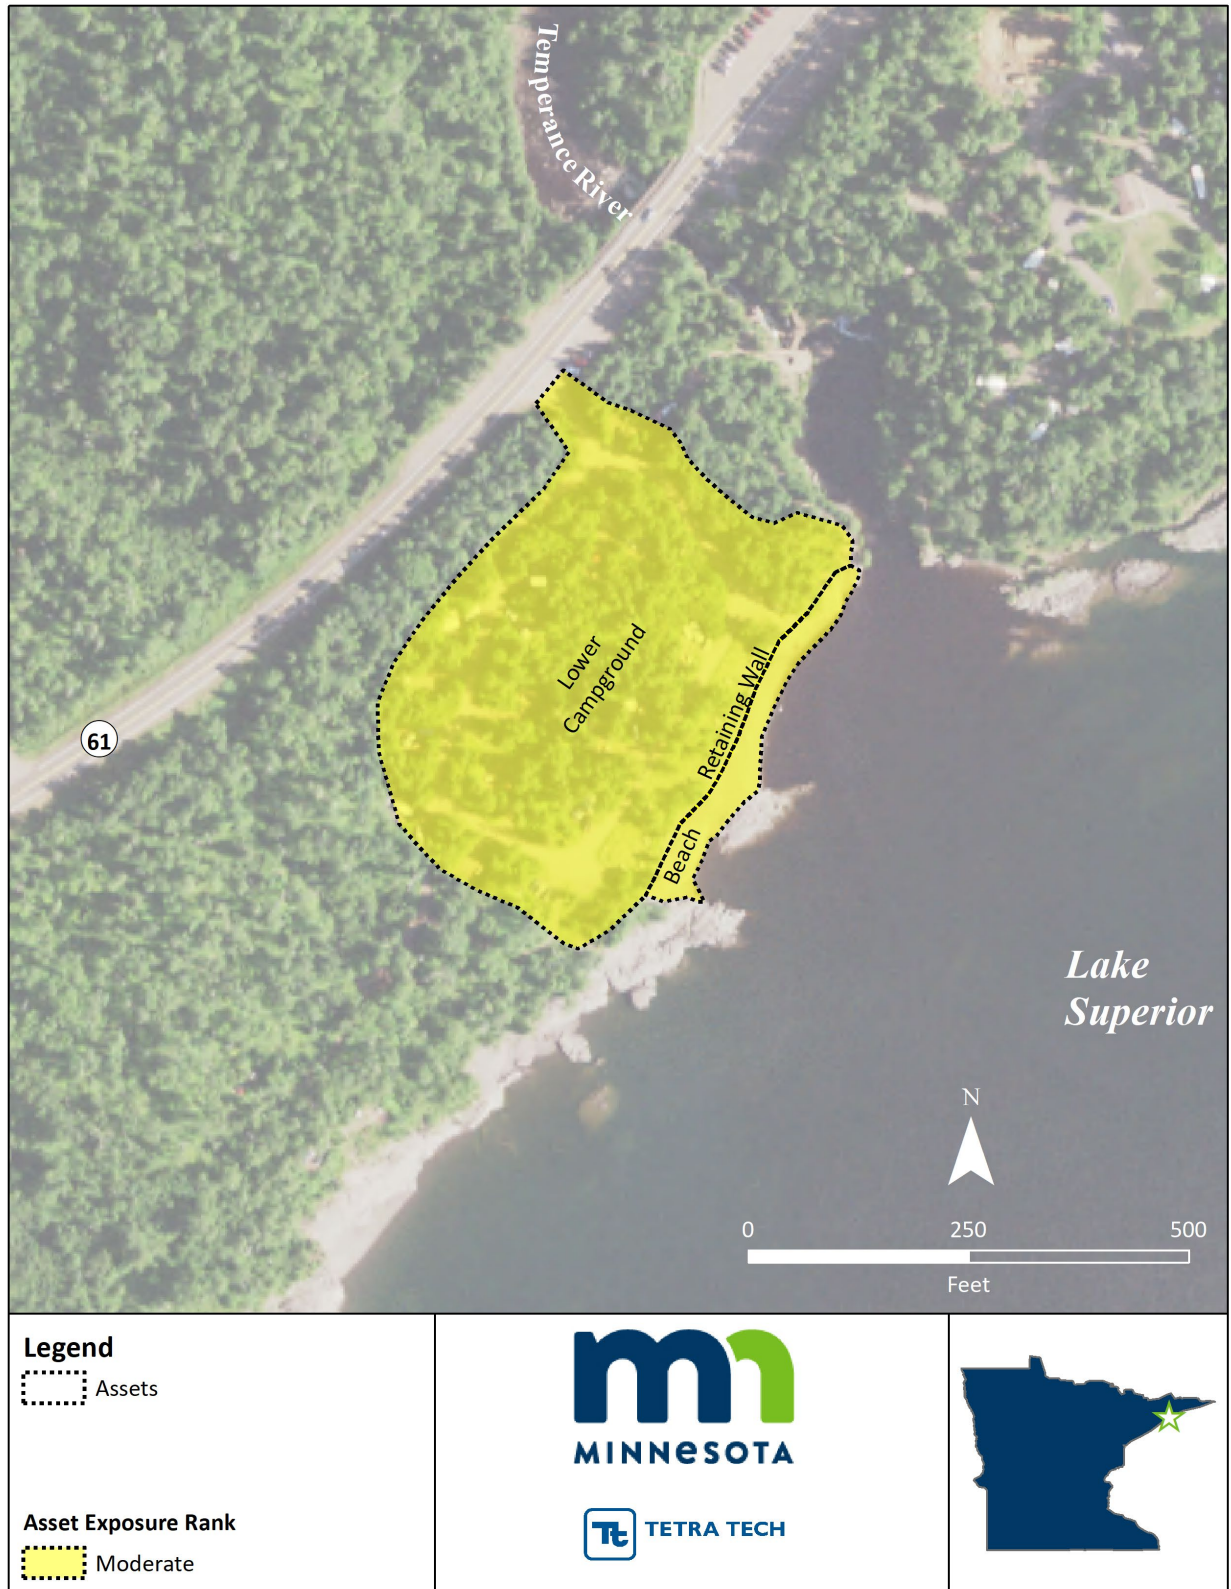
Figure 3. Temperance River State Park Exposure Analysis Results Map

The results of the exposure analysis indicated all assets have a moderate exposure rank (Table 2, Figure 3). Full results of the exposure analysis are available in the provided TRSP vulnerability assessment spreadsheet (Appendix A).

All assets fall into the moderate exposure rank. Because the beach is low-lying elevation and the retaining wall is meant to protect the lower campground from eroding, the lower campground also had a moderate exposure rank. An “override” was utilized by the assessor for the beach and retaining wall for the flooding indicator because both assets are assumed to be equally impacted by flooding. The override was used to give the assets the same flooding indicator score. An override was also used by the assessor for the historical flooding indicator for the retaining wall because the assessor assumed the retaining wall was built to protect against flooding that had historically occurred. The same reasoning was used by the assessor for the erosion indicator for the retaining wall. The retaining wall also had an override for the fish and wildlife habitat indicator because, while the asset is located within fish and wildlife habitat polygons, it is not actually fish and wildlife habitat itself. Therefore, the fish and wildlife habitat exposure indicator was zero for this asset.

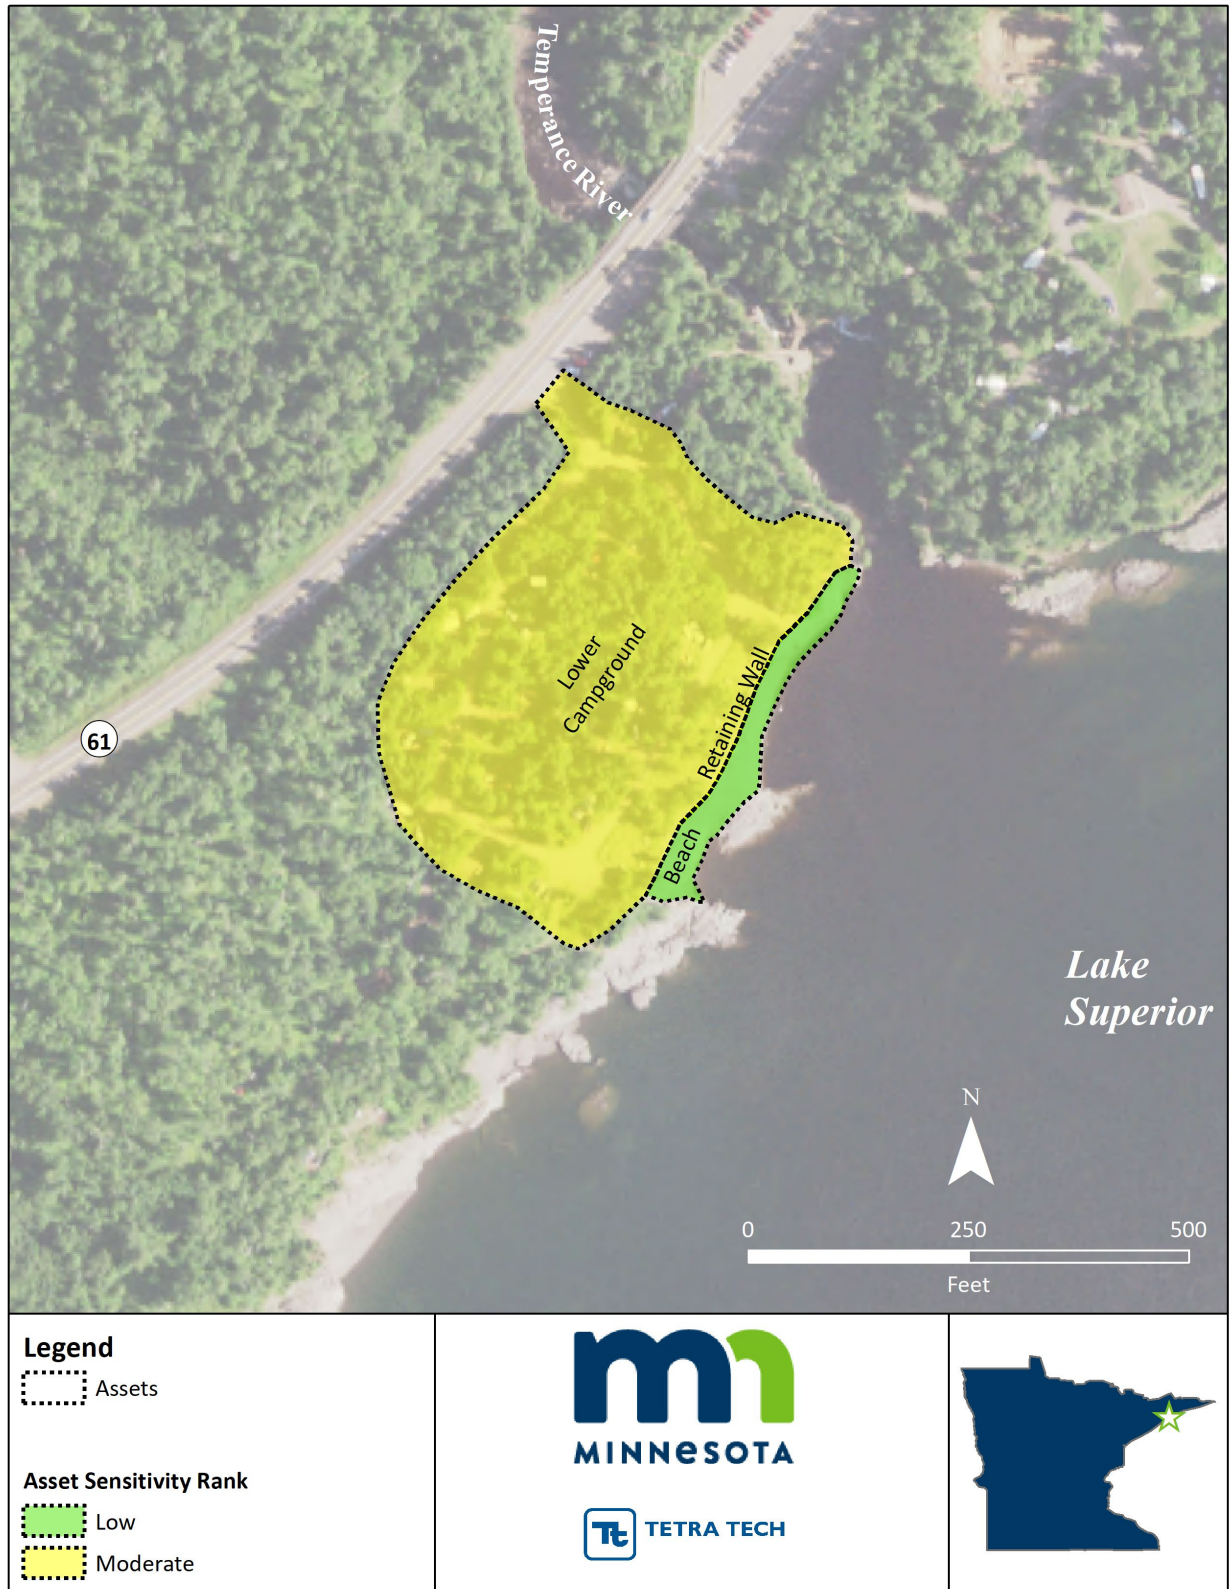
Figure 4. Temperance River State Park Sensitivity Analysis Results Map

The results of the sensitivity analysis indicated the lower campground and retaining wall had a moderate sensitivity rank while the beach had a low sensitivity rank (Table 3, Figure 4). Full results of the sensitivity analysis are available in the provided TRSP vulnerability assessment spreadsheet (Appendix A).

The beach was ranked as low sensitivity while the lower campground and retaining wall are ranked as moderate sensitivity. The beach was low sensitivity because natural assets that have a natural resistivity make them better adapted to adjust to potential impacts. The lower campground and retaining wall are built assets that are more sensitive to potential impacts because they do not have natural resistivity like the natural assets. The assessor applied overrides in the sensitivity analysis for the retaining wall for the flood damage potential indicator because the assessor assumed flood damage potential was higher since the retaining wall had to be built. Similar to the exposure analysis, the assessor applied an override to the retaining wall for the fish and wildlife habitat indicator. While the asset is located within fish and wildlife habitat polygons, the asset is not fish and wildlife habitat. Therefore, the fish and wildlife habitat sensitivity indicator was zero for this asset.

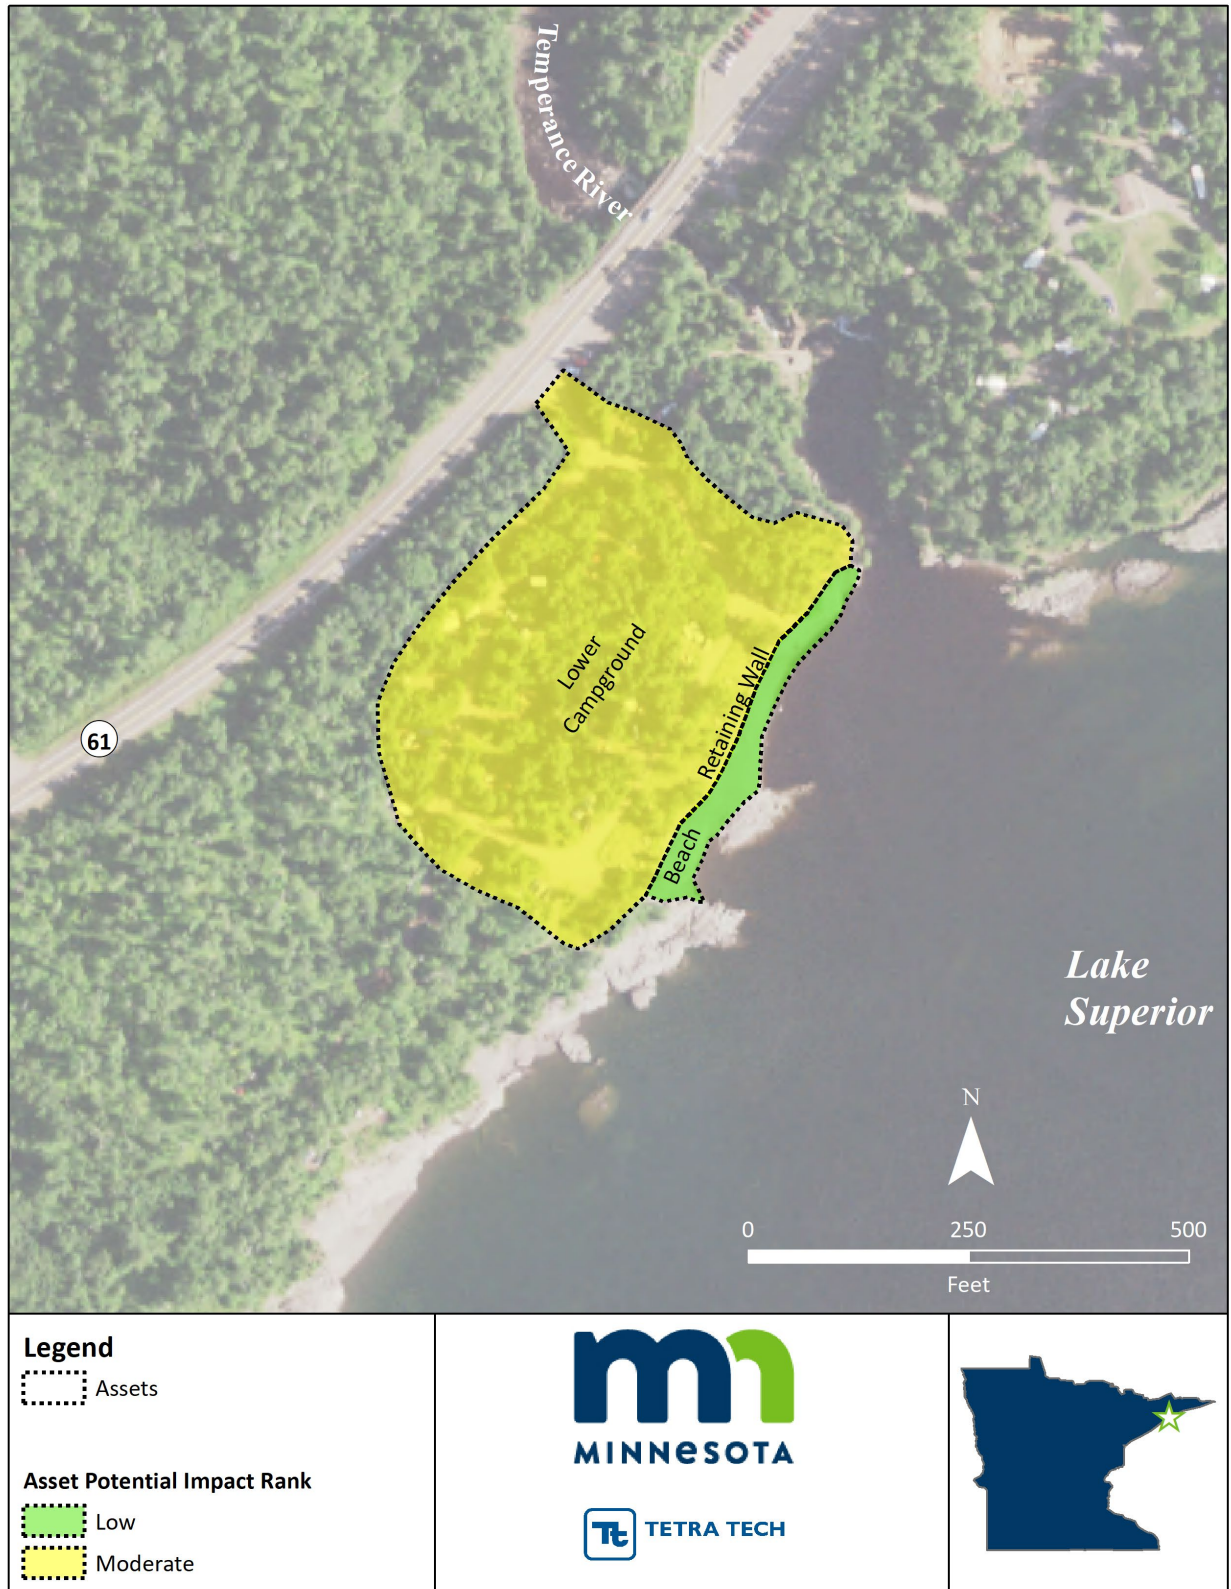
Figure 5. Temperance River State Park Potential Impact Results Map

The potential impact analysis for the TRSP assessment characterized the results of the exposure and sensitivity analyses. The potential impact to the assets was calculated by averaging the exposure and sensitivity scores from the previous analyses. The results of the potential impact analysis indicated the lower campground and retaining wall had a moderate potential impact rank while the beach had a low potential impact rank (Table 4, Figure 5). Full results of the potential impact analysis are available in the provided TRSP vulnerability assessment spreadsheet (Appendix A).

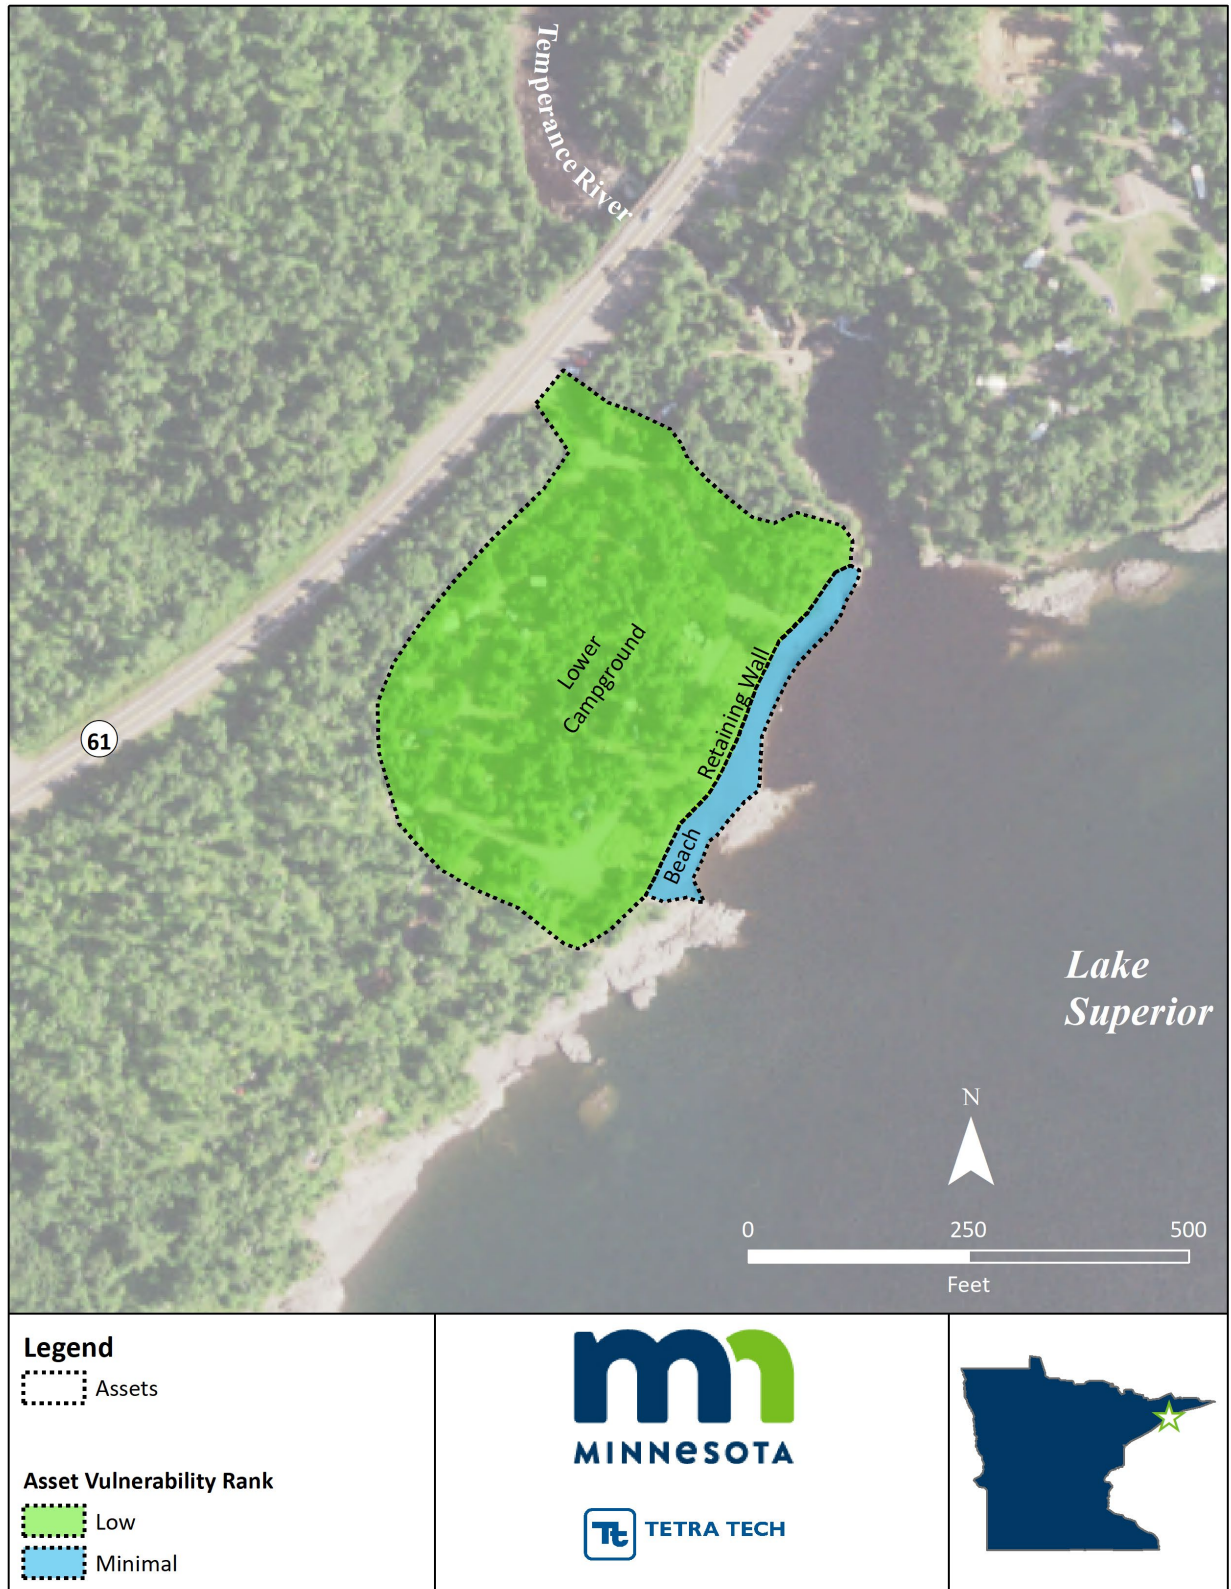
Figure 6. Temperance River State Park Vulnerability Rank Map

This final vulnerability analysis for the TRSP site sums the potential impacts and subtracts the adaptive capacity scores. Based on the final vulnerability score for each asset, the asset was assigned to one of four categories: high vulnerability, moderate vulnerability, low vulnerability, or minimal vulnerability. By utilizing the adaptive capacity strategies described previously, the vulnerability of the beach and retaining wall can be reduced to minimal while the lower campground vulnerability can be reduced to minimal (Table 6, Figure 6). While the lower campground does not have any adaptive capacity strategies identified, implementing a living shoreline approach and removing the retaining wall would reduce the vulnerability of the asset by making the site as a whole less sensitive to potential impacts.

While Table 6 above shows the potential reduction of vulnerability of assets at TRSP, this reduction is dependent upon implementing the highest impact adaptive capacity strategies identified in Table 5. Site managers at TRSP may not have the ability to fund these options or may not be able to implement these actions in a timely fashion. This vulnerability assessment has also been performed as a desktop analysis without a visit to the site itself. Site managers should utilize the best available knowledge of the site and the knowledge of what adaptive strategies are most readily available or feasible in order to fully assess the vulnerability of the assets. As new datasets become available or old datasets are updated, it may behoove the site manager or others interested in the site to integrate it into the assessment. Furthermore, if adaptive capacity strategies are implemented on certain assets, the vulnerability assessment can be redone to update the vulnerability rank of the assets or of any new assets that might be identified or built at the site.
