Flood Bay State Wayside Vulnerability Assessment

May 2022

Flood Bay State Wayside, Minnesota

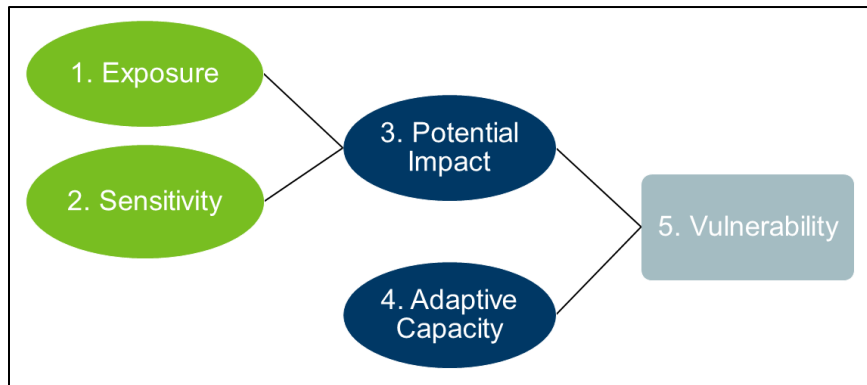
Figure 1. Vulnerability Analysis Process Adapted from Glick et al. (2011) and NPS (2016)

To answer that question, the Minnesota Department of Natural Resources (MN DNR) and the National Oceanic and Atmospheric Administration’s Office for Coastal Management (NOAA OCM) followed a standardized process documented in “Vulnerability Assessment Protocol for Minnesota’s Public Access Sites” (MN DNR and NOAA OCM 2022a). The five steps in the process as outlined in Figure 1 are:

1. Exposure Analysis (see Section 9, Glossary, for a definition of exposure)
2. Sensitivity Analysis (see Section 9, Glossary, for a definition of sensitivity)
3. Potential Impact Analysis
4. Adaptive Capacity Analysis (optional analysis based on site and asset[s])
5. Vulnerability Analysis

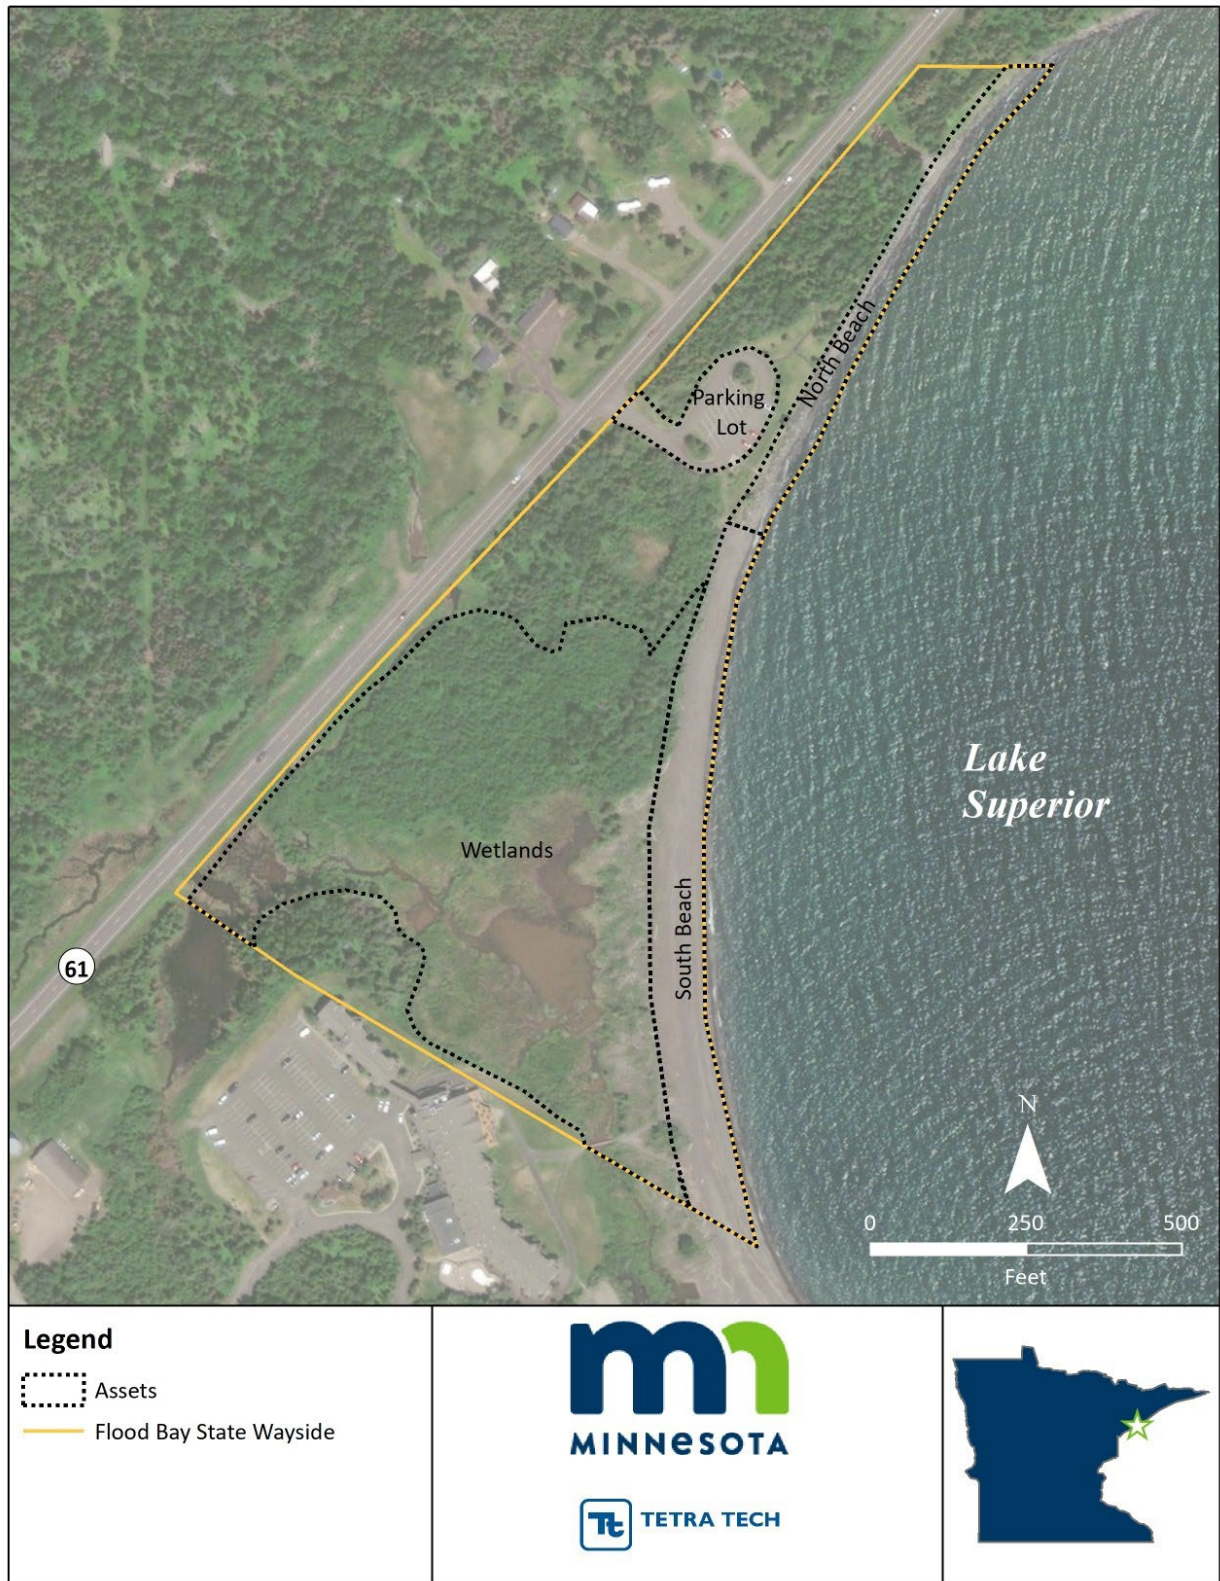
Figure 2. Flood Bay State Wayside Location Map

FBSW is located on State Highway 61 immediately northeast of the city of Two Harbors, Minnesota, in Lake County along the north shore of Lake Superior. The site was established in 1963 and features a long stretch of beach and a wetland complex with a small parking lot (Figure 2).

The FBSW assessment identified four site assets (Figure 2) including the parking lot, the north beach, the south beach, and the wetlands complex (Table 1). The parking lot asset includes the parking lot surface as well as the entrance road to the parking lot. The beach is separated into the north and south based on the presence of rip rap along the north end of the beach. The wetlands were identified using the National Wetlands Inventory (NWI) dataset. The wetlands asset is not separated by wetland types.

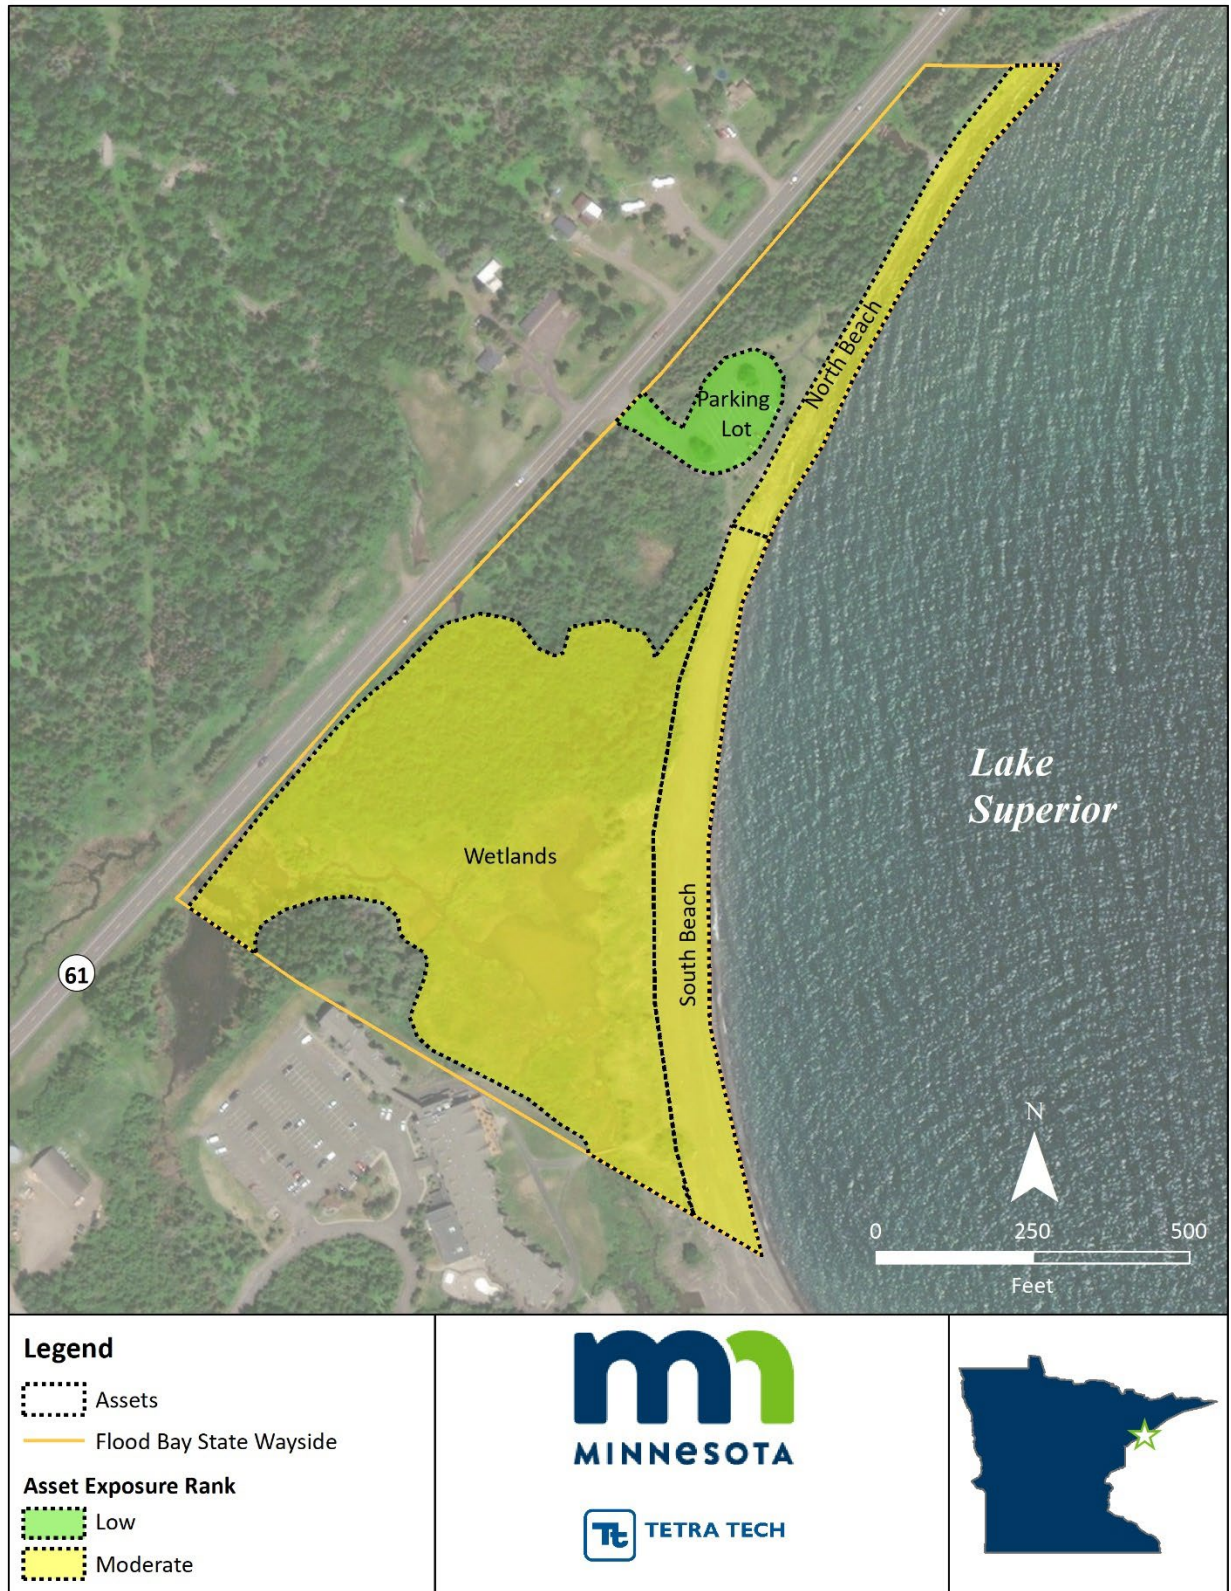
Figure 3. Flood Bay State Wayside Exposure Analysis Results Map

The results of the exposure analysis indicated the parking lot has a low exposure rank while north beach, south beach, and the wetlands have a moderate exposure rank (Table 2, Figure 3). Full results of the exposure analysis are available in the provided FBSW vulnerability assessment spreadsheet (Appendix A).

The parking lot exposure rank is lower than the north beach, south beach, and wetlands because the parking lot is at a higher elevation than the other assets and is therefore less exposed to high water or large waves as the low-lying assets are. The parking lot exposure analysis also included an “override.” While the parking lot is within a native plant community, wetland, and site of biodiversity significance, the parking lot is not fish and wildlife habitat itself. Therefore, the fish and wildlife habitat exposure indicator was set to zero for the parking lot asset.

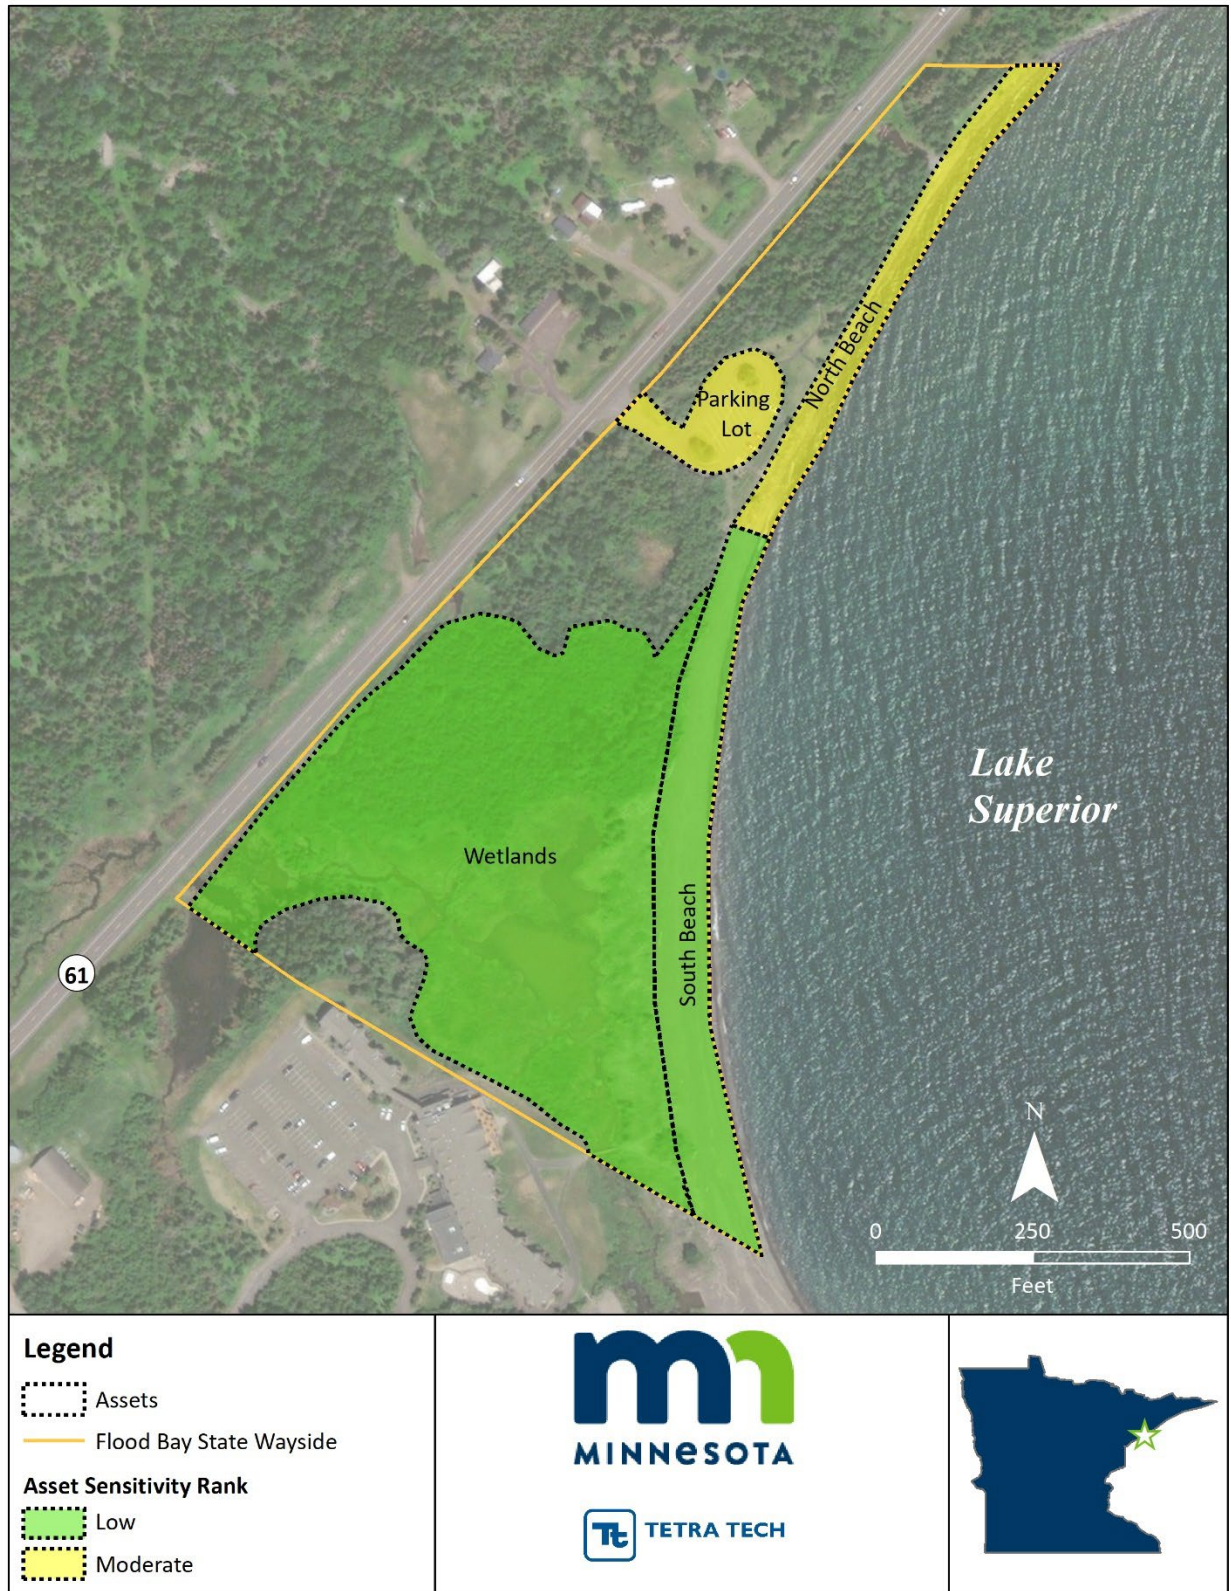
Figure 4. Flood Bay State Wayside Sensitivity Analysis Results Map

The results of the sensitivity analysis indicated the parking lot and north beach have a moderate sensitivity rank while the south beach and the wetlands have a low sensitivity rank (Table 3, Figure 4). Full results of the sensitivity analysis are available in the provided FBSW vulnerability assessment spreadsheet (Appendix A).

The parking lot and north beach scored higher in the sensitivity rank than the south beach and wetlands because the parking lot and north beach feature built environments (i.e., paved surface in the parking lot and rip rap protection on the north beach). These built assets are more sensitive to increased lake levels and increased erosion potential than the south beach and wetlands assets which have a natural resistivity and adaptability to potential impacts. Similar to the exposure analysis, the only “override” in the sensitivity analysis was for the parking lot asset. While the parking lot is within a native plant community, wetland, and site of biodiversity significance, the parking lot is not fish and wildlife habitat itself. Therefore, the fish and wildlife habitat sensitivity indicator was zero for this parking lot asset.

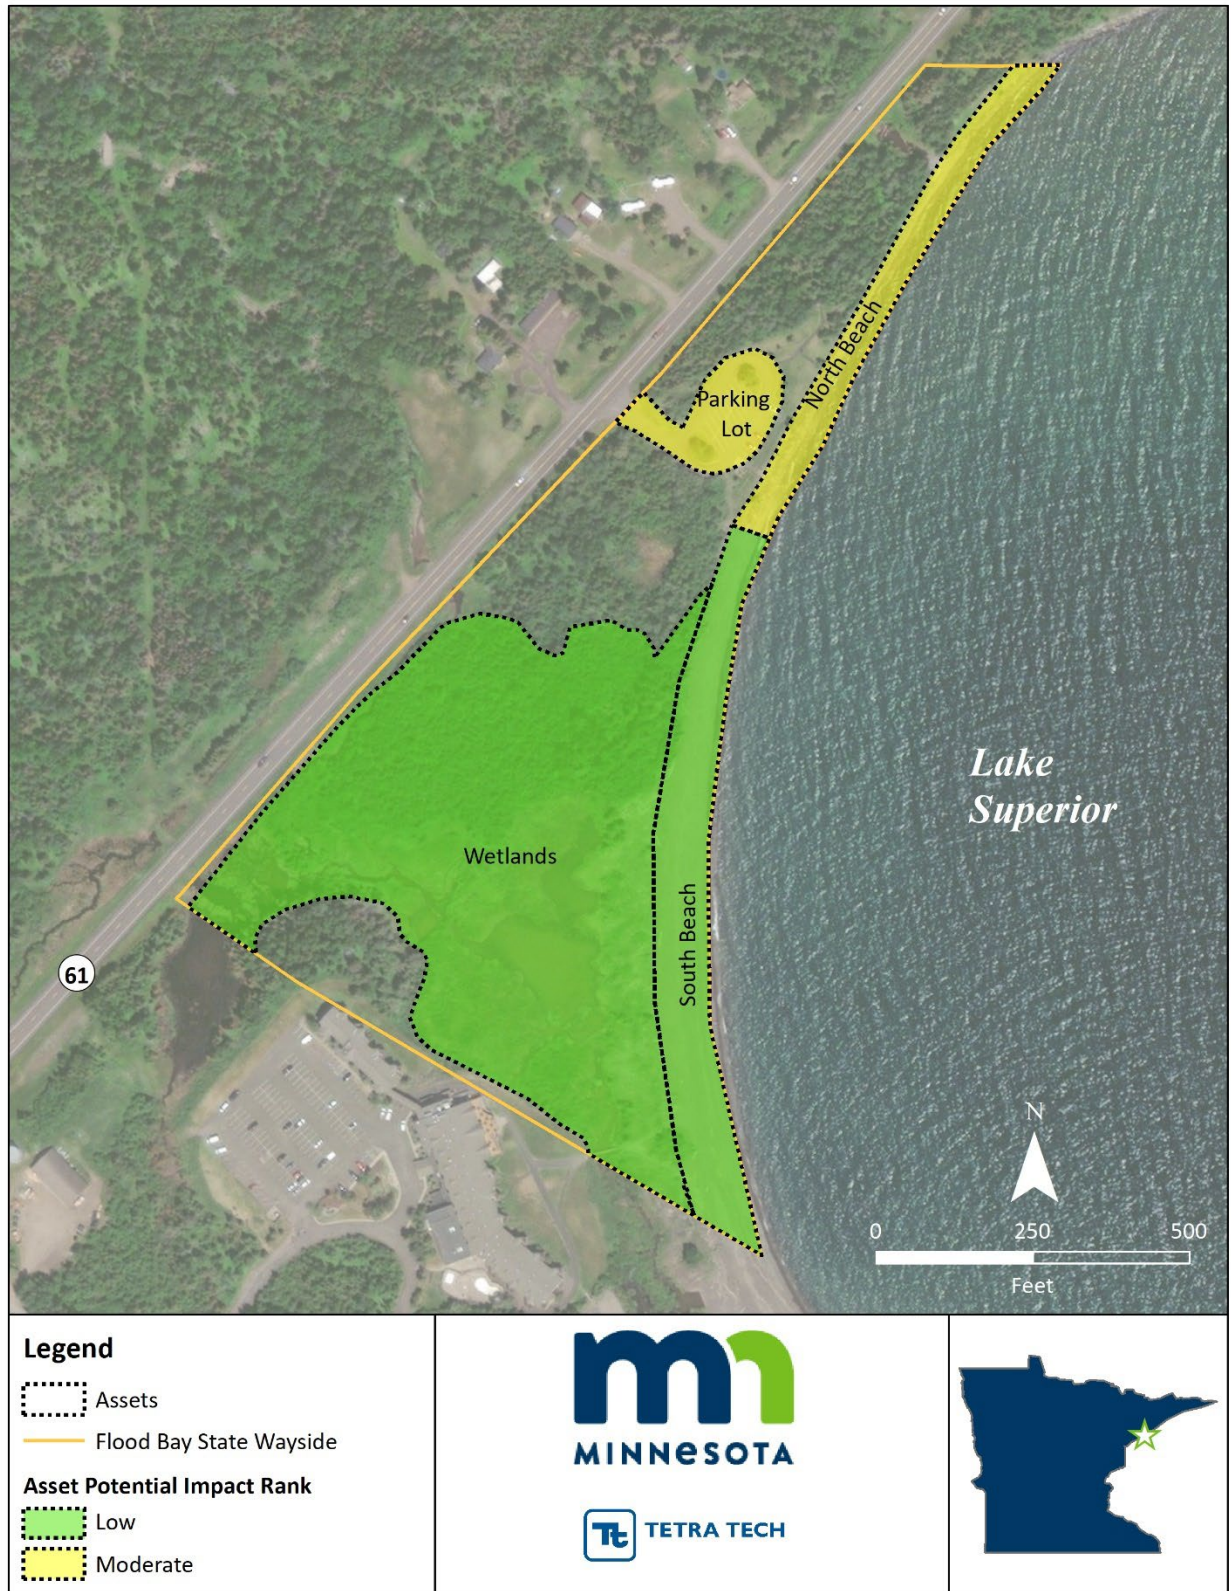
Figure 5. Flood Bay State Wayside Potential Impact Results Map

The potential impact analysis for the FBSW assessment characterized the results of the exposure and sensitivity analyses. The potential impact to the assets was calculated by averaging the exposure and sensitivity scores from the previous analyses. The results of the potential impact analysis indicated the parking lot and north beach have a moderate potential impact rank while the south beach and the wetlands have a low potential impact rank (Table 4, Figure 5). Full results of the potential impact analysis are available in the provided FBSW vulnerability assessment spreadsheet (Appendix A).

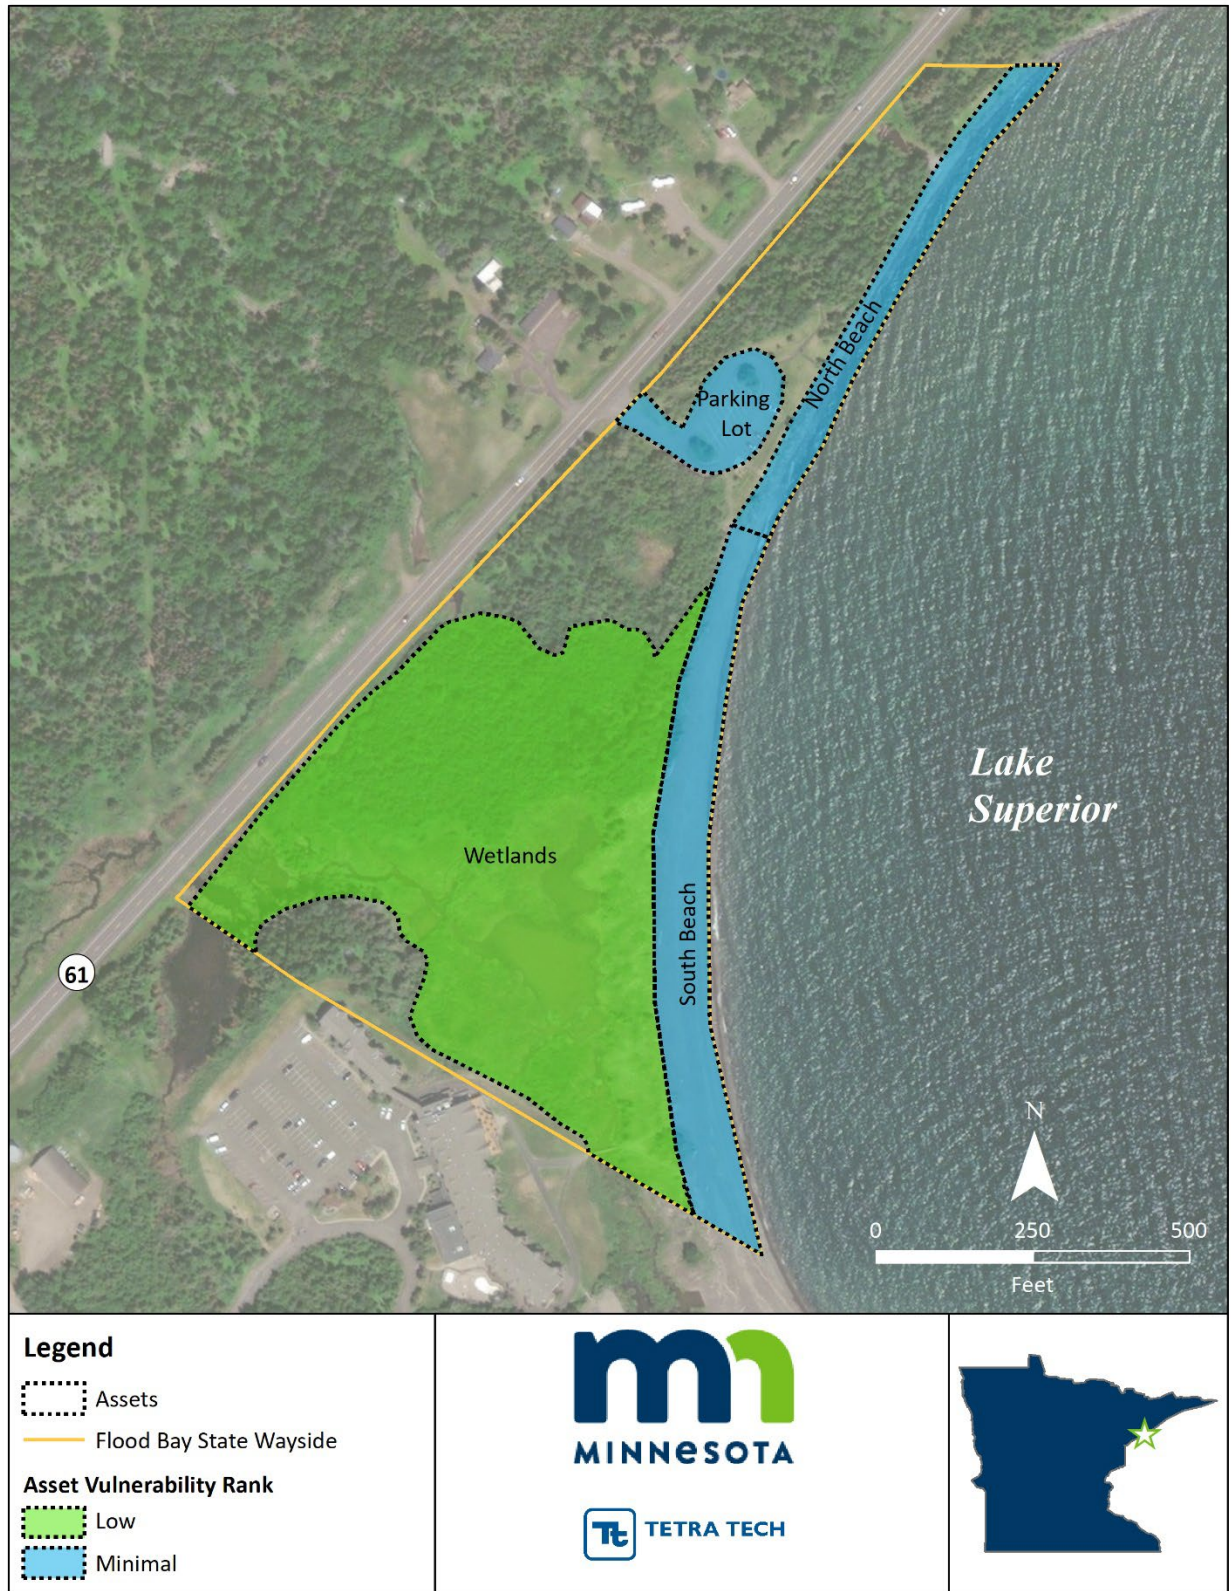
Figure 6. Flood Bay State Wayside Vulnerability Rank Map

This final vulnerability analysis for the FBSW site sums the potential impacts and subtracts the adaptive capacity scores. Based on the final vulnerability score for each asset, the asset was assigned to one of four categories: high vulnerability, moderate vulnerability, low vulnerability, or minimal vulnerability. By utilizing the adaptive capacity strategies described previously, the vulnerability of the parking lot, north beach, and south beach can be reduced to minimal (Table 6, Figure 6). The wetlands do not have any adaptive capacity strategies identified because the asset is already buffered against impacts from climate change with a natural adaptive capacity.

While Table 6 above shows the potential reduction of vulnerability of assets at FBSW, this reduction is dependent upon implementing the highest impact adaptive capacity strategies identified in Table 5. Site managers at FBSW may not have the ability to fund these options or may not be able to implement these actions in a timely fashion. This vulnerability assessment has also been performed as a desktop analysis without a visit to the site itself. Site managers should utilize the best available knowledge of the site and the knowledge of what adaptive strategies are most readily available or feasible in order to fully assess the vulnerability of the assets. As new datasets become available or old datasets are updated, it may behoove the site manager or others interested in the site to integrate it into the assessment. Furthermore, if adaptive capacity strategies are implemented on certain assets (i.e., on the parking lot but not on north beach), the vulnerability assessment can be redone to update the vulnerability rank of the assets or of any new assets that might be identified or built at the site.
