Attachment B:
Data and Location Errors

Background

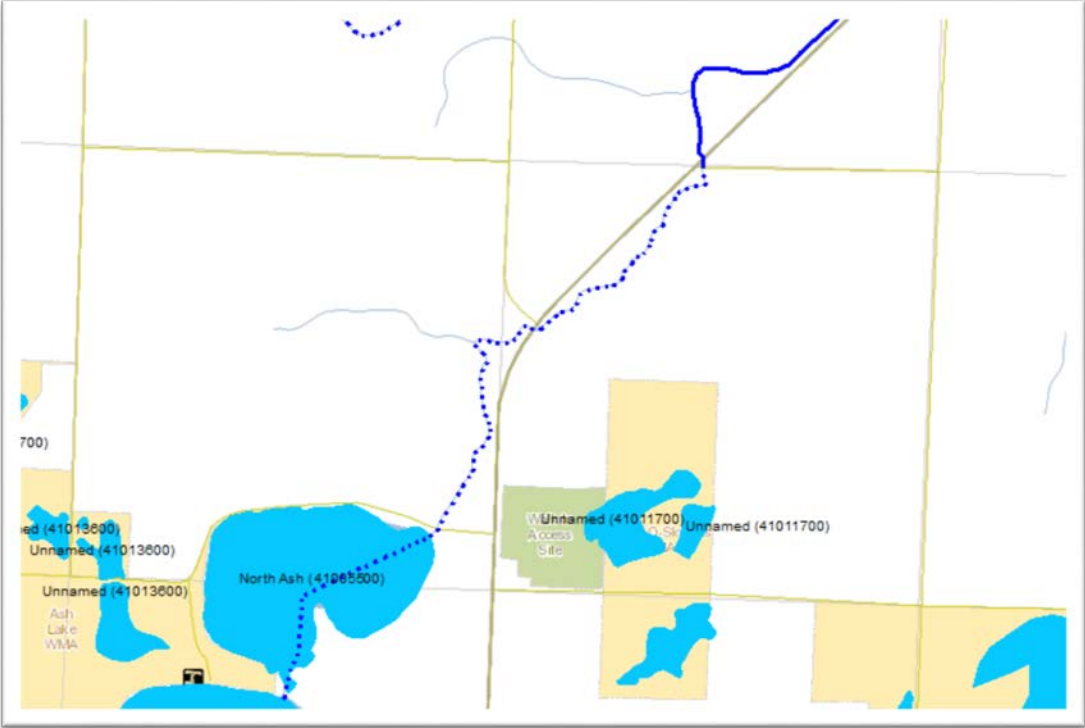
Figure 2. The PWI data layer indicates shows this as a dashed line (blue, dashed line), indicating it is an altered natural watercourse.

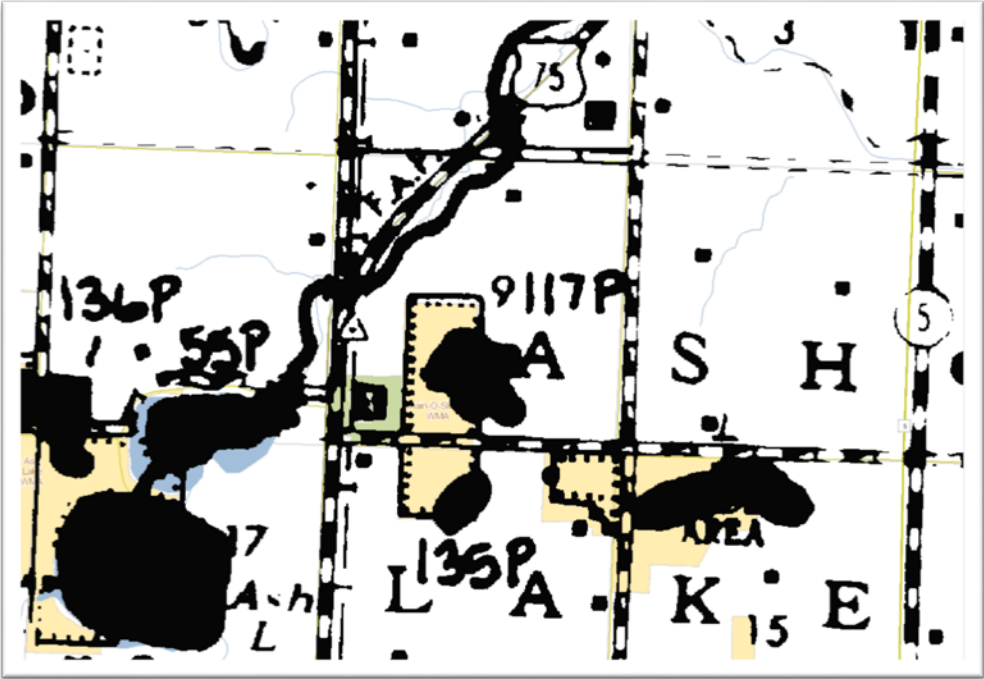
Figure 3. Original PWI map showing solid line in same location of purple line in Figure 1.

Figure 4. Excerpt from the Lincoln County PWI list. It indicates that the PWI watercourse 'unnamed to Yellow Medicine River' begins at South Ash Lake (PWI #41-57P) in T111 R45 Sec 17 and extends to T111 R 45 Sec 4. This description is consistent with the watercourse in purple in Figures 1-3 that was included in Appendix A.

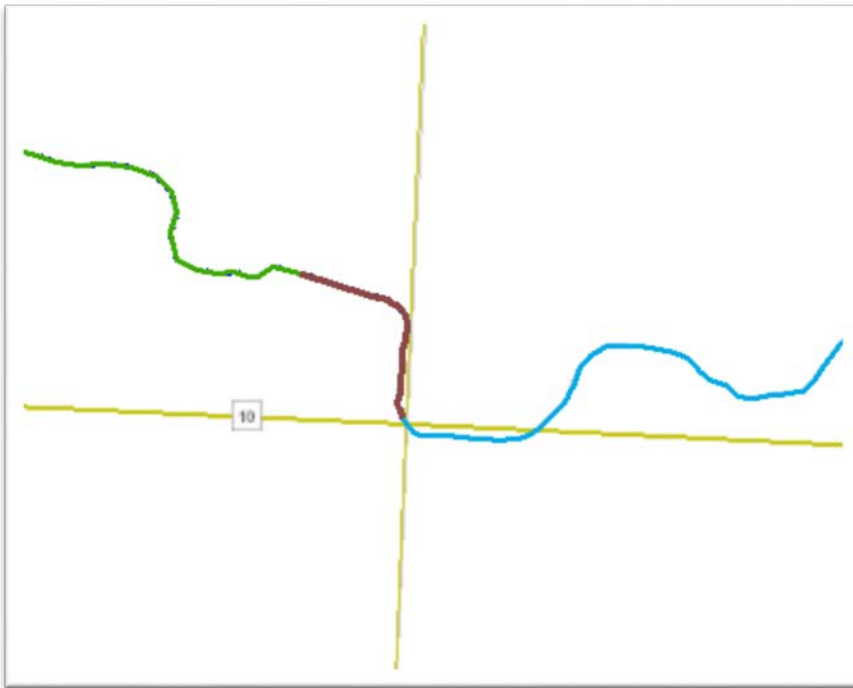
Figure 5. Location in Kittson County. The green line is the public ditch, the red line is a 0.3 mile segment removed and the blue line is a natural public watercourse.

This location (Figure 5) is in Kittson County. A 0.3 mile segment (in red) was removed via the Commissioner's Order. The green line represents the location of the public ditch as provided in 2016 by the County for the buffer map. The blue line is a public watercourse. The PWI data layer (Figure 6) shows the public ditch (dashed blue line) extending east to the section line. The PWI data layer is consistent with the original PWI map (Figure 7). A number of explanations might explain why this 0.3 mile segment was mapped as a public ditch during the original PWI. The actual reason may never be known. Is it actually currently a public ditch but the county's data provided for the buffer map did not include it? Did the location change, dropping the 0.3 mile segment since the PWI? Is the current ditch location correct on the buffer map, but due to the map scale and map making methodology of the original PWI, using hand-drawn lines, was

the ditch extended to the section line. (Given a map scale of $\frac{1}{2}$ in per mile, a 0.3 mile segment would have been represented by a miniscule line $\frac{3}{16}$ of an inch long on the original PWI map.)

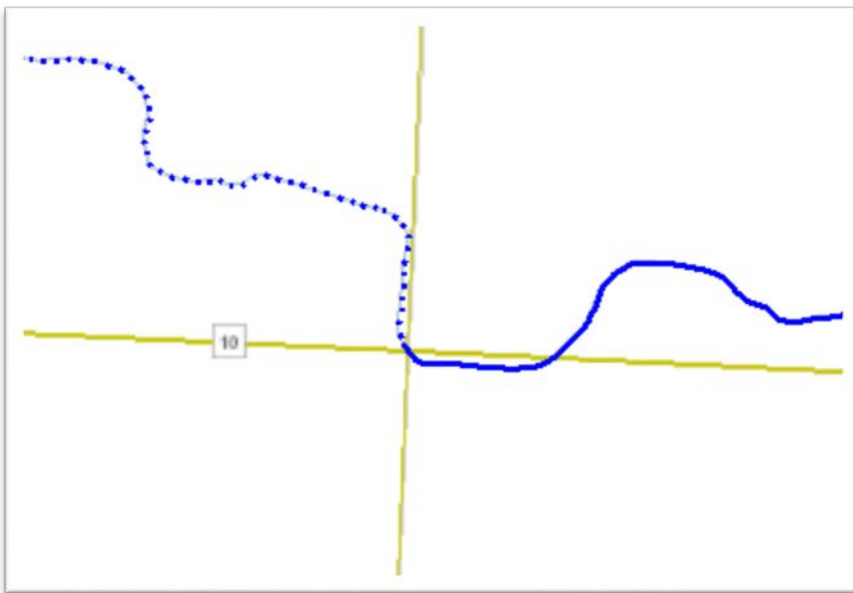
Figure 6. The PWI map layer shows the altered natural watercourse (dashed line) extending east to the section line.

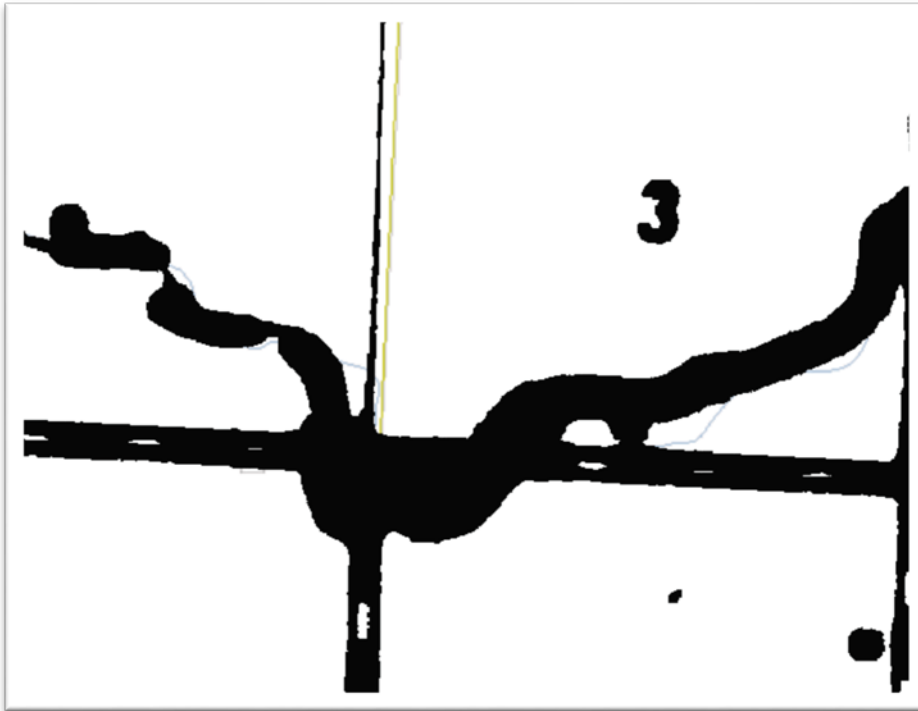
Figure 7 Original PWI map is consistent with the PWI data layer (see Figure 6).

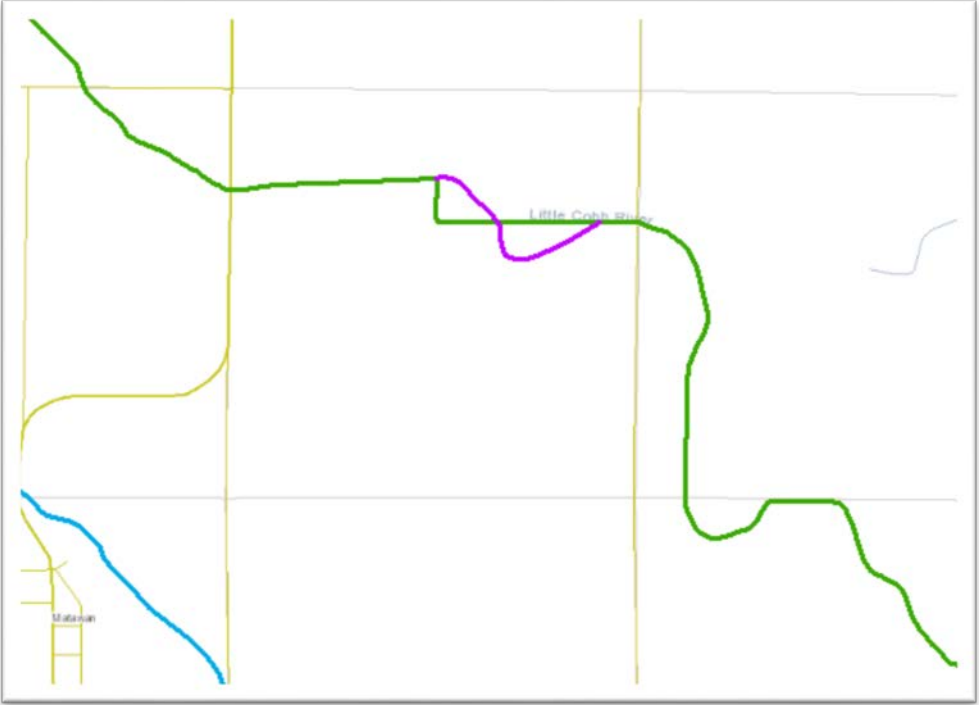
Figure 8. An example from the buffer map in Waseca County where the public watercourse and the public ditch lines did not coincide and were not merged as intended into a single watercourse. The green line represents the public ditch and the purple line represents the portion of the PWI watercourse that was not merged with the ditch. Due to this error, the purple line was included in Appendix A of the Commissioner’s Order.

The buffer map was created using DNR PWI data from the PWI data layer and public ditch location data provided by the drainage authorities. In many cases, the location of a watercourse in the PWI data layer and the location of a public drainage ditch are the same. In these cases, when the drainage authority provided the ditch data, DNR merged the PWI data layer record and the ditch location record, combining attributes from both into a single watercourse record. In some cases, usually in a very small geographic area, the merging of the line work from the two datasets was not completed because the watercourse has been relocated (or mapped at a location slightly different). A 'double line' appears on the buffer map in these locations, one representing the PWI data and one the ditch data. Many of these were corrected via the map review process but some situations still exist. If the PWI watercourse was an altered natural watercourse, it would have been included in Appendix A of the Commissioner's Order because the public ditch attribute would have been 'no' because the attributes from the 2 sets of line work had not been combined. In most cases, the removal has no practical impact on the buffer map -- the public ditch line is still there. The removal partly corrected the error by removing the extra line but the watercourse is no longer a public water. See Figure 8 for an example from the buffer map.
