Minnesota Department of Natural Resources
Minnesota Board of Water and Soil Resources

Appendix B: 2020 Legacy Fund Restoration Evaluation

Report March 2020

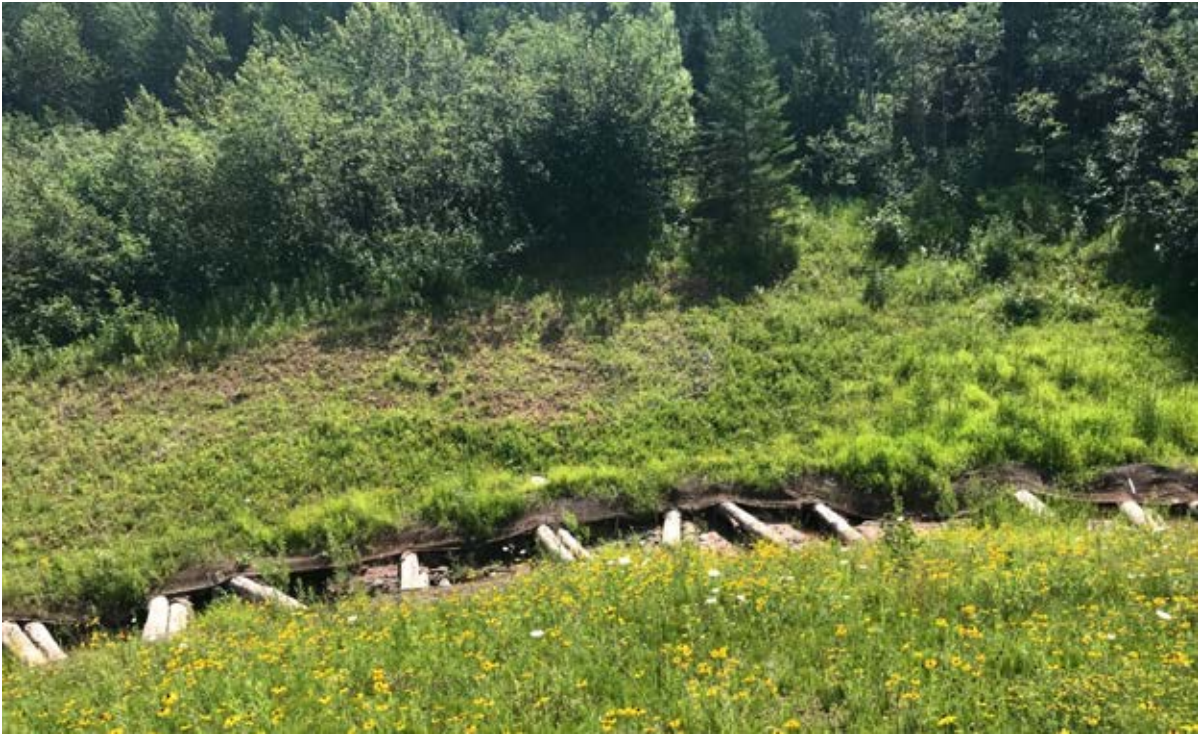
Photo 1-2 Michaelson Dam showing re-graded side slopes with native vegetation establishment. Log grade control structures were installed within the restored stream channel of the unnamed tributary to Deer Creek. Photo taken by Mike Majeski on 7/23/2019.

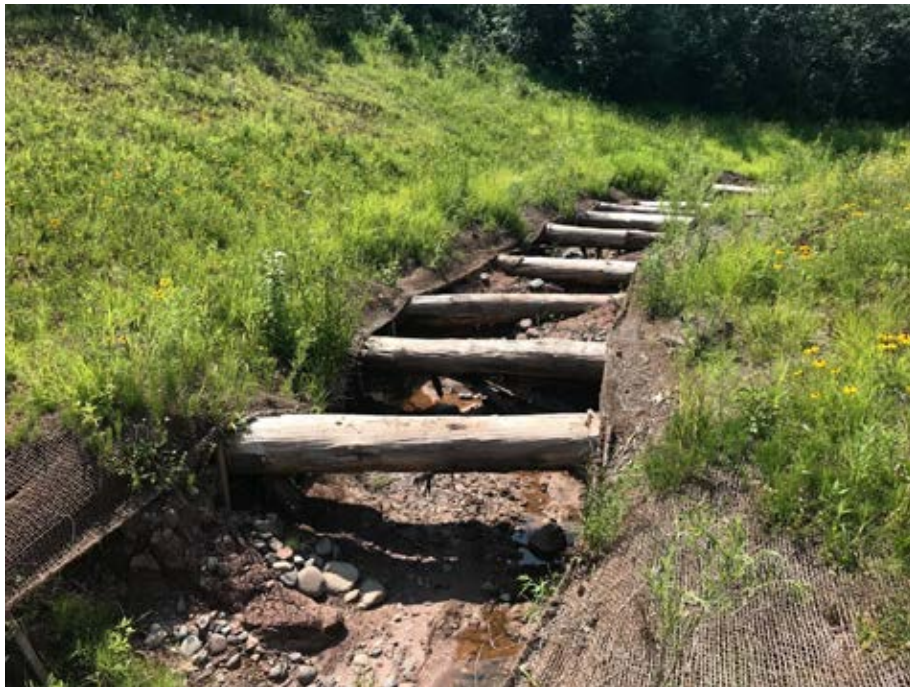
The re-sloping of the dam, side slopes, and creation of a stream channel within the impoundment area has greatly reduced the threat of dam failure and subsequent mass-wasting and erosion of the side-slopes. However, the stated goal to create a stable stream channel has not yet been achieved due to headcutting within the constructed "B" channel.

The failed grade control structures have resulted in unintended channel erosion and have reduced the number of pools available for fish and other aquatic organisms within the tributary.

Photo 1-3 Failed log grade control structures within the old dam impoundment. A headcut has advanced throughout the middle section of the project site in an area where sediment deposits were likely the deepest. Photo taken by Mike Majeski on 7/23/2019.

Yes, to achieve goals in the near term the project will require repairs to the constructed stream channel where grade control structures have failed within the middle section of the project reach. The failed

Follow-up assessments are necessary if the site is proposed for repair. An assessment should be conducted prior to any repairs to determine if further degradation has occurred within the restored stream channel, or if any other grade control structures have failed. It is strongly recommended to conduct a few soil borings near the failed grade control structures to determine the depth of the historic sediments within the impoundment to help guide the repair design (i.e. a change in the type or quantity of material to create stable grade control structures).

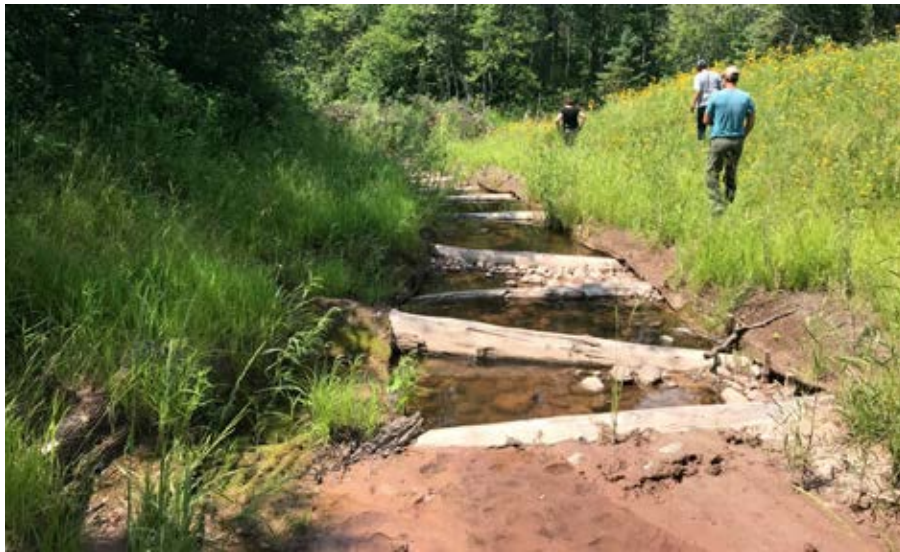
Photo 1-4 Log grade control structures near the confluence with Deer Creek. These structures are intercepting some sediment and are providing small pool habitat for aquatic organisms. Photo taken by Mike Majeski on 7/23/2019.

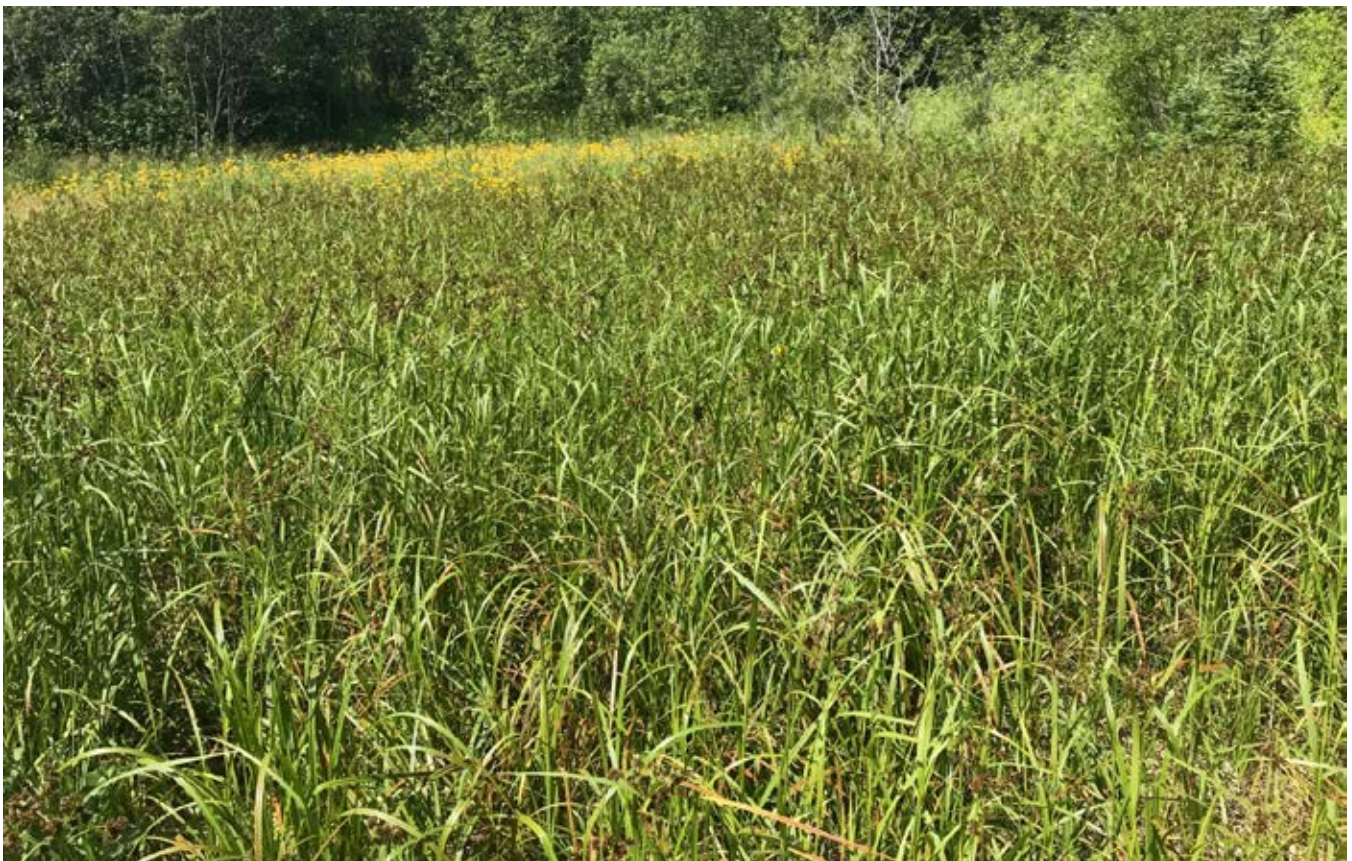
The establishment of native vegetation within the project site is outstanding with good diversity of native plants observed throughout. Invasive species do occur but are in low density.

Photo 1-5 Dense native vegetation within the project site. This image shows a large colony of dark green rush with black-eyed Susan in the background. Photo taken by Mike Majeski on 7/23/2019.

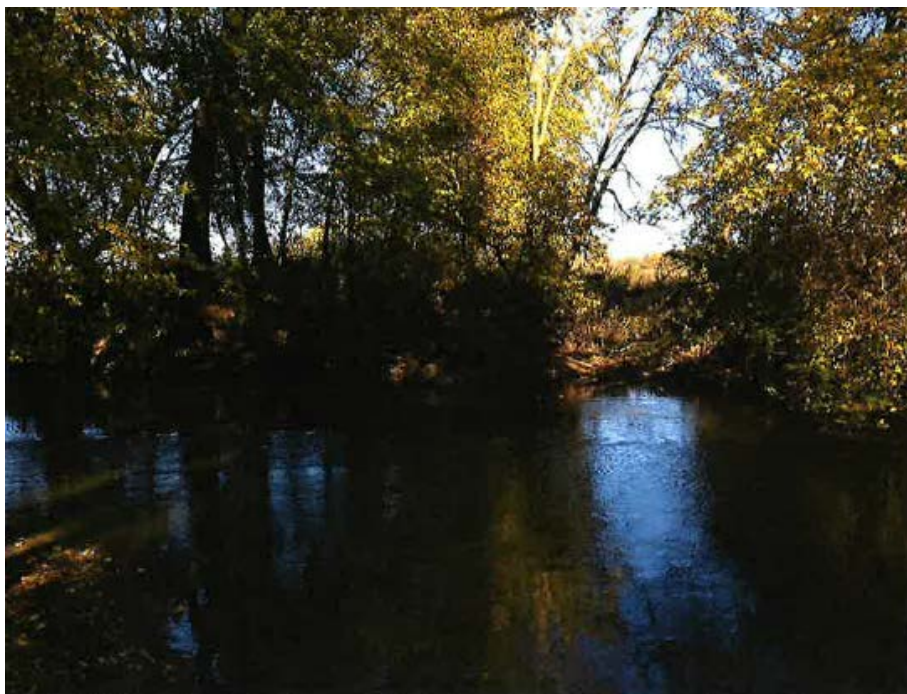
Photo 2-1 View of Adams washout area before construction. Photo provided with project documentation.

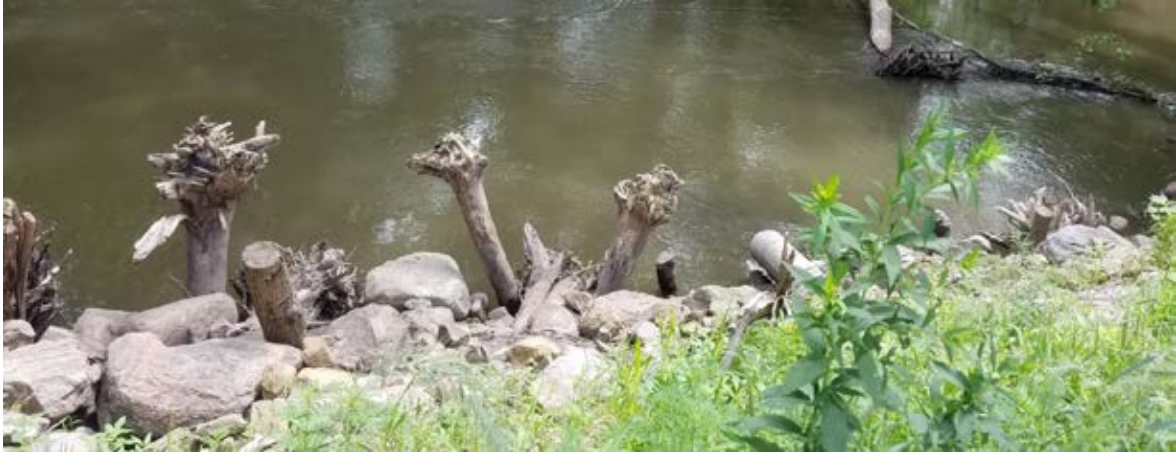
Photo 2-3 View of Adams Washout. Boulders, rootwads and pins holding bank. Photo taken by Ed Matthiesen during site visit (8/13/19).

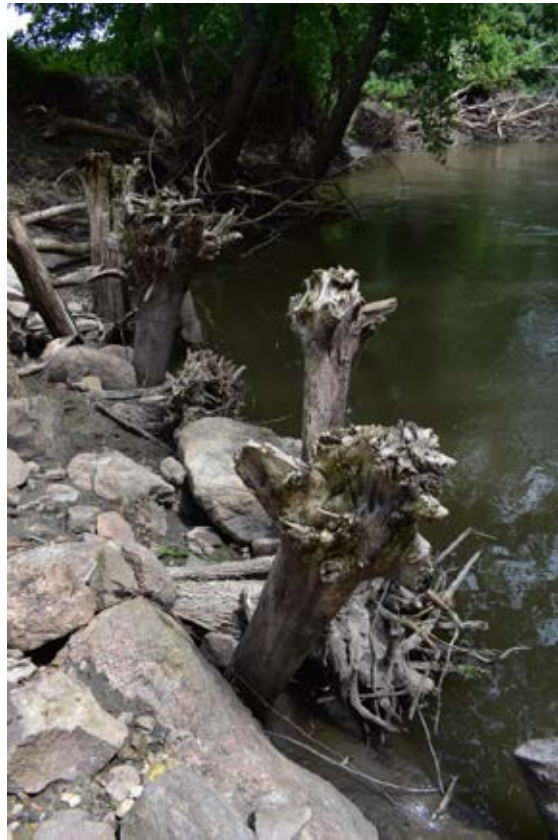
Photo 2-4 Close-up view of the rootwad stabilization at the toe of the Adams Washout slope. The rootwads installed vertically with the other rootwads and boulders are unique to this site. Photo taken during site visit (8/13/19).

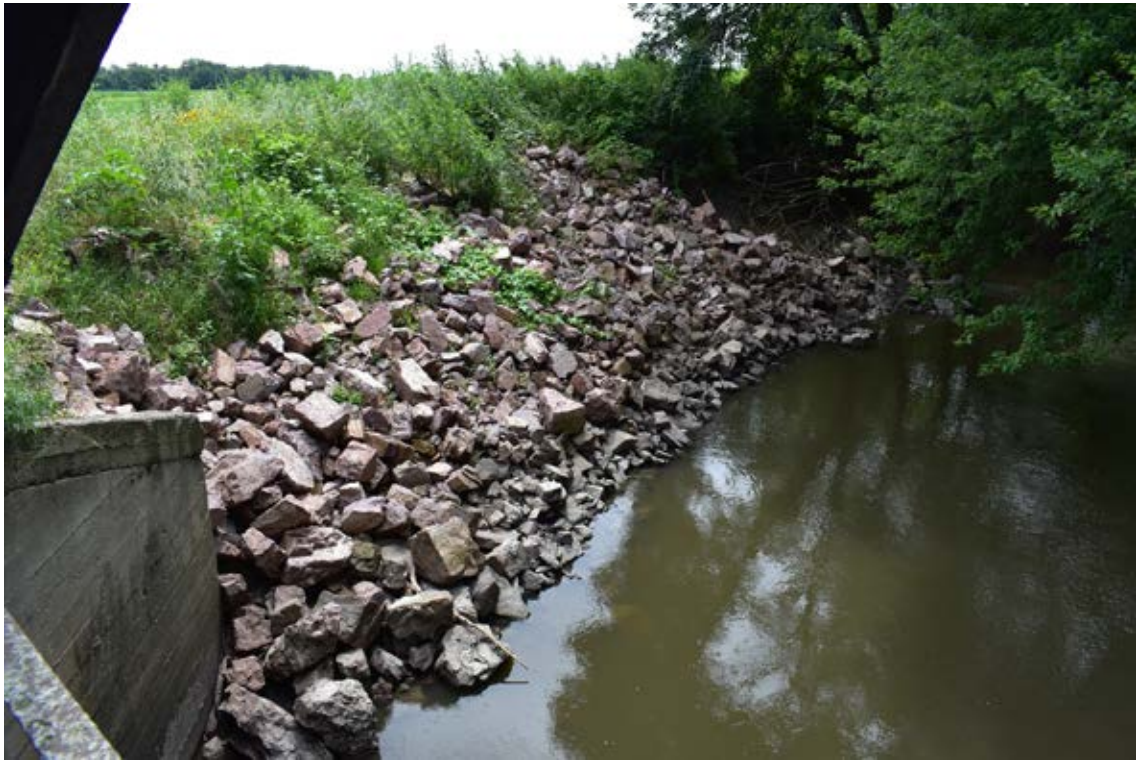
No. The riprap protection of the bridge does not provide much habitat, but the rootwad revetment may provide improved habitat over pre-existing conditions.

Photo 2-5 View of Adams near Bridge. Riprap protection bank. Photo taken by Ed Matthiesen during site visit (8/13/19).

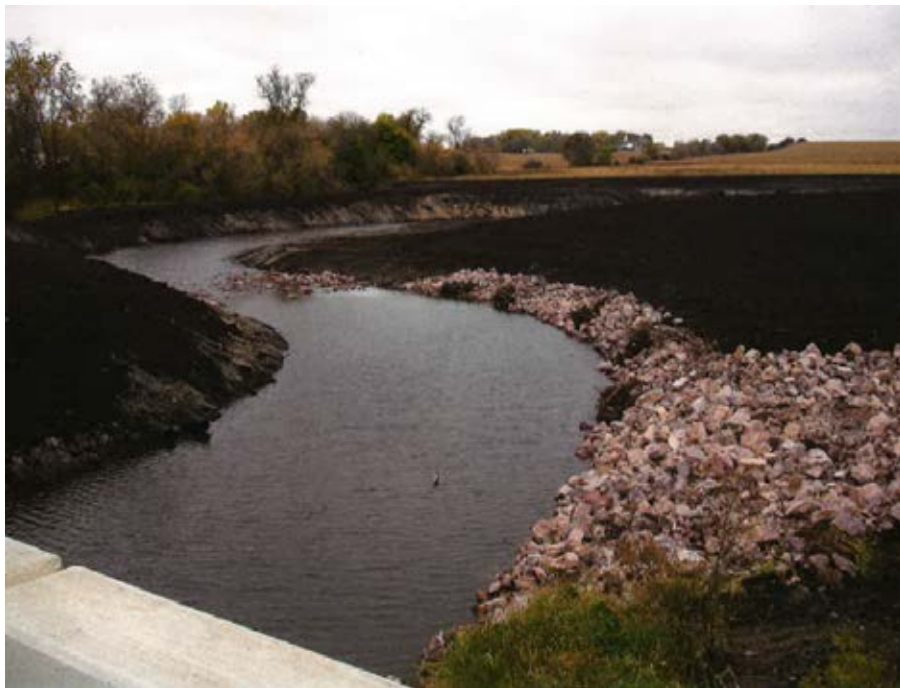
Installing rootwads as bank stabilization on outside bends of new channel alignments is industry standard in MN to protect the toe of the new banks while vegetation is established. Rootwads usually require foundational footer logs or riprap to supplement the rootwads and protect the entire toe of the stream bank.

Photo 3-1 View of Elm Creek project from County Highway 36 bridge after construction and before vegetation establishment. Site evaluator questions the intended effect of rootwad placement in riprap and the elevation that the rootwads were installed. Photo taken during construction (2014).

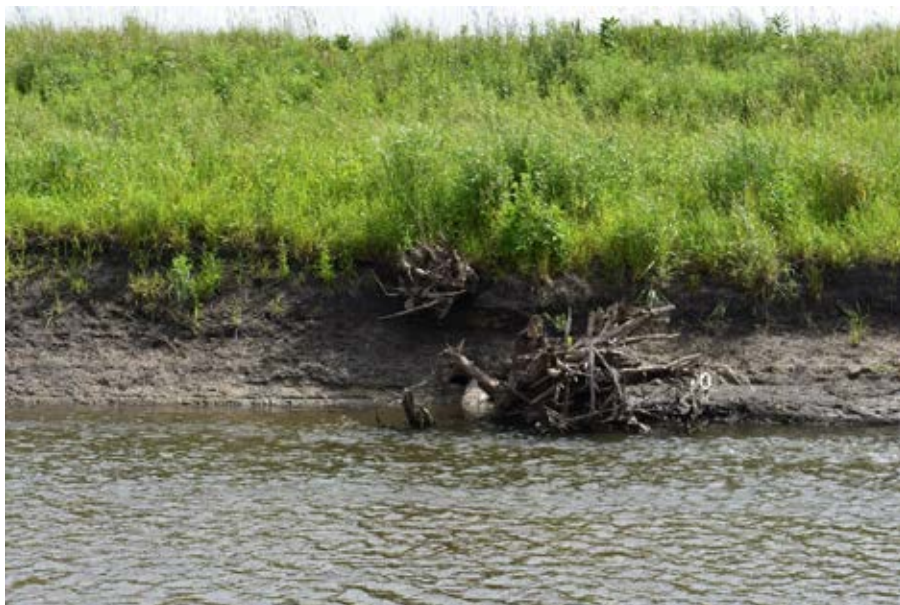
Photo 3-2 View of Elm Creek project showing a single exposed rootwad. Evaluator recommends rock/boulders on both sides of the rootwad near station 7+00 to prevent bank scour behind the rootwad. Photo taken by Ed Matthiesen during site visit (8/13/19).

Project has been in place for six years and needs some maintenance to protect the first 90° bend on the upstream side. Recommend installation of riprap on that section of bank. The realignment and lengthening of the channel is largely successful. There is one area upstream that could use some touch up but is not currently detracting from the gains of realigning and lengthening the channel.

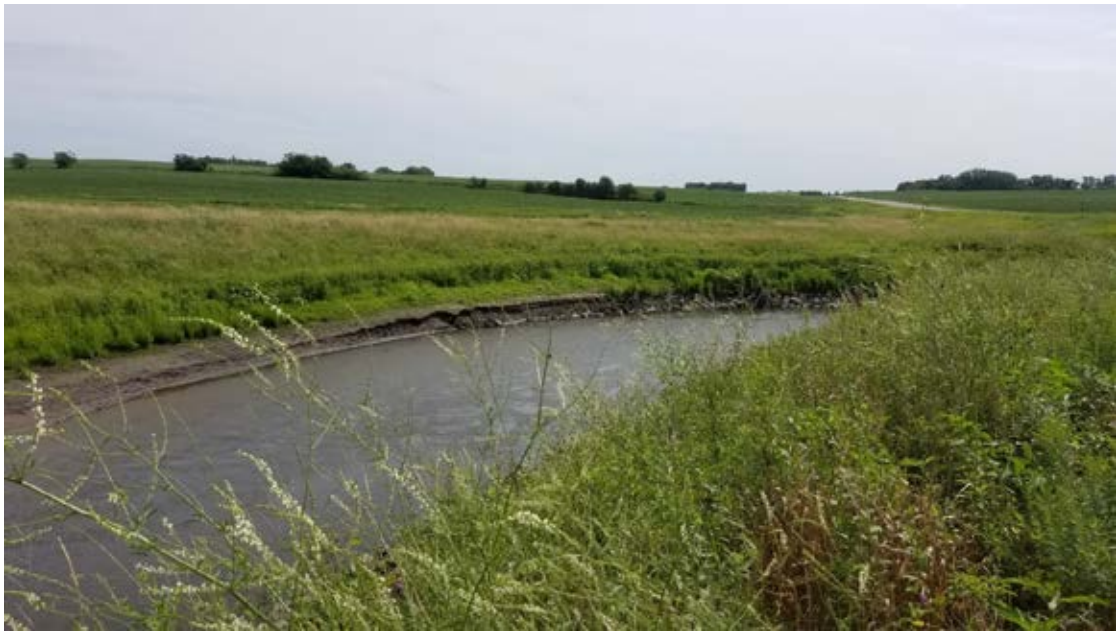
Photo 3-5 View of Elm Creek. Looking downstream to 10+00. Sediment deposition covering rock. Photo taken by Ed Matthiesen during site visit (8/13/19).

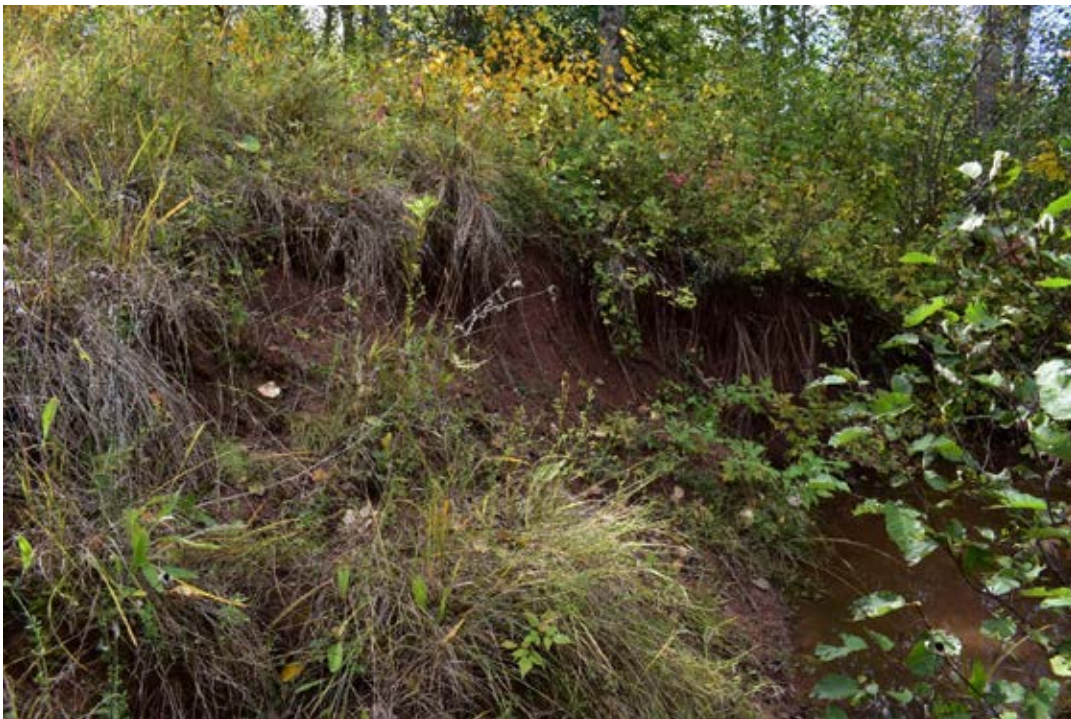
Photo 4-4 Minor instability immediately downstream of the terminus of the Toe Wood installation.

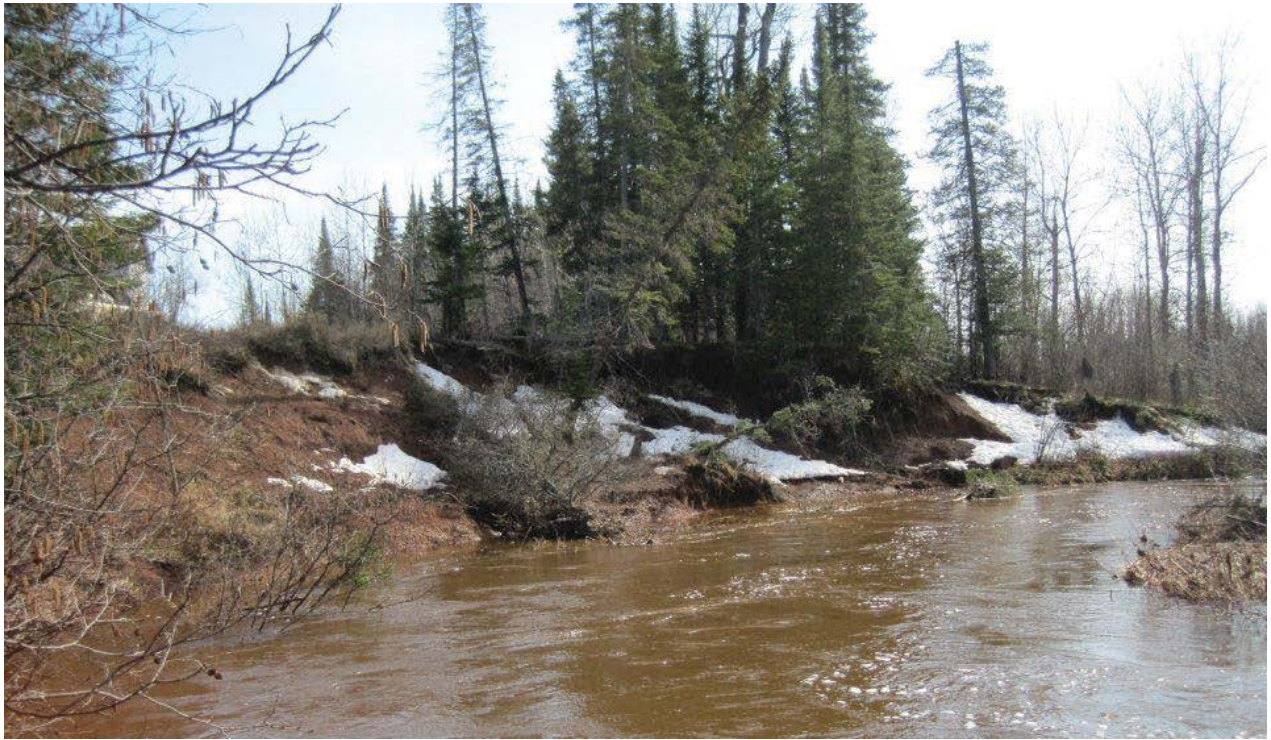
Photo 4-5 Eroding bank 04/12/2011 increasing sediment load and threatening access road and structure above. Photo South St Louis SWCD.

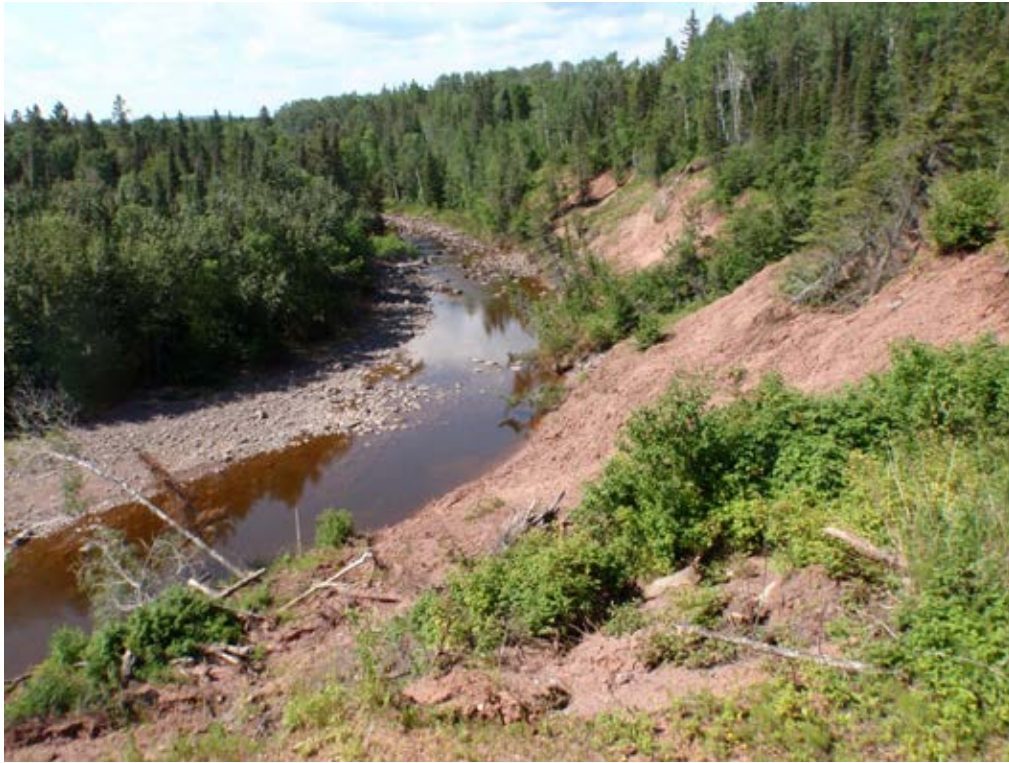
Photo 5-1 Pre project view of the project site July 10, 2012. Slumping and mass wasting of the large clay bank was contributing significant sediment loads to the Knife River.

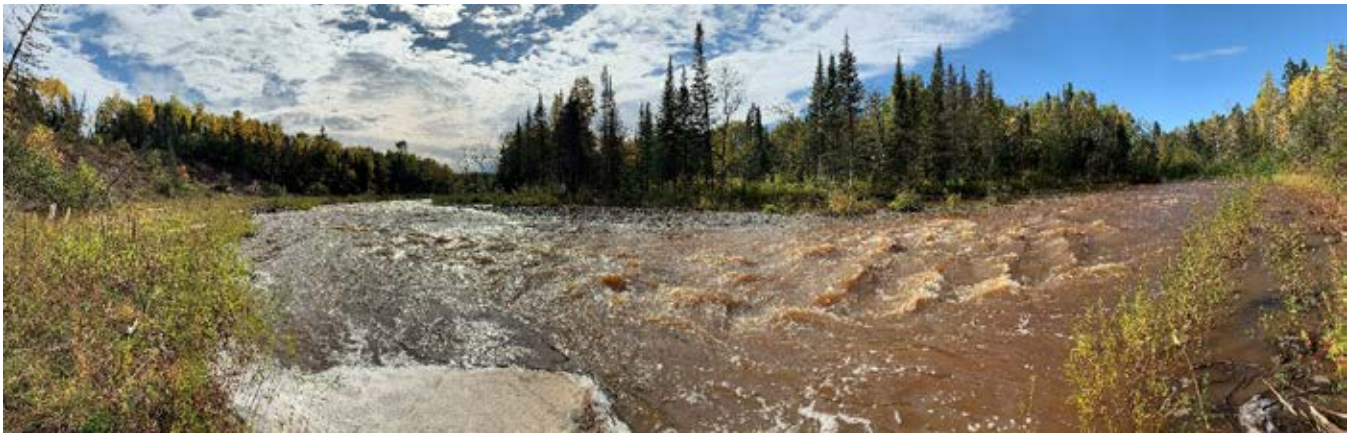
Establishing vegetation on these bluffs on the north shore has been problematic to date. Many projects, such as this one, have limited or eliminated vegetation inputs on the bluff itself, as vegetation establishment on the extreme conditions as proved to be exceptionally challenging. The resulting/remaining unvegetated bluff may appear alarming, but this project and others have dramatically reduced sediment yields by relocating the stream thalweg and actively eroding toe away from the bluff and creating a bench to capture sedimentation from the bluff (see Photo 5-2). Discrete areas of concentrated surface flow, when they occur on the bluff (see Photo 5-3), should be the focus of vegetation and erosion control inputs where needed. The example in photo 5-3 was addressed in the initial project design with a small vegetated settling basin.

Photo 5-3 Panoramic of project from upstream end of the project, with bluff in question on the left. Photograph taken by Kevin Biehn on 10/1/2019 site evaluation.

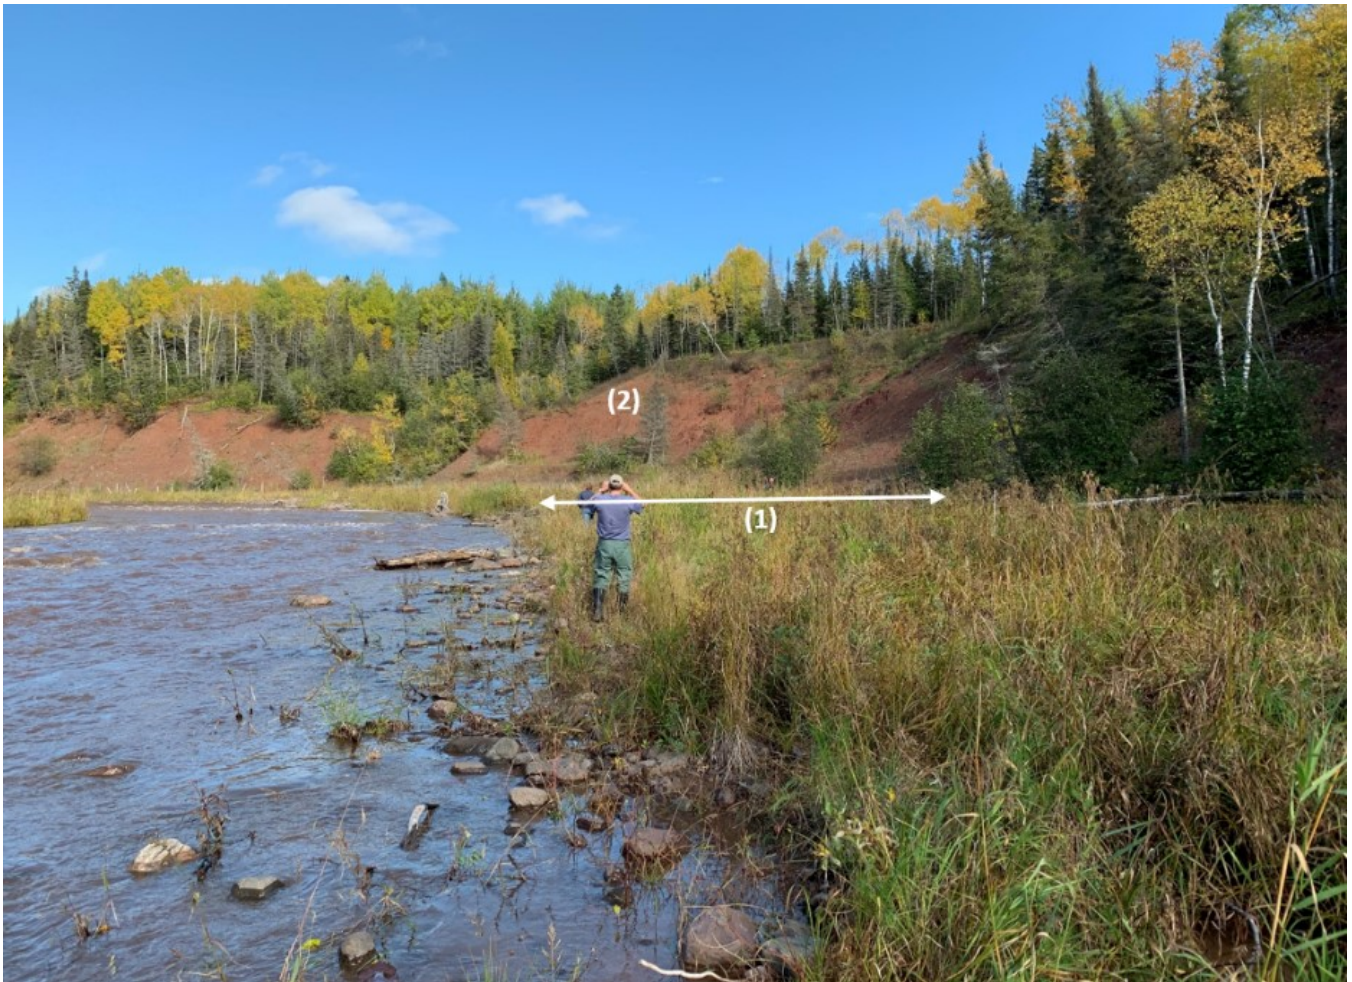
Photo 5-4 Representative image of created floodplain bench (1) and bluff (2) the river was actively moved away from. Photograph taken by Kevin Biehn on 10/1/2019 site evaluation.

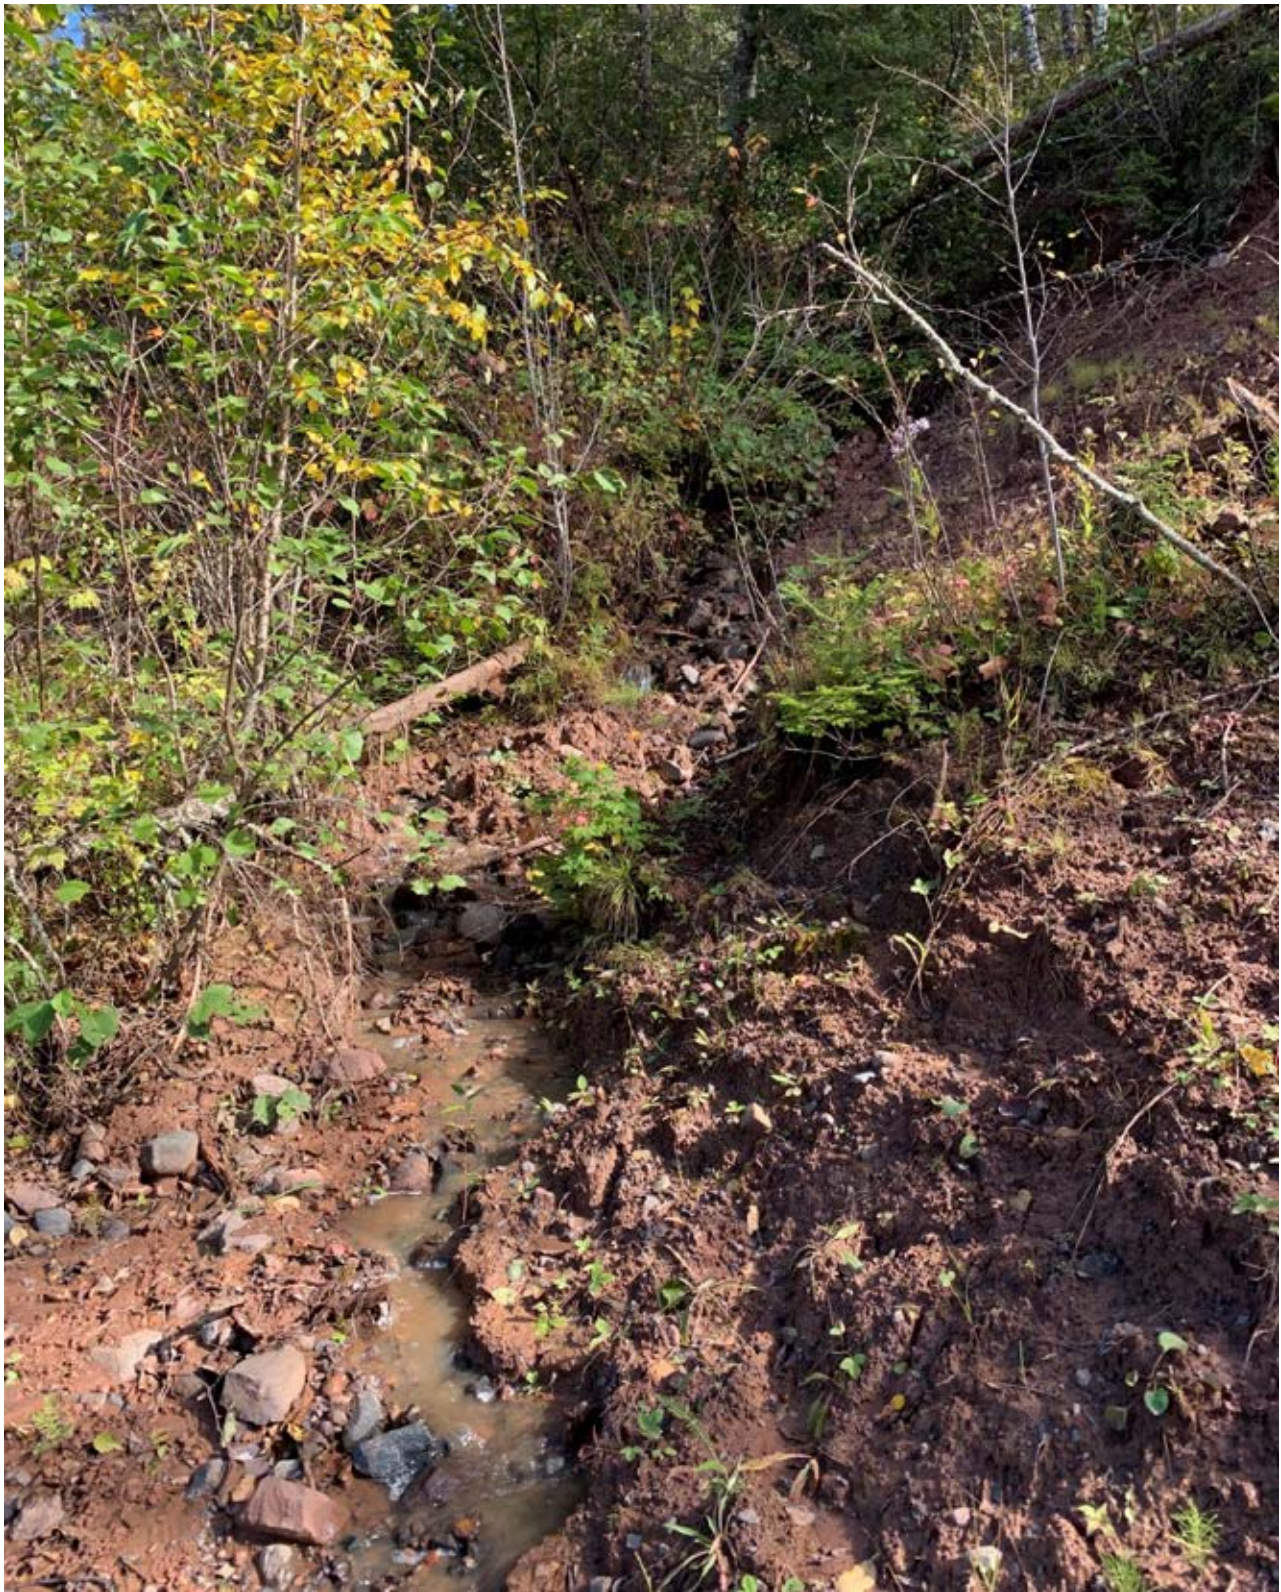
Photo 5-5 Representative image of concentrated runoff within the project reach following a previous day storm, which is yielding sediment to the Knife River. Photograph taken by Kevin Biehn on 10/1/2019 site visit.

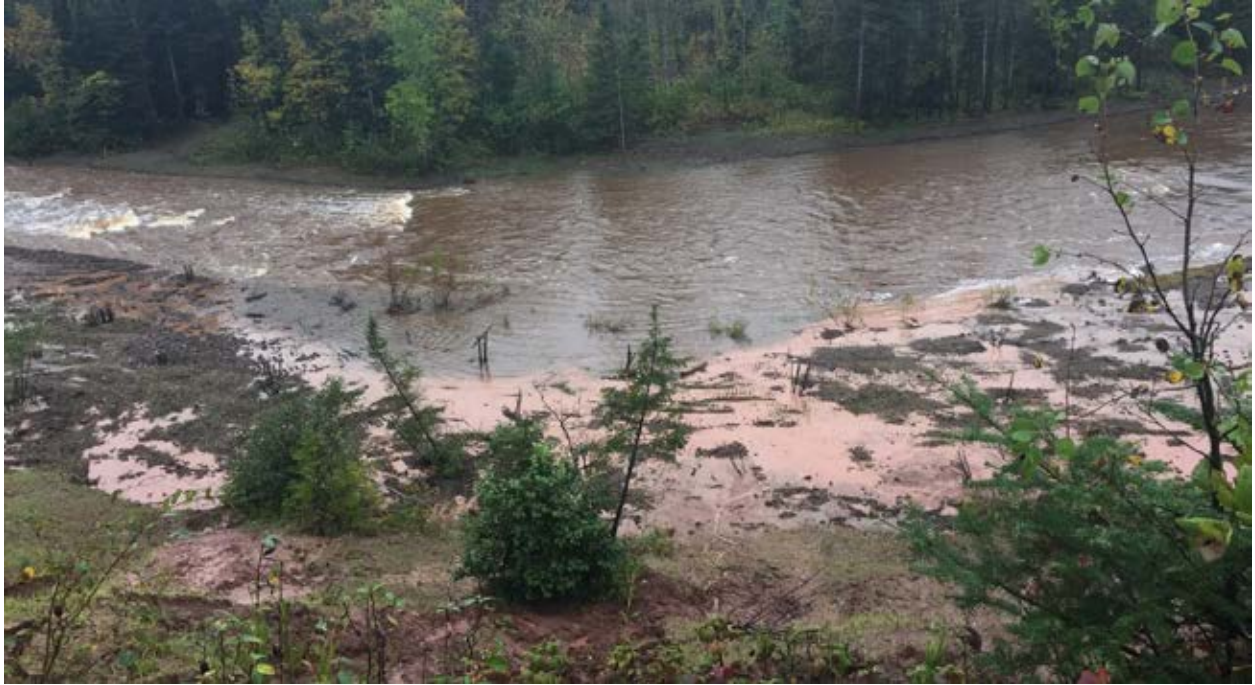
Figure 5-5 - Representative image of stabilization (bankfull bench). As illustrated in the photograph the created bankfull bench was appropriately being accessed (over-topped) by a near bankfull flow event. Date 09/24/2015.

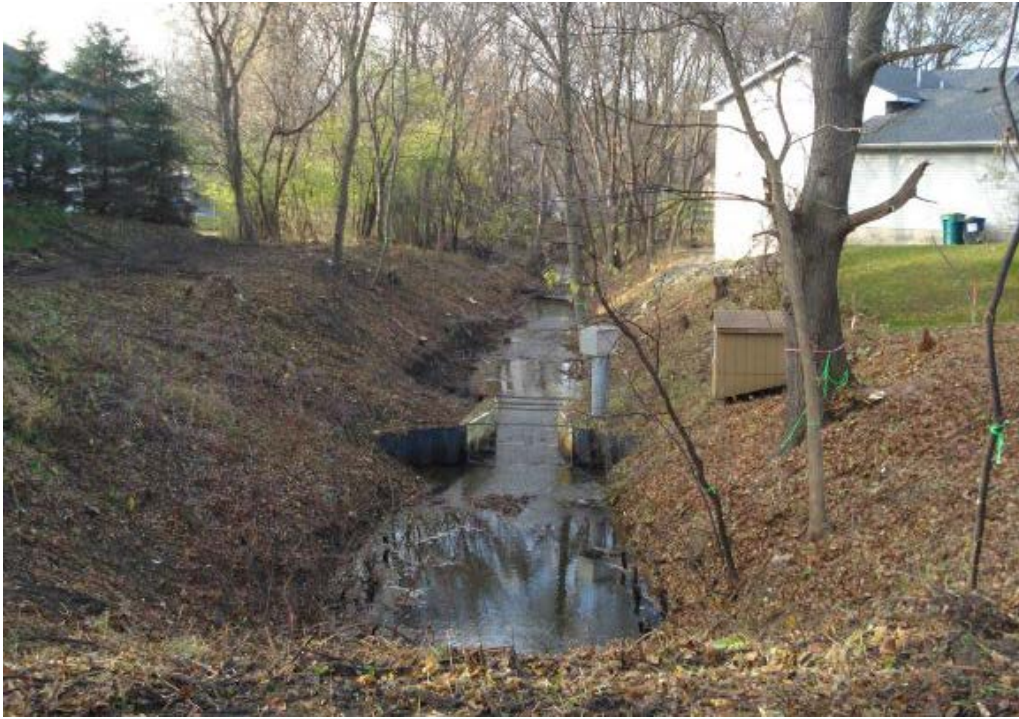
The project does not reasonably allow for achieving the stated load reductions, as it appears that the pre-project annual loading may have been over predicted. Based on professional judgment and cursory review of pre-project conditions (See Photo 6-1 for reference) an annual phosphorus (TP) reduction of 8.04 lbs and annual sediment (TSS) reduction of 9.46 tons is unlikely from this 210 linear foot stream stabilization project.

Photo 6-1 Image of project area on Lambert Creek from Koehler Road looking downstream (South). Photograph taken after vegetation clearing was completed, but prior to the start of stabilization measures. Photograph provided by Ramsey County – date unknown. Note: The visible restriction in the photograph is a flume intended to aid in water quality and quantity monitoring. This channel narrowing may have contributed to local stream instability,

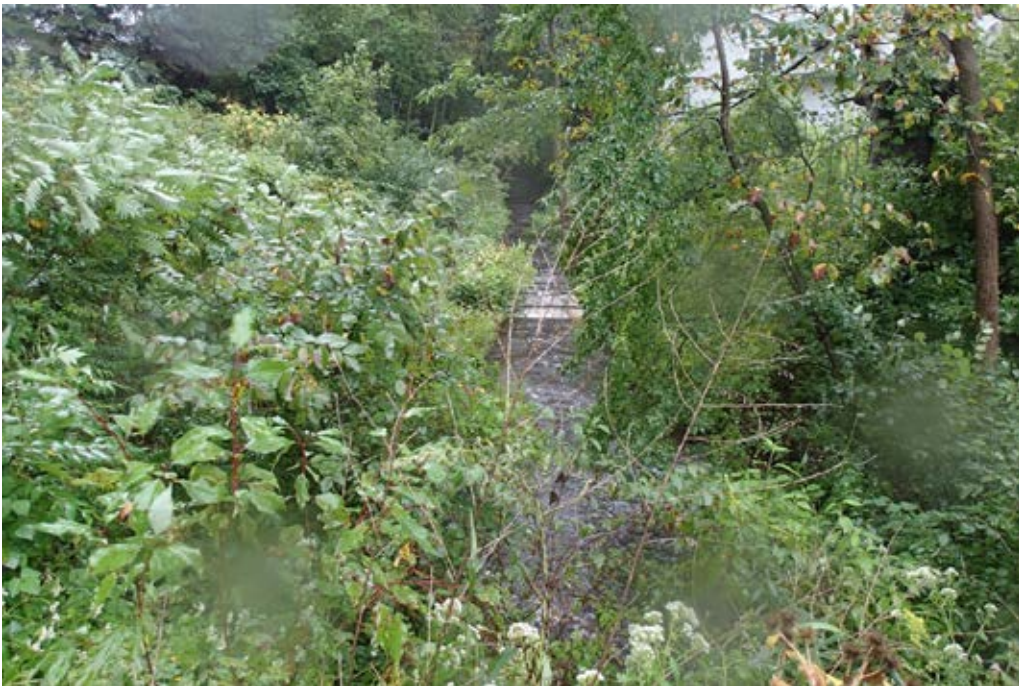
Photo 6-2 Image of project area on Lambert Creek from similar perspective as Photo 6-1. Photograph taken during 9/11/2019 site visit.

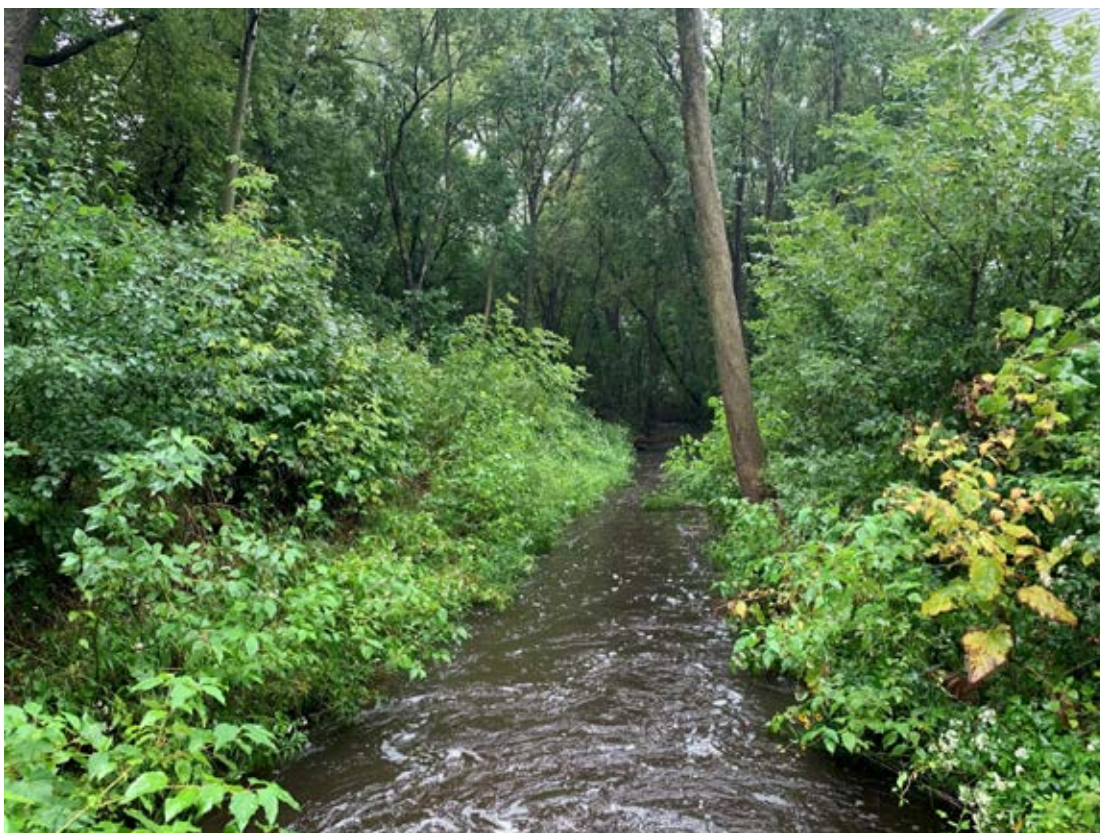
Photo 6-3 Facing downstream, immediately downstream of flume. Photograph taken by Kevin Biehn during 9/11/2019 site visit

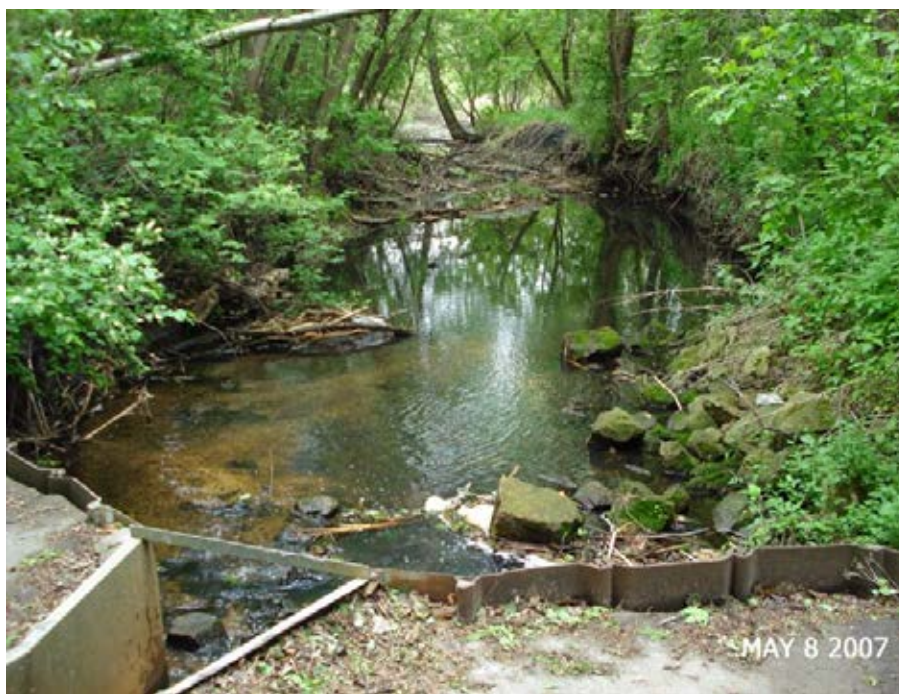
Photo 7-1 Before project image immediately downstream (west) of existing flume. Photograph provided by VLAWMO, dated May 8 2007.

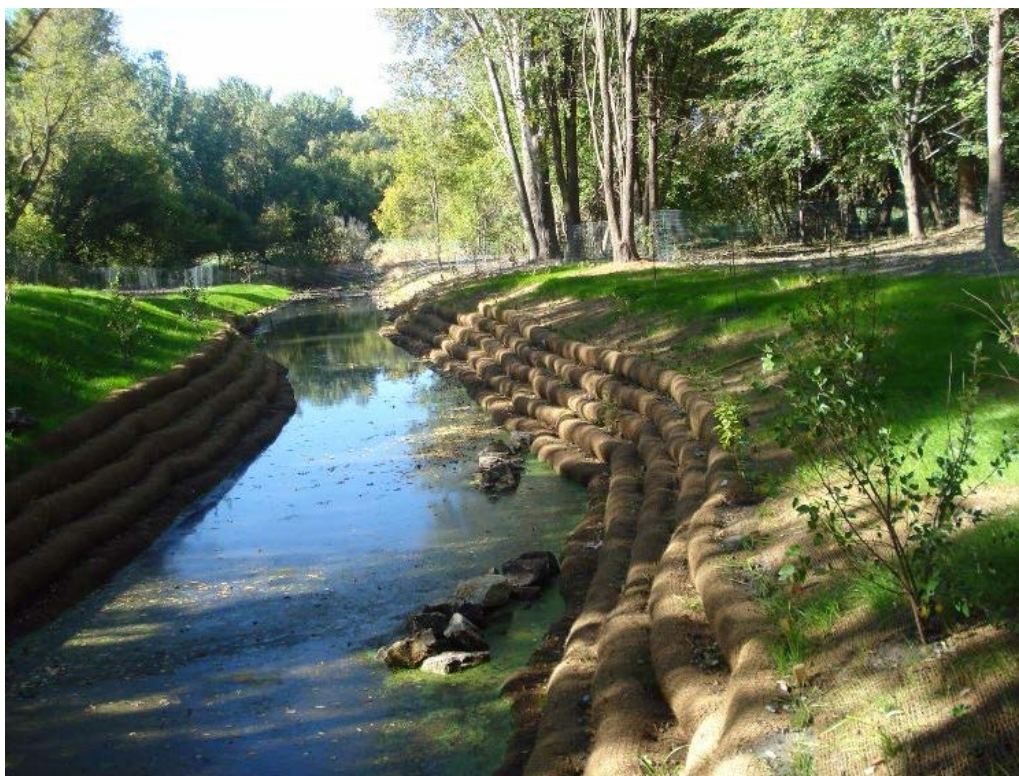
Photo 7-2 Image of completed project from similar location and perspective as Photo 6-1. Photograph provided by VLAWMO, September 2013.

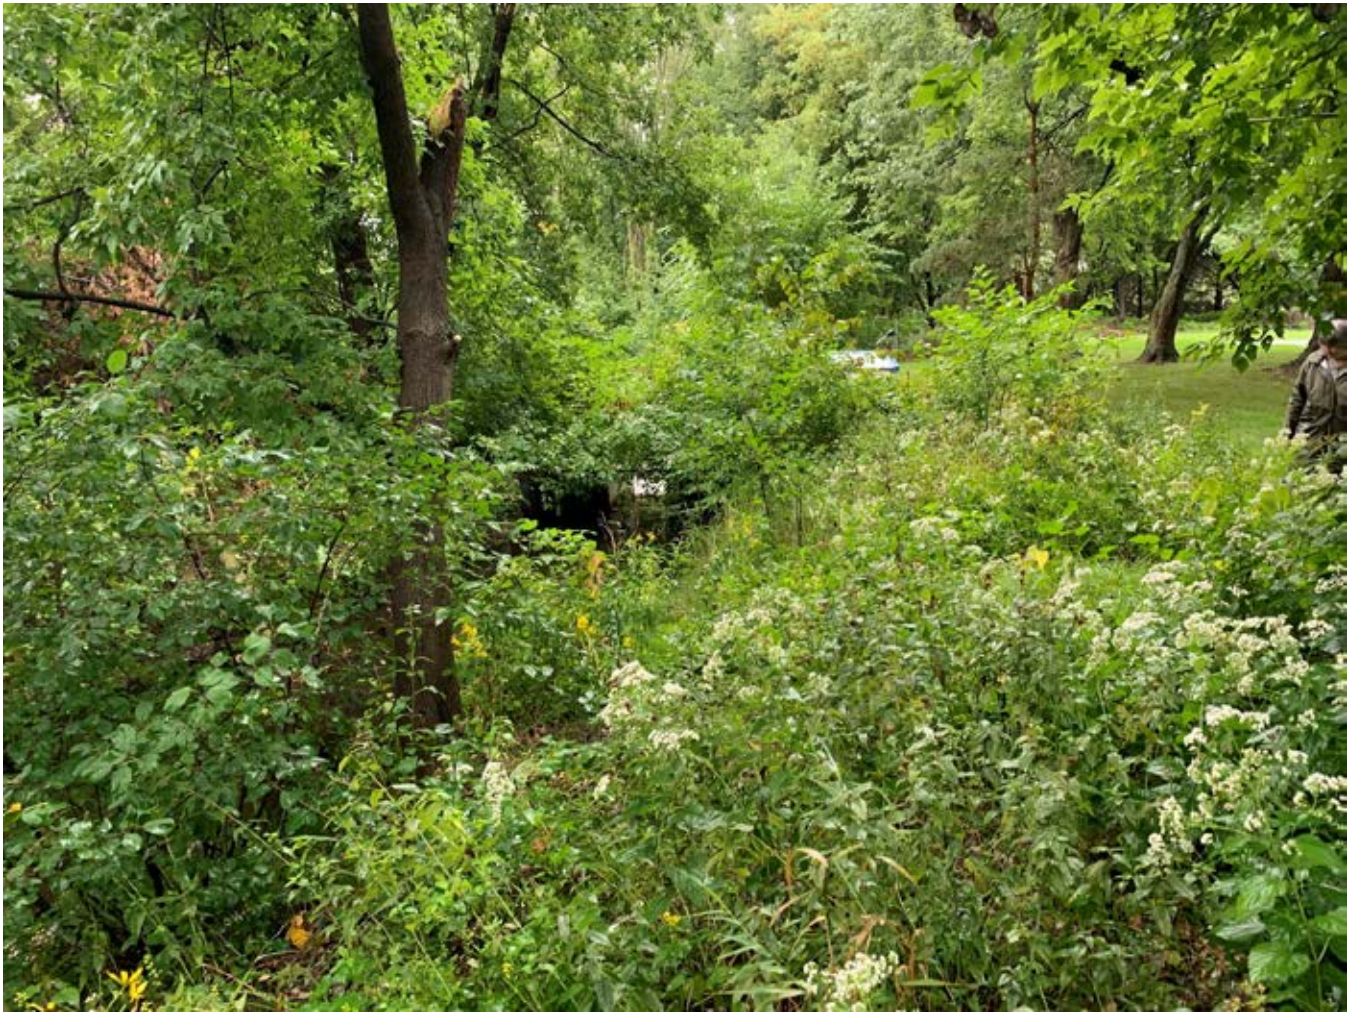
Photo 7-3 Image of project from similar location and perspective as Photo 7-1 & Photo 7-2 taken during project evaluation, Photograph taken by Kevin Biehn during 9/11/2019 site visit.

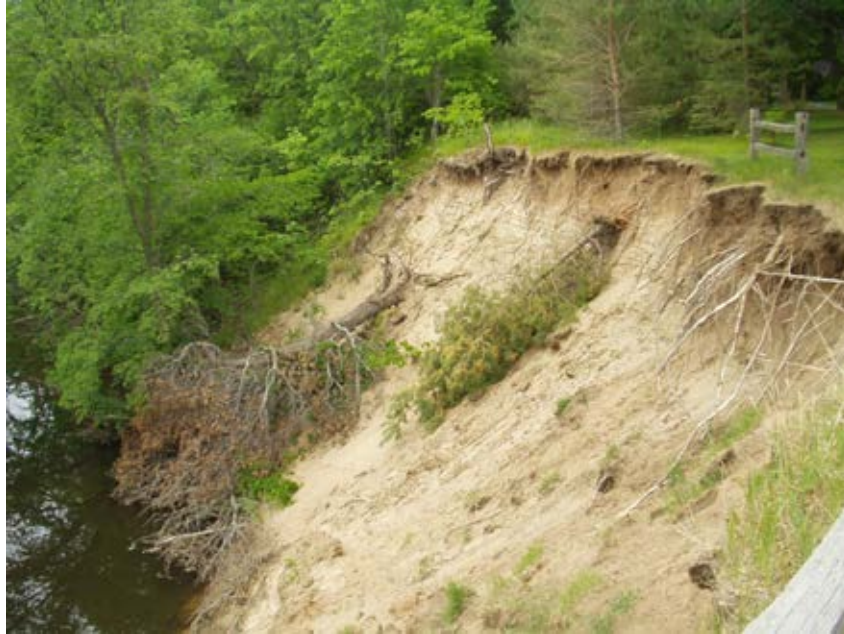
Photo 8-3 Existing steep bank of the West Branch of the Rum River before construction.
