Minnesota Department of Natural Resources
Minnesota Board of Water and Soil Resources

Appendix B: 2020 Legacy Fund Restoration Evaluation

Report March 2020

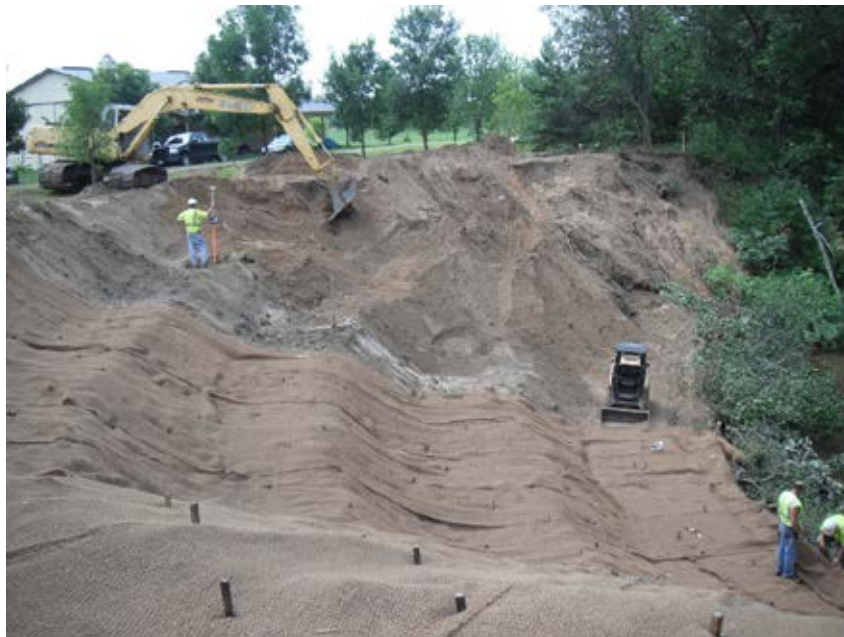
Photo 8-4 Bank resloping and terracing during construction. Seed and erosion control blanket installation is occurring as construction progresses and the anchored trees and brush, and brush fascine are installed at the two of the slope on the river.

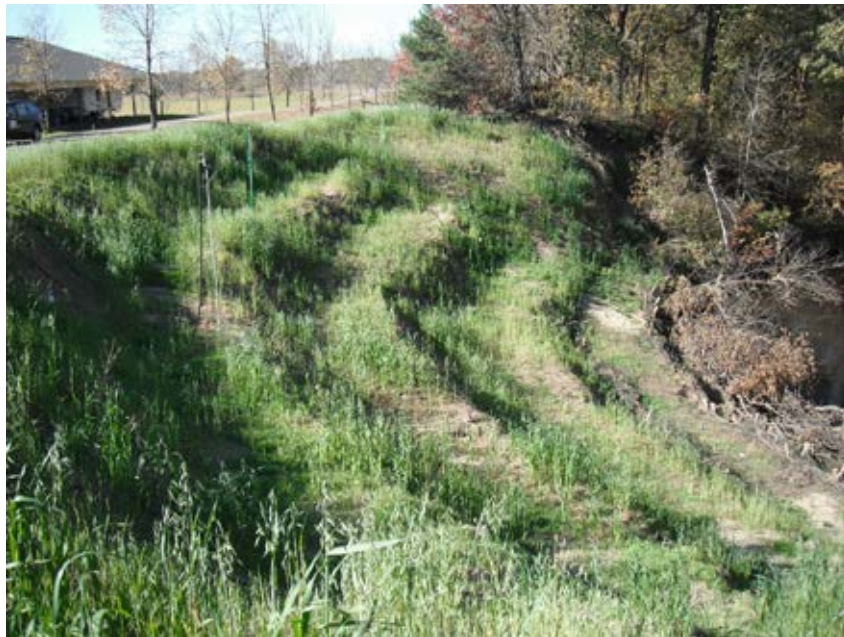
Photo 8-5 Resloped project area during the first growing season. Landowner provided irrigation during the first growing season, 2010.

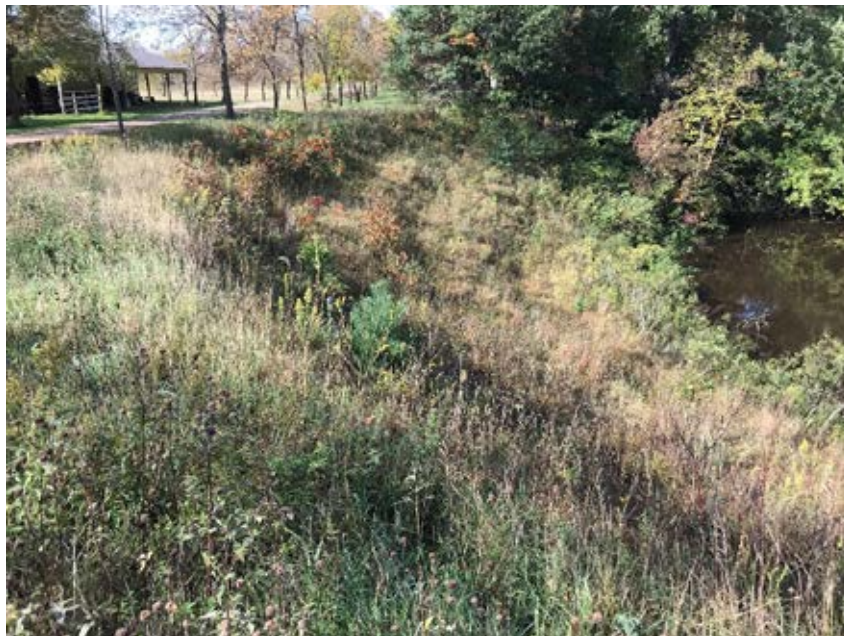
During revegetation, shrub planting was spread throughout but did not establish as hoped. It was observed during the site assessment that almost all of the shrubs on the flat parts of the terraces have failed. Any only shrubs planted, and pioneering shrubs and trees, have survived or established on the slopes of the terraces. During the site assessment it seemed that there were more volunteer than planted shrub species. It was observed during the site visit that some of this slopes were bare soil and eroding where the natural fiber erosion control blanket installed during the project has deteriorated. The reason for the lack of establishment of the shrubs on the terraces is not obvious

Photo 8-6 Resloped project area observed during the site visit. (Rum River West River Branch – Miskowic property, photo taken by Lucius Jonett during site visit 09/19/2019).

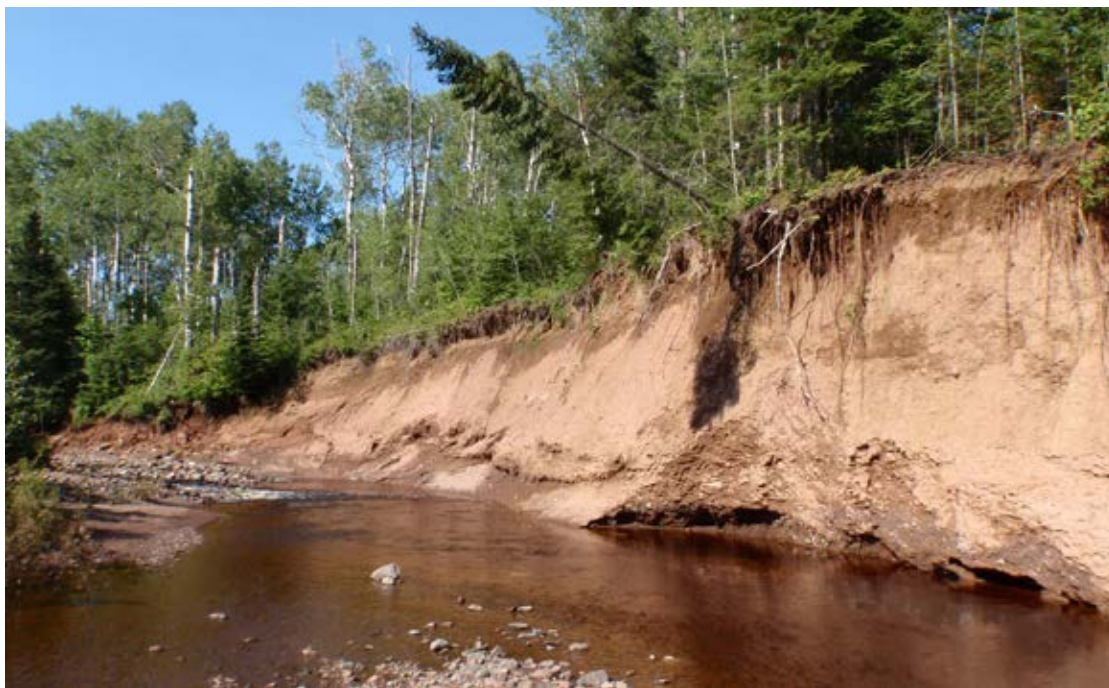
Photo 9-1 Eroding bank in the project reach June 2012 prior to 2015 project construction.

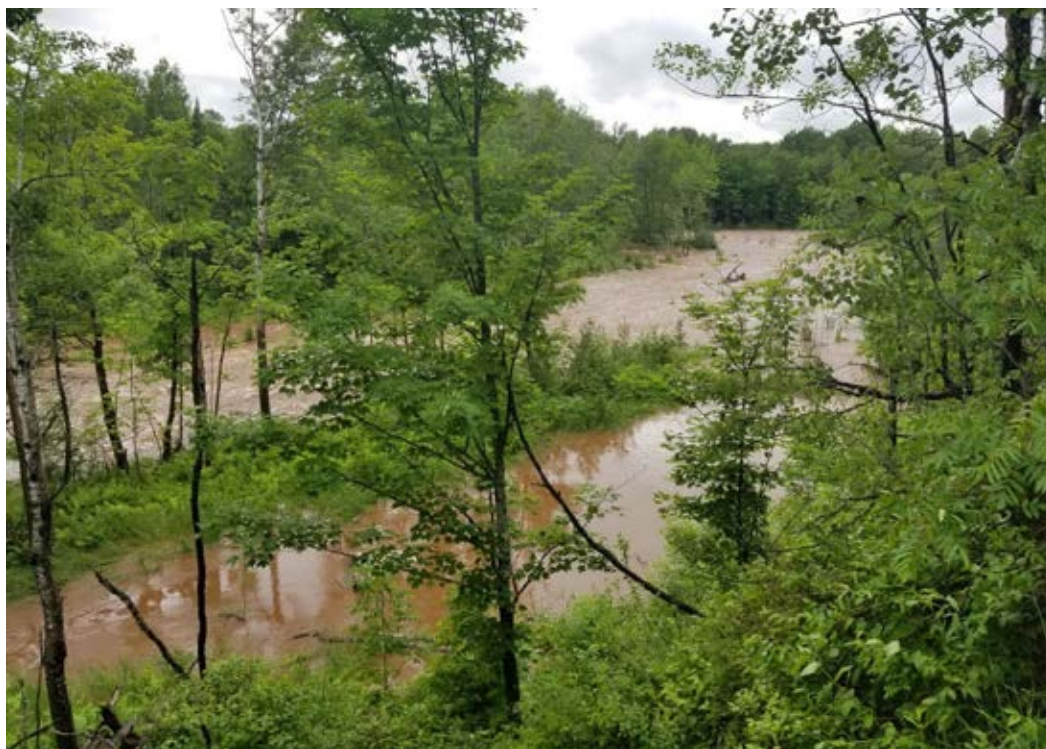
Photo 9-2 Spring 2018 100-year flood event on the Stewart River. Image provided by Ann Thompson.

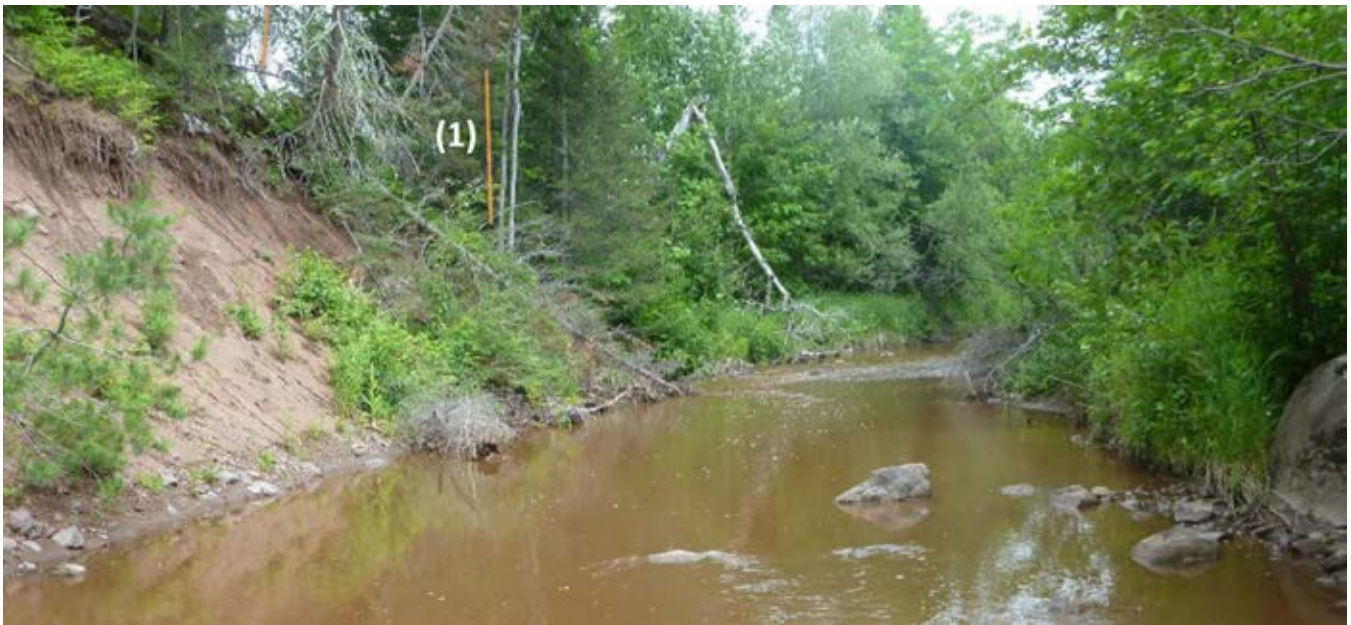
Photo 9-3 Representative 'before' image (prior to 2015 restoration) of Stewart River restoration. Note point of reference for comparison between Photo 9-3 & Photo 9-4 (1). Image provided by Ann Thompson.

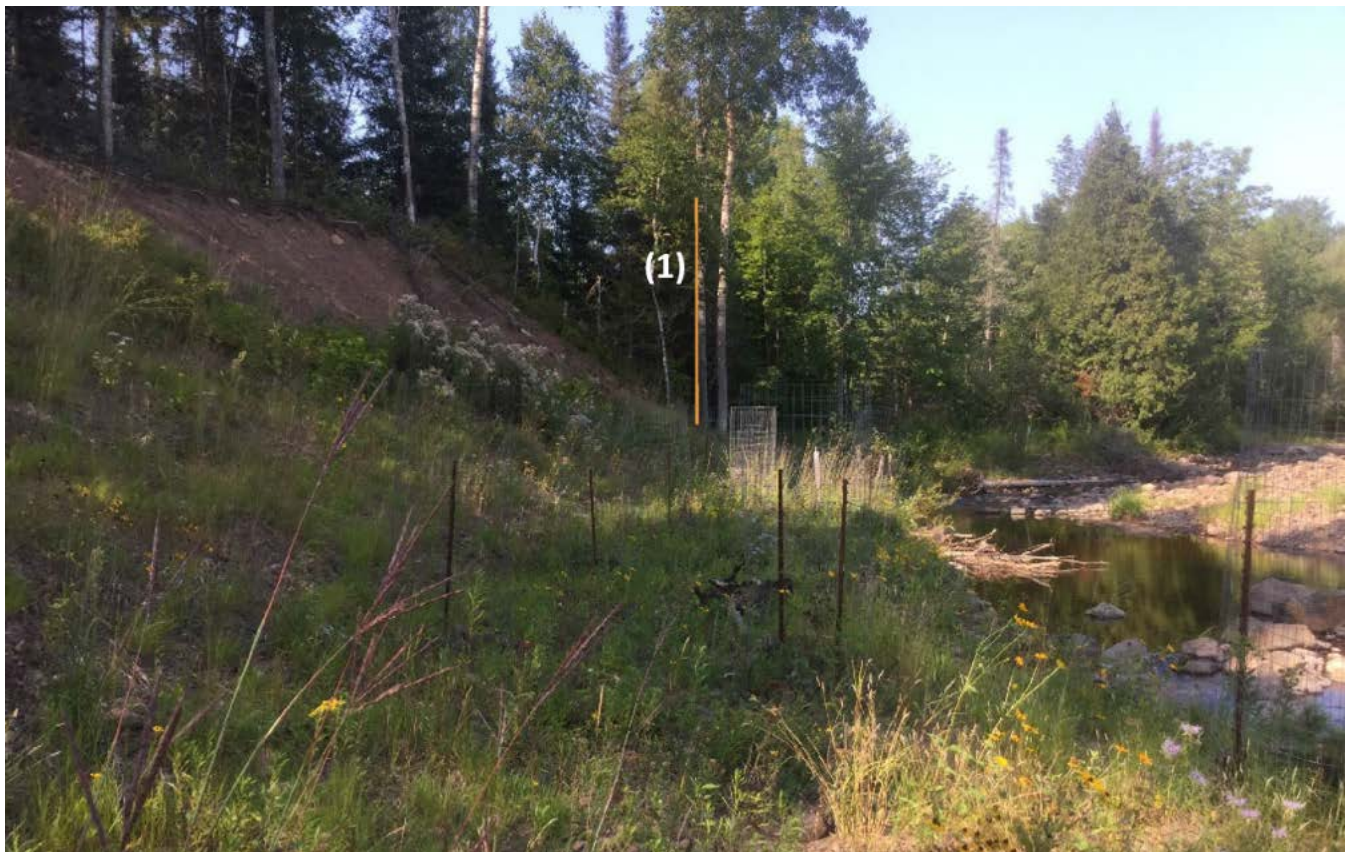
Photo 9-4 2018 'after' image from same perspective as Photo 9-3. Note that the thalweg has been moved away from formerly steep, eroding, clay bank. Note point of reference for comparison between Photo 9-2 & Photo 9-3 (1). Image provided by Ann Thompson.

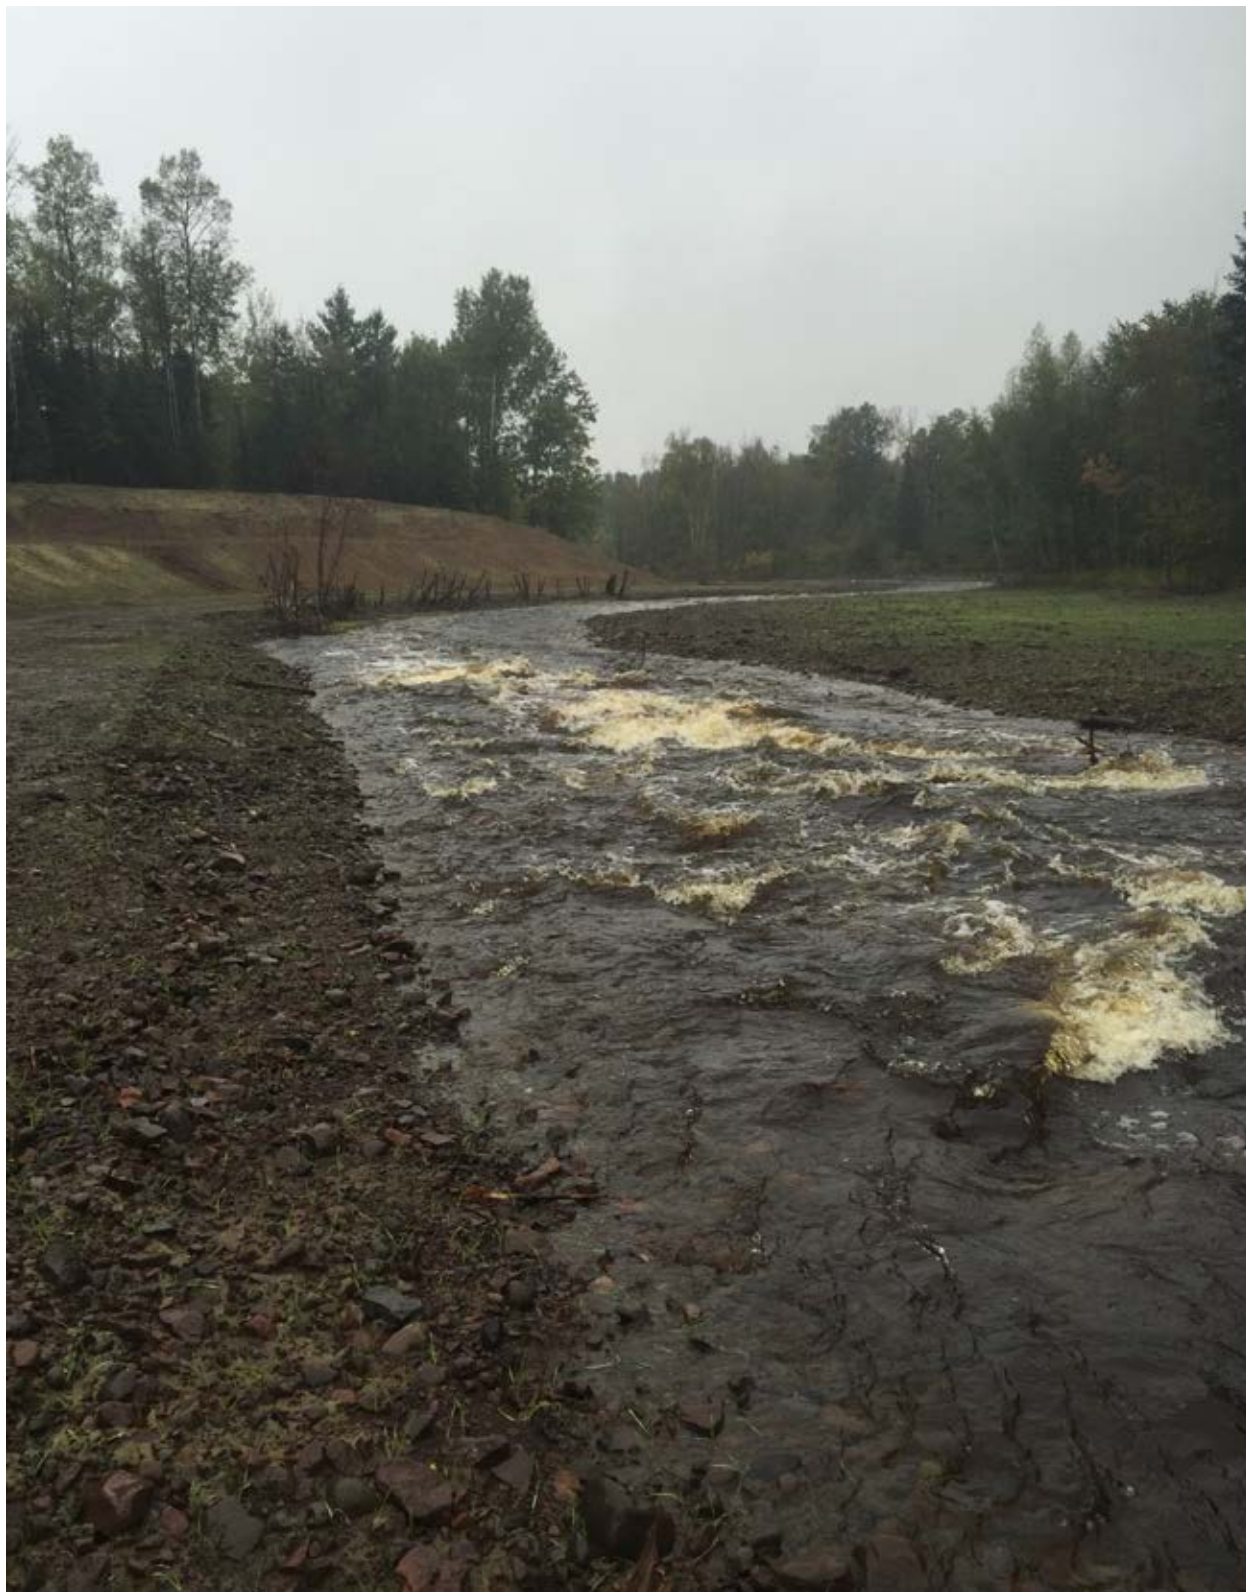
Photo 9-7 Representative image of restoration. Stream was near bankfull discharge during site evaluation 09/24/2015.

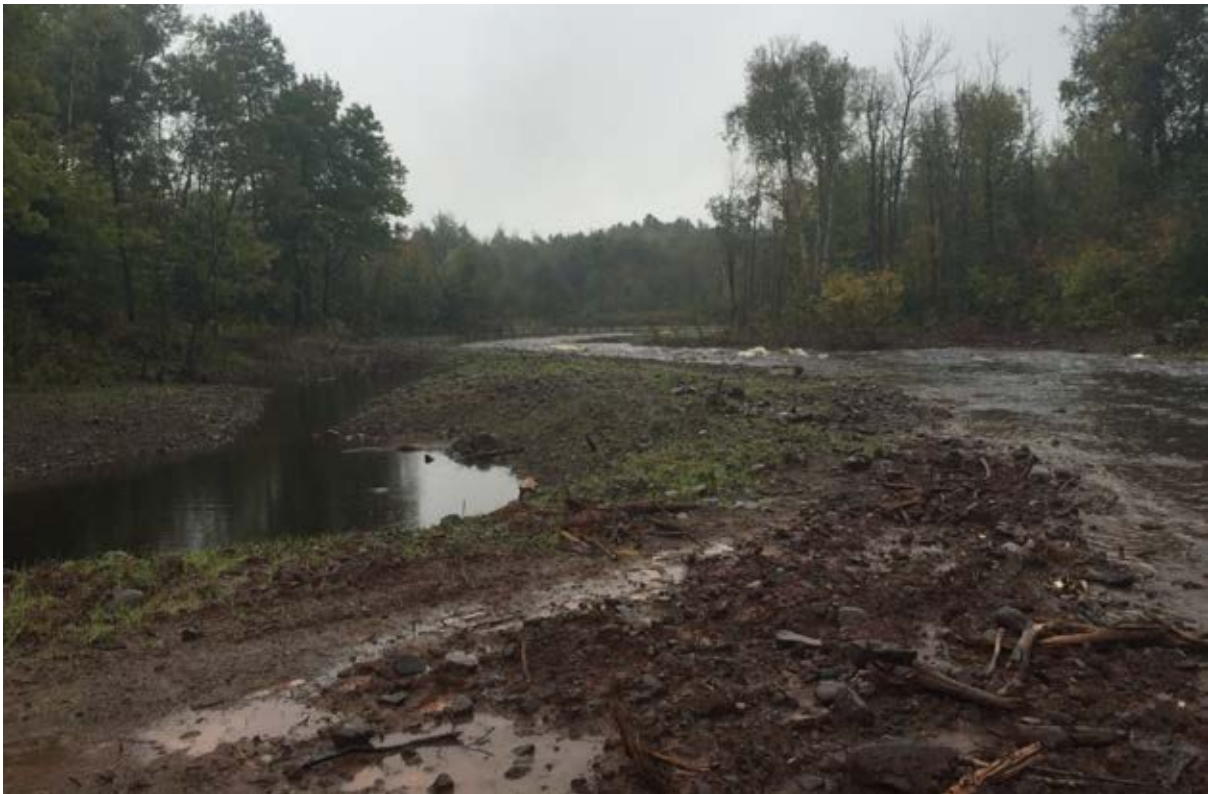
Photo 9-8 Representative image of one of the created ponds (left) 09/24/2015.

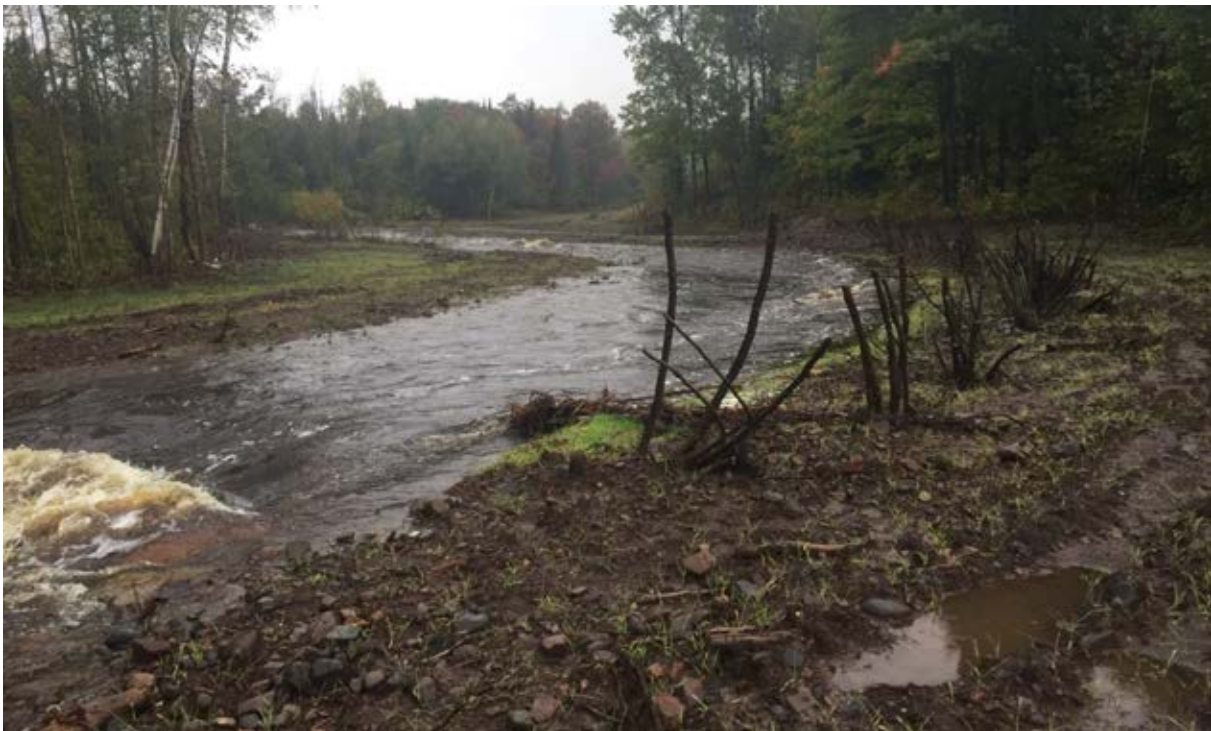
Photo 9-9 Representative image of project elements: Toe Wood (right) with willow harvested mats above and Log J Hook with Rootwad downstream (left) 09/24/2015.

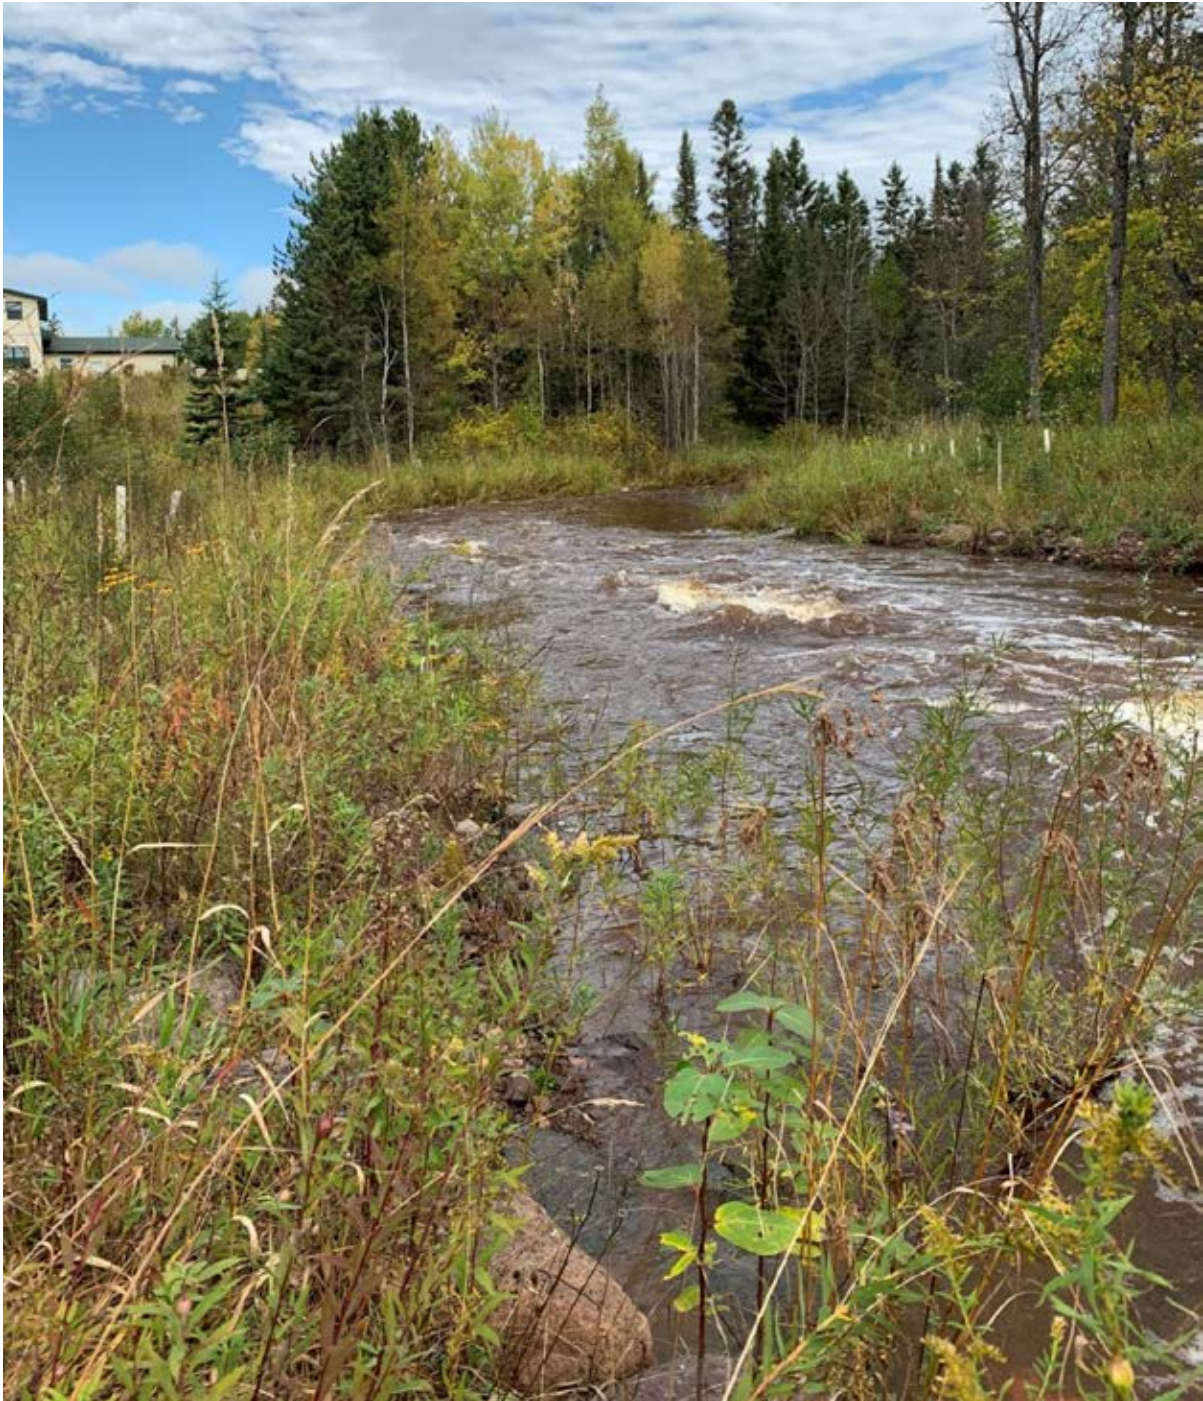
Photo 10-1 – Current representative image of 2015 stabilization efforts on the Steward River – Liukkonen Site. Photograph taken looking downstream at a period of high (near bankfull) river stage. Photograph taken by Kevin Biehn during 10/1/2019 site visit.

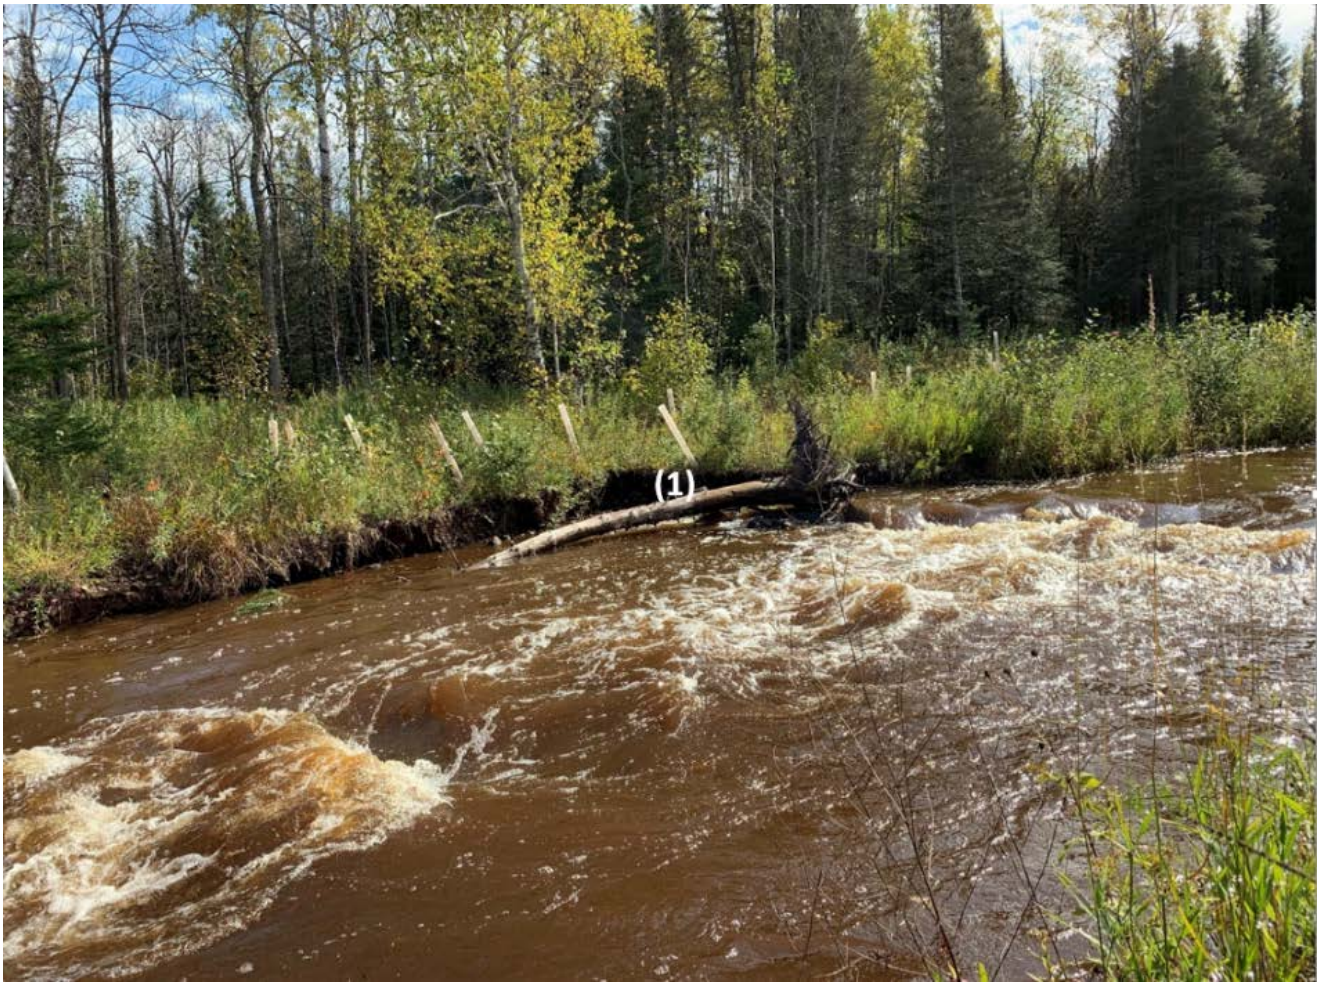
- 7. Are corrections or modifications needed to meet proposed outcomes?**
Bank erosion is occurring in conjunction with a constructed grade control structure (boulder riffle). The landowner stated on the visit that the bank had not been eroding until a large tree was caught on the structure this spring, which was re-directing some of the flow into the bank at this point (see **Photo 10-2**). This structure and log should be closely watched and corrected if erosion worsens and/or the structure is threatened.

Photo 10-2 – Image of grade control structure (rock riffle) at a period of high (near bankfull) river stage. Note the erosion on the opposite bank, which is likely a product of water deflection from a log (1), which was caught on the structure this past spring. Photograph taken by Kevin Biehn during 10/1/2019 site visit.

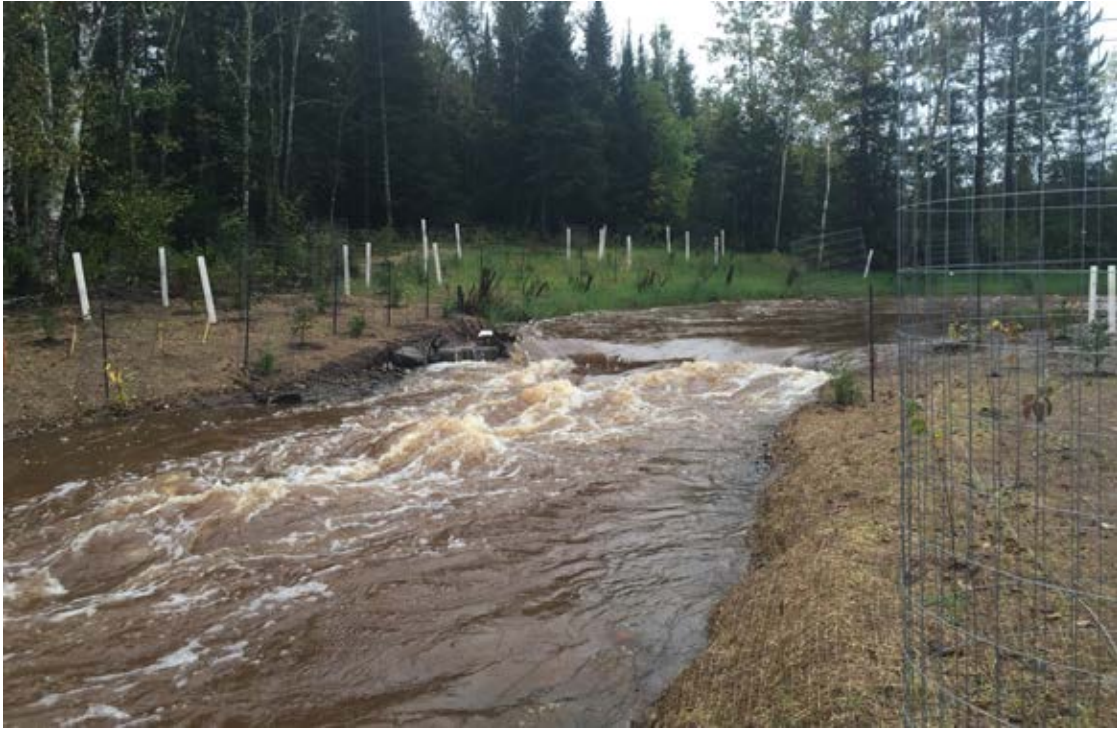
Photo 10-3 Representative image of stabilization. Note the grade control structure (center images) was a project add-on (understood to have been requested and/or funded separately by Minnesota Trout Unlimited). Date 10/24/2015.

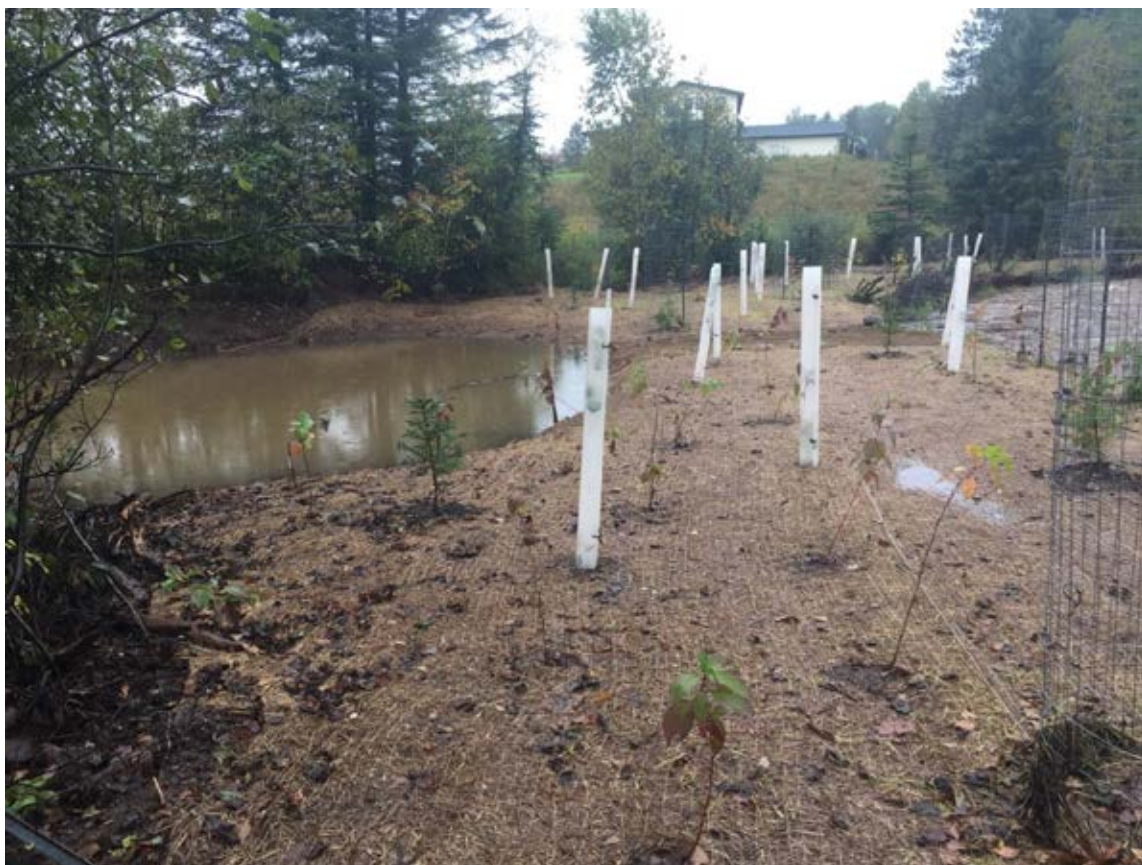
Photo 10-5 A constructed offline "wildlife pond" (left side of image), a minor project change, was a product of balancing cut & fill. Date 10/24/2015.

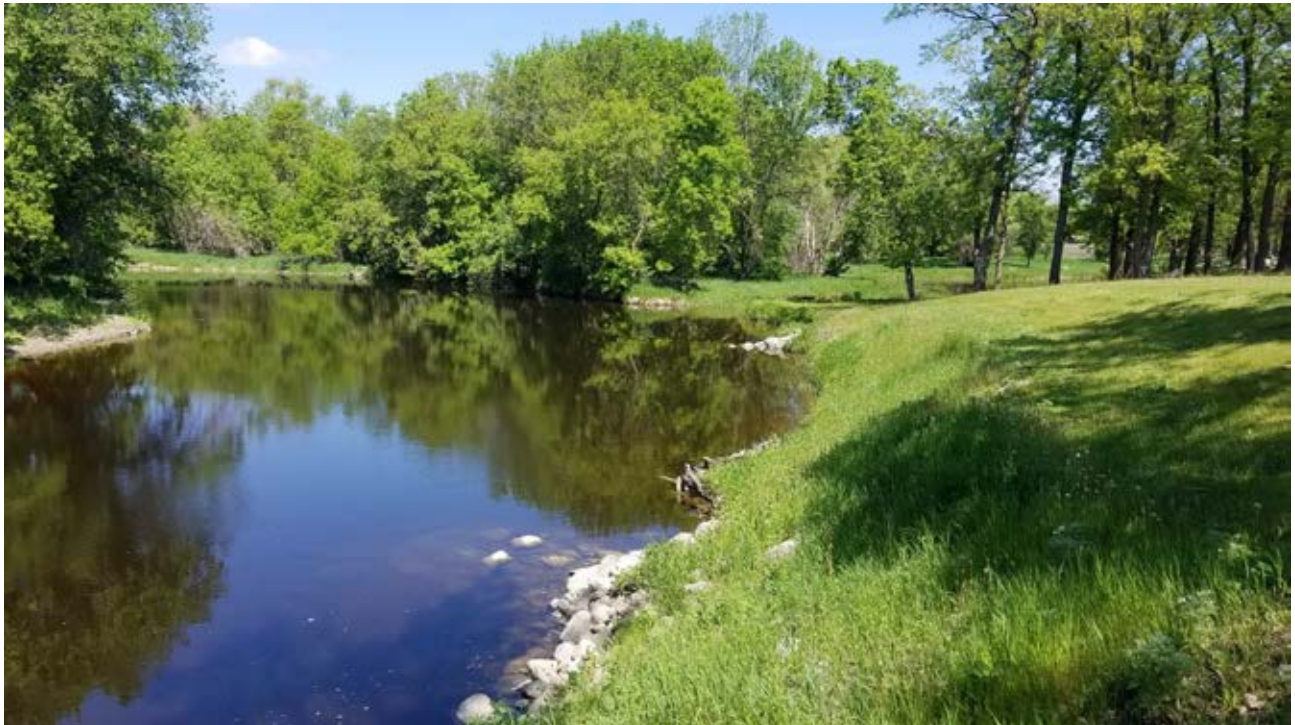
Photo 11-2 Upstream view of stream barbs 1, 2, and 3. Photo taken by Ed Matthiesen during site visit (6/5/2019).

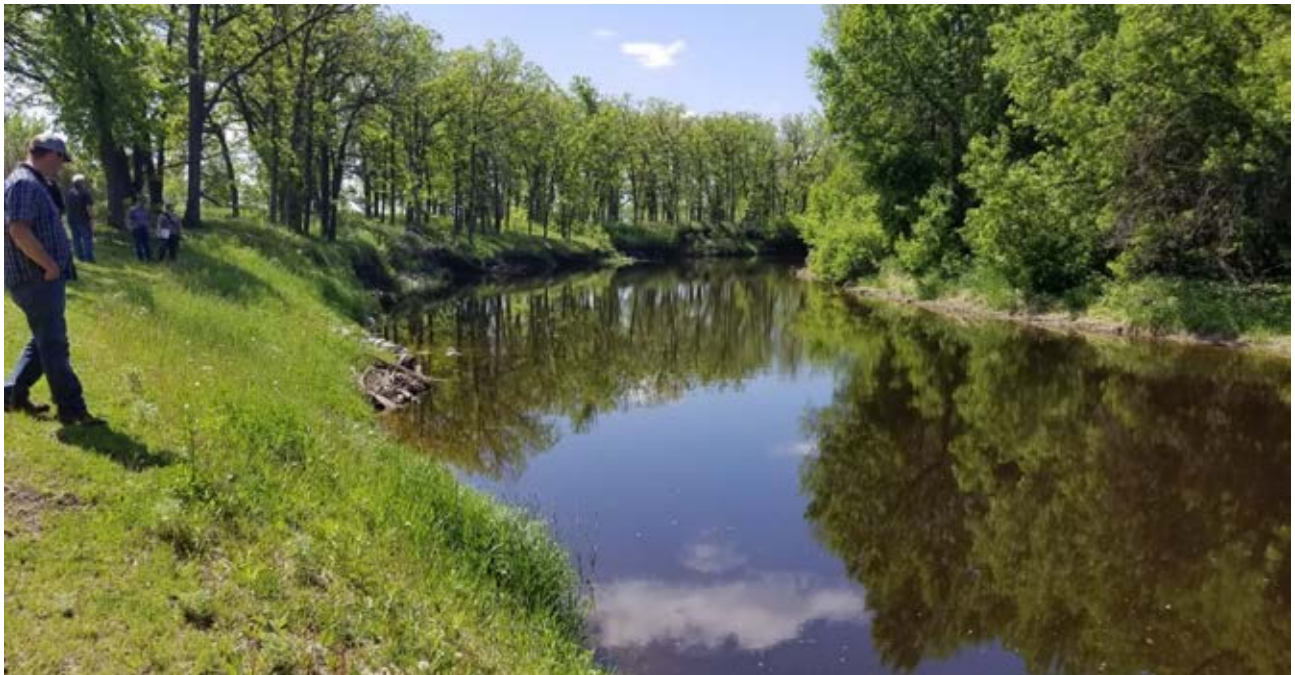
The long-term maintenance for the project will be provided by the landowners as agreed upon in the operation and maintenance plan for the Erikson Group—developed with the Pennington SWCD. Along a small portion of the project mowing to the bank and scraping down to bare soil was observed. This activity is not currently causing problems, but should be monitored.

Photo 11-4 Upstream view of stream barbs 4 and 5. Mowing to the top of the bank and bare soil can be seen on the left side of the photo. Photo taken by Ed Matthiesen during site visit (6/5/2019).

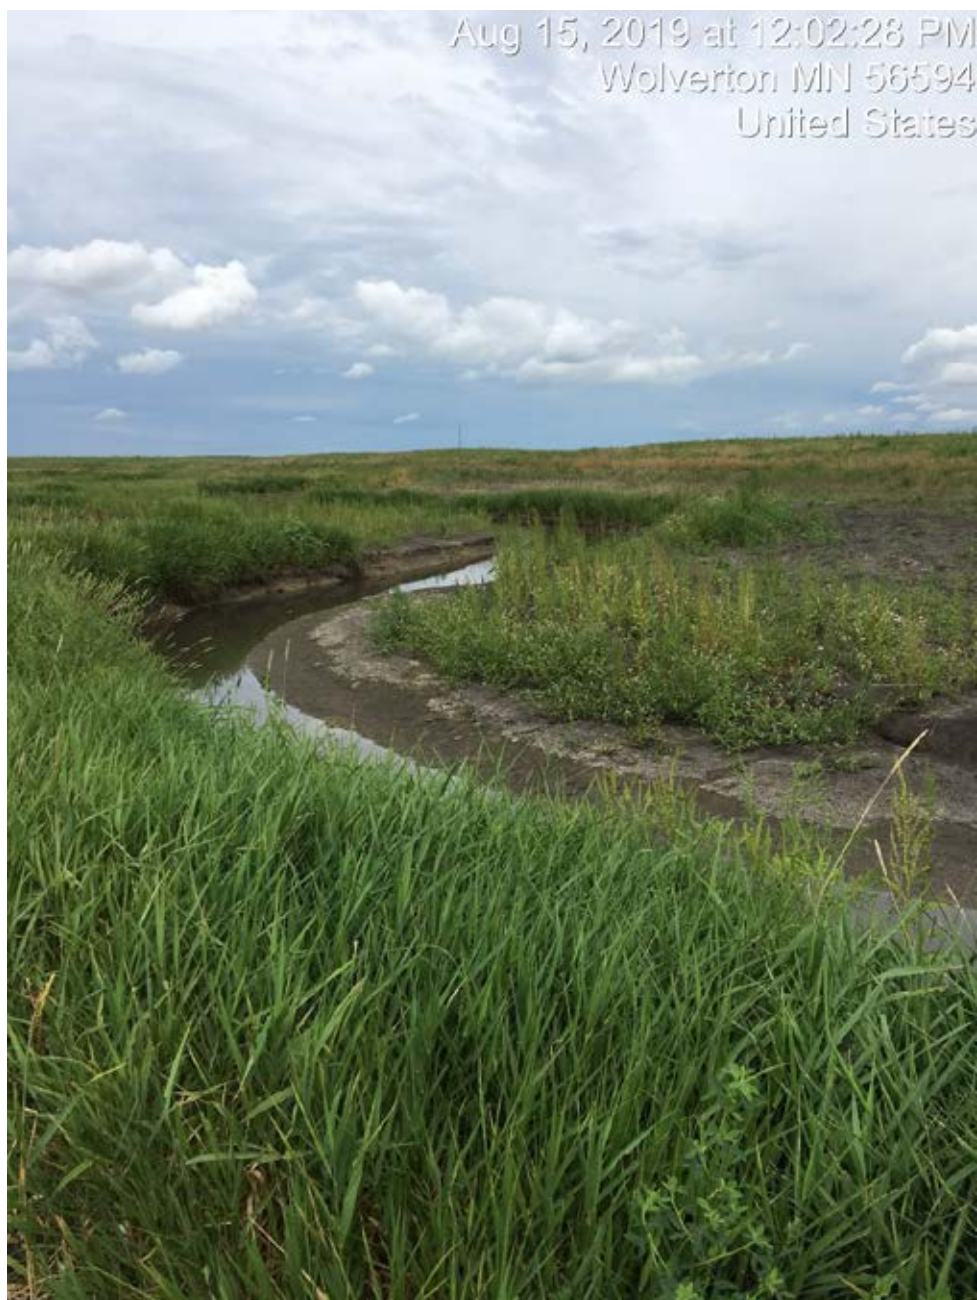
Photo 13-5. Stream channel starting to adjust from a Rosgen E type channel to C type channel. Photo taken by Anna Varian during site visit (8/15/2019).

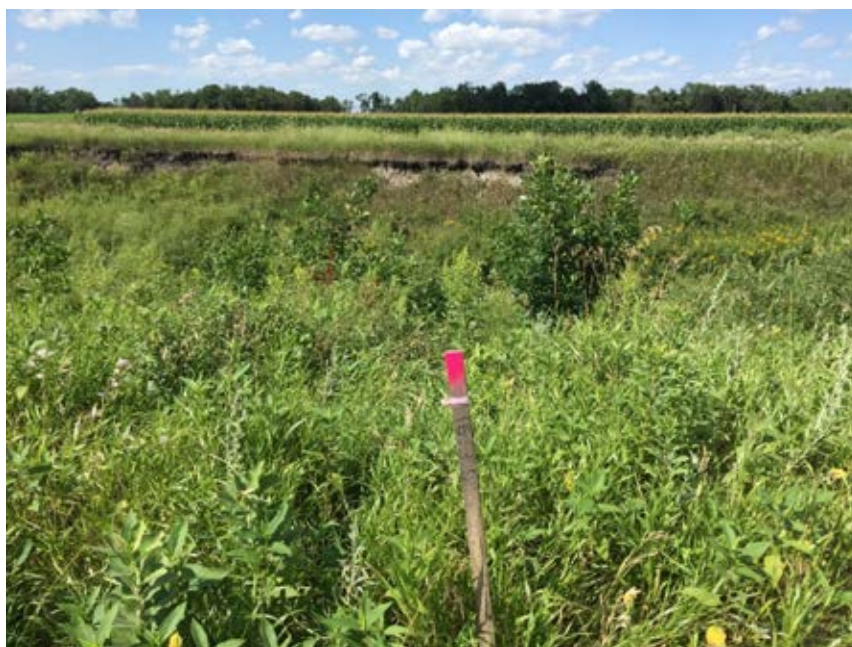
Photo 15-1 View of existing bank slump failure at project Station 91+85. Photo taken by others during pre-construction visit (8/2/2016).

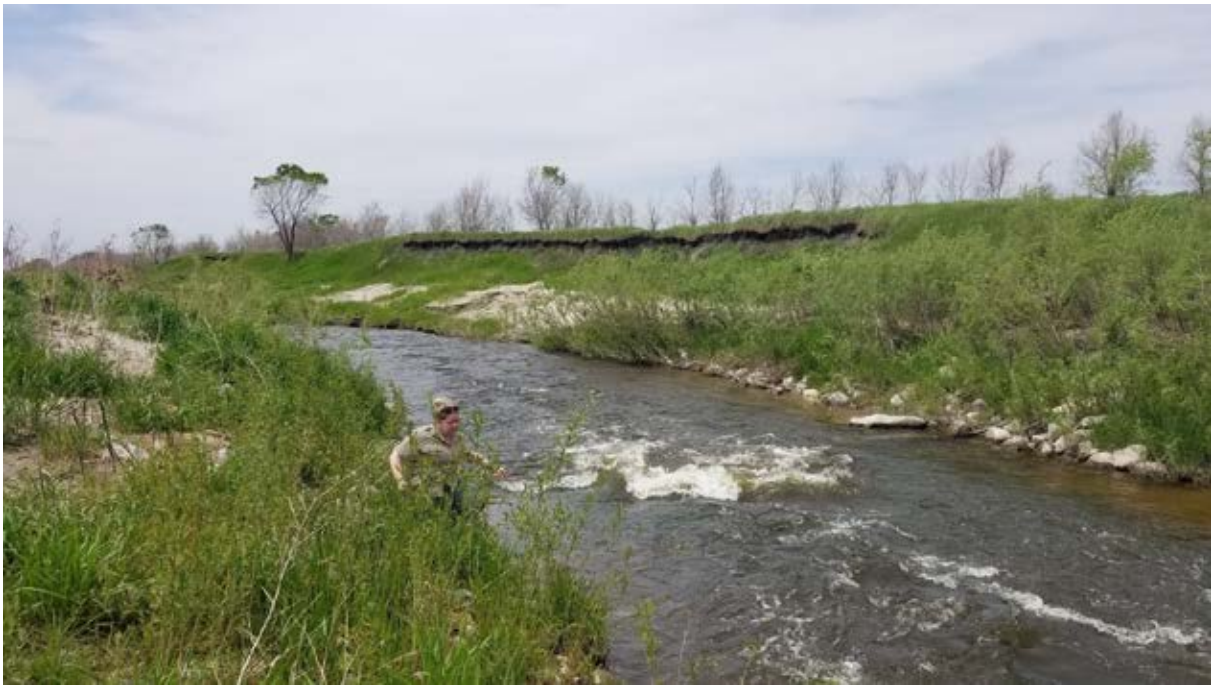
Photo 15-5 Upstream view of riffle #13. Photo taken by Ed Matthiesen during site visit (6/4/2019).

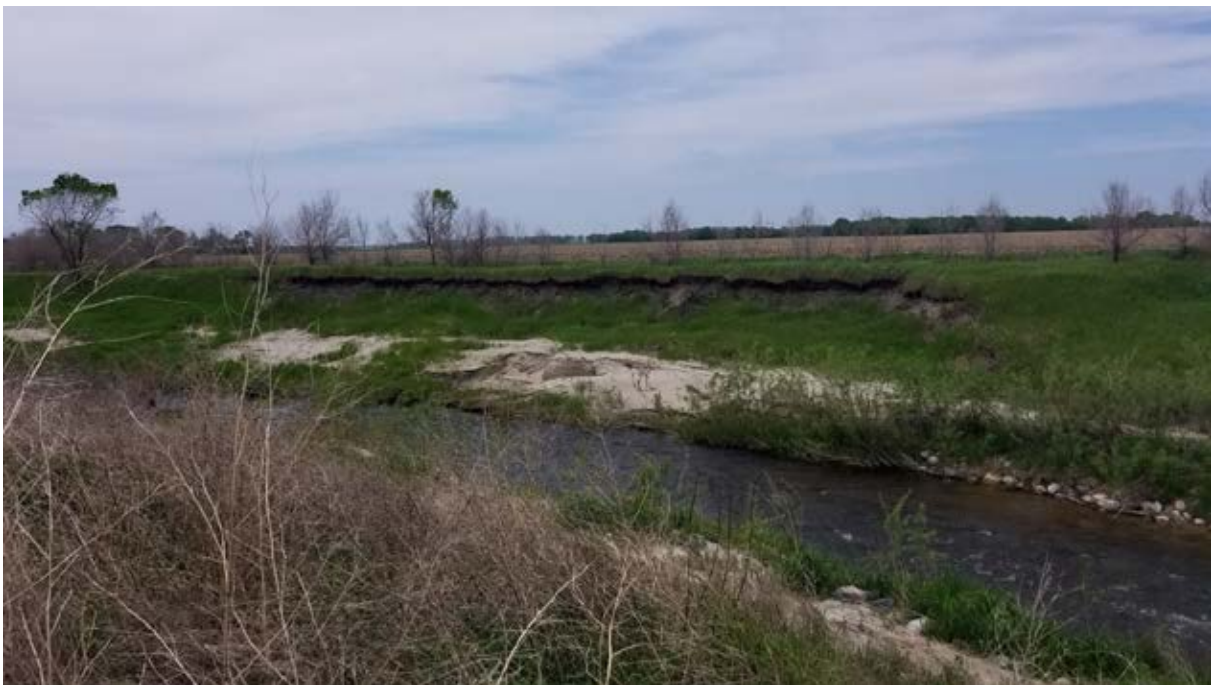
Photo 15-6 Downstream view of riffle #13. Note the erosion on the bare slopes of the far bank. Photo taken by Ed Matthiesen during site visit (6/4/2019).

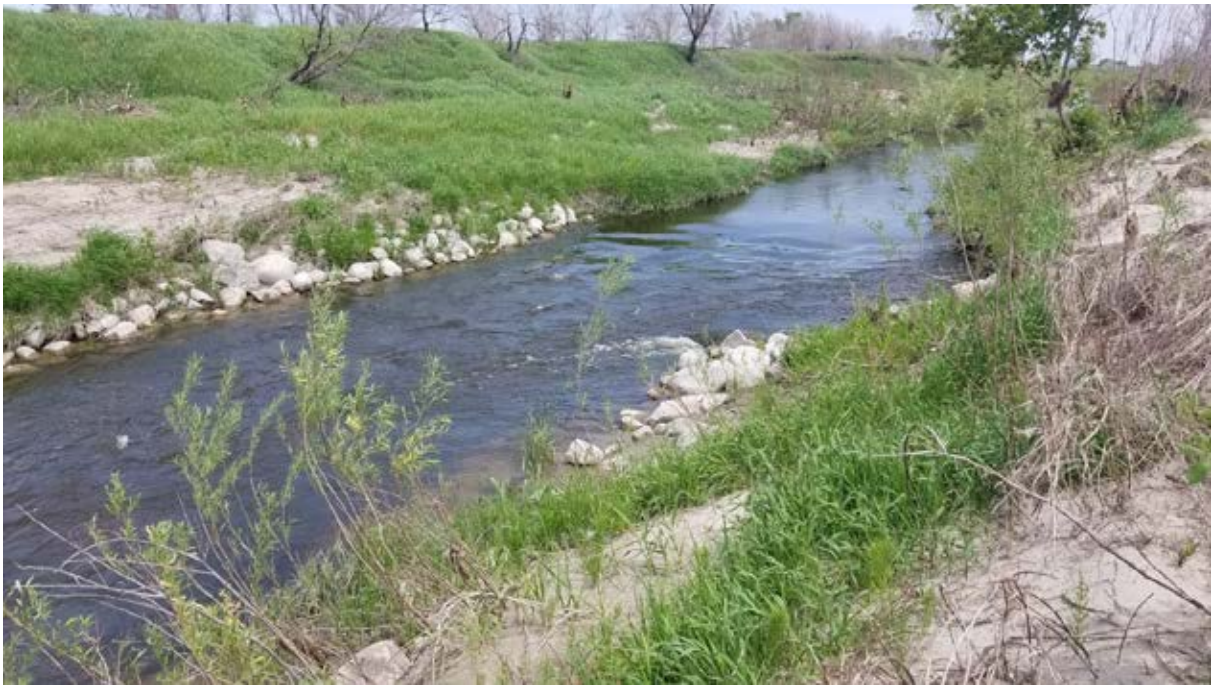
Photo 15-7 Downstream view of riffle #11. The banks are well-vegetated and held in place by willow and dogwood. Photo taken by Ed Matthiesen during site visit (6/4/2019).

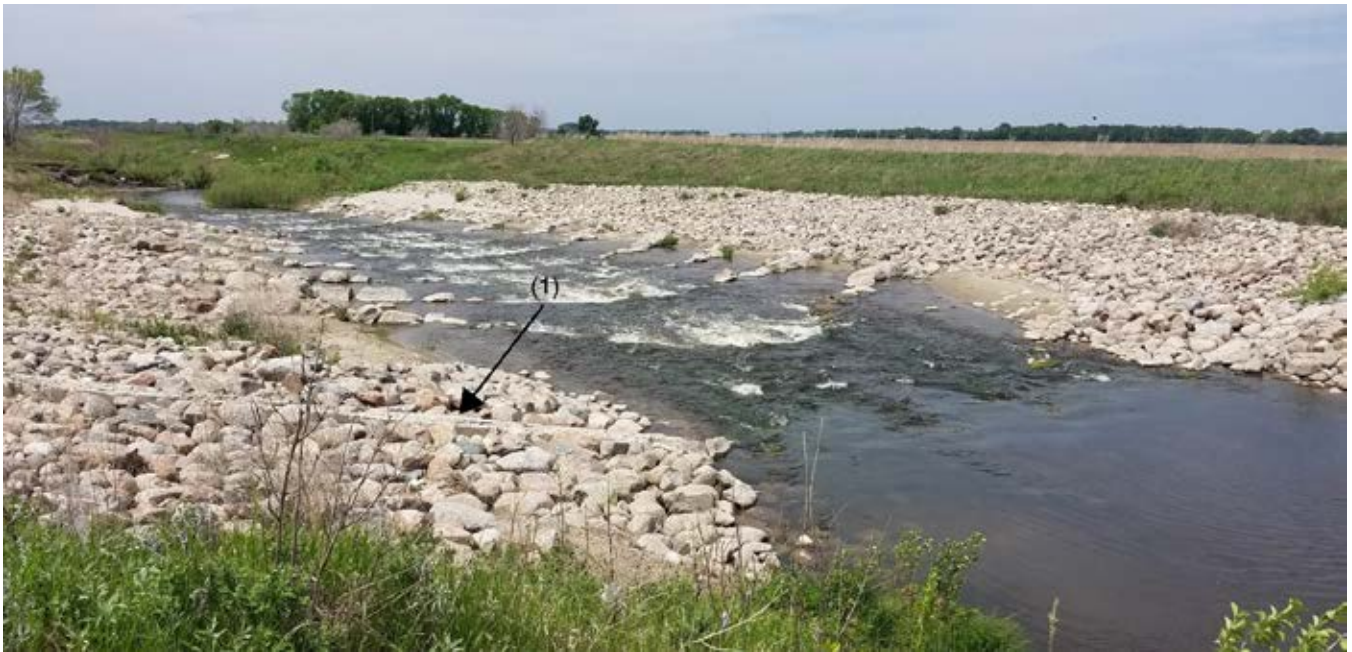
Photo 16-5 Sand Hill River fishway ramp #1 after the original drop structure was modified for fish passage. Note the cut-off weir/sheet pile in the foreground (1). Photo taken by Ed Matthiesen during site visit (6/4/2019).

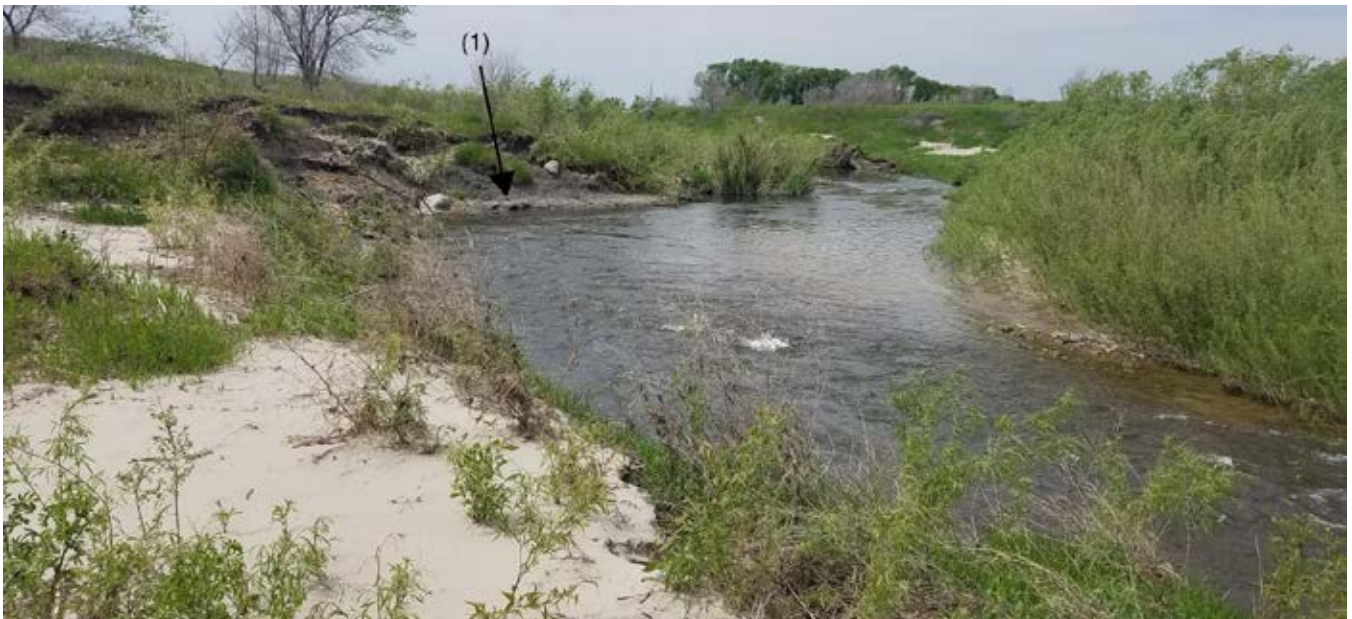
Photo 16-6 View downstream of Sand Hill River fishway ramp #1. Note the area of un-vegetated sluffing bank outside of the project area where additions of sandbar willow at the bend could increase stability (1). Photo taken by Ed Matthiesen during site visit (6/4/2019).
