Minnesota Department of Natural Resources
Minnesota Board of Water and Soil Resources

Appendix B: 2020 Legacy Fund Restoration Evaluation

Report March 2020

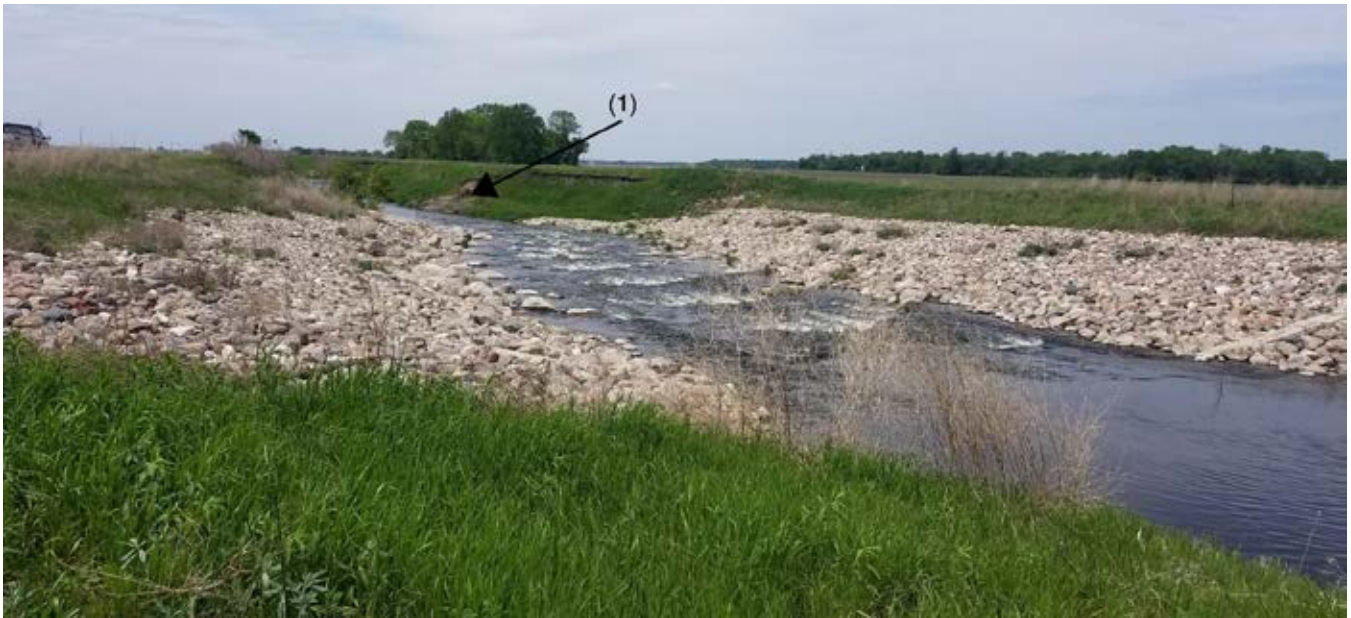
Photo 16-7 Sand Hill River fishway ramp #2 after the original drop structure was modified for fish passage. Note the bank outside of the project where the addition of shrubs beyond the slip may increase stability (1). Photo taken by Ed Matthiesen during site visit (6/4/2019).

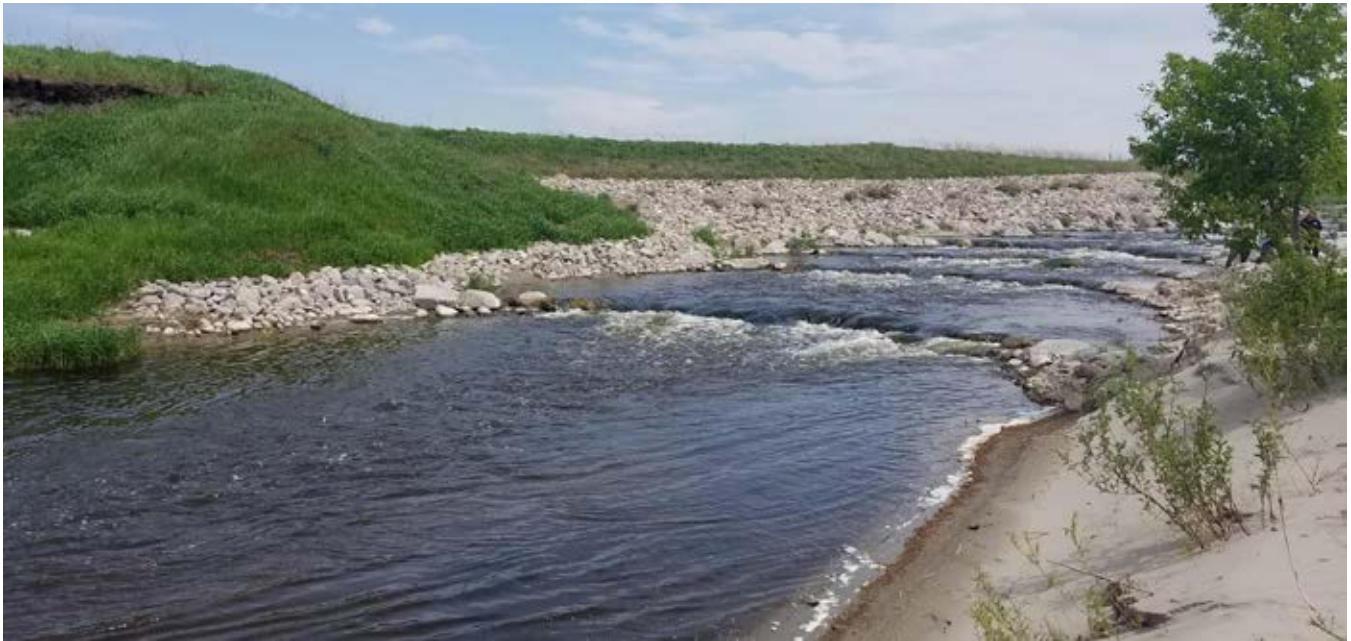
Photo 16-8 Sand Hill River fishway ramp #2 after the original drop structure was modified for fish passage. Volunteer sandbar willow is establishing on the right bank. Photo taken by Ed Matthiesen during site visit (6/4/2019).

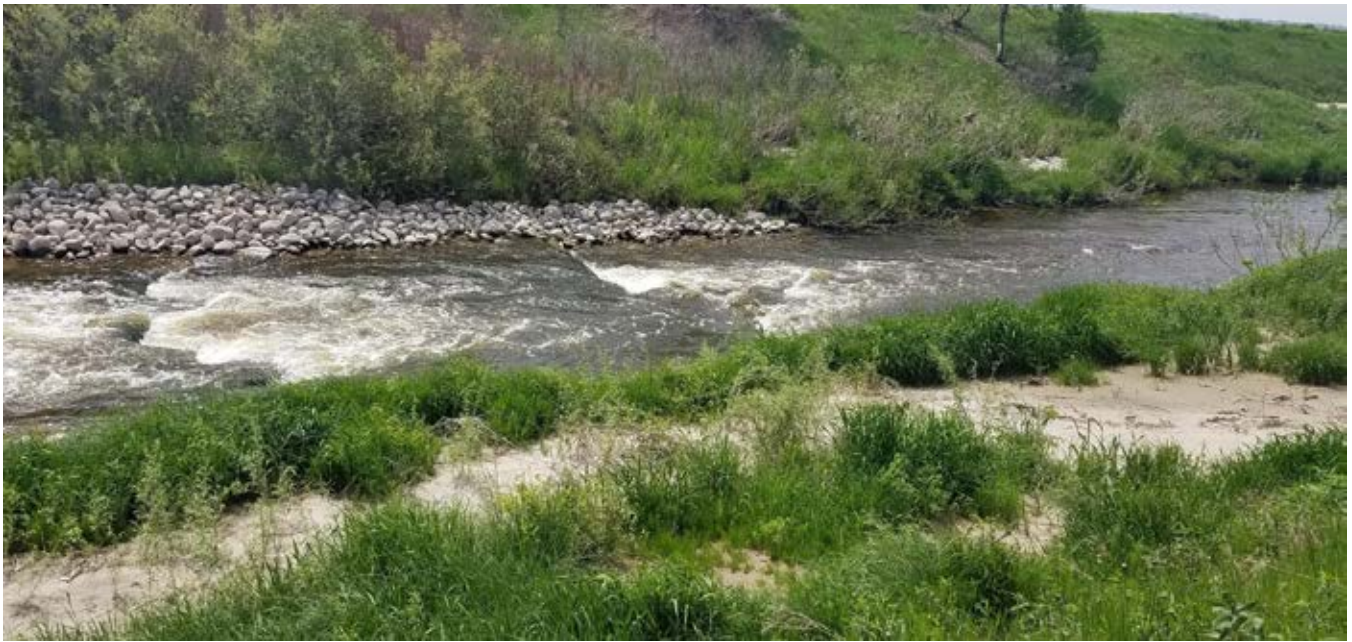
Photo 16-9 Sand Hill River fishway ramp #3 after the original drop structure was modified for fish passage. Shrubs at downstream end are holding the soil in place. Photo taken by Ed Matthiesen during site visit (6/4/2019).

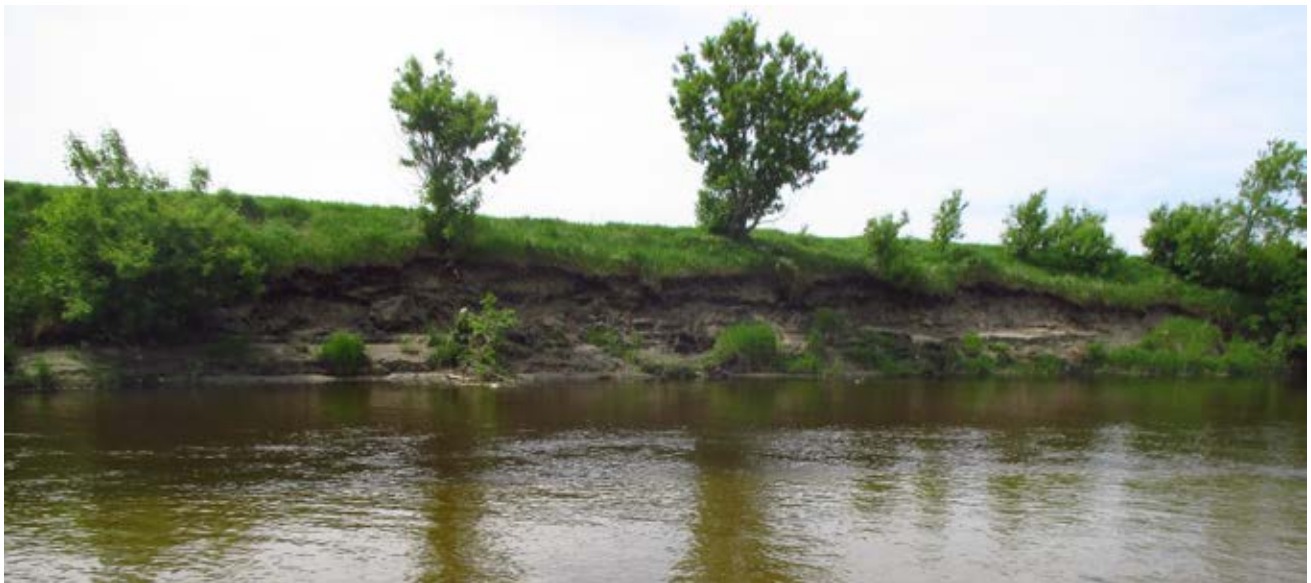
Photo 16-14 Eroding back across from the perched culvert upstream of structure #4 where stabilization and habitat work will be completed with remaining funds. Photo taken during site visit (6/4/2019).

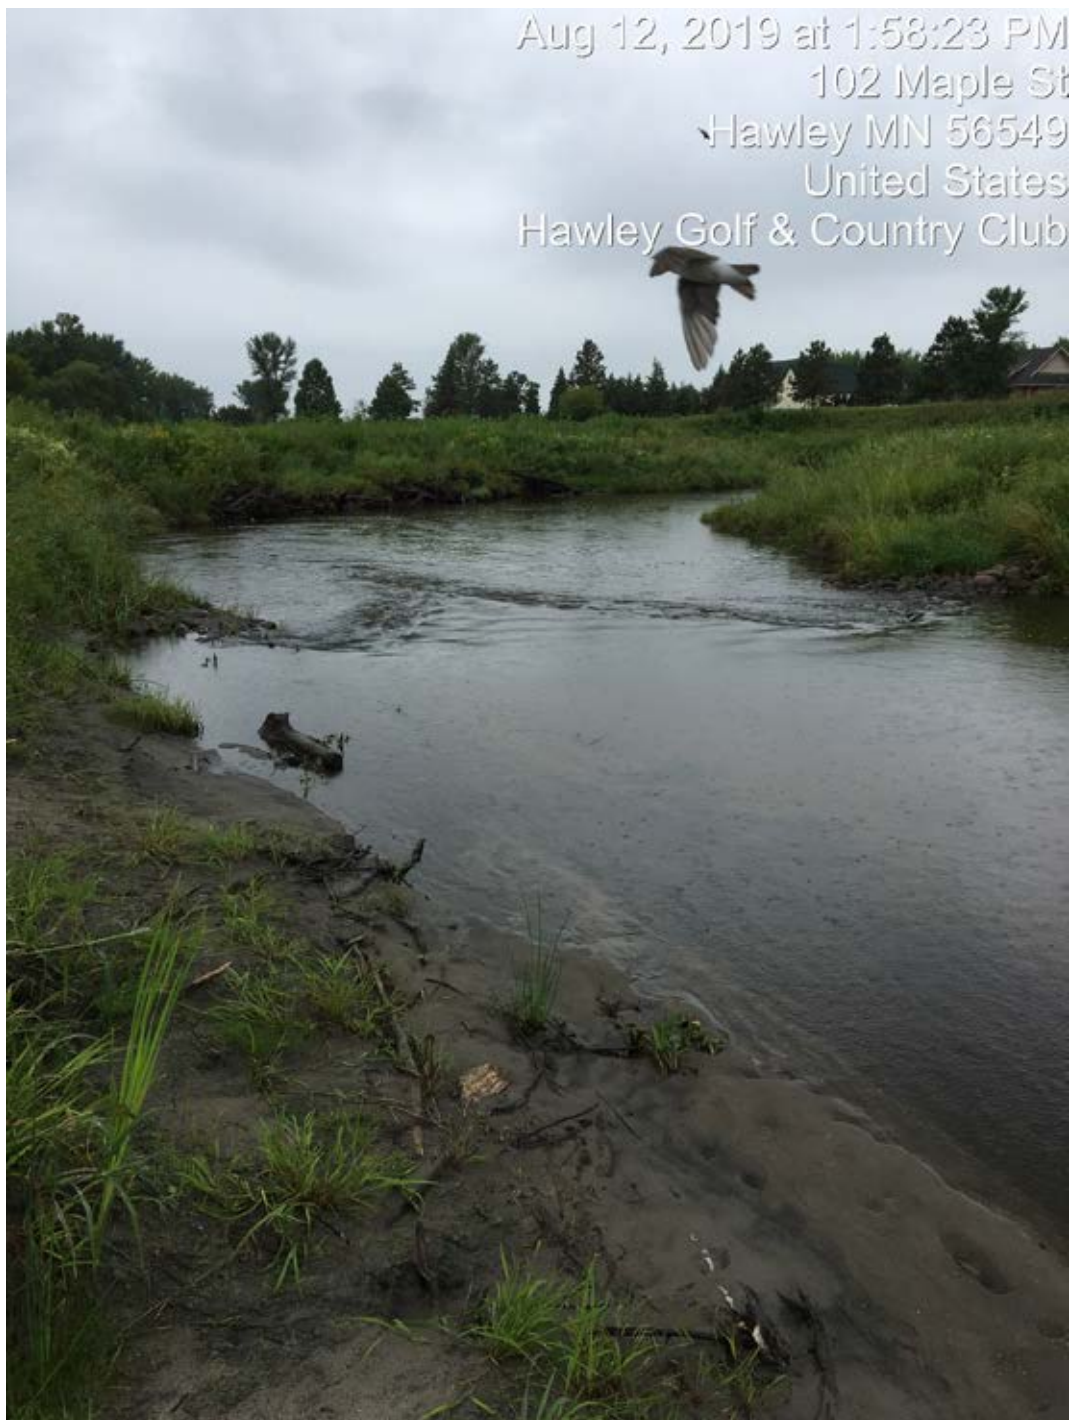
Photo 17-3. Buffalo River looking downstream at riffle, standing on point bar collecting sediment. Photo taken by Anna Varian during site visit (8/12/2019).

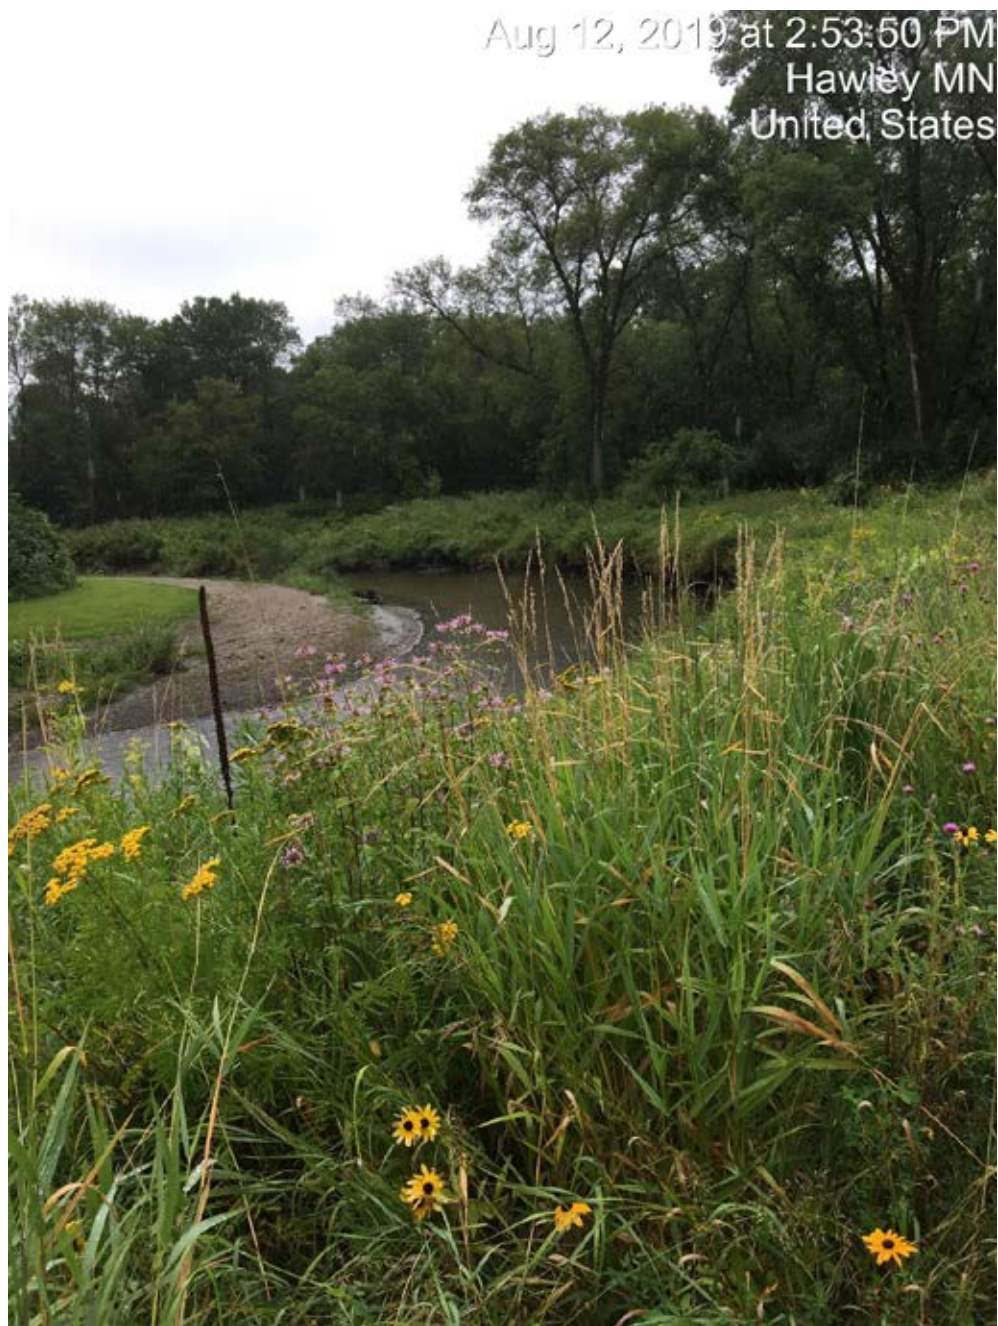
Photo 18-3. Restored meander with sediment depositing and mowing activity on the inside bend and fully vegetated outside bend. Photo taken by Anna Varian during site visit (8/12/2019).

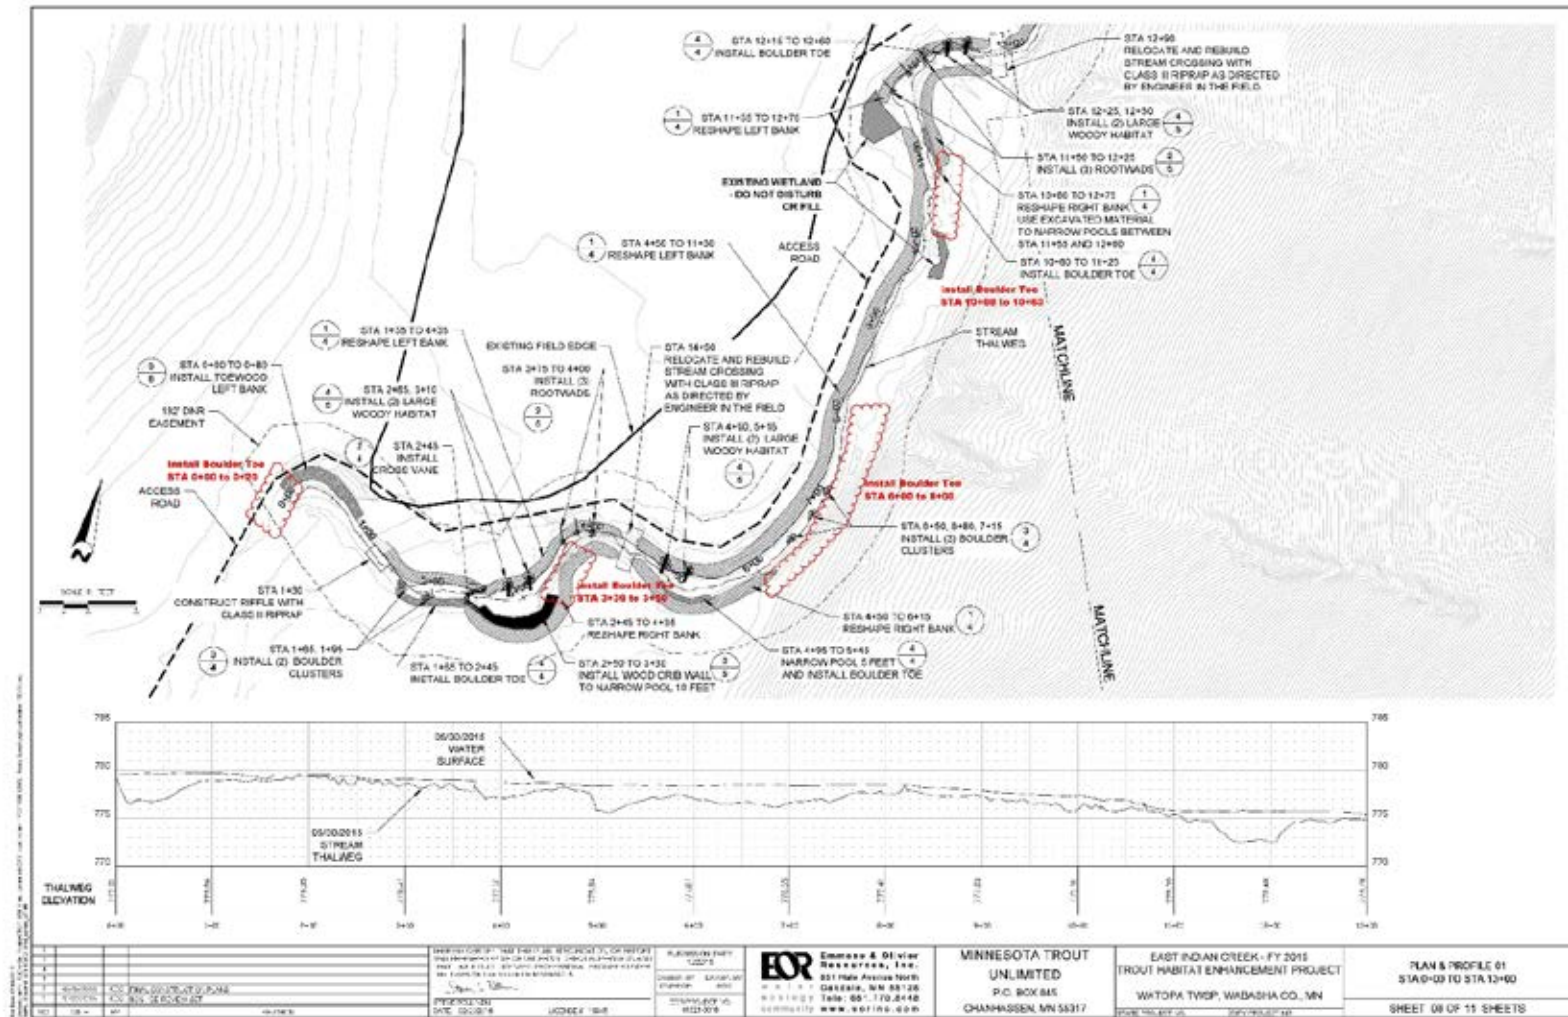
Figure 19-1 Construction plans with profile and locations of additional rock added in 2019.

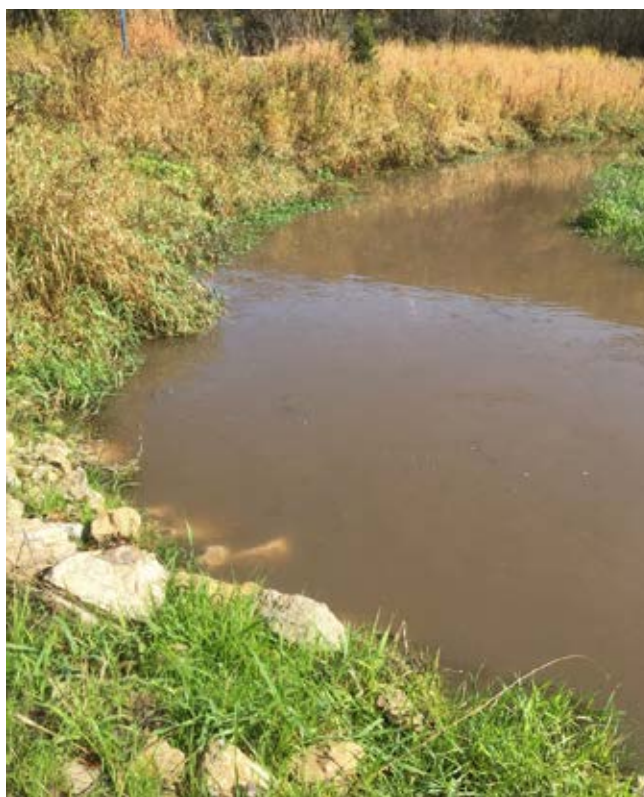
Photo 19-2 Bend in the river where toe-wood was installed, and rock added in 2019. Photo taken 10/21/2019 by Anna Varian.

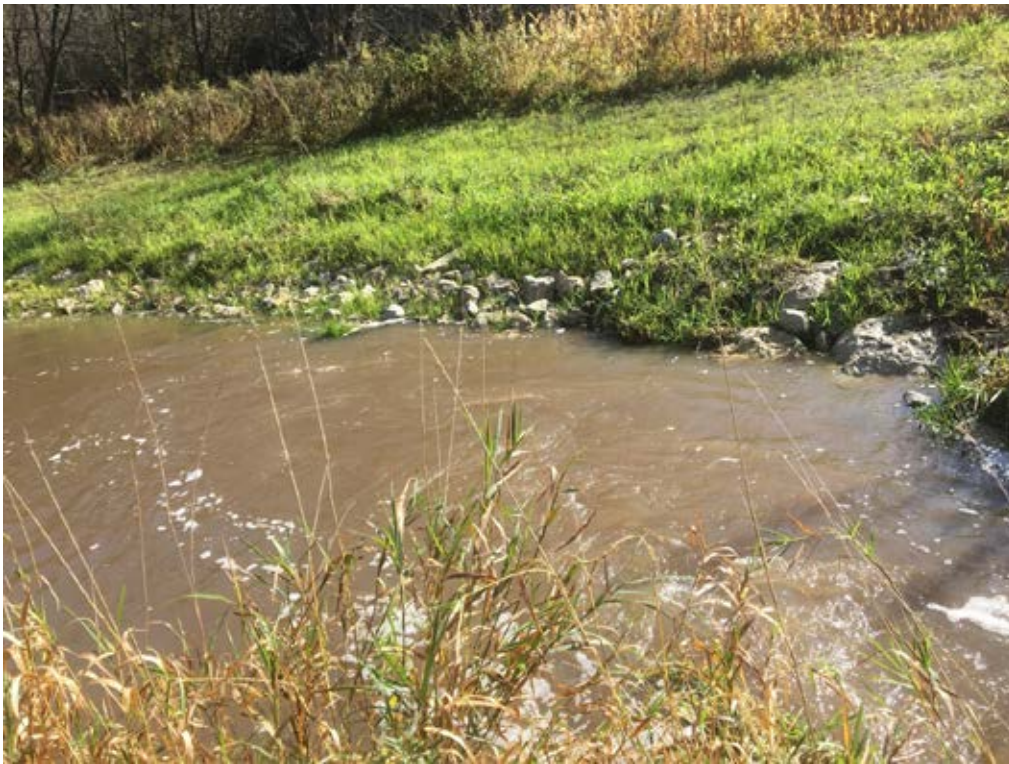
Photo 19-3 Additional rock added in 2019. Photo taken 10/21/2019 by Anna Varian.

Yes, Trout Unlimited's current contractor and designer contract includes 2 years of post-construction monitoring and repair which has been put to use on this site with the addition of rock. Vegetation contracts also currently include 2 years of management and will likely include 3 years in the future. This project was a habitat improvement project and not a full restoration project, as a habitat improvement project the treatments used will improve habitat and reduce sedimentation downstream. The number of locations that required additional rock is a little concerning in regards to continued stability, these locations need to be monitored for any future erosion.

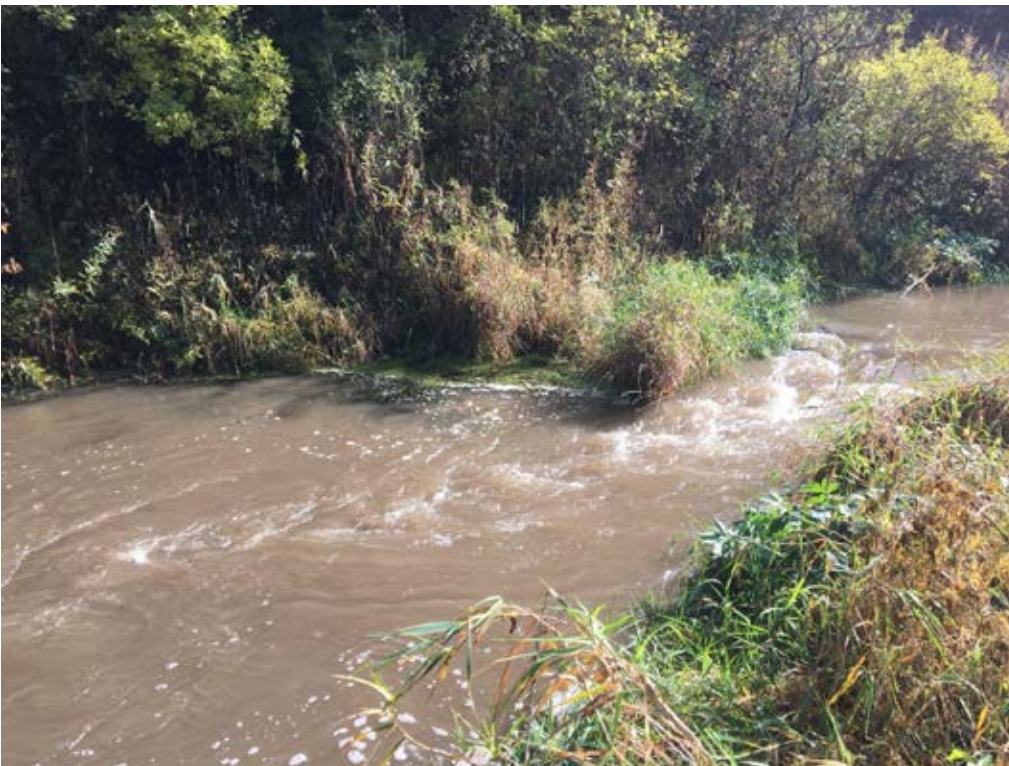
Photo 19-4 View of a location where a rock vane was added to the stream. Photo taken 10/21/2019 by Anna Varian.

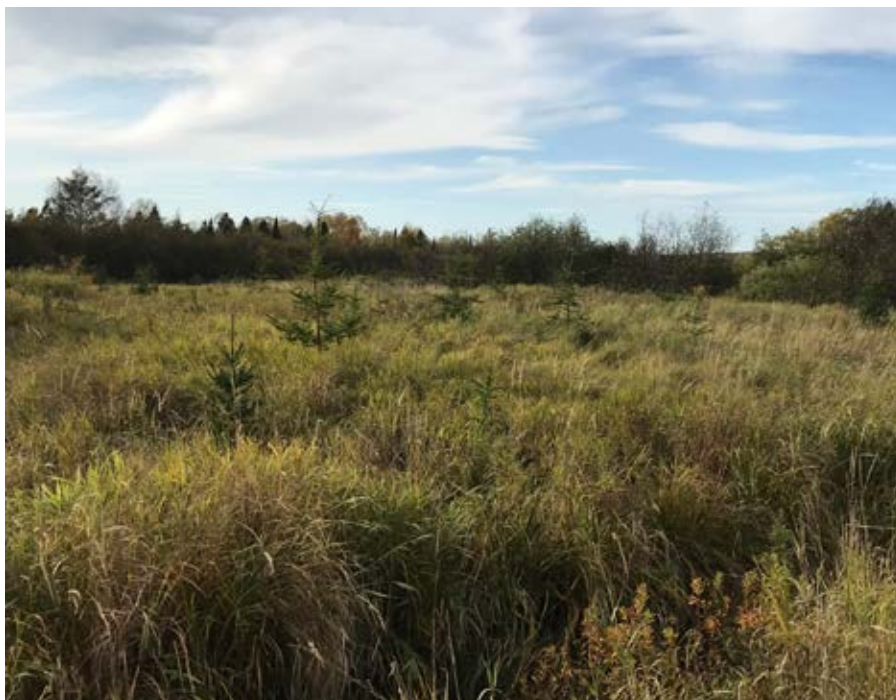
Photo 20-2. Little Stewart River tree planting area. The taller trees within the sedge meadow are primarily planted tamarack, white pine, and white spruce.

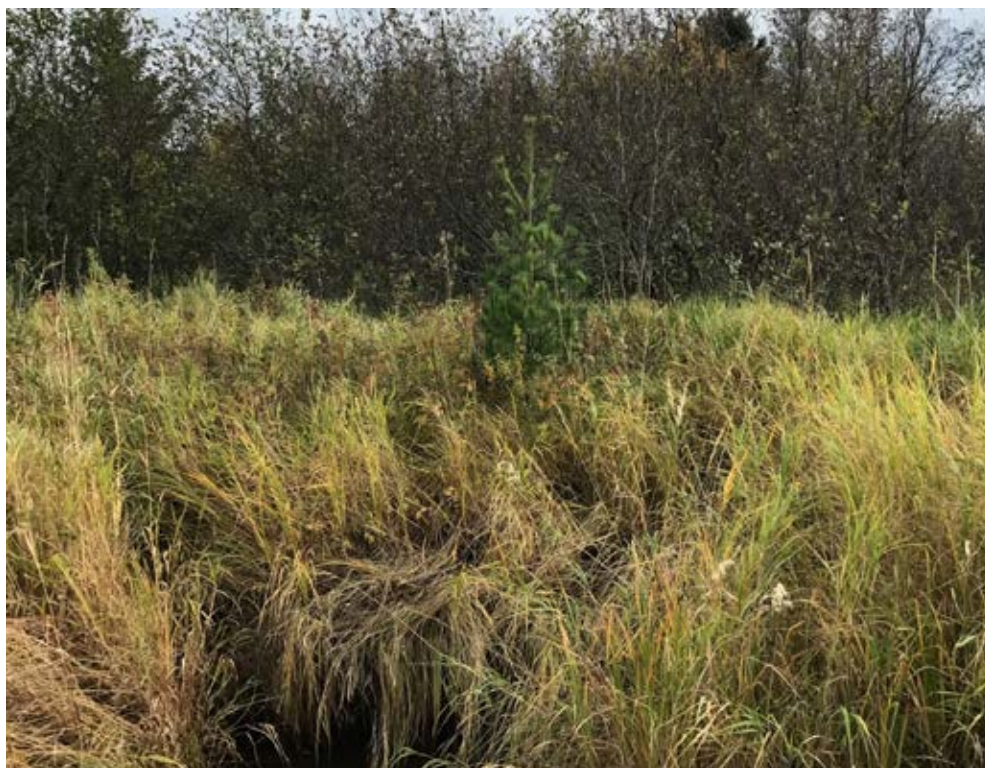
Photo 20-3. Little Stewart River tree plantings. The conifer in the background is a planted white pine.

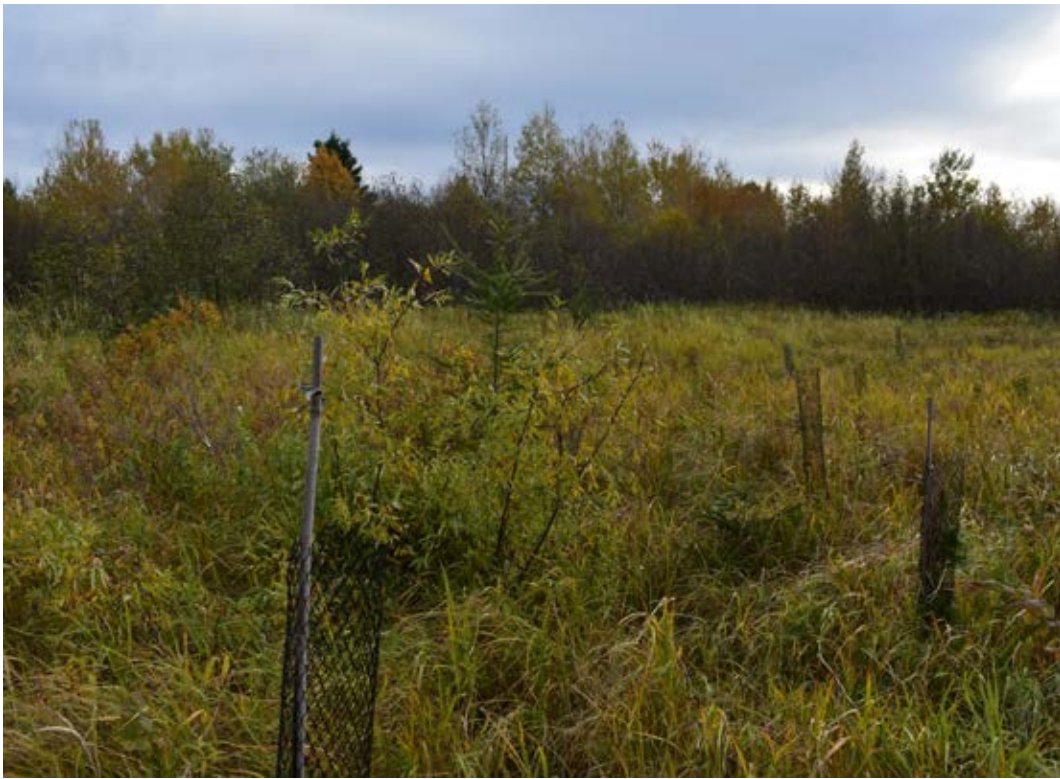
Photo 20-4. Little Stewart tree planting area with tamarack, white spruce, white pine, and white cedar. The browse protection devices surround the small planted stock.

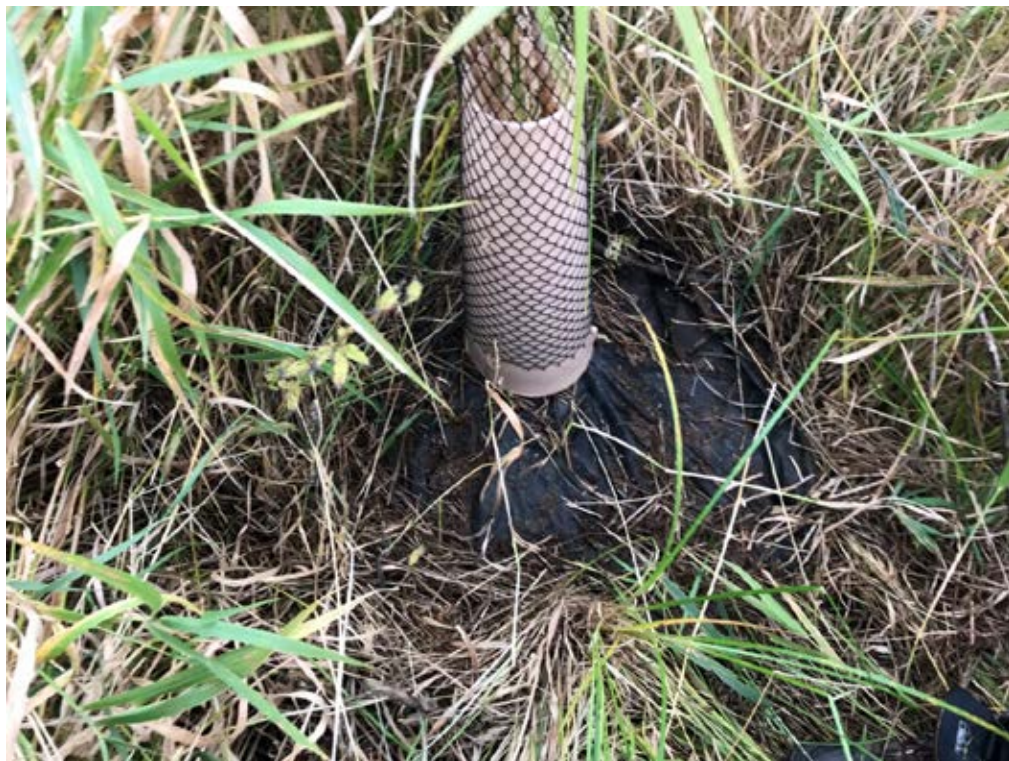
Numerous tree planting stakes with weed suppression mats and animal browse protection devices were observed through the project area. The tamarack and white pine plantings have established well, with several individual trees over 7 feet in height.

Photo 20-5. Close-up image of weed suppression geotextile and browse protection installed around a planted tree.

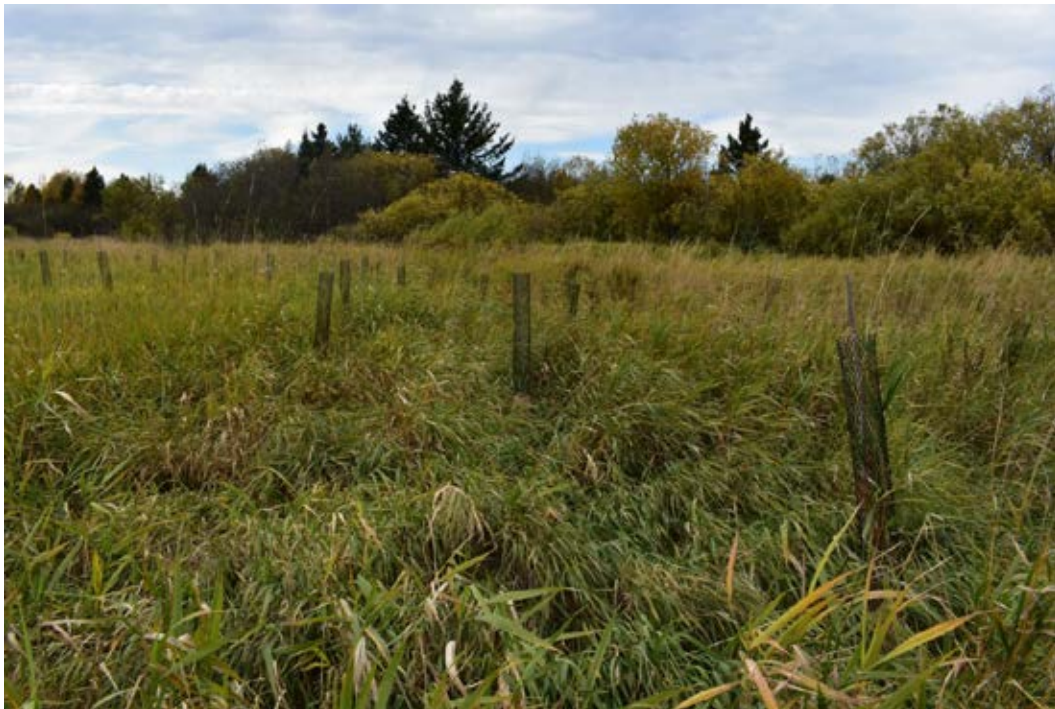
Photo 20-6. Tree planting die-off area on the south side of the Little Stewart River. It appears most of the planted trees in this area were white cedar.

Yes, it is advised that monitoring be continued in the near future to determine growth rates and survivorship of the species planted. Additional trees should be planted if further die-off is observed.

Re-planting tamarack and white pine is recommended within the area where die-off has occurred. White cedars do not appear to grow well in this particular soil and landscape setting.

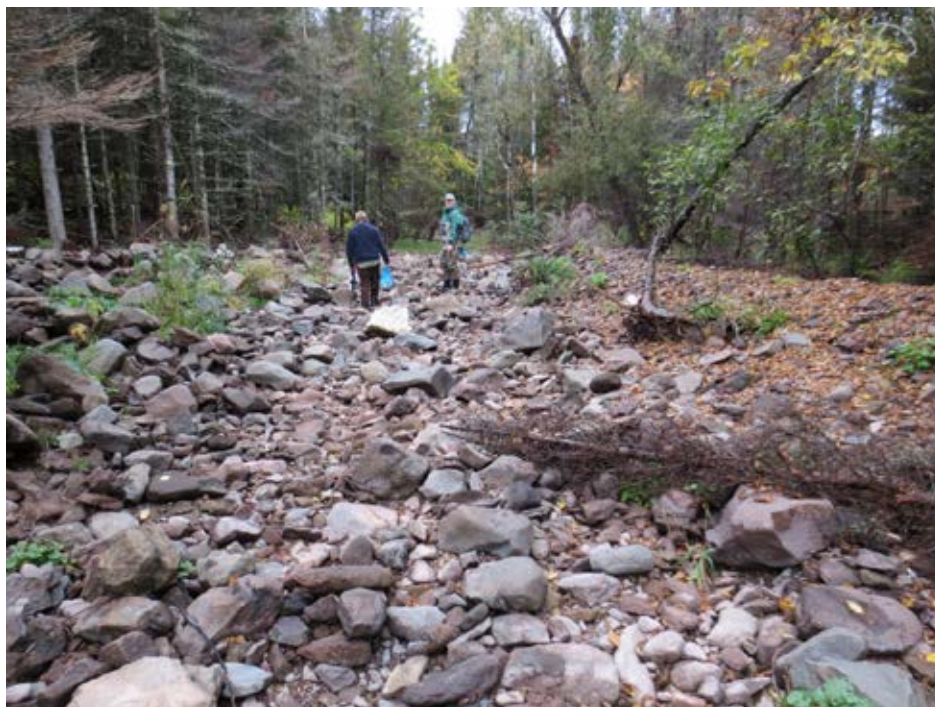
Photo 21-1 Pre-project image of the upper reach of the Little Stewart River on 9/29/2014. Photo credit MNTU.

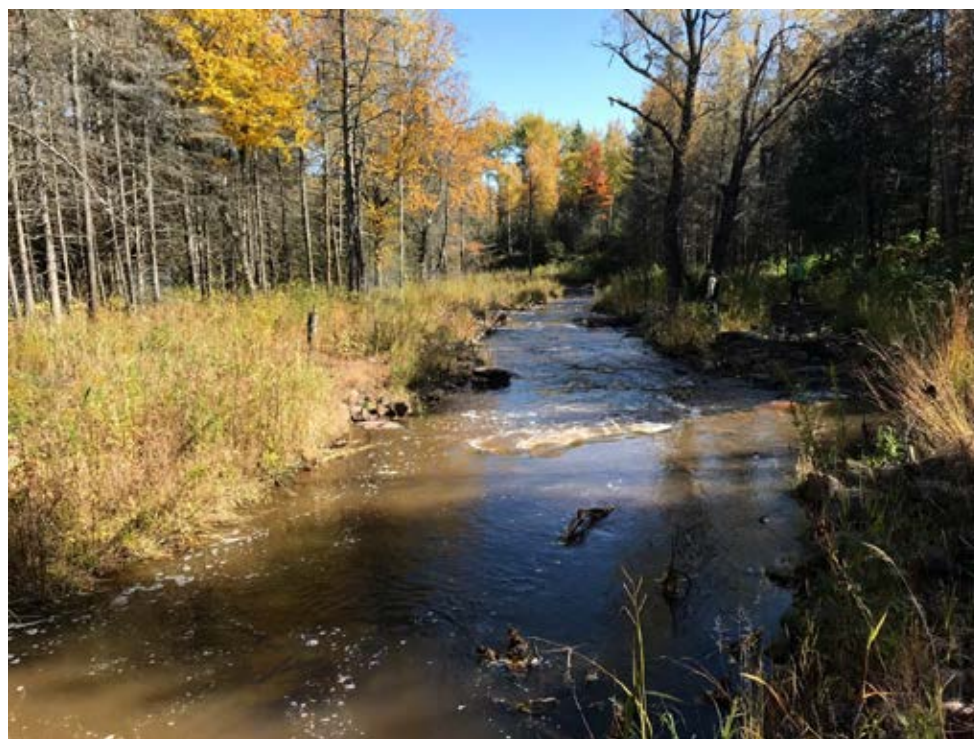
Photo 21-2 Post-project image of the upper reach of the Little Stewart River taken on 10/08/2019.

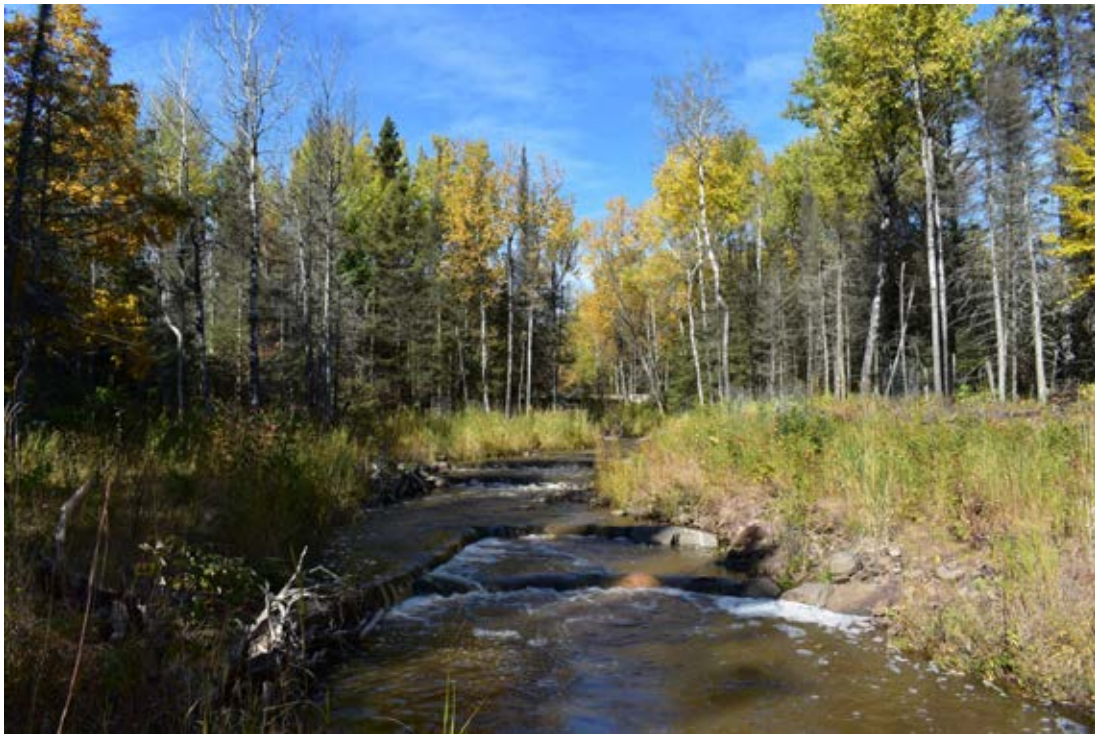
Photo 21-3 Post-project image of the upper reach of the Little Stewart River taken on 10/09/2019.

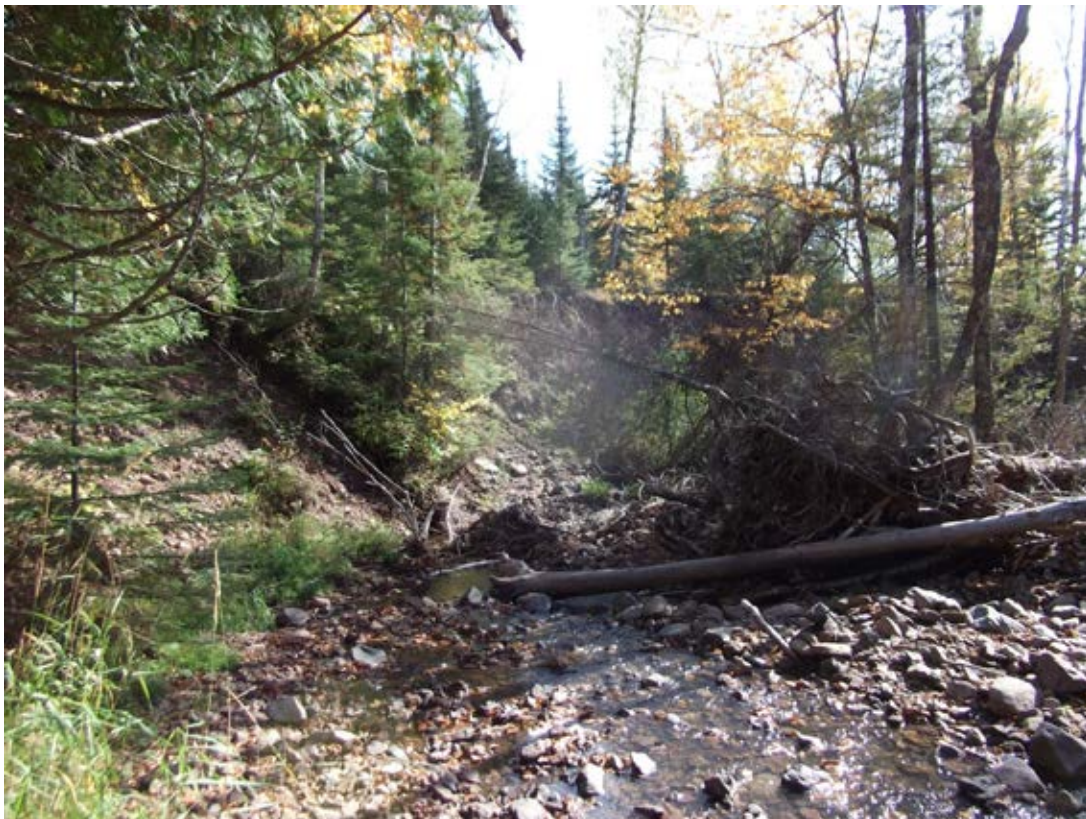
Photo 21-4 Pre-project image of the lower reach of the Little Stewart River taken on 10/10/2013. Photo credit MNTU.

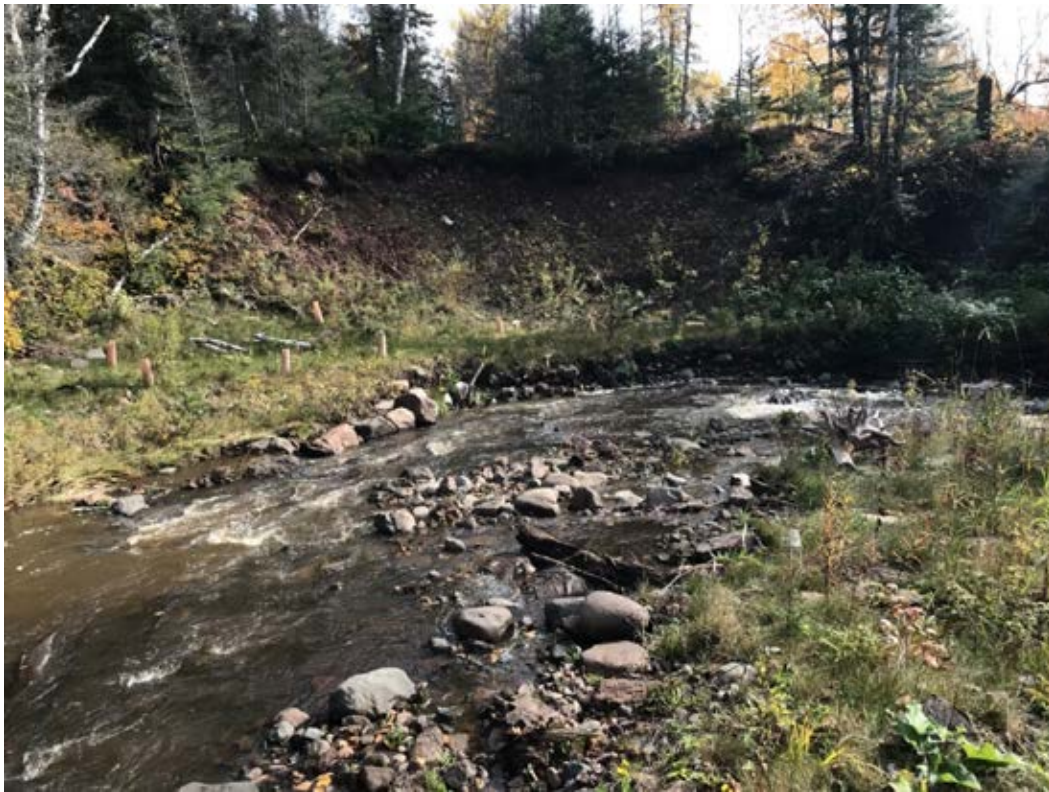
Photo 21-5 Post-project image of the lower reach of the Little Stewart River taken on 10/8/2019.

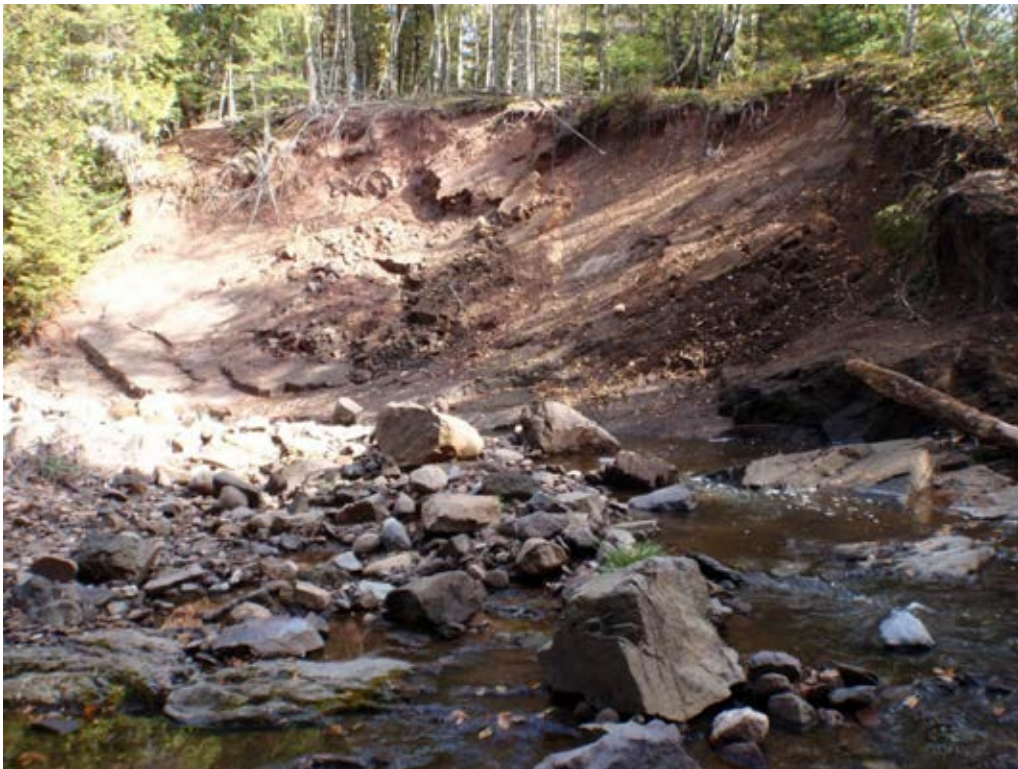
Photo 21-6 Pre-project image of the lower reach of the Little Stewart River taken on 10/10/2013. Photo credit MNTU.

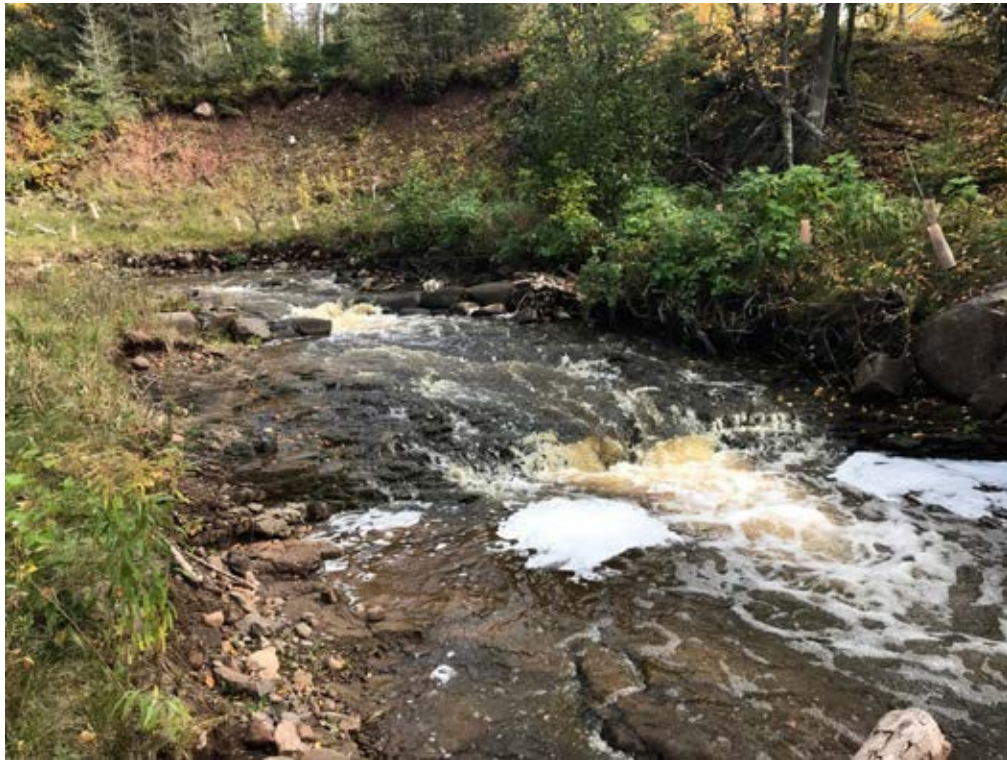
Photo 21-7. Post-project image of the lower reach of the Little Stewart River taken on 10/8/2019.

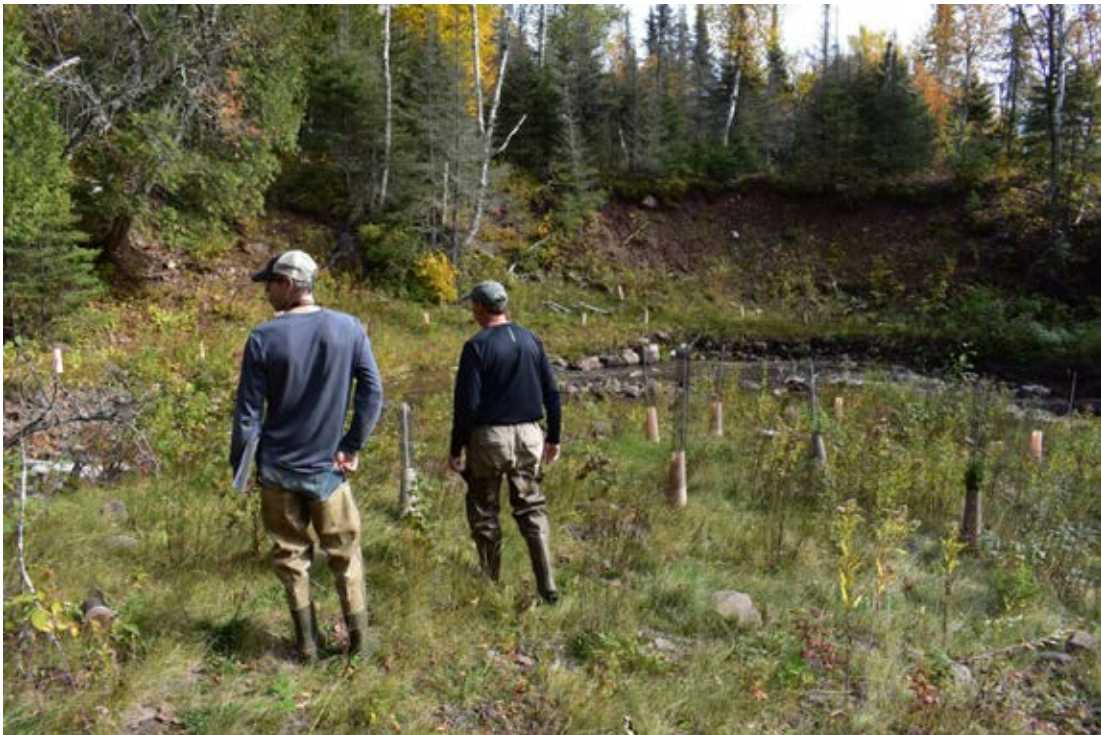
Photo 21-8. Post project image of tree plantings in the lower reach of the Little Stewart River taken on 10/8/2019.

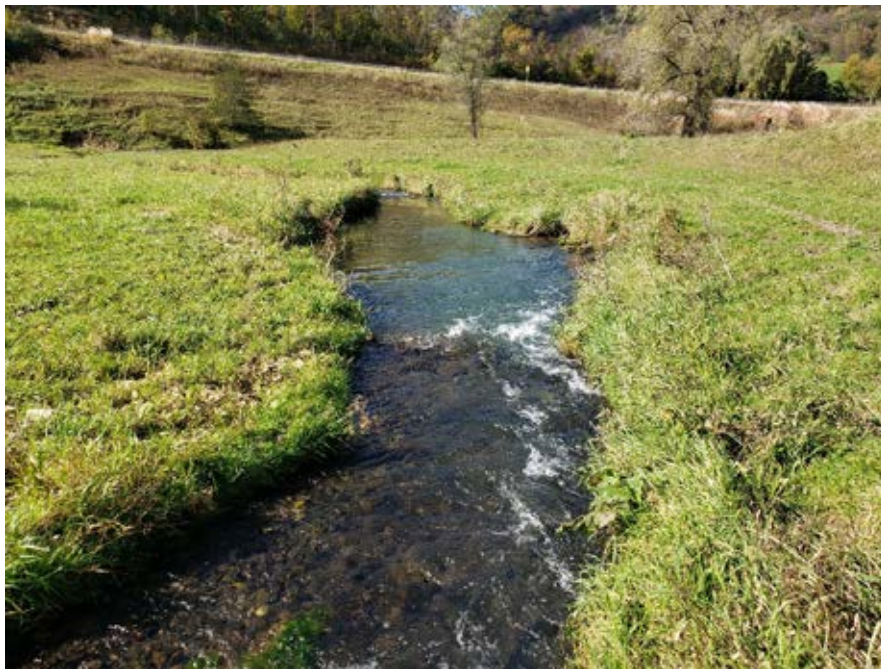
Photo 22-1. Example of Pickwick Creek eight years after construction. Much of the stone toe used to line the channel is overgrown with vegetation. Low banks help to support the stability of the stream. Photo taken 10/17/19 by Mark Prancus, Cardno.

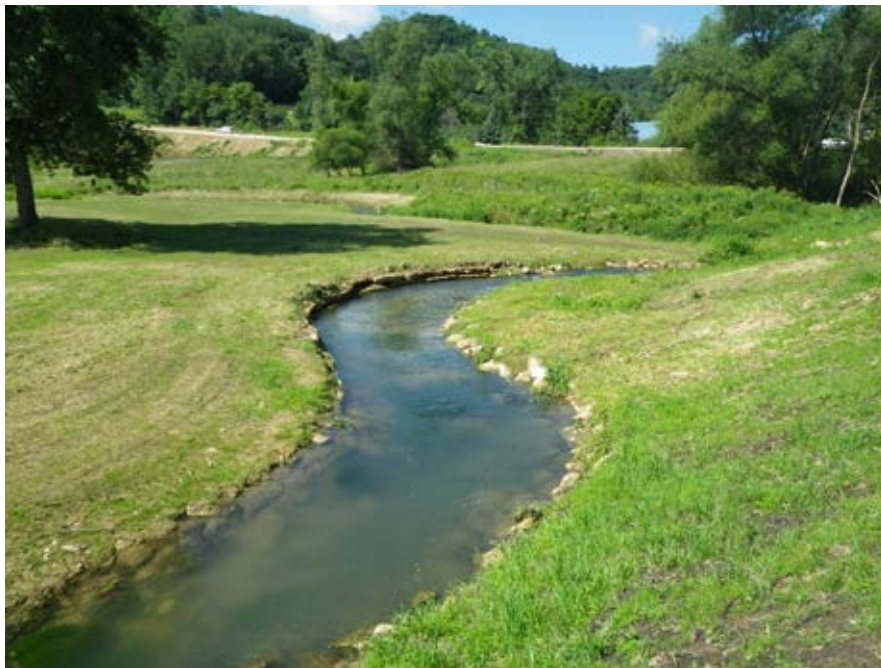
Photo 22-2. Example of Pickwick Creek following construction. Notice the stone used along the toe of the bank to provide stabilization. In later years, this has been covered by vegetation. Photo taken August 2011 and provided by MN DNR.

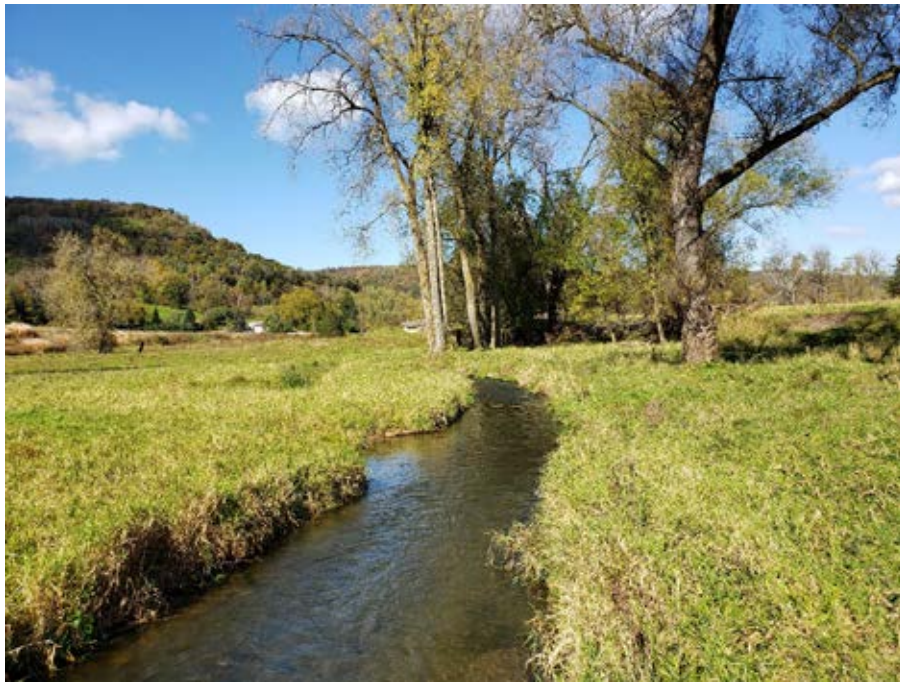
Photo 22-3. Example of Pickwick Creek in 2019. Banks are stable with well-developed vegetation. Deep pools and riffles present. Photo taken 10/17/19 by Mark Prankus, Cardno.
