Minnesota Department of Natural Resources
Minnesota Board of Water and Soil Resources

Appendix B: 2020 Legacy Fund Restoration Evaluation

Report March 2020

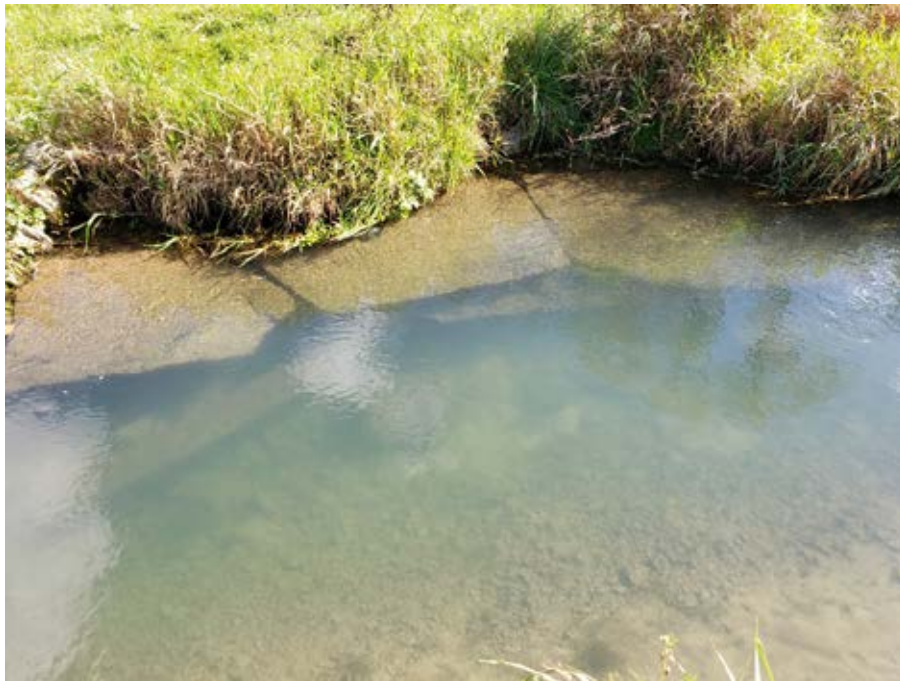
Photo 22-4. Example of Minnesota sky hook structure where rock is used instead of lumber. The structure provides overhead cover. This structure had some erosion occurring because the stone should not be visible because soil and vegetation covers it. Photo taken 10/17/19 by Mark Prankus, Cardno.

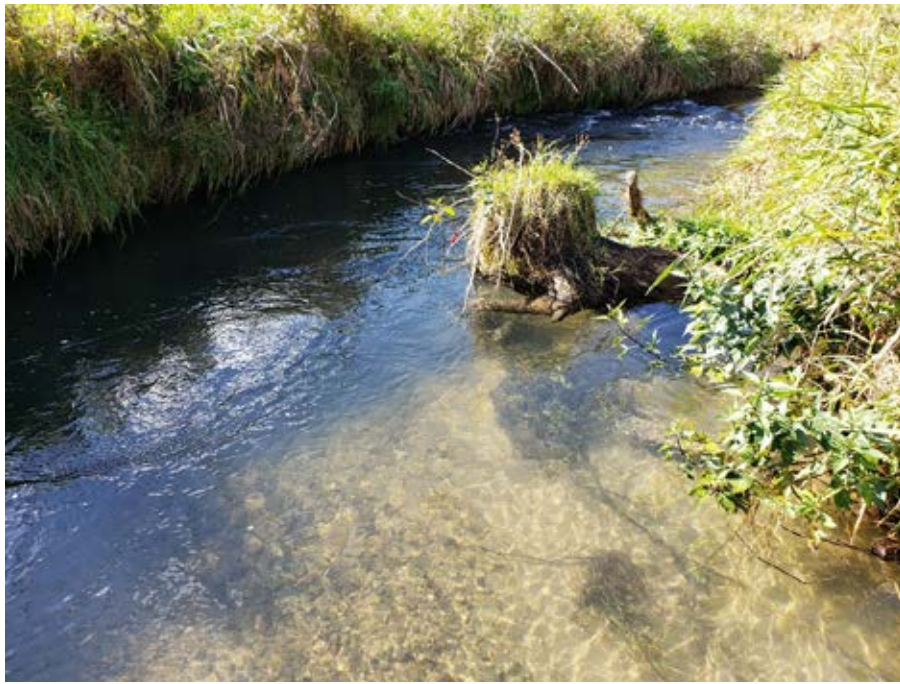
Photo 22-5. Example of log deflector used to provide overhead cover. Photo taken 10/17/19 by Mark Prankus, Cardno.

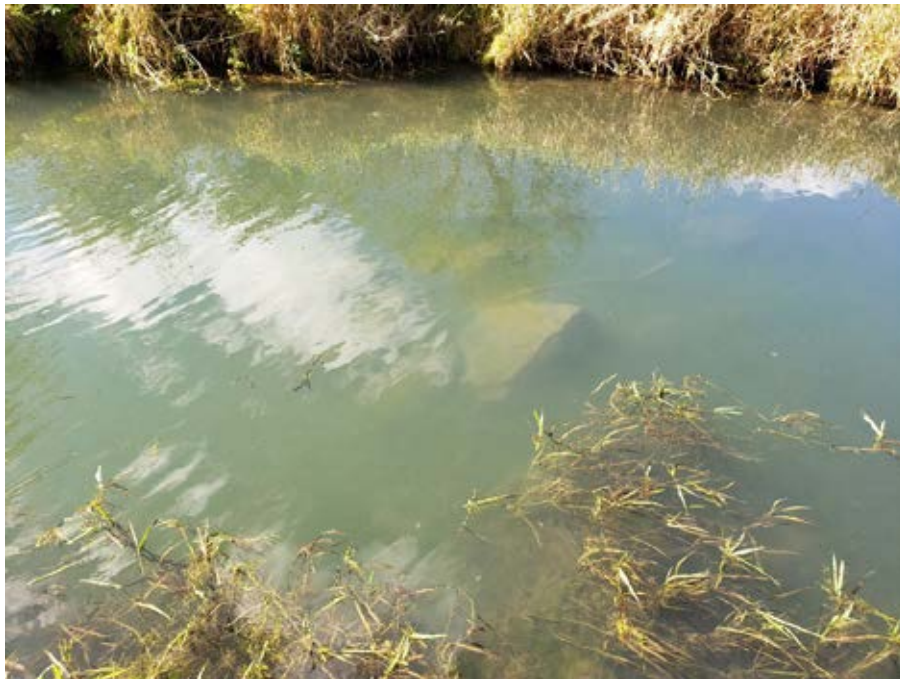
Photo 22-6. Example of a random boulder cluster used to provide in-stream cover for feeding trout. Photo taken 10/17/19 by Mark Prankus, Cardno.

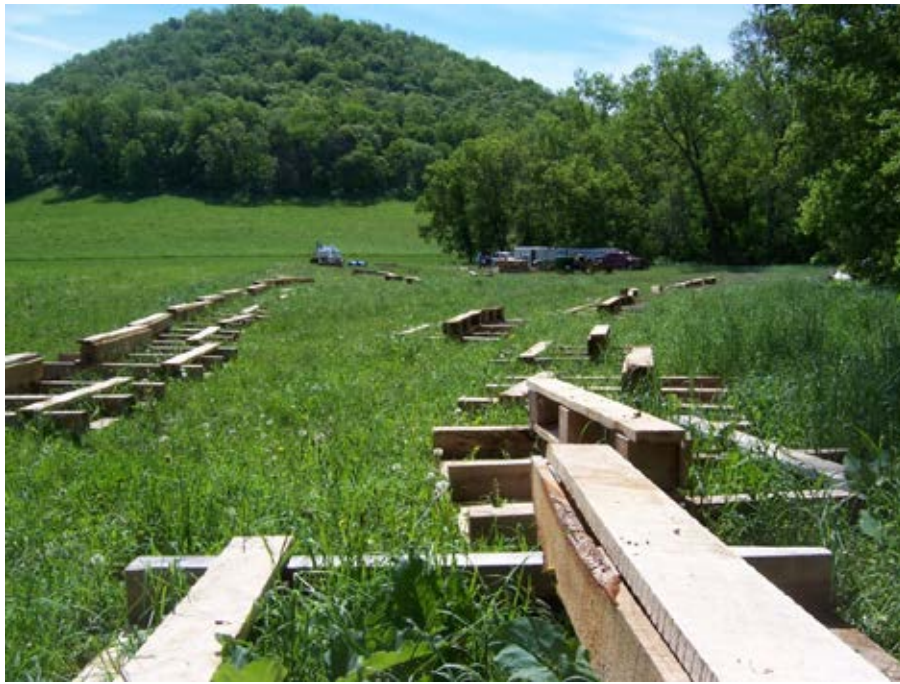
Photo 22-7. Example of Minnesota sky hook structure. The structure provides overhead cover for fish. It is assembled in the dry and placed into the bank. Photo taken August 2011 and provided by MN DNR.

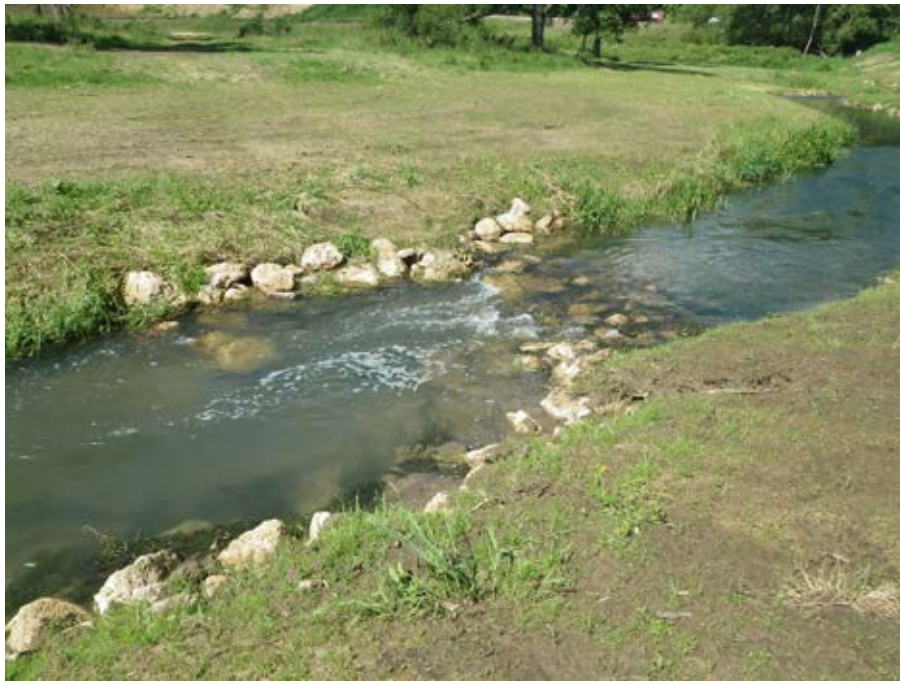
Photo 22-8. Example of a vortex weir installed in 2011. It is used to hold the grade of the upstream pool and create a plunge pool on the downstream end. Photo taken August 2011 and provided by MN DNR.

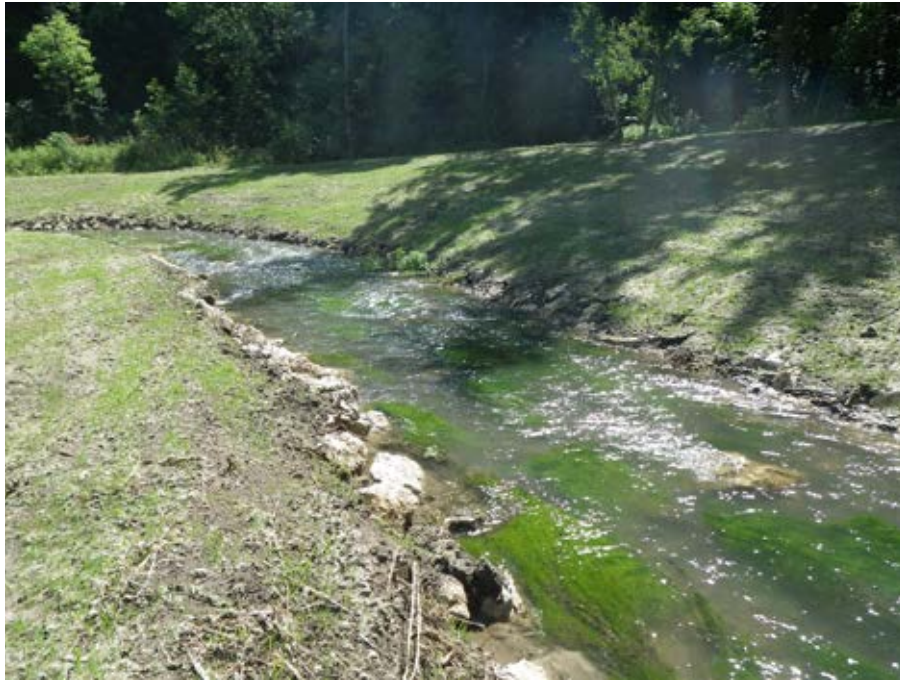
Photo 22-9. Example of Pickwick Creek following construction in 2011. Banks were seeded and straw mulched. The low bank on the left helps to reduce shear stress on the outside bend during high flows. Photo taken August 2011 and provided by MN DNR.

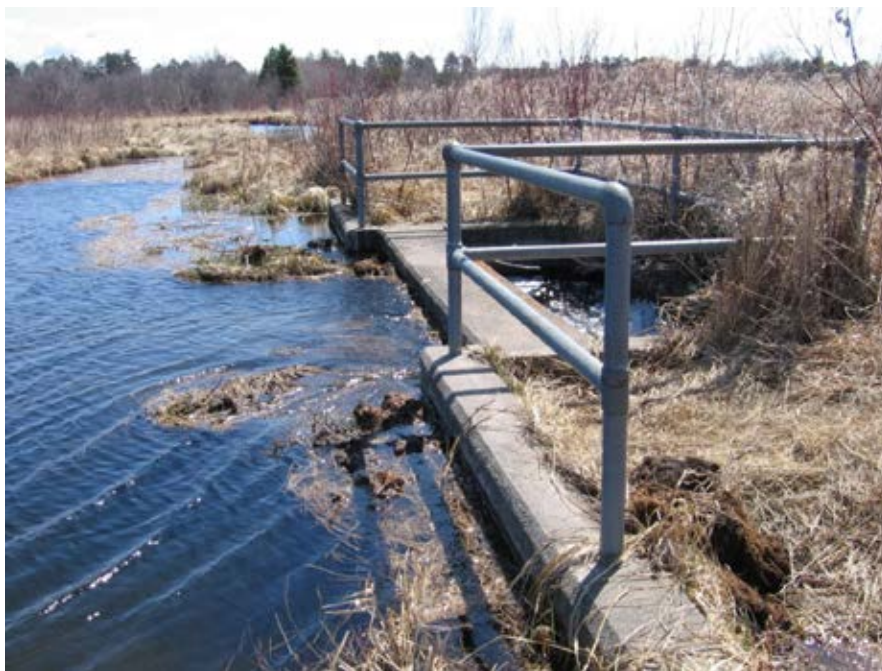
Photo 23-1 Upstream view of the Portage Lake dam prior to removal.

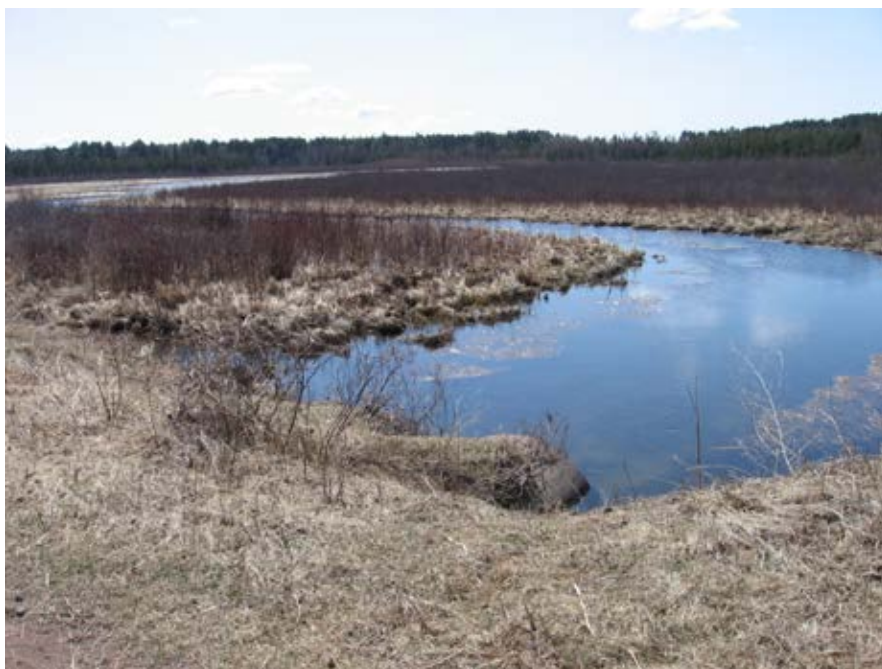
Photo 23-2 Downstream view from the Portage Lake dam prior to removal.

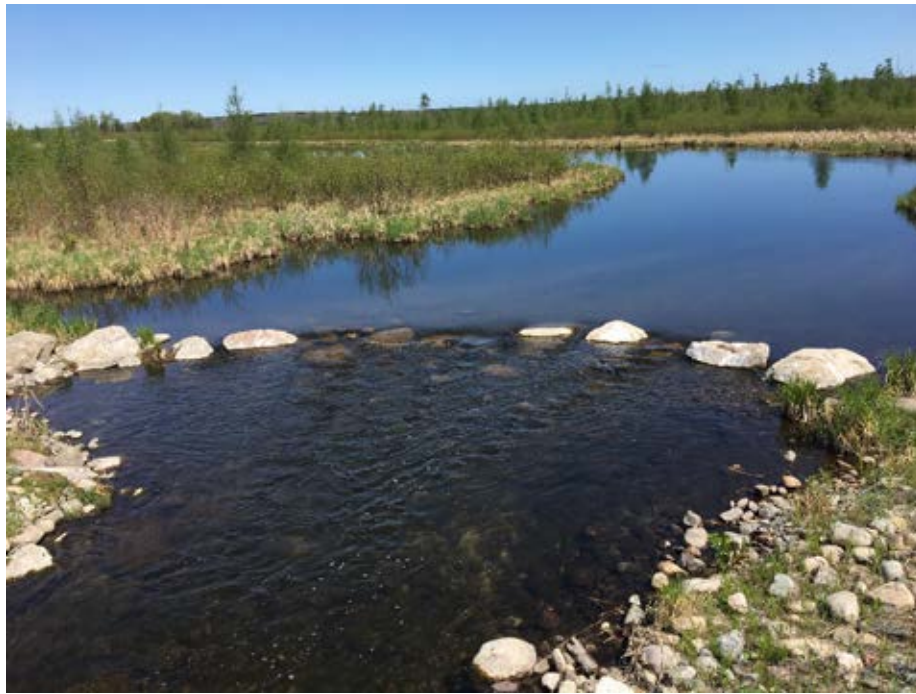
Photo 23-3 View from Soo Line Trail looking upstream at topmost boulder weir on Portage Creek, taken 5/28/2019.

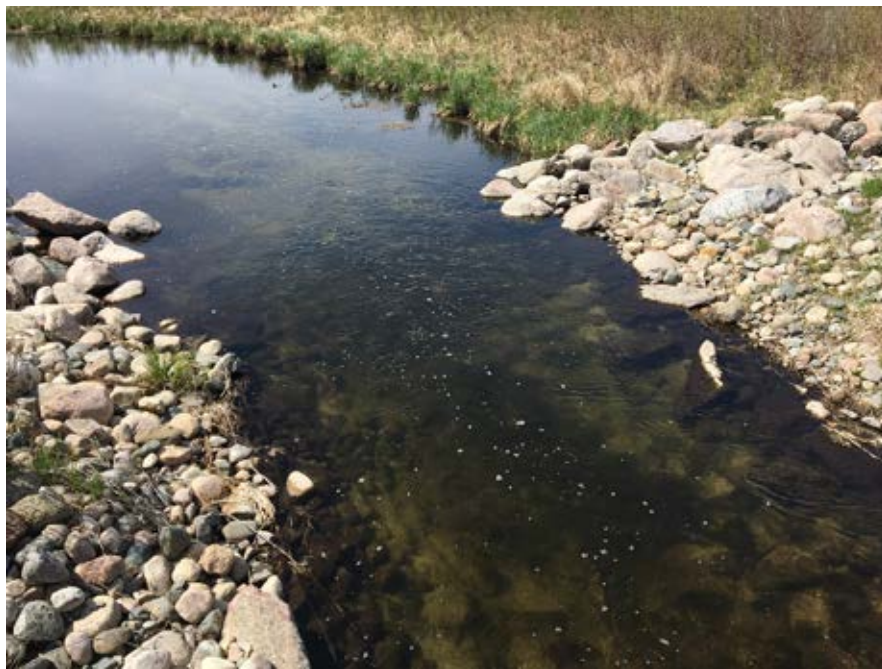
Photo 23-4 View from Soo Line Trail looking downstream at pool below one of the boulder weirs on Portage Creek, taken 5/28/2019.

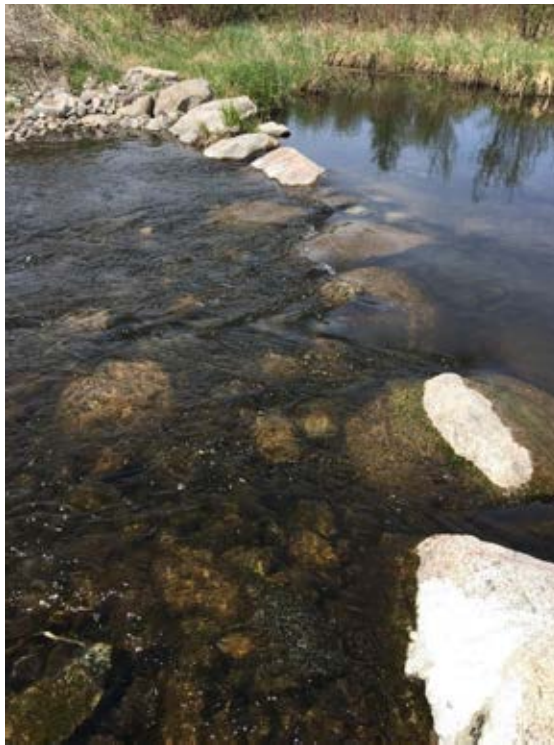
The low head dam has been removed and fish passage looks possible. Attempts were made to conduct a fishery survey downstream of the weirs however otters destroyed the nets preventing completion of the survey. Lowering the water levels of Portage Lake were expected to help reduce ice damage to the shoreline and properties, this expectation would be difficult to measure.

Photo 23-5 View of topmost weir and spaces between weir for fish passage, taken 5/28/2019.

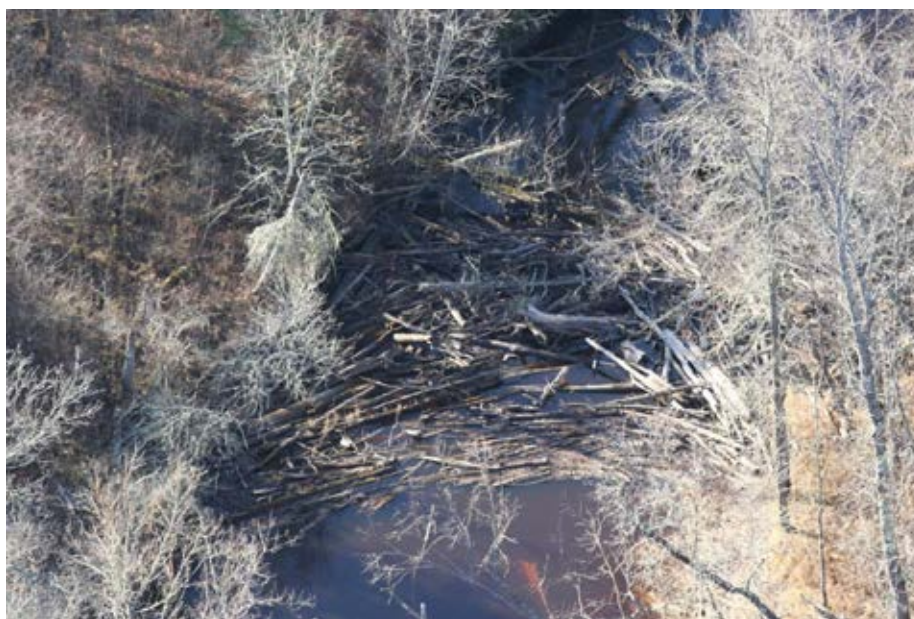
Photo 24-1. Example of a large, channel-spanning log jam in the Rat Root River prior to removal. Photo provided by Koochiching County SWCD.

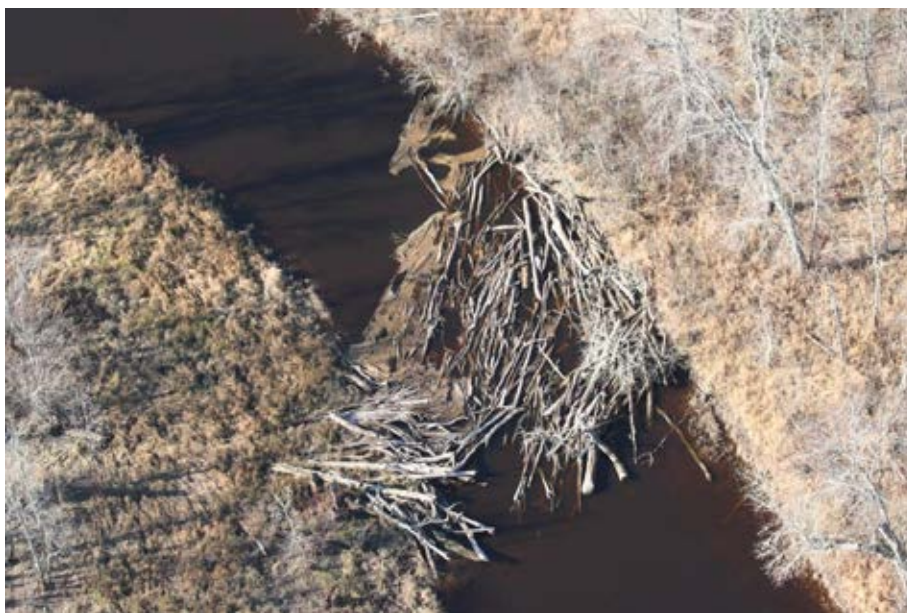
Photo 24-2. Example of a large, channel-spanning log jam in the Rat Root River prior to removal. Photo provided by Koochiching County SWCD.

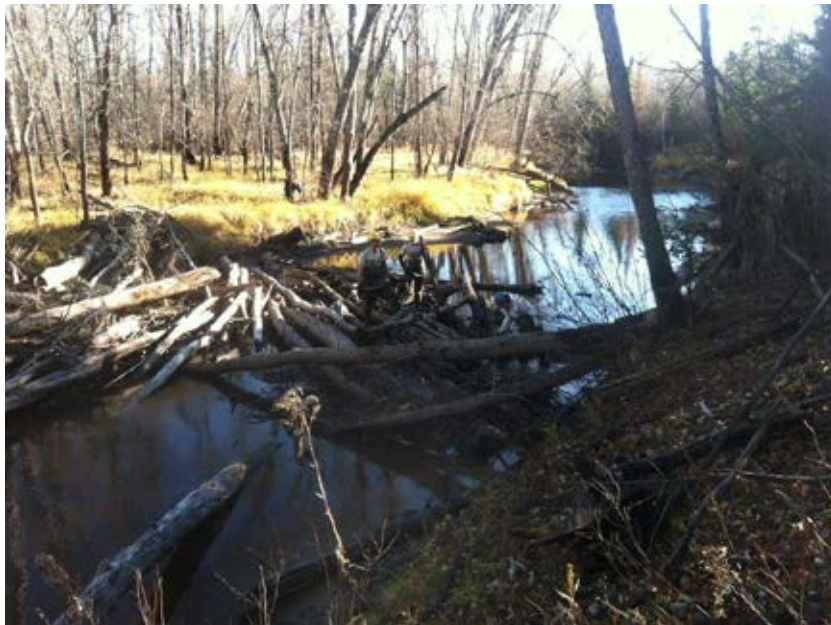
Photo 24-3. Example of a large, channel-spanning log jam on the Rat Root River prior to removal. To provide scale of the jam, notice the two individuals standing on top of the jam in the middle of the channel. Photo provided by Koochiching County SWCD.

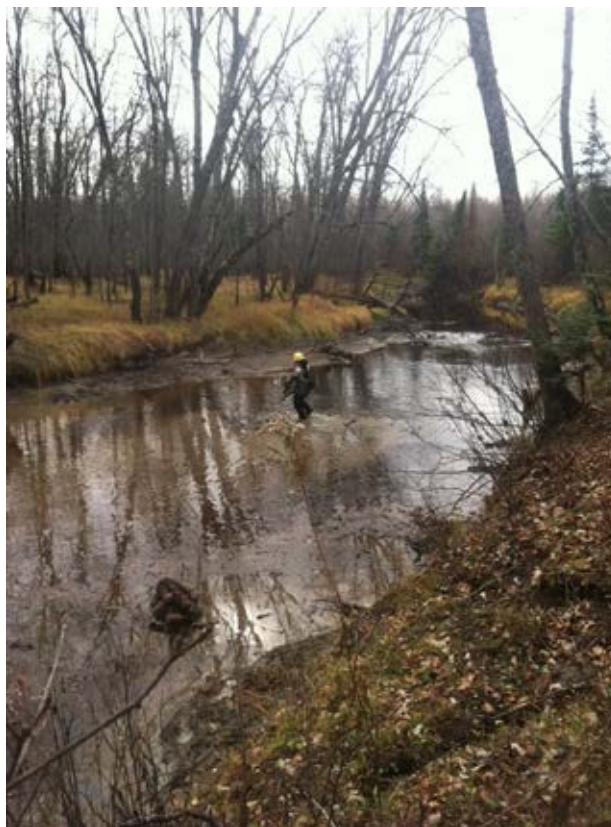
Photo 24-4. Example of the Rat Root River post-log jam removal. Photo is a match to Photo 24-3 above. Photo provided by Koochiching County SWCD.

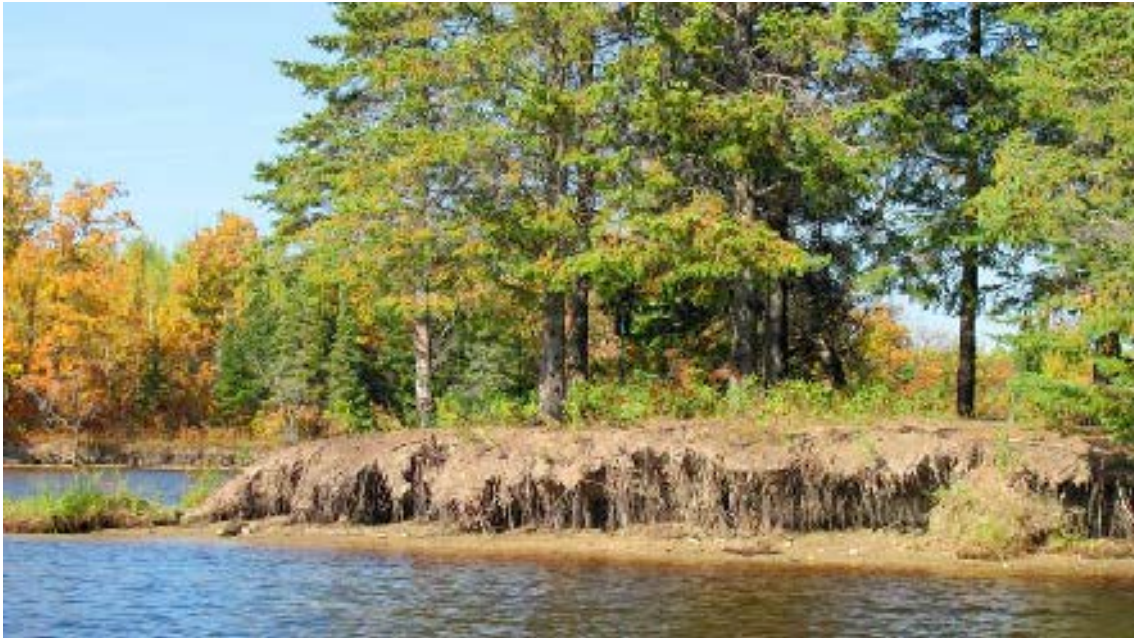
Photo 25-1. Example of the Fish Camp bank stabilization site on the Rat Root River in 2011 prior to construction. Photo provided by Koochiching County SWCD.

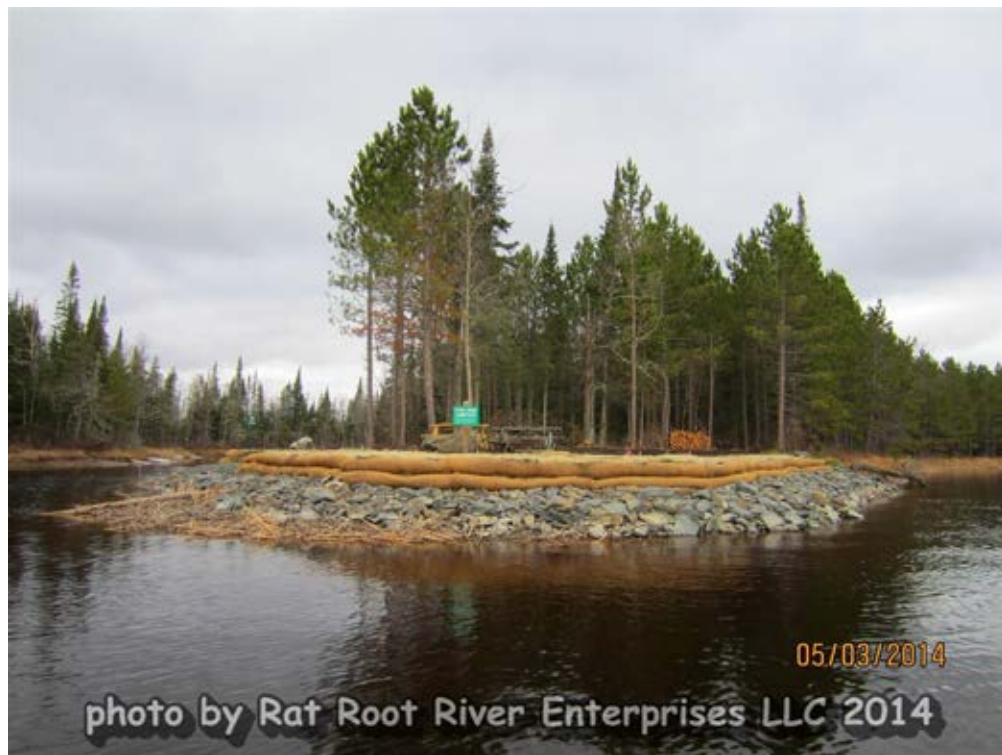
Photo 25-2. Example of the Fish Camp bank stabilization site in spring 2014 following construction in fall 2013. Photo provided by Ed Lombard, Rat Root River Enterprises, LLC.

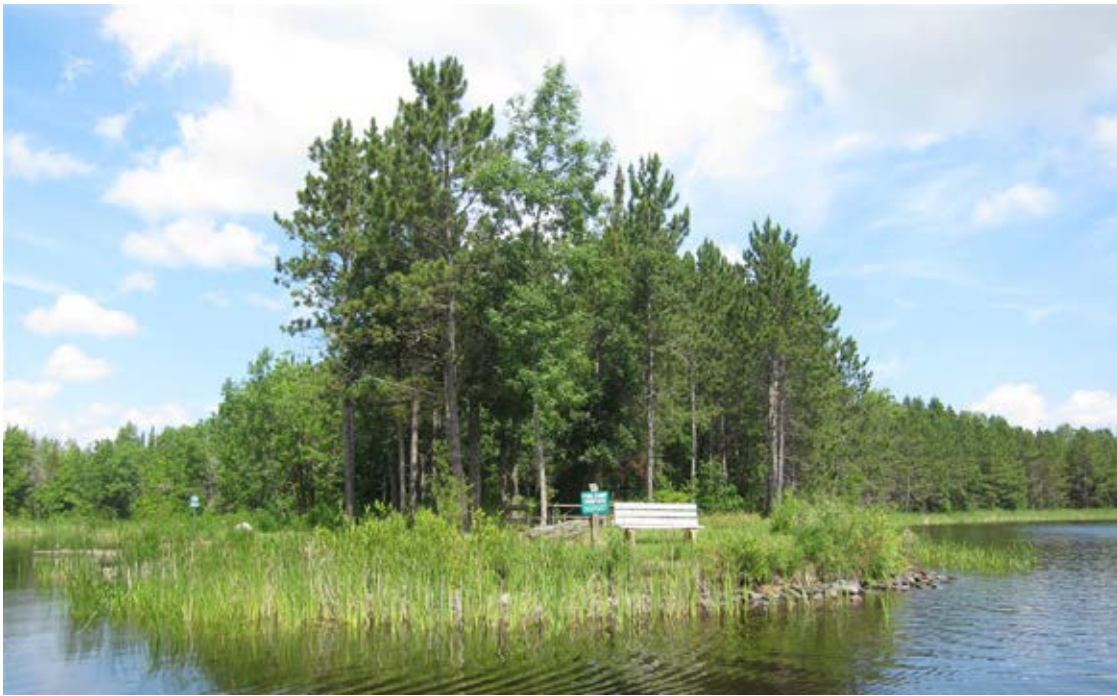
Photo 25-3. Example of the Fish Camp bank stabilization site in summer 2019 following construction in fall 2013. Photo provided by Ed Lombard, Rat Root River Enterprises, LLC.

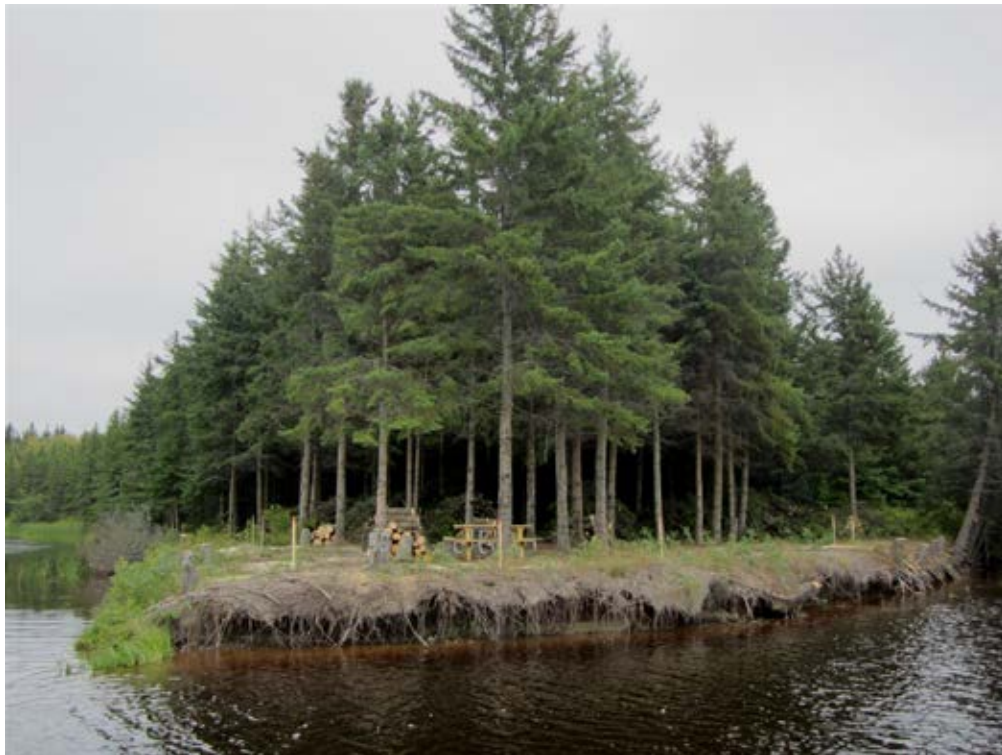
Photo 25-4. Example of the Picnic Site bank stabilization site in 2013 prior to construction. Photo provided by Ed Lombard, Rat Root River Enterprises, LLC.

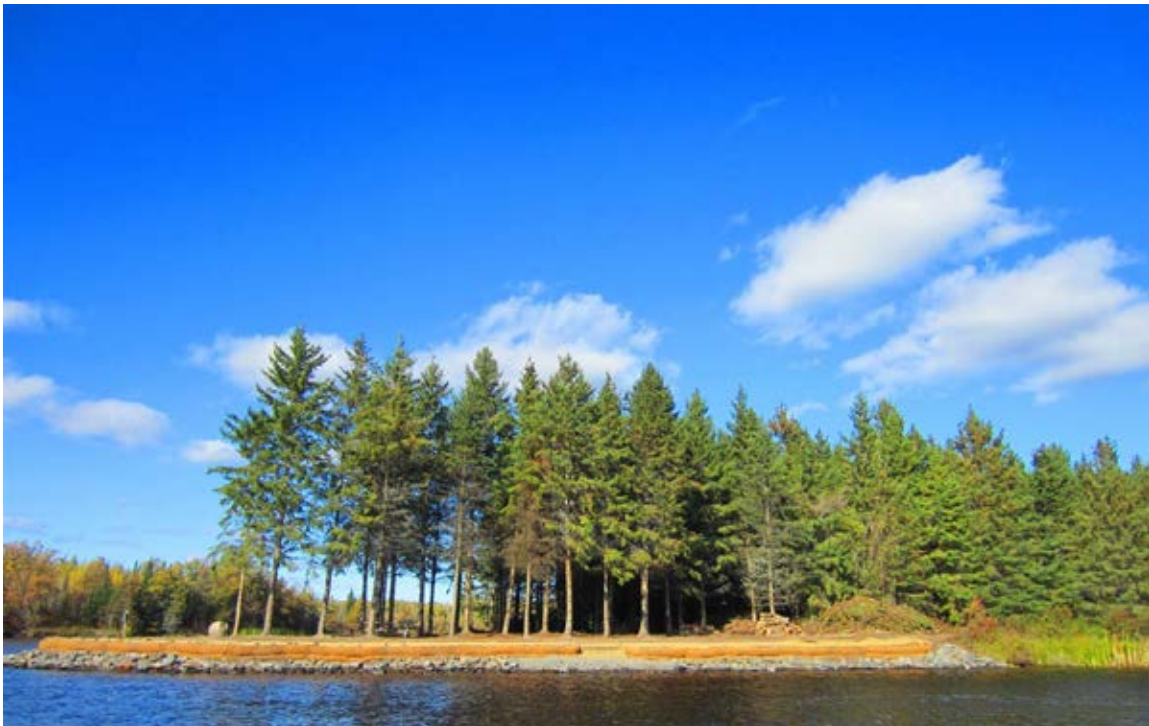
Photo 25-5. Example of the Picnic Site bank stabilization site following construction in fall 2013. Photo provided by Ed Lombard, Rat Root River Enterprises, LLC.

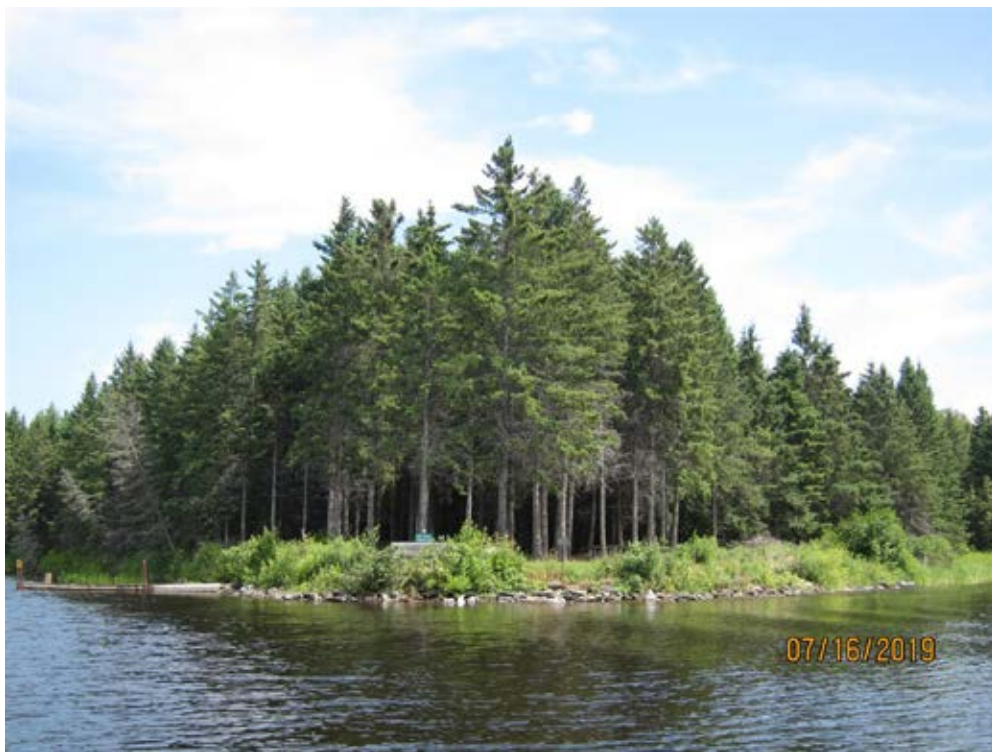
Photo 25-6. Example of the Picnic Site bank stabilization site in summer 2019 following construction in fall 2013. Photo provided by Ed Lombard, Rat Root River Enterprises, LLC.

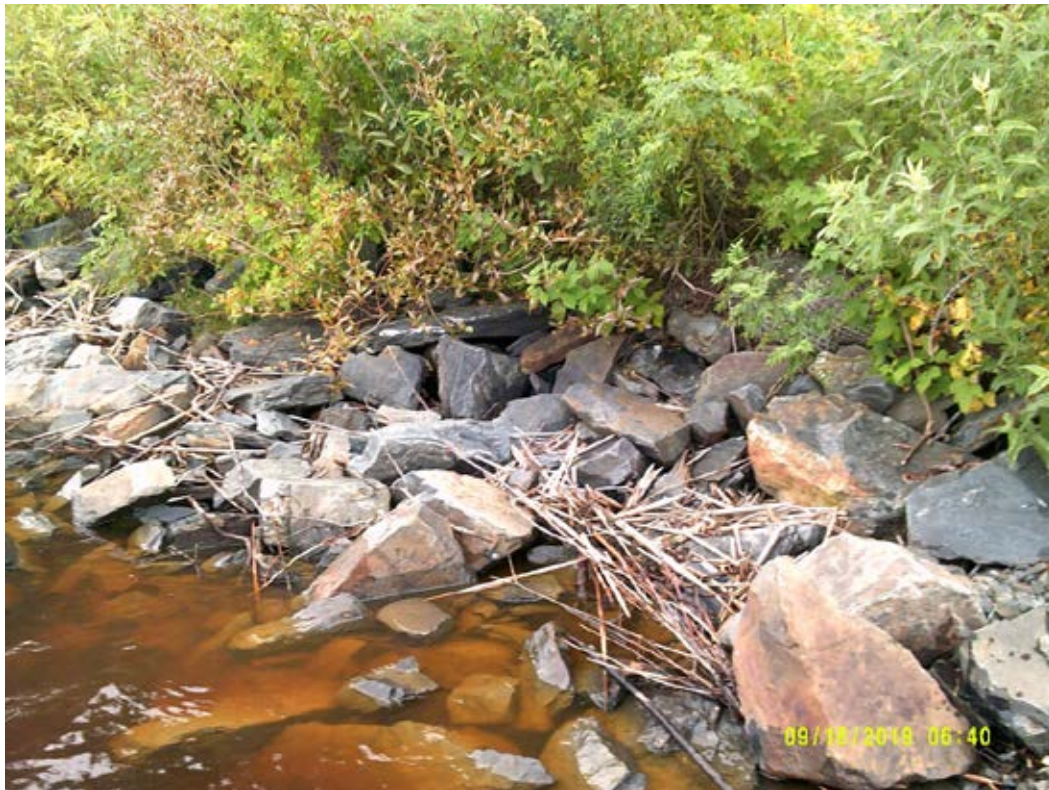
Photo 25-7. Example of rock toe and vegetated bank at the Fish Camp Site. Photo taken during site visit 9/18/2019.

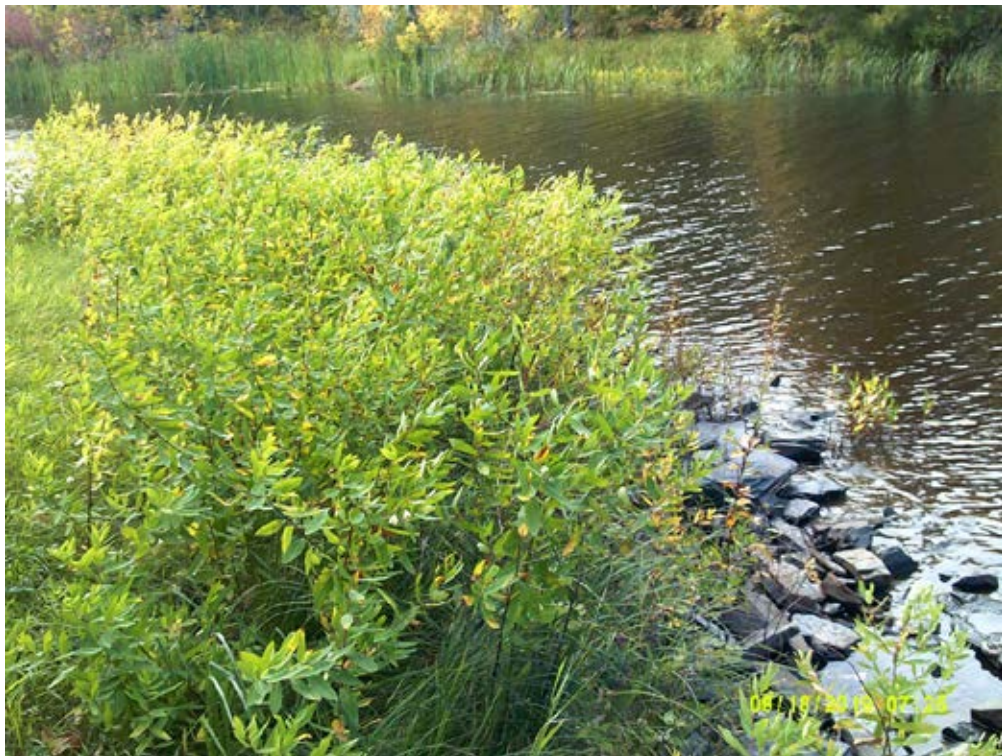
Photo 25-8. Example of rock toe and vegetated bank at the Picnic Site. Photo taken during site visit 9/18/2019.

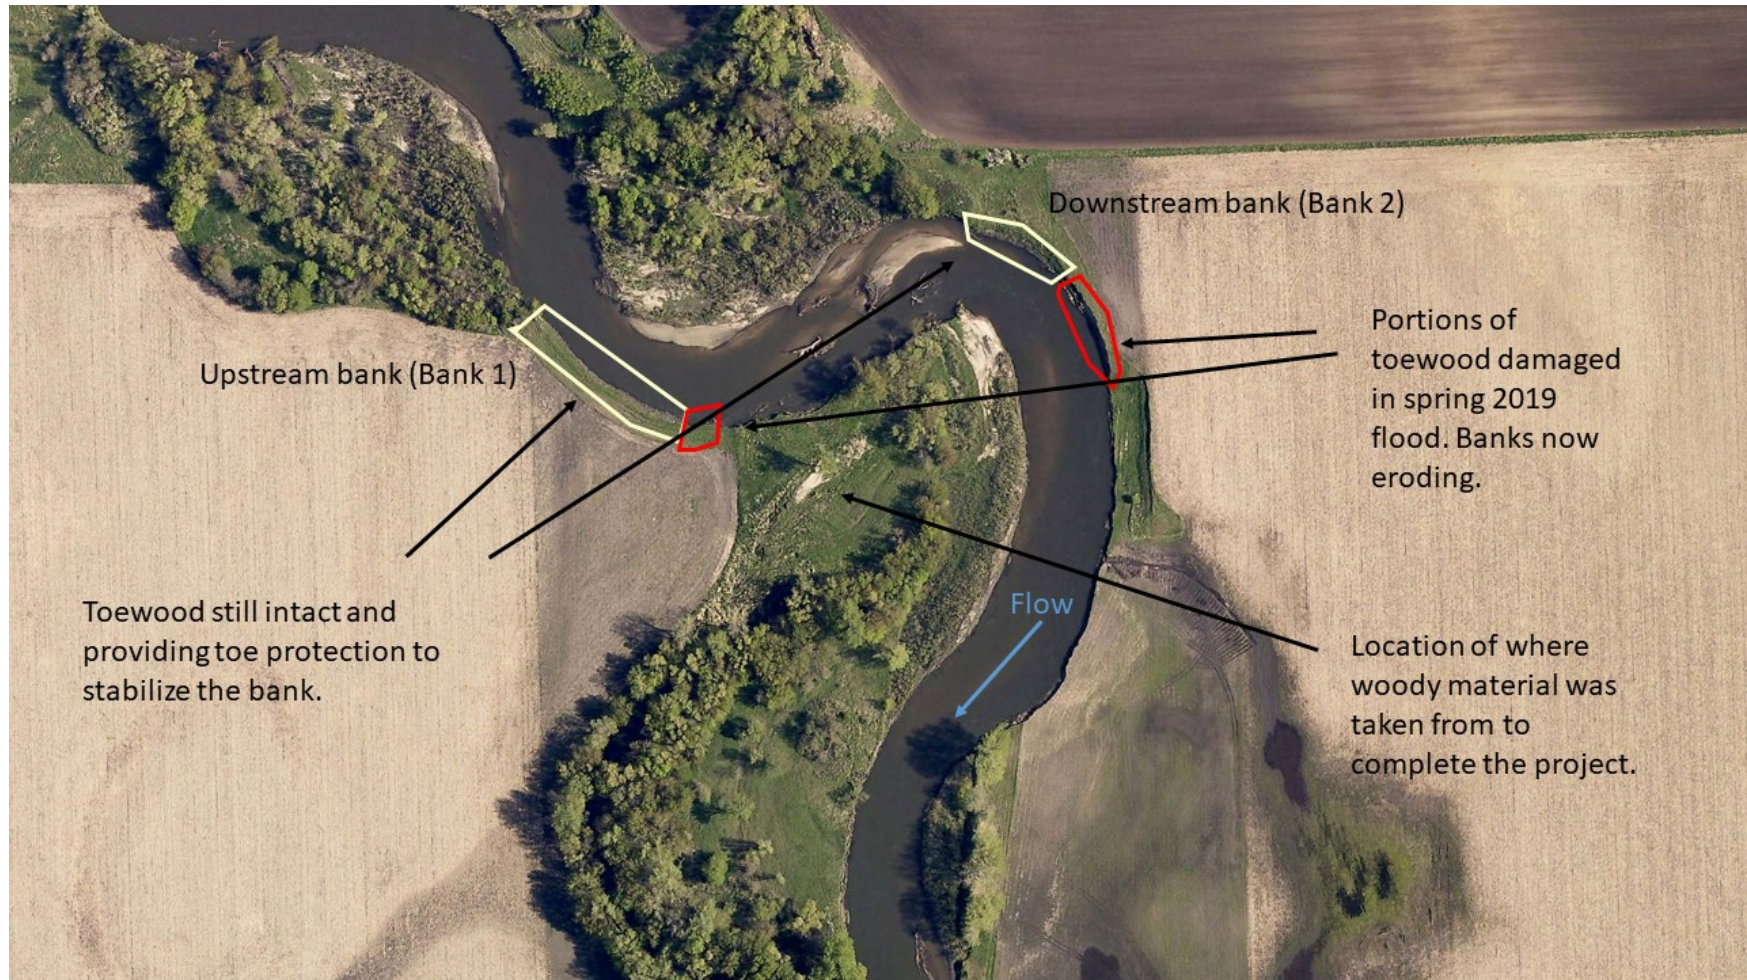
Greater than 50 percent of the total bank length had a stable toe and vegetation established above the toewood. Based on an interview with the farmer who rents the property, the toewood was in place and working prior to spring 2019. A flood event in spring 2019 damaged and blew out the downstream sections of toewood on each bank.

Figure 27-1. Aerial from spring 2019 following flooding. Areas where the toewood remains intact are highlight along with areas where erosion occurred, blowing out the toewood. Aerial image provided by Rock County (<http://rock.houstoneng.com/>).

No immediate corrections are required. It is recommended that the two banks that started eroding following the 2019 spring flood be monitored to determine if they continue to erode at a high rate and/or get worse (i.e. aerial map or bank pin monitoring).

There is an opportunity to improve the project by repairing the eroding sections of toewood and potentially extending them in either an upstream or downstream direction, if additional funding and resources were available.

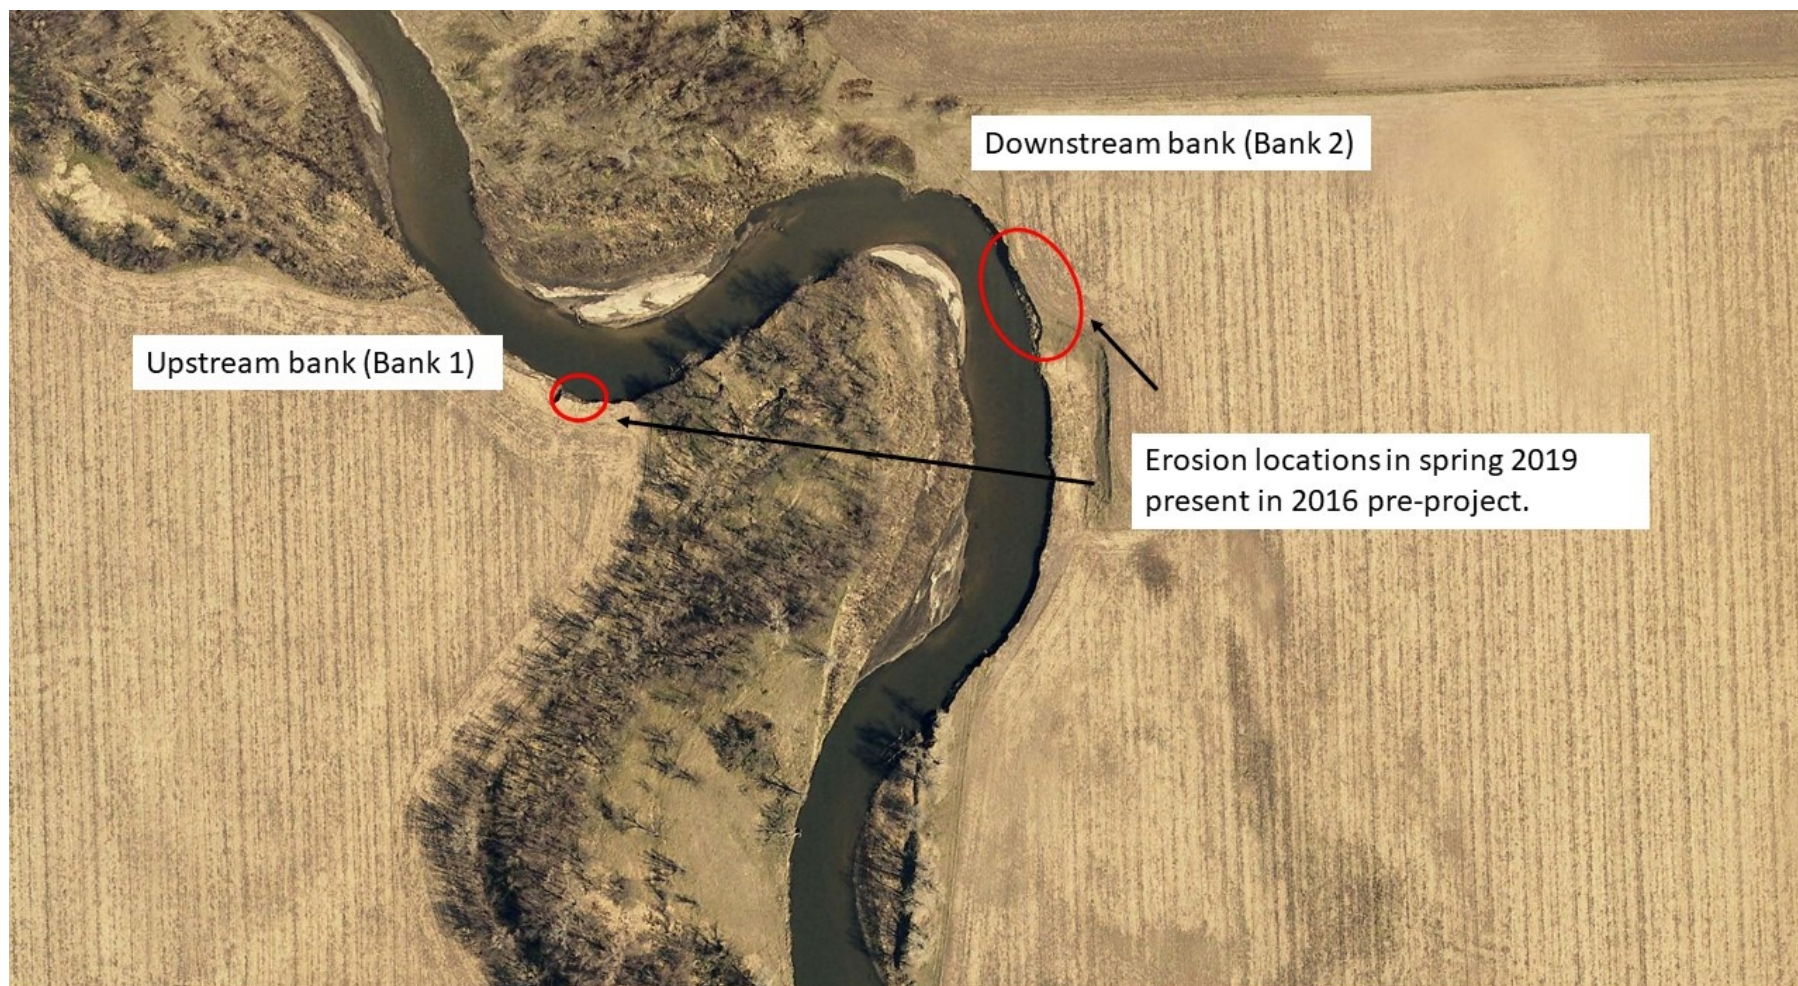
Figure 27-2. 2016 aerial of the project prior to construction. Areas highlighted show where erosion occurred in spring 2019. Aerial image provided by Rock County (<http://rock.houstoneng.com/>).

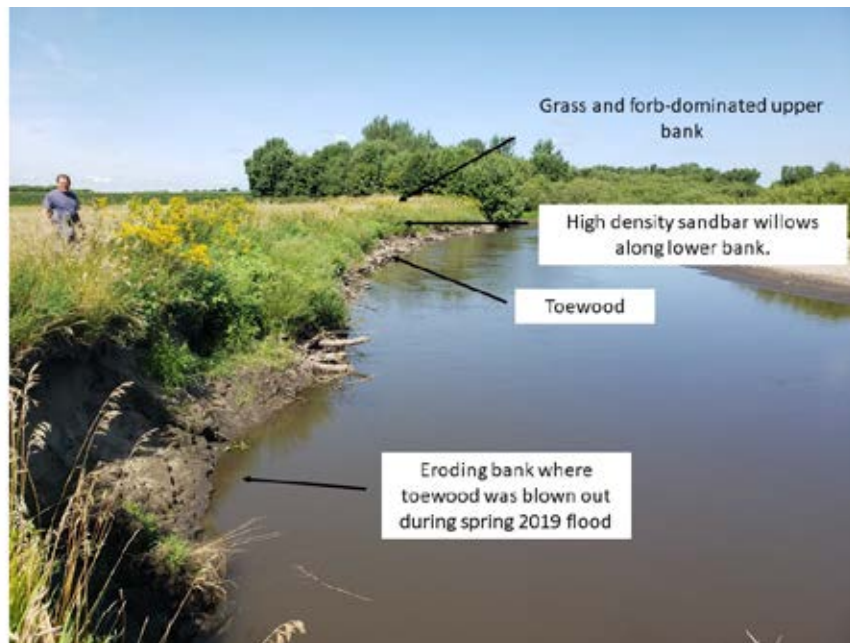
Photo 27-1. Looking upstream at the Upstream Bank (Bank 1). The upstream portion of the bank demonstrates the existing toewood used to stabilize the bank. Above the toewood, sandbar willow have colonized the lower bank. At the top of the bank, grasses and forbs comprise the majority of the cover. Approximately the last 50 feet of toewood blew out during spring 2019 flooding. (Photo taken 8/22/19 by Mark Prancus, Cardno).

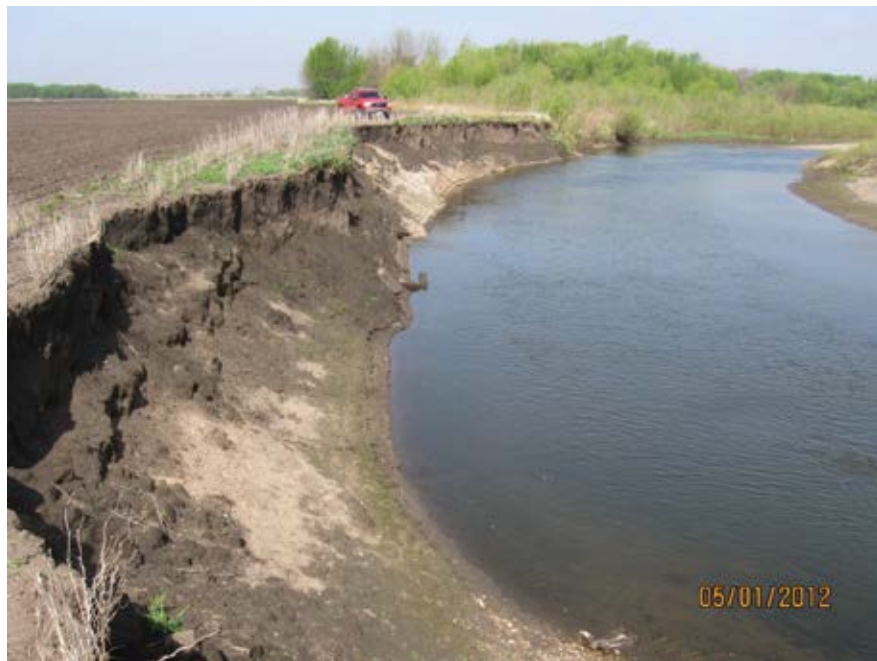
Photo 27-2. Looking upstream at the Upstream Bank (Bank 1) in 2012. In 2014, a significant flood event caused additional bank erosion prior to construction of the project (Photo provided by Scott Ralston, USFWS).

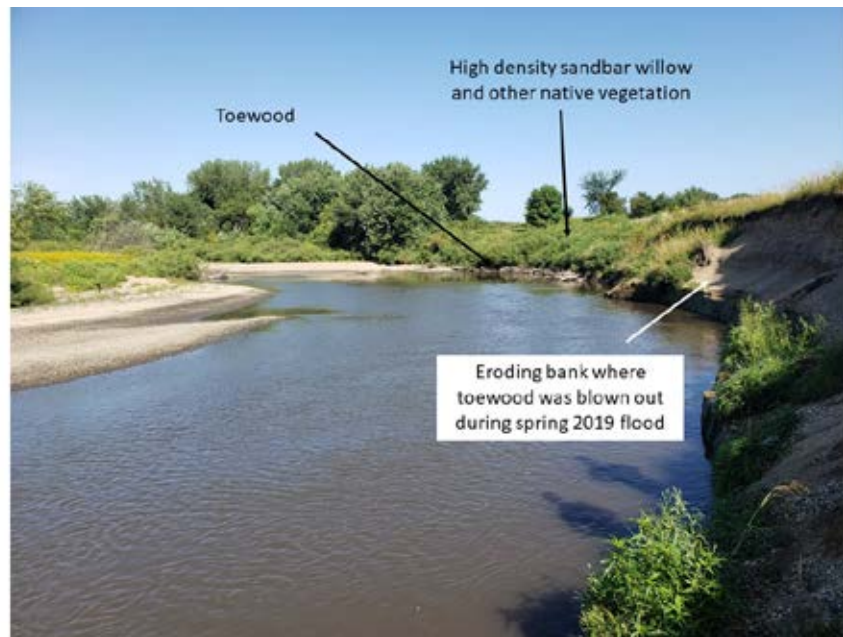
Photo 27-3. Looking upstream at the Downstream Bank (Bank 3). The upstream portion of the bank demonstrates the existing toewood used to stabilize the bank. Above the toewood, sandbar willow have colonized the lower and upper banks. At the top of the bank, primarily smooth brome and other comprise the majority of the cover. Approximately the last 150 feet of toewood blew out during spring 2019 flooding. (Photo taken 8/22/19 by Mark Prancus, Cardno).

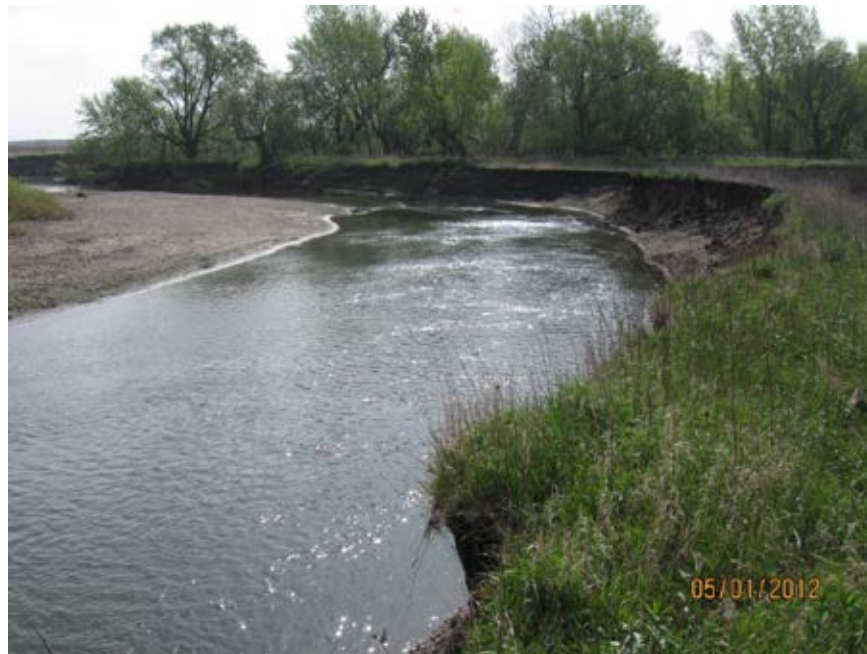
Photo 27-4. Looking upstream at the Downstream Bank (Bank 2) in 2012. In 2014, a significant flood event caused additional bank erosion prior to construction of the project (Photo provided by Scott Ralston, USFWS).
