Minnesota Department of Natural Resources
Minnesota Board of Water and Soil Resources

Appendix B: 2020 Legacy Fund Restoration Evaluation

Report March 2020

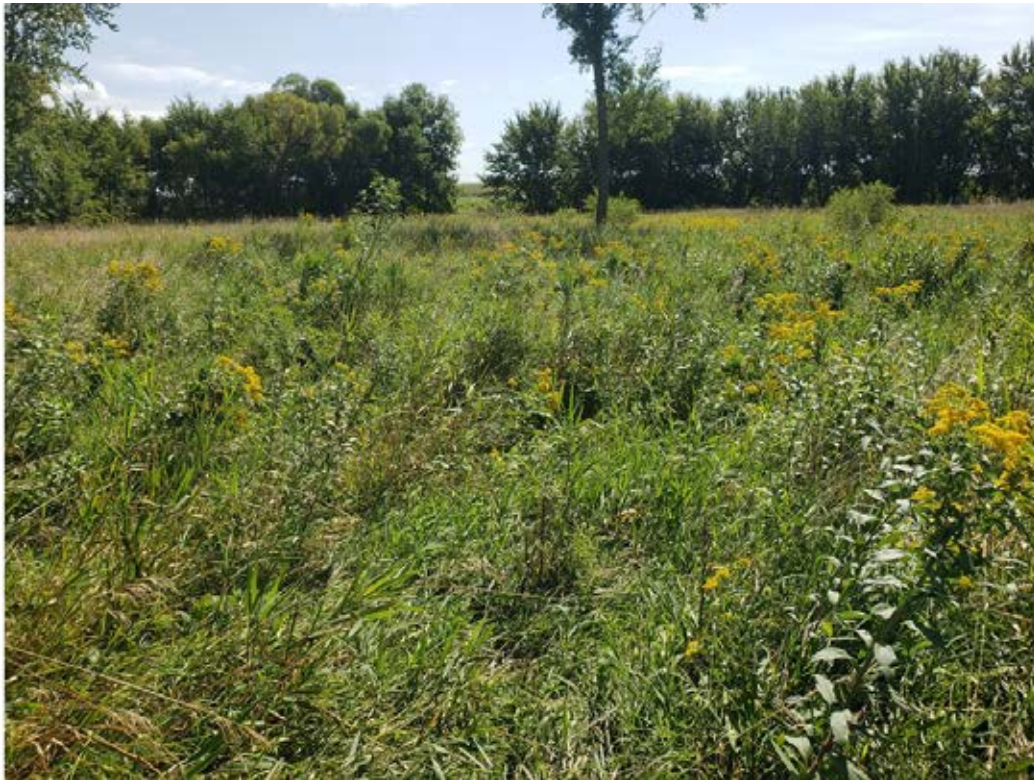
Photo 27-5. Looking at the area adjacent to the Upstream Bank where trees for the toewood were harvested. The site was re-seeded with a combination of native grasses and forbs. (Photo taken 8/22/19 by Mark Prankus, Cardno).

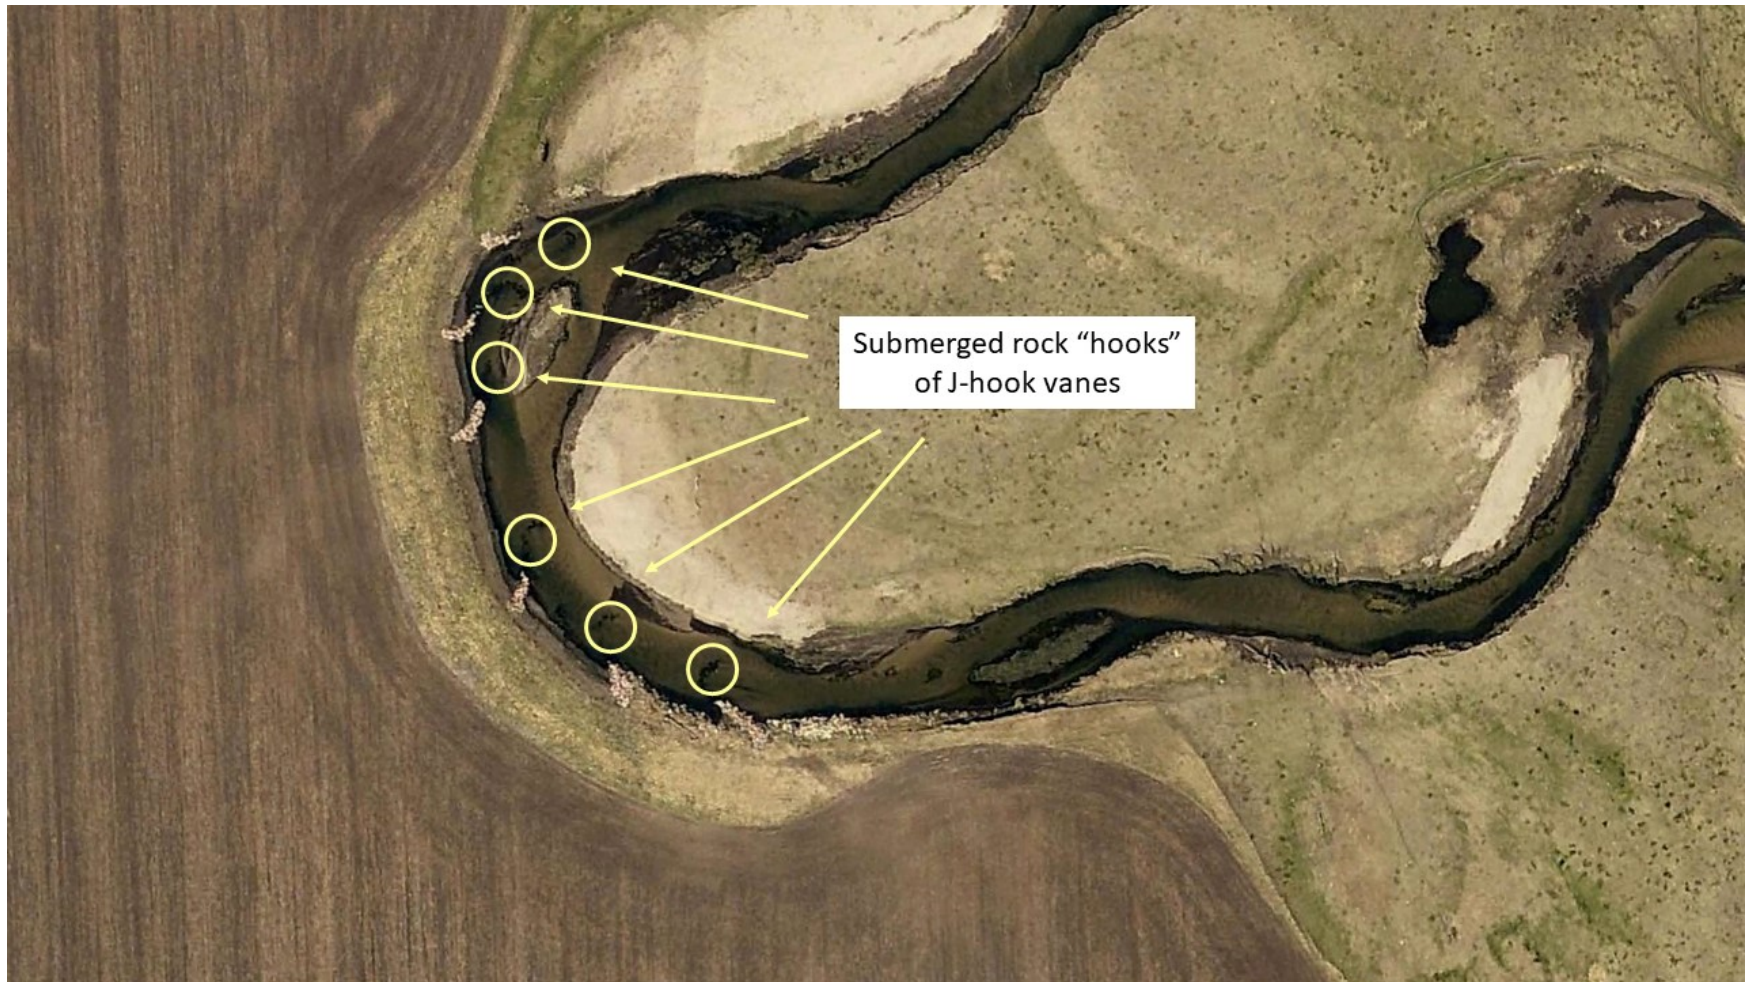
Figure 28-2. 2016 aerial of the upstream project area following construction. The six rock J-hook vanes are clearly visible including the submerged “hooks” highlighted with the circles. Aerial image provided by Rock County (<http://rock.houstoneng.com/>).

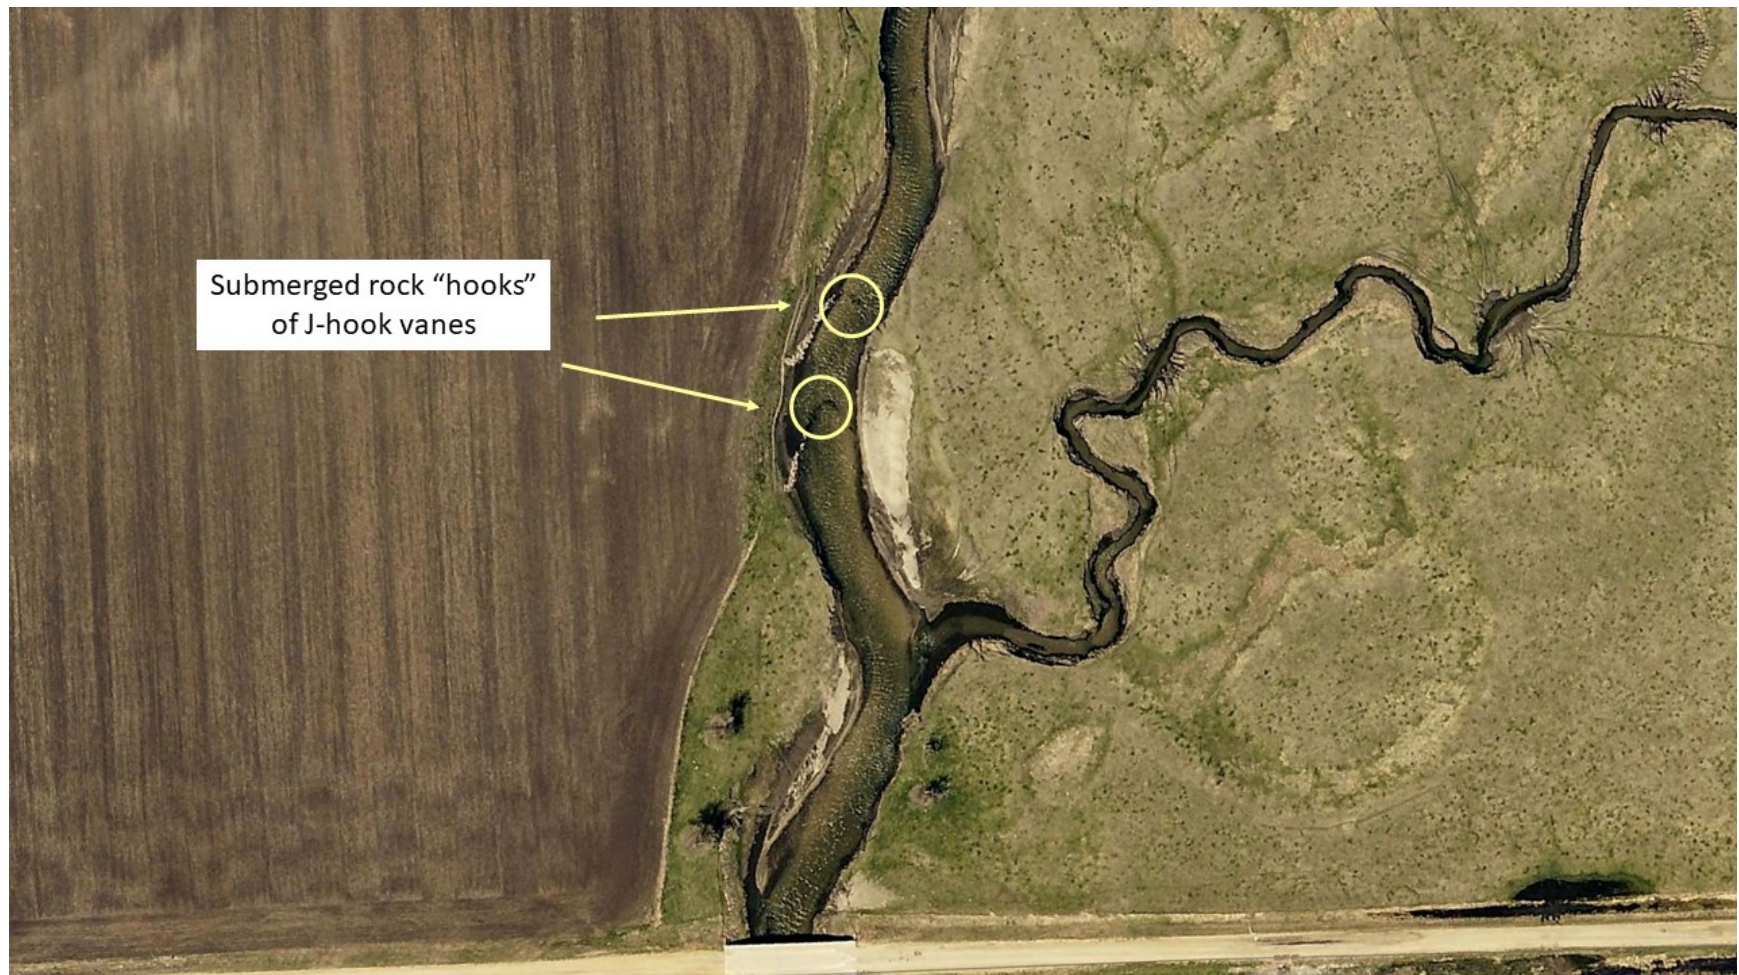
Figure 28-3. 2016 aerial of the downstream project area following construction. The two rock J-hook vanes are clearly visible including the submerged “hooks” highlighted with the circles. Aerial image provided by Rock County (<http://rock.houstoneng.com/>).

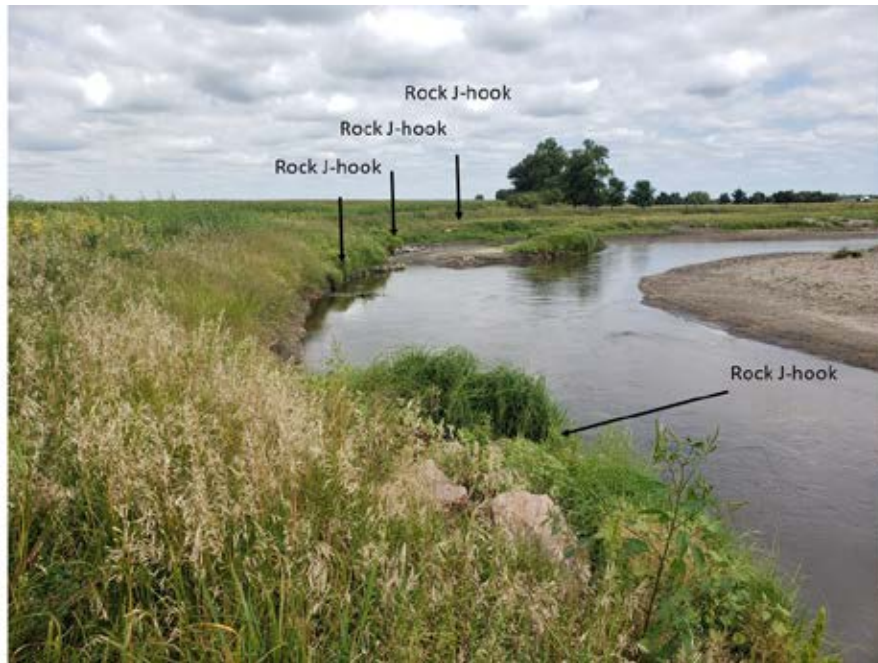
Photo 28-1. Looking upstream at the upstream project area. Locations of four of the six rock J-hook vanes are identified. Vegetation along the bank is 3 to 4 feet tall and well-established. (Photo taken 8/22/19 by Mark Prankus, Cardno).

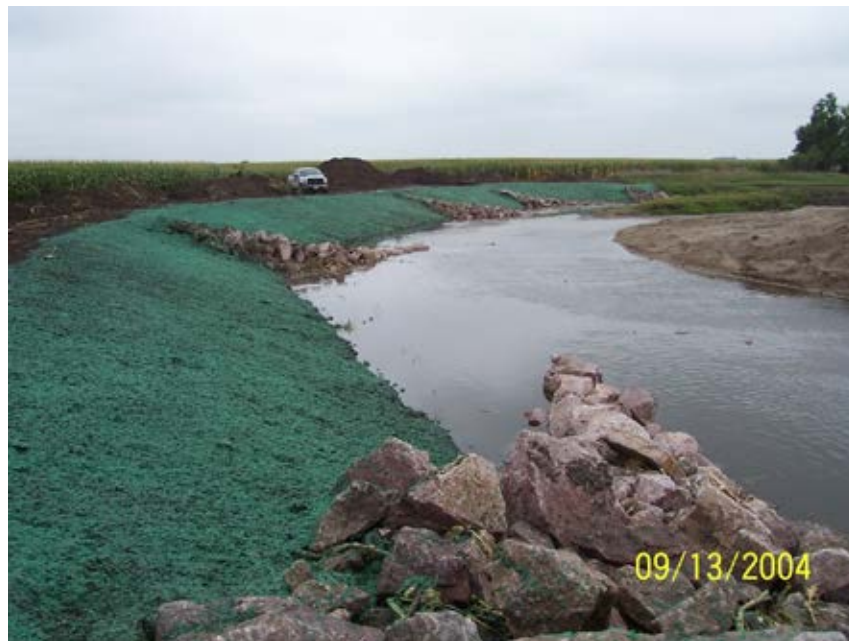
Photo 28-2. Looking upstream at the upstream project area following construction in 2014 showing five of the six rock J-hook vanes. The areas between the vanes were graded to a 3:1 slope hydroseeded with native seed mix. Notice when compared to Photo 28-1, the elevation of rock on several structures have decreased, potentially due to rock moving during high flows. Photo provided by Scott Ralston (USFWS)

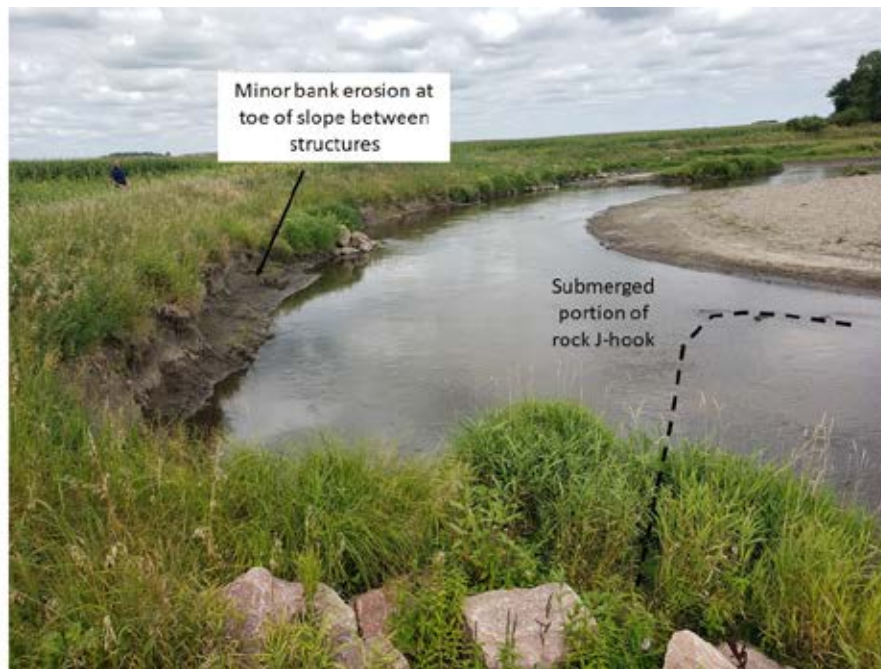
Photo 28-3. Looking upstream at the upstream project area. Minor bank erosion is occurring along the toe between J-hook vanes No. 4 and 5. (Photo taken 8/22/19 by Mark Prankus, Cardno).

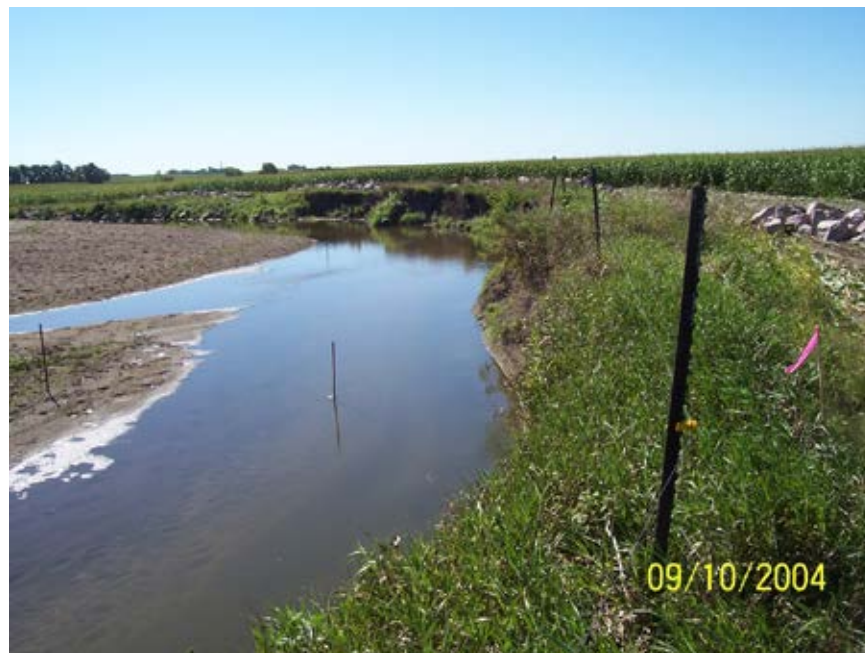
Photo 28-4. Looking downstream near the upstream end of the upstream project area prior to construction in 2014. Note the nearly vertical, severely eroding banks. Rocks used to create the J-hook vanes can be observed along the top of the bank. Photo provided by Scott Ralston (USFWS).

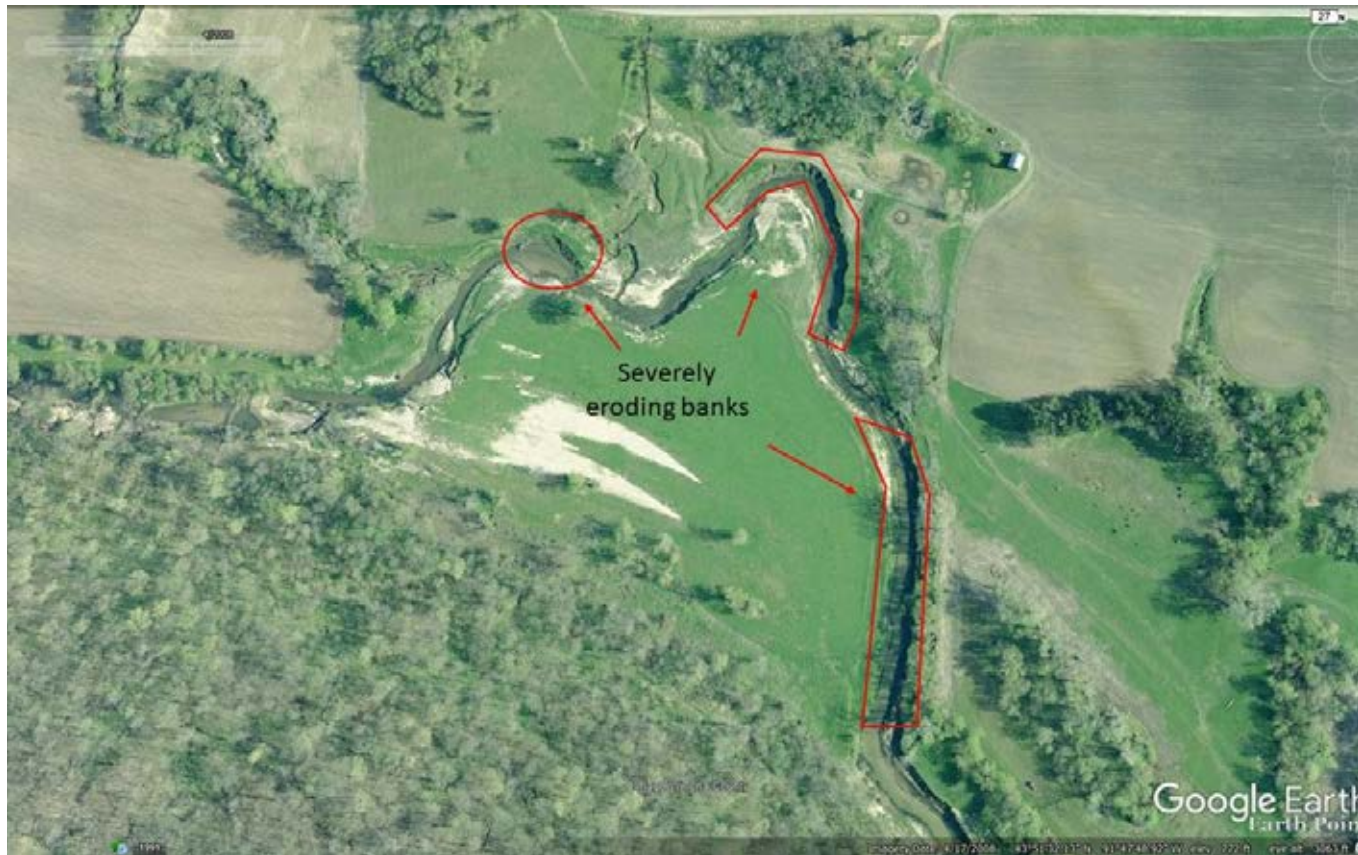
Photo 29-2 Aerial image of the project site from 2008, prior to construction in 2011. Areas highlighted in red indicate severely eroding banks. Aerial photography is from April 2008 and provided by Google Earth.

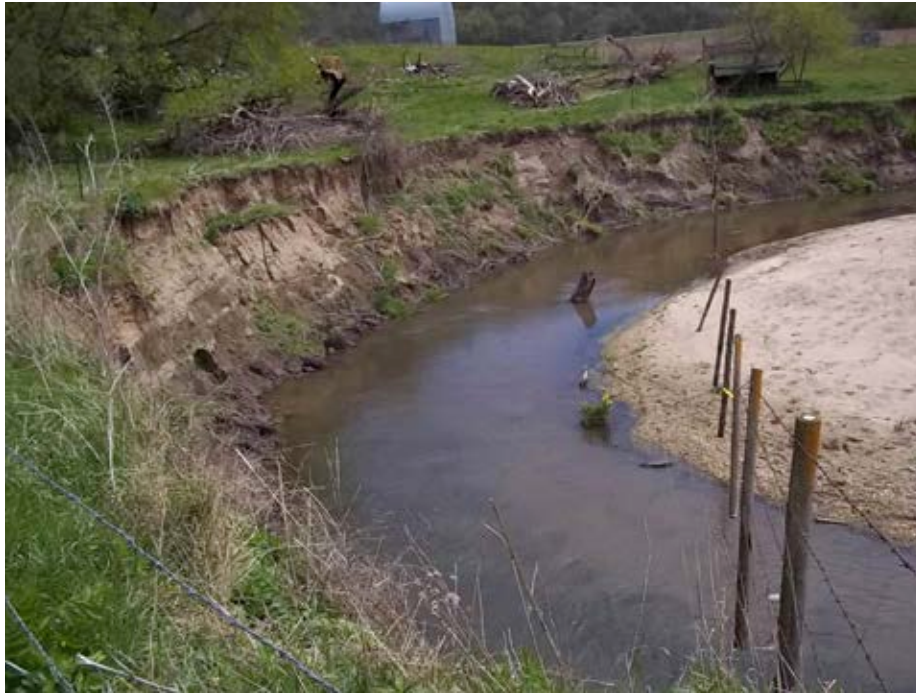
Photo 29-3 Example of an eroding bank taken in 2011 prior to the construction project. Photo provided by John Lenczewski, MNTU.

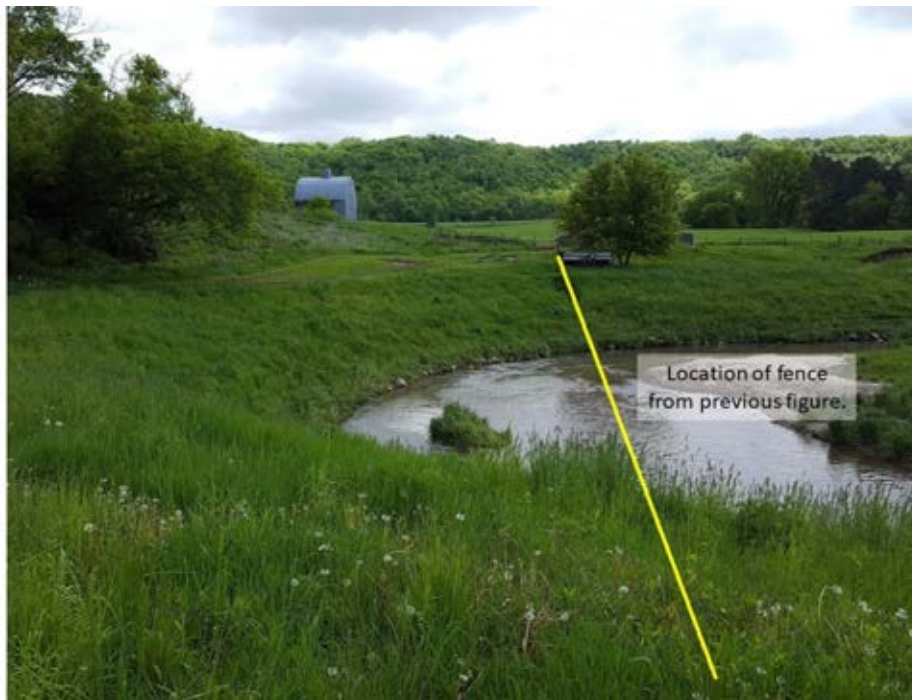
Photo 29-4 Example of the same bank as Photo 29-1 in July 2019, 8 years after the project was completed. Photo provided by John Lenczewski, MNTU.

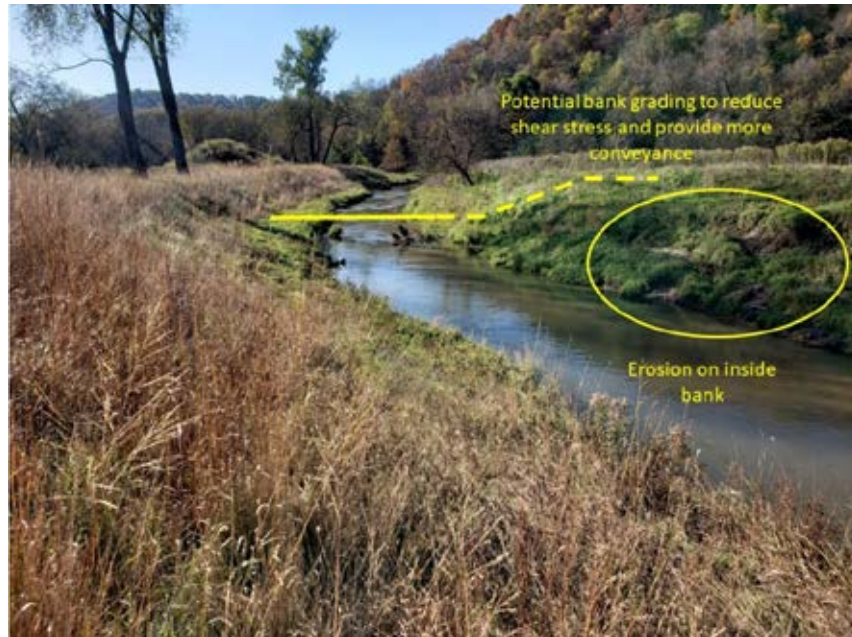
The floodplain connection goal is probably the weakest under the current design. In the upper two-thirds of the project area there was at least some bank grading on the point bars and inside bank. On the lower third, there was none and that's where the most current erosion and bank slumping is occurring. It's currently nothing like previous conditions. A missed opportunity, likely driven by NRCS specifications and funding at the time, would have been to lower at least one bank to provide greater flood conveyance and floodplain connection for higher frequency floods. The obstacle likely was, and still is, the cost associated with moving a large amount of soil to accomplish the desired outcome. Increased duration, intensity, and frequency of flooding will present future changes and limitations to maintaining project success. The project received a significant flood event in the summer 2019 and had limited negative impacts. If the project area were to receive several more similar type events in consecutive years, some of the vegetative bank protection may be impacted causing the potential for bank erosion. Currently, a portion of the project area is grazed and a portion has been grazed in the past, but it was not currently grazed at the time of the assessment. Continuous, unmanaged grazing through the project would represent a potential challenge to the stability of the site

Photo 29-5 Example of looking downstream at the lower third of the project. A bench is forming on the left downstream bank where sediment is depositing on top of riprap. The dashed line represents where grading could have occurred to further improve floodplain connection and promote stream stability. Photo taken on 10/18/19 by Mark Pranckus, Cardno.

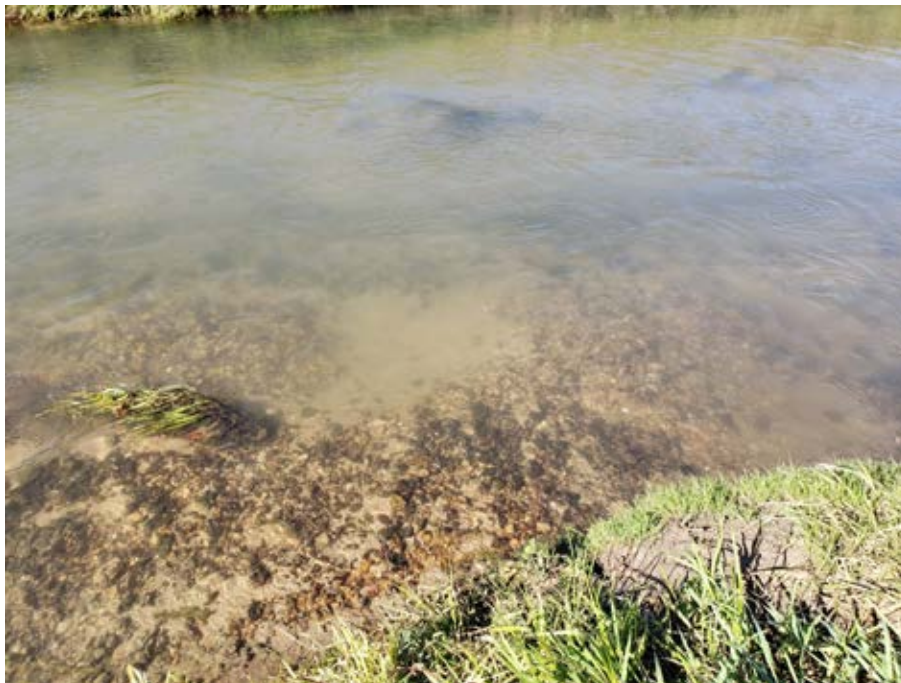
- Trout were observed on a spawning bed during the assessment where gravel had deposited due to the influence of a cross vane and random boulder clusters.

Photo 29-10 Example of small gravel associated with a downstream cross vane and upstream random boulder cluster. Gravel serves as a spawning location for trout where they make a depression to lay eggs (redd). Adults were observed on a redd during the field assessment. Photo taken on 10/18/19 by Mark Prancus, Cardno.

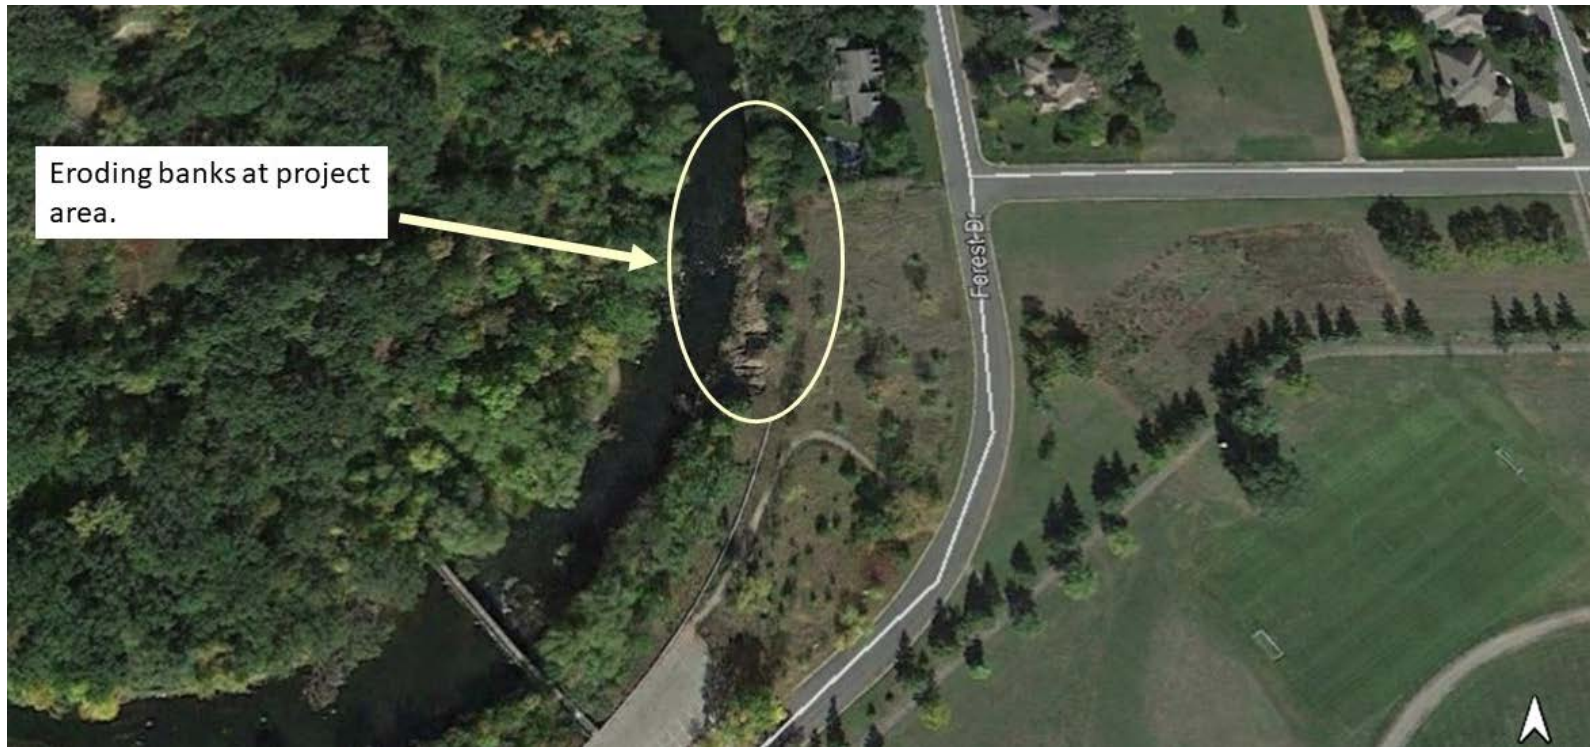
Figure 30-2. Aerial image of the project site in 2013 prior to the construction project. The area highlighted in the circle demonstrates the severely eroding bank. Aerial photography is from September 2013 and provided by Google Earth (link <http://www.google.com/earth/download/ge/>).

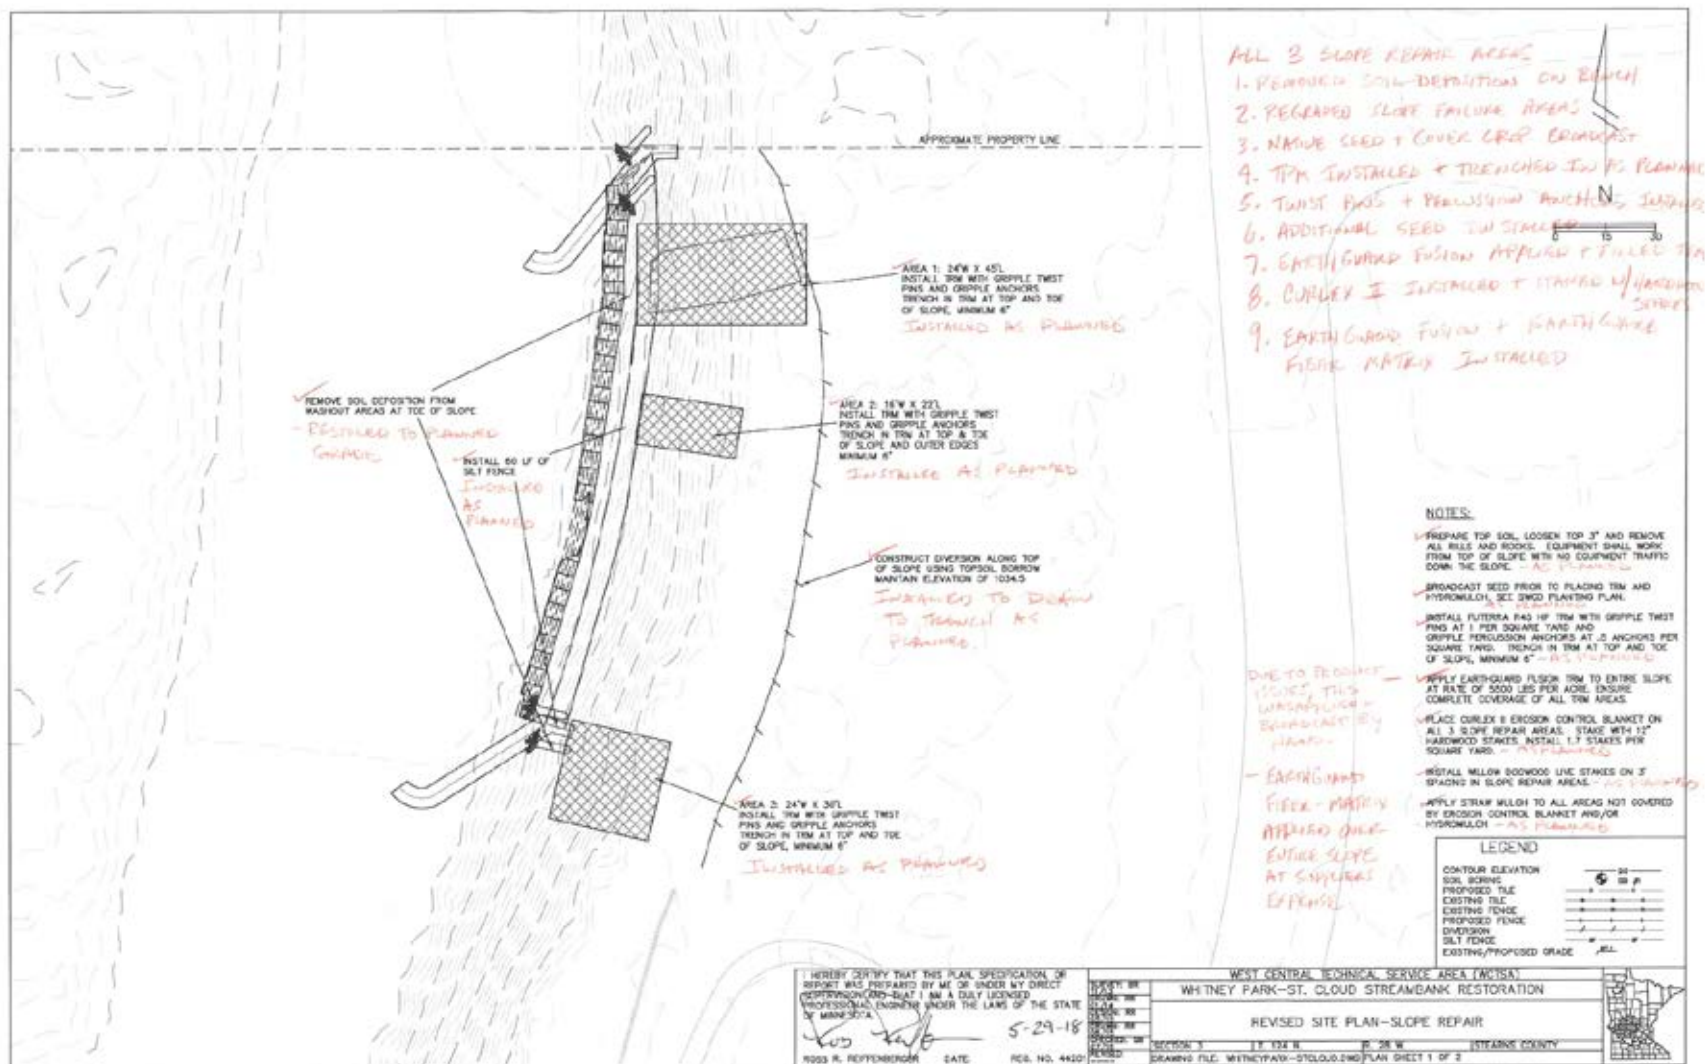
Repairs were made to three areas along the upper slope to groundwater seeps causing slope failures post-project. Two iterations of the repairs were required to stabilize the slope. The first iteration used heavy duty erosion control materials including turf reinforcement matting and a technical anchoring system. The second iteration used draintiles to capture groundwater and carry it to the bottom of the slope to prevent bank saturation and slumping.

Figure 30-11. Sheet 2 of the as-built construction plan set for the slope repairs following construction. The sheet details the drain tile slope and details of the tile installation.

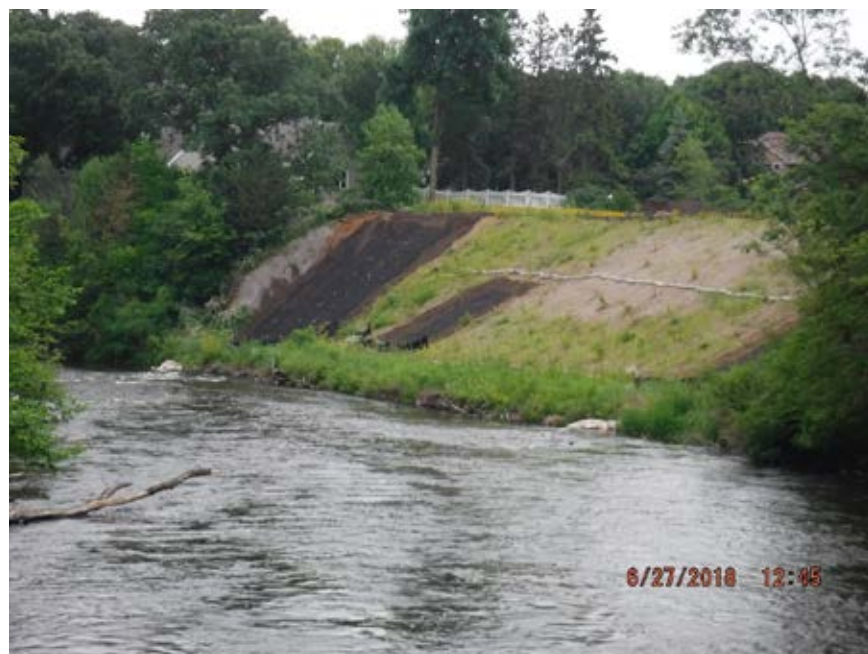
Photo 30-2. View looking downstream to the project area on the right hand side of the image after follow-up planting where vegetation had not established and robustly. (Photo provided by project partners, taken 6/27/2018).

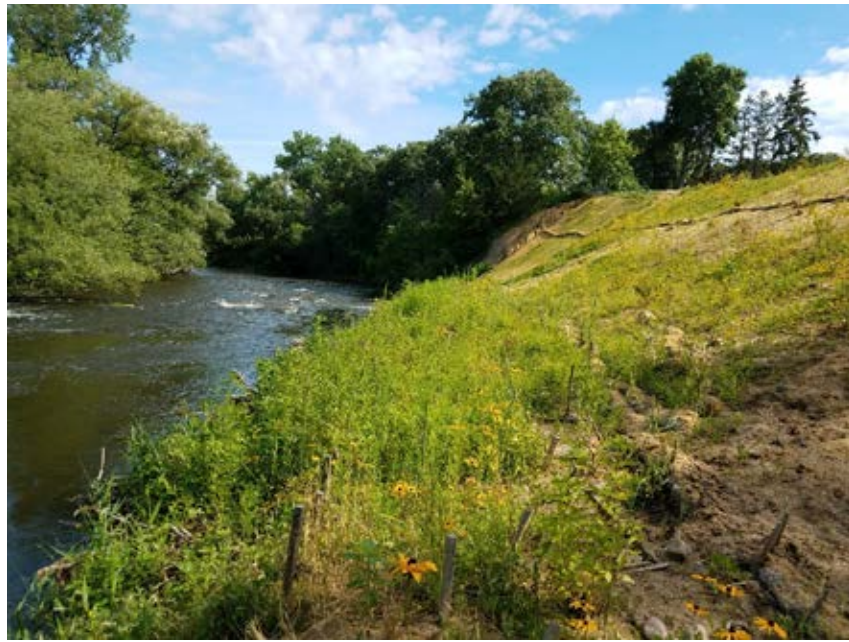
Photo 30-3. View looking downstream to the project area on the right hand side of the image after second planting. (Photo provided by project partners, taken 7/18/2018).

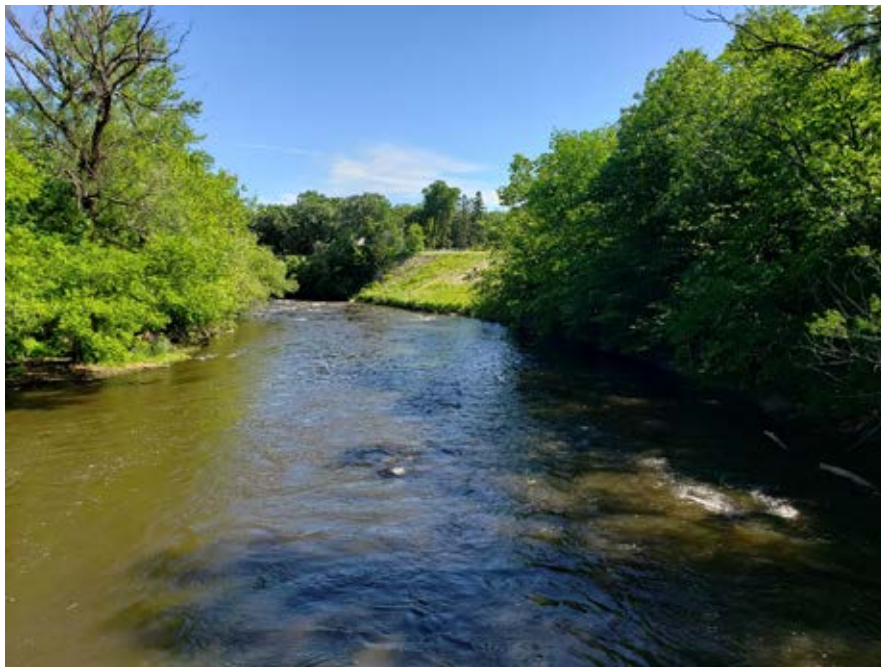
Photo 30-4. View looking downstream to the project area on the right hand side of the image. Photo was taken from the pedestrian bridge where the low head dam was removed. (Photo taken 6/26/19 by Mark Prancus, Cardno).

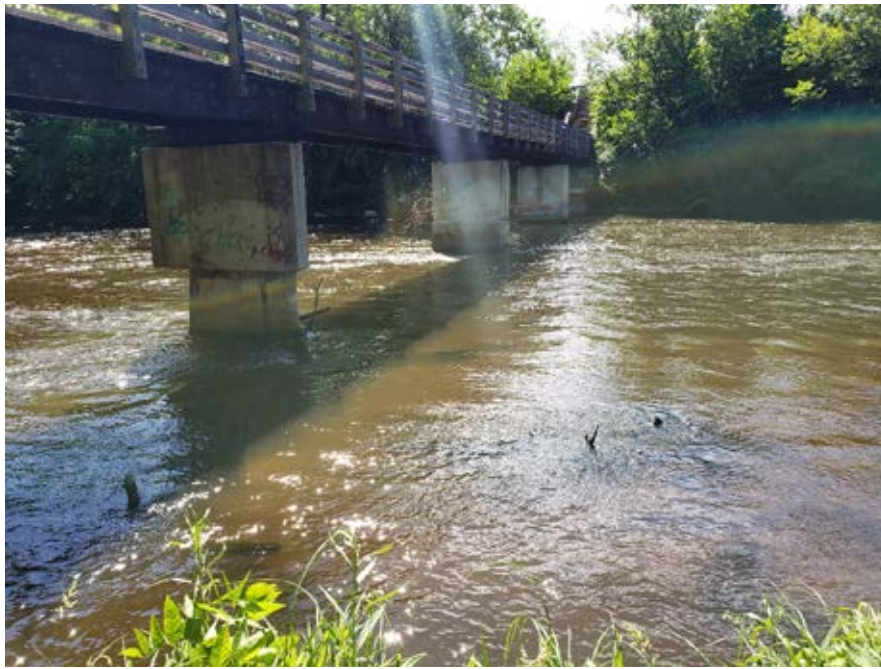
Photo 30-5. Looking at the form location of the low head dam at the top of the project. The dam was higher through the middle section than on the sides pushing water against the bank on the downstream end. (Photo taken 6/26/19 by Mark Prankus, Cardno).

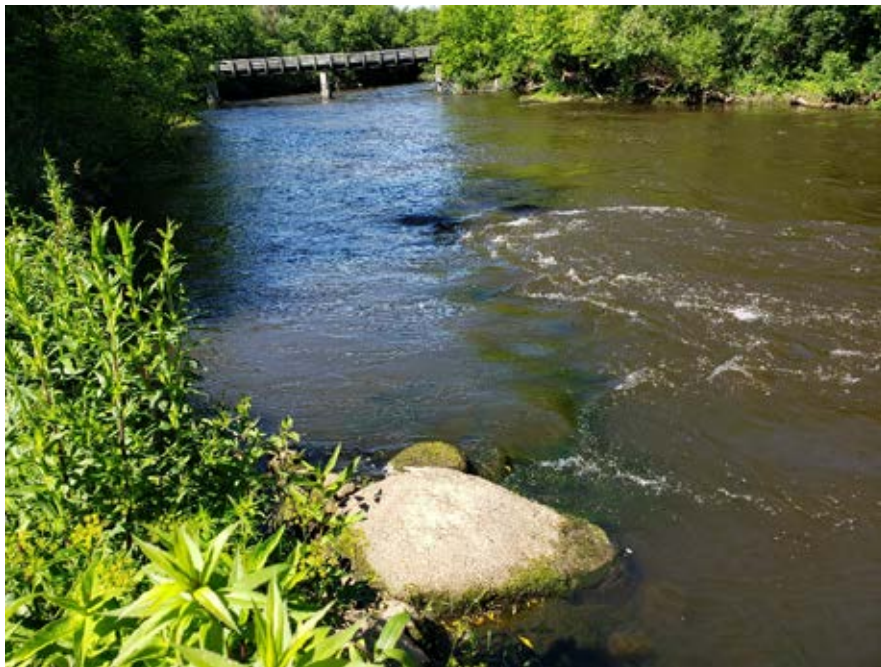
Photo 30-6 – Looking upstream at the upstream stream barb from the toewood bench. The majority of the stones for the barb are submerged, but are deflecting flow to the center of the channel and away from the treatment bank. (Photo taken 6/26/19 by Mark Prankus, Cardno).

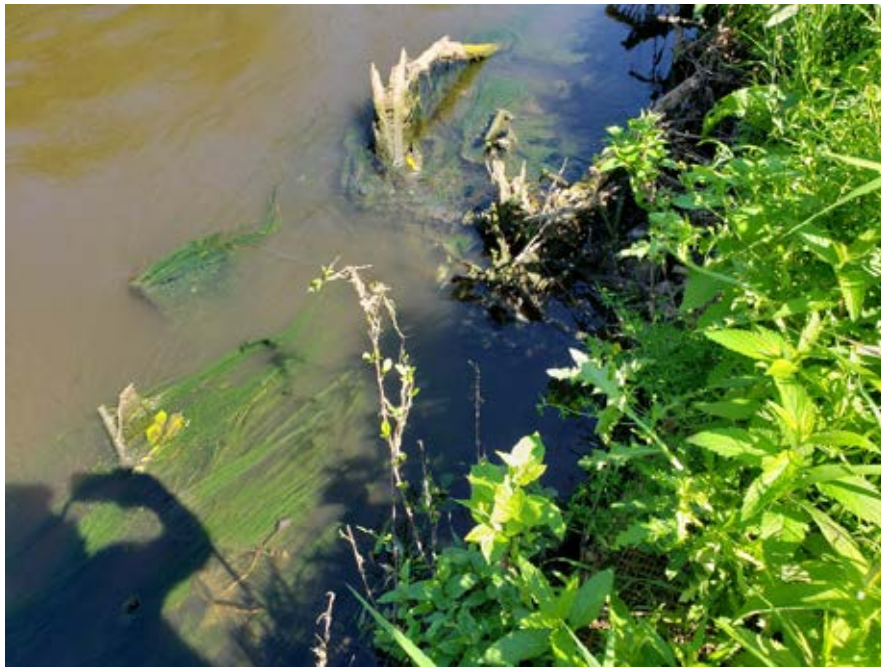
Photo 30-7. Example of the toewood bench on the treatment bank. Typically in the toewood installations the majority of the rootwads, logs, and other coarse woody material remains submerged to prevent rotting, reduce shear stress against the bank, and provide aquatic habitat for fish and invertebrates. (Photo taken 6/26/19 by Mark Prankus, Cardno).

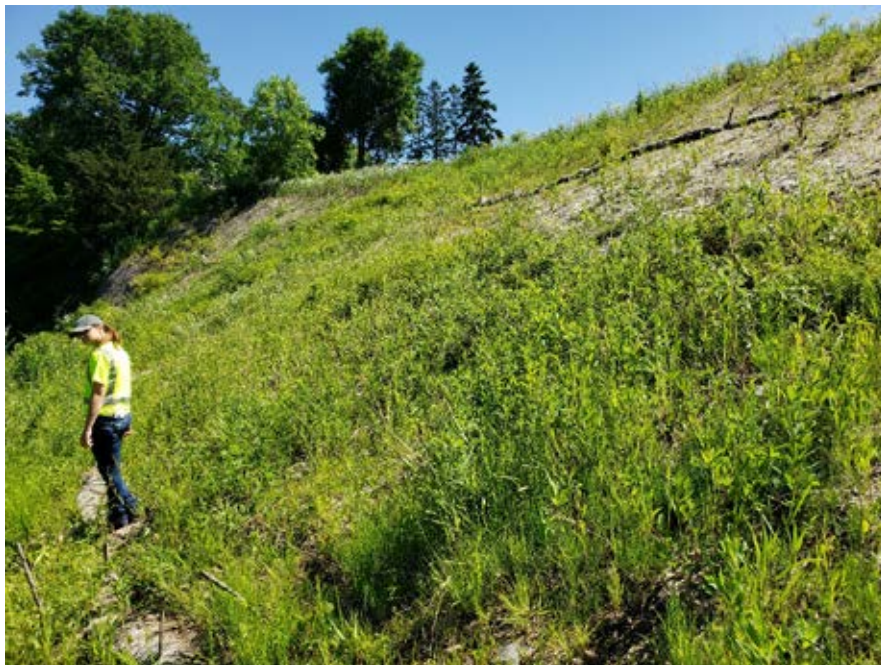
Photo 30-8. Example of vegetation development on the treatment bank. Vegetation on the bench and the lower portion of the slope are developing nicely. Bare areas on the upper slope where additional repairs were completed can be observed, but will fill in over time. (Photo taken 6/26/19 by Mark Prankus, Cardno).

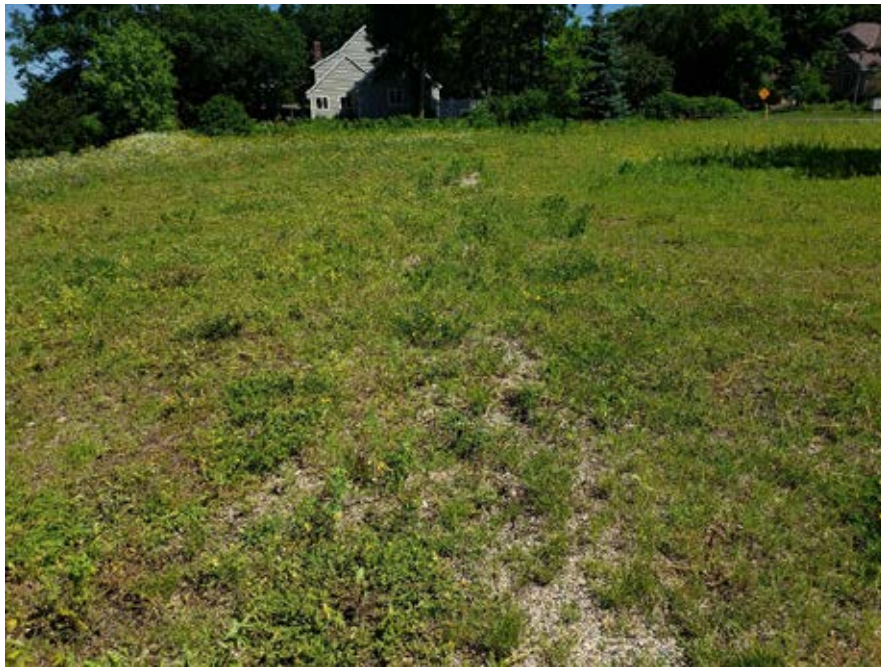
Photo 30-9. Example of the native vegetation seeded at the top of the slope to control surface water. Water flowing on the surface during storm events is ponded and captured in the French drain and is routed via drain tile to the base of the slope. (Photo taken 6/26/19 by Mark Prancus, Cardno).

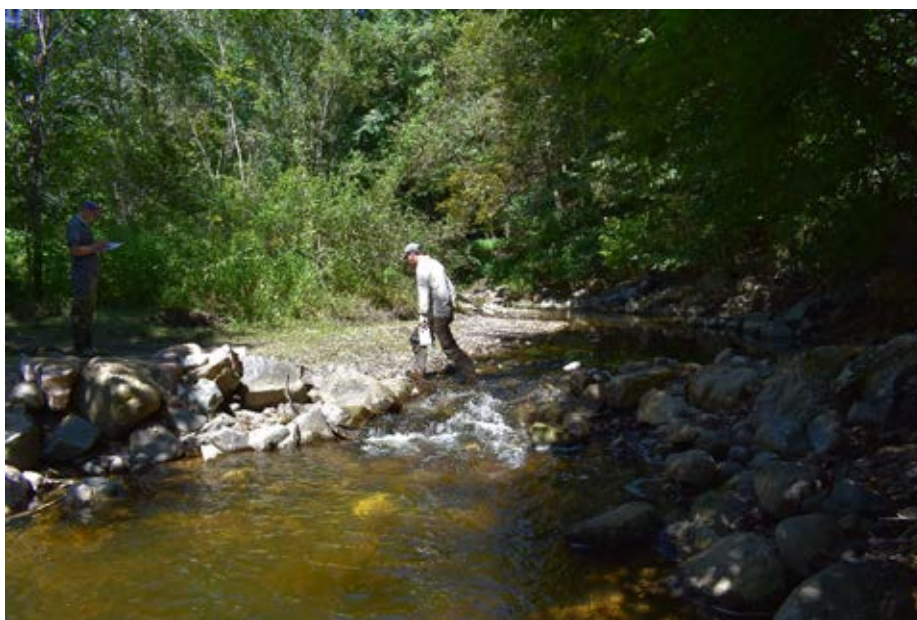
Photo 31-2 Upstream most riffle observed during site visit. (Seven Mile Creek County Park, photo taken during site visit 08/30/2019).

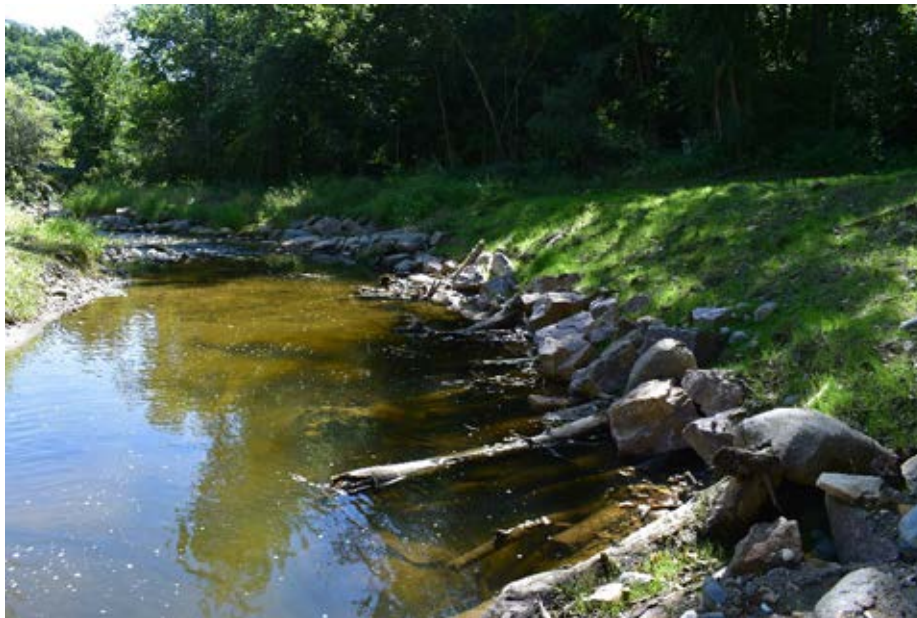
Photo 31-8 Cribwall bank after reconfiguration from parallel to streambank to perpendicular and placement of additional stone for ballast during final stream maintenance activities in August 2019. (Seven Mile Creek County Park, photo taken during site visit 08/30/2019).

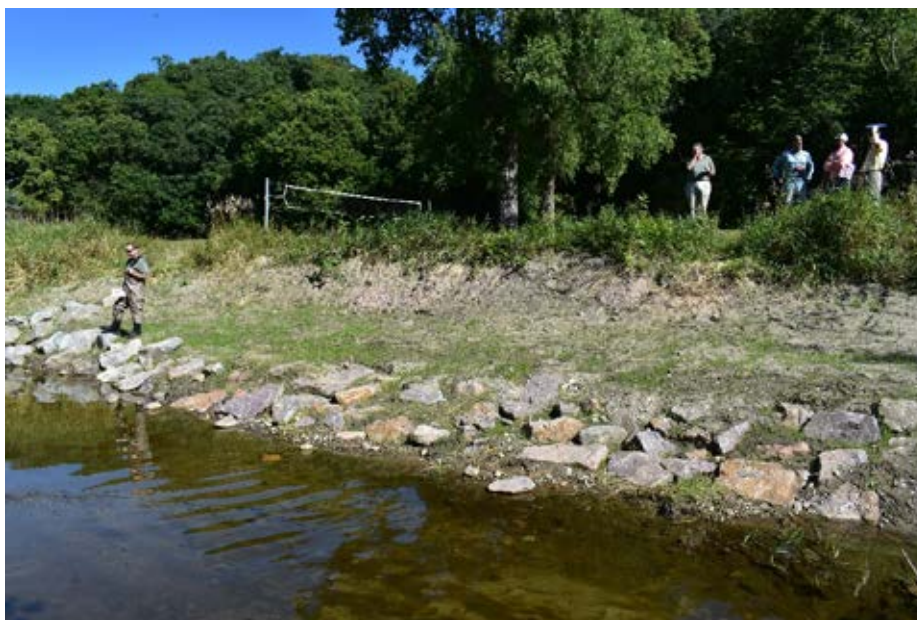
Photo 31-10 Bank regrading creating floodplain terrace within the incised channel completed during final streambank maintenance activities in August 2019. (Seven Mile Creek County Park, photo taken during site visit 08/30/2019).

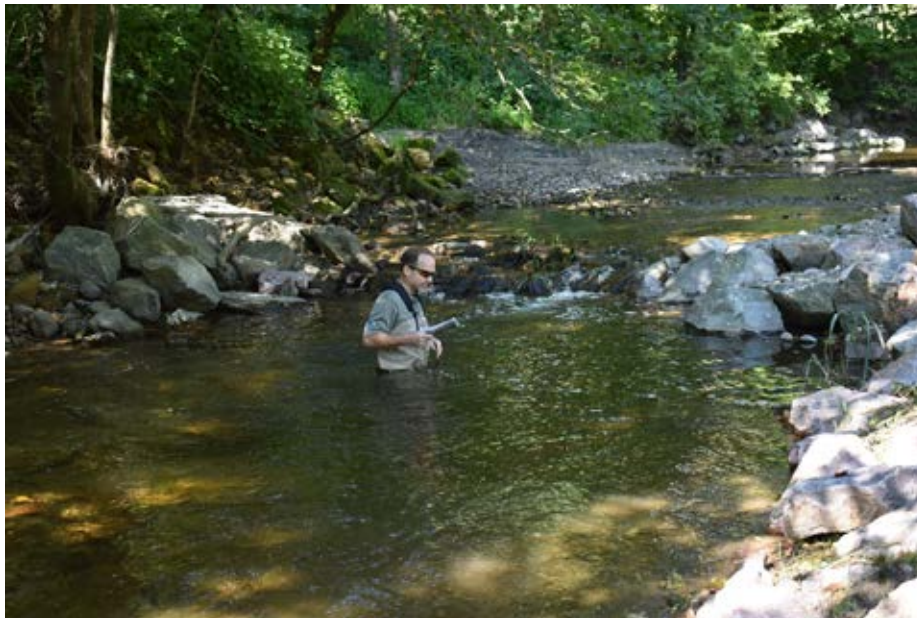
Photo 31-11 Proof of pool depth. (Seven Mile Creek County Park, photo taken by Lucius Jonett during site visit 08/30/2019).

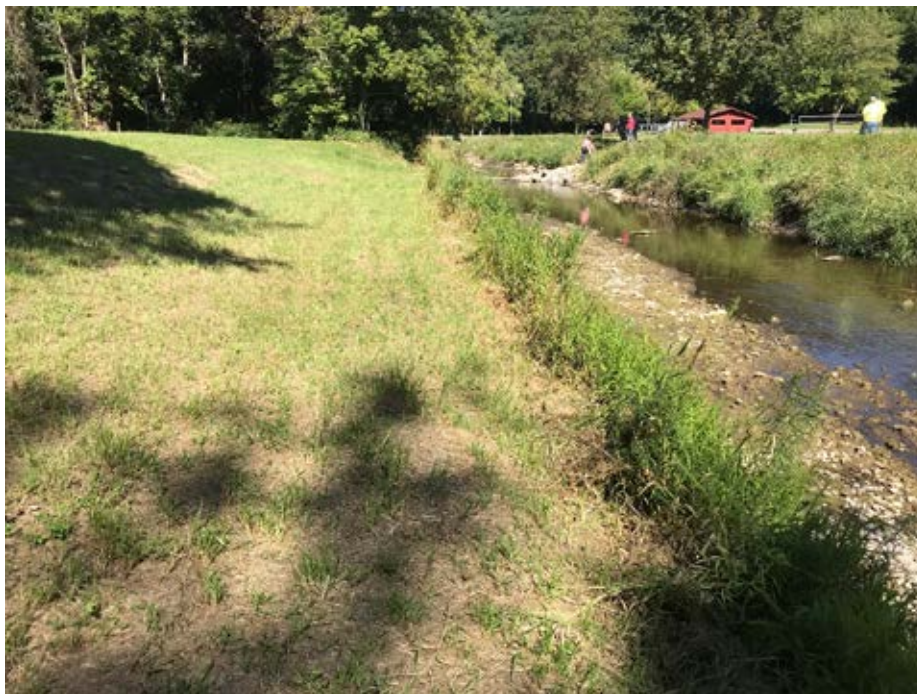
Photo 31-12 Park maintenance mowing off the stream buffer to the top of the stream bank. (Seven Mile Creek County Park, photo taken by Lucius Jonett during site visit 08/30/2019).
