Minnesota Department of Natural Resources
Minnesota Board of Water and Soil Resources

Appendix B: 2020 Legacy Fund Restoration Evaluation

Report March 2020

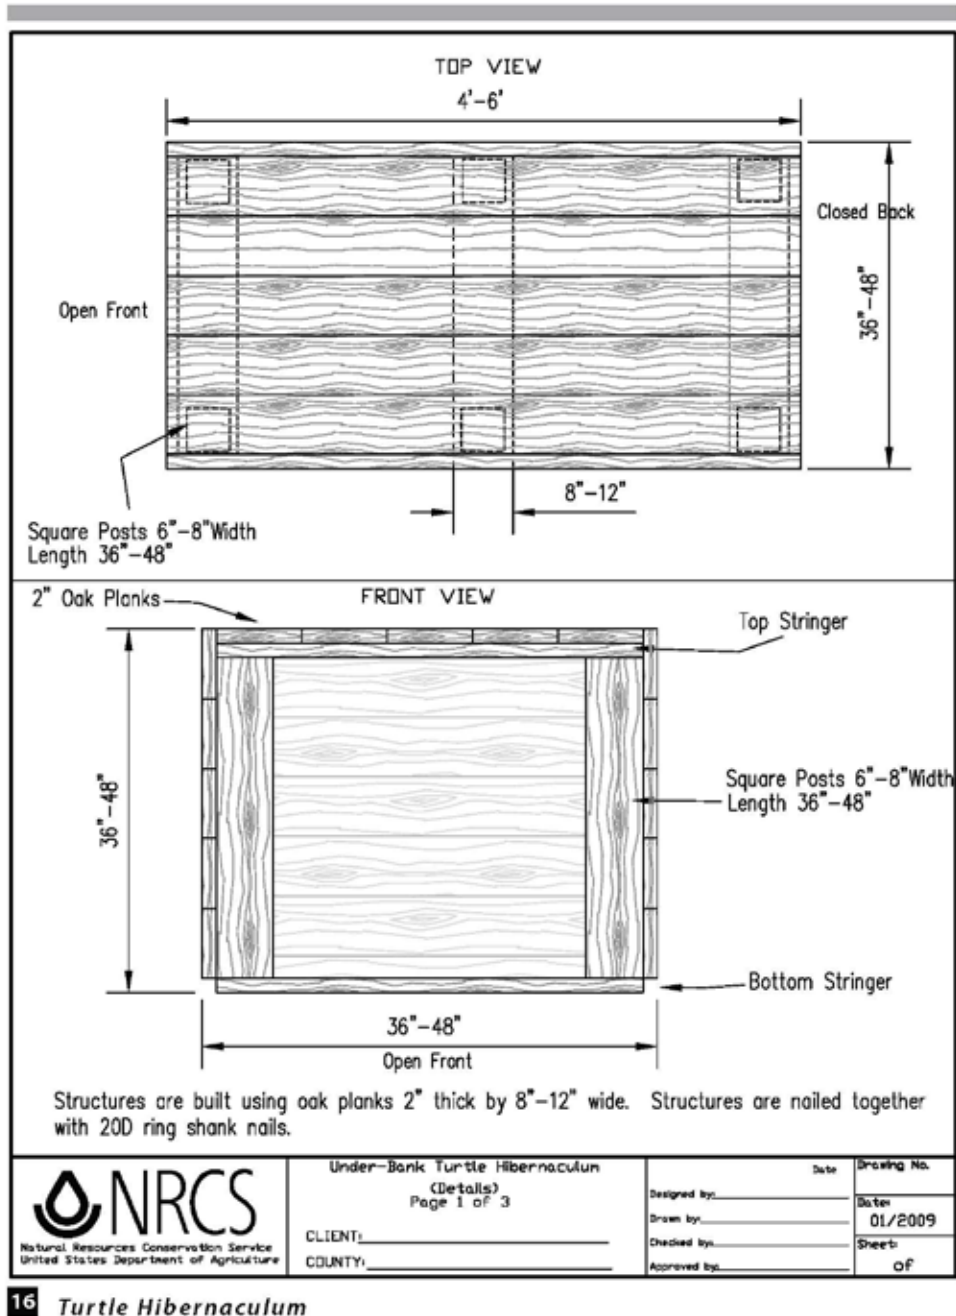
Figure 32-14 Wedge Creek Reach 3 NRCS habitat improvement construction detail. Similar plans were included for the other project reaches. During construction, the turtle hibernaculum were constructed out of limestone rock versus the wood shown in the construction detail.

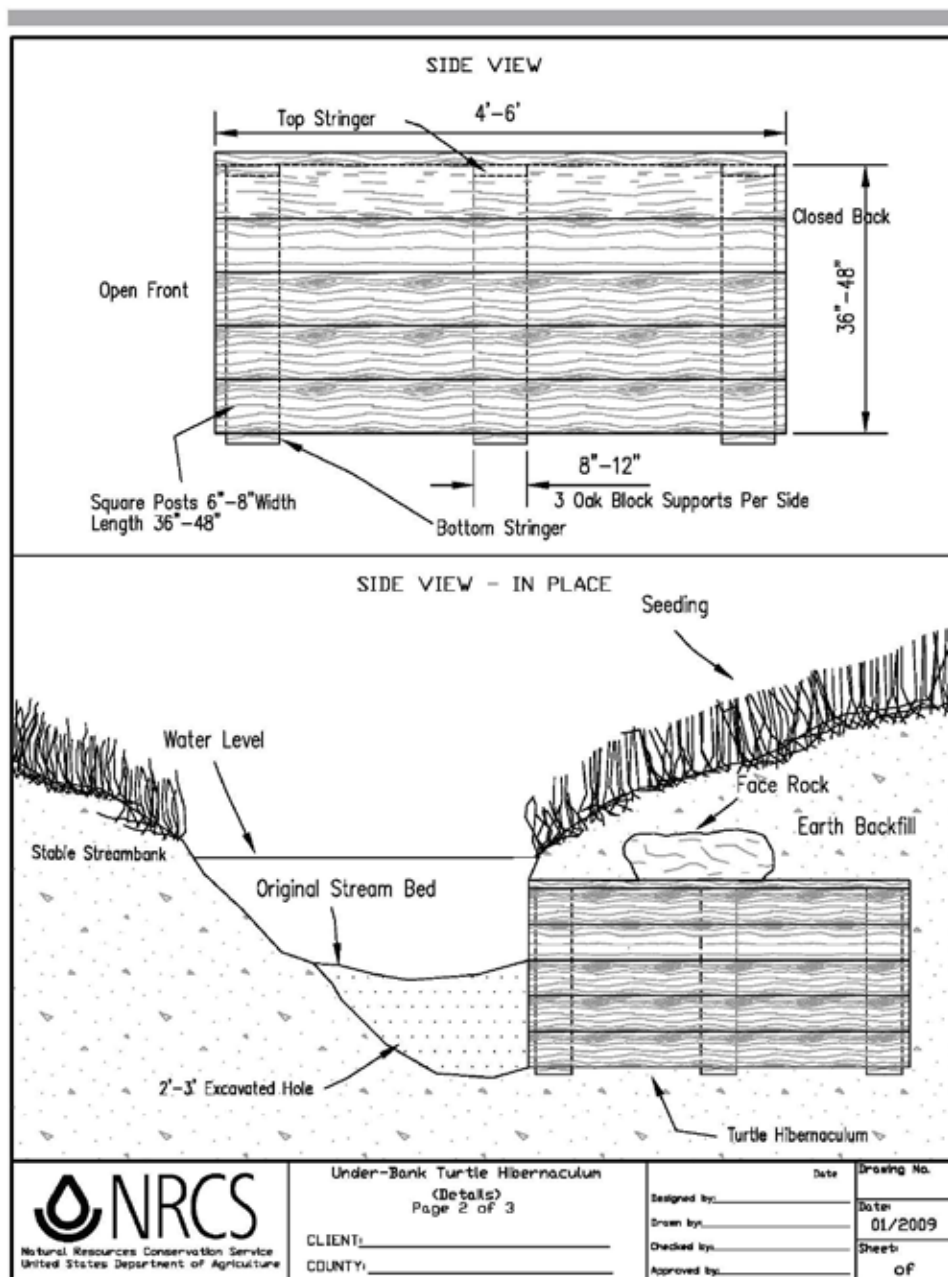
Turtle Hibernaculum 17

Figure 32-15 Wedge Creek Reach 3 NRCS habitat improvement construction detail. Similar plans were included for the other project reaches. During construction, the turtle hibernaculum were constructed out of limestone rock versus the wood shown in the construction detail.

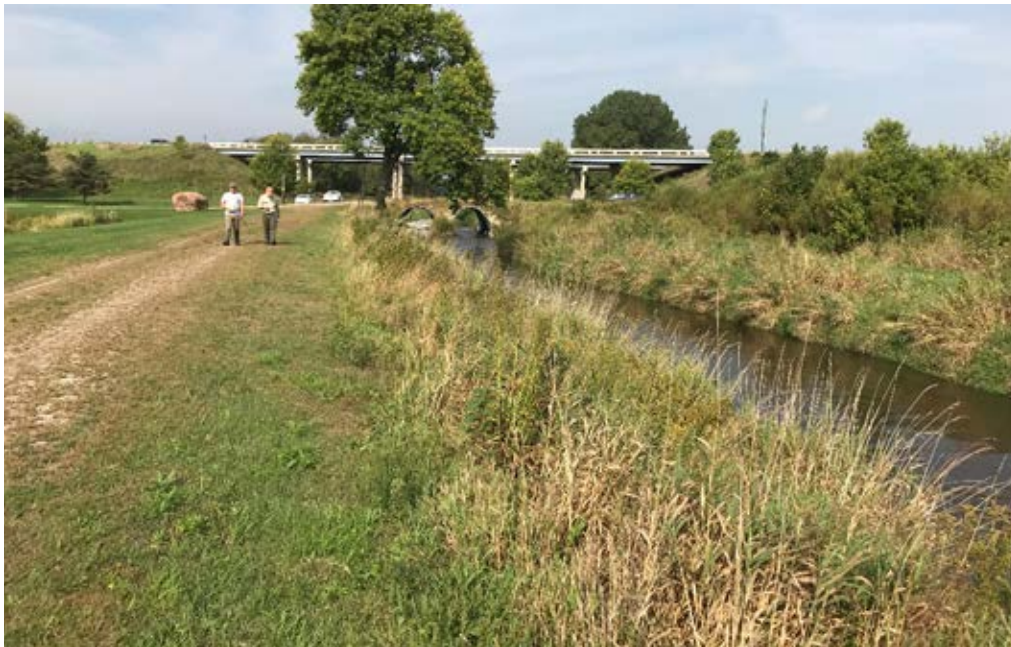
Photo 32-2 Photo looking upstream at the 12' replacement culverts. Straightened channel is typical of what is found upstream in the agriculture landscape. (Wedge Creek – Reach 6, photo taken by Lucius Jonett during site visit 09/20/2019).

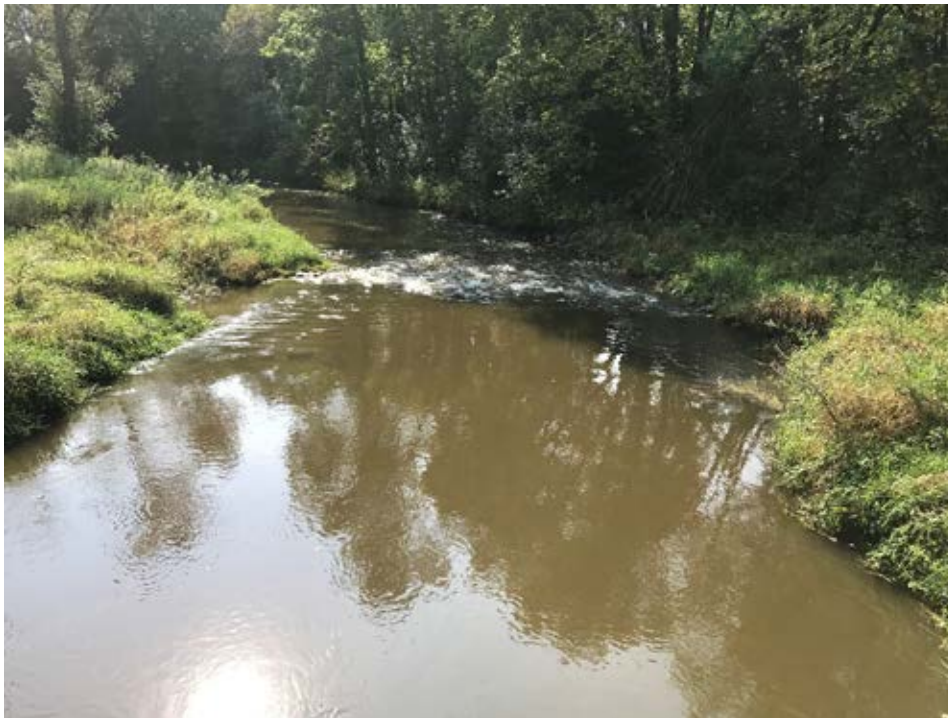
Photo 32-4 Rock vane installed on the reach 6 project of Wedge Creek. Stream water is very turbid following 1.88" of rain the previous day and is assumed to be a result of agriculture drainage upstream. (Wedge Creek – Reach 6, photo taken by Lucius Jonett during site visit 09/20/2019).

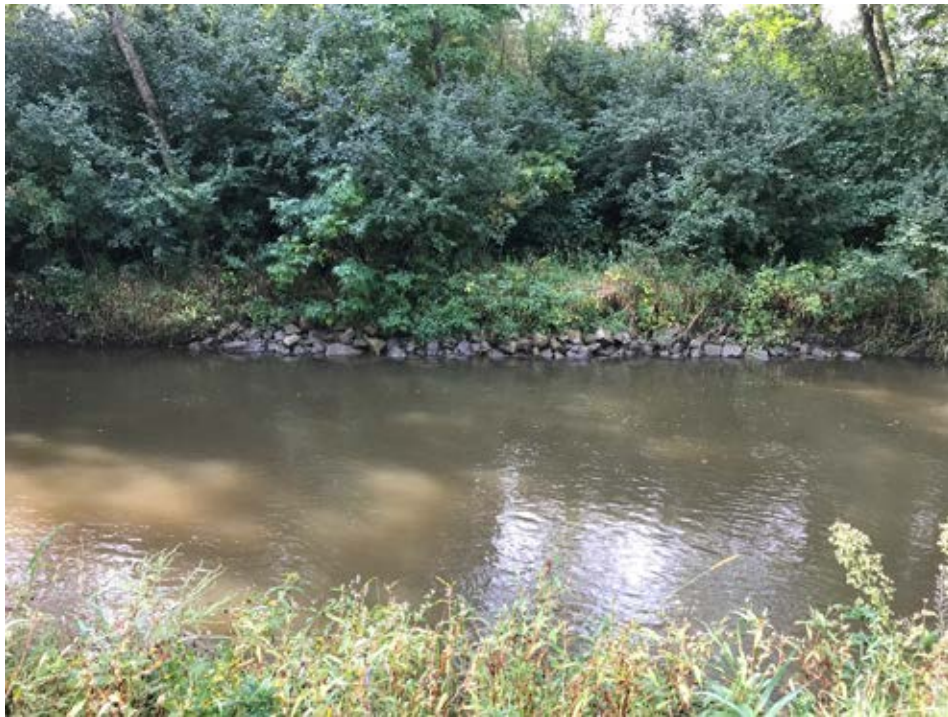
Photo 32-5 Riprap toe installed on the reach 6 project of Wedge Creek. (Wedge Creek – Reach 6, photo taken by Lucius Jonett during site visit 09/20/2019).

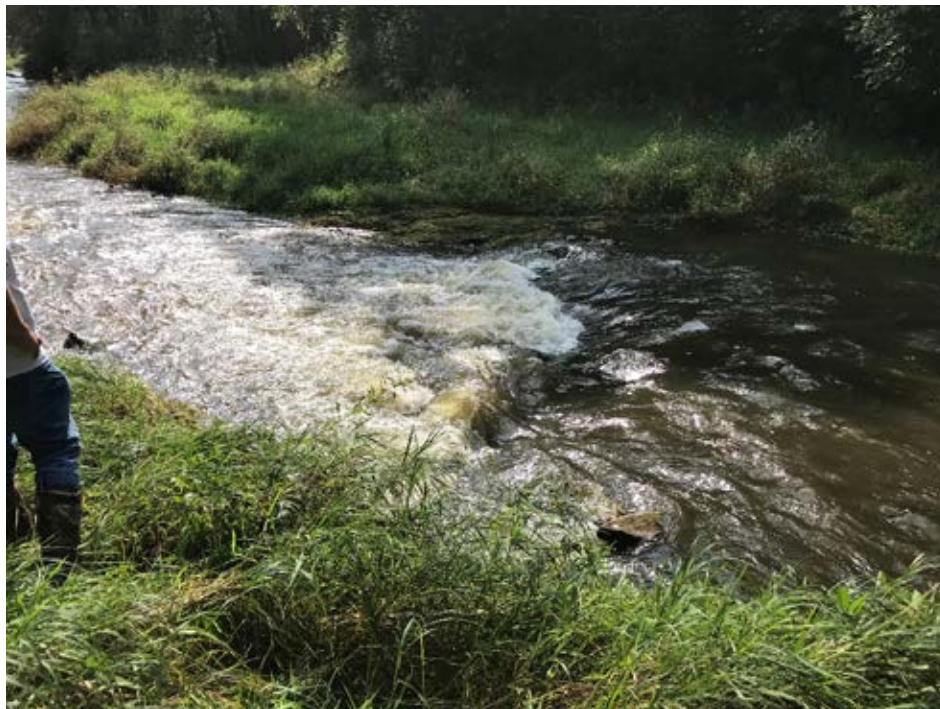
Photo 32-6 Cross log installed on the Reach 5 project of Wedge Creek. Cross log was located based on landowner input to create and maintain a wet crossing upstream of the cross log. (Wedge Creek – Reach 5, photo taken by Lucius Jonett during site visit 09/20/2019).

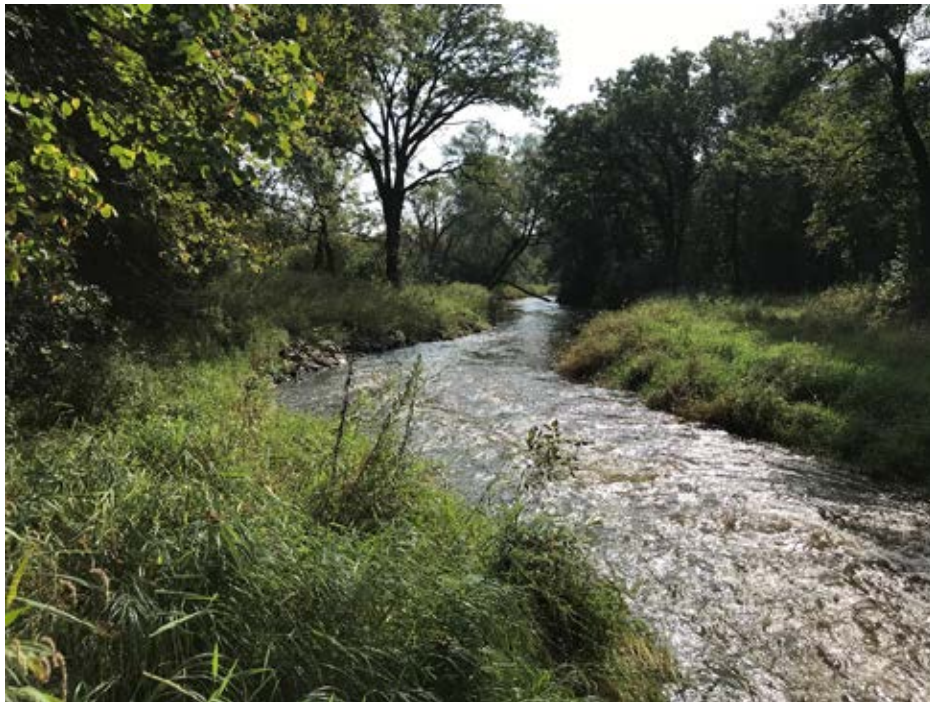
Photo 32-7 Downstream view of the cross log depicted in the previous photo. Riprap toe is visible on the downstream outside bend where flow is traveling from the cross log. (Wedge Creek – Reach 5, photo taken by Lucius Jonett during site visit 09/20/2019).

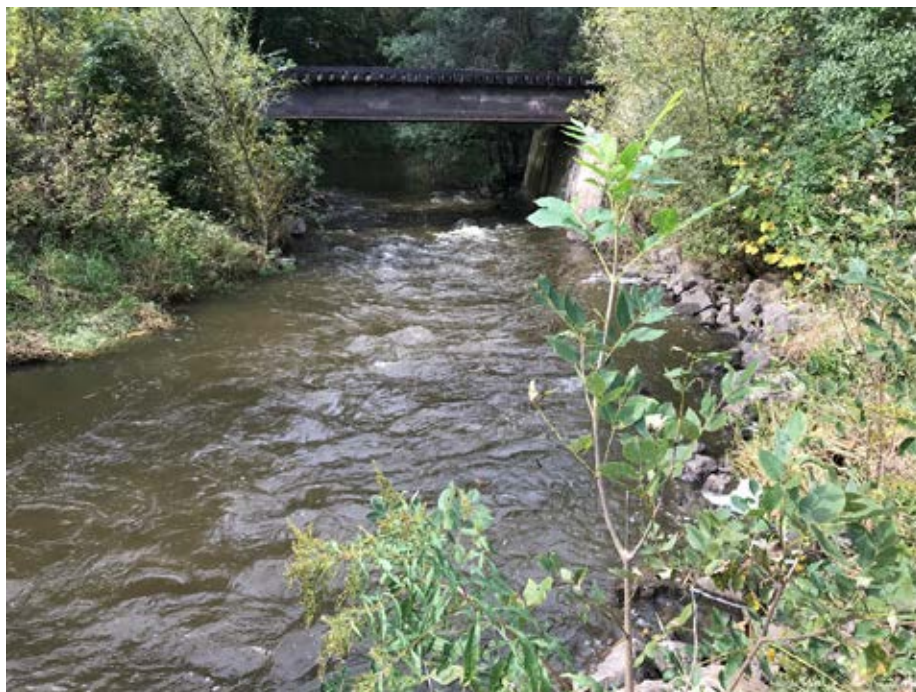
Photo 32-8 Looking upstream under a railroad bridge on the reach 4 project of Wedge Creek. Riprap was placed under bridge to control grade. Wedge creek turns 90 degrees to the left of the photo so riprap toe was installed to deflect the flow and prevent scour of the bank. State Highway 13 is immediately behind the viewer. (Wedge Creek – Reach 4, photo taken by Lucius Jonett during site visit 09/20/2019).

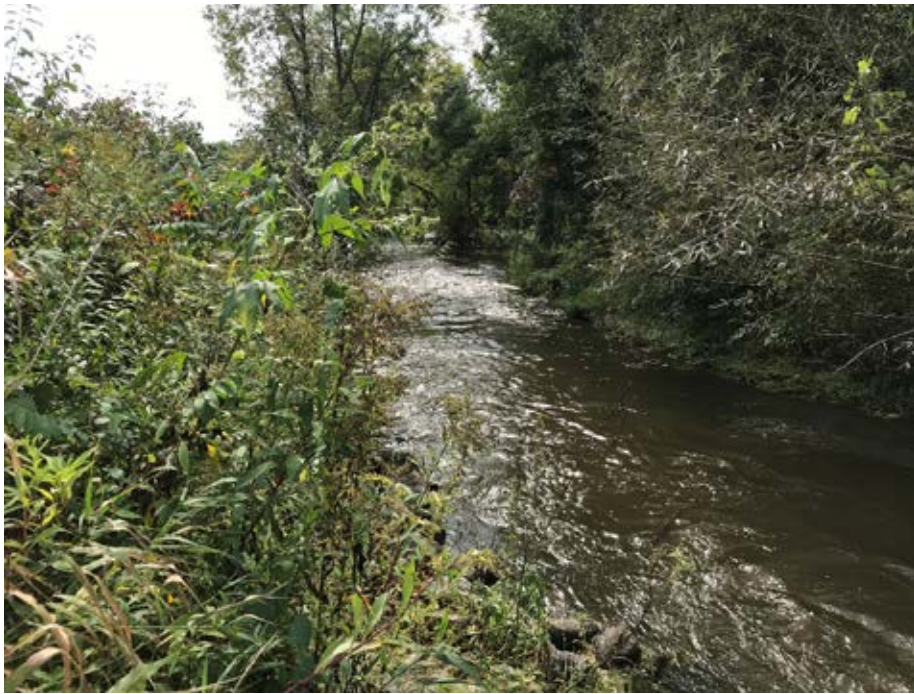
Photo 32-9 Looking downstream of the 90 degree bend shown in the previous photograph. (Wedge Creek – Reach 4, photo taken by Lucius Jonett during site visit 09/20/2019).

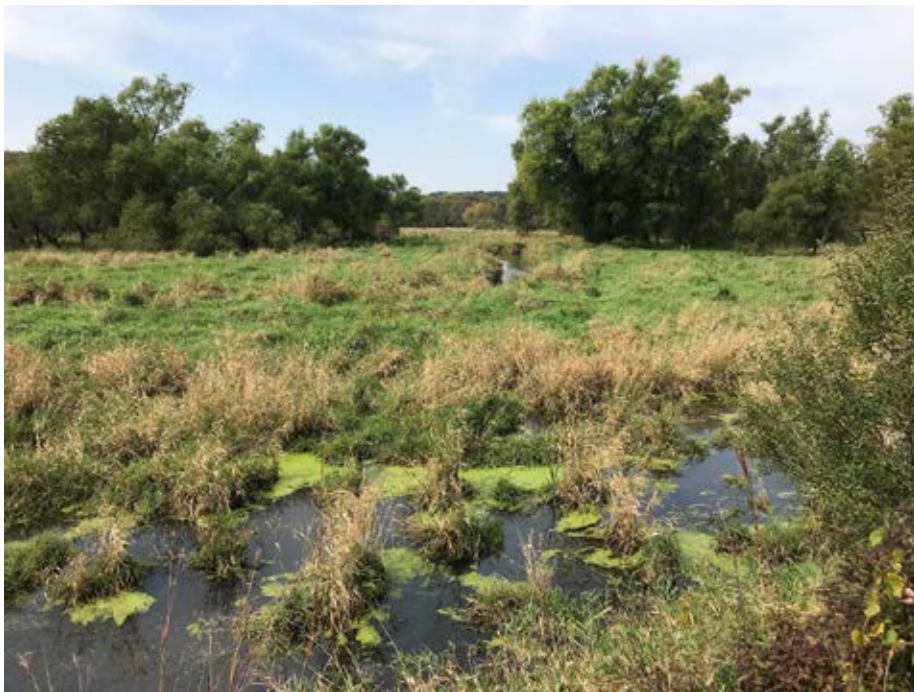
Photo 32-10 Reed canary grass, wet meadow surrounding reach 3 of the Wedge Creek project. (Wedge Creek – Reach 3, photo taken by Lucius Jonett during site visit 09/20/2019).

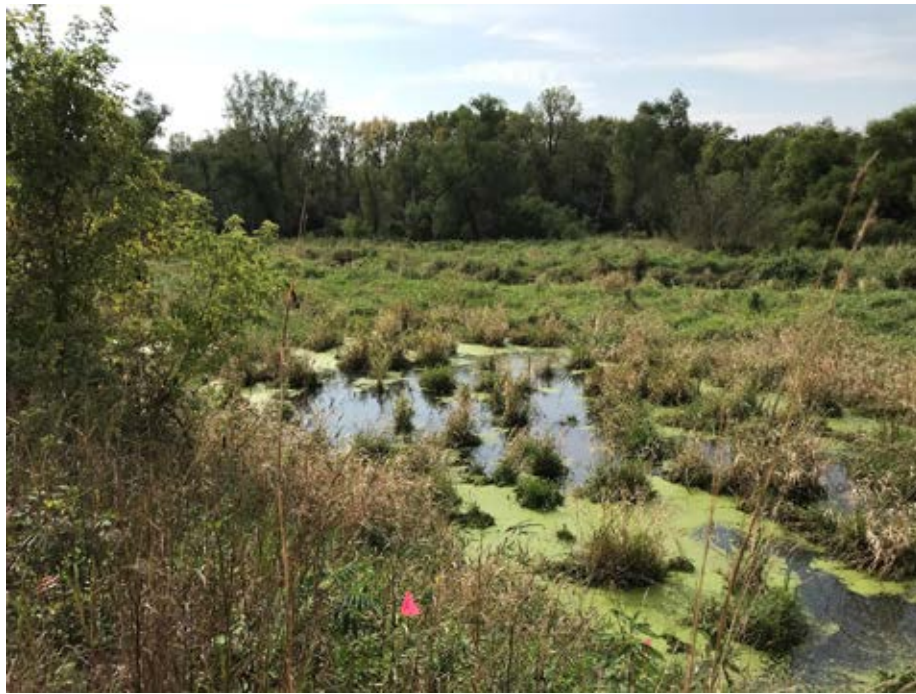
Photo 32-11 Reed canary grass, wet meadow surrounding reach 3 of the Wedge Creek project. (Wedge Creek – Reach 3, photo taken by Lucius Jonett during site visit 09/20/2019).

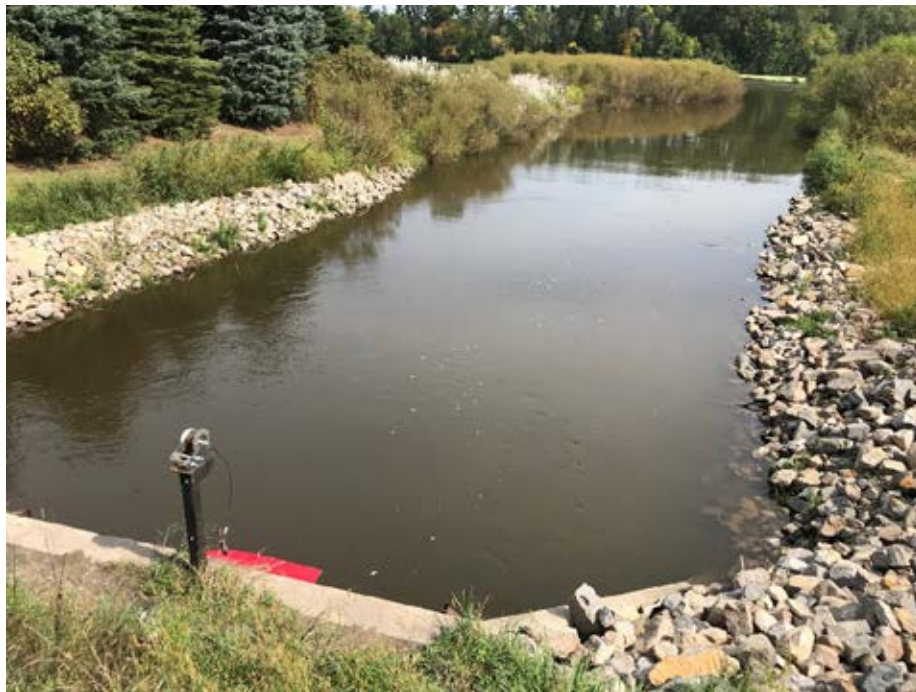
Photo 32-12 Looking downstream as Wedge Creek enters Fountain Lake. The winch and pulley with red bracket of the electric fish barrier is visible on the apron of the box culvert. (Wedge Creek – Reach 1, photo taken by Lucius Jonett during site visit 09/20/2019).

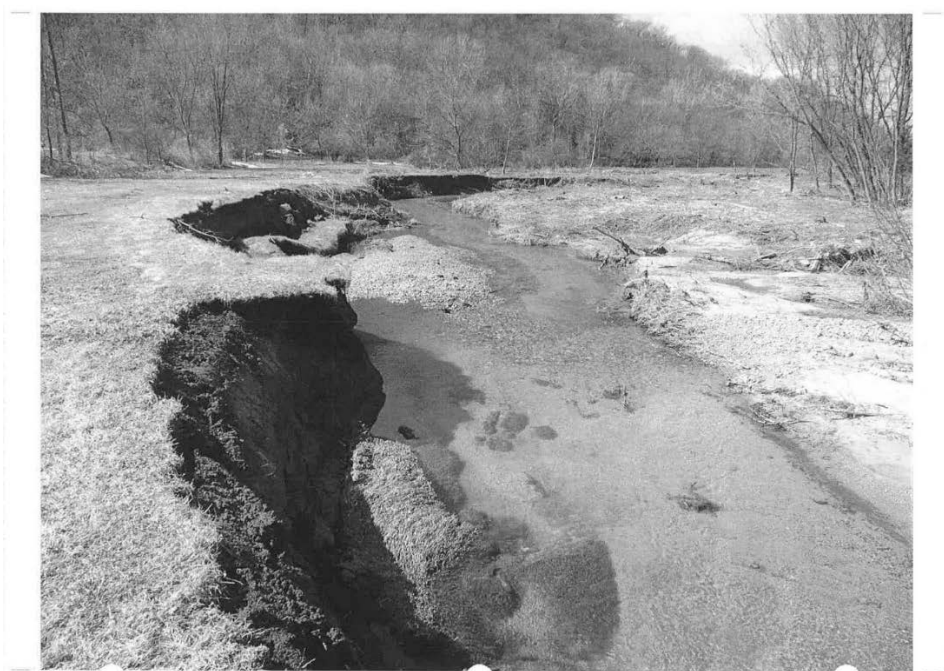
Photo 33-1 Stream conditions pre-construction. High vertical banks and overly wide stream with reduced instream habitat.

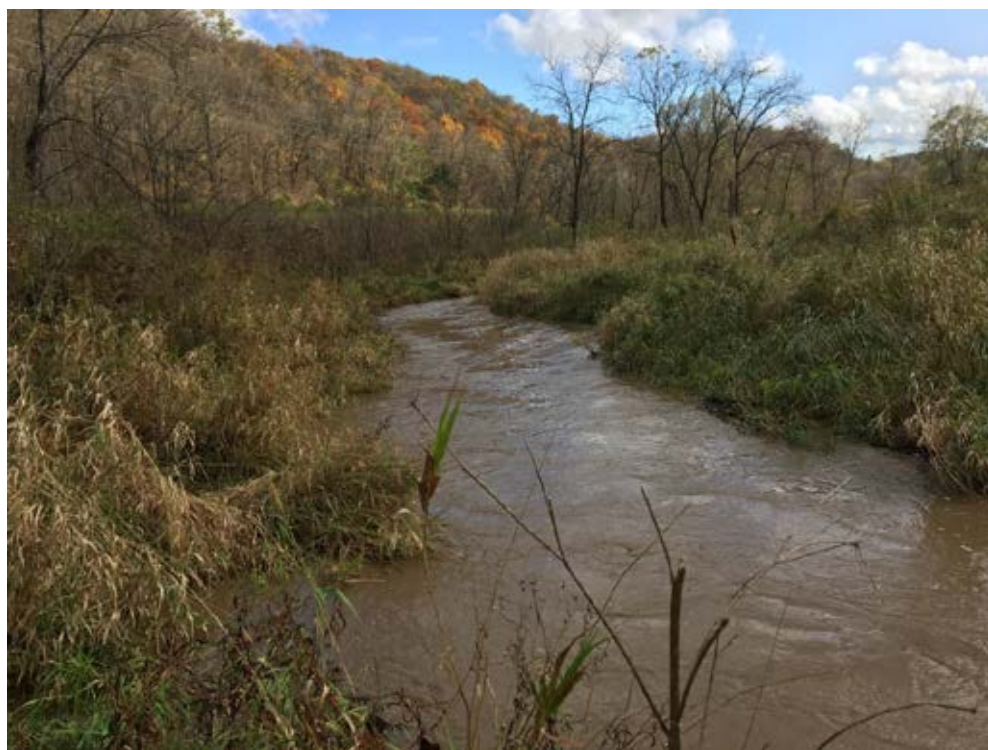
Photo 33-2 View of upstream reaches of habitat improvement project

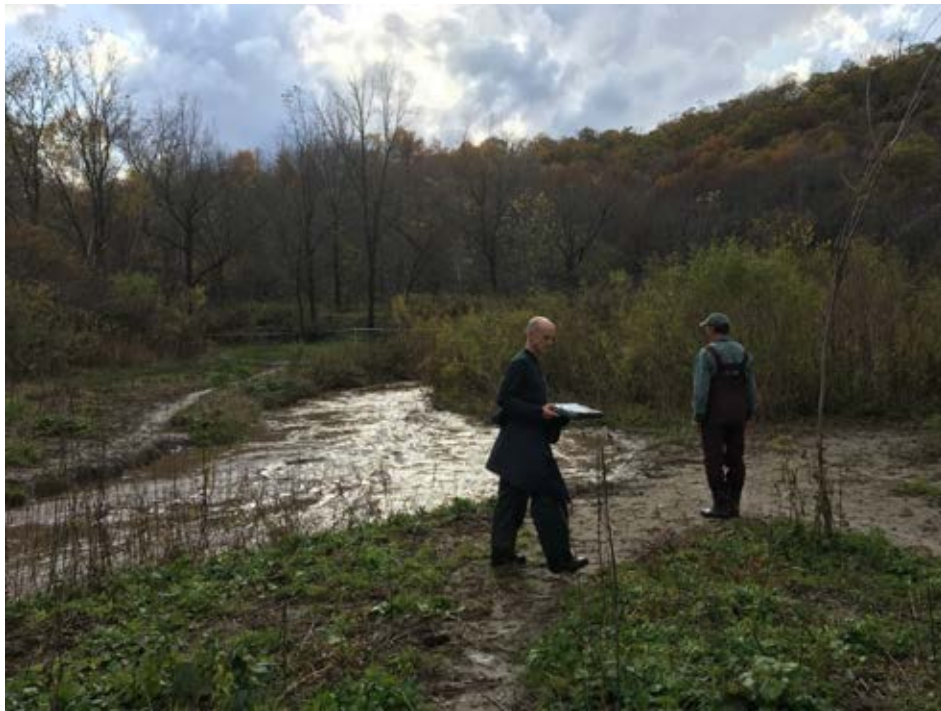
Photo 33-3 Area of project that horses are impacting, stream bank has eroded and vegetation is clearly being disturbed by the activity.

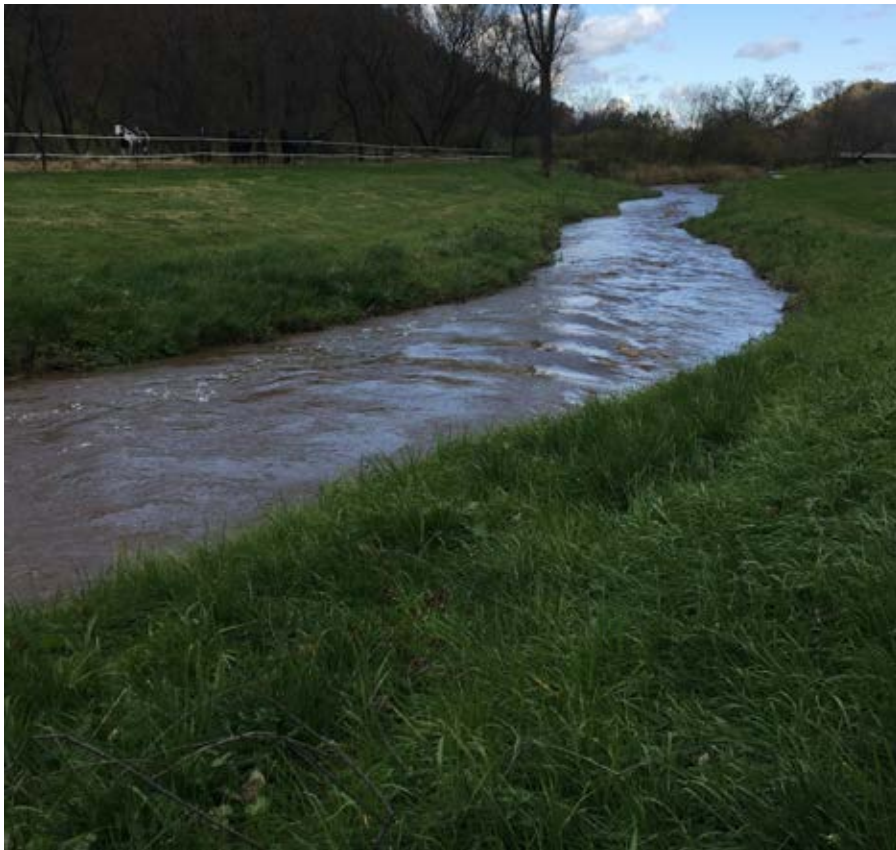
Photo 33-4 View of downstream reaches of project area within campground.

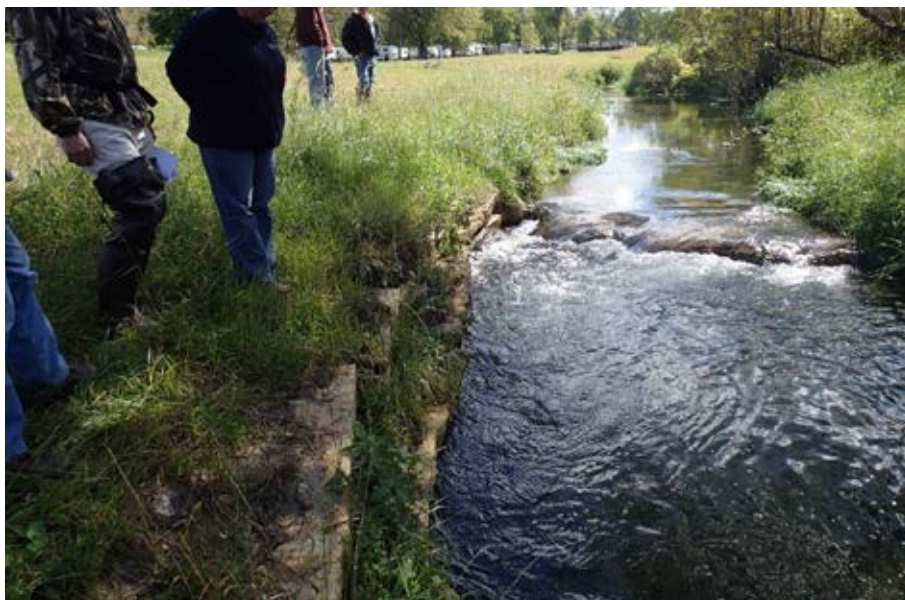
Photo 33-5 Reggraded slope, Rock deflector and Rock weir. Site visit 09/18/2012.

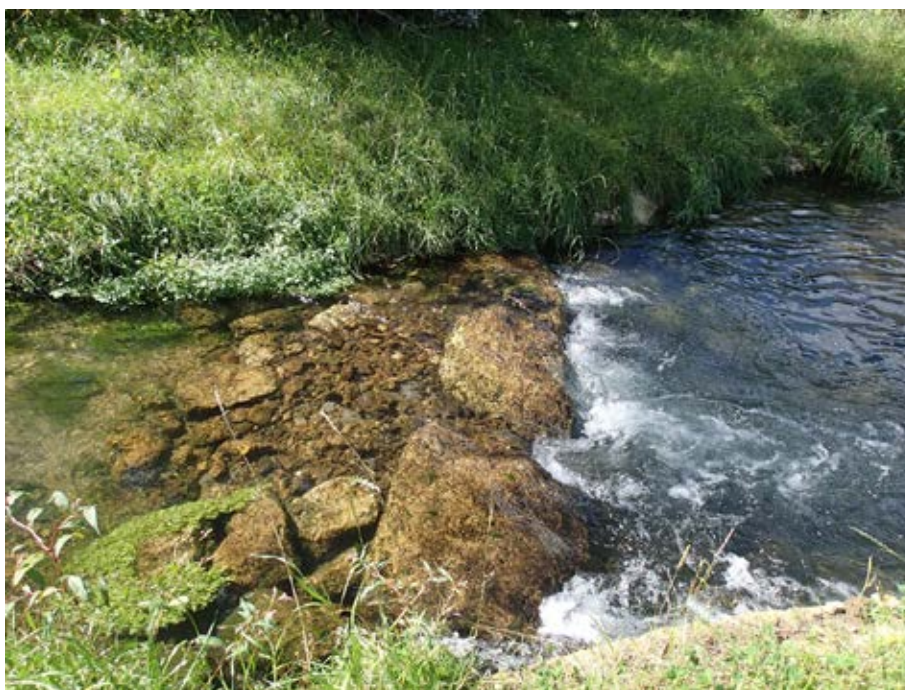
Photo 33-6 Rock weir structure. Site visit 09/18/2012.

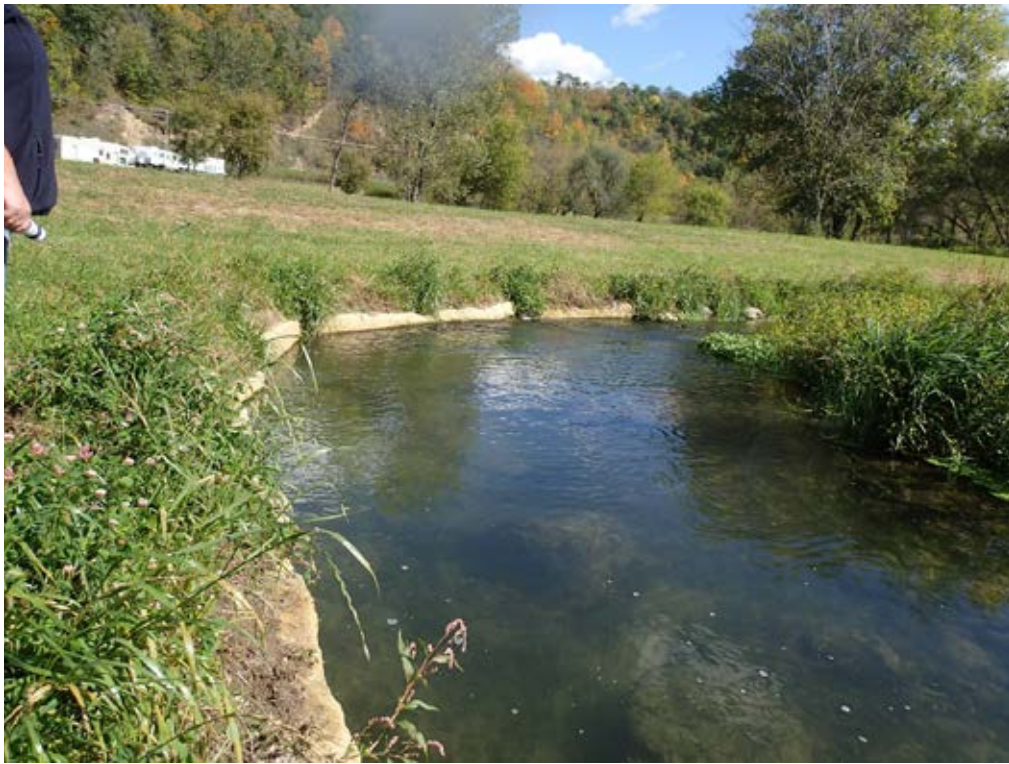
Photo 33-7 “Sky Hook” structure in stream bend. Site visit 09/18/2012.

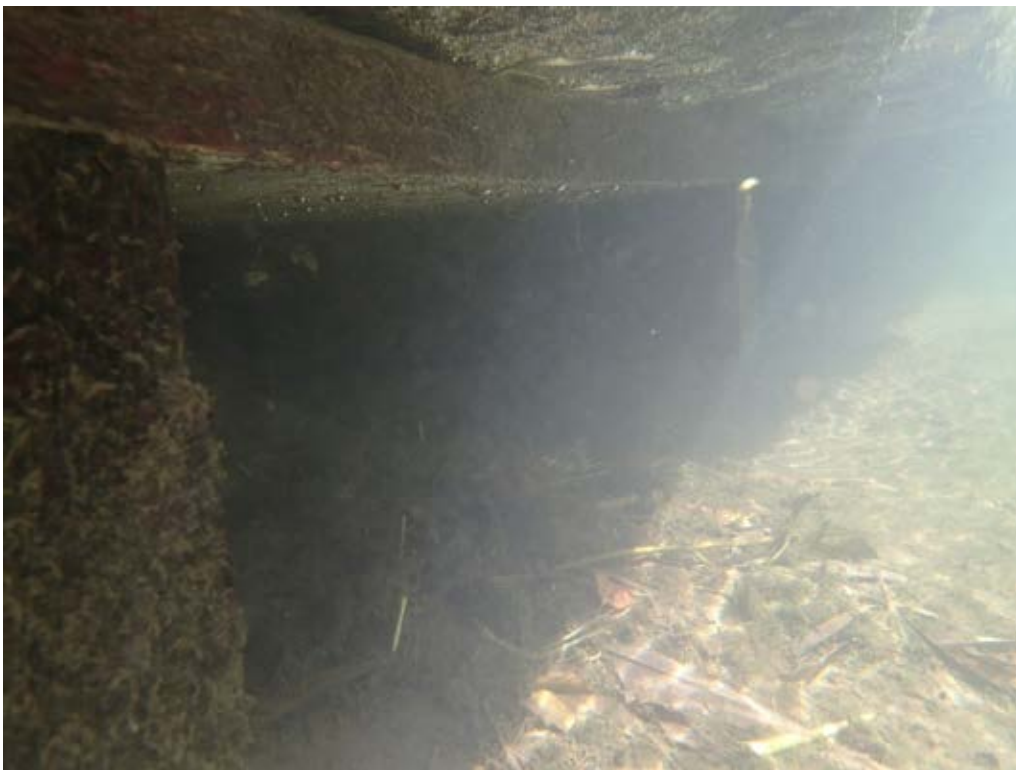
Photo 33-8 Underwater support for Sky-hook structure shown in Photo 33-7. Site visit 09/18/2012.

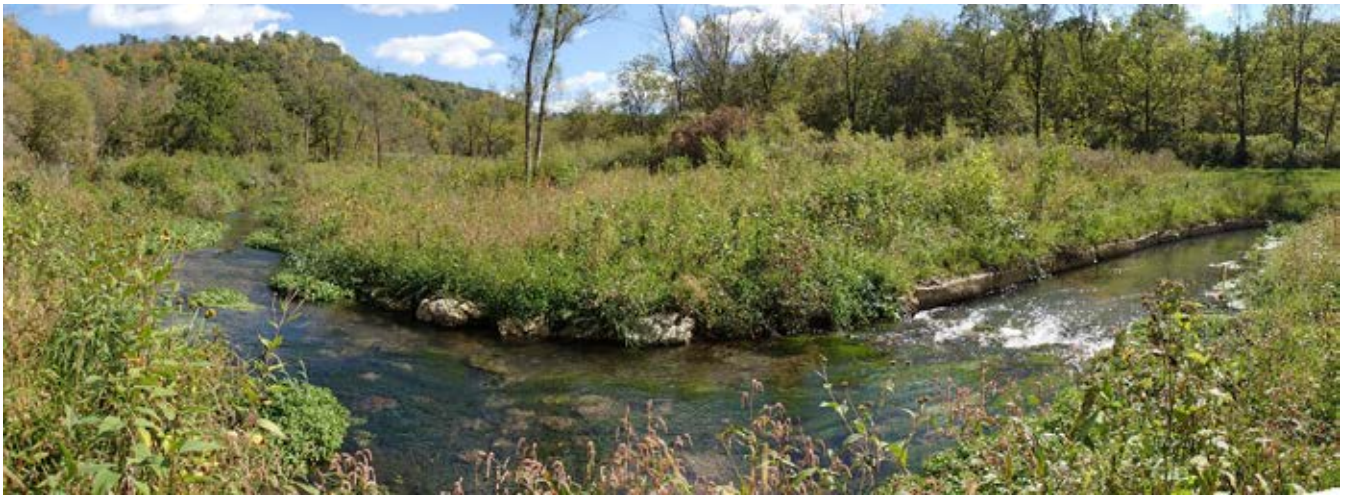
Photo 33-9 Panoramic photo of reconstructed stream bend with rock weir and rip rap and sky hook on opposite streambank. Site visit 09/18/2012.

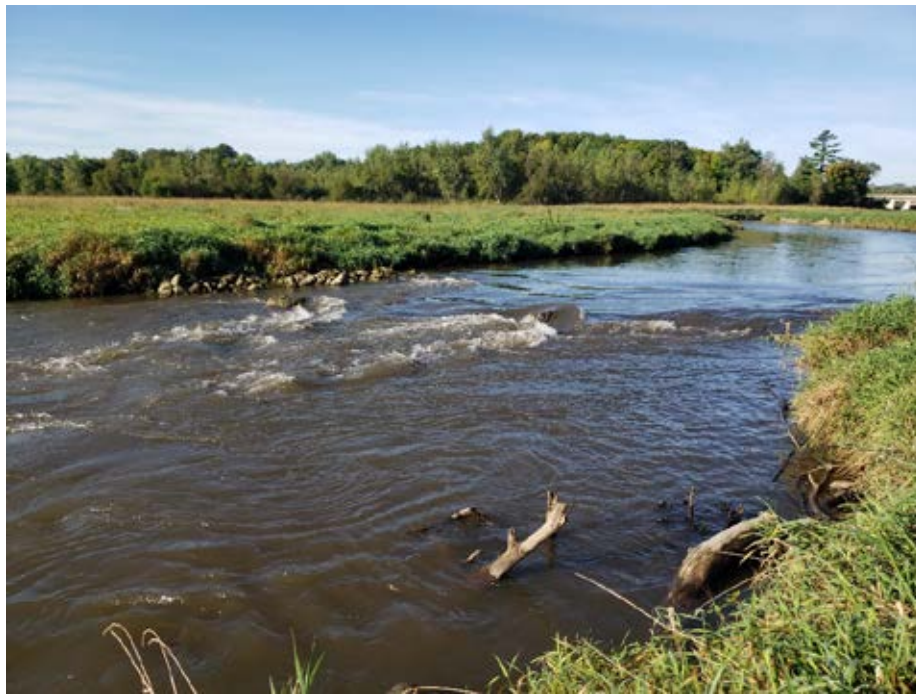
Photo 34-1 Example of a boulder J-hook near the upper third of the channel through the former Lake Shady bed. Water levels were elevated during the site assessment. Photo taken 9/16/19 by Mark Prancus, Cardno.

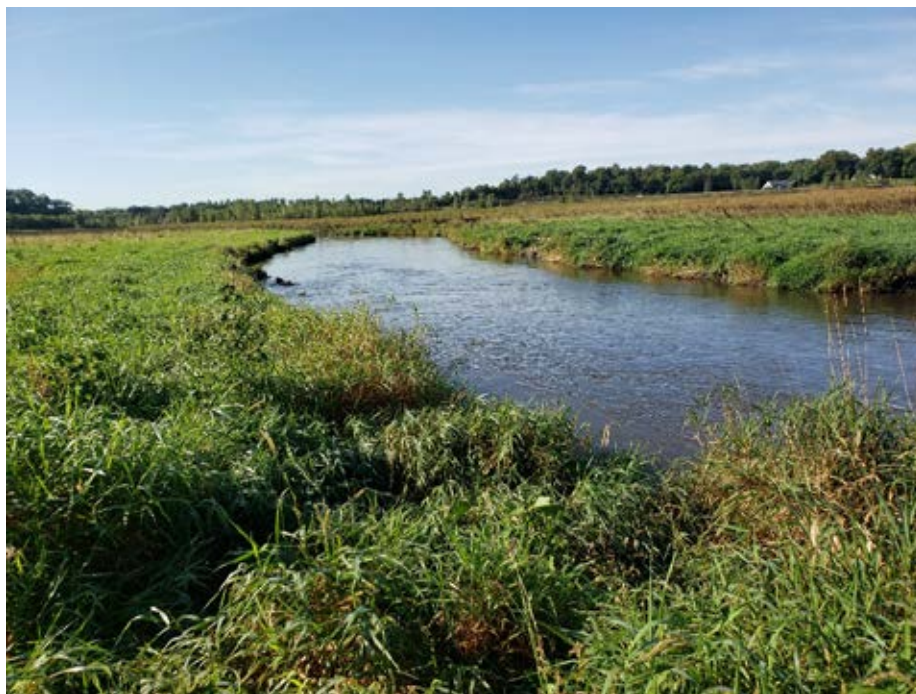
Photo 34-2 Example of a meander bend through the former Lake Shady bed. The bank on the left has toewood, which is currently underwater. Photo taken 9/16/19 by Mark Prancus, Cardno.

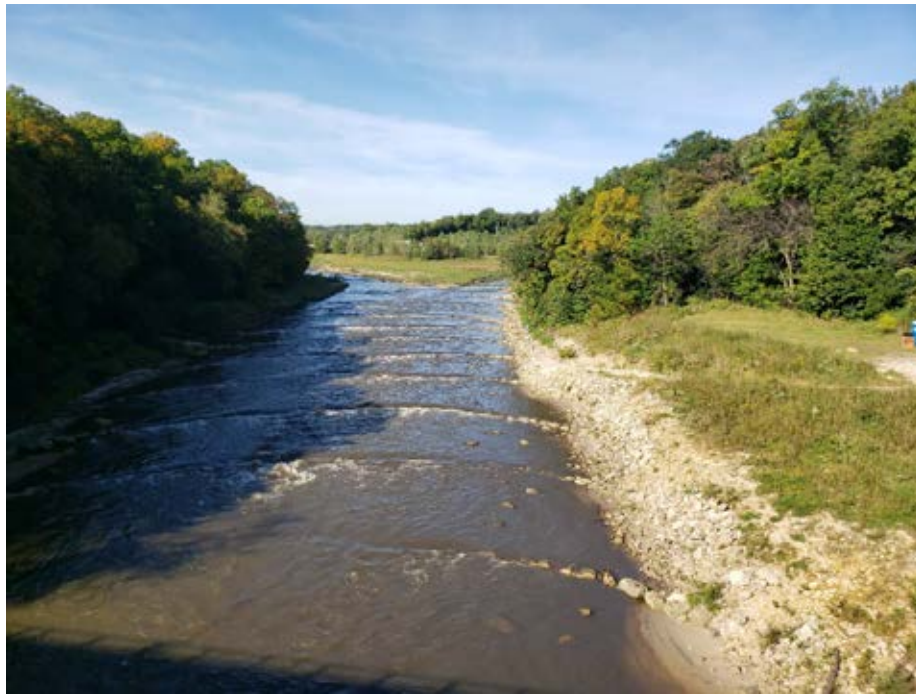
Photo 34-3 View looking upstream at the rock arch rapids from the Highway 52 bridge. The dam was formerly near the bottom of this photo. Photo taken 9/16/19 by Mark Pranckus, Cardno.

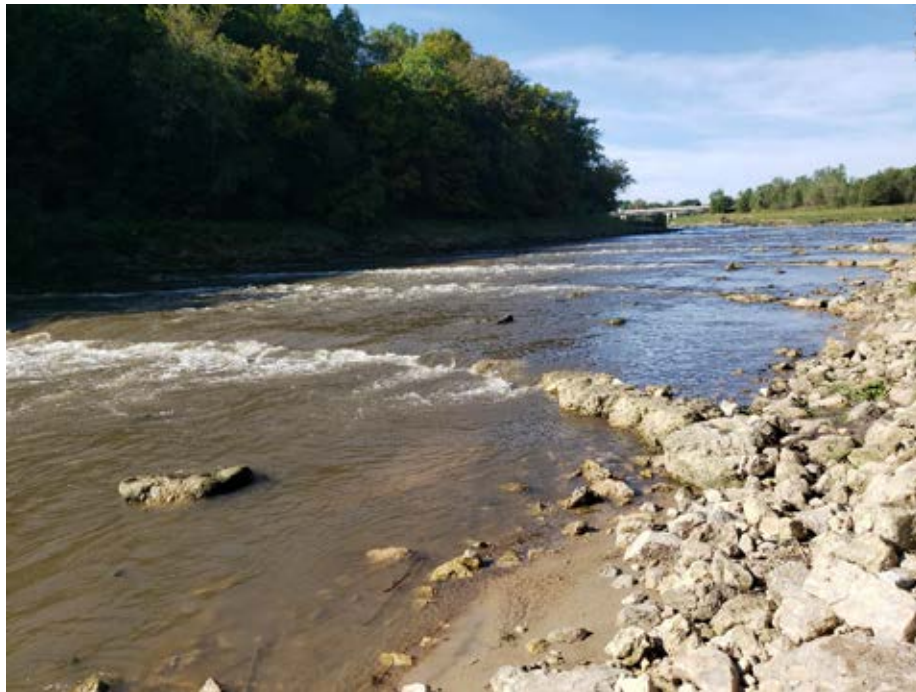
Photo 34-4 View looking upstream from streamside of the rock arch rapids. The structures are installed in an arch facing upstream and also in elongated “U” shaped in the cross section to keep turning flows into the center of the channel as water elevation increases, which reduces bank erosion potential. Photo taken 9/16/19 by Mark Pranckus, Cardno.

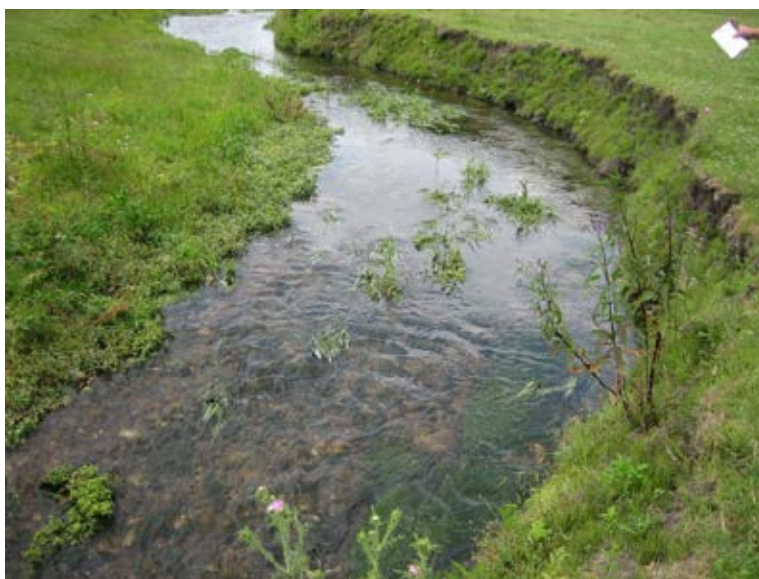
Photo 35-1 Pre-construction photo of Crow Springs showing eroding banks. Photo taken on 7/15/2009.

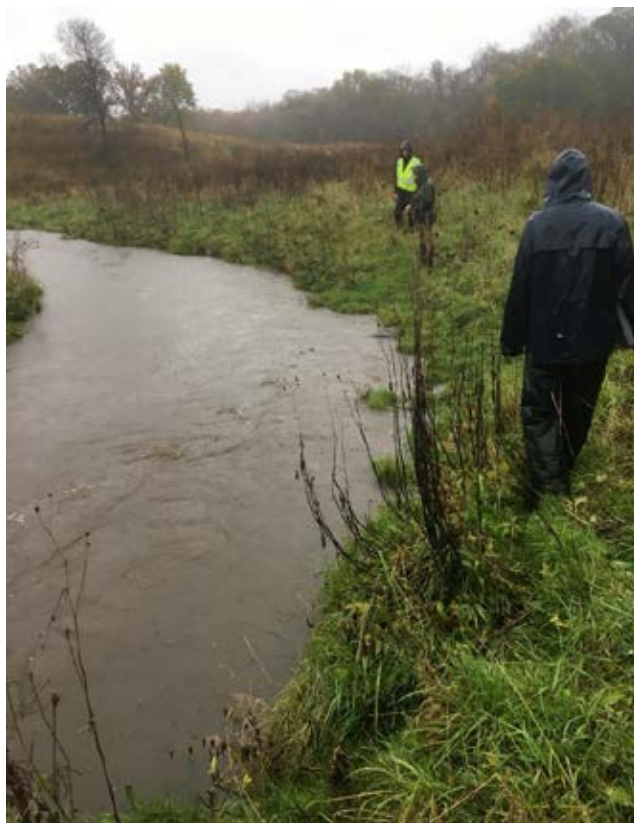
Photo 35-2 Crow Springs project area where stream bank slopes were re-shaped, and rock added. Photo taken 10/21/2019 by Anna Varian.

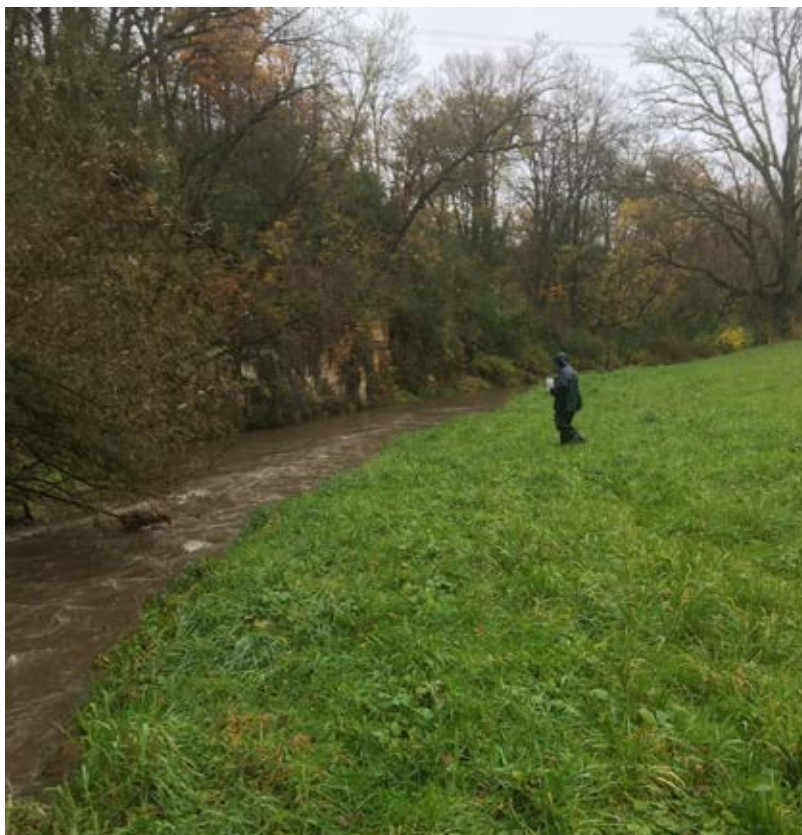
Photo 35-3 Middle Branch Whitewater River, area where stream width was reduced, banks were re-shaped and rock added to banks. Photo taken 10/21/2019 by Anna Varian.

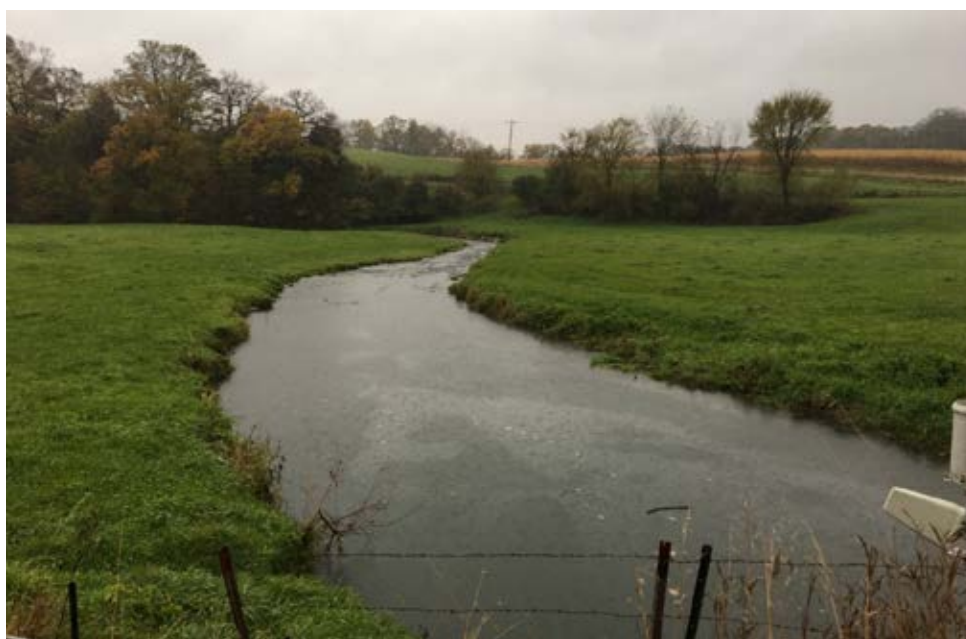
Photo 35-4 Middle Branch Whitewater River looking downstream from County Road 107 at area where banks were re-shaped and rock added. Photo taken 10/21/2019 by Anna Varian.

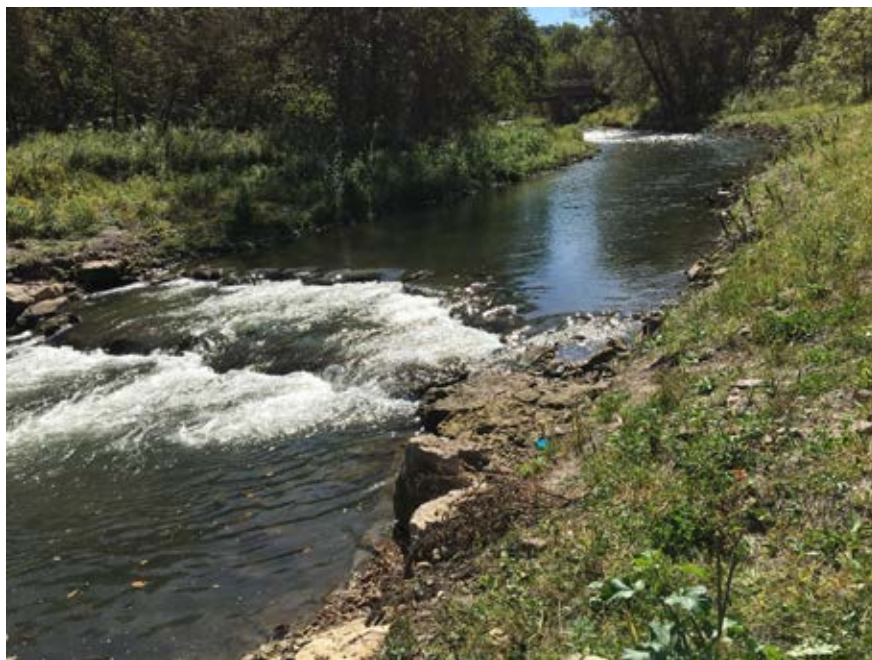
Photo 36-2 Looking upstream at reconstructed boulder vane 1. Photo taken during site visit 9/16/19 by Anna Varian

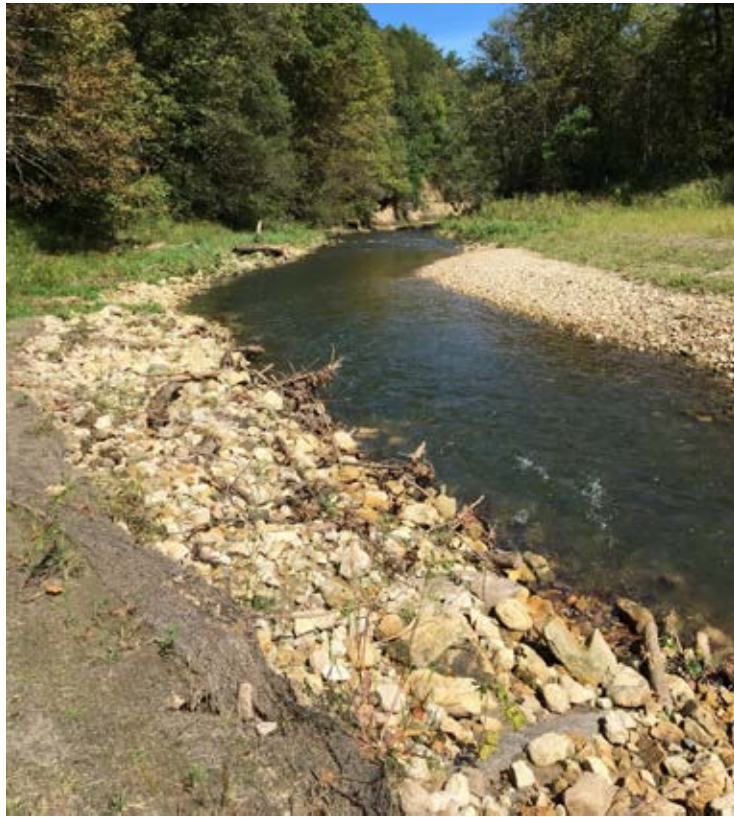
Photo 36-3 View of toe wood looking downstream toward end of project area. Photo taken during site visit 9/16/19 by Anna Varian.
