Minnesota Department of Natural Resources
Minnesota Board of Water and Soil Resources

Appendix B: 2020 Legacy Fund Restoration Evaluation

Report March 2020

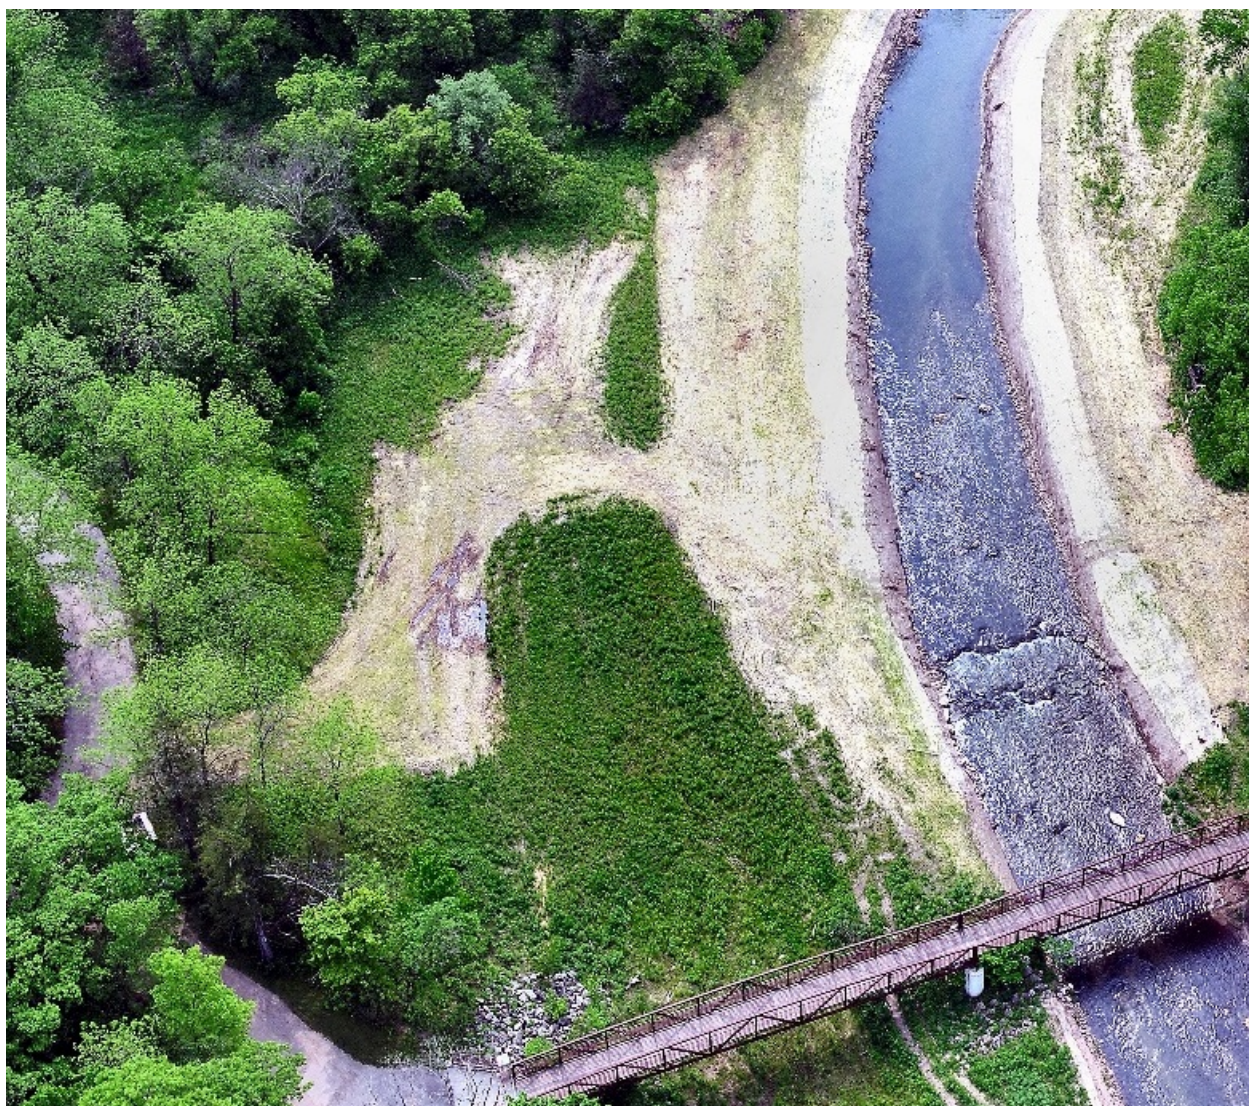
Photo 37-1. Aerial view of project site taken after new construction in early summer 2019. Areas impacted by 2019 construction work is evidenced by bare soil. Unimpacted areas of the 2016 seeding project is the green herbaceous cover near the center of the photo.

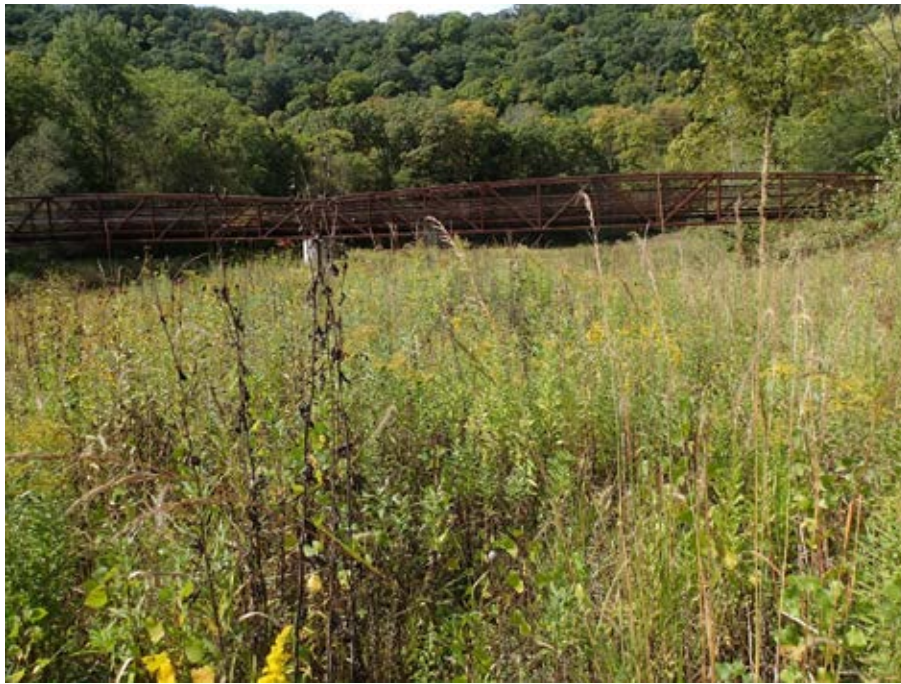
forested condition over time. If the grass forb community is to be maintained, Cottonwood will likely need to be managed.

Photo 37-2 Established area of 2016 seeding. Cottonwood seedlings can be seen beginning to establish, 08/16/2019.

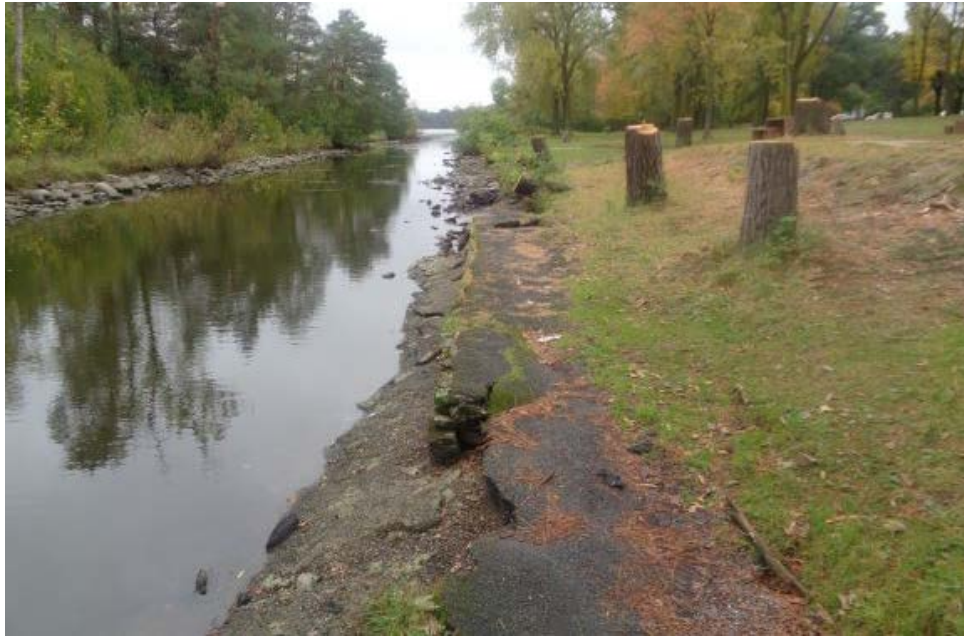
Photo 38-1 Before project photograph of planting area looking downstream (South). Image provided by Ramsey County, date 10/03/2017.

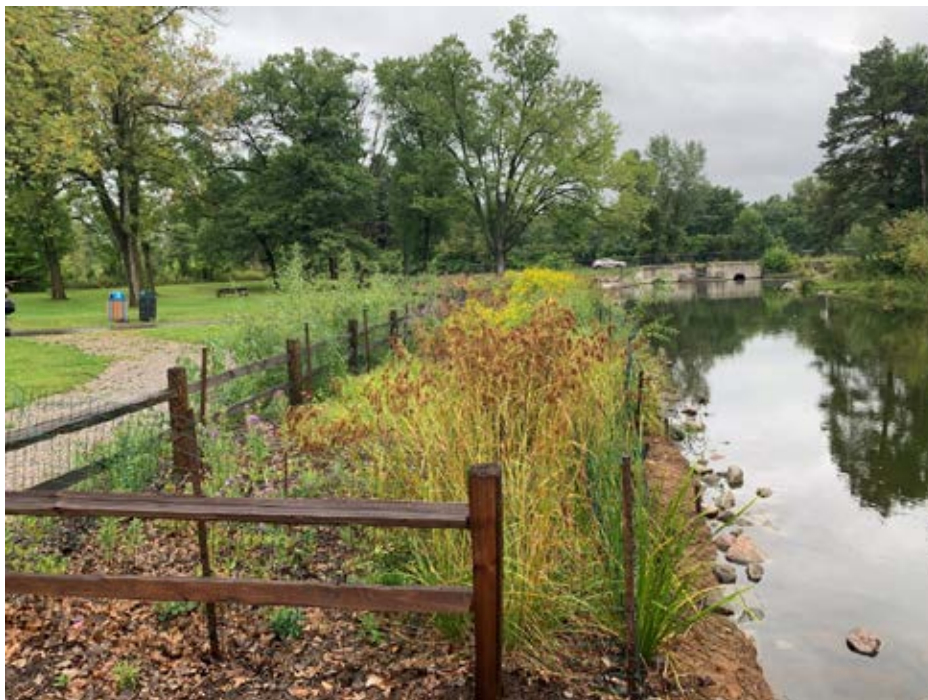
Photo 38-2 Representative image of native planting looking upstream (north). Photograph taken by Kevin Biehn during 9/11/2019 site visit.

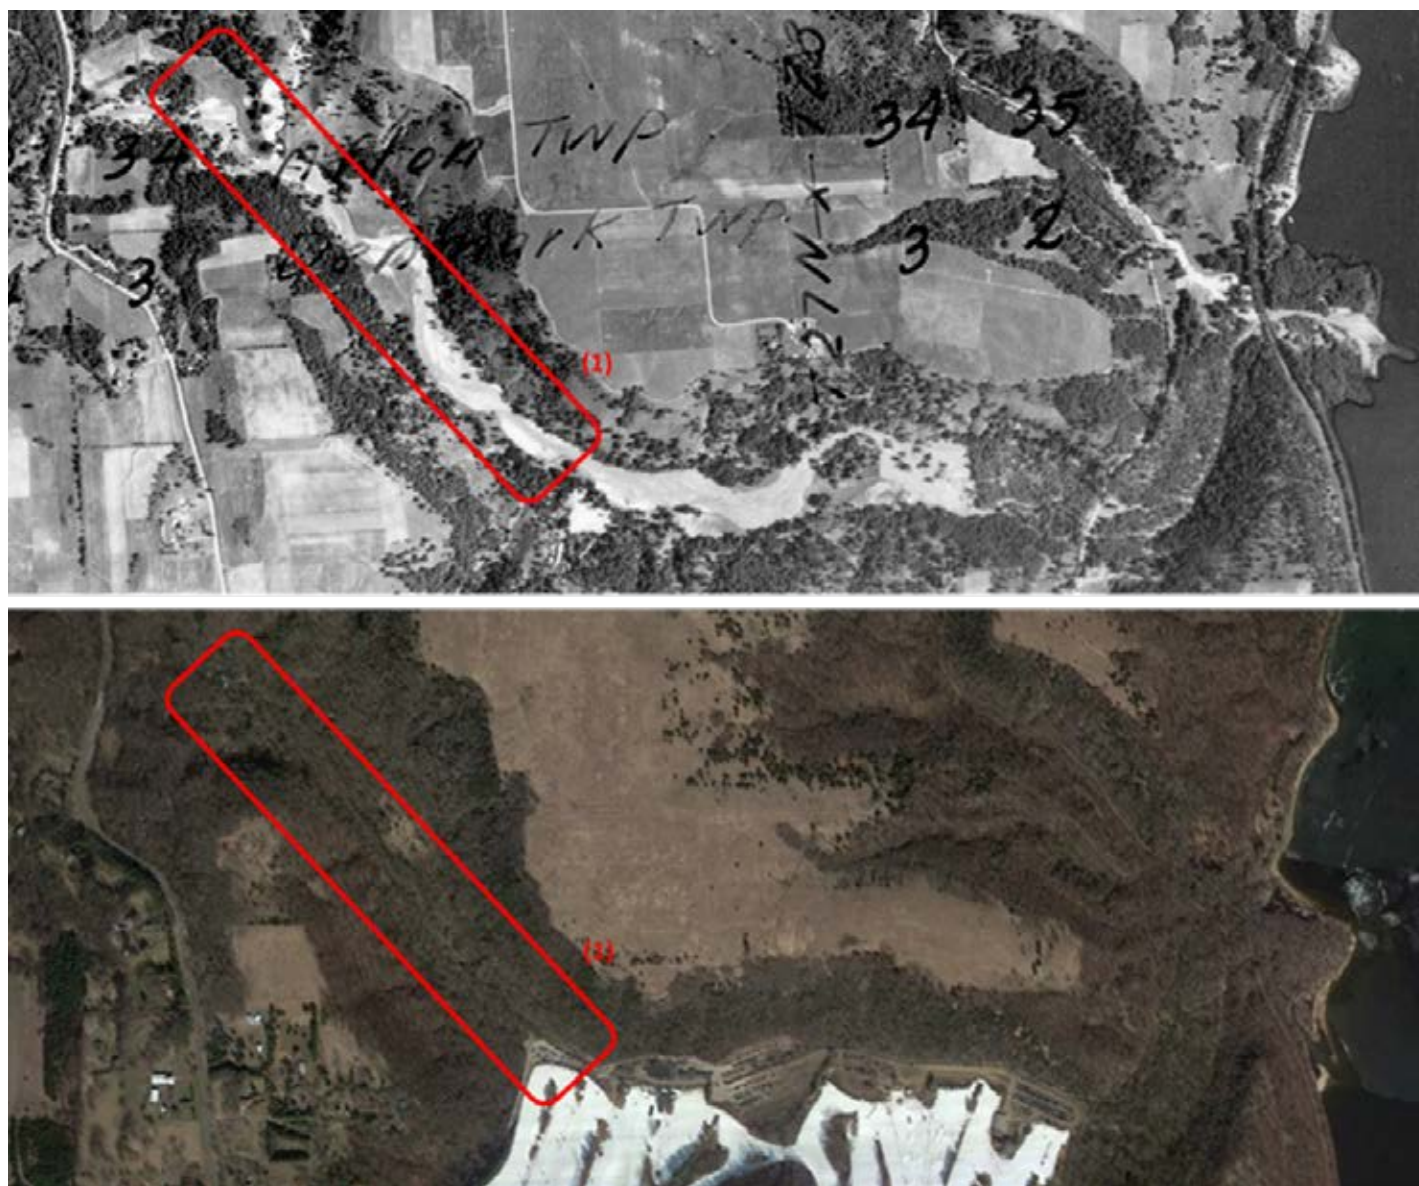
Figure 39-2 Aerial Photo comparison of 1938 imagery (upper) and 2016 imagery (lower). Note lateral instability and aggradation of project area (1) apparent 1938 photograph.

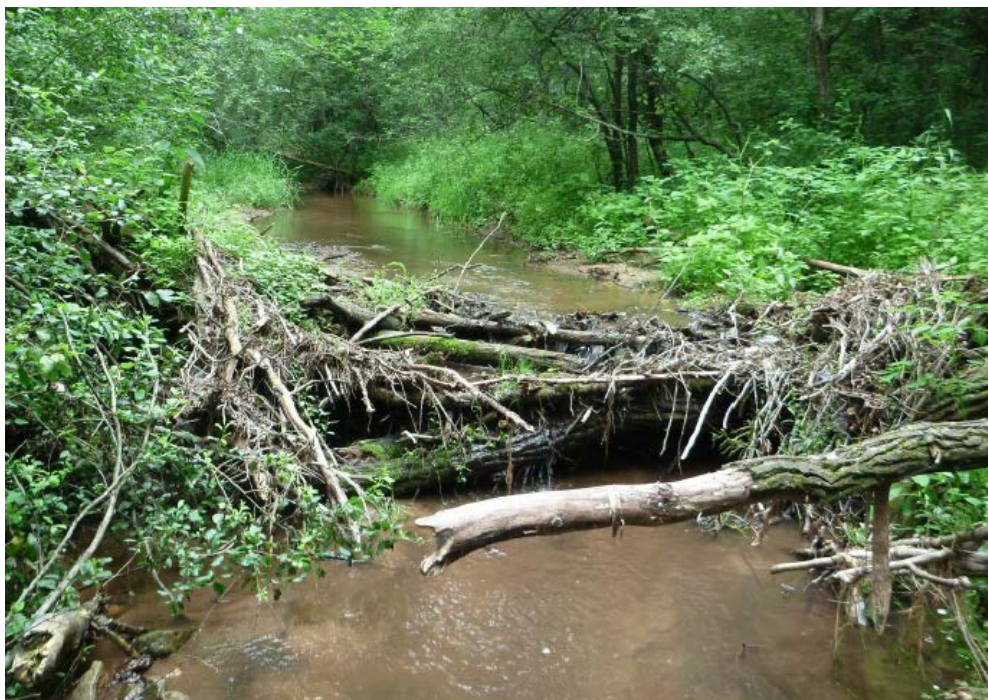
- Passage – debris dams, which were causing aggradation and restricting fish passage have been removed; the formation of new debris dams was occurring (Photo 39-1 & Photo 39-2)
- Pool number and depth – pools frequency and depth was not consistent, project improvement not likely (**Error! Reference source not found.**)

Photo 39-1 Representative photograph of pre-project debris jam and associated barrier to fish passage, taken at Site 26. Image provided by MNDNR, date unknown.

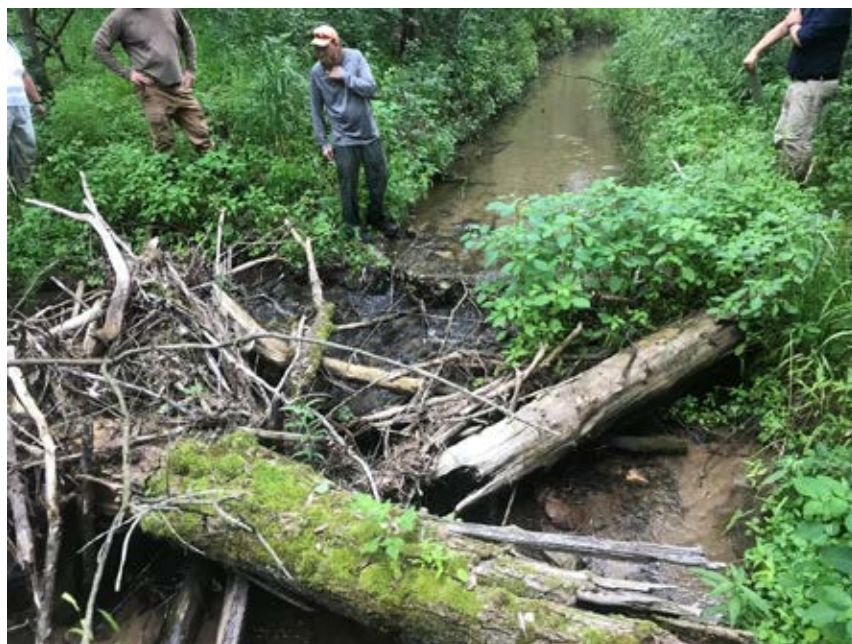
Photo 39-2 Representative image of formation of new debris jam within project area. Photograph taken by Kevin Biehn during 7/18/2019 site visit.

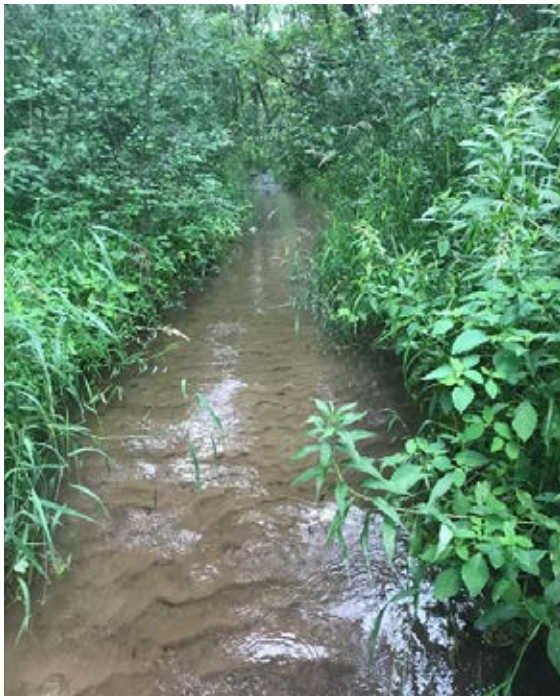
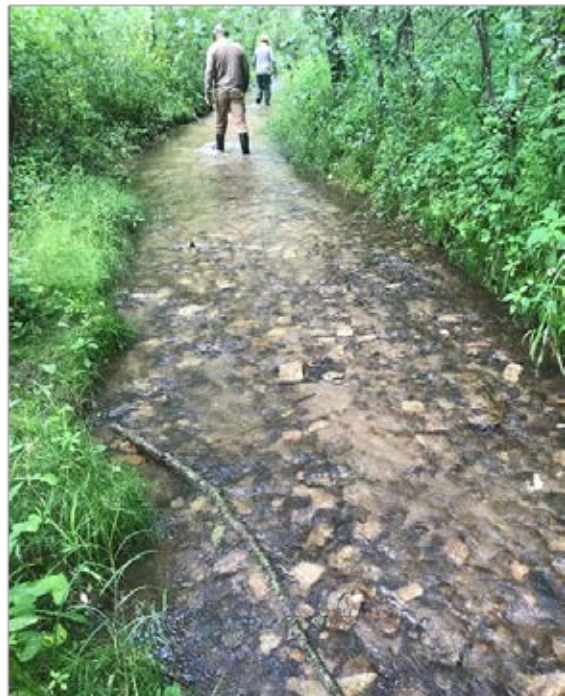
Photo 39-3 Representative images of both low gradient (left) and high gradient (right) reaches of project area. Note lacking pool frequency & depth in both images and sand substrate in lower gradient stretches (left). Photos taken by Kevin Biehn on 7/18/2019.

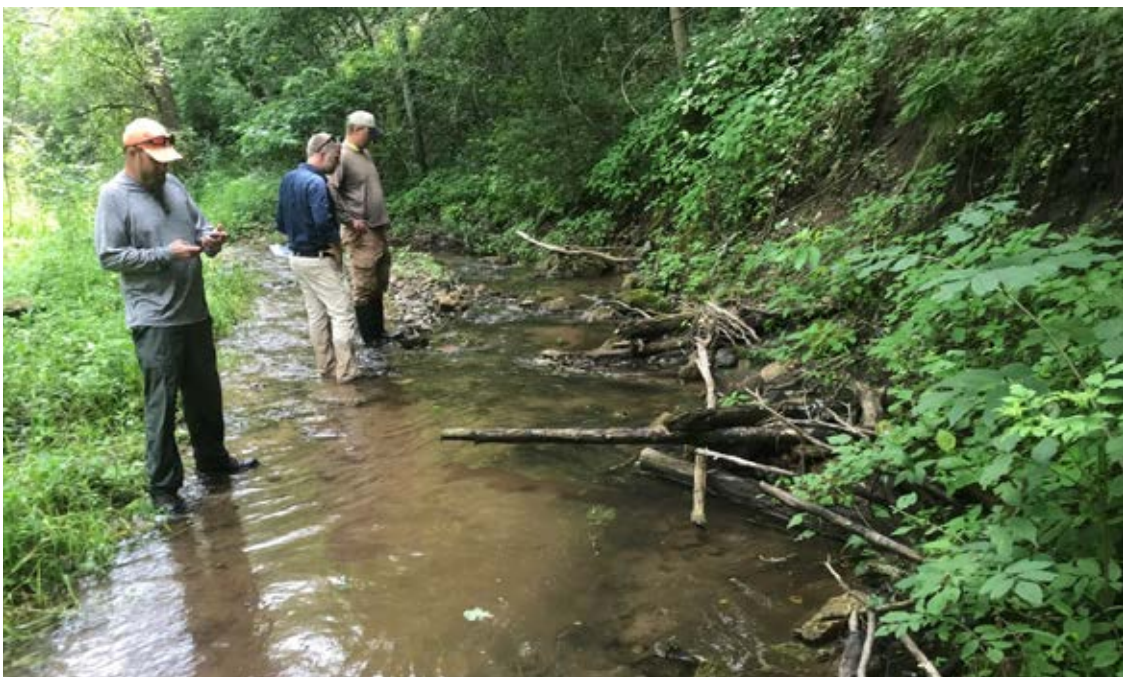
Photo 39-4 Photograph of Toewood Stabilization (right side of photo) constructed by hand labor. Structure has degraded substantially in 4 to 5 years since installation but is still provide some habitat and stability benefit. Photograph taken by Kevin Biehn during 7/18/2019 site visit.
