# MILE POST 7 WEST RIDGE RAILROAD RELOCATION, DAM EXTENSIONS, AND STREAM MITIGATION PROJECT ENVIRONMENTAL ASSESSMENT WORKSHEET (EAW)

RECORD OF DECISION – FINDING OF FACT 28.i 1975 BAKER REPORT

# GEOTECHNICAL EVALUATION ON-LAND TAILINGS DISPOSAL PLAN RESERVE MINING COMPANY Mile Post No. 7 Site

PREPARED FOR STATE OF MINNESOTA AUGUST, 1975

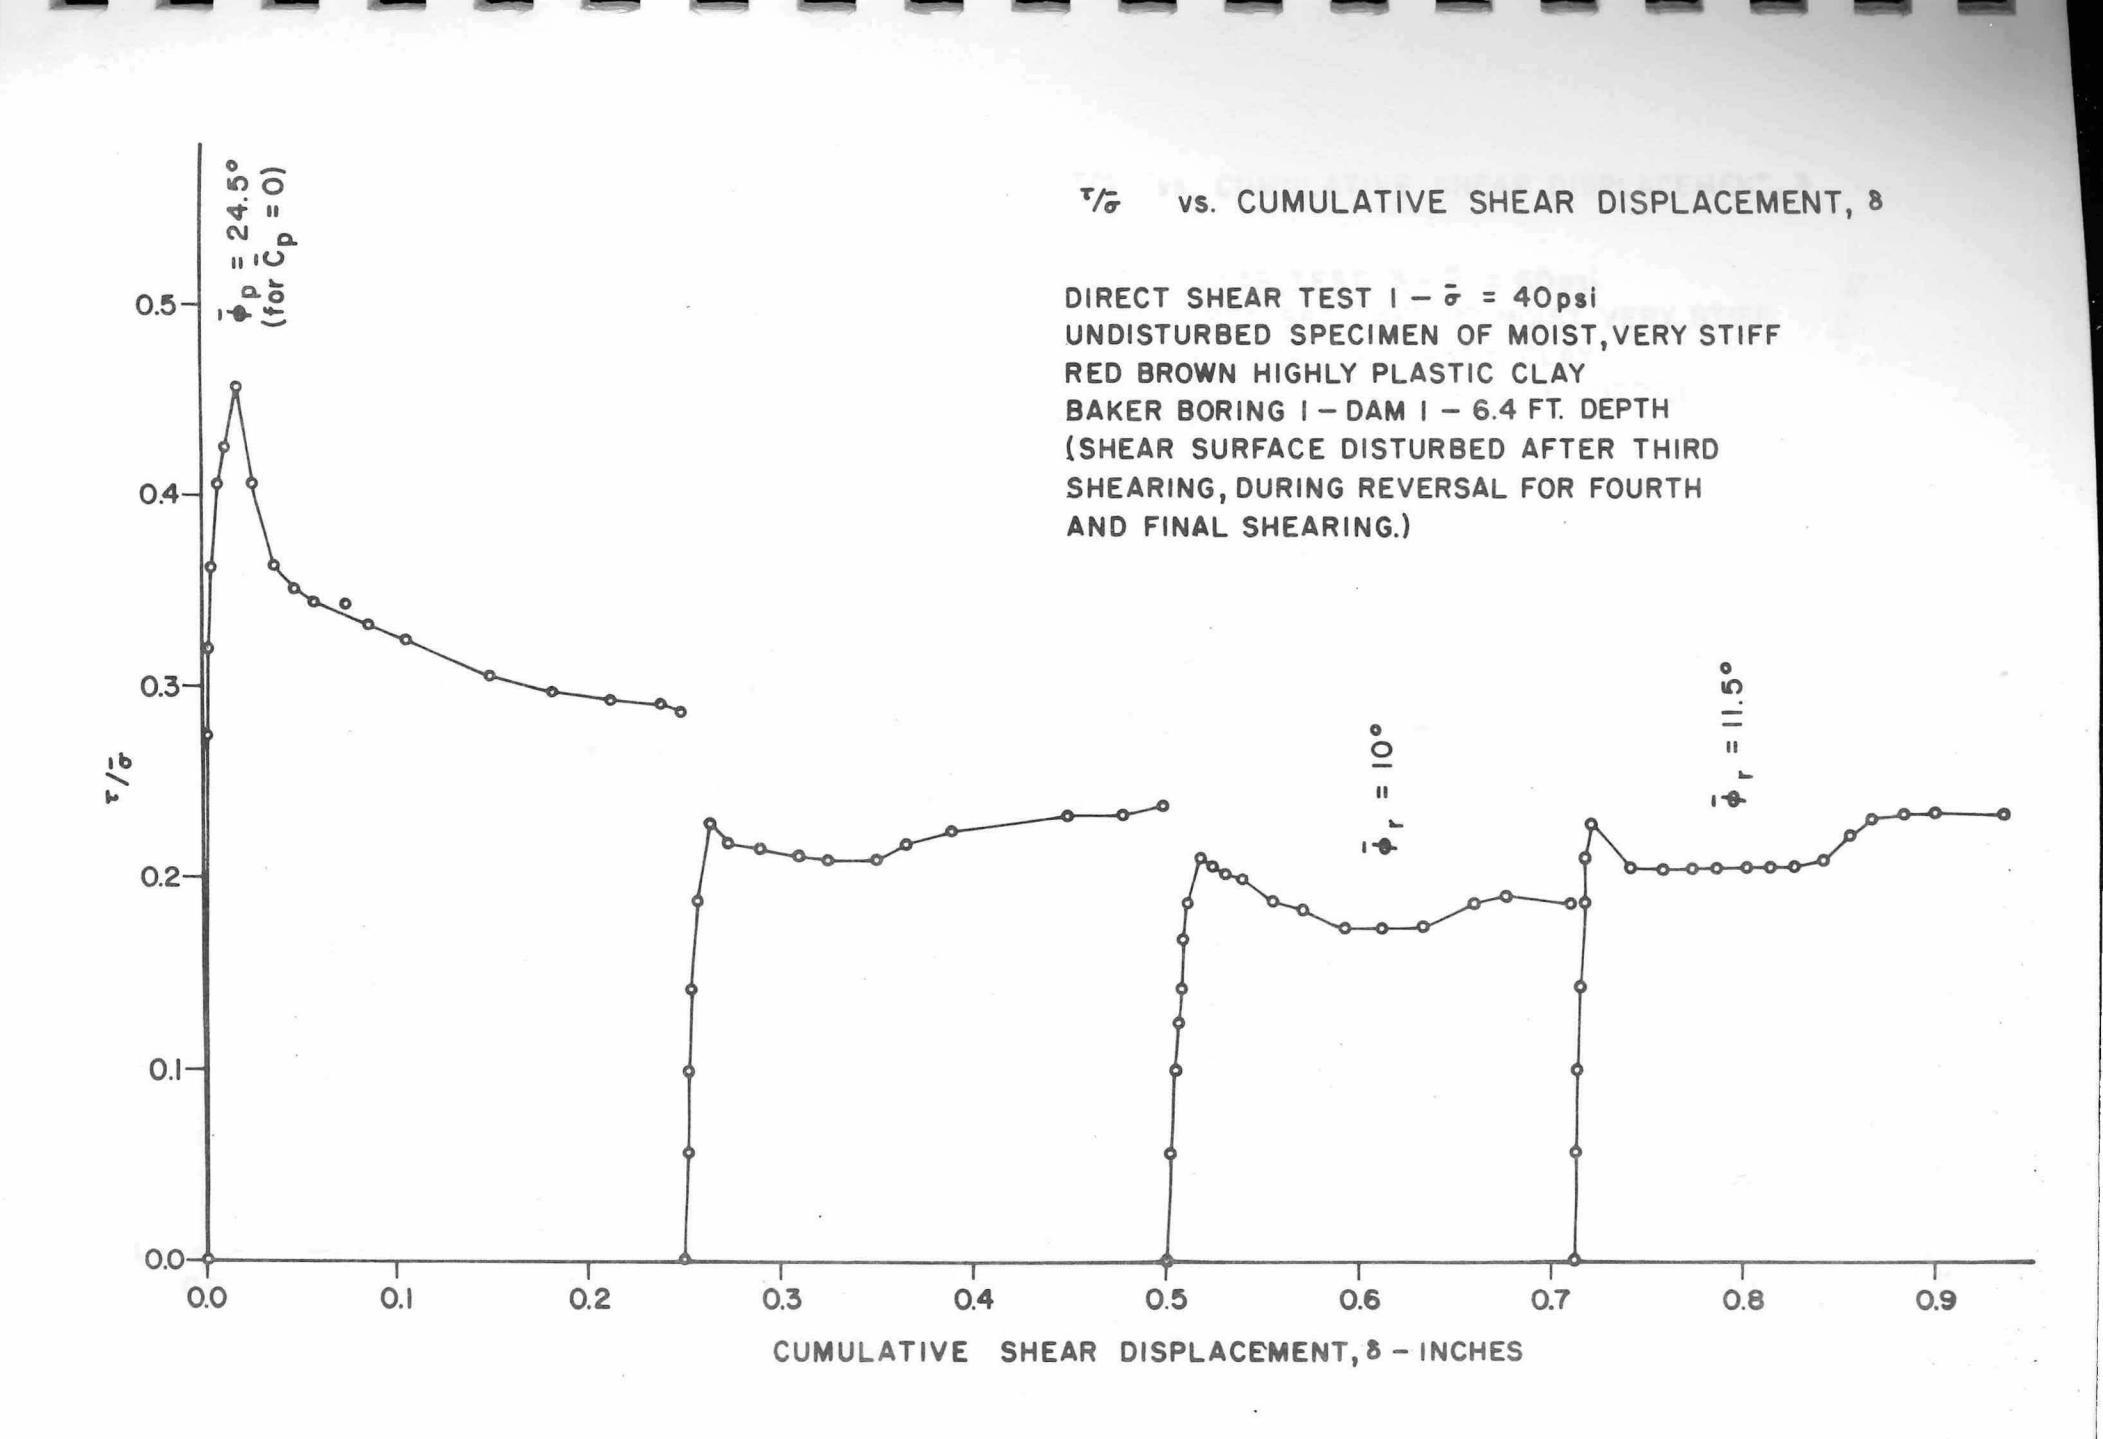
FIGURE D-I

The failure surface of Specimen 1 was inspected and photographed at the end of the test. This failure surface was very highly slickensided with a slight waviness which was insufficient to influence test results. There was a very thin (approximately 1 mm thick) lamination of intensely remolded clay on each side of the failure surface. Specimen breakdown and extrusion between the shear box halves during the test was minimal. The results of this test are considered reliable.

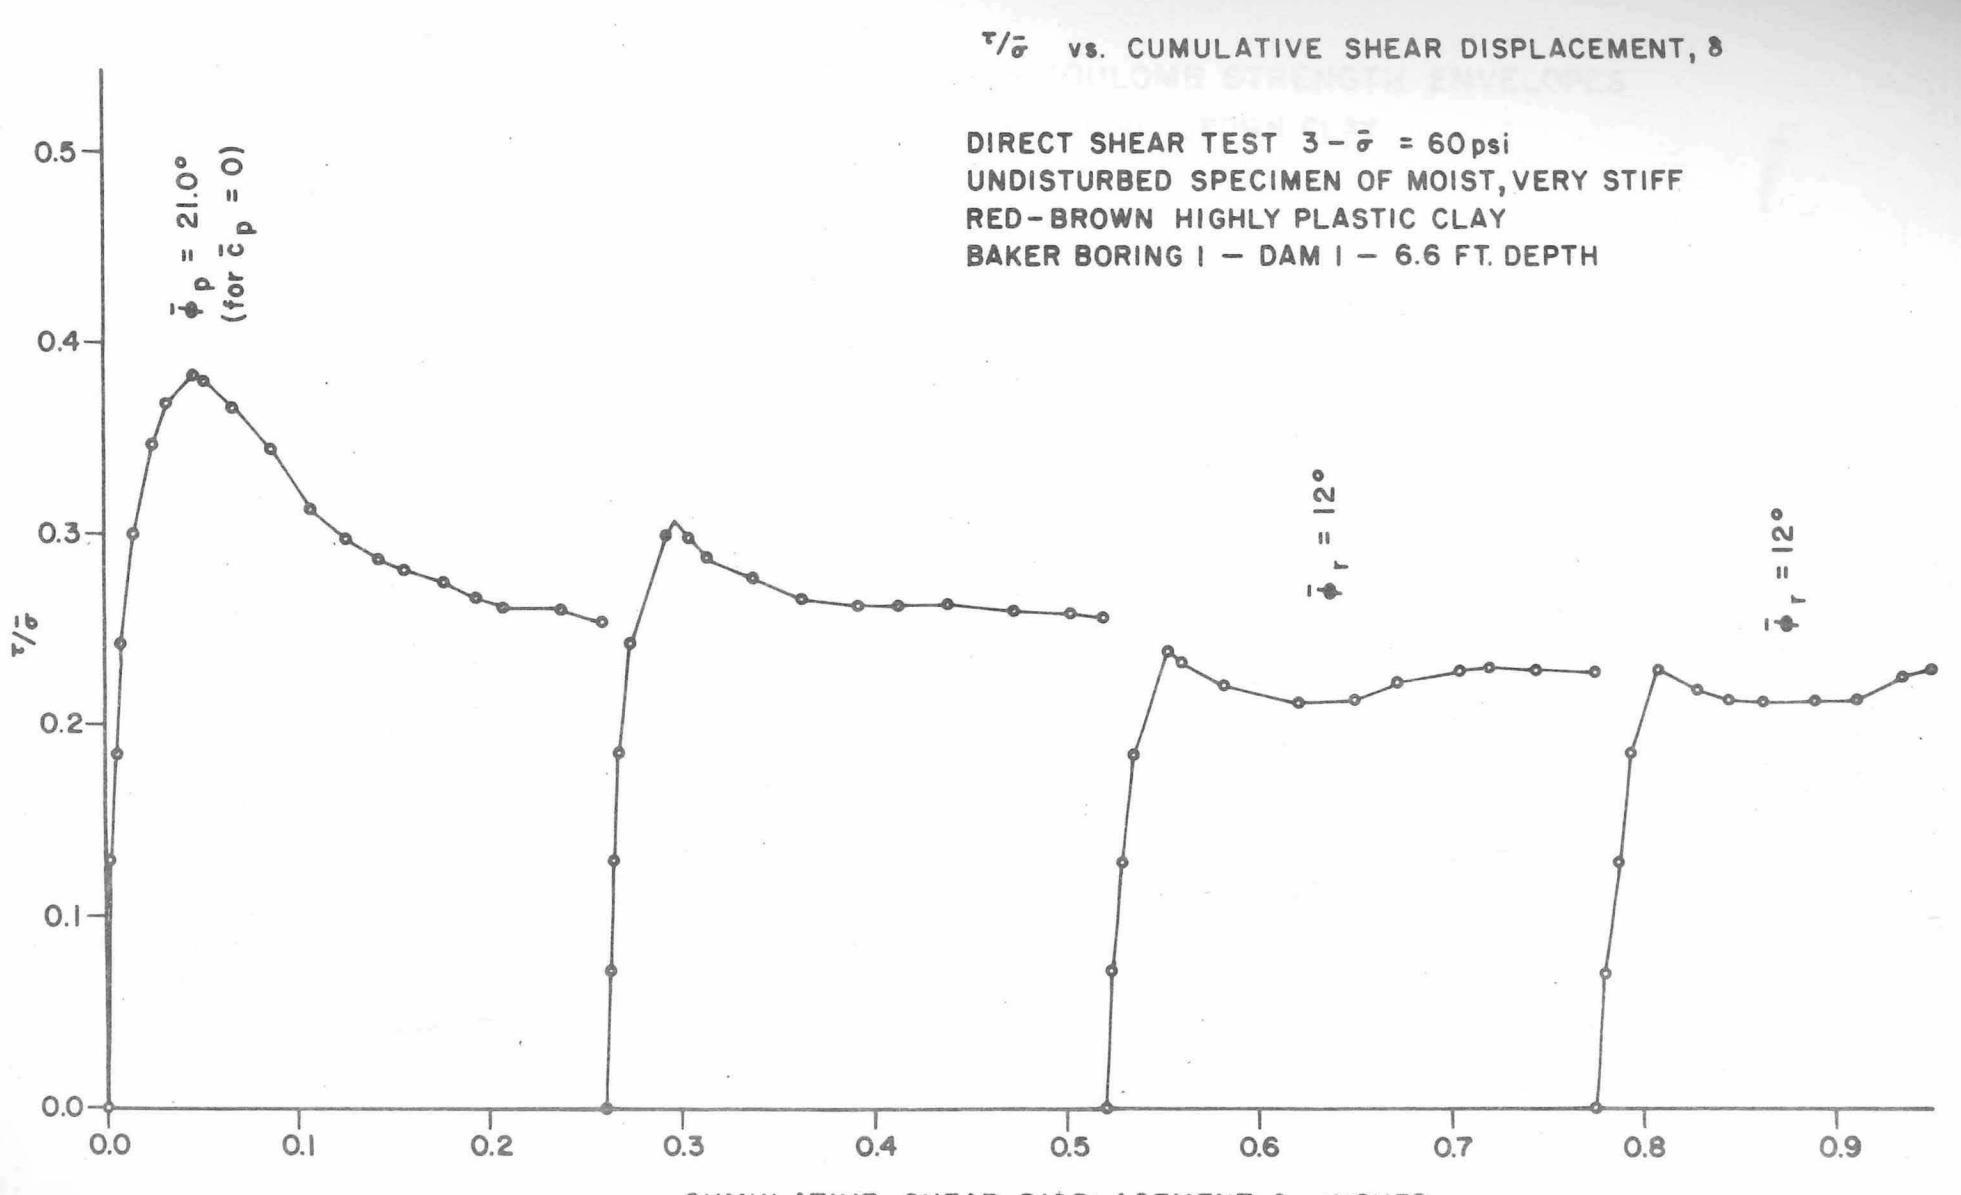
FIGURE D-2

The failure surface of Specimen 3 was inspected and photographed at the end of the test. This failure surface was highly slickensided with undulations of 1/8 inch maximum amplitude. There was a paste of remolded clay around the specimen edges in the gap between the shear box halves and there appeared to have been some interference of shear box edges in the failure surface. (This interference probably occurred during shear box reversal at the end of each shearing.) Specimen breakdown and extrusion between the shear box halves during the test was noticeable. All of these things taken together suggest that a true residual strength probably was not reached in this test. The peak strength from this test is considered reliable but not quite as reliable as that from the first test.

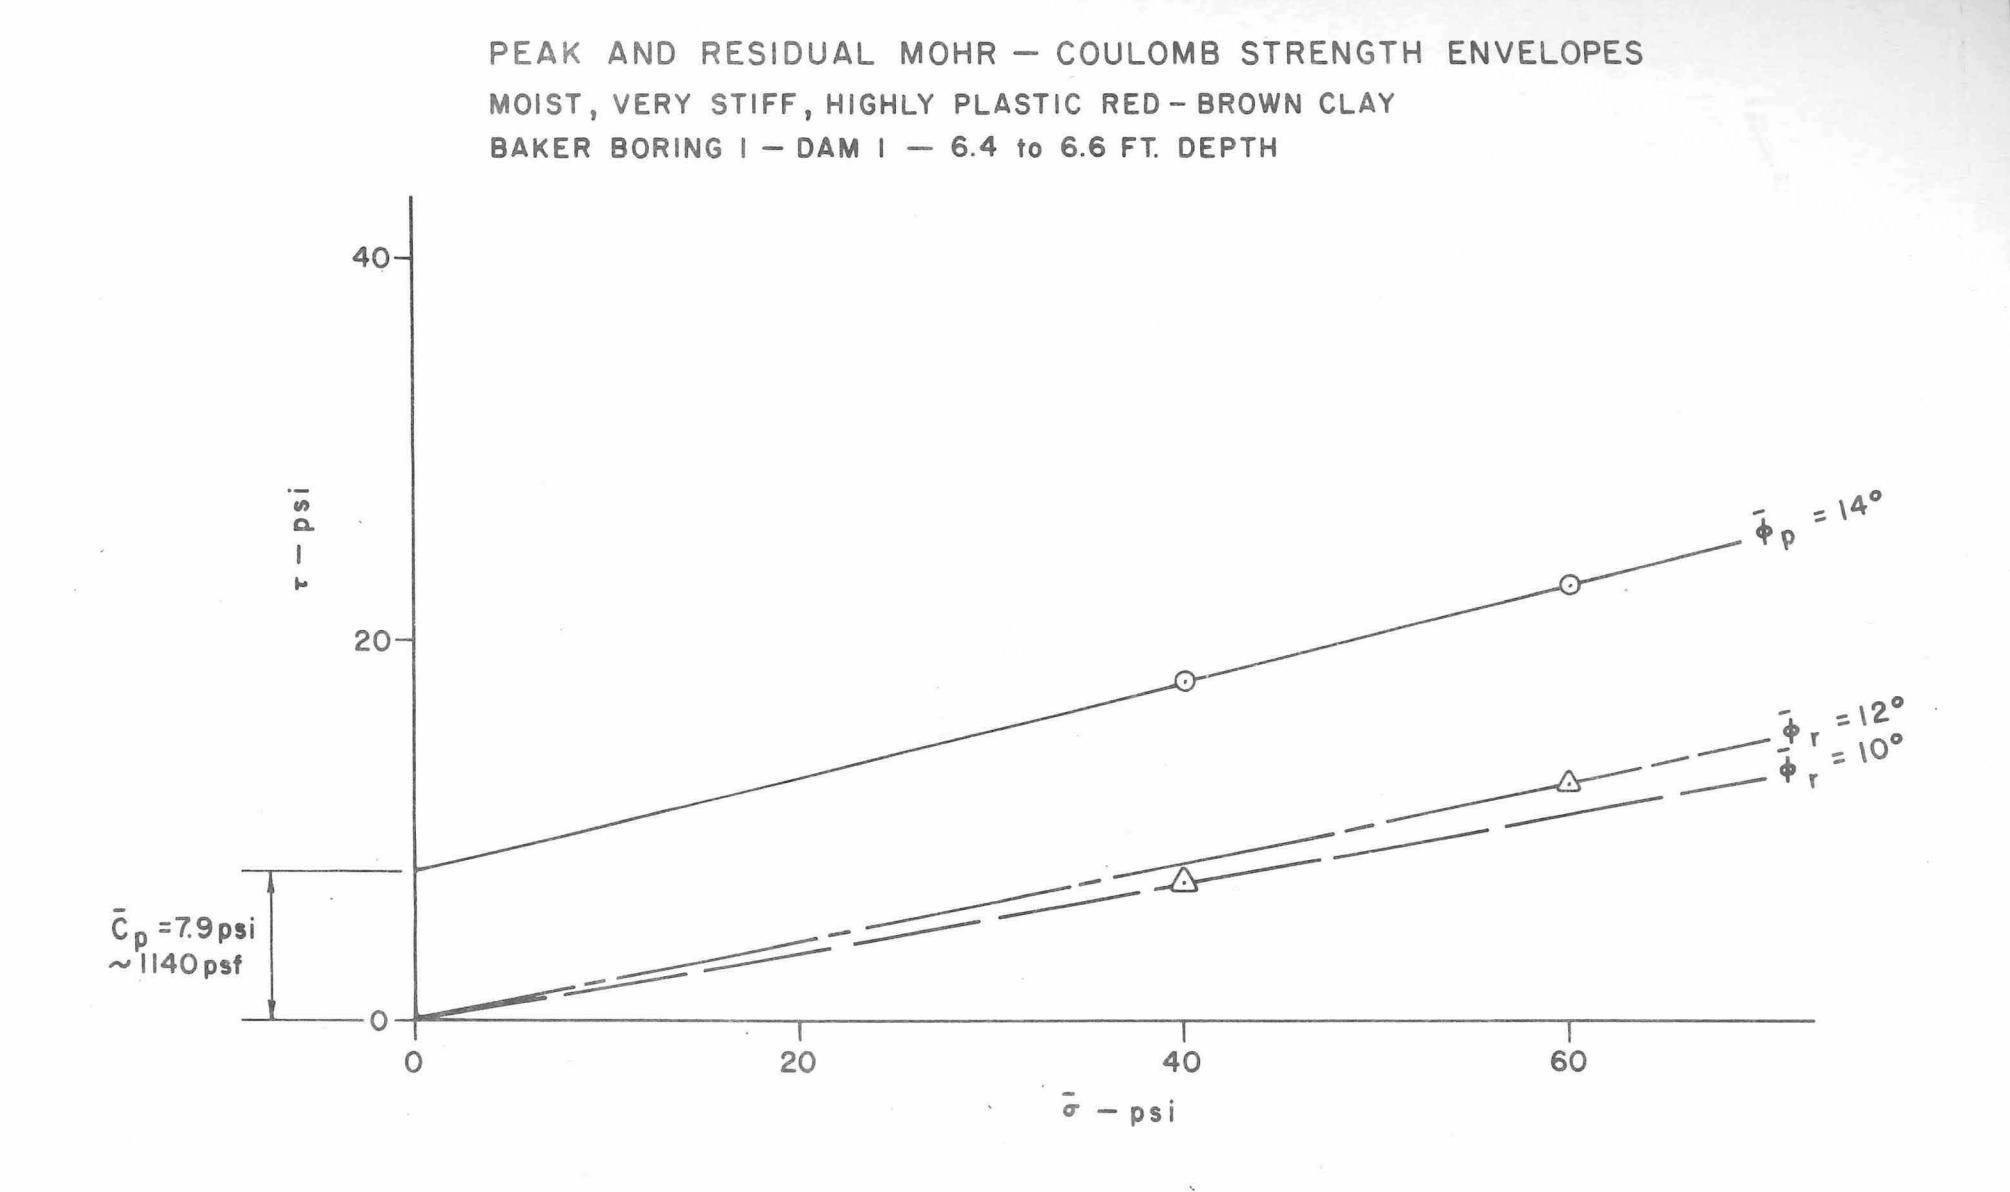
FIGURE D-3

Peak and residual strength data and Mohr-Coulomb failure envelopes from Tests 1 and 3 are plotted in Figure D-3. The peak strength envelope has  $\overline{c} = 7.9 \text{ psi} = 1140 \text{ psf}$  and  $\overline{\phi} = 14^{\circ}$ . The residual friction angle from Test 1 is 10° and that from Tests 3 is 12°. For the reasons mentioned above, Test 3 probably did not reach a true residual strength. We therefore consider the residual friction angle of the clay tested to be on the order of 10°.
